### **Failure investigation – Burst coolant pipes**

Several polybutylene pipes used to carry coolant to and from engine blocks were rupturing during use. No particular batch was deemed to be at fault, and the supplier had not changed the grade or manufacturer.

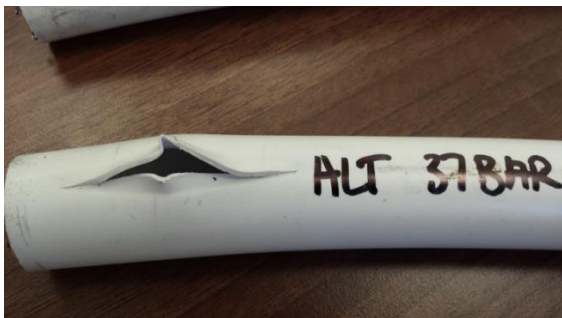
Figure 1: PB Pipe ruptured at PPRC using burst tester to simulate the problem

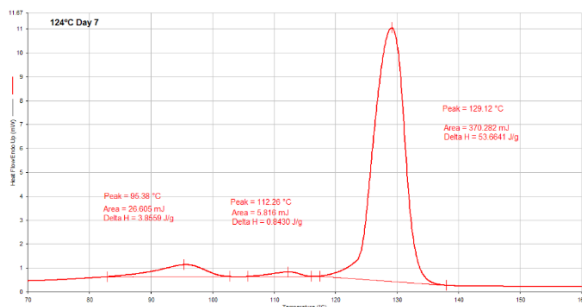
Both the failed and good pipes had their melting characteristics measured using a standard DSC method, and evidence of secondary metastable crystallites were seen in the presented failed pipe at a melting temperature of 95°C.

Heating of the samples to termination temperatures less than 114°C had no detrimental effect on the overall crystallization of the pipe and no secondary metastable crystallites were formed. However, above this temperature secondary metastable crystallites of varying sizes were seen at every termination temperature with increasing amounts. These crystallites were small and imperfect causing mechanical vulnerability within the pipe and would result in both; an increased amount of PB material phase transitioning from the solid to the liquid state, and a lower overall melting point. The secondary metastable crystallites formed at the 124°C termination can be seen in Figure 2.

Figure 2: Melting characteristics of pipe with recreated failure

Since the lowest melt crystal at 95°C was seen in the burst pipes, it was determined that this section of/or entire pipe had experienced coolant temperatures within the range of 116 - 124°C, which was well in excess of the

The serious implications on the structural performance of the pipe would result in bursting under the internal coolant pressure. The customer installed temperature sensors within the coolant pipes, which alerted the operator when excesses of 90°C was seen and the engine removed from service to cool down.
