Monitoring Report No. 63

Redhall Ballycarry Co. Antrim

AE/06/122

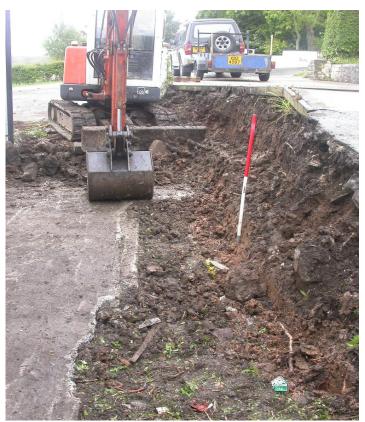
Plate 1: View of site from north after clearance and prior to excavation of foundation trench.

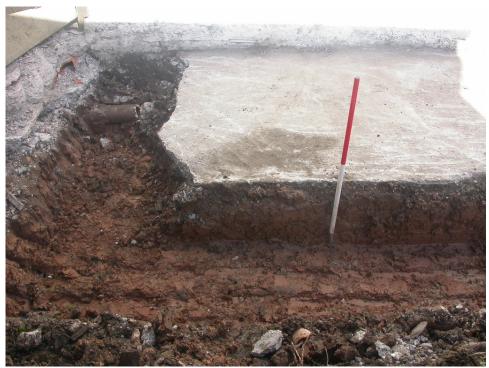
Plate 2: View of site from west after excavation of foundation trench.

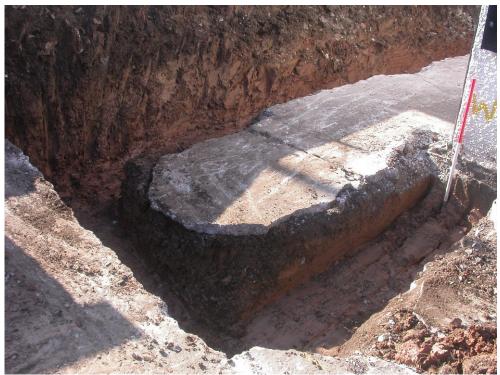
Plate 3: View of excavated foundation trench from south-east.

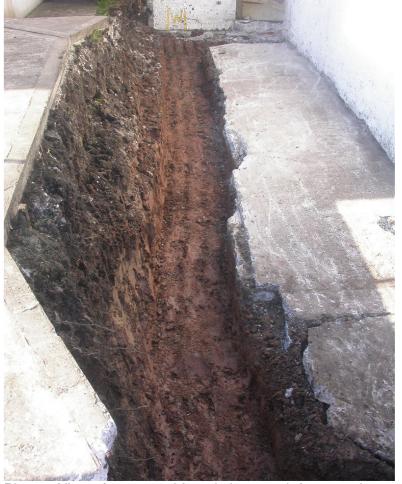
Plate 4: View of excavated foundation trench from south.

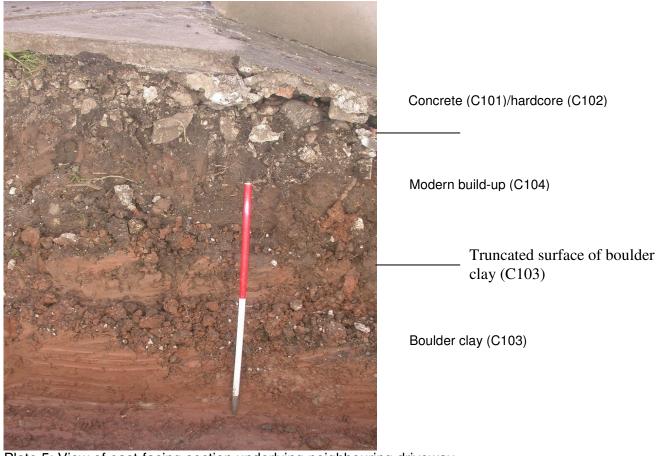
The existing building and the neighbouring properties are located on an east-facing slope, with the extension to be built on the western side and slightly upslope of the existing building. The driveway of the neighbouring building to the west was located approximately 1.25m above the level of the concrete base on the extension site. The retaining wall between these properties was removed during the clearance. The material underlying the neighbouring driveway was modern build up (C104) and overlay the red boulder clay subsoil (C103) (Plate 5).

Plate 5: View of east-facing section underlying neighbouring driveway.
