Monitoring Report No. 162

Monitoring of the consolidation of Harryville Motte (ANT 037:022)

Ballymena
County Antrim

LICENCE NO.: AE/08/120

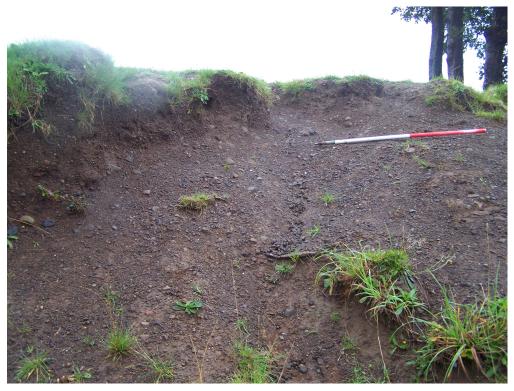
Substantial erosion to the summit of the motte has occurred, primarily due to the use of the monument as a recreation area for a local housing estate. Spoil had been removed from the top of the motte and used to construct several causeways across the ditch at the base of the monument. These were used to provide access to quad bikes and off road motorcycles which further damaged and eroded the side of the motte.

Plate 1: Erosion scars at the top of the motte, looking east.

The spoil removed from the causeways was then moved to the top of the motte by means of a crane. A retaining fence was constructed to produce the desired shape of the top of the motte. The excavation of the support posts for this fence was also monitored, as they had to be dug into the side of the motte itself. Each support hole (12 in total) was excavated to a depth of approximately 0.3m. Nothing of archaeological significance was observed in either the excavation of the causeways of the excavation of the support uprights for the retaining fence.

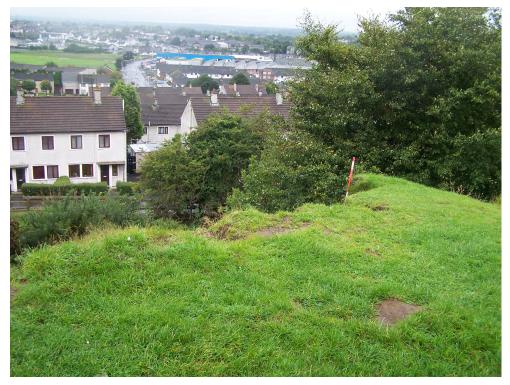
Plate 2: Erosion scar at the top of the motte, looking west

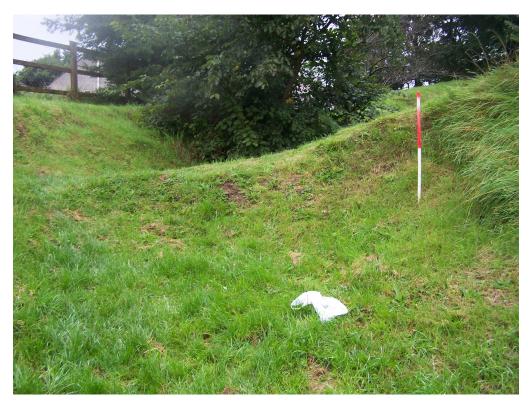
Plate 3: Modern Causeway across the ditch at the base of the motte, looking east.

The causeways were mechanically removed under archaeological supervision to ensure that archaeologically sensitive deposits in the ditch were not disturbed. Numerous sherds of modern glass bottle, beer cans and metal debris, along with burnt planks were observed during the removal of the causeways, perhaps testamount to the continued use of the monument as a recreation area. These causeways, on average were 0.8m in depth and approximately 2.5-3m in width, and spanned the width of the ditch (upwards of 3m wide). Nothing of archaeological significance was observed during the monitoring exercise.

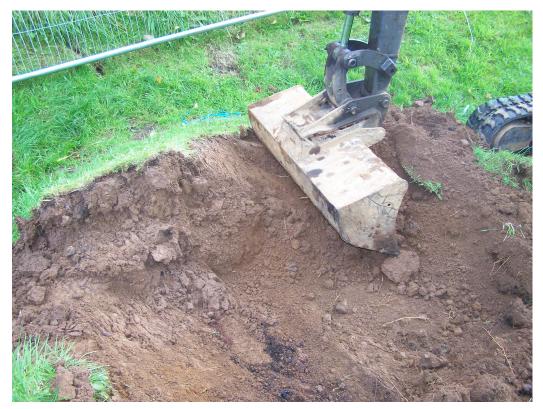
Plate 4: Excavation of the causeways by mechanical digger.

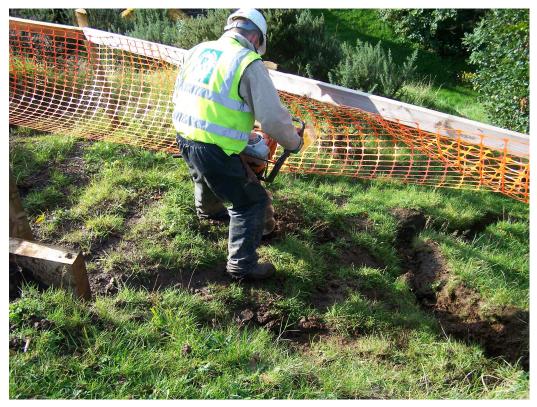
Plate 5: Excavation of the holes for the support uprights of the retaining fence, looking west.

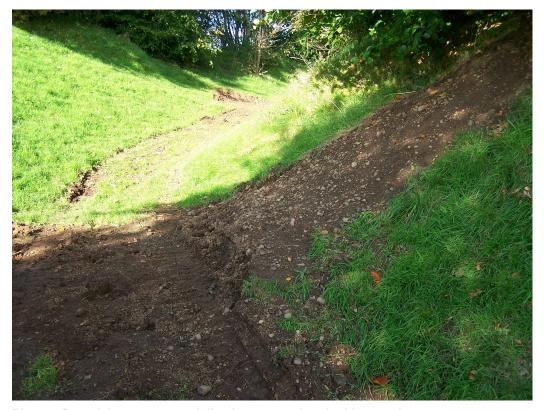
Plate 6: One of the causeways following excavation, looking north-east.

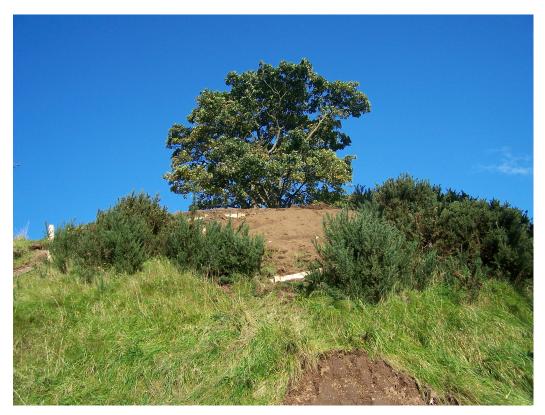
Plate 7: view of the top of the motte following the consolidation works. Geo-textile was then spread over the fresh earth and grass seed planted, looking north-east.
