Evaluation Report No. 234

Glynn Old Church
Glynn townland
Glynn
County Antrim

AE/11/111

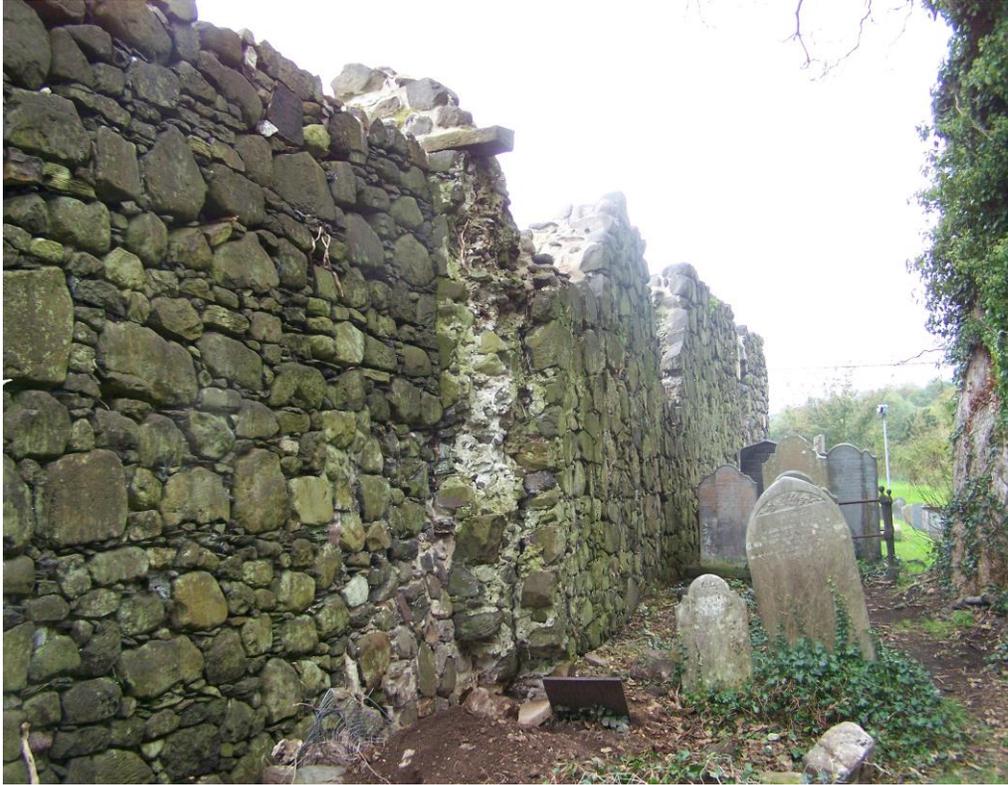
Stonework missing from the exterior junction of the chancel and nave was to be replaced. Some of this part of the wall had had stones replaced by the DOE in the recent past, this is evident by/in the different coloured mortar in this part of the wall (eg Plates 2 and 4).

Plate 2: Exterior north walls of chancel and nave, showing corner where the two meet; looking south-west. Areas of lighter mortar show where work was done by the DOE in recent years.

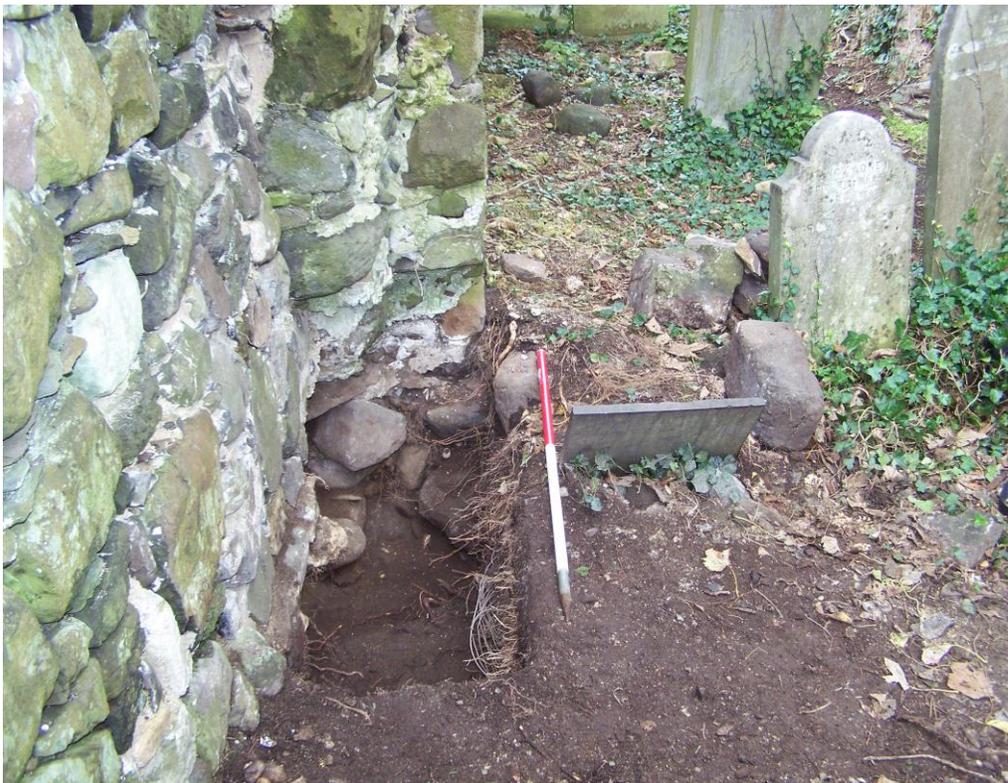
An area 1.00m (along wall) by 0.50m (out from wall) was opened. Only one context was excavated, a graveyard soil of dark brown loam, which contained some bone. Stones became loose and fell from the wall below ground level as soil from round them was removed. During the second day of excavation Andrew Gault requested that work be discontinued due to health and safety concerns and concerns about the undermining of the walls. An average depth of 0.60m had been reached in the test pit.

Plate 3: Test Pit 1, fully excavated; looking west. (scale 1m)

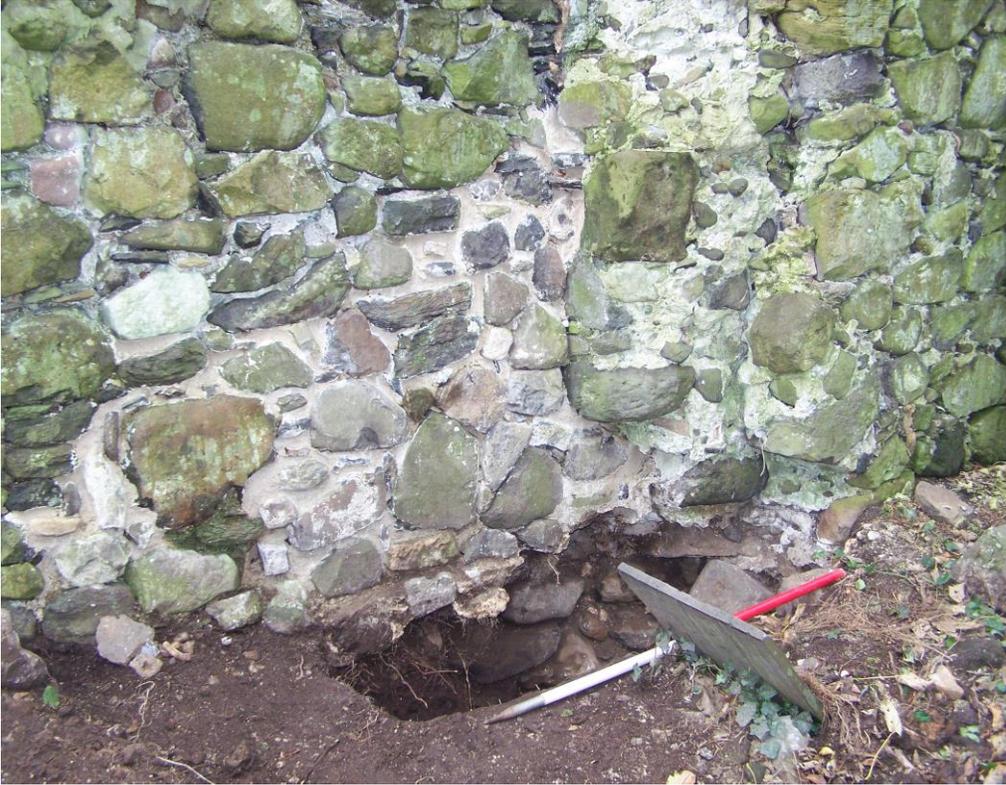
Plate 4: Corner of chancel and nave, and Test Pit 1; recent work on the wall is indicated by the lighter mortar; looking south-west. (scale 1m)

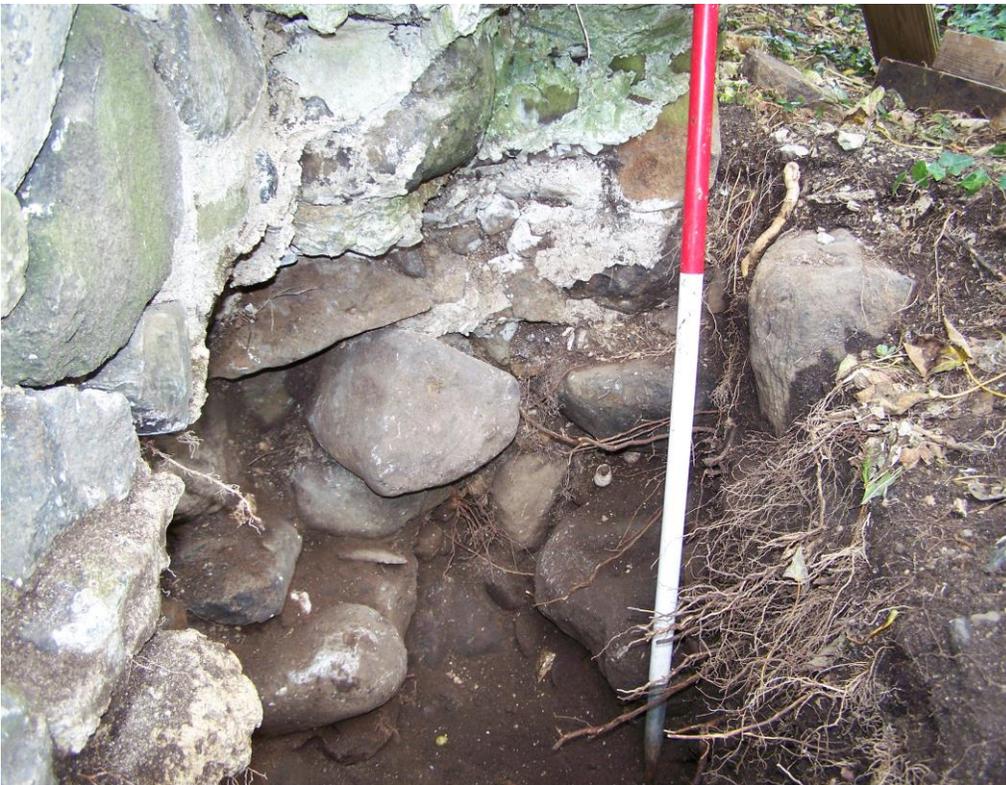
Plate 5: Stones of exterior corner of nave exposed below surface level, and lowest level of recent mortar, in Test Pit 1; looking west. (scale 1m)

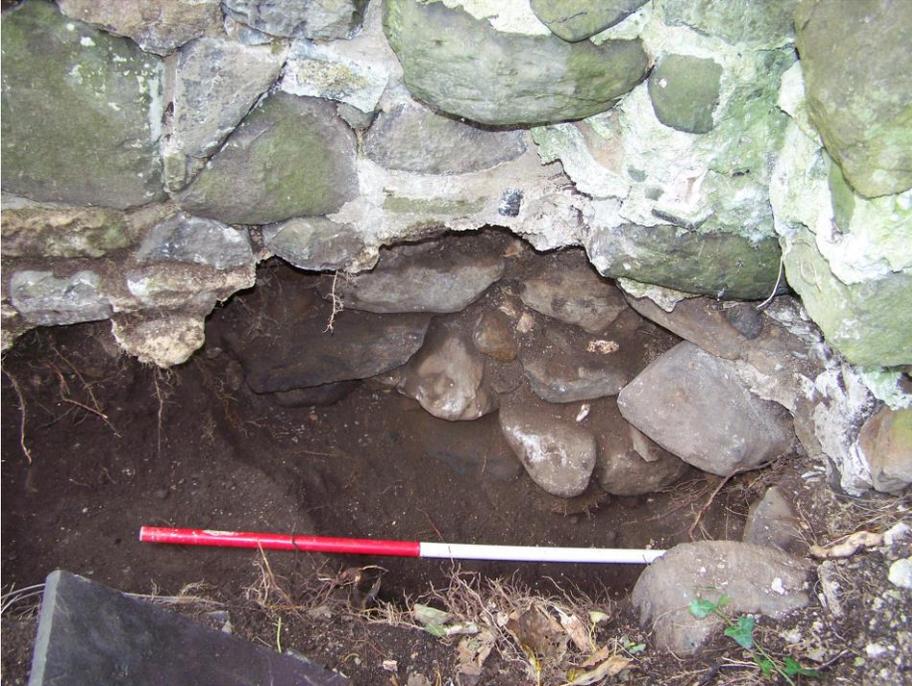
Plate 6: Stones below surface level exposed in Test Pit 1 in wall of chancel, and lowest level of recent mortar; looking south. (scale 1m)

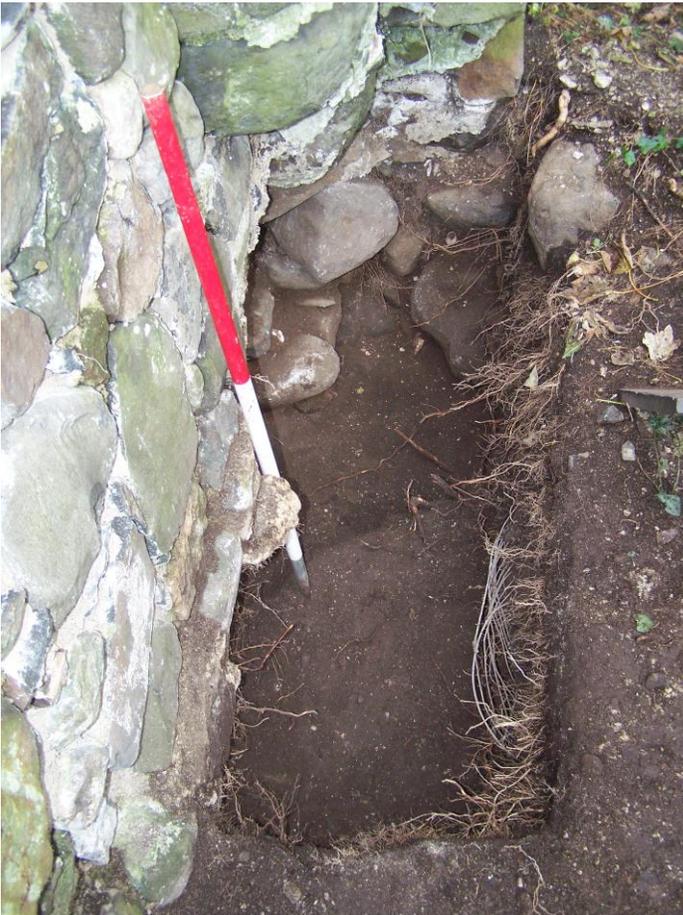
Plate 7: Test Pit 1 fully excavated; looking west. (scale 1m)

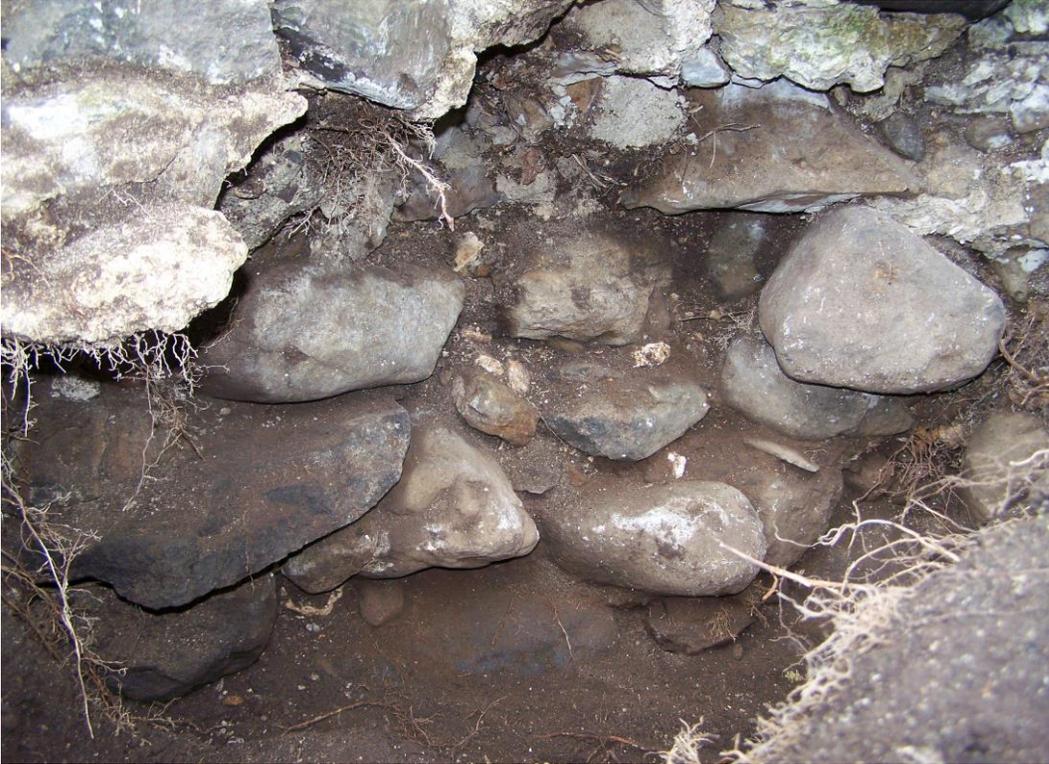
Plate 8: Stones exposed below ground level in Test Pit 1, at corner of chancel and nave; looking south-west.

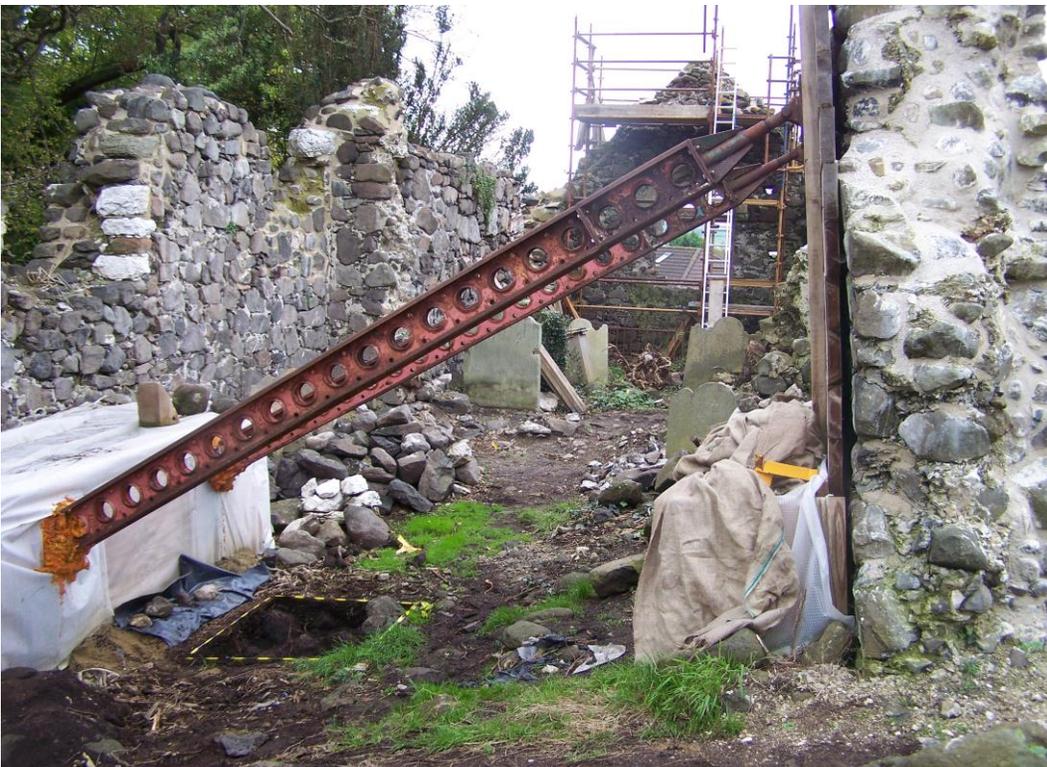
Test Pit 2 was located in the interior of the nave, it measured 1.00m by 1.00m and was an average depth of 0.15m to 0.20m. A structural engineer's report stated that the prop pad would have to be set 0.15m into the ground and would have dimensions of 0.90m square. This test pit was required to hold a prop pad, the prop would lean against the interior of the longest south wall of the nave to help support it. Removed from this test pit was soil that had built up inside the church containing some bone (30 pieces, probably human), stone and modern waste (plastic). No articulated human remains were encountered.

Plate 11: Interior of church looking north-east from south-west end of nave, with Test Pit 2 post-excitation in left foreground and wall to be propped in right foreground.
