Monitoring Report No. 183

**Nendrum,
Mahee Island,
Co. Down.**

AE/09/157

Type of monitoring: Monitoring of mechanical excavation of trench for drainage pipe at Nendrum car park.

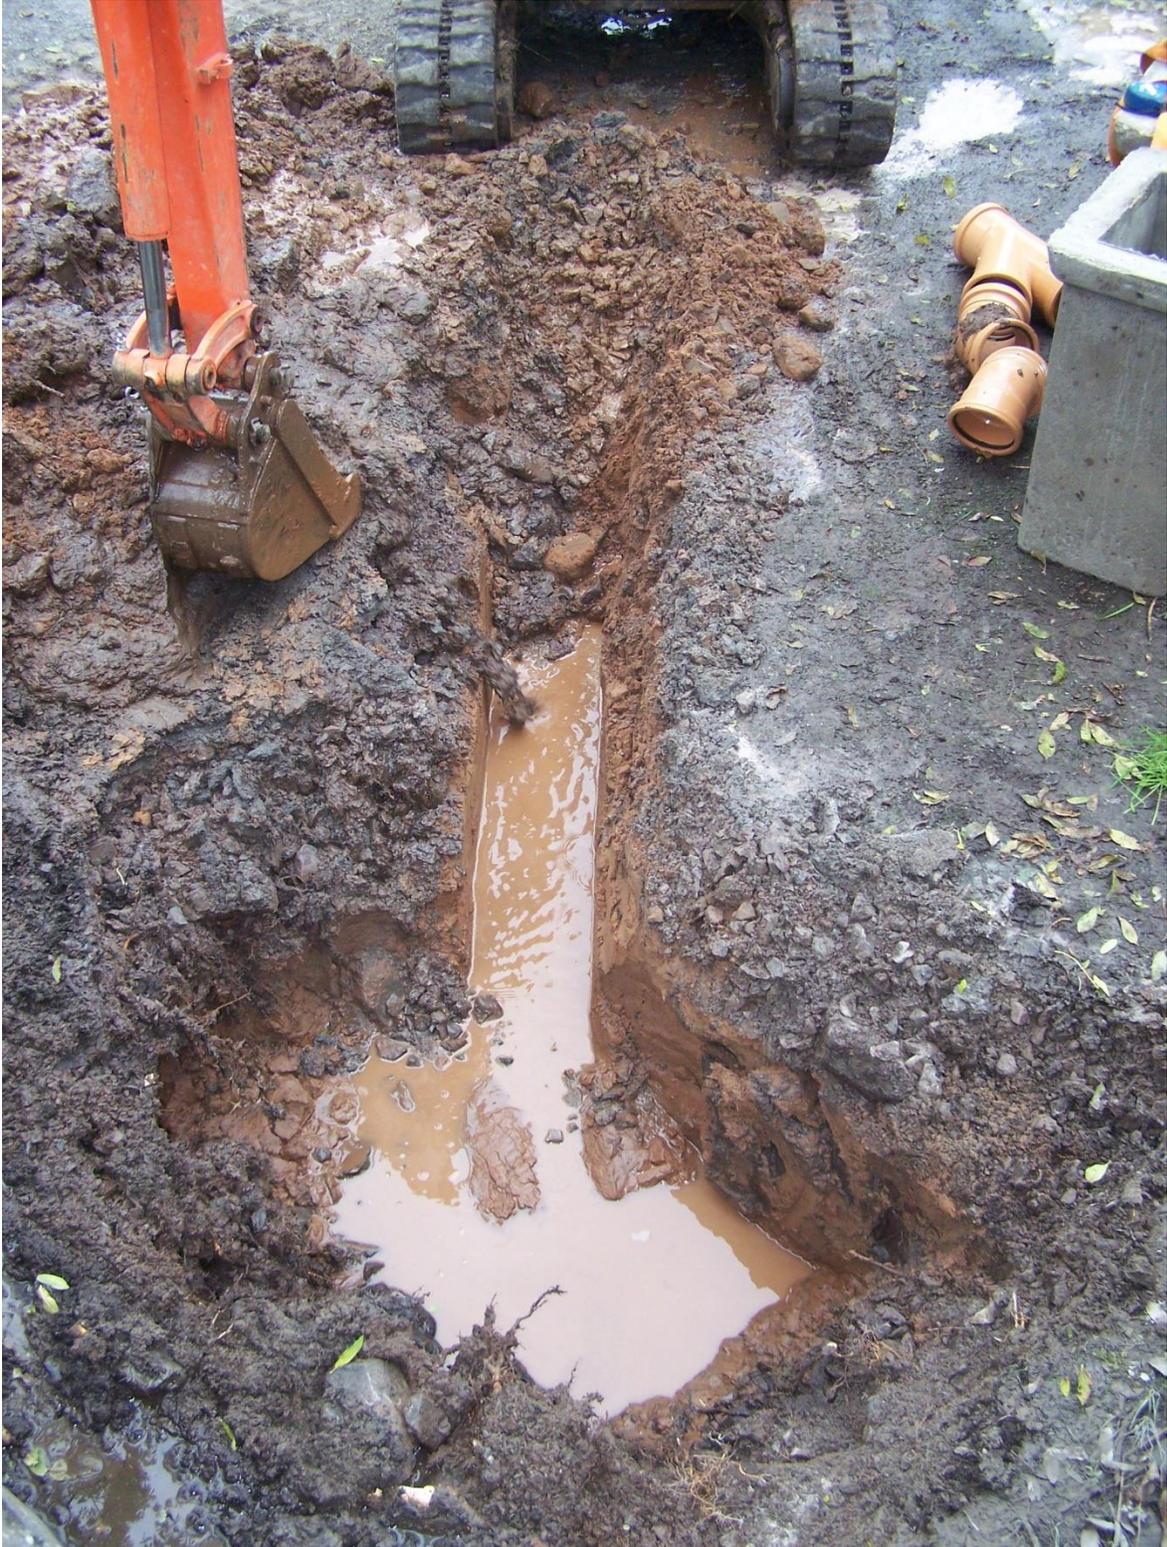
No archaeological features or artifacts were uncovered during the excavation. For the first 6m of the excavated trench orange clay subsoil was encountered immediately beneath the tarmac (Photo 1 and 2)however between 7 and 8m from the southwest of the trench the level of the subsoil began to fall off, possibly indicating the approximate position of the shore before the construction of the modern road. During the construction of the road the ground, from this point onwards, seems to have been levelled up by large quantities of stone (Photo 3). There was a dark humic material around these stones resulting from organic matter, possibly sea weed, being incorporated between them as the area was being in-filled. For the rest of the length of the trench the excavation did not penetrate to subsoil but simply dug into this stony fill material (Photo 4). There was no suggestion that this stony material was in any way archaeological.

Photo 1: Excavation trench showing cut for grating and drainage gully showing orange brown clay subsoil beneath tarmac and gravel road surface

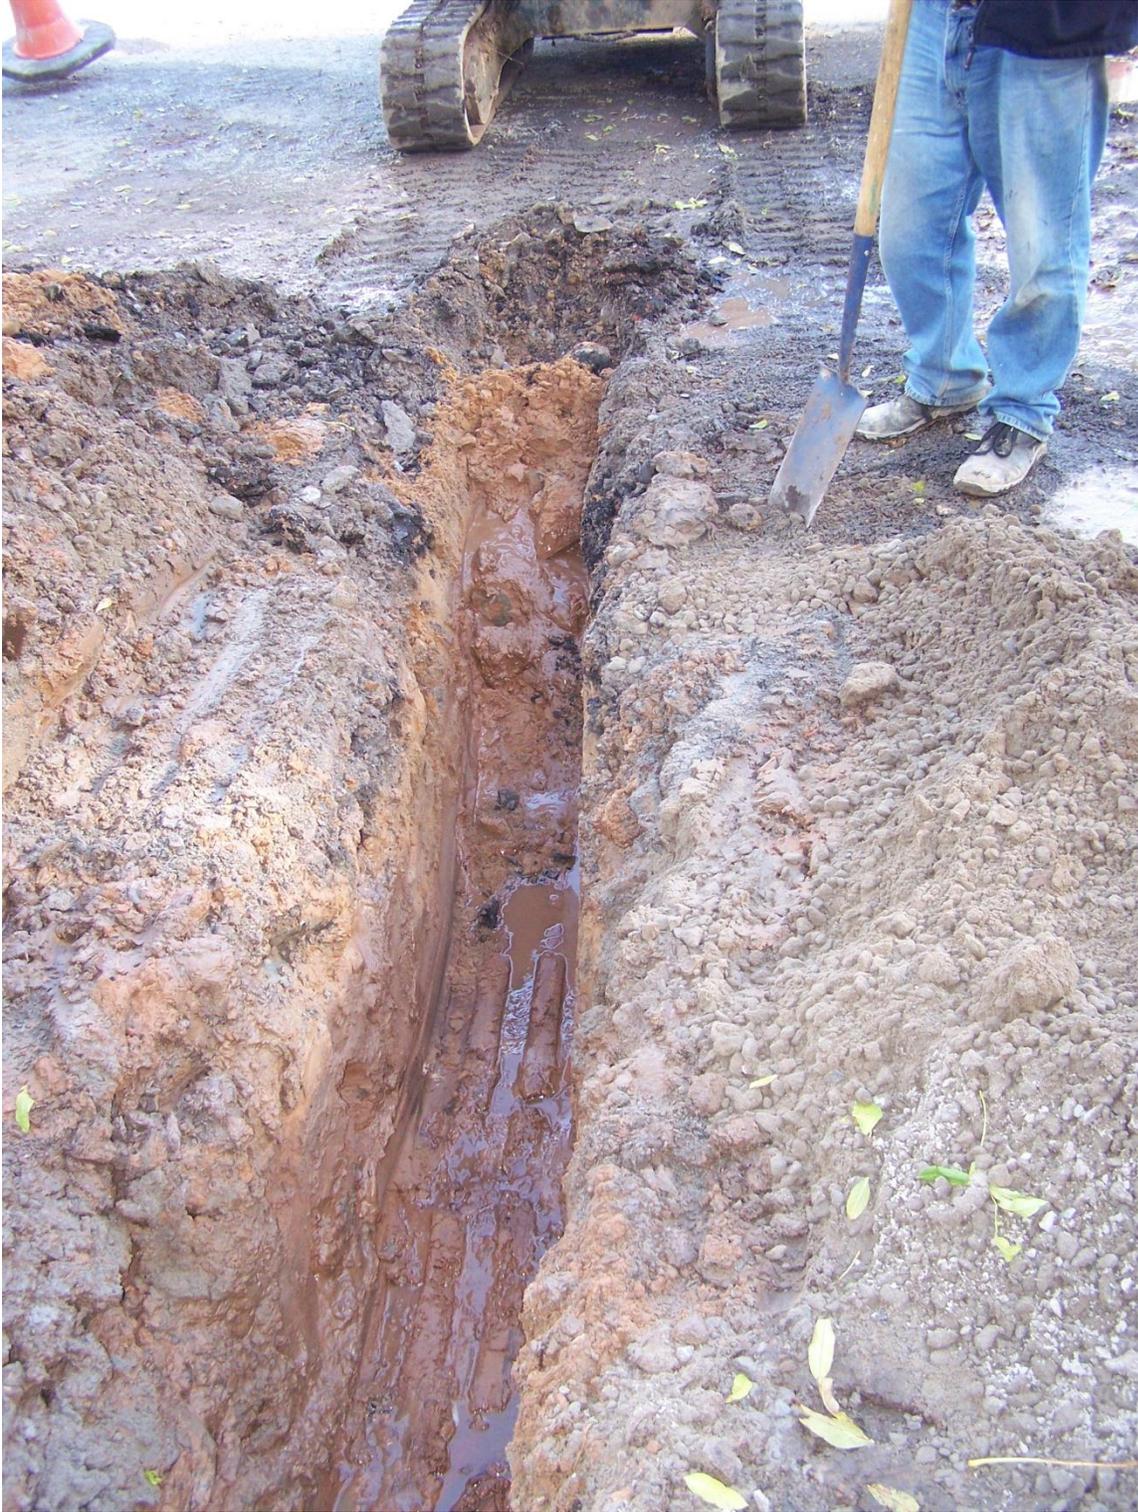
Photo 2: Continuation of cut for drain

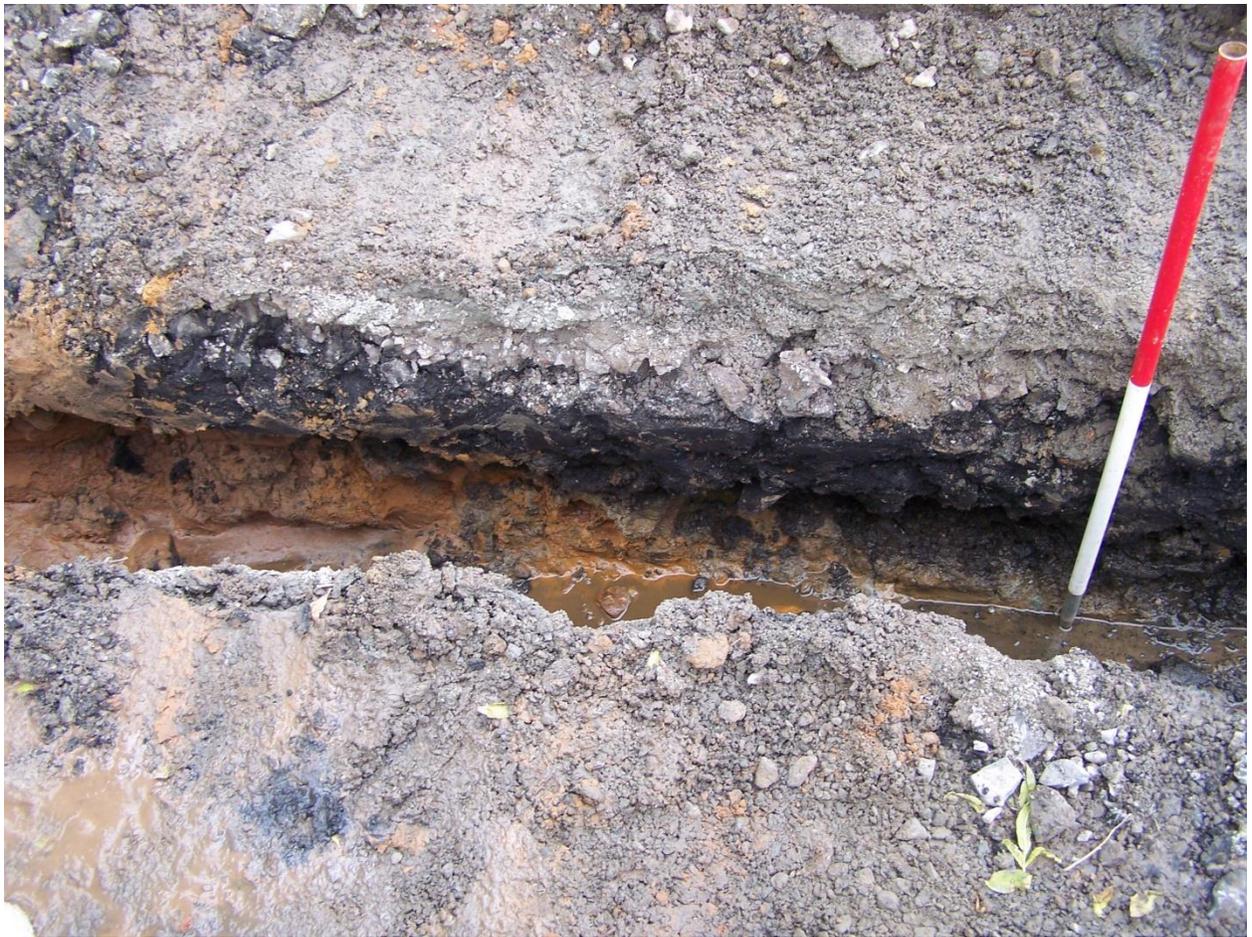
Photo 3: Interface between subsoil and stone and humic fill, approximately 8 m from southwest end of trench

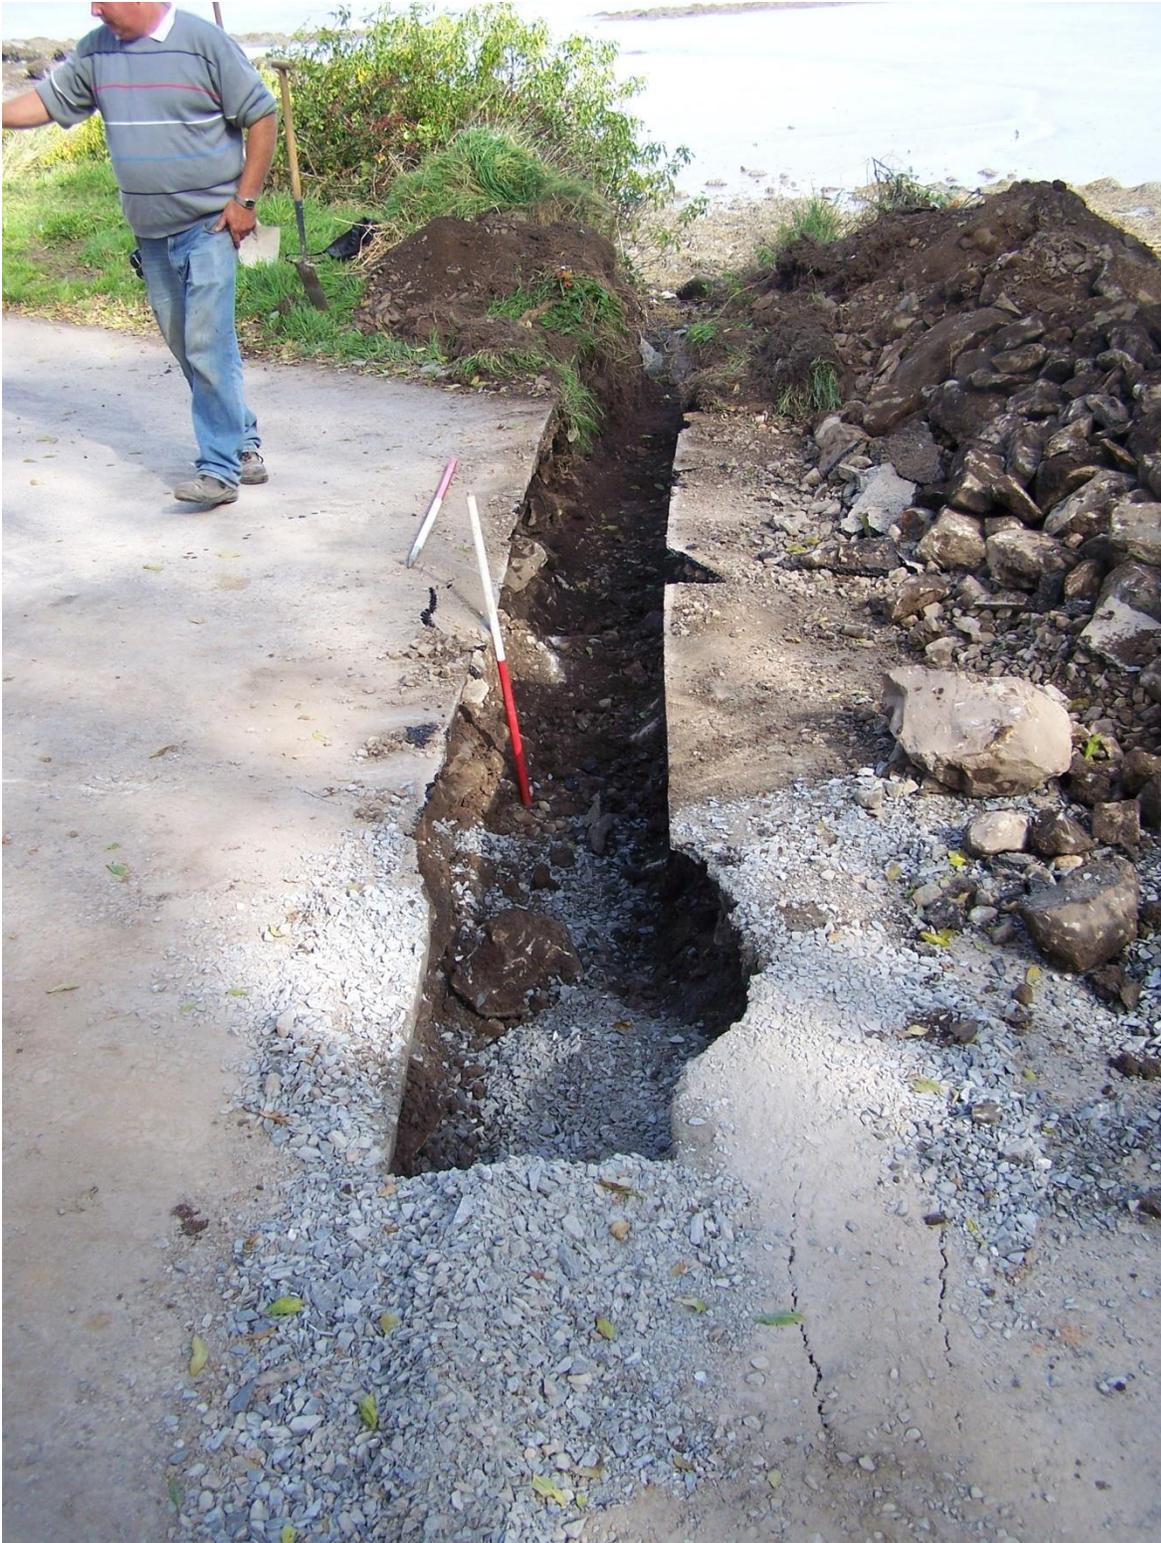
Photo 4: Final section of cut for drain extending to shoreline
