Evaluation/Monitoring Report No. 186

Castle Curlews
County Tyrone

LICENCE NO.: AE/07/195

Excavation at Castle Curlews, Co. Tyrone

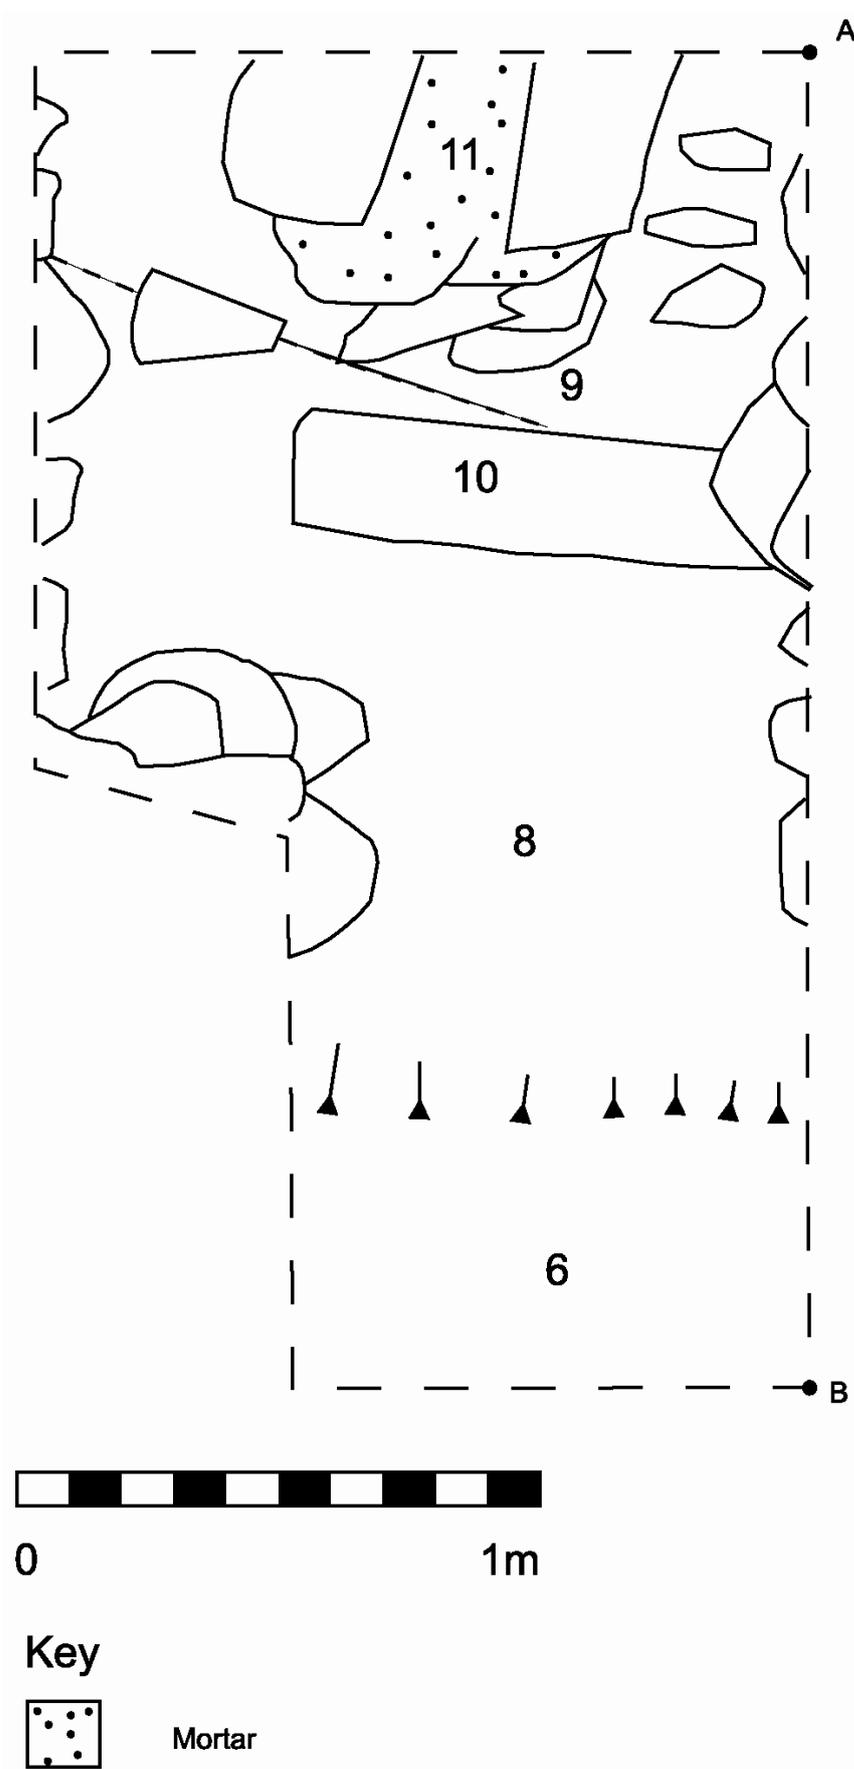
Figure 3: Plan of excavated trench

A trench 1.5m southeast-northwest by 2.0m northeast-southwest was excavated in the northern corner of the fireplace inserted into the northwest wall of the building. The topsoil (Context 1) was a brown loam, which varied from 5cm to 30cm thick. On the northwest side of the trench there was a lens of mortar rich loam (Context 2) which underlay the topsoil. Both of these layers overlay a layer composed of large rounded and angular stones surrounded by loose gritty loam but with considerable voiding (Context 5). The considerable voids between the stones gave the impression that this layer was the result of quite recent collapse of a substantial portion of the monument. Beneath Context 5 was a layer of stones and mortar (Context 3) which was up to 15cm thick. This layer appears to represent the collapse of an occasional stone from the walls coupled with flecks of collapsed mortar and humic build-up in the interior of the building. Context 3 overlay Context 4 a much firmer layer composed of sandy soil, medium sized rounded stones and quite a lot of creamy mortar which was up to approximately 30cm thick. Like Context 3 this layer appears to have been the result of a gradual build-up of humic material and collapse of small amounts of material from the walls. The absence of stones from the south west end of the excavated area in Context 4 suggests that there were no significant collapses of masonry from the castle walls during the deposition of the strata. Located beneath Context 4 was a layer of loam and mortar (Context 6) which was up to 50cm thick. There were within this layer quite a few ill sorted stones varying in size from boulder with diameters in excess of 40cm to small fist sized stones. These stones were variously rounded to sub angular and evenly spread throughout the layer, in contrast to Contexts 3 and 4 where the stones were concentrated closest to the northeast wall of the castle. This is indicative, as with Context 5, of the collapse of a large chunk of masonry in a single event rather than a gradual accumulation of occasional stones fallen from the nearest castle wall. The lack of voiding within this layer suggests that it is a significantly older layer than the other strata suggestive of a significant collapse event (Context 5). Context 6 sat above a setting of thin flat stones (Context 7) which seemed too slight to be load bearing. They look in some respects like they may have been part of an attempt to roughly re-floor the building interior they did not extend over the whole of the trench but the trench is so small it could just be that the rough re-floor was irregular and patchy, or damaged in places. Context 7 sat above a mid grey to brown loam (Context 8). It for the most part contained few stones and no artefacts, although there were many more stones in the upper parts of Context 8, presumably settling from the much more stony layer (Context 6) immediately above it. Context 8 was at least 50cm thick and was not completely excavated. Context 8 was above the dressed stone (Context 10) which is likely to have been part of the original fireplace jamb and attached to the tusker stones (11) protruding from the castle wall.

The tusker stones (Context 11) appeared to be sitting on the yellow sandy clay subsoil (Context 9). It was less certain whether the dressed stone (Context 10) sat upon subsoil or on

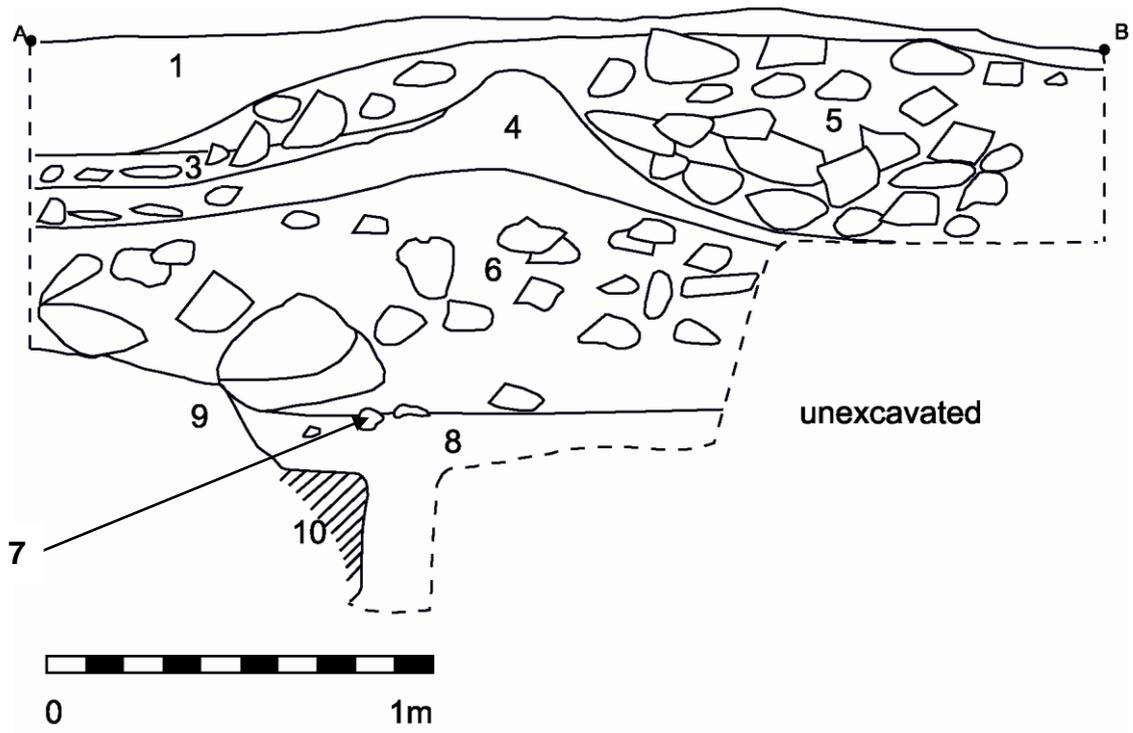
Figure 4: Section of excavated trench

The sequence of build-up of strata revealed by the excavation reveals something of the likely later history of the building. The lowest strata found during the excavation (Context 8) was a loam with no mortar and few stones within it. It is clearly a period when there was humic material building up within the building but perhaps before the building had started to collapse. It is possible that this could represent a period after the use of the building as a house, but while it was still roofed, when it is likely to have been used for agricultural purposes, such as animal shelter. There is some evidence for a deposit of thin flat stones (Context 7), fairly carefully laid on to the surface of Context 8. These stones may have been the result of an attempt to re-floor the interior of the castle. However this is not an indication of an attempt to in any way restore the house to its former condition, the floor was rather an attempt to tidy up a mucky deep loam deposit and make it a cleaner surface to work upon or store equipment or animals. The significance of this deposit is that if Context 7 is part of a floor of a bier or the like it strongly suggests that it was laid while the roof was still on the building implying that the house survived the 1641 rebellion relatively intact. This raises the possibility of later seventeenth century, or even eighteenth century, occupation at the site before it's utilisation as an agricultural building.

The strata (Context 6) located immediately above (Context 7) is rich in mortar and has within it many large stones. It is much more clearly a collapse / destruction layer. The absence of any dressed stones from this layer, and the an absence of the dressed stones from the fireplace jamb itself, is suggestive of stone having been robbed for the purposes of construction, possibly for use in the adjoining farm which has a number of stone built buildings. It is difficult to accurately date this collapse but the few finds recovered from this trench suggest collapse may have occurred in or before the nineteenth century. Contexts 4 and 3, with more occasional stones and bands of mortar suggest more gradual collapse. Context 5 however is different with lots of large stones, with significant voids between them and is suggestive of another episode of significant collapse, although this time a much more

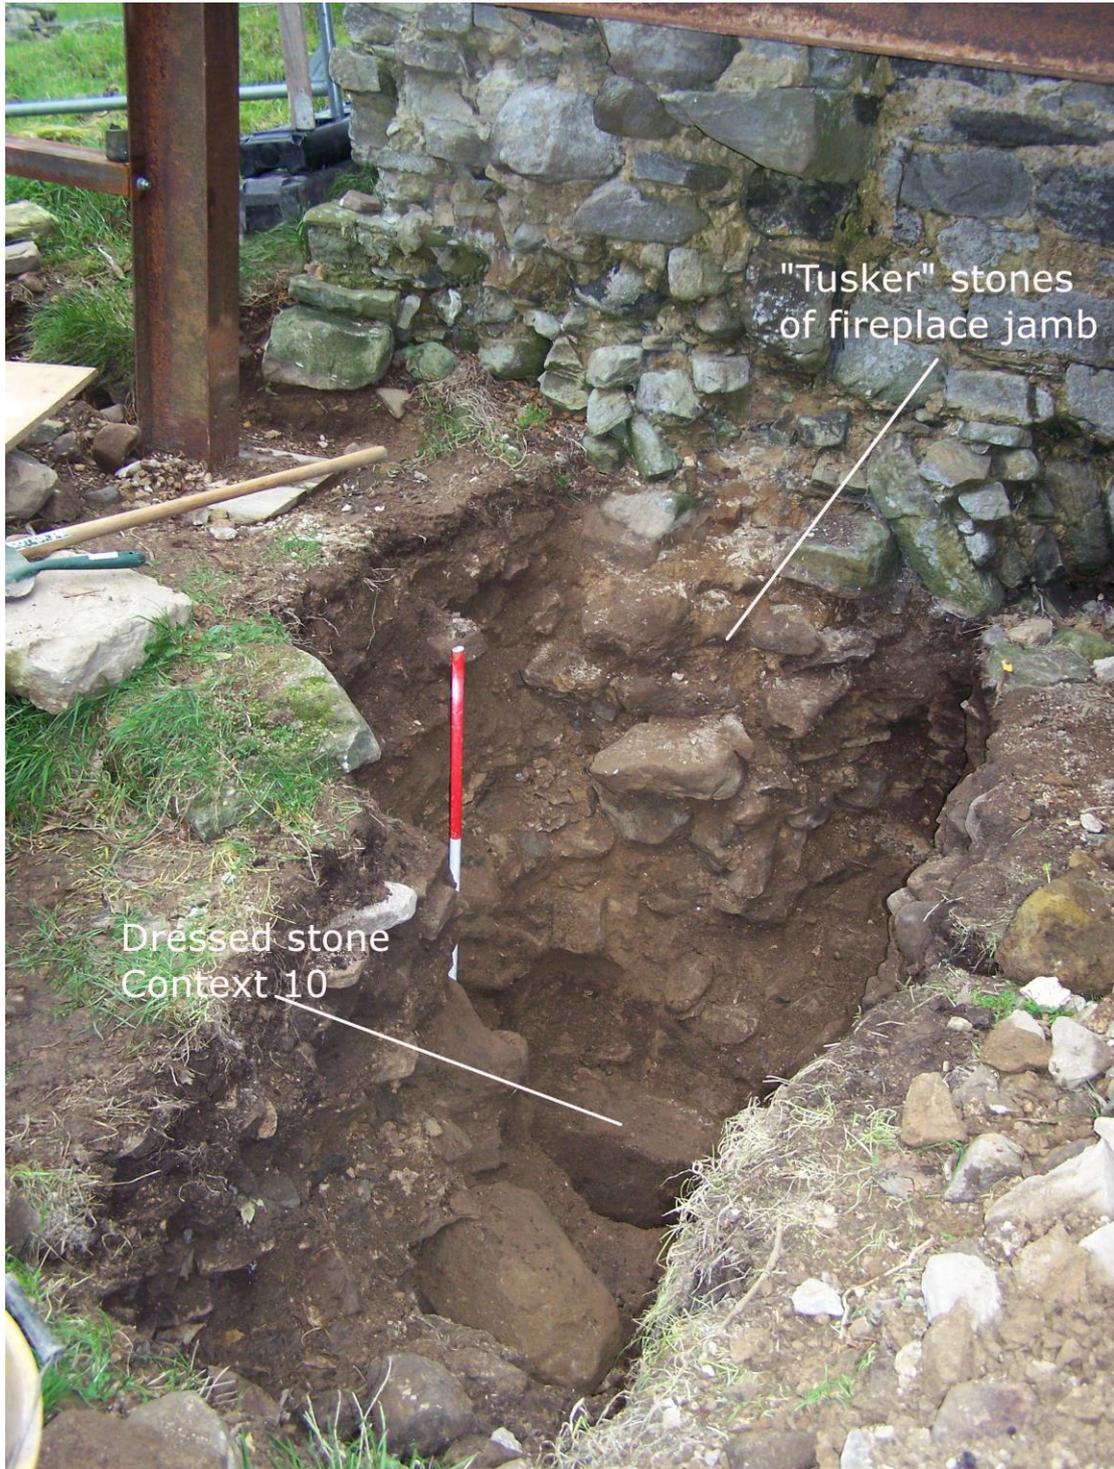
Photo 1: excavated Trench at Castle Curlews showing dressed stone Context 10 and Tusker stones which would originally have joined fireplace to wall

The dressed stone (Context 10) appears likely to have been part of the fireplace jamb. Although it was impossible to fully excavate around this stone because of the health and safety considerations mentioned above it seems to be well set.

The excavation at Castle Curlews succeeded in its primary objective of finding stonework suitable for basing the fireplace jamb reconstruction. It unfortunately failed to locate, because of the difficulties of safely excavating a small, deep trench in a historic building, original occupation strata. However the excavation was able to shed light on the post-abandonment history of the castle, tentatively suggesting a period of pre-collapse use for a non domestic, possibly agricultural, purpose. This was followed by a phase of significant collapse, with a subsequent period of gradual decay, before a second period of significant, and possibly quite recent, collapse. The absence of jamb stones from the fireplace and the lack of dressed stones from these collapse layers suggests that stone was taken from these layers for use in buildings elsewhere raising the possibility that parts of the castle may have been deliberately demolished for its stone.

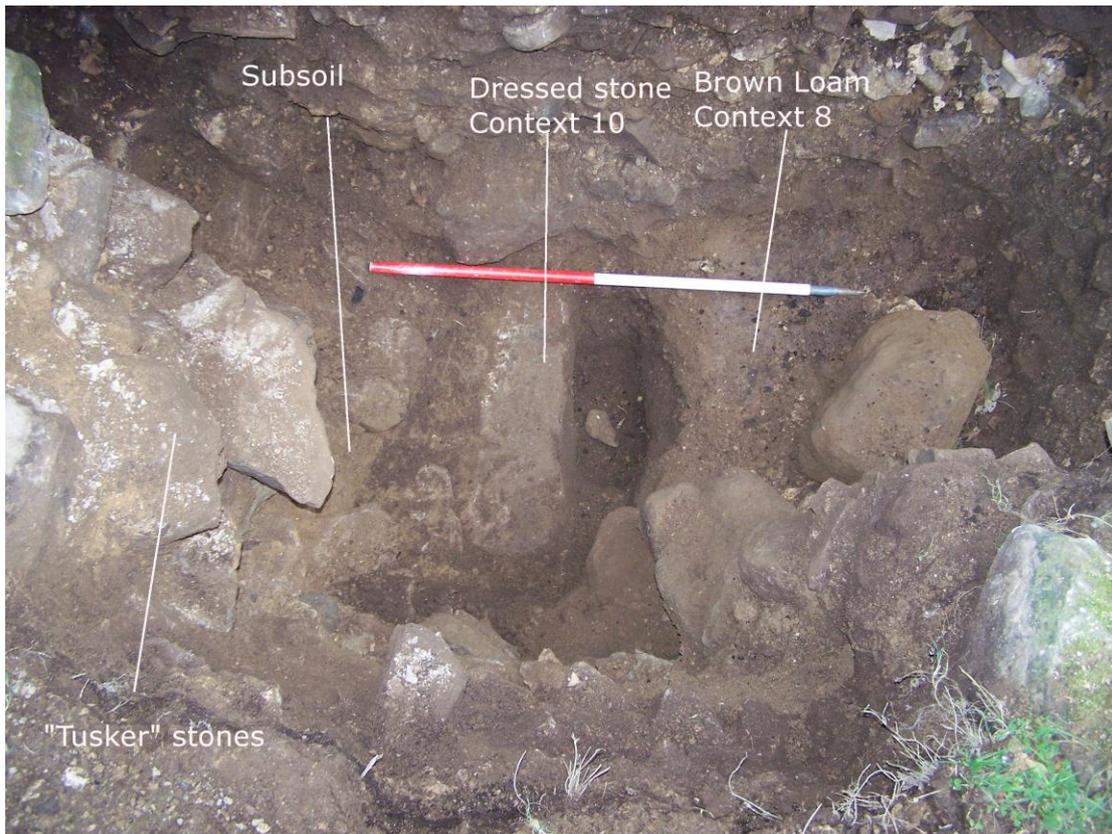
Photo 2: Photo showing dressed stone Context and stratigraphically later loam Context 8. Tusker stones and subsoil are also visible

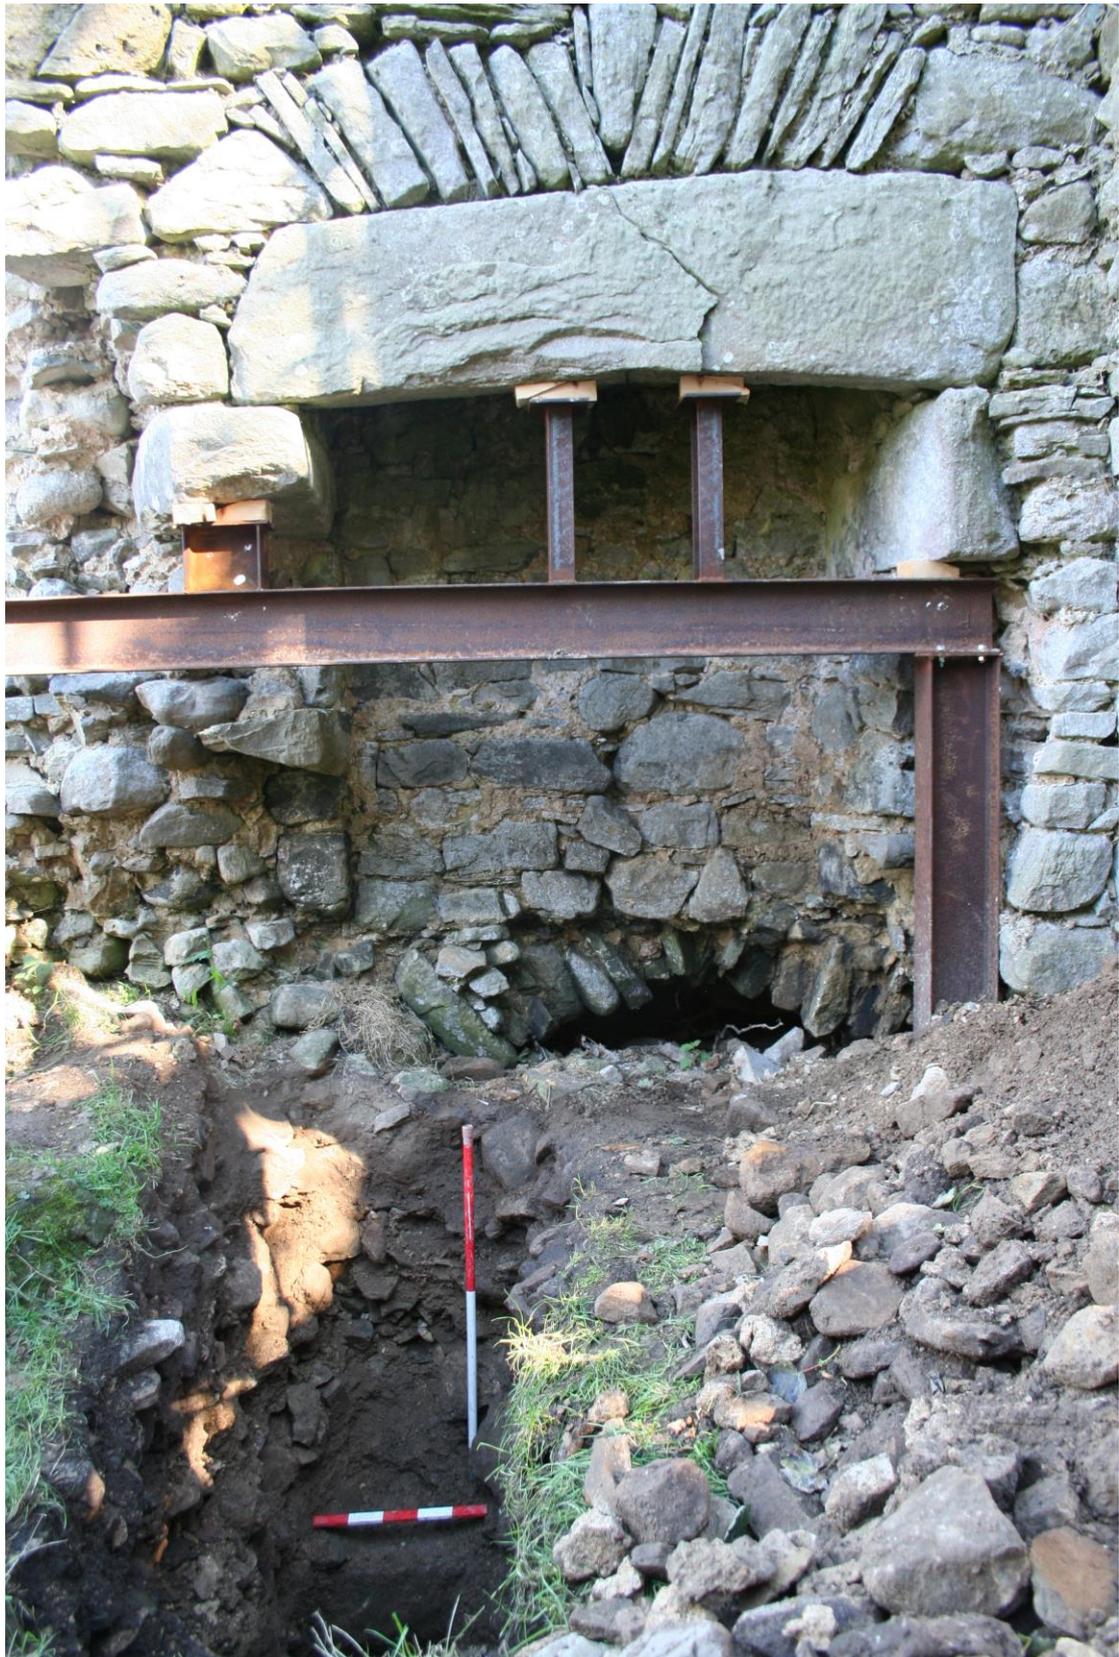
Because of the location of the trench beneath a large cracked fireplace lintel, and the possibility of not just the collapse of the lintel but the several metres of masonry above it, an iron supporting structure was erected by the EHS to allow work to proceed safely.

Photo 3: View of trench under excavation, showing iron masonry supports
