## **Monitoring Report No. 278**

**Roe Valley Country Park Hydroelectric Restoration Scheme  
Roe Valley Country Park  
Largy townland  
County Derry**

**AE/14/30**

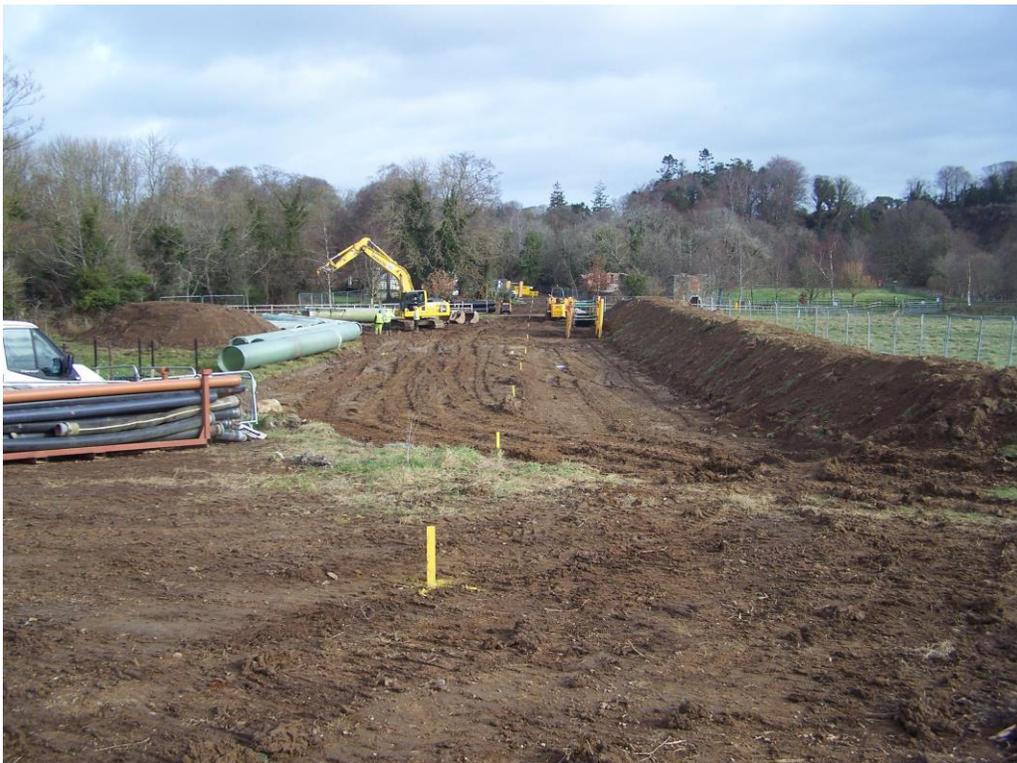
As the work was taking place in an historic industrial landscape and close to a beetling mill archaeological surveillance was requested by the Gail Howell, Archaeologist, Historic Monuments Unit, NIEA. The element of the work which required an archaeologist was the installation of a new penstock pipe to the original power house. The pipe, 1m in diameter and c. 200m in length, was to run underground laid at a depth of 2.3m. The trench was dug in 14m lengths at a time with a section of pipe then laid, which meant that any monitoring of the work was intermittent. The pipe laying started near the power house, ran between the beetling mill and mill pond, and along the western edge of the bleach green. (Figure 1, Plate 1)

Plate 1: Line of pipe trench, marked by yellow posts, pre-excitation with bleach green at right of photo (looking north-north-east).

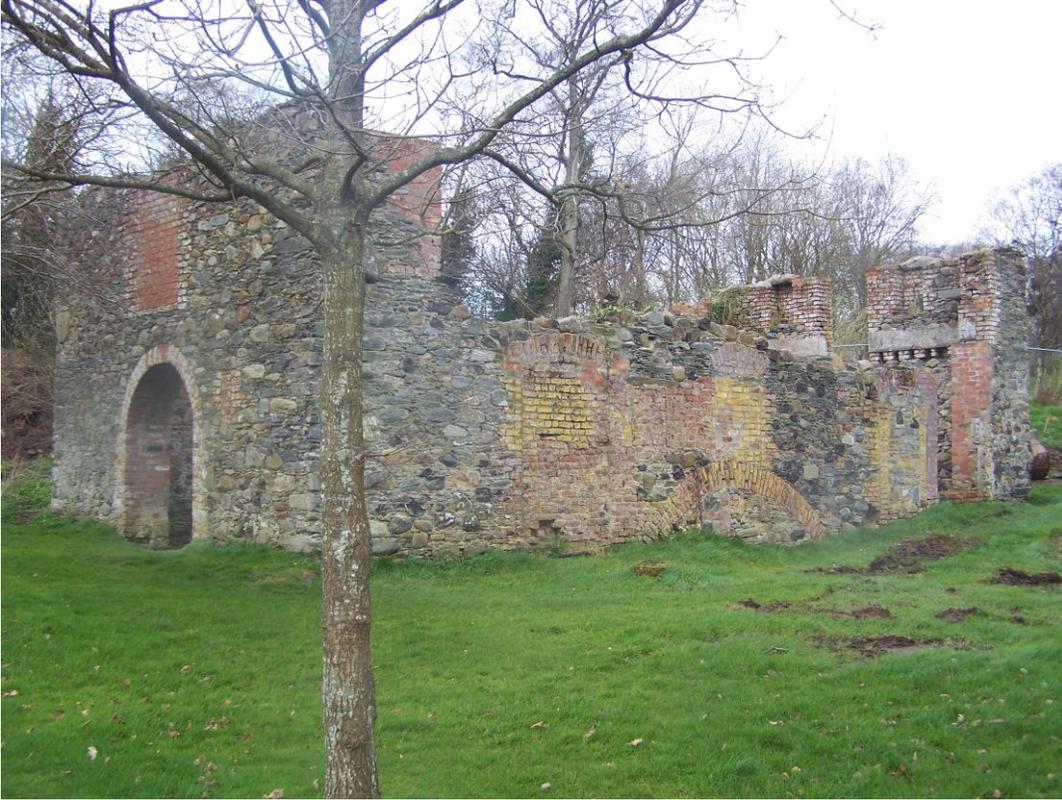
More monitoring was carried out as the pipe trench went past (to the west) of the beetling mill. The building is aligned north-west/south-east and is situated in modern landscaping near the mill pond. It is a two storey stone building with brick trims to the openings, it is now roofless and derelict with only the four external walls surviving. The mill race which was channelled from the River Roe would have run underneath the beetling mill, turning the water-wheel. There is no remaining trace of the water-wheel, which would have been located internally, and the head and tail race were in-filled in the early 1970s. Beetling was a process in the production of linen, after weaving, to finish the cloth by giving it a shine as the result of continual hammering. Nothing relating to the mill was uncovered during trench excavation. (Plates 2 to 4)

Plate 2: Beetling mill (looking west).

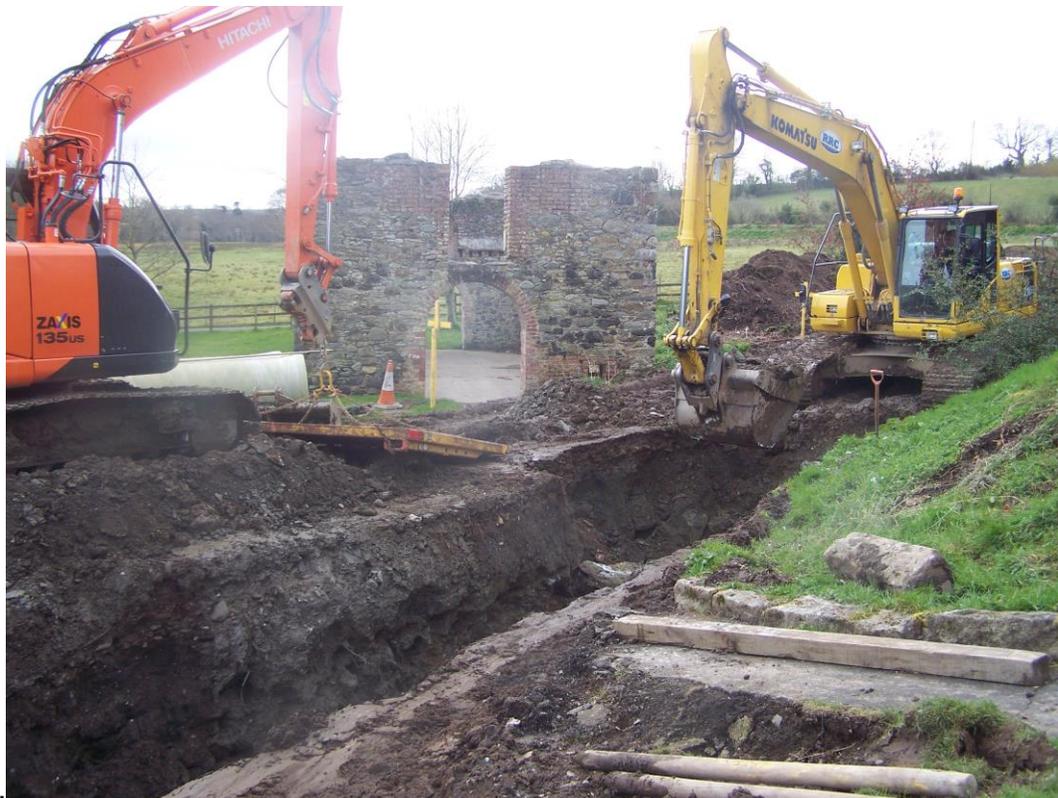
Plate 3: Pipe trench passing beetling mill, with former bleach green in background (looking south-east).

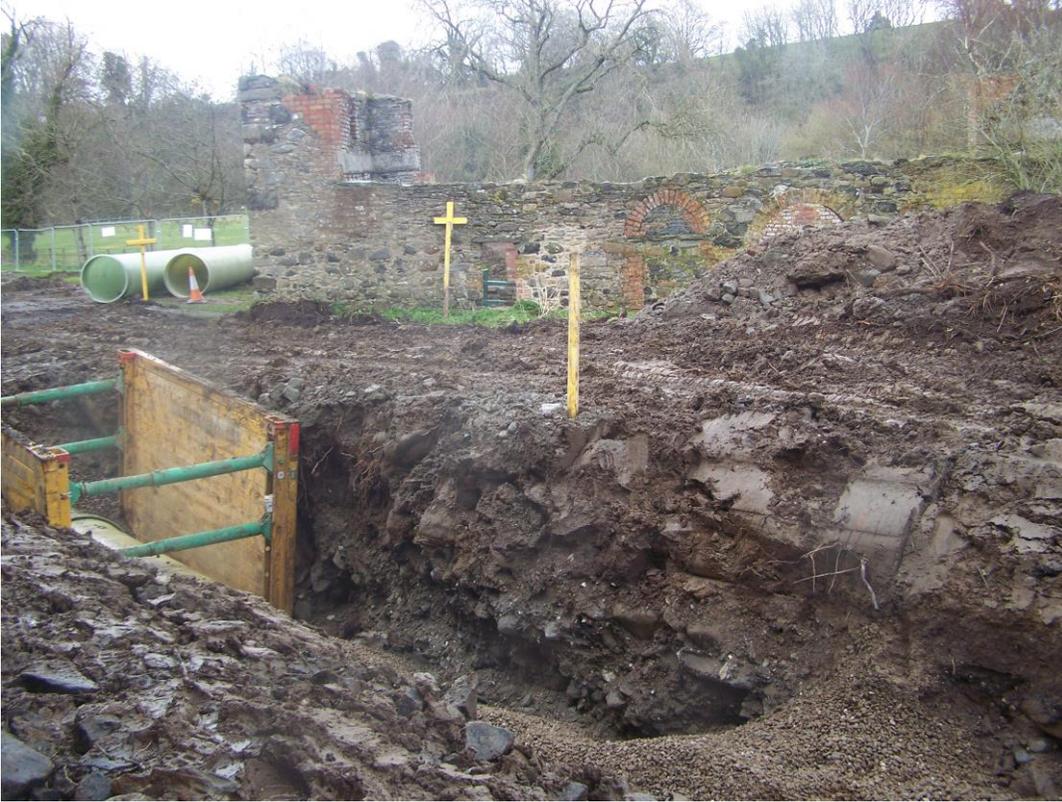
Plate 4: Pipe trench passing south-west facing side of beetling mill (looking north-east).

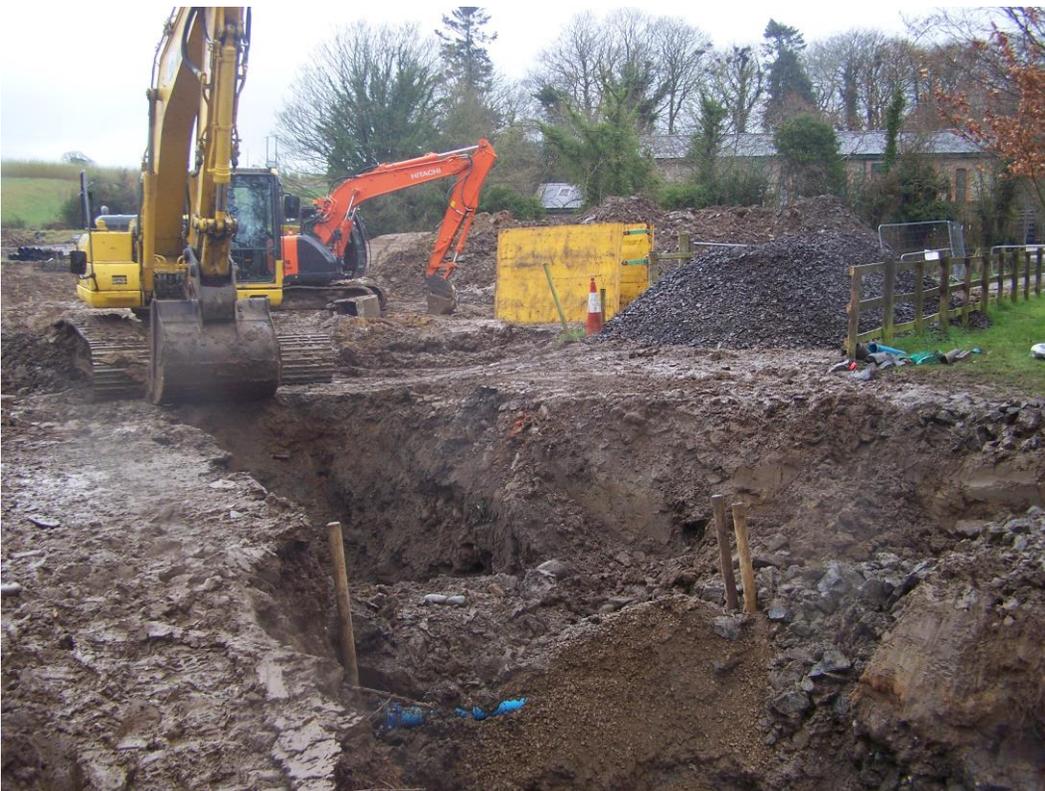
Past the beetling mill the trench cut across a path and then into a field which was a former bleach green. This last stretch of the pipe trench was monitored and again nothing of archaeological significance was noted. (Figure 1, Plates 5 to 7)

Plate 5: Pipe trench crossing path, with former mill building (now Green Lane Museum) in background to right (looking south-west).

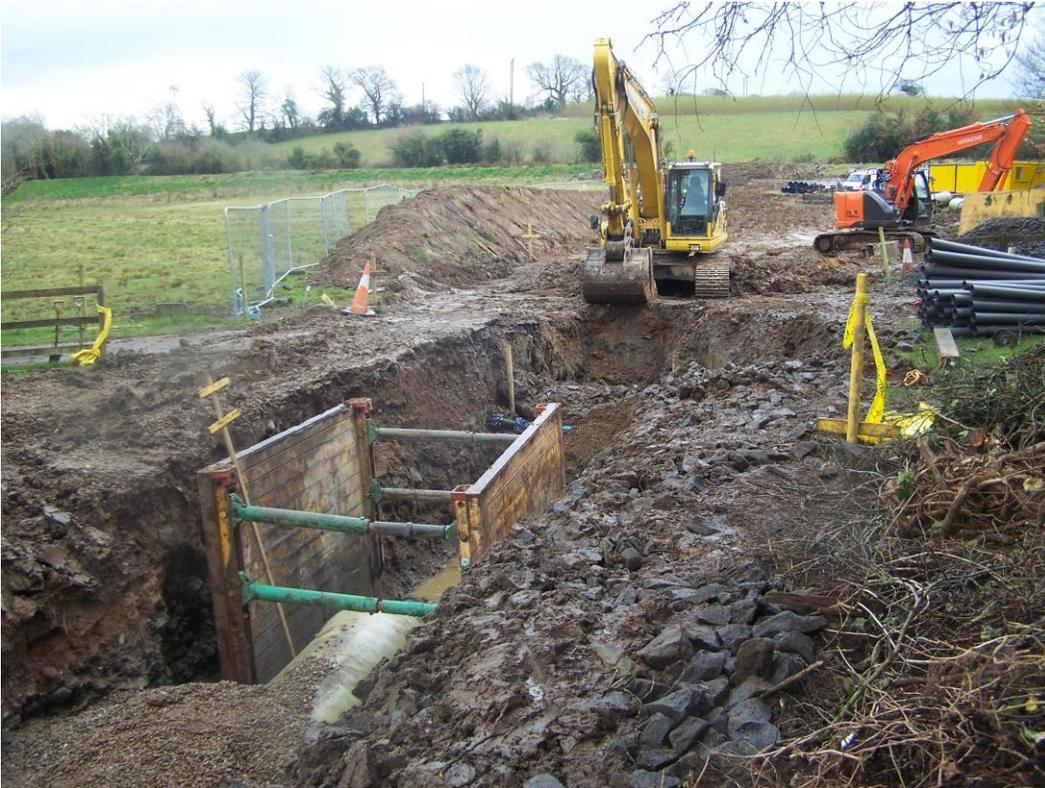
Plate 6: Pipe trench crossing path, with former bleach green to left (looking south).

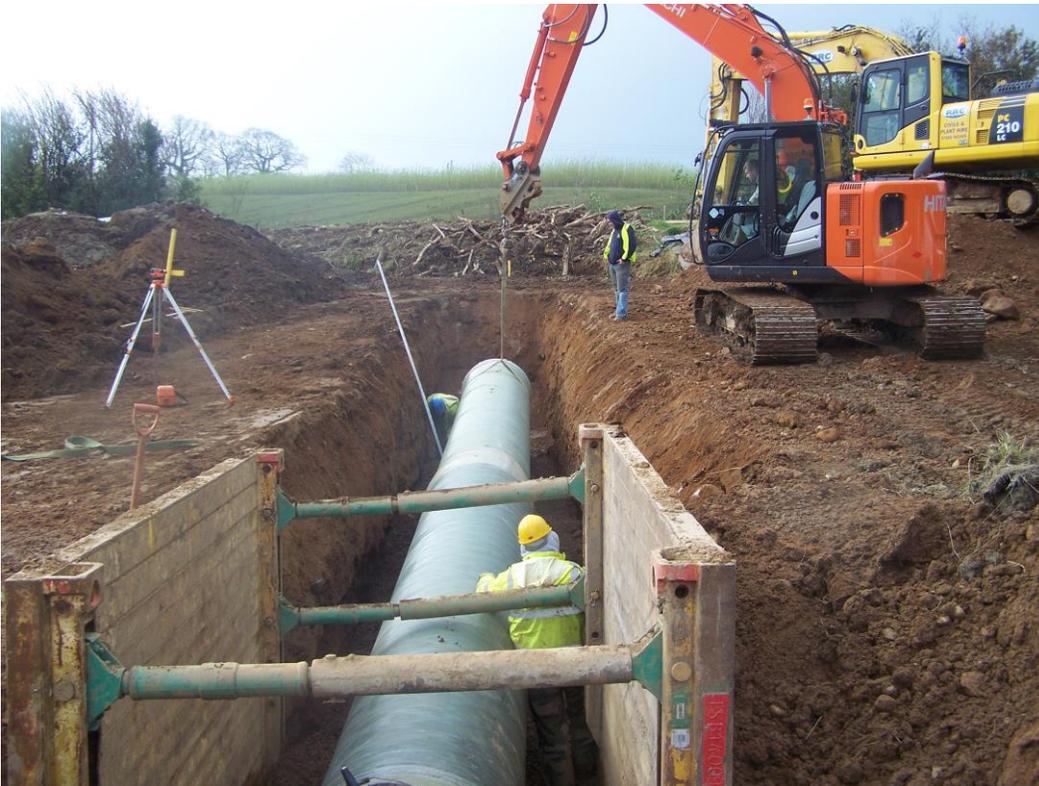
Plate 7: Last section of pipe trench, with section of pipe being put in place (looking south-south-west).
