ULSTER ARCHAEOLOGICAL SOCIETY

Survey Report: No. 17

**Survey of the Doon Enclosure at Murlough Bay,
County Antrim
UAS/09/02**

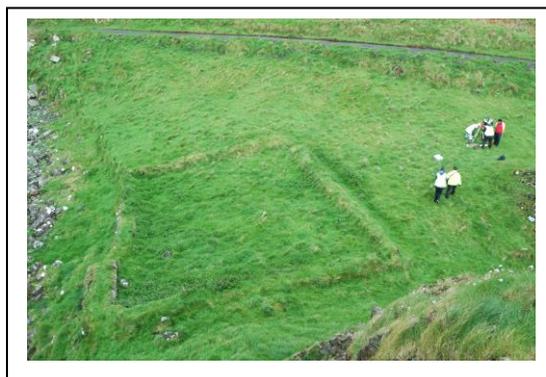
Figure 1(DSC3147): Plan view of the monument - looking south, from top of Doon Rock

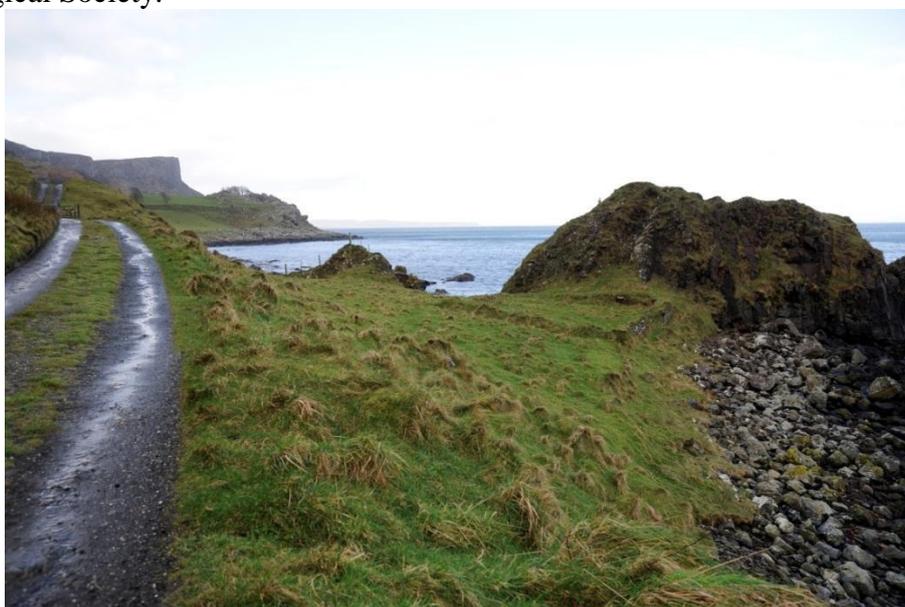
Figure 2 (DSC1785): View of Enclosure - looking North-West towards Fair Head

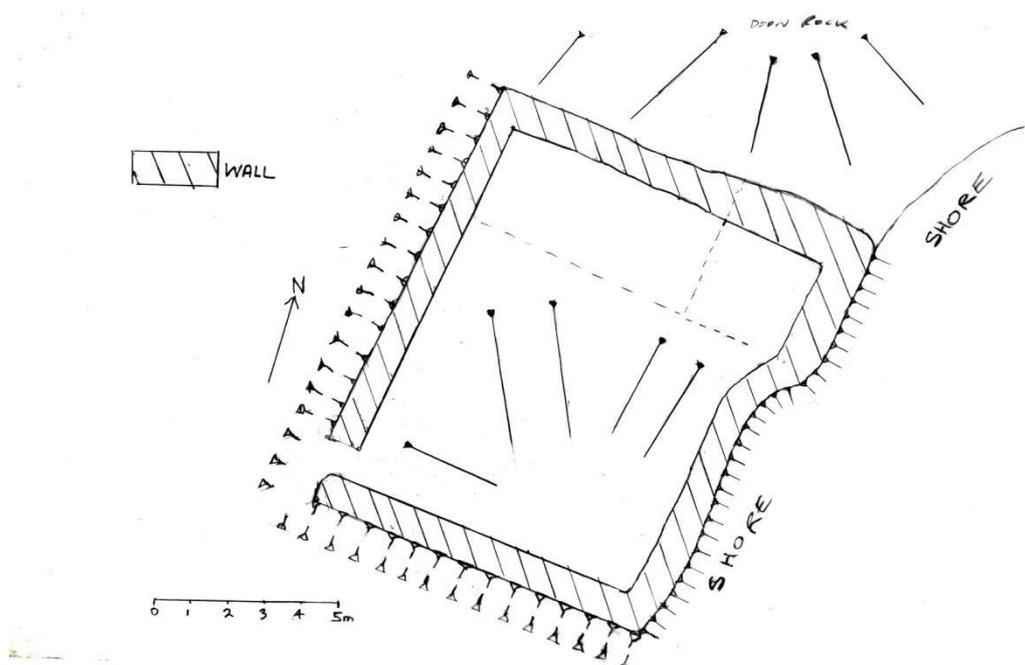
Figure 5: Enclosure Drawing - Plan View

As can be seen from the plan drawing in Fig. 5 above, the enclosure is not perfectly rectangular; the eastern side wall is not linear as it follows the contours of the shoreline. The interior surface of the enclosure is not flat, as can be seen from the slope to the south east (Fig.12).

Drainage channels on the outside of the western and southern walls are illustrated by hachures in Fig. 5 and are also visible in Fig. 6.

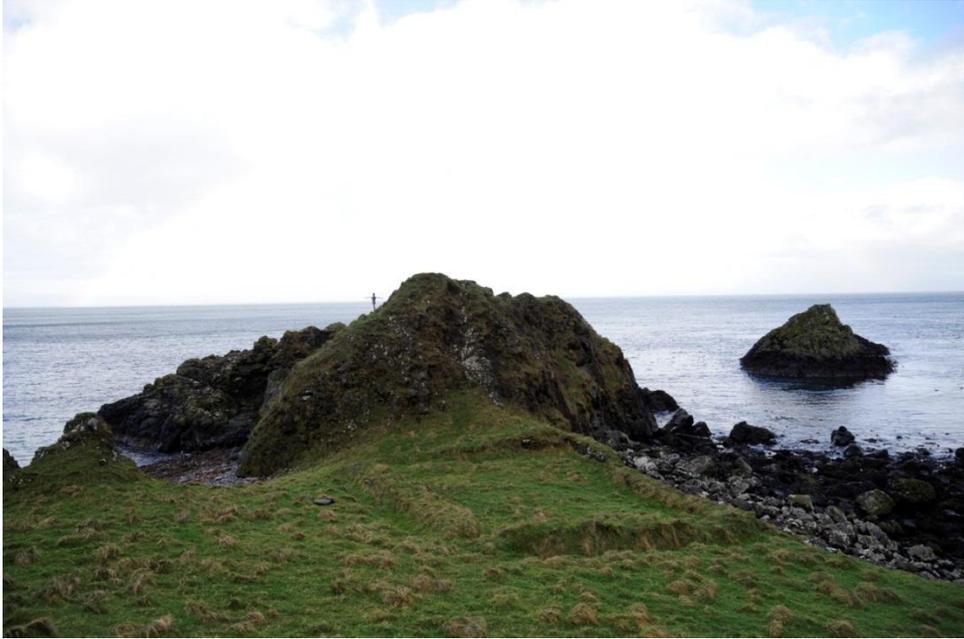
Figure 6 (DSC 1782): Enclosure View looking North-East, with Doon Rock in background

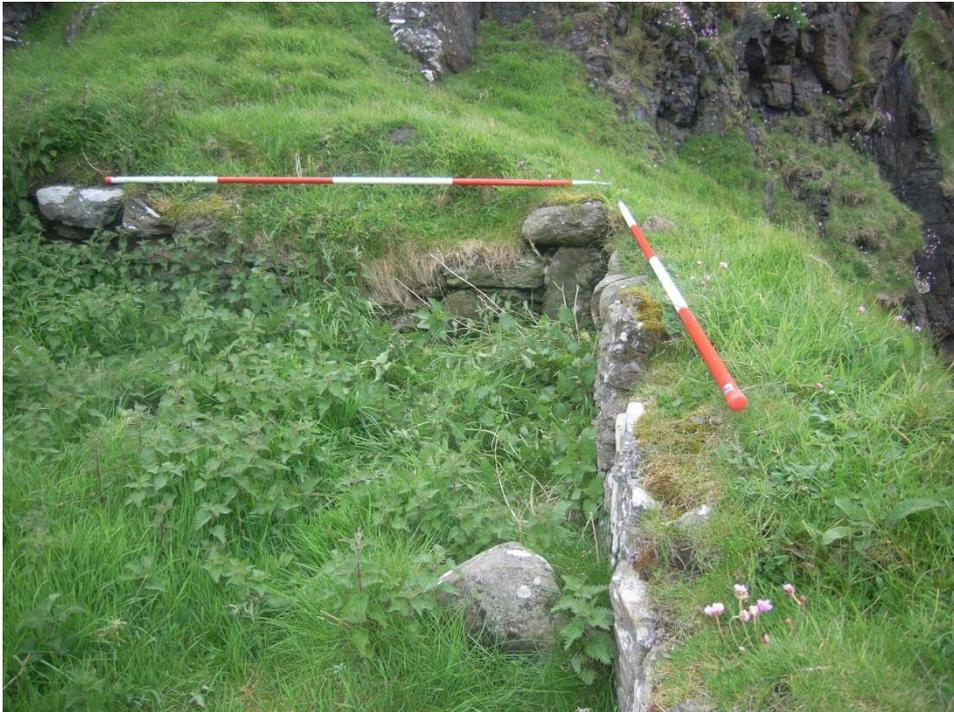
Figure 7 (RIM G0015): Detailed view of North-East corner of enclosure

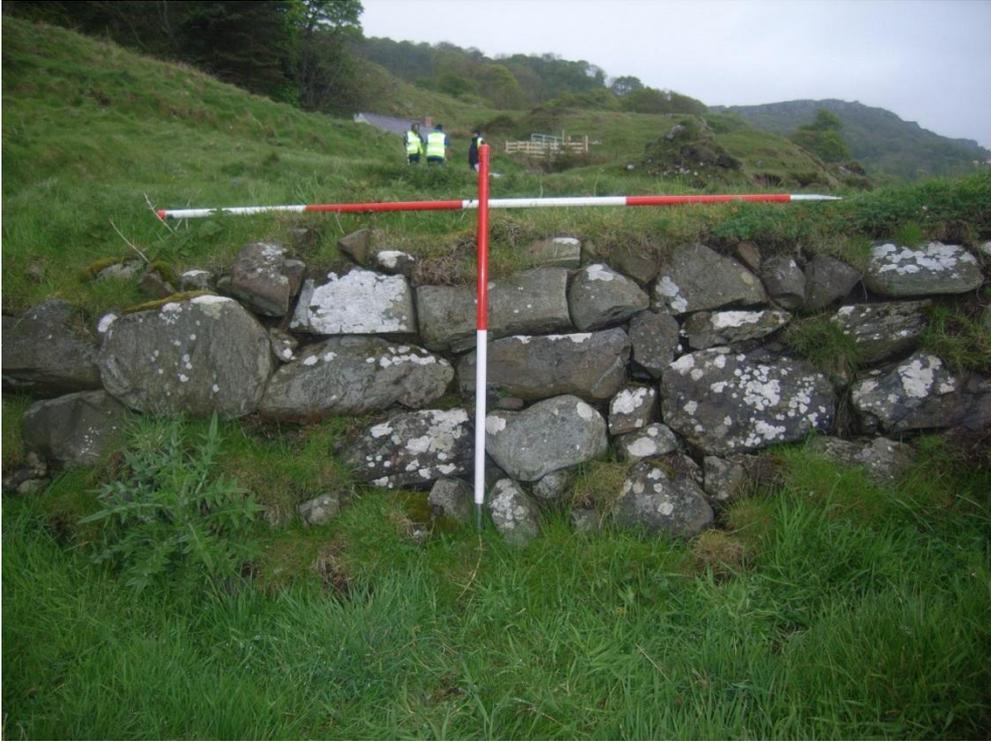
Figure 8 (RIM G0013): Exterior view of NE corner stonework –looking West from shoreline

The walls at the north east end of the enclosure are more substantial. They are approx. 1 m wide, constructed mainly of uncut stones (Fig.8) with evidence of lime mortar bonding in the joints of the inner facing northern wall (Fig.11). A similar mortar bonding can also be seen on the northern section of the outer eastern (seaward facing) wall (Fig.10). The rectangular construction of the north - eastern wall remains are consistent with a building or hut. If so, it would be provided with maximum shelter from northerly winds. There are no visible remains of dividing walls within the enclosure.

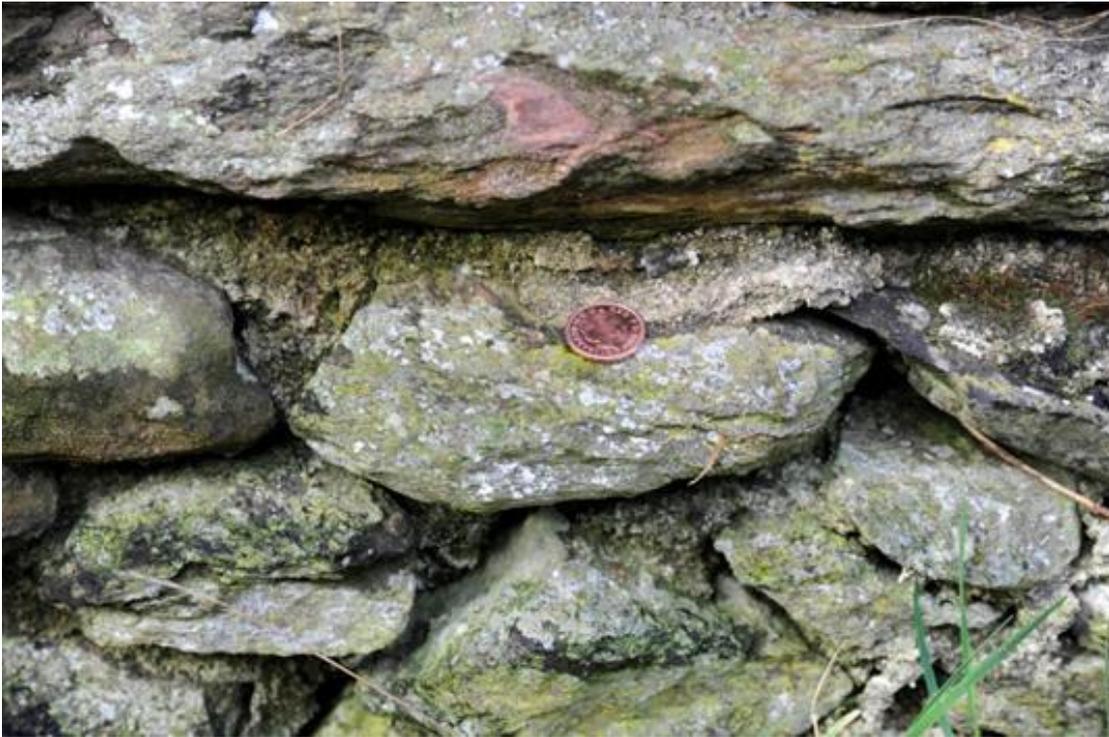
Figure 10 (DSC 1812): Mortar bonding on seaward facing eastern wall

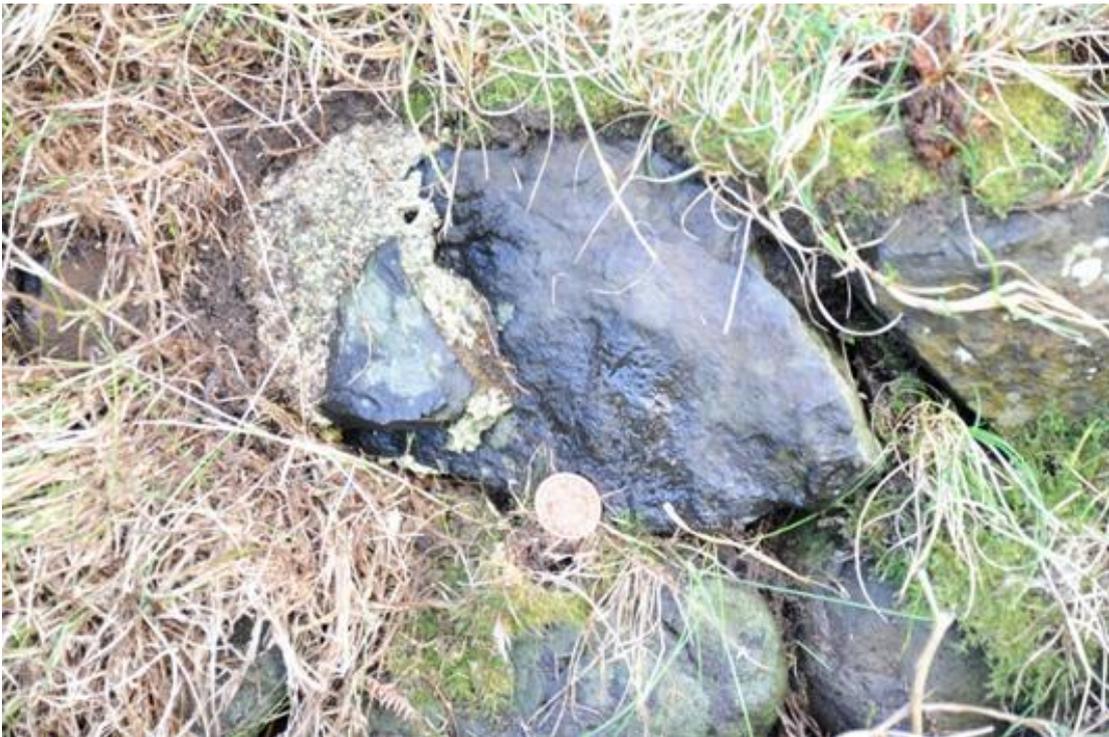
Figure 11 (DSC 1820): Mortar bonding on inner face of northern wall

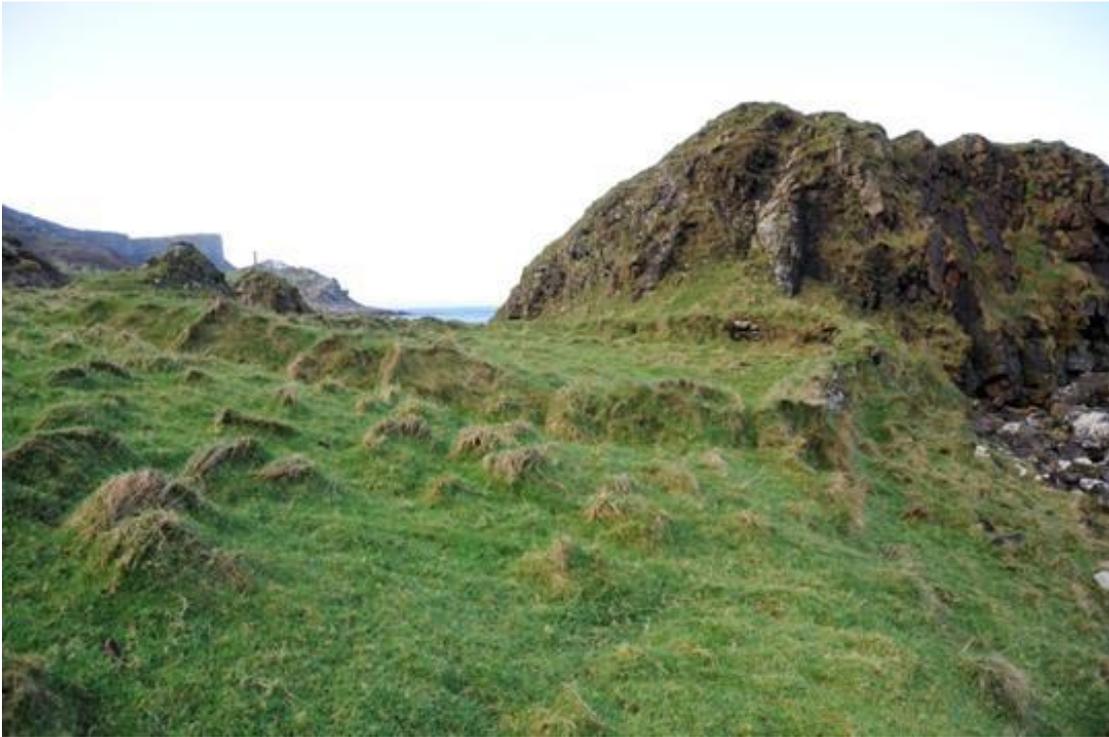
Figure 12 (DSC 1819): View looking North showing site sloping toward the SE corner
