ULSTER
ARCHÆOLOGICAL
SOCIETY

Survey Report

Reference: **Survey Report No. 56**

**Horse Gin
Creevyloughgare
Saintfield
County Down**

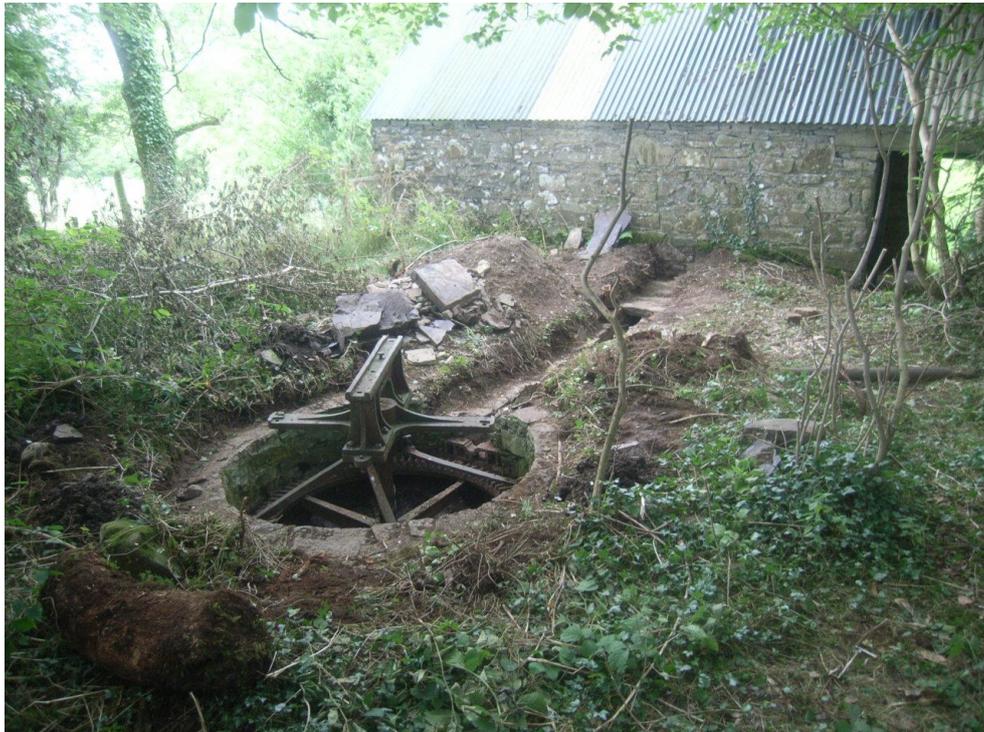
The remains of the horse gin consist of the central drive mechanism, set within a stone-built pit and a stone-built tunnel, which held the drive shaft that connected the central drive mechanism and the machine that it powered in an adjacent building (Structure A). There is no visible evidence of this machine inside the building. A surface artefact (one sherd of pottery) was recovered from the horse gin pit during the survey.

Figure 06: Horse gin, with Structure A in background, looking west

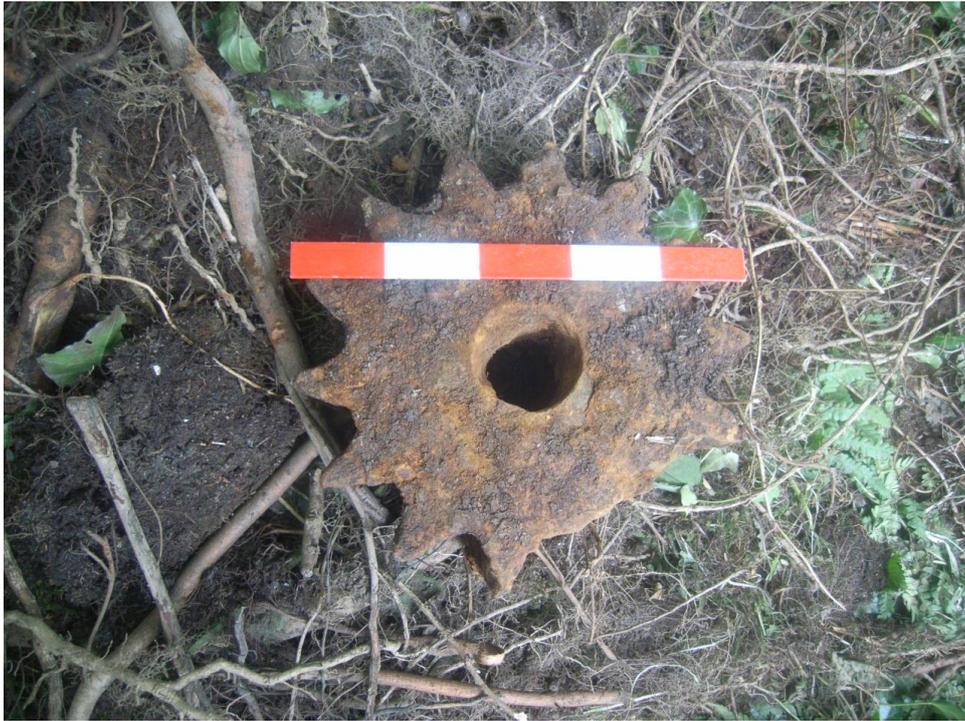
Two machine parts were observed in the immediate area of the excavation and were presumed to be part of the drive mechanism and connecting rod assembly. One of these parts, a toothed cog (Figure 07), displayed damage in the form of two broken

teeth, which would have rendered the gin inoperative. The cog is 26cm in diameter and 11cm thick.

Figure 07: Cast iron cog, with 2 missing teeth [scale 0.25m]

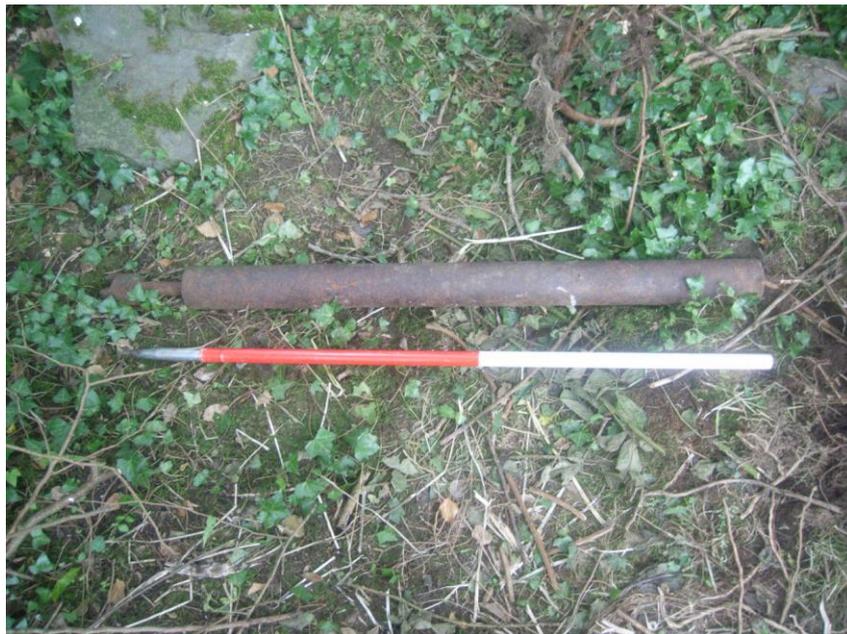
Figure 08: Cast iron machinery part, probably part of the drive shaft [scale 1m]

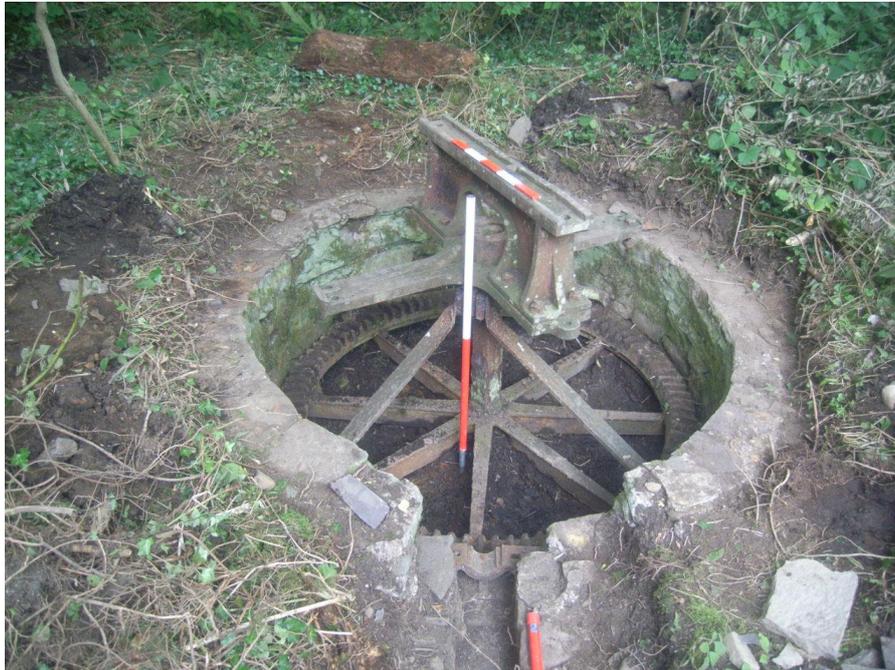
The central pivot of the horse gin consists of a stone-built circular pit, 1.68m in inner diameter. Set within this is a cast iron circular cog wheel, 1.60m in outer diameter and 1.41m in inner diameter, with 96 teeth regularly spaced on the upper surface. The cog wheel has 8 integral and supporting cast iron spokes. There are 4 regularly spaced

supporting struts, each secured into the stone-built pit immediately above the cog wheel and attached to a cast iron collar to the central pivot, 8cm in diameter. These are to prevent the central shaft from oscillating while the gin is being operated. At the top of the pivot shaft, 2 operating arms are set at right angles, one above the other, presumably to accommodate the attachment of several horses at the same time, which may have been necessary due to the limited diameter of the horse walk. The lower arm is 1.22m in length, 0.12m in width and the upper is 0.89m in length, 0.12m in width. The gin mechanism is 0.64m from the base of the pit to the top of the upper operating arm and the top of the upper operating arm is 0.5m above the surface level of the horse walk (Figure 09).

Figure 09: Cog wheel, supporting struts and rotating arms
[scales 1m vertical, 0.5m horizontal]

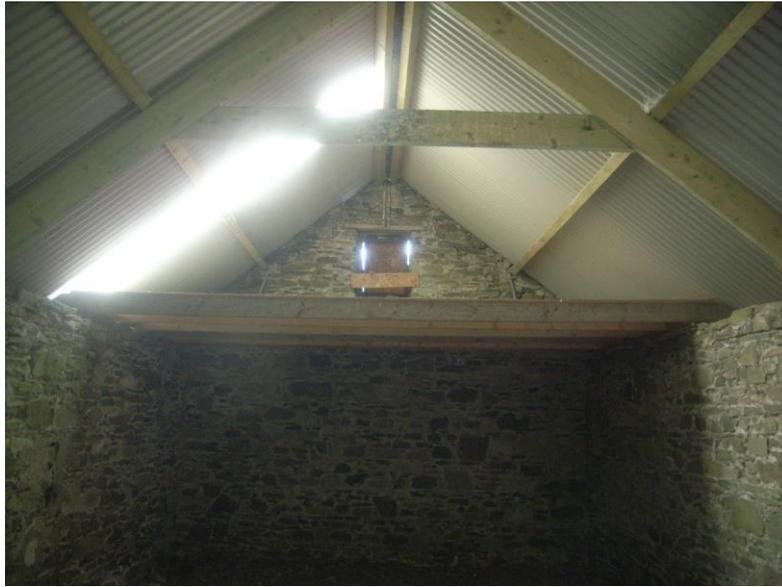
This building is substantially complete. It is rectangular in plan, 10.1m in length north/south by 4.6m east/west. There are doors present in the east and west walls. A mezzanine floor, without access, is present at the southern part of the building, where it extends across the entire width of the building and 2.4m to the north. It is of timber joists set on wall plates with plywood flooring. The walls are of split stone, bonded with lime mortar and are 0.5m in thickness. They stand to a height of 2.4m at the east and west and gables at the north and south stand to a height of 4.4m. The building is currently roofed with corrugated iron sheeting on timber rafters, with two translucent

corrugated plastic panels on the eastern side to provide natural lighting. The floor is of loose stones, with patches of lime mortar visible.

Figure 10: Structure A, with mezzanine and gable window, looking south

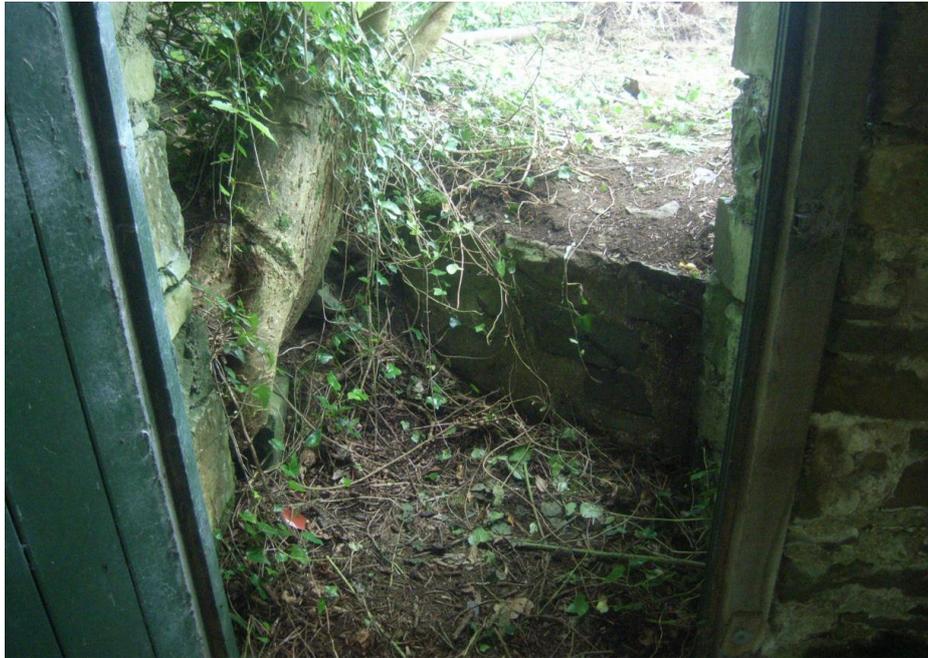
The doorway at the east leads directly to the horse walk associated with the gin, via a single step of 0.5m in height, which is formed by the stone revetment of the horse walk (Figure 11). It is probable that Structure A was already extant when the decision was made to construct the horse gin. The restricted space to the east determined the small diameter of the horse walk and the necessity to construct it as close as possible to the east wall of the building, thus creating the step. Another consequence of this decision was that there was no access for horses to the gin through Structure A and these must have been brought directly from the south, where the roadway now stands. An Ordnance Survey bench mark (365.7ft [112.5m] + OD) is located close to the south-west corner of the building.

Figure 11: Revetment to horse walk at east of Structure A, looking east

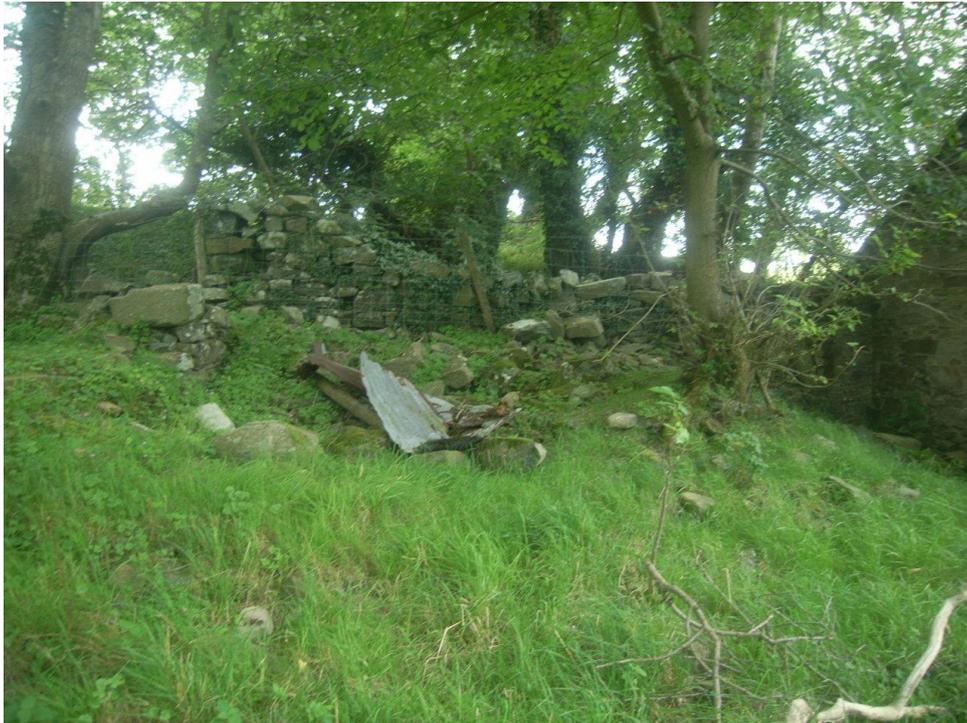
Structure C is the remains of another collapsed building, immediately to the north of Structure B. The remains consist of low, rubble strewn walls forming a rectangular building 5.46m in width (north/south) by 4.9m (east/west). Fragments of corrugated iron sheeting are present in this area and may represent part of the roof structure. The walls appear to be of dry stone construction.

Figure 12: Remains of Structure C, looking east

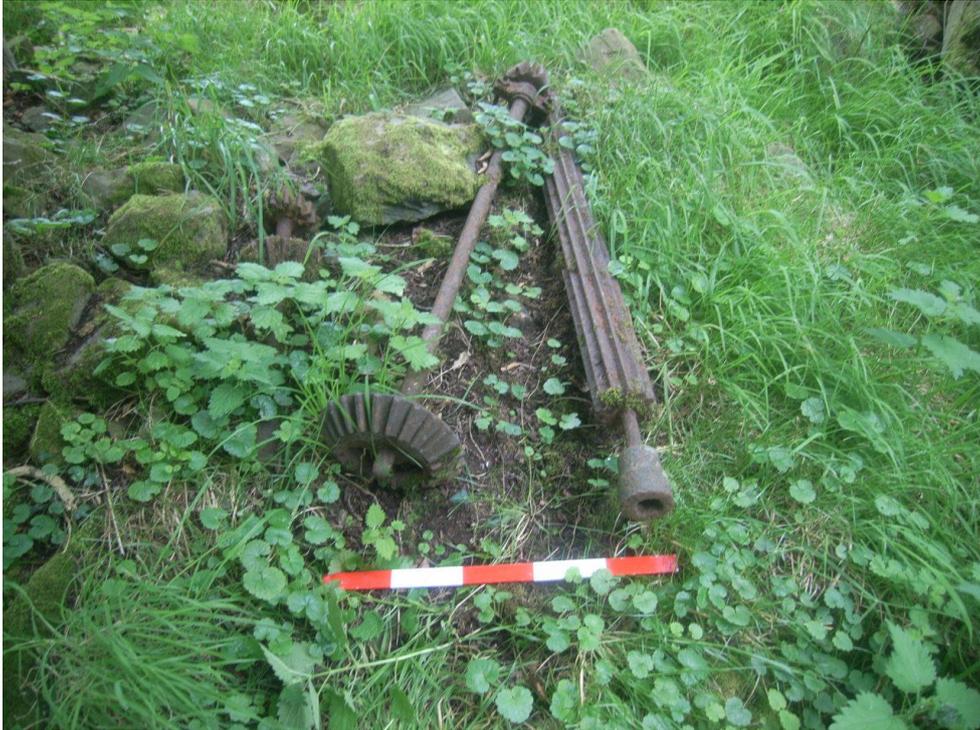
Evidence of one further vernacular building is present 8.6m due west of Structure D. The remains represent a collapsed building and consist of low, rubble-strewn walls forming a rectangular building 6m in length (east/west) by 4m in width (north/south). The walls are substantial, at 0.8m in thickness and the remains of a doorway are present at the east. The remains of a low wall extend to the south from the southwestern corner of this building, turning to the east and then south, to form an enclosed area, or yard, with access to Structures A-E. A cast iron cog wheel was observed, resting against the south wall of Structure E (Figure 14). The cog wheel was 66m in diameter and 7cm thick. Three further cast iron machinery parts were observed to be resting on top of the low wall due east of Structure B (Figure 13).

Figure 13: Machinery parts on wall due east of Structure B [scale 0.5m]

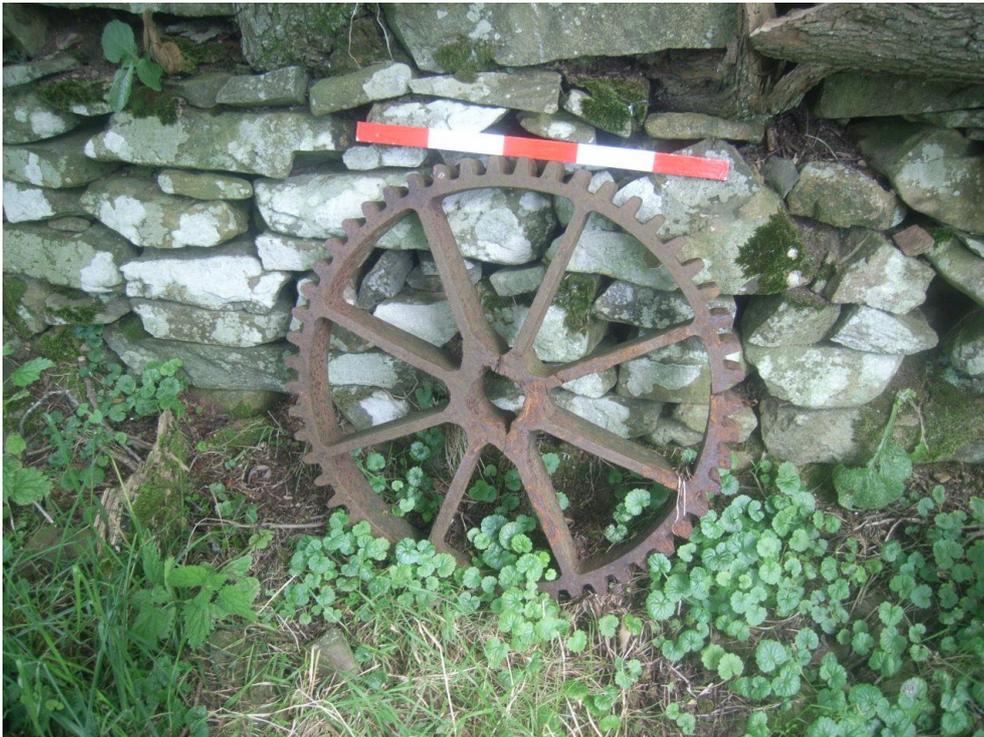
Figure 14: Cog wheel adjacent to Structure E [scale 0.5m]

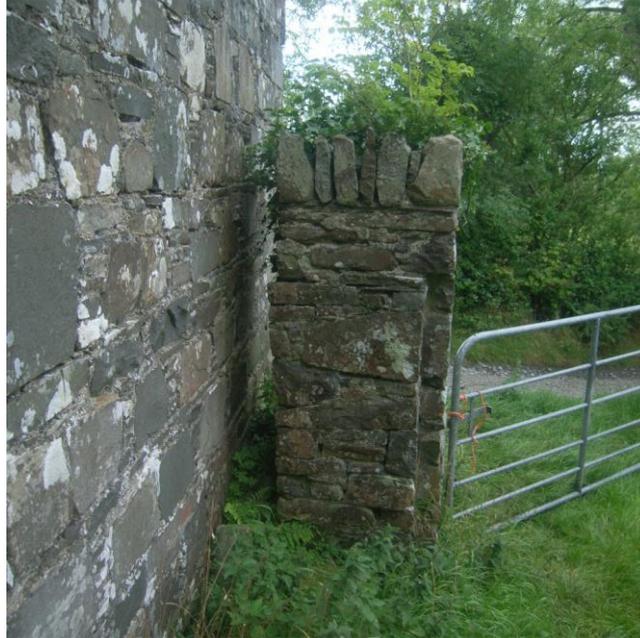
A single gate post is present at the entrance to the site, located at the south-west corner of Structure A. It is 0.74m in length (east/west) by 0.68m in width (north/south) and currently stands 2m in height. A rebate is present at the north-west corner, probably to accommodate a gate, which is no longer present. There is no visible evidence of a second gate post.

Figure 15: Gate post, looking south

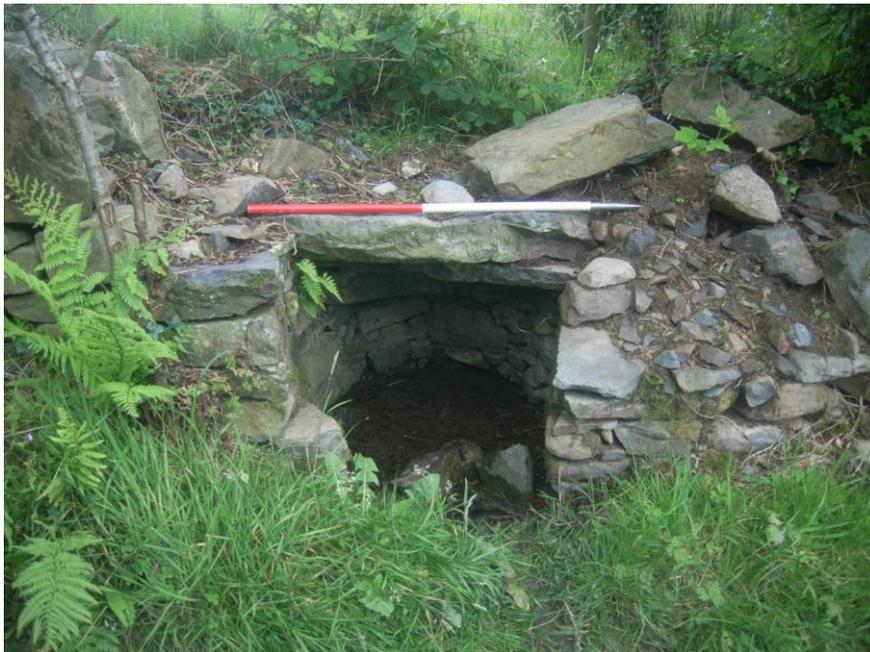
A roadside well is located across a lane, 4m to the south of Structure A. It is 0.75m in width (east/west), by 1.05m in length (north/south). It is 0.7m in height, of dry-stone construction and is partially roofed at the south with stone corbelling.

Figure 16: Roadside well, looking south
