ULSTER ARCHAEOLOGICAL SOCIETY

Survey Report: No. 24

Survey of Gasworks, Castle Ward, County Down UAS/10/02

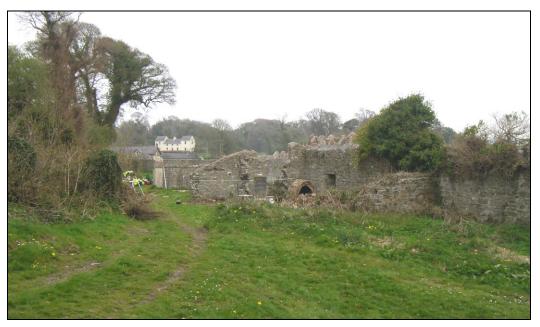
Fig. 7: General view of gasworks from SW. (RIMG0003).

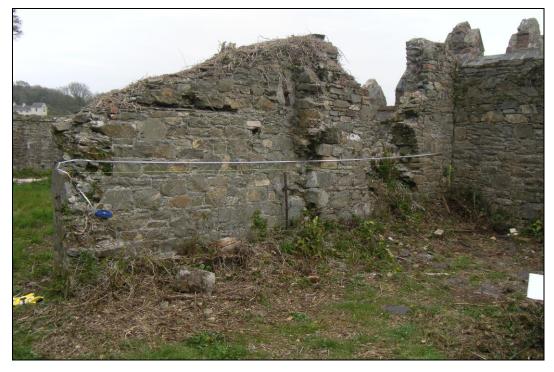
Fig. 12: North wall of Gashouse, interior. (RIMG0007).

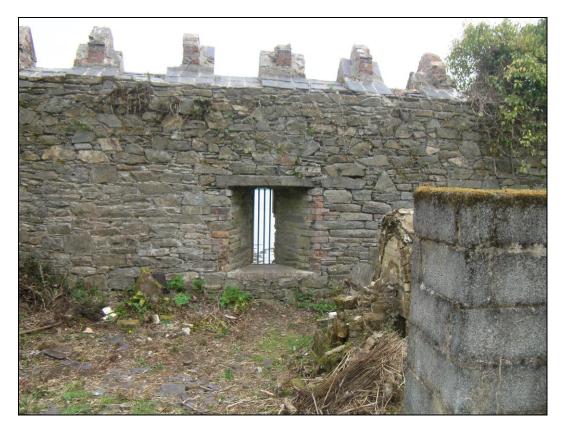
Fig. 13: East wall of Retort House. (RIMG0008).

The section of wall coinciding with the length of the retort house is heightened and the creasing course sits 2.96m above the interior ground level (fig. 13). This section carries nine double-stepped merlons. The first and last rise above the height of the others and mark the eastern corners of the retort house. The east face of this row generally presents corners of squared sandstone, both red and yellow, showing horizontal tooling. The copings of the lower steps are also finished in sandstone. The upper steps are faced with sandstone (except one, which is composed of red brick) each having a dwarf niche similar in proportion and size to those fashioned in brick near the gasholder. The copings of the crenelles are finished, sometimes with a single shaped sandstone, sometimes with a setting of bricks, but all have a small opening formed by a dwarf transverse ridge at the centre, next to the creasing course. On the inside all merlons are red brick and all sloping surfaces are finished with roofing slates. The east wall of the retort house combines with the demesne wall to give greater width, but the merlons are no wider than on other sections. The roofing slates continue to the inside edge of the retort house wall where they make an unbroken line for the length of the house.

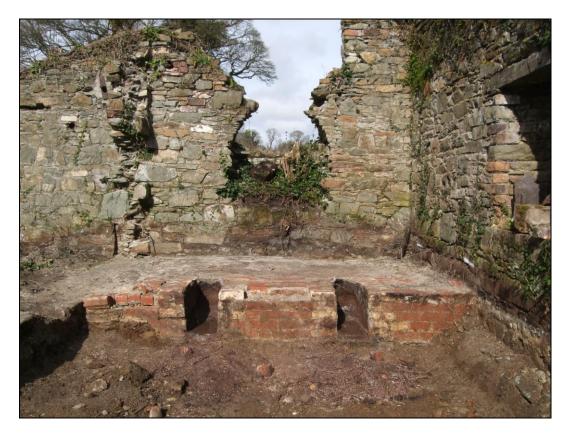
In the north wall about 2.5m above ground level and about 0.2m from the west wall a 3" cast iron pipe goes straight through to the outside (fig. 14).

Fig. 14: Exposed ash pits and north wall of gashouse, 2011. (DSCF0856).

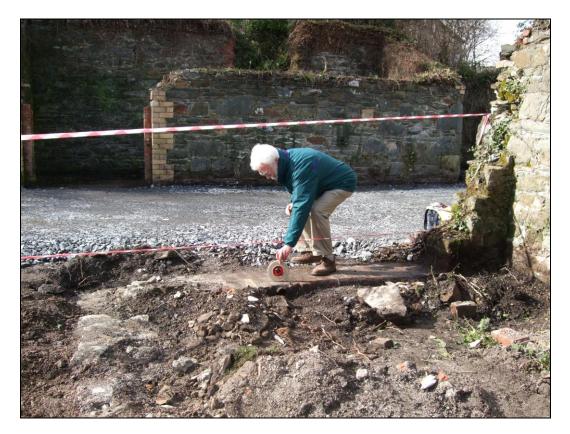
Fig. 15: Purifier house looking east (March 2011): the tape box rests on the threshold directly above the exiting pipe. (DSCF054).

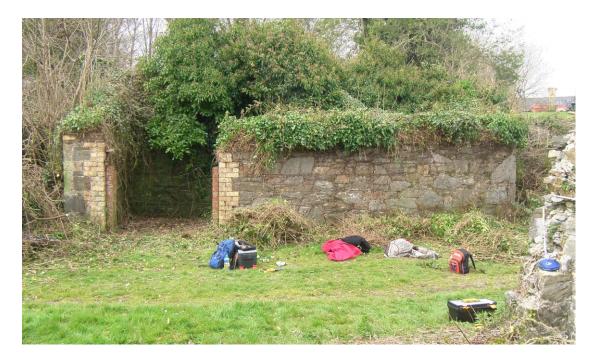
Fig. 16: Coal Store viewed from the east. (RIMG0015)

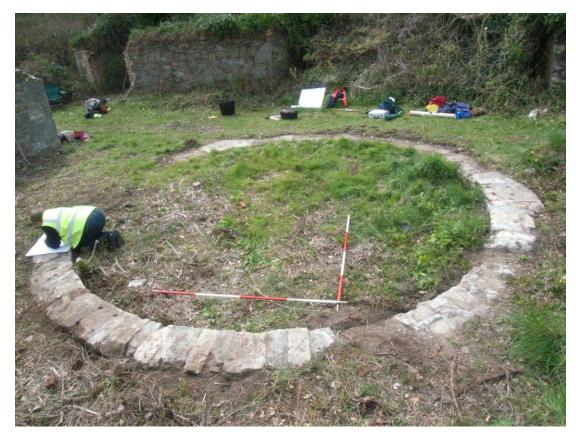
Fig. 17: Coping of gasholder tank. (RIMG0110)

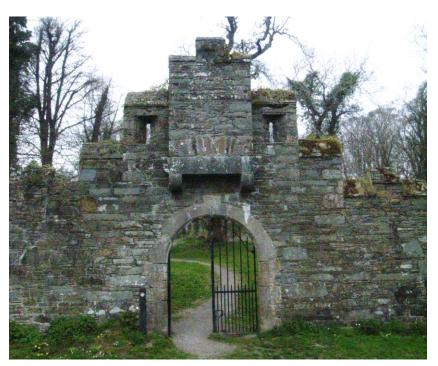
Extra height is given above the gate by a crow-stepped gable with a splayed slit on either side of a mock machicolation which projects towards the quay (fig. 22). The gateway has a semicircular arch on the outside with shaped quoins and voussoirs of imported stone, probably grey carboniferous limestone. The heavy supports for the machicolation are of the same material. On the inside is a shallow elliptical arch with narrow voussoirs of shaped sandstone.

Fig. 22: Quay Gate, viewed from quay. (RIMG0088)

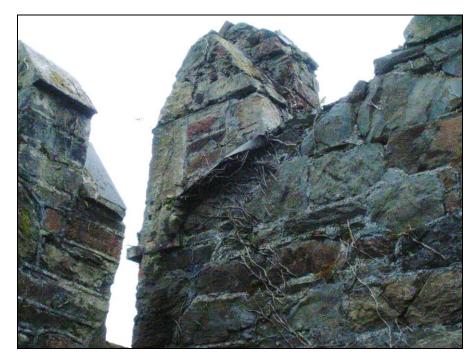
A single block of yellow sandstone with sculpted decoration (weathered, but perhaps foliate) on two faces is built into the northern of the tall merlons on its NE corner (fig. 26). Its singular appearance suggests a previous use in another building.

Fig. 26: Merlon at NE corner of gashouse. (RIMG0097)

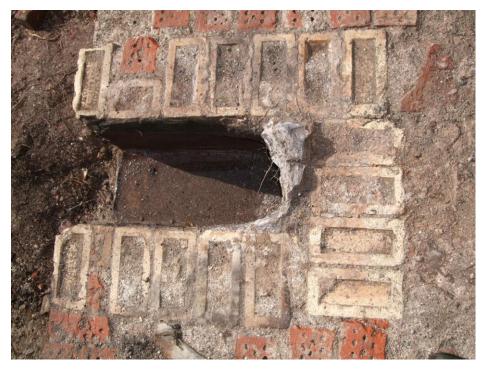
The firebricks lining the ashpits displayed clearly readable maker's marks in the frogs: ALLAN & MANN / PATENT / GLASGOW. A loose brick bears this legend on one side and the other frog is blank. Some bricks *in situ* present lettered and others blank frogs. Allan and Mann made common brick from 1837 to 1887 (Douglas: 15) and Hugh Allan's diary (1867-70) reveals that their Rutherglen Pottery was largely occupied in fireclay production by 1867 (Hume: 3). Clay was transported from Rochsolloch and Govan pits for the purpose. The firm's city office was at 48 Enoch Square, Glasgow, and sales outlets were established at Port Eglinton and Greenock. Unfortunately the present state of knowledge does not permit a commencement date for the use of our frog mark.

Fig. 33: Eastern ashpit. (DSCF0858)

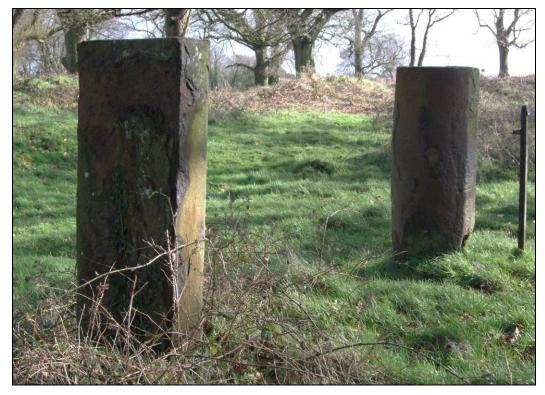
Fig. 37: Cast-iron retorts used as gate piers, Derrymore.

Six iron D-section retorts survive in the Bessbrook area where they have been reused as gate piers, the open mouth sunk into the ground and the closed end uppermost (fig. 37). The internal breadth and depth of one was measured through a hole – it was $19^{3}/4^{\circ\circ} \times 12^{\circ\circ}$ (50 x 31 cms). The external measurements were $23^{1}/2^{\circ\circ} \times 15^{3}/4^{\circ\circ}$ (60 x 40 cms). The curved roof was twice the thickness of the floor. Accretions and defoliation of layers of rust may account for a variation of 2" in the breadths and depths within the group. The "length" above ground level was 5' 3" (1.6m). Engineers defined retorts by the internal measurements.

The surviving retorts in Bessbrook can only be expected to suffer accelerating deterioration. The National Trust, Northern Ireland Environment Agency: Built Heritage, or the Bessbrook Development Company (or a partnership of them) might explore the possibility of selecting examples to acquire, conserve, and exhibit in a suitable environment.

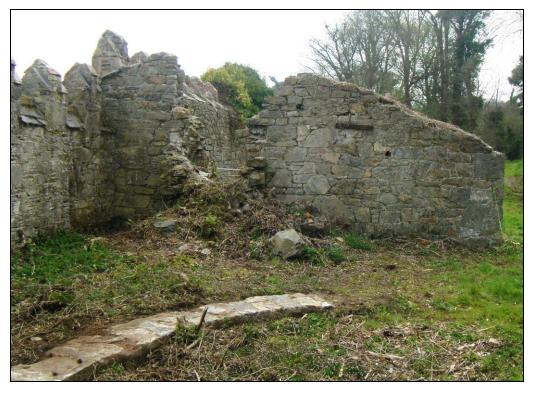
The remnants of pipe through walls allow us to draw conclusions on the arrangement of plant. We can postulate condensers on the outside north wall of the purifier house. Gas produced in the retorts would reach them via the pipe through the wall of the retort house. The strip of iron attached to the gashouse wall probably secured the condensers in an upright position. After most of the tar had been precipitated, the gas would progress to the purifier through the angled pipe. From the purifier the gas would travel through the pipe under the threshold and continue underground to feed into the gasholder.

Fig. 38: North wall of gashouse, exterior. (RIMG0021)
