ULSTER
ARCHÆOLOGICAL
SOCIETY

Survey Report

Reference: **Survey Report No. 28**

**Anne's Point Bridge
Mount Stewart
County Down**

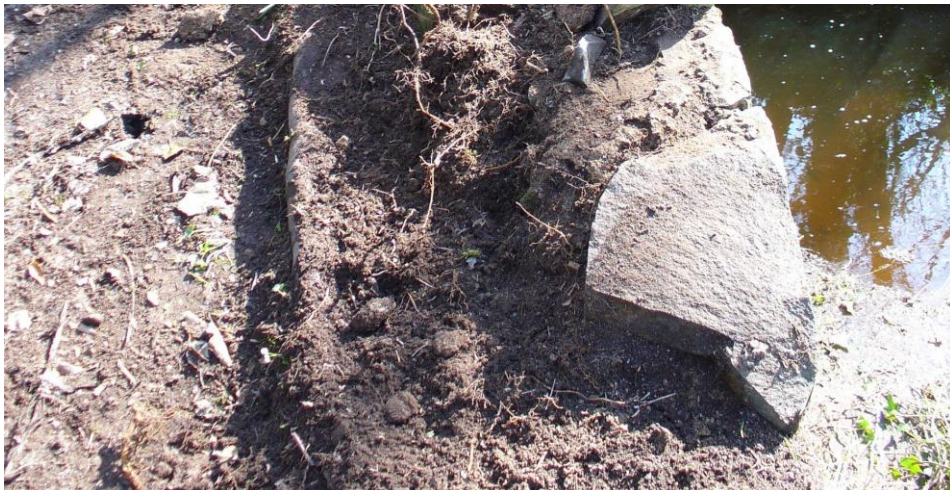
Figure 09: Example of root damage to bridge deck.

The bridge, which is of a segmented arch construction, built of rough local cut stone, spans a stream approximately 2.25 metres wide. The deck is approximately 2.6 metres wide. The parapet walls are in poor condition, mainly due to root damage. In the centre of the span on the north-eastern face, the parapet has disintegrated down to the segmented arch, severely compromising the strength of the structure. Its strength is further compromised by the fact that there are at least two heavy roots growing along the deck of the bridge, close to the parapets and the north-eastern parapet has been pushed out from the segmented arch.

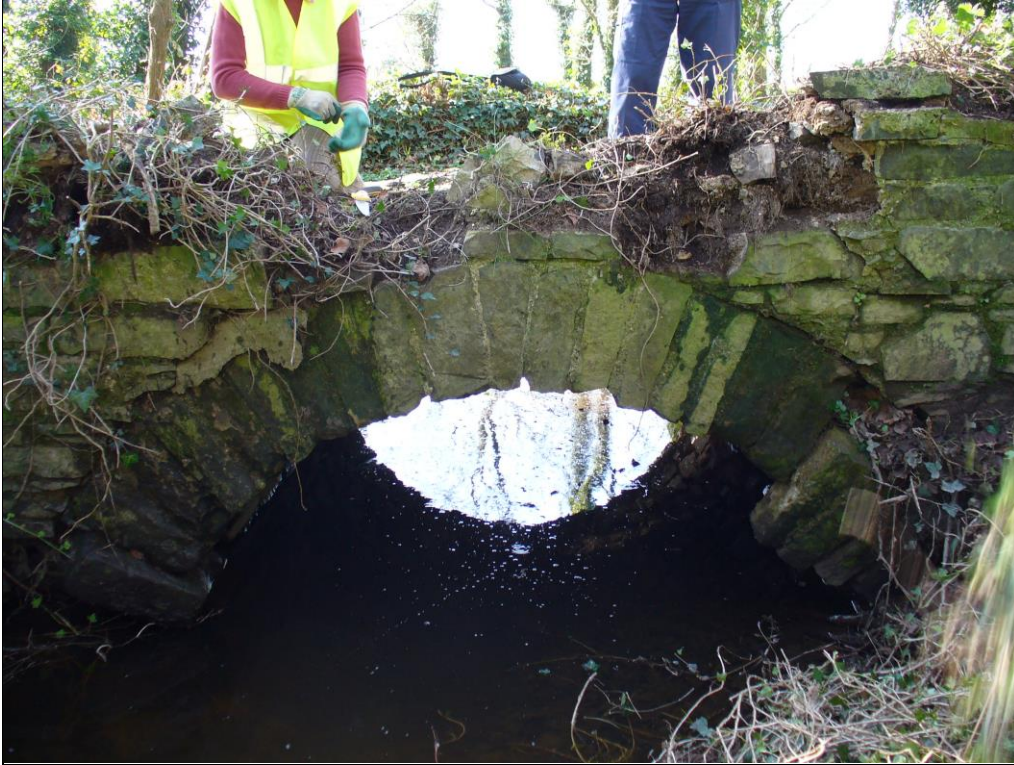
Figure 10: North-eastern face showing parapet damage

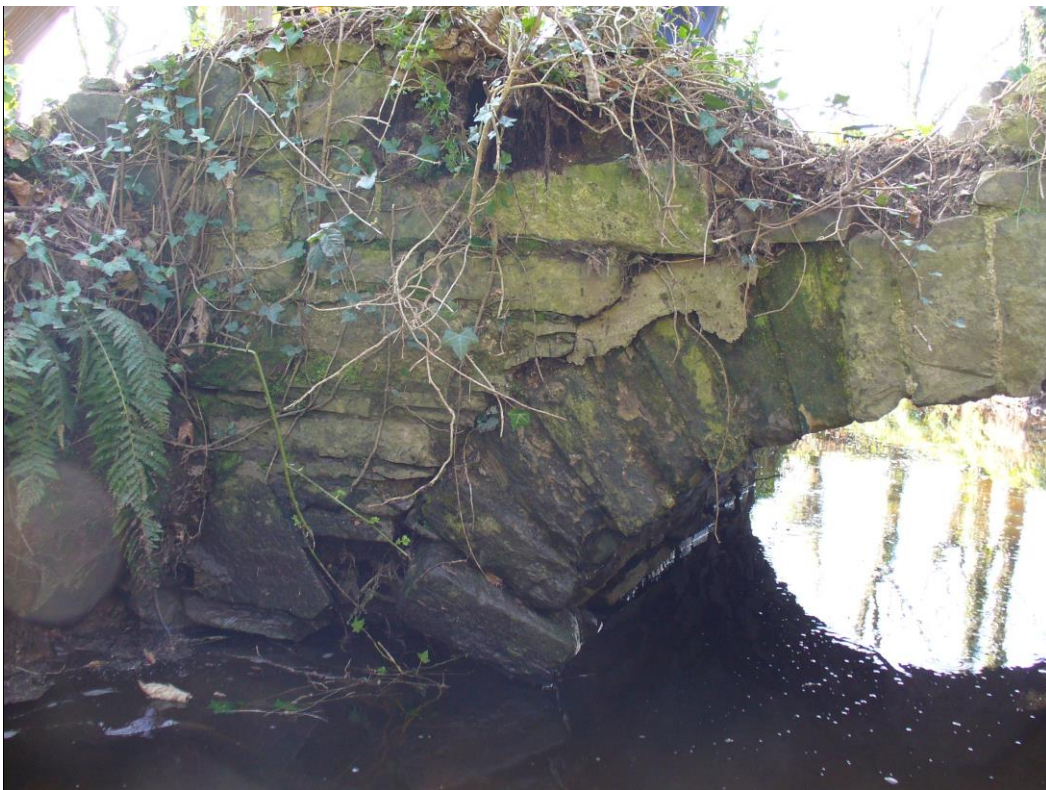
Figure 11: Damage to north face western abutment

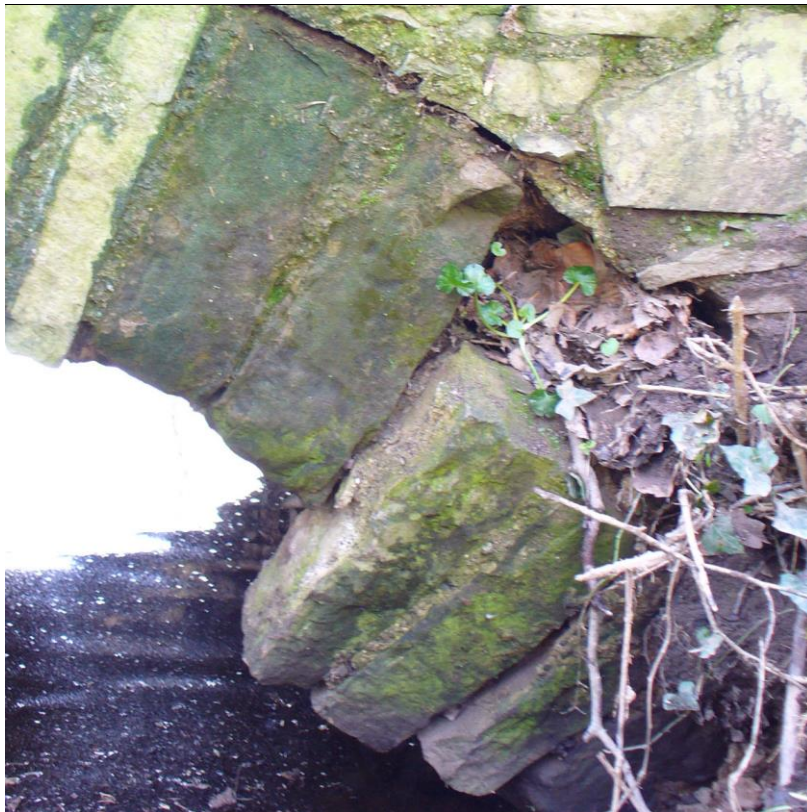
Figure 13: Damage to north-eastern face abutment

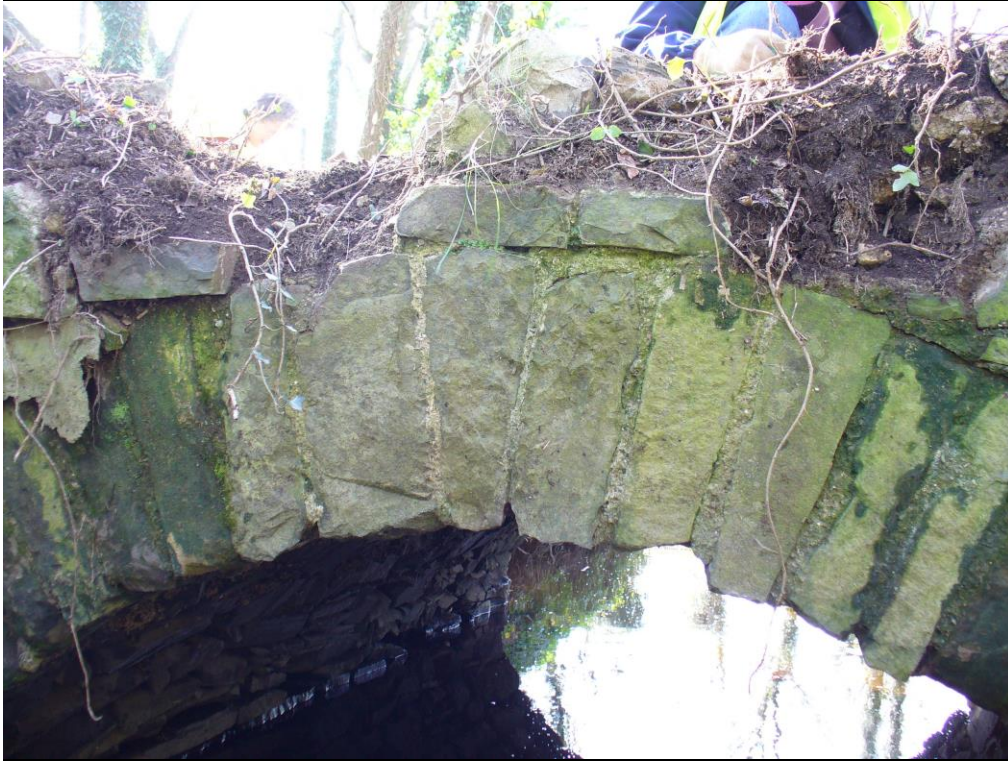
Figure 14: Damage to parapet on north-eastern face

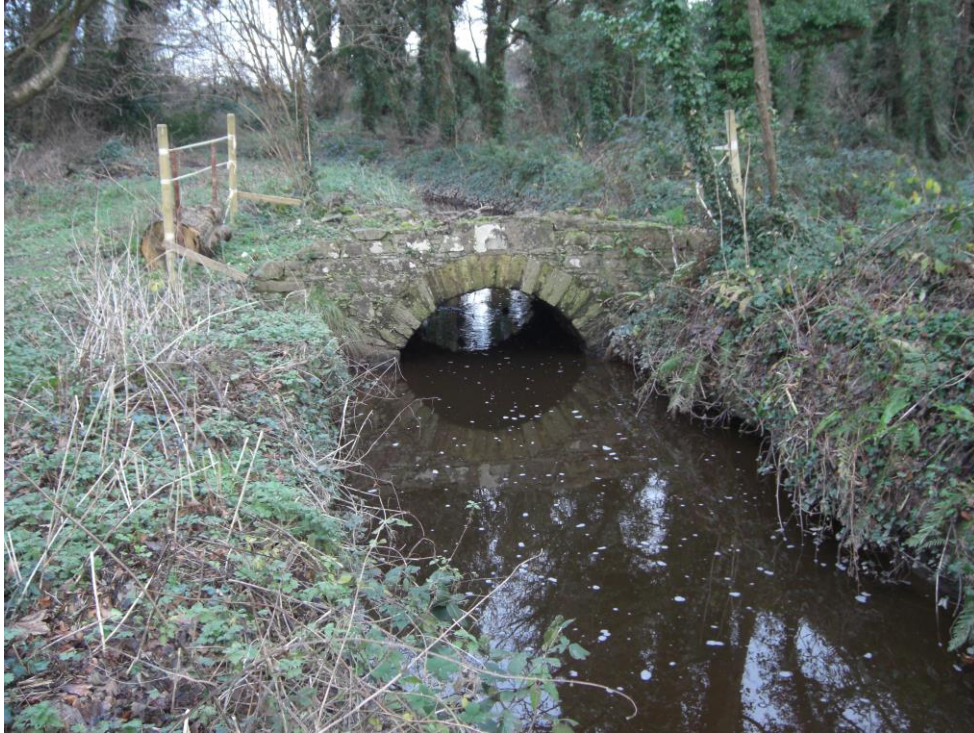
Figure 15: View of bridge with restricted access (December 2015)

Note: Since the survey was carried out, the bridge has been put out of use, by blocking access for vehicles by the placing of a large tree trunk across the approach. There are also warning tapes and notices to prevent pedestrians gaining access. We understand that the National Trust has commissioned an engineer's survey, with the intention of reinstating the bridge.
