ULSTER
ARCHÆOLOGICAL
SOCIETY

Survey Report

Reference: **Survey Report No. 78**

**Survey of Ringneill Quay
Ringneill
County Down**

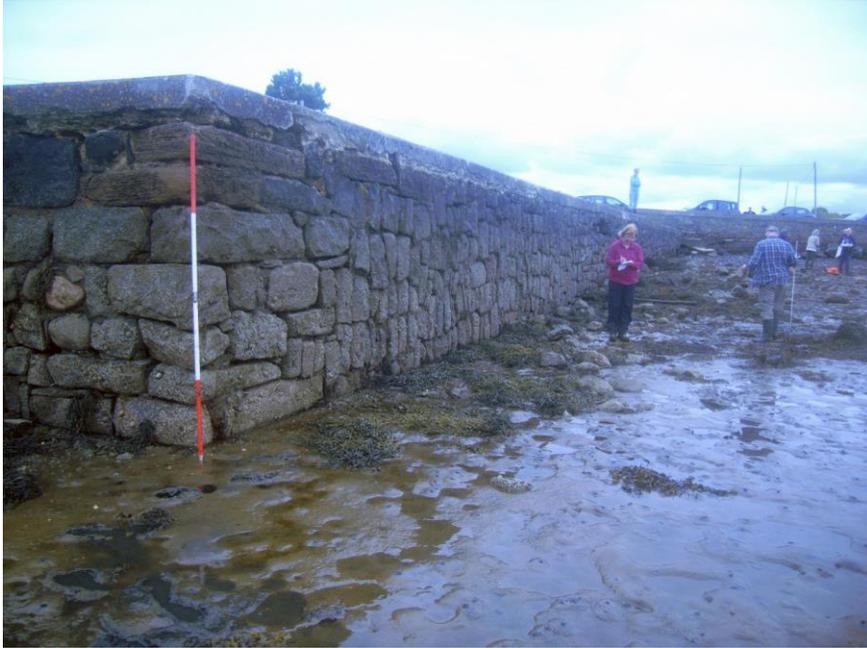
Figure 10: View of north-facing wall of quay, looking west

Figure 10 shows the construction materials and methods of the quay. The seaward end of the quay is formed of rectangular boulders, with some effort made to bond these together horizontally for added strength. This is more obvious at the upper level, where sandstone blocks have been carefully laid for this purpose. However, towards the landward end of the quay, boulders have predominantly been laid vertically, leading to reduced horizontal strength and increased liability to subsidence and collapse.

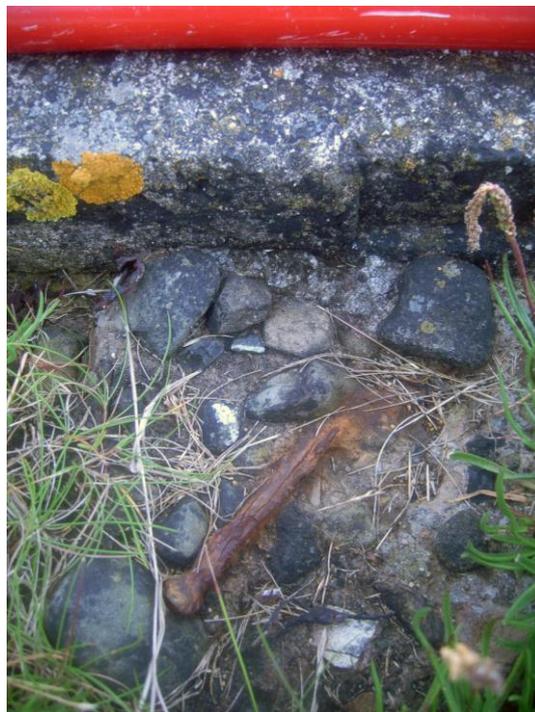
Figure 11: Quay composition materials, including iron nail

Figure 11 demonstrates the materials used to infill the quay, behind the stone external walls. Where it is exposed, this material is predominantly small cobbles, pebbles, sand and earth. It is not clear if there were internal walls to provide support for the external stone walls. Perhaps geophysical survey, such as ground-penetrating radar might provide confirmation of these.

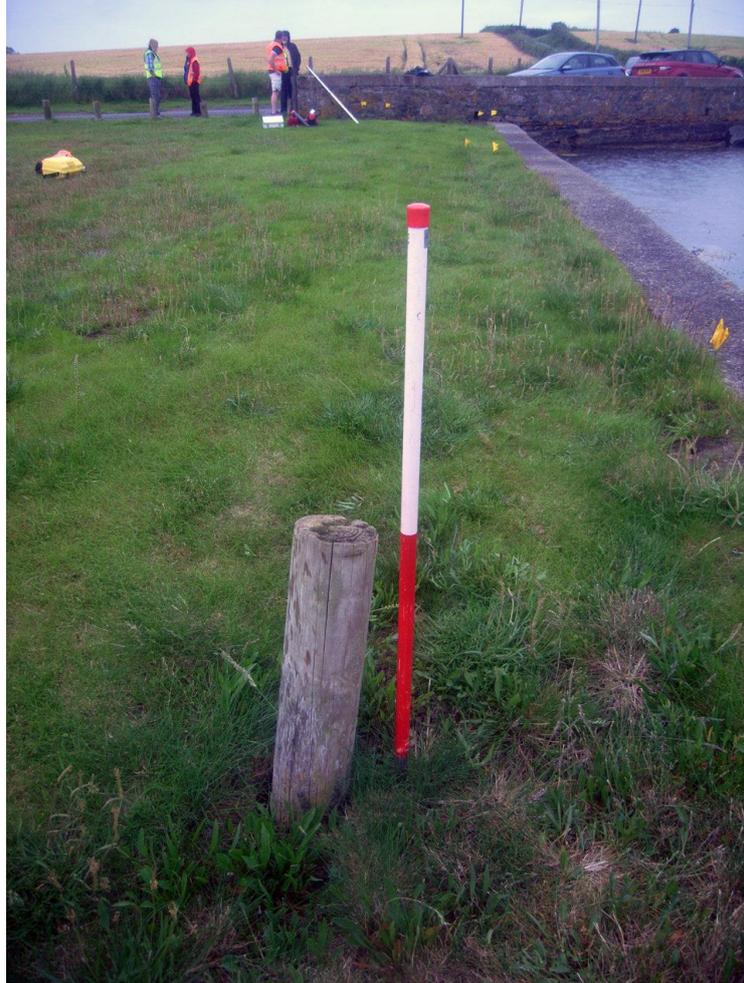
Figure 12: Northern mooring point location (with modern post)

Figure 12 provides a view of the position of one of four mooring points provided on the quay for securing ship's lines. These are currently provided with wooden posts, approximately 10cm in diameter and are clearly modern. A photograph taken of the quay in *c.*1938 (McErlane et al. 2002, 383) shows a ship tied up to the quay, but no bollards are visible. It is likely that the mooring points on the quay, at least in 1938, consisted of steel rings, similar to that investigated on the foreshore during the 2019 UAS survey (Figure 17). These have been removed at some point in the past, presumably after the quay fell out of use.

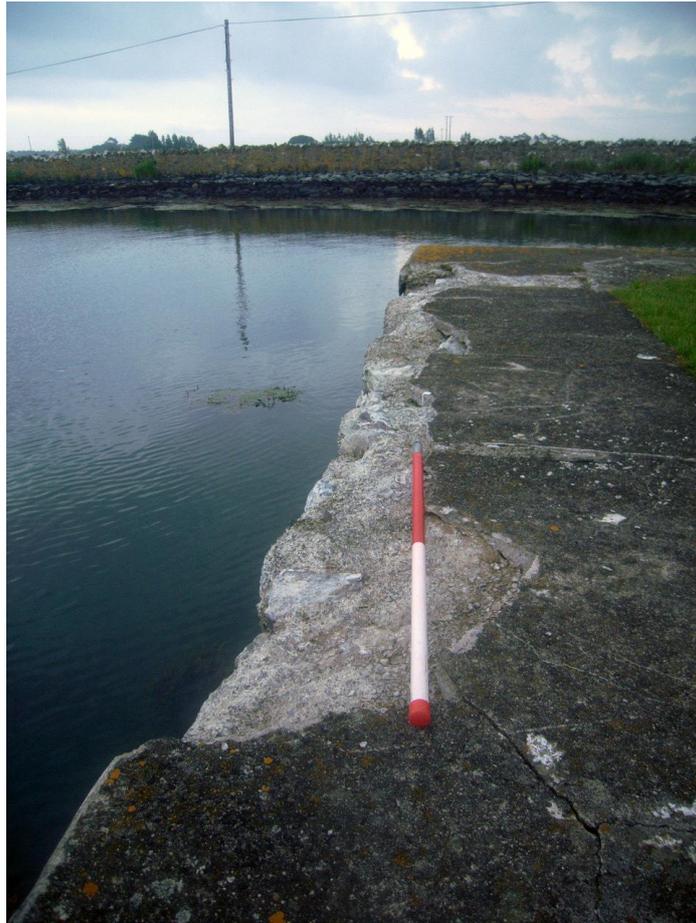
Figure 13: Modern damage to coping on north wall of quay

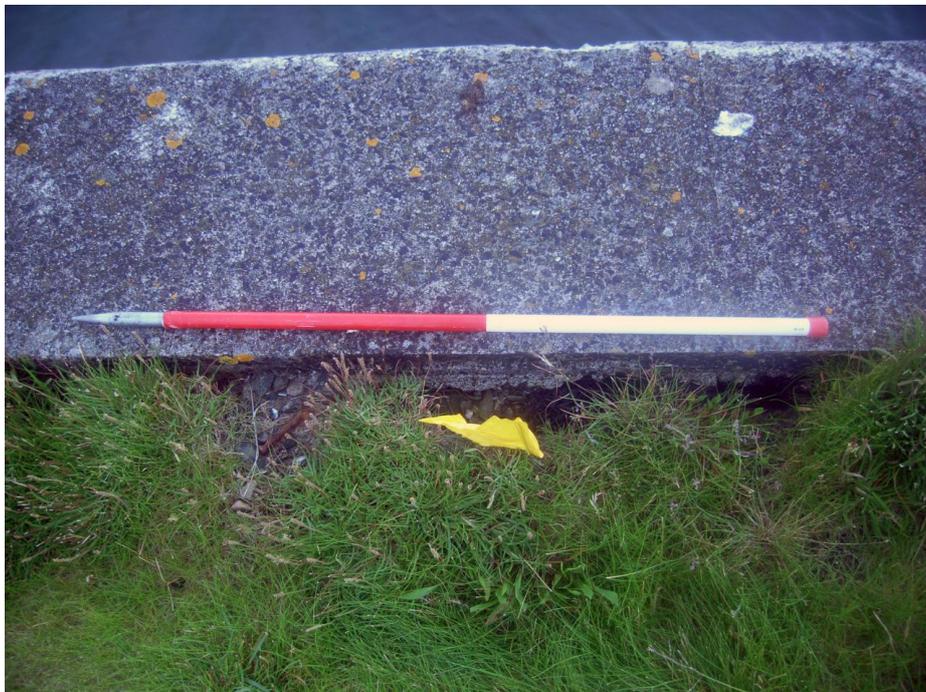
Figure 14: Portion of partial collapse of quay

Areas of partial collapse, visible at ground level on the quay, indicate that the quay was constructed of stone boulders with a rubble and earth infill. There is little evidence of mortar bonding the boulders together and it is presumed this has been gradually washed away. The greywacke boulders are rounded and of various dimensions, suggesting a local origin and little effort has been made to lay these in horizontal layers or bond them together for strength, suggesting the quay was constructed by unskilled workers (Figure 16). Similar methods of construction are visible at the Horse Ferry Slip and the Watch House Quay at Strangford village (McErlane et al. 2002, 241-242). These have also been dated to between 1834 and 1858 and are probably contemporary with Ringneill Quay, perhaps even constructed by the same engineers.

It is clear from the limited survey carried out by the UAS that Ringneill Quay is in a poor state of repair and partial collapse. It will be for the National Trust to decide if the structure should attract the substantial expenditure required to stabilise it and prevent further deterioration.

In any event, it is recommended that regular inspections be made by competent engineers to ensure that the structure remains safe for public access, as it is currently one of the attractions visited by many people in the area.

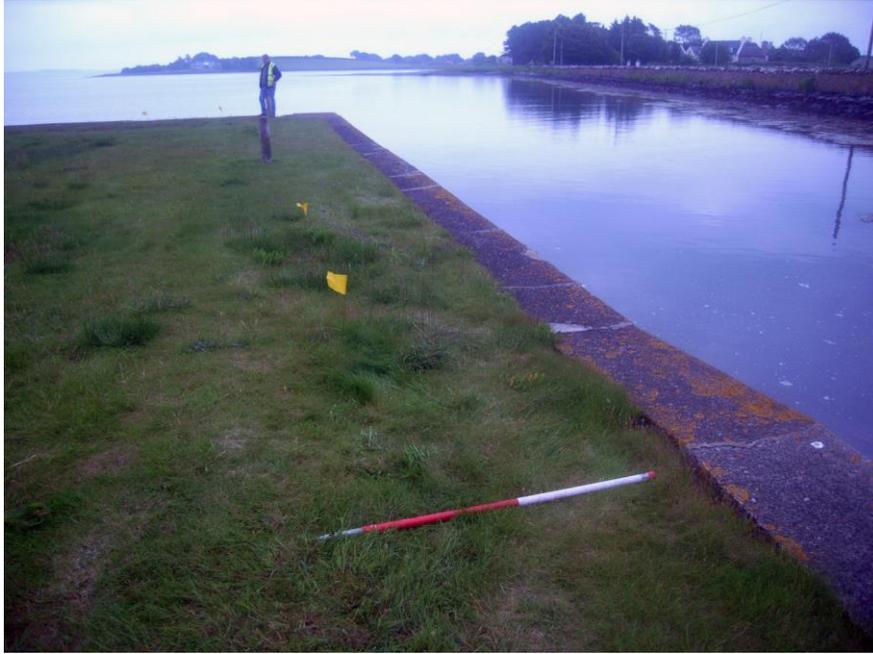
Figure 15: Partial collapse of southern wall of quay, indicated by change of levels in coping. Yellow flags indicate areas of collapse at surface level

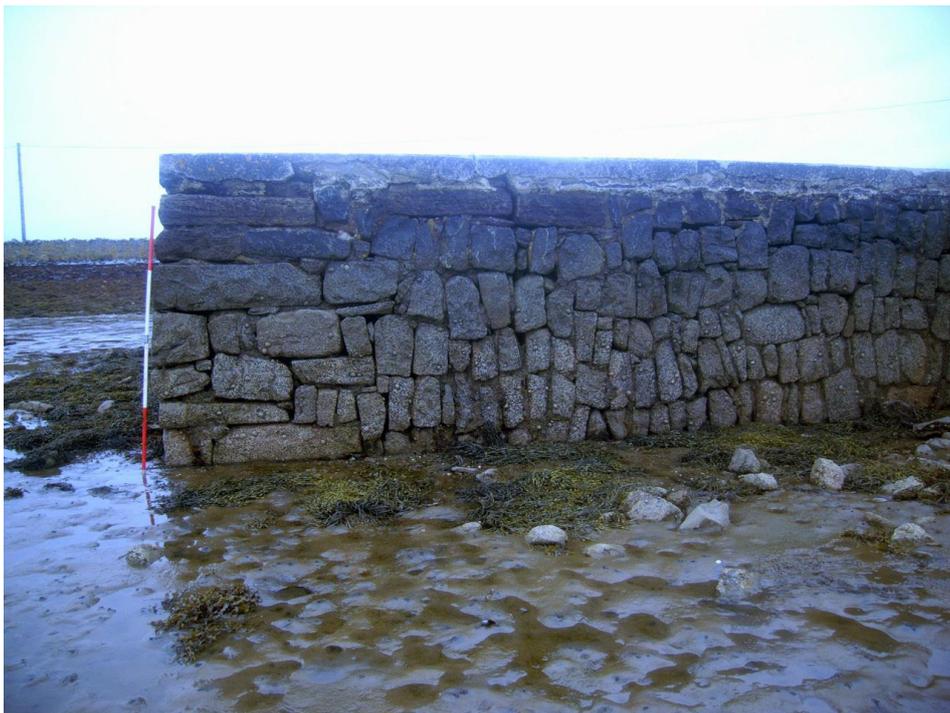
Figure 16: View of north-facing (seaward end) of the quay wall, showing construction materials and techniques

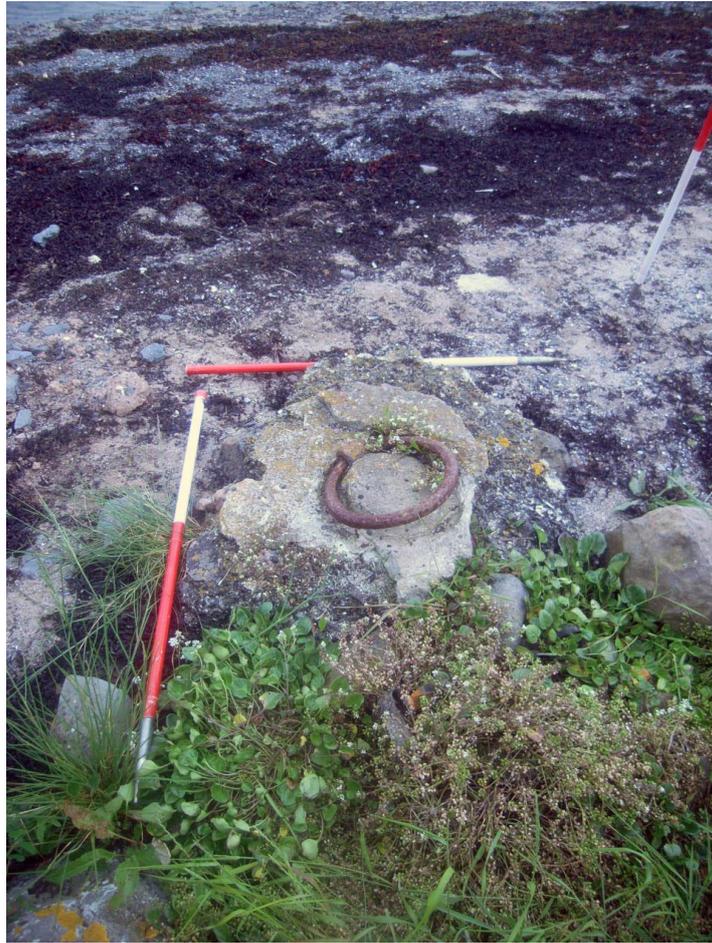
In addition to the four mooring points provided on the quay itself, three other mooring points were observed during the 2019 survey. These included a mooring ring, set in concrete on the shore, some 50m to the north-west of the quay (Figure 17). Two mooring points were observed within the structure of the south-western sea wall and

Figure 17: Mooring ring to the north-west of the quay

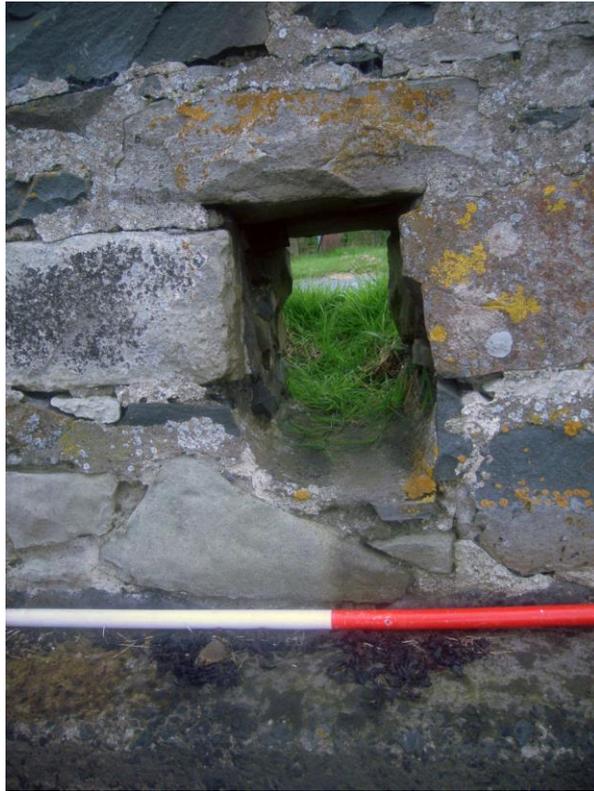
demonstrate rounding by the rubbing of mooring lines (Figures 18 and 19). These mooring points currently serve as drainage channels from the causeway road surface.

Figure 18: Mooring point re-used as drainage channel

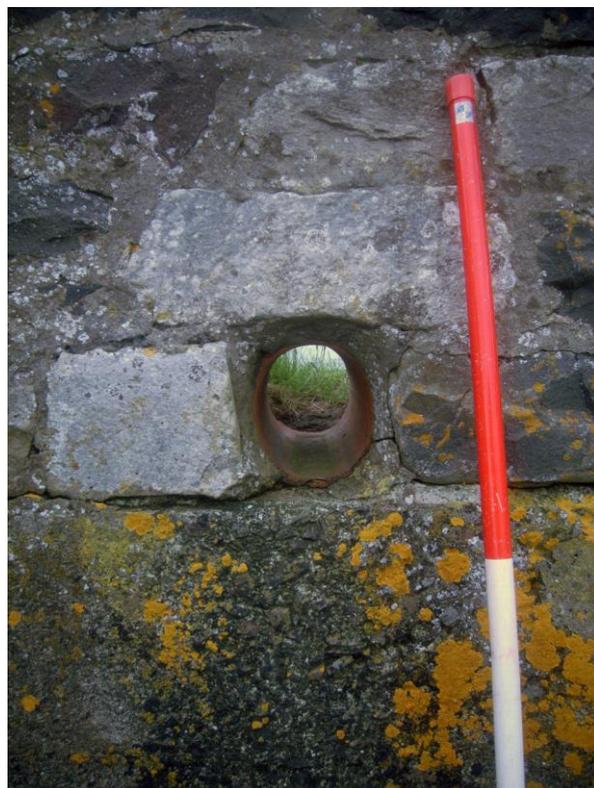
Figure 19: Mooring point re-used as drainage channel
