Survey Report

Reference: Survey Report No. 68

Survey of Revolving Summer House Sea Plantation, Mount Stewart, County Down In association with: **National Trust**

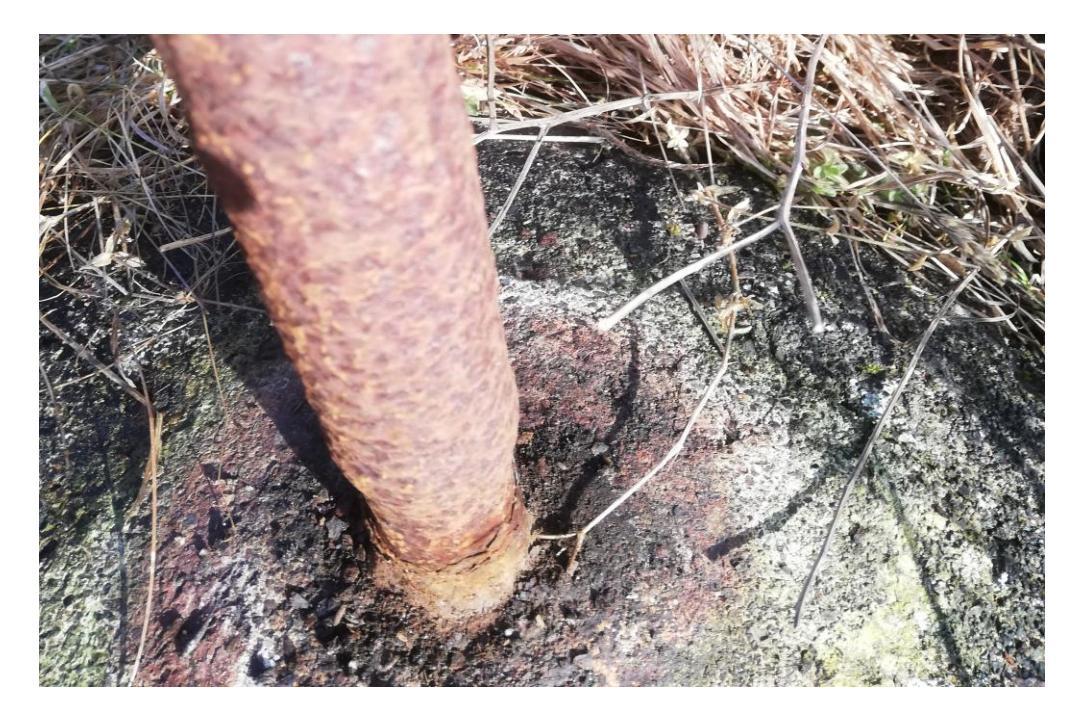
Fig 12 Close up of the base of the axle showing corrosion

4.2 The visible remains of the summer house are the protective wall around it, which still has a complete finished surface, the circular platform of the summer house, with the circular iron rail, and the central iron axle for the revolving mechanism, which shows

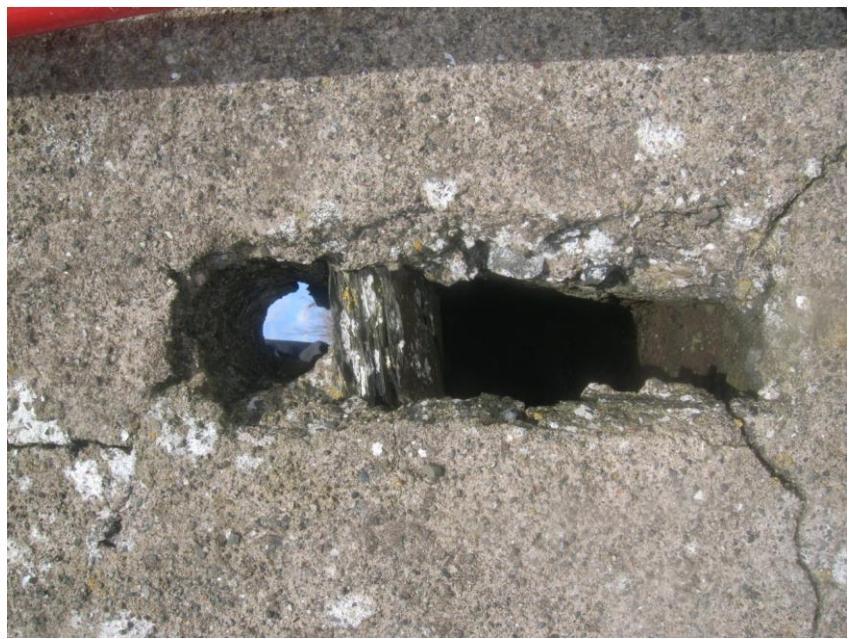
Fig14 Hole in the wall showing cracks going right through the wall.

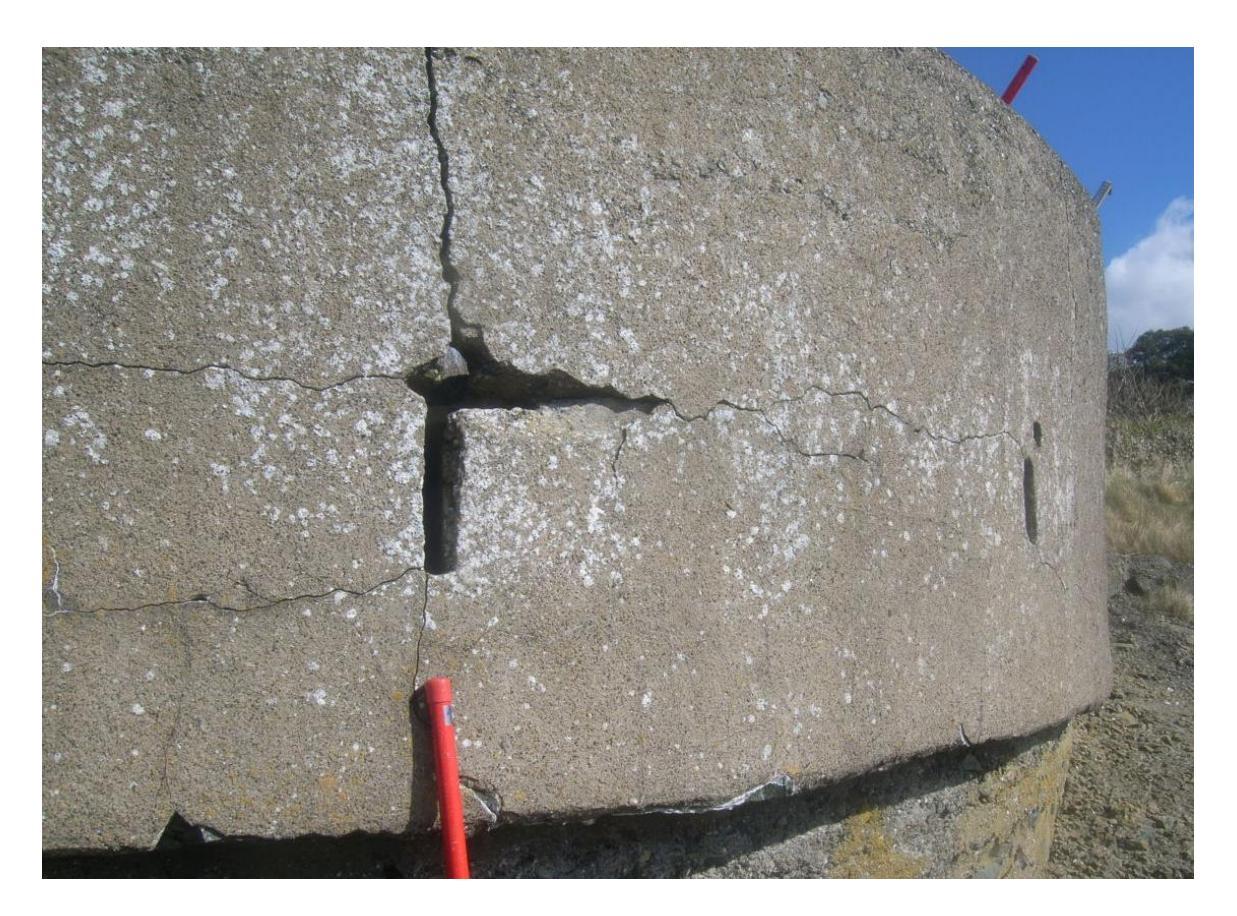
Fig16 Cracks going three ways, vertical and horizontal. The horizontal cracks follow the junction of the protective wall and the platform.

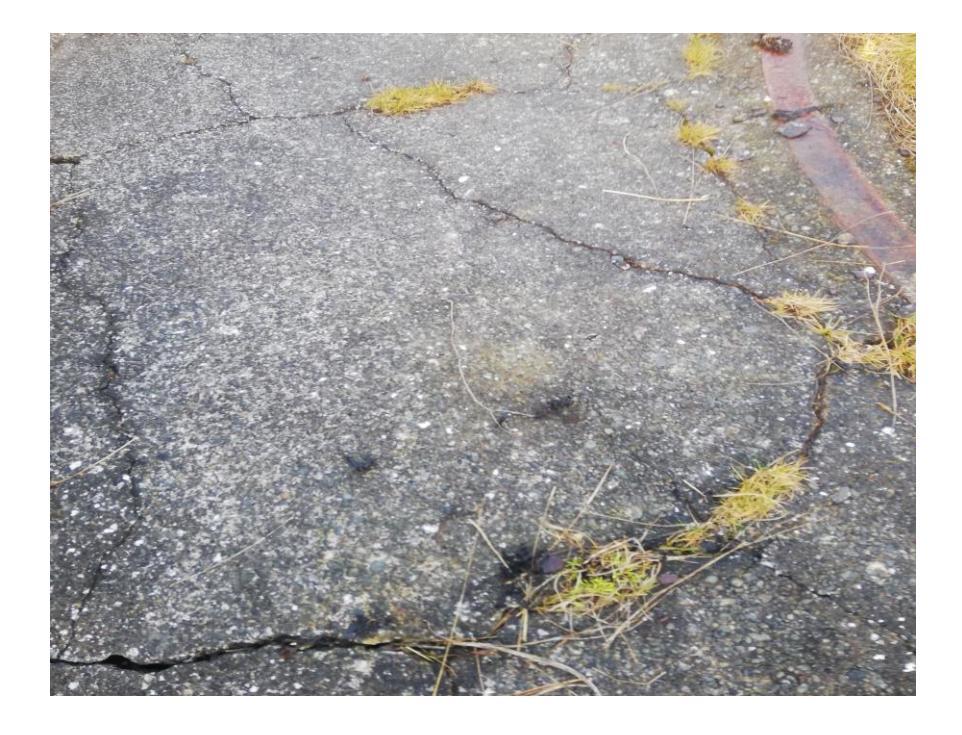
Fig 17 Cracks on the concrete circular platform for the summer house near the iron rail

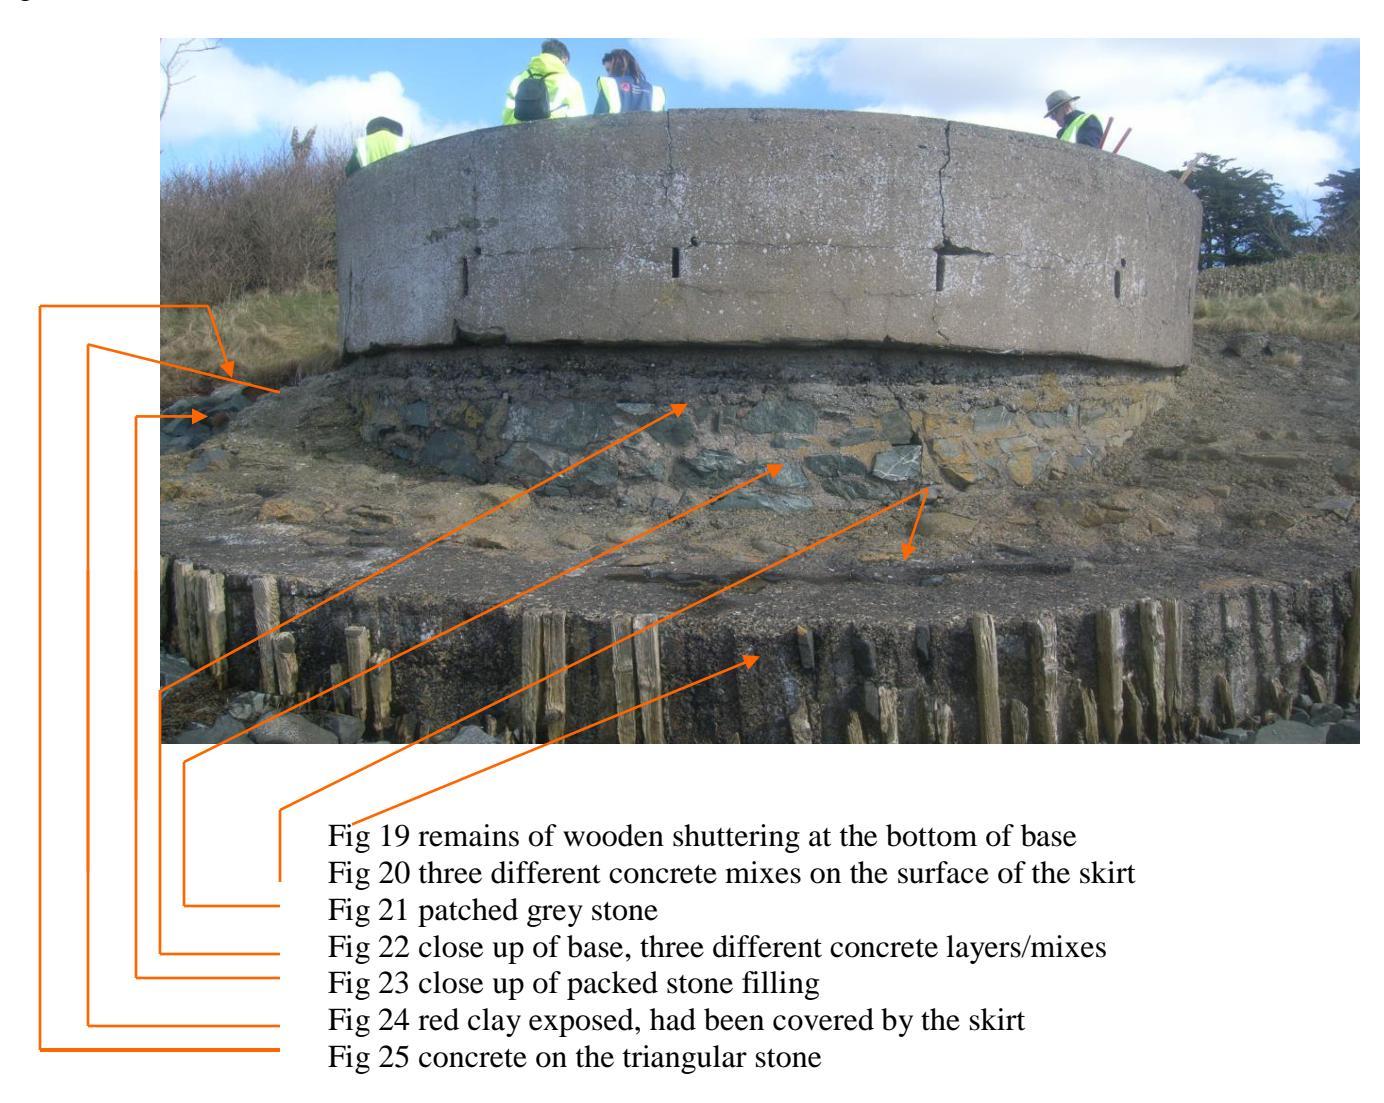
Fig 18 the summer house base foundation

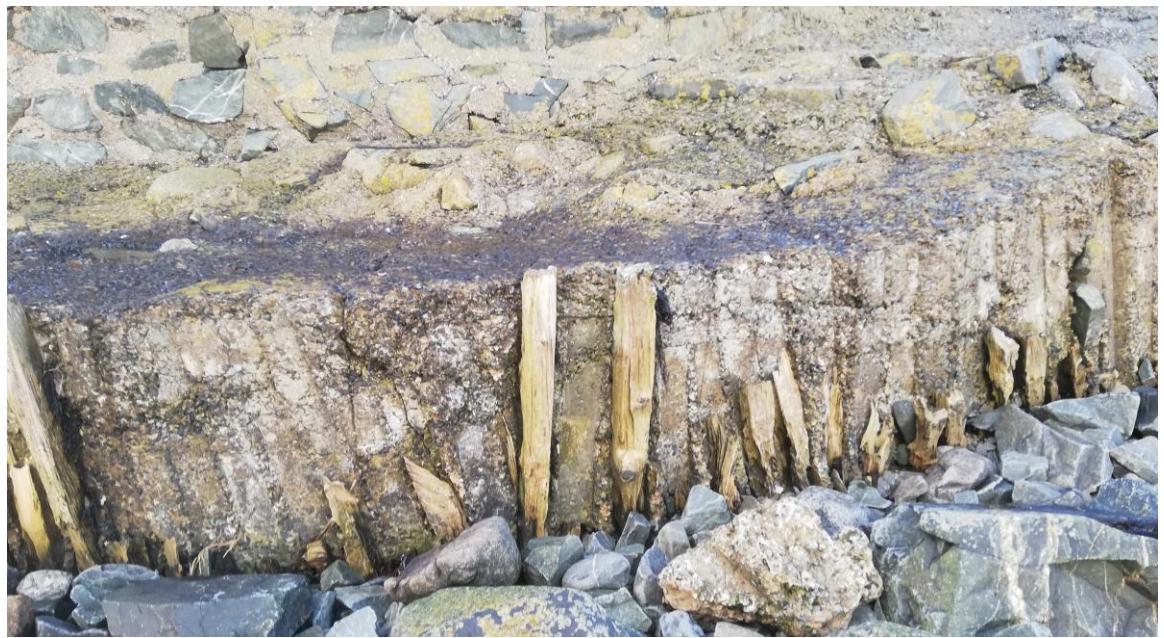
Fig 19 remains of wooden shuttering at the bottom of the base. Again note the layers of different concrete

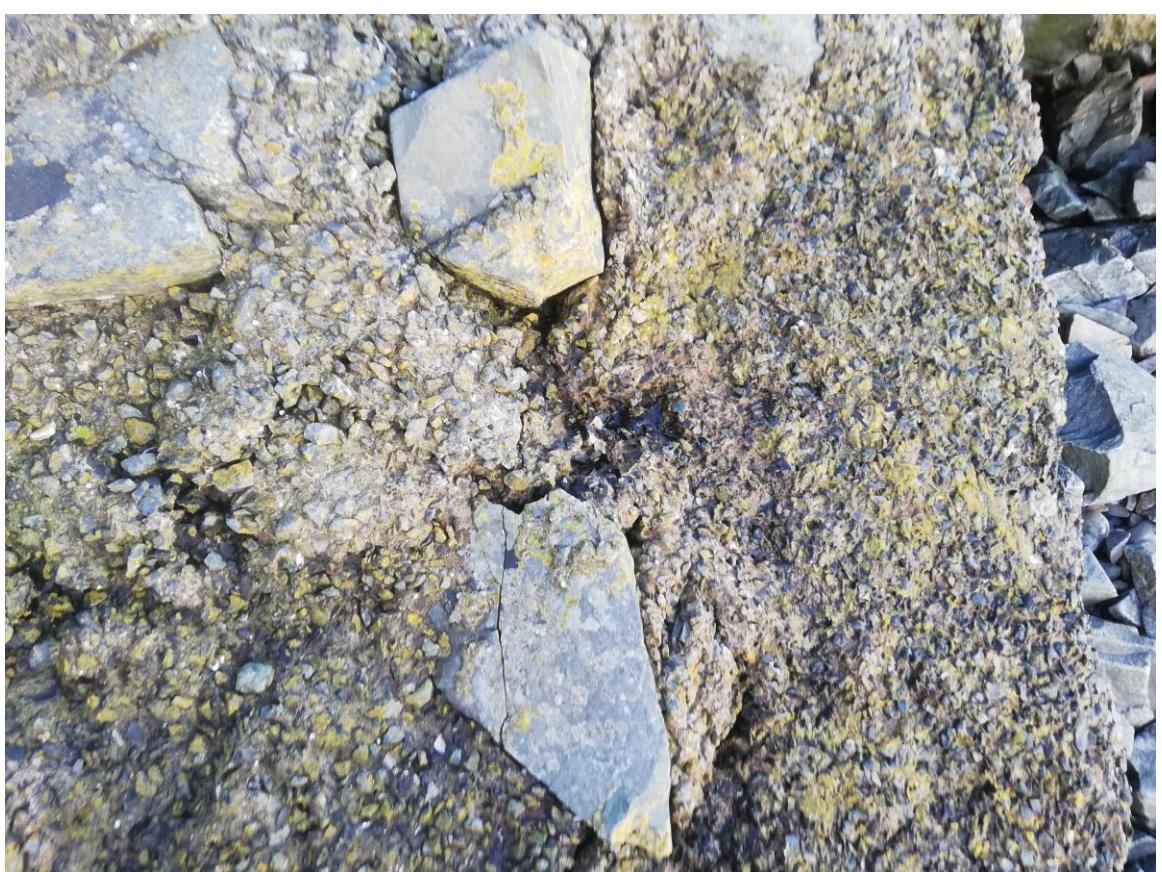
Fig 20 three different concrete mixes on top of base skirt. Note the crack in the stone at the bottom of the picture.

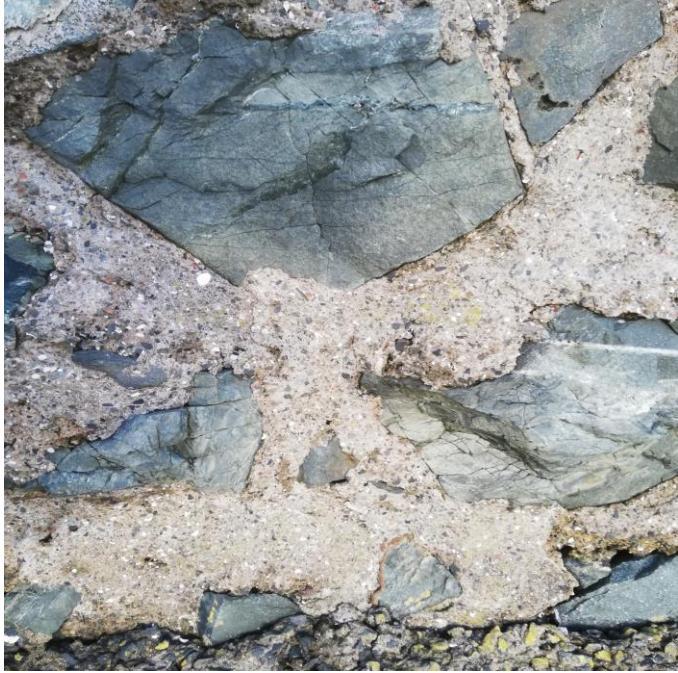
Fig 21 Patched grey stone work, patches at different times

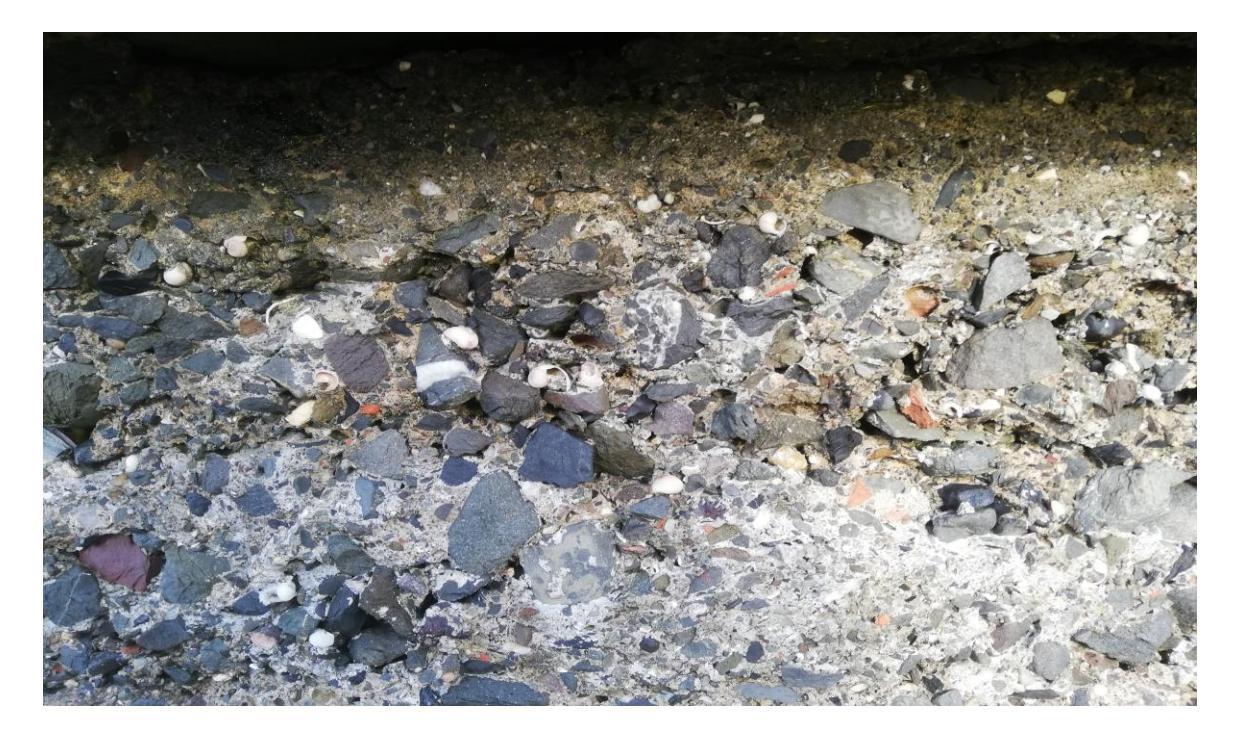
Fig 22 Close up of base, three different concrete mixes, very poor quality aggregate including seashells.

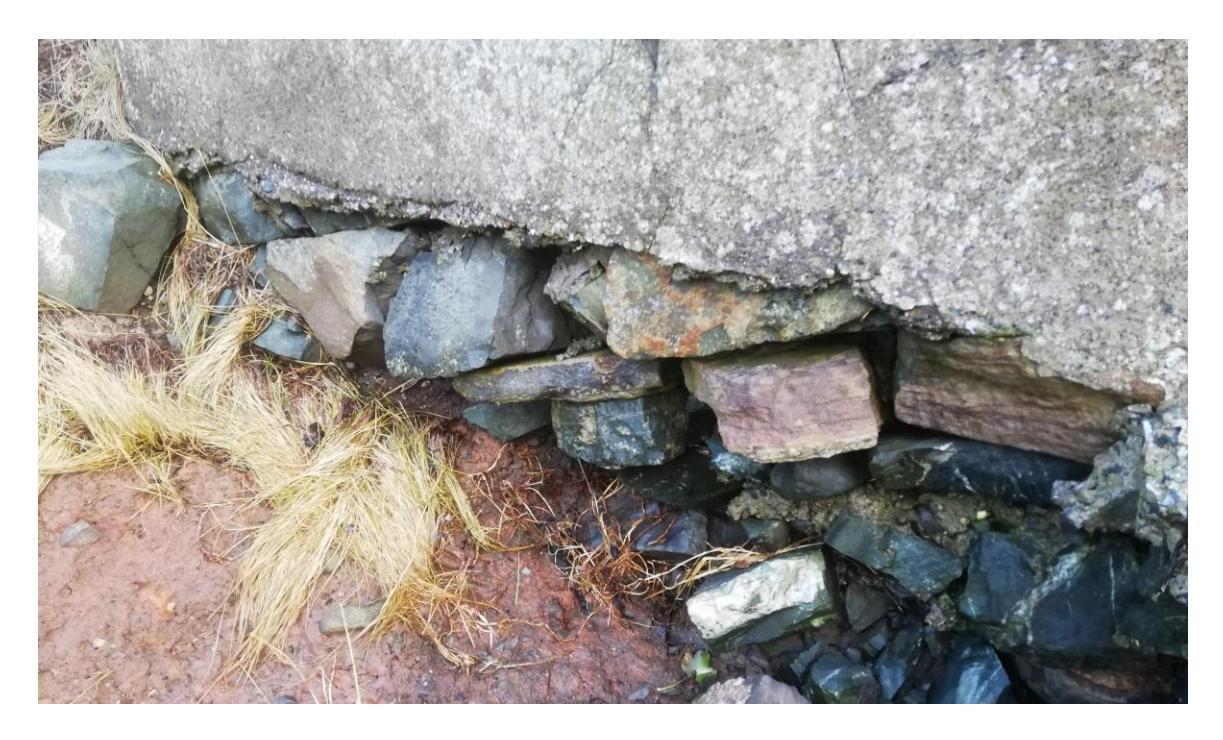
Fig 23 close up of packed stone filling a gap at the clay bank, where the base has been undermined.

signs of corrosion. Below the wall from the bank to the shore, the base of the whole structure is being undermined, especially at the edge of the red clay bank. There are layers of concrete patched and cracked in places, in other places the volume of concrete has been increased by inserting quite large stones and the area has been patched with concrete with, poor quality aggregate. The remains of the wooden shuttering used at the bottom of the base structure are still visible. It is doubtful that what is visible below the surface of the platform was provided by a civil engineering contractor, such as was employed in the original construction of the pool complex.

It is recommended that consideration be given by the National Trust to stabilising the existing revolving summer house structure before it is lost completely. It seems likely that further images and documentary evidence for the construction and use of the revolving summer house are available in the archives of the National Trust and at the Public Record Office for Northern Ireland. Time constraints prevented further research at the time of this report. There may also be research material for old features of the Mount Stewart estate such as the dove cote, stables and gas works.

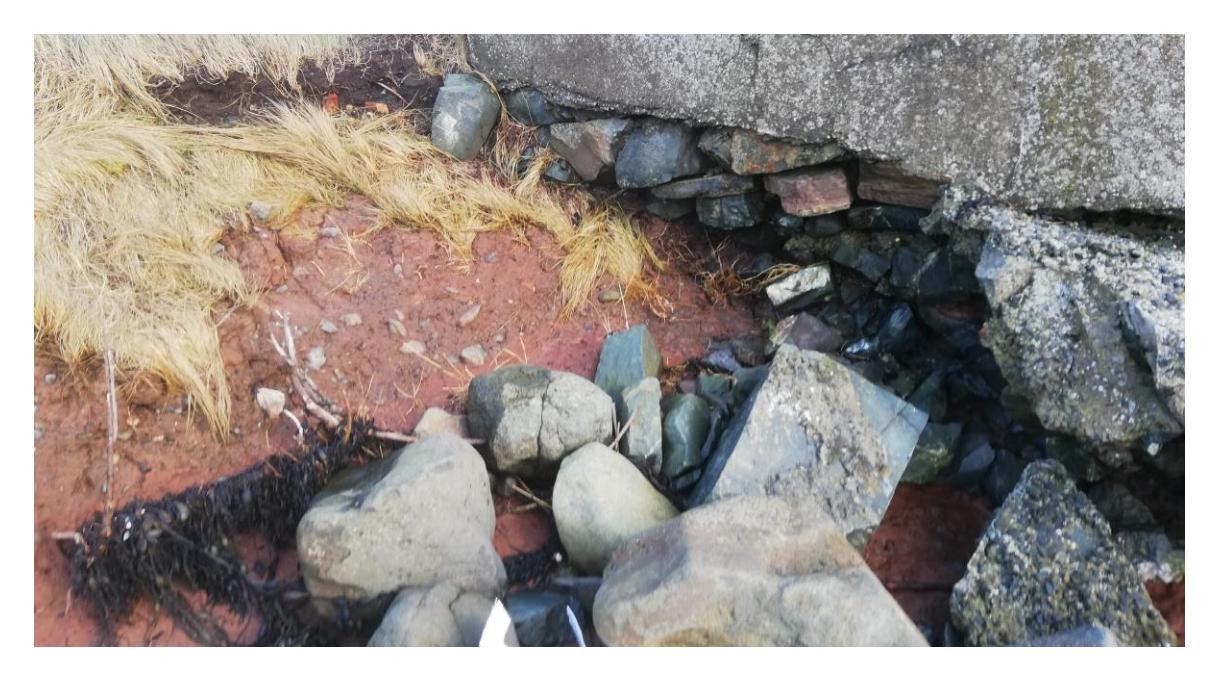
Fig24 Red clay exposed, which had been covered by the skirt.

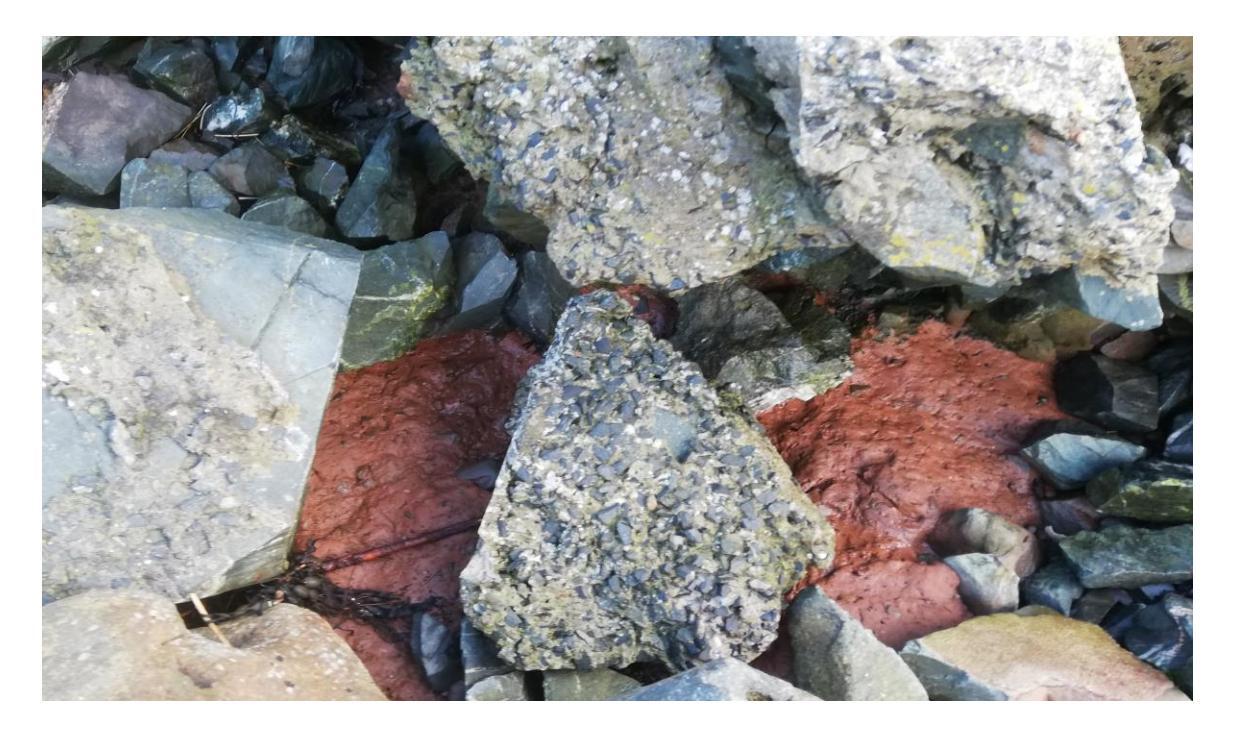
Fig 25 the concrete on the triangular stone is the same as on the adjacent stones on the surface of the skirt, showing that everything from below the surface of the skirt to the clay layer has been washed out.

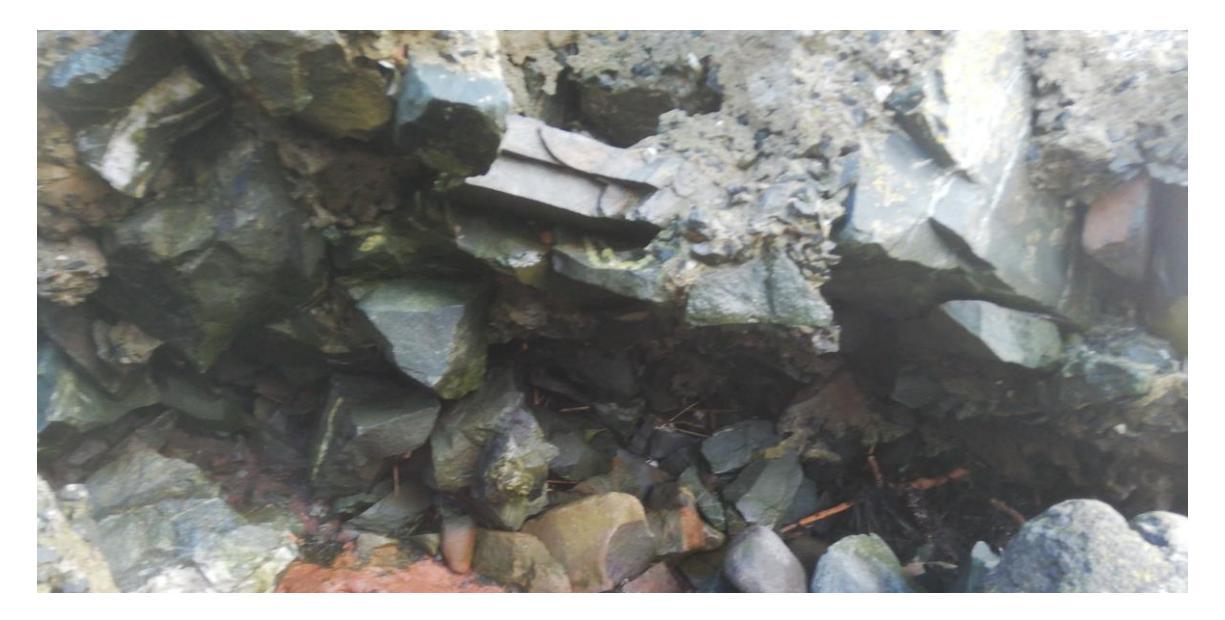
Fig 26 More undermining of the base, east of Fig 24

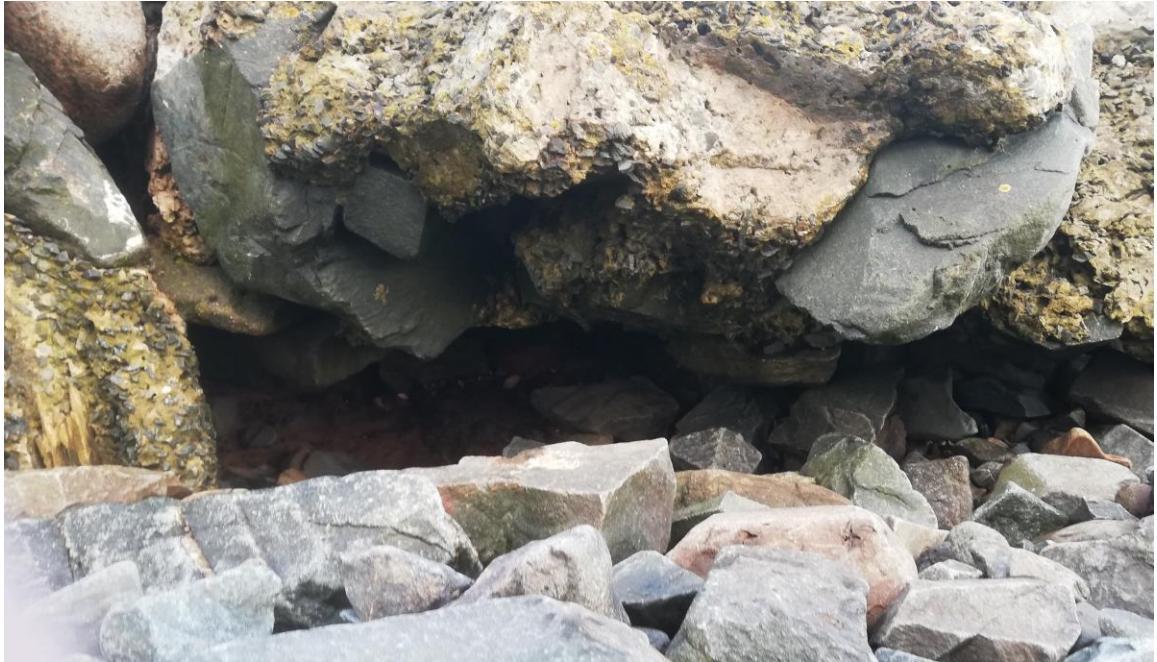
Fig27 Undermining at the east side of the skirt. The eastern side of the base skirt is in similar condition to the west side.

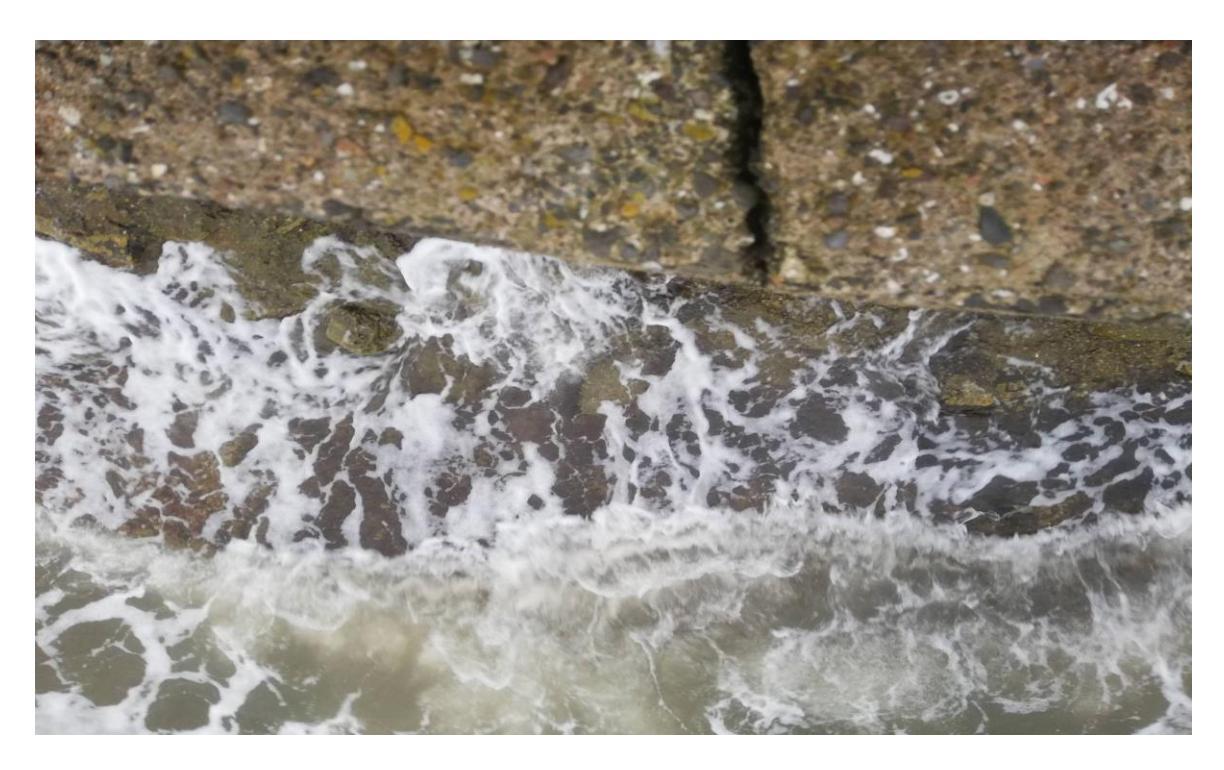
Fig 28 Waves covering the base on a normal tide.

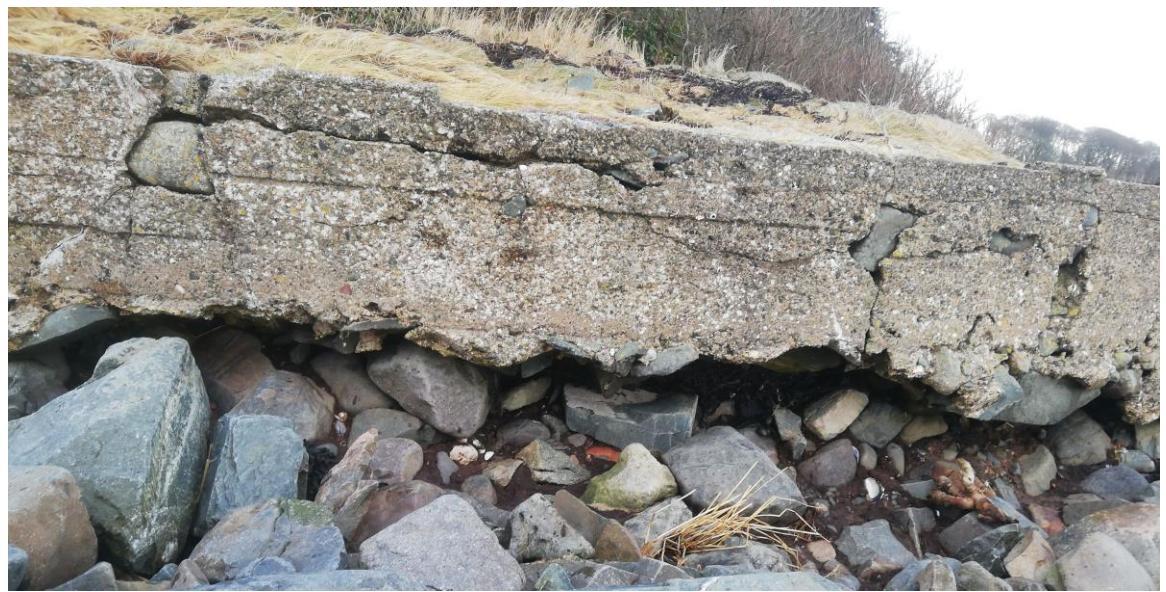
Fig 30 Undermining of the base of second summer house
