**Monitoring Report No. 17**

**WOODGRANGE TOWER HOUSE  
WOODGRANGE  
COUNTY DOWN**

**AE / 04 / 153**

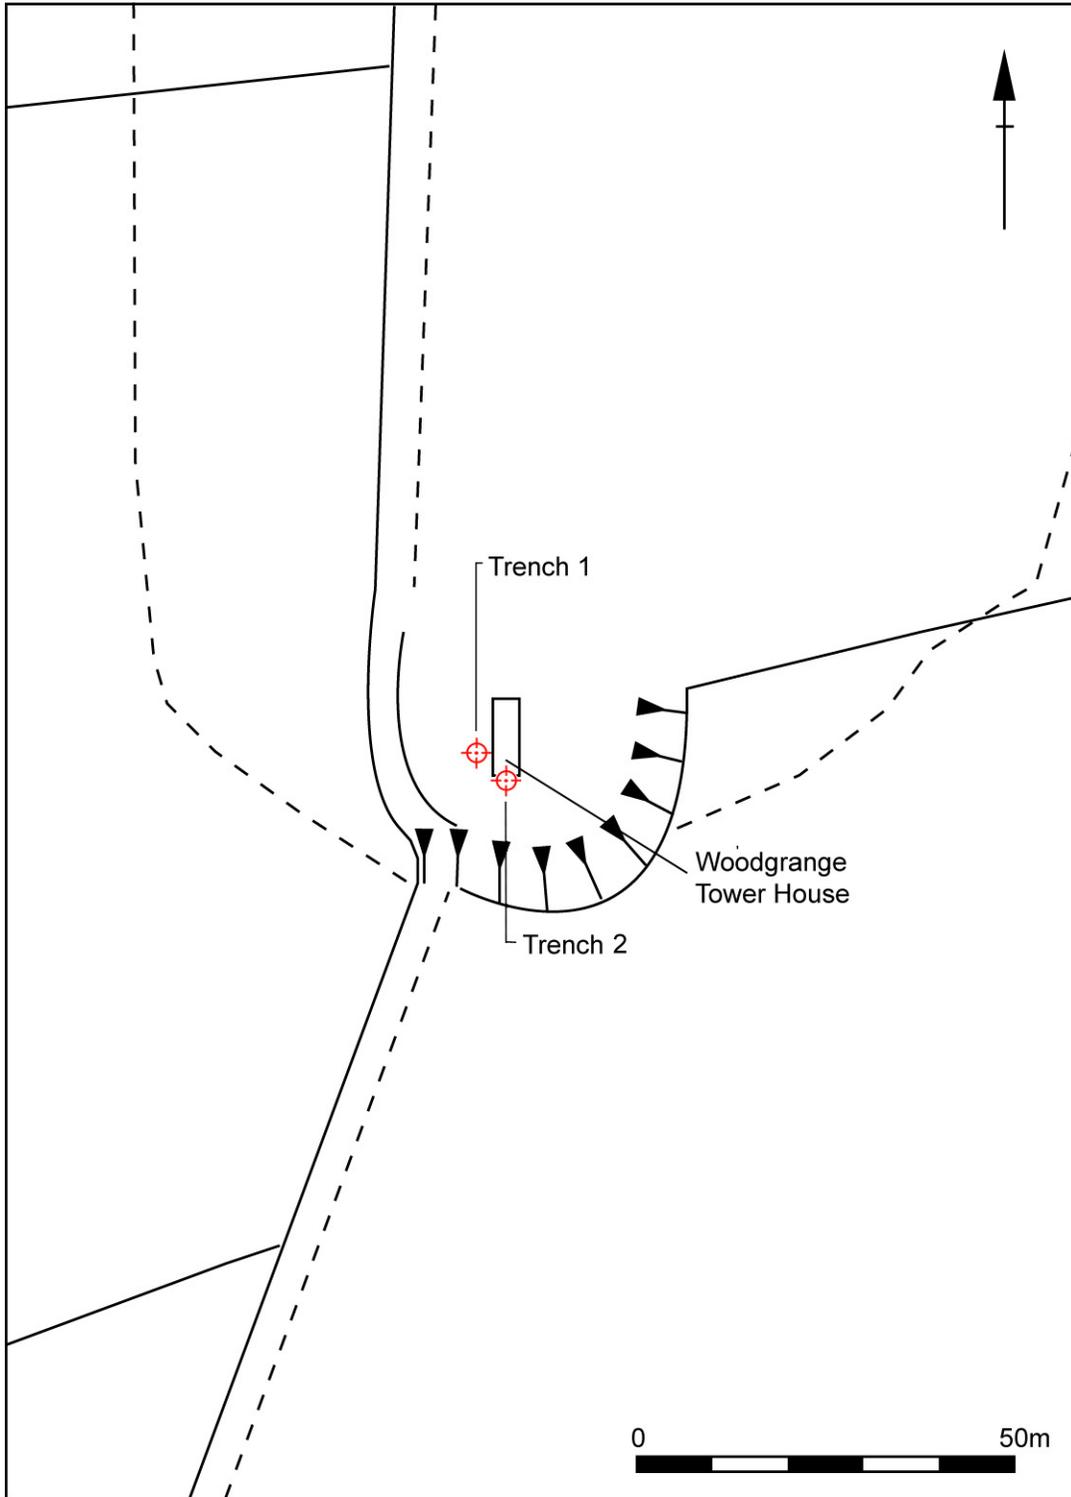
Figure One: Plan showing location of Woodgrange Tower House, Co. Down, and location of Trenches 1 and 2.

Test-trench and monitoring was conducted in advance of structural consolidation of monument; consolidation work will involve excavation of foundations for supporting wall to carry overhanging masonry at south and west of existing wall (Figure One; see SMC). The work was undertaken in two phases, as outlined in License Application (Section 14). It was agreed that, prior to foundation excavation, a test-trench (Phase 1: Trench 1) would be excavated to west of wall, in order to investigate the nature of underlying deposits, and to assist in predicting likely foundation depth required for consolidating wall. No archaeological features or artefacts were identified. Subsequently, excavation of wall foundation (Phase 2: Trench 2) was monitored; similarly, no archaeological features or artefacts were found.

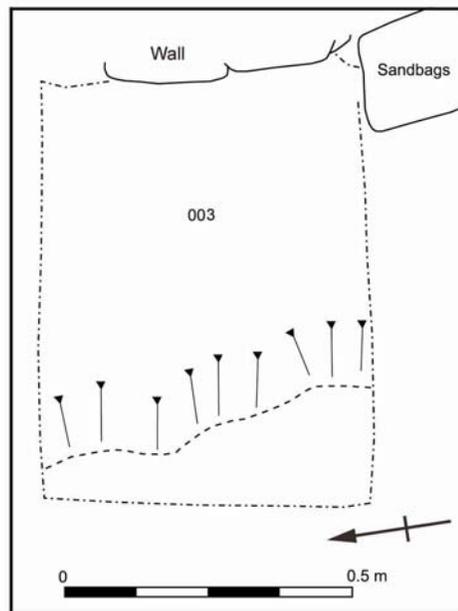
Figure Two: Plan of Trench 1 after excavation, showing westerly slope of natural subsoil (C003). Trench 1 extended westward from the west face of the structure.

Phase 1: A preliminary test trench measuring <1m (north-south) by 1m (east-west) was opened to the west of the existing wall (Figures One-Three; Plate Two). The excavation of this test trench was intended to clarify the nature of the underlying soils, with a view to predicting the likely foundation depth required for consolidating the structure.

A thin layer of mortar debris (C001: c 3cm) was removed to reveal a thin deposit of topsoil (C002: c 5-8cm), which was then removed to immediately descend onto an extremely compact, natural subsoil (C003). No archaeological features or artefacts were identified. The integrity of underlying deposits to the west of the wall had therefore been ascertained, suggesting that similar stratigraphic remains may be encountered during the excavation of the footprint (Trench 2) for the support wall. The compactness of the subsoil was such that it was considered suitable for foundation, and should similar deposits be found in Trench 2, then little excavation would be required.

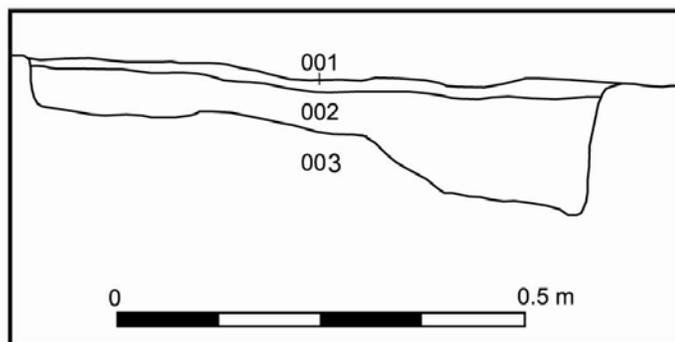
Figure Three: North-facing section, Trench 1, showing shallow deposits of rubble/mortar debris (C001) and topsoil (C002), overlying natural subsoil (C003).

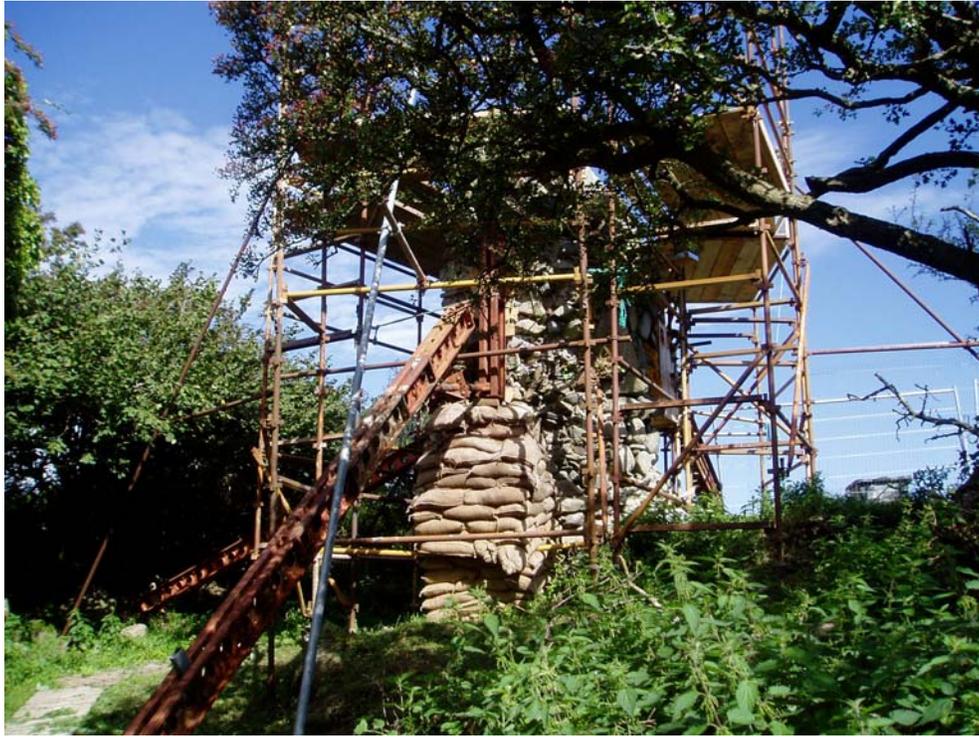
Plate One: Woodgrange Tower House: from south, prior to monitoring.

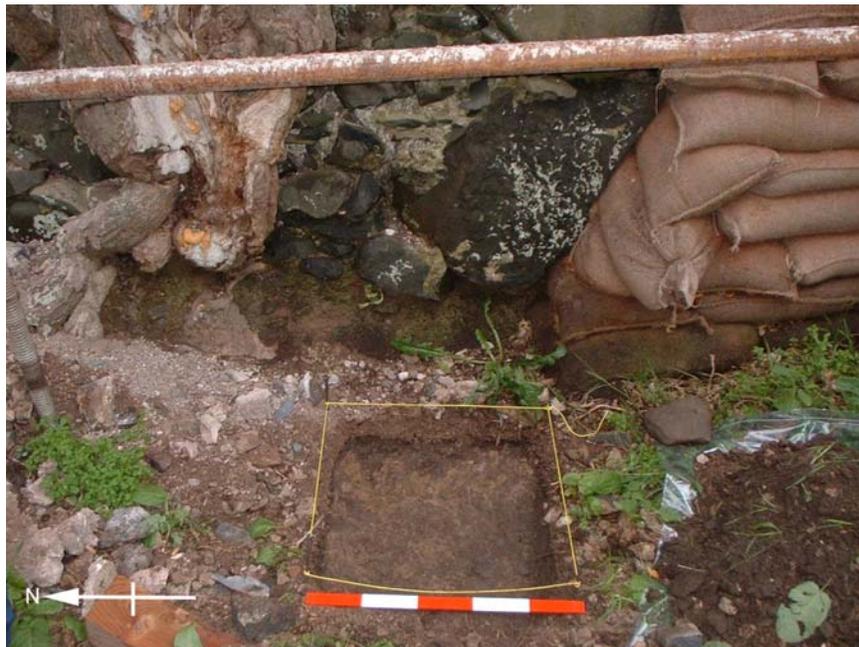
Plate Two: Phase 1: Trench 1 Post-excavation, showing excavation to subsoil (C003) facing east.

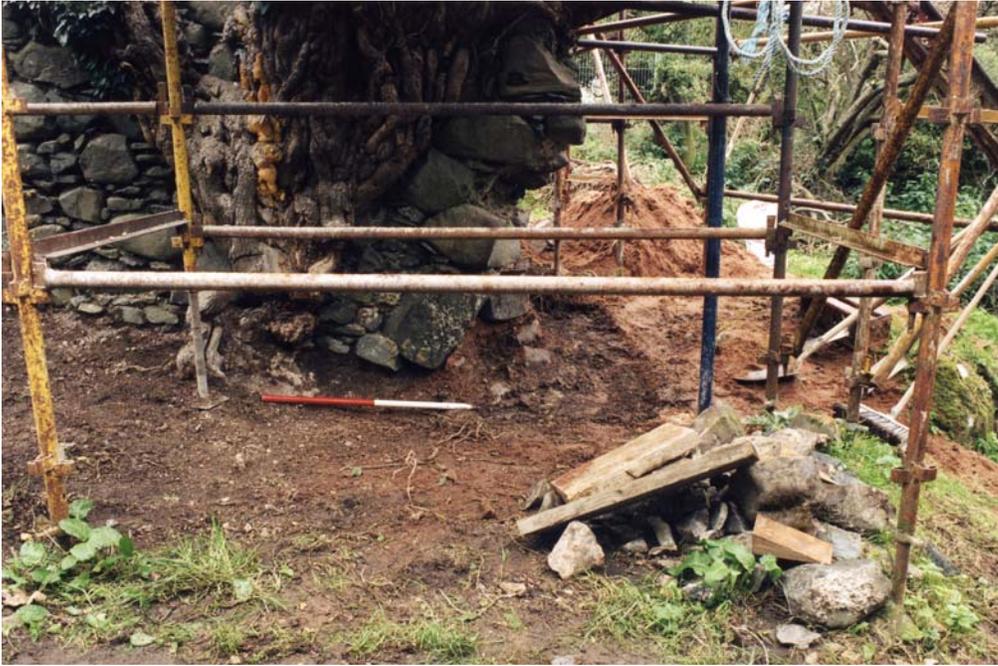
Plate Three: Phase 2: Showing area to be monitored, beneath overhanging masonry.

Prior to archaeological monitoring, the supporting sand-bags were removed, and the area cleared of mortar debris/rubble (C001) by the PHM District Labour Force (Plate Three). The extent of excavation was dictated by the requirements of the footprint for the new wall, and depended upon the density and strength of underlying deposits. A thin layer of topsoil (C002: c 5-8cm) was removed to reveal an extremely compact, natural subsoil (C003) at a depth of less than 10cm (Plate Four). Given the fortitude of the subsoil deposits, it was agreed that an excavation measuring approximately 1.5m (north-south) by 1.5m (east-west) in which only topsoil was removed, would be

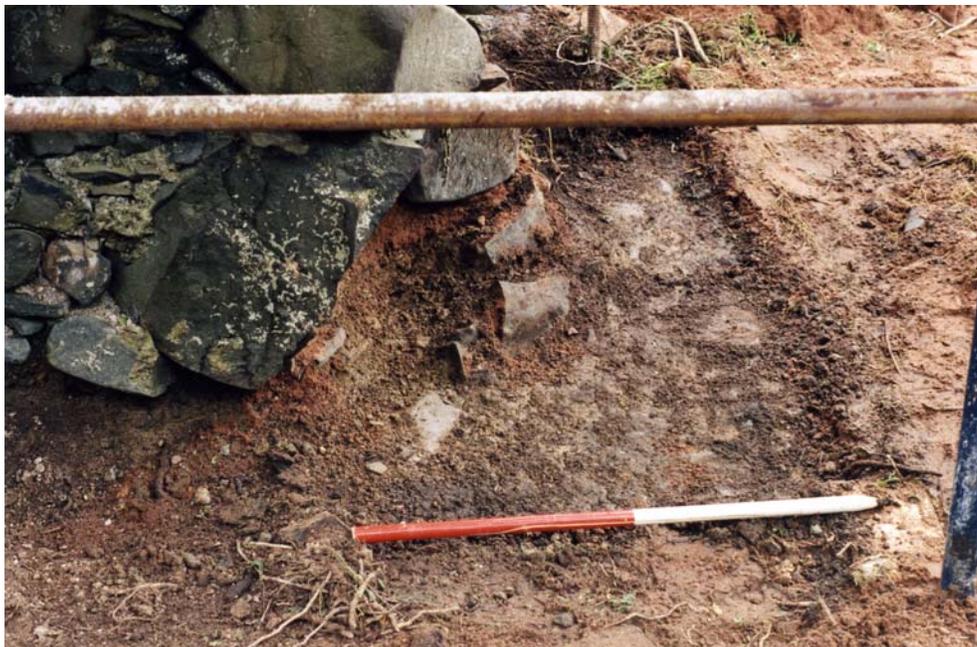
Plate Four: Phase 2: Trench 2 Post-excitation, showing excavation to subsoil (C003), facing east.

sufficient to provide foundation for the new supporting wall. The excavation was undertaken and completed by staff of the PHM District Labour Force, using long-tail shovels, and monitored by the License holder. Due to the instability of the structure, however, personnel were not permitted to enter Trench 2 in order to undertake a drawn record of the excavation, and it was felt that a photographic record of the excavation of Trench 2 would suffice.
