Development Control Report No. 299

**200 metres north of 11 Castleraw Road
Castleraw
Co. Armagh**

AE/10/179

Summary for Incorporation into the SMR Database

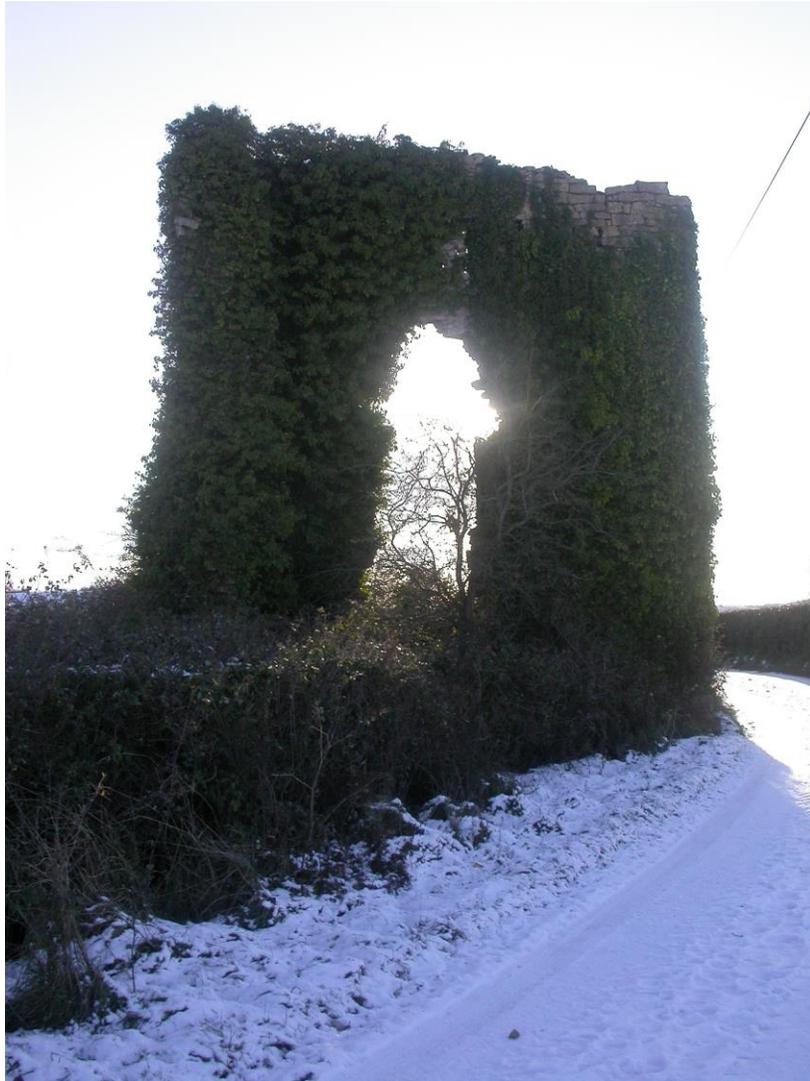
Figure One: The ruined remains of the fortified house at Castleraw from the adjacent lane, looking south (1.12.10).

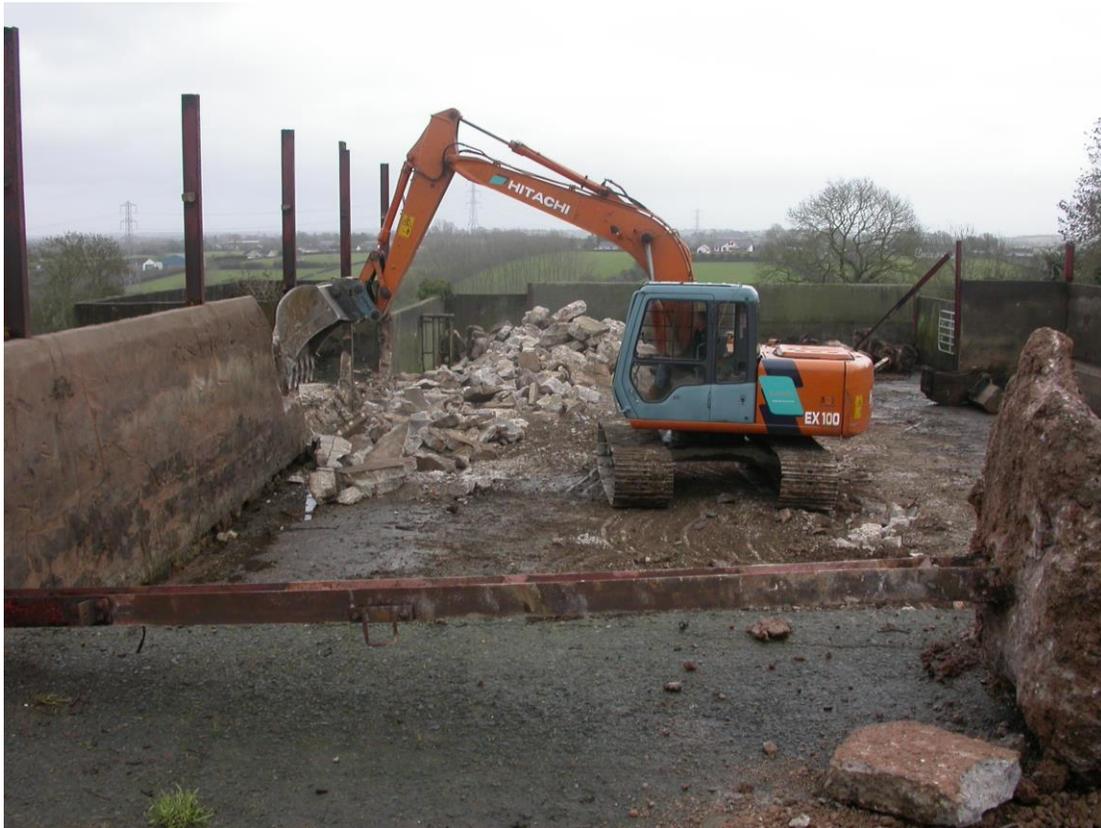
Figure Two: Demolition of the barn in progress, looking east (12.1.11).

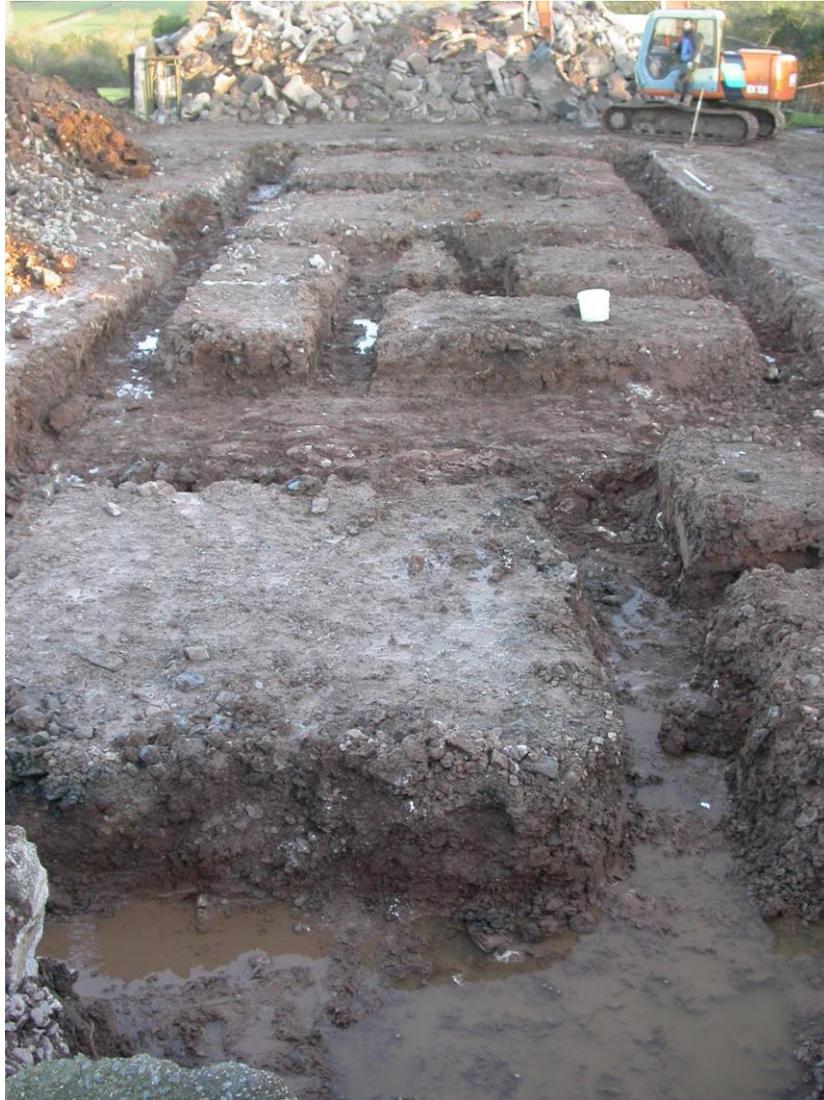
Figure Three: The development site following the excavation of the foundation trenches through the hardcore deposits underlying the removed floor of the demolished barn, looking east (18.1.11).

Given the truncation of the ground surface associated with the construction of the terrace that the barn and attached yard were built upon, most of the area occupied by the barn and yard represented a zone of archaeological destruction, although the built-up area beneath the southeastern corner of the yard formed an area of preservation where archaeological features, if they were present, might reasonably be expected to survive. The footprint of the replacement dwelling was located in the western part of the larger footprint of the barn and entirely within the zone of archaeological destruction. Following the demolition of its superstructure, the concrete floor of the barn was removed, although the underlying hardcore of rubble was left intact and the foundation trenches for the replacement dwelling were cut through the hardcore. The cutting of these trenches on the 18th January 2011 confirmed that the footprint of the replacement dwelling was entirely located within an area of archaeological destruction. Excavation revealed that the hardcore deposits, which had a maximum depth of 0.30 metres, were laid directly onto the truncated surface of the natural subsoil of orangey brown boulder clay. No evidence of archaeological deposits or features was observed. Given the distinctive character of the natural subsoil, if sub-surface features were present then they would have been highly visible. Consequently, the absence of any surviving

archaeologically significant deposits or features can be accepted with a high degree of confidence. Given that the foundation trenches were excavated within an area of archaeological destruction created by the construction of the terrace upon which the barn was built, then the absence of any evidence of features or deposits cannot be considered as definite proof that there had not once been settlement activity on the site.

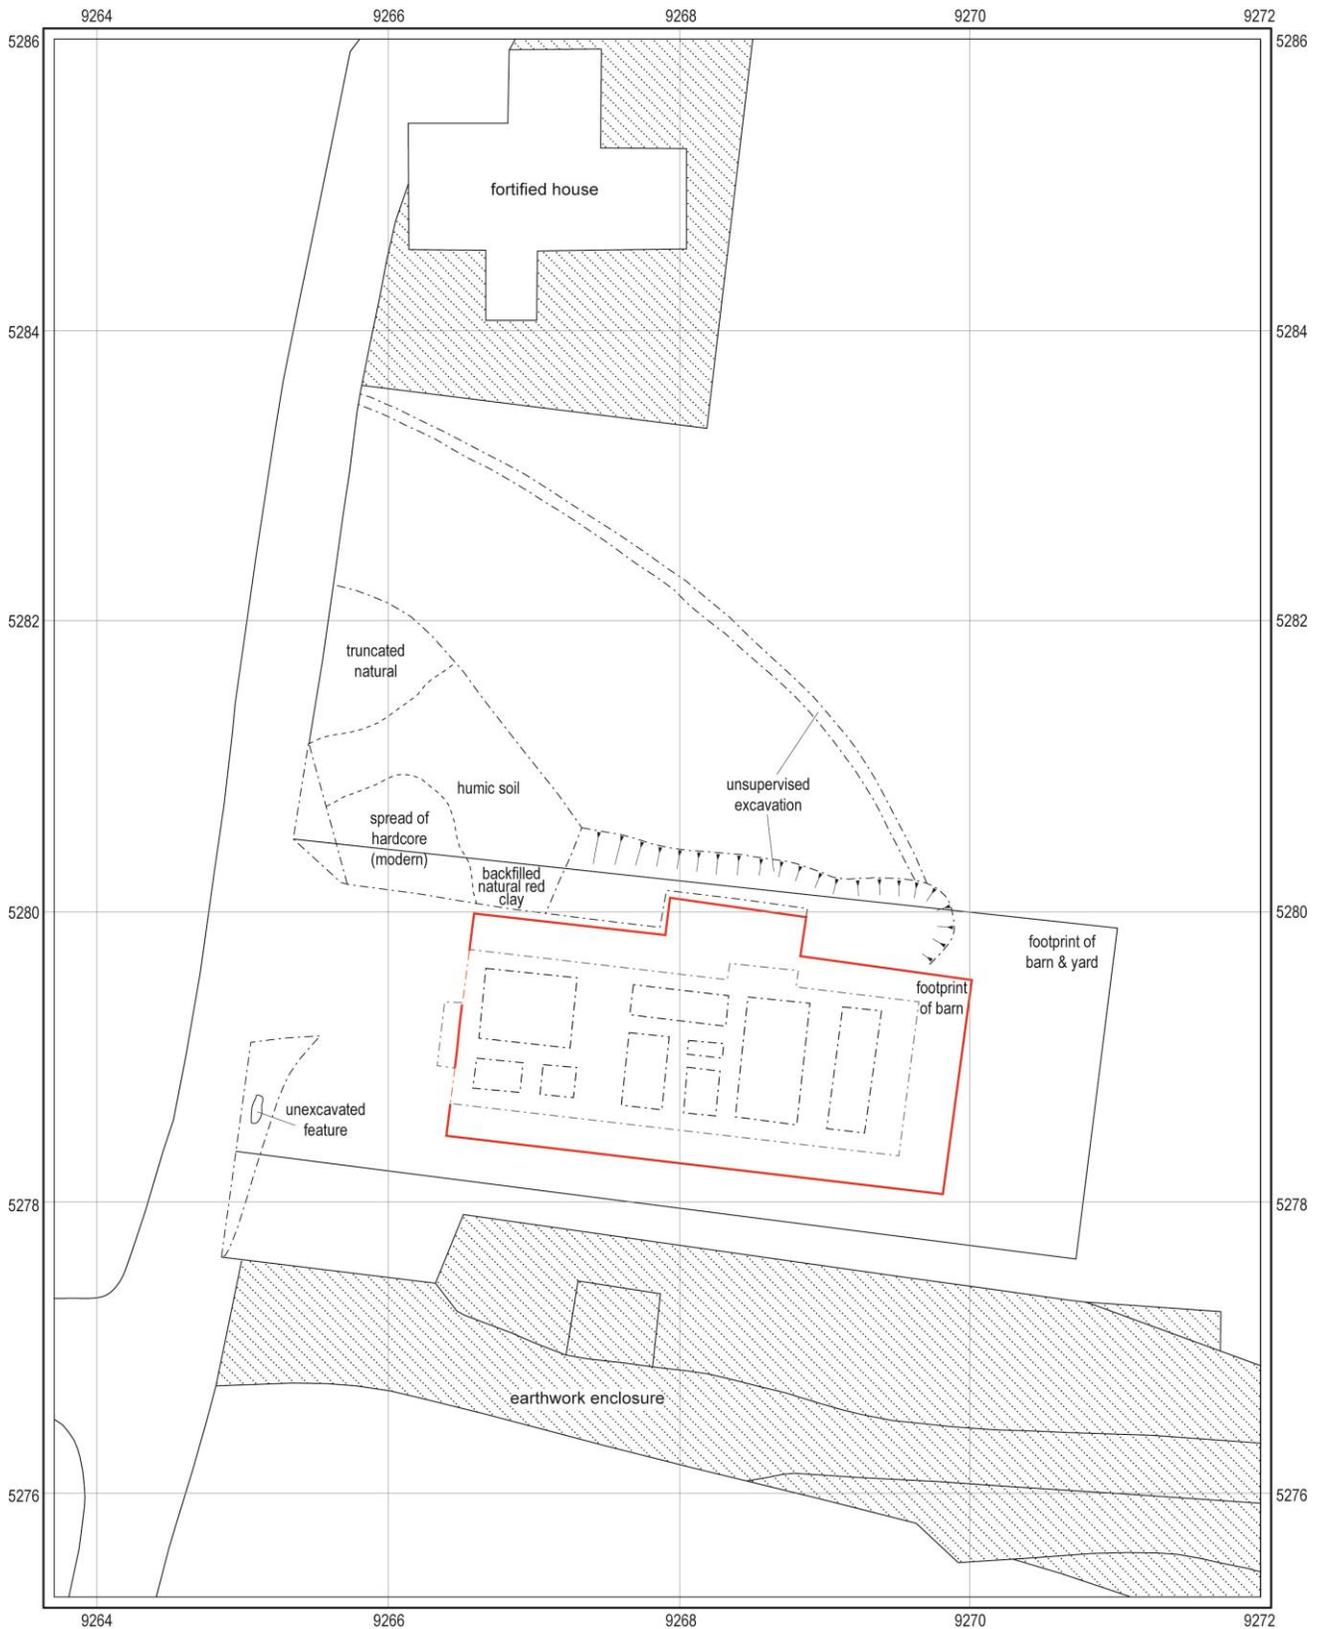
Figure Four: Plan showing location of trenches, footprint of demolished barn (outlined in red), and location of scheduled areas (shaded) associated with both the fortified house to the north of the development site and the earthwork enclosure immediately to the south.

Plans / Drawings: A single post-excavation plan (Scale 1:200) of the site (partially reproduced here as Figure Four), temporarily held by the Centre for Archaeological Fieldwork, Queen's University Belfast.
