Data Structure Report: No. 3.

Excavations at Boho High Cross, Co. Fermanagh
AE/02/49

Data Structure Report: Boho High Cross, Toneel North, Co. Fermanagh

CAF DSR 003

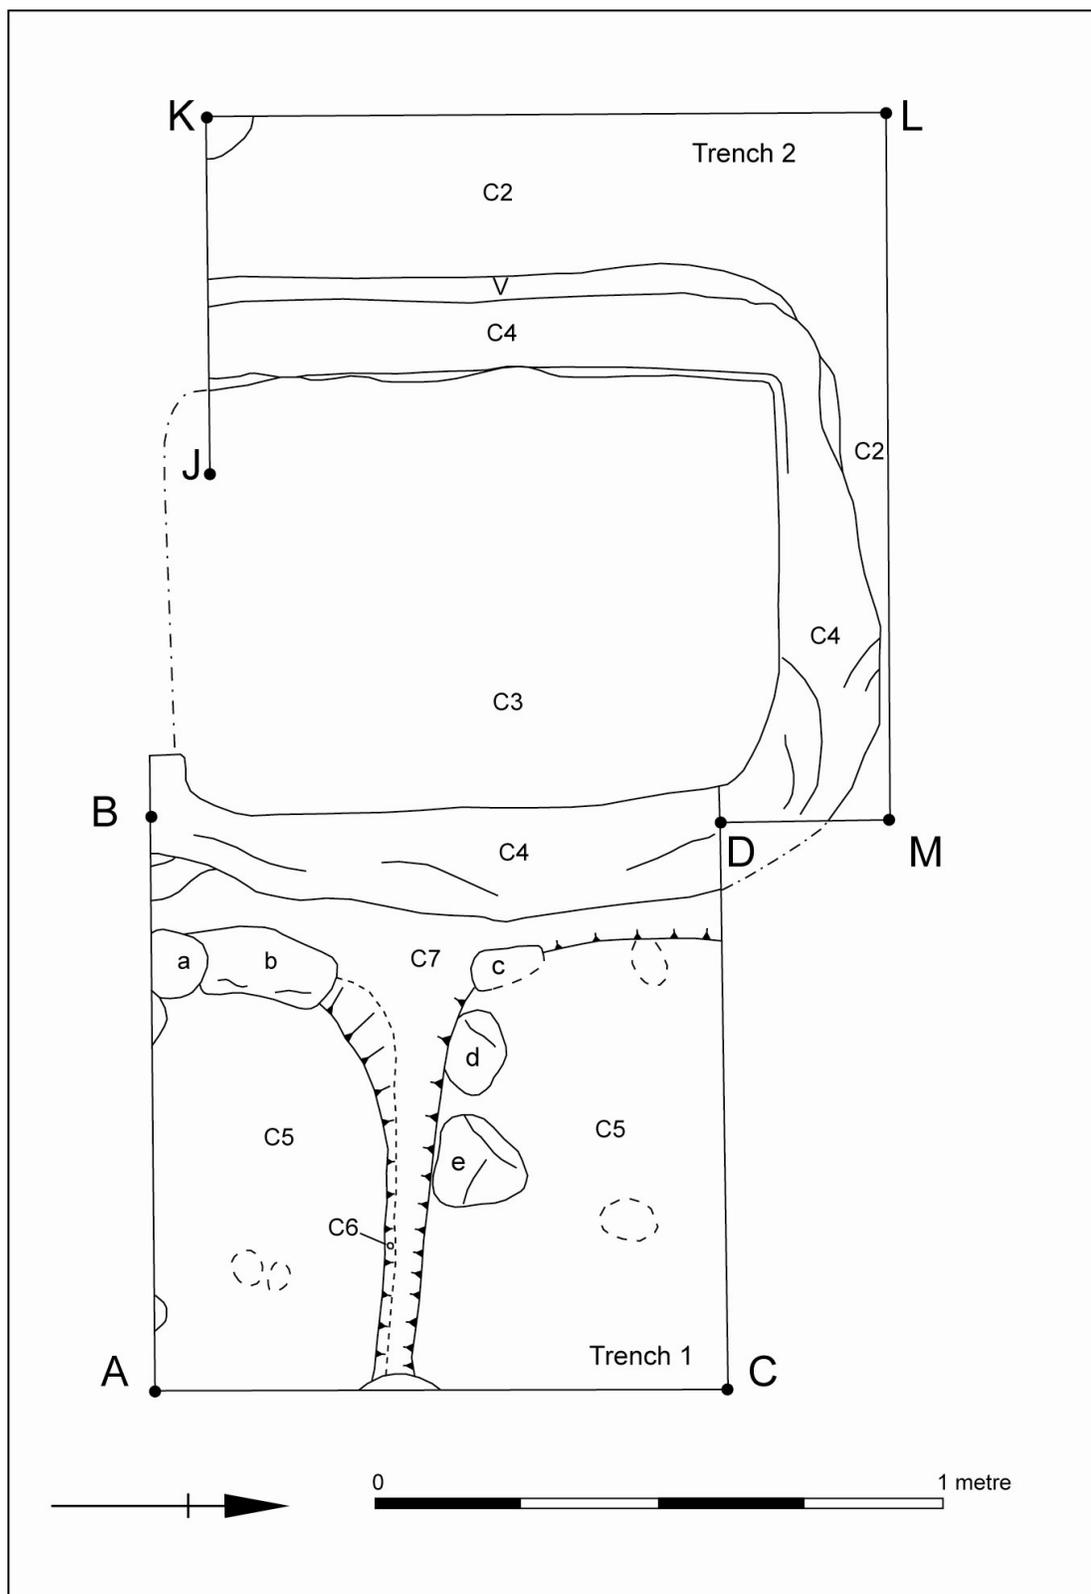
Figure 2: Plan of Trench One and Trench Two.

3.3.1 Trench One was one metre square in size, and aligned north-south and east-west. Underneath the turf line (Context No.1) was a mixed, dark brown, humic layer (Context No.2) which varied in depth from 0.15 to 0.35 metres and extended throughout the trench. Artefacts recovered from this layer potentially ranged in date throughout the post-medieval period and up to the present day. They included a single sherd of post-medieval pottery (Small Find No.7), a clay pipe stem (Small Find No.14), 21 iron coffin nails (Small Find Nos.19-24, 37-51), two fragments of glass (Small Find Nos. 9 and 13) and a modern glass Rosary bead (Small Find No.12). The humic layer also contained a relatively small number of disarticulated human bones. Following its excavation the stratigraphic sequence for Trench One split into two separate elements: the socketed base and underlying foundation slab of the high cross (Context Nos. 3 and 4) and a relatively modern capping deposit and associated gully (Context Nos.5, 11 and 6).

3.3.2 Underlying the humic layer, and located c.0.05 - 0.10 metres to the east of the High Cross, was a thick deposit of dark grey sandy clay loam (Context Nos.5 and 11) which extended as far as the eastern edge of the trench. The deposit varied in thickness from 0.10 to 0.23 metres and appeared to be deliberately deposited as it respected the eastern edge of the foundation slab of the High Cross (Context No.4). Artefacts recovered from it included a modern glass Rosary bead (Small Find No.11) identical to the one found in the overlying humic layer (Context No.2), as well as several undiagnostic fragments of ironwork (Small

- 3.3.3 Cut through the top of the capping deposit (Context Nos.5 and 11) was a straight, narrow gully (Context No.6) which ran for a length of c.0.70 metres from the western edge of the clay cap towards the eastern end of the trench. The gully narrowed along its length from a width of 0.20 metres at its western end to a width 0.07 metres, and it varied in depth from 0.15 to 0.20 metres. The function of the gully is not certain but given its relatively recent date, demonstrated by the recovery of a modern glass Rosary bead from the deposit it is cut into, it may be related to a previous attempt to halt the tilting of the High Cross by improving the drainage around the monument. The presence of a number of medium sized stones bedded into Context Nos. 5 and 11 (see stones marked “a” to “e” in Figure 2) may also relate to this programme of work.

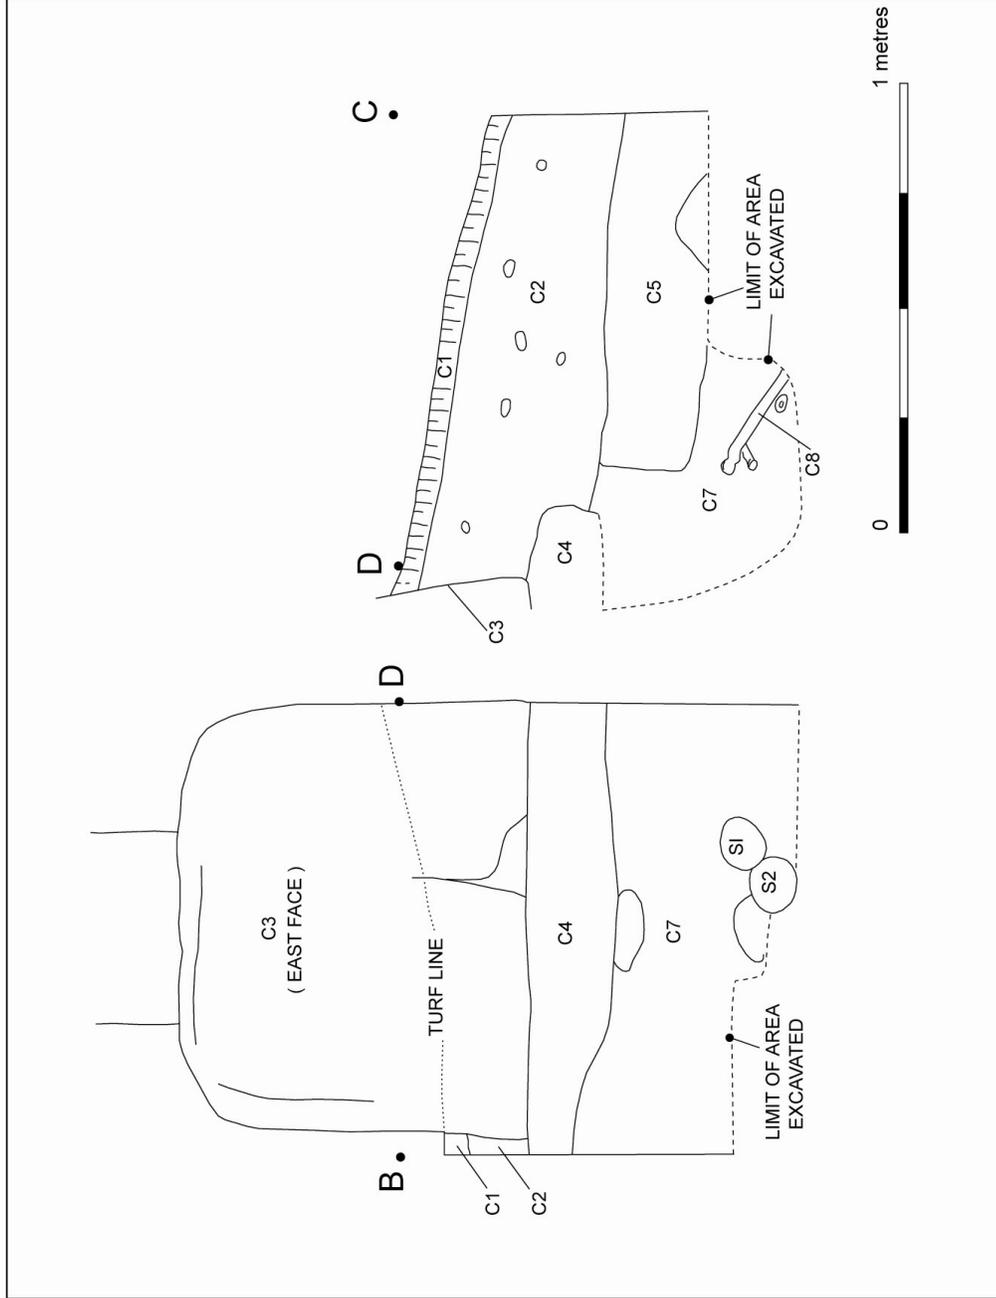
Figure 3: Trench One - Sections.

3.3.7 Stratigraphically underlying both the capping deposit (Context Nos. 5 and 11) and the foundation slab (Context No.4), was a dark grey brown silty clay loam (Context Nos. 7 and 10) which included a charnel pit deposit (Context No.8) physically located underneath the foundation slab. These deposits were only partially excavated to a depth of 0.45 metres. The silty clay loam contained a relatively small amount of disarticulated human bones and four iron coffin nails (Small Find Nos. 99-101, 133) and probably represents a mixed graveyard soil.

3.3.8 The charnel pit deposit (Context No.8) located within the graveyard soil (Context Nos. 7 and 10) contained three iron coffin fittings (Small Find Nos.102, 131-132), 28 iron coffin nails, some with surviving fragments of partially mineralised wood, (Small Find Nos. 103-130) and a large amount of disarticulated human bone as well as the skulls and long bones of at least three individuals (the location of two of which are marked as S1 and S2 in Figure 3), some of which were partially articulated. The survival of fragments of partially mineralised coffin wood suggests that both the charnel pit (Context No.8) and the dark grey brown silty clay loam (Context Nos. 7 and 10) are not deposits of any great antiquity. As the surviving elements of the High Cross are stratigraphically later this suggests that the monument was only erected on its current site at some point in the relatively recent past.

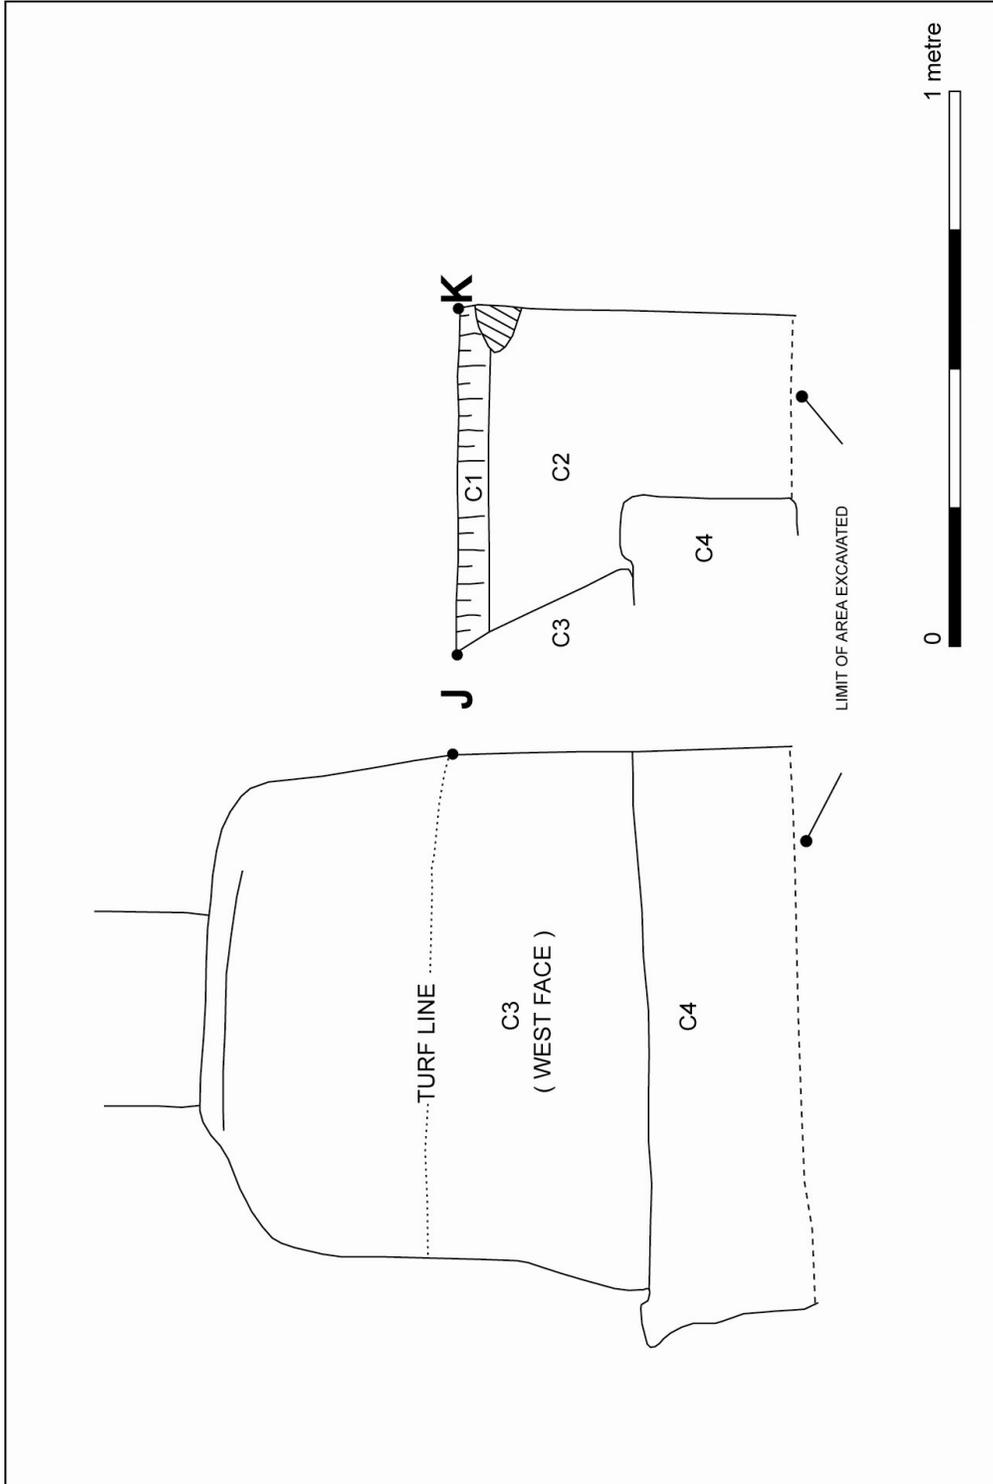
Figure 4: Trench Two - Sections.

3.4.1 Trench Two was a small L-shaped trench, c.0.2 metres wide, cut around the western and northern sides of the monument. The only deposits uncovered were the turf line (Context No.1) and the mixed, dark brown, humic layer (Context No.2) which was only partially excavated to a depth of 0.55 metres. The humic layer (Context No.2) contained disarticulated human bone and a variety of artefacts including worked slate (Small Find Nos.1-2), two clay pipe stems (Small Find Nos.3, 10), two fragments of glass (Small Find Nos.5, 8), a piece of plastic (Small Find No.4), a pocket knife (Small Find No.25), an iron coffin mount (Small Find No.16) and 13 iron coffin nails (Small Find Nos.17-18, 26-36). As with Trench One, the excavation of these deposits uncovered the socketed base (Context No.3) and foundation slab (Context No.4) of the High Cross. A longitudinal void (denoted as "V" in Figure 2) was present along the line of the foundation slab. This void was created by the forward movement of the foundation slab away from the dark brown humic layer when the monument began to lean eastward.

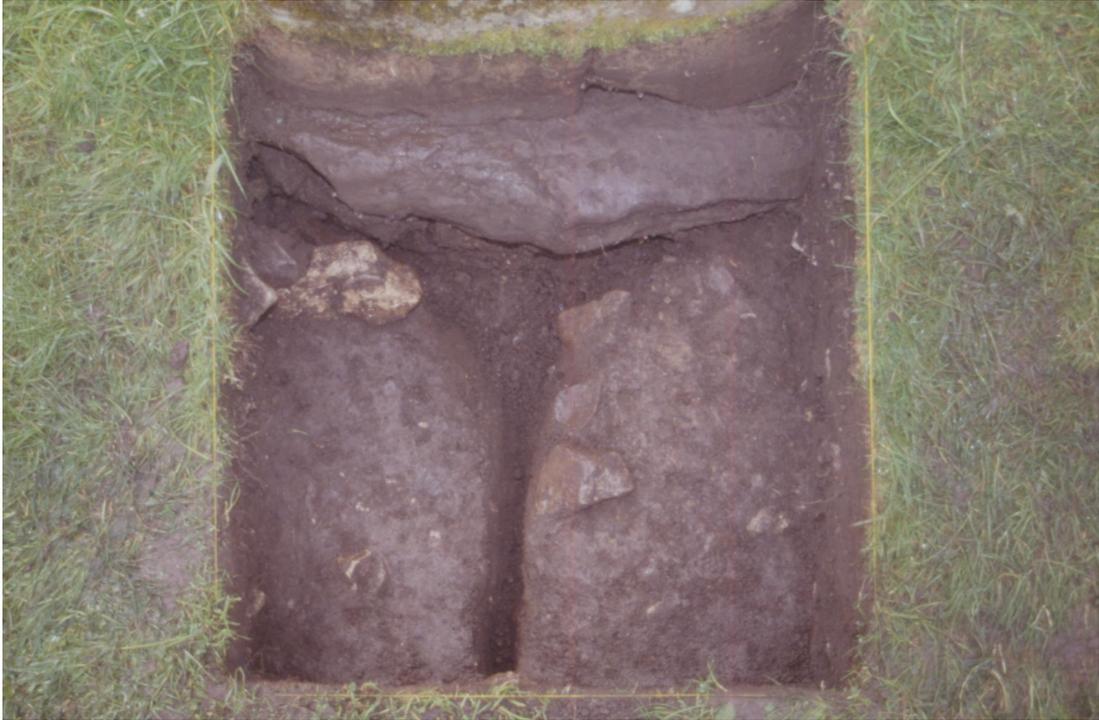
Plate One: Trench One showing clay capping (Context Nos.5 and 11) and gully (Context No.6).

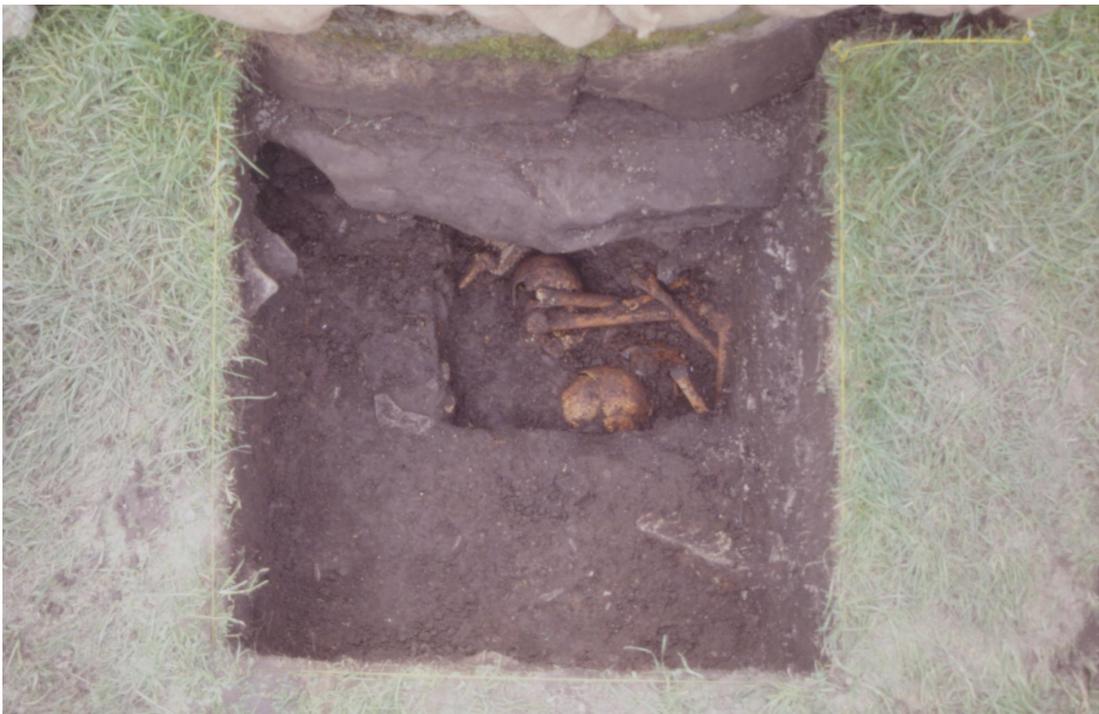
Plate Two: Trench One showing charnel pit deposit (Context No.8).

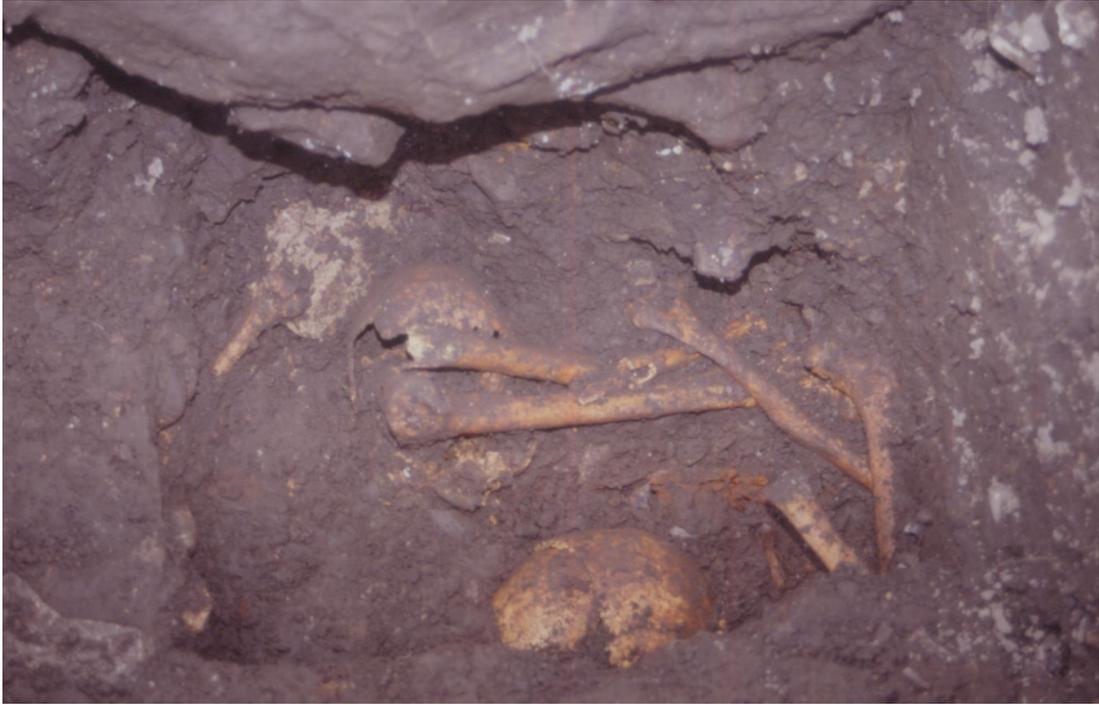
Plate Three: Trench One showing charnel pit deposit (Context No.8)

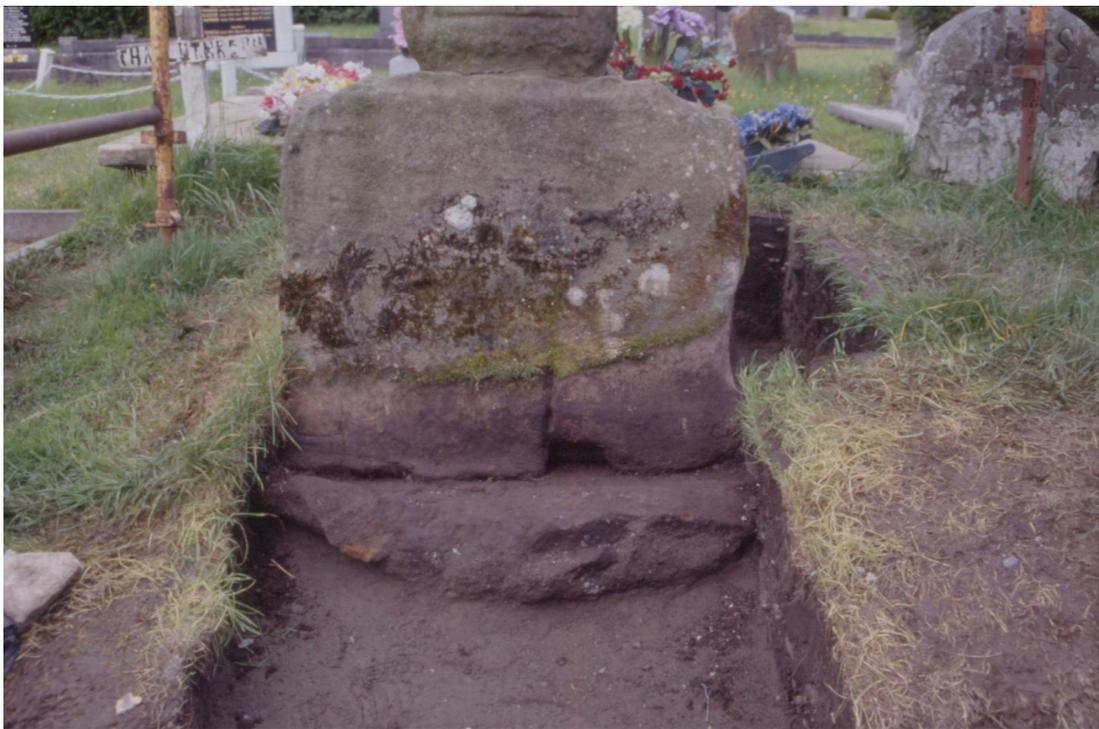
Plate Four: Trench One following the excavation of the humic layer (Context No.2) (looking west).

- 3.3.5 The rectangular-sectioned sandstone socketed base, which is decorated with a double roll moulding at the edges, had not been fully exposed prior to the 2002 excavations and so previous descriptions of the monument have not included a record its true dimensions. Excavations demonstrated that it is 0.80 metres high while, at its base, it measures 0.97 metres (north-south) by 0.77 metres (east-west). The socketed base was noticeably more weathered below the turf line giving its generally flared profile a slightly waisted character from the monument’s eastern and western sides. In addition to the small circular depression previously recorded by Harbison (1992, fig.79) adjacent to the upper western corner on the socketed base’s southern face, a second circular depression (diameter 0.03 metres) was uncovered on the northern side of the base in a relatively low, central position, c.0.15 metres above the foundation slab (Context No.4). Although on opposite faces of the socketed base, these two small circular depressions do not correspond and their original function is not obvious. The bottom of the socketed base was cracked and weathered on its eastern and western sides.

- 3.3.6 Excavation revealed that the socketed base (Context No.3) was set on a large red sandstone foundation slab that varied in thickness from 0.15 - 0.30 metres but had a flat upper face (Context No.4). The slab was not fully exposed during the excavations but measures at least 1.28 metres (north-south) by 1.13 metres (east-west). The upper surface of the foundation slab is recessed to accommodate the socketed base (Context

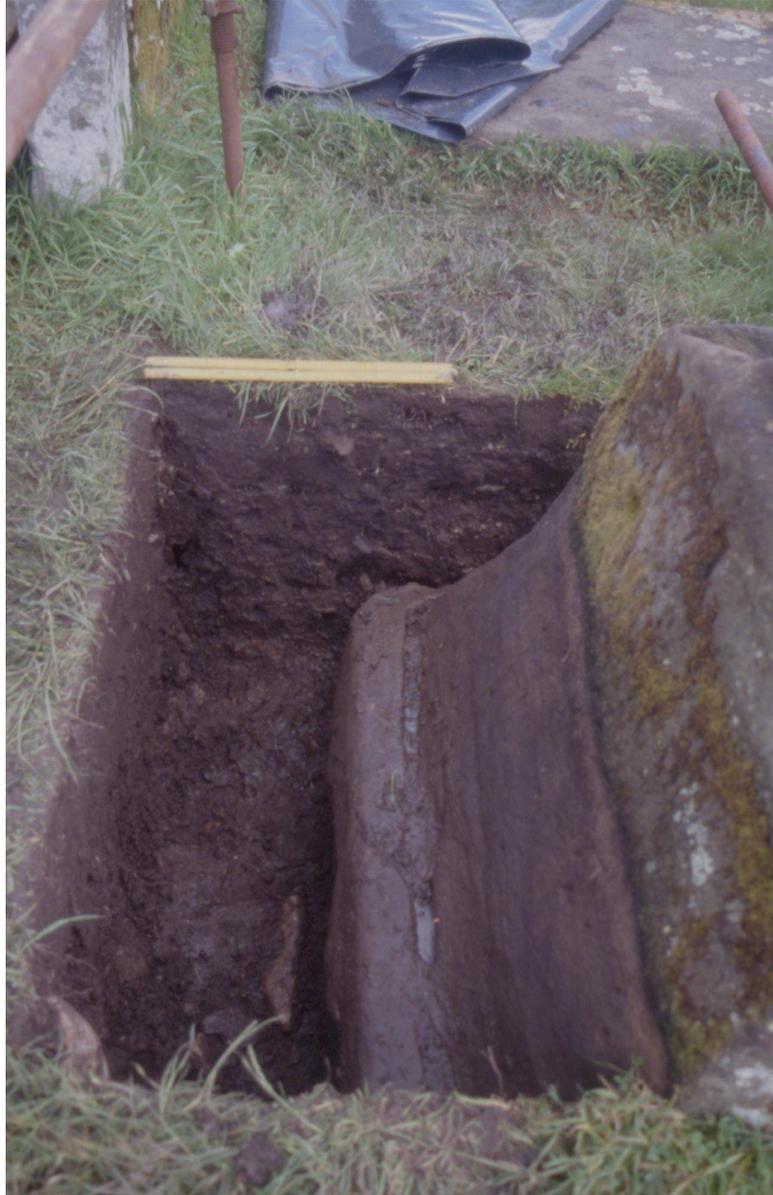
Plate Five: Trench Two following partial excavation of humic layer (Context No.2) (looking north). Note the exposed the raised western edge of the foundation slab (Context No.4) which meets flush with the edge of the High Cross's socketed base (Context No.3).

No.3). This recessing survives best on the western edge of the slab where a neatly formed raised edge meets flush with the edge of the socketed base (Plate Five).

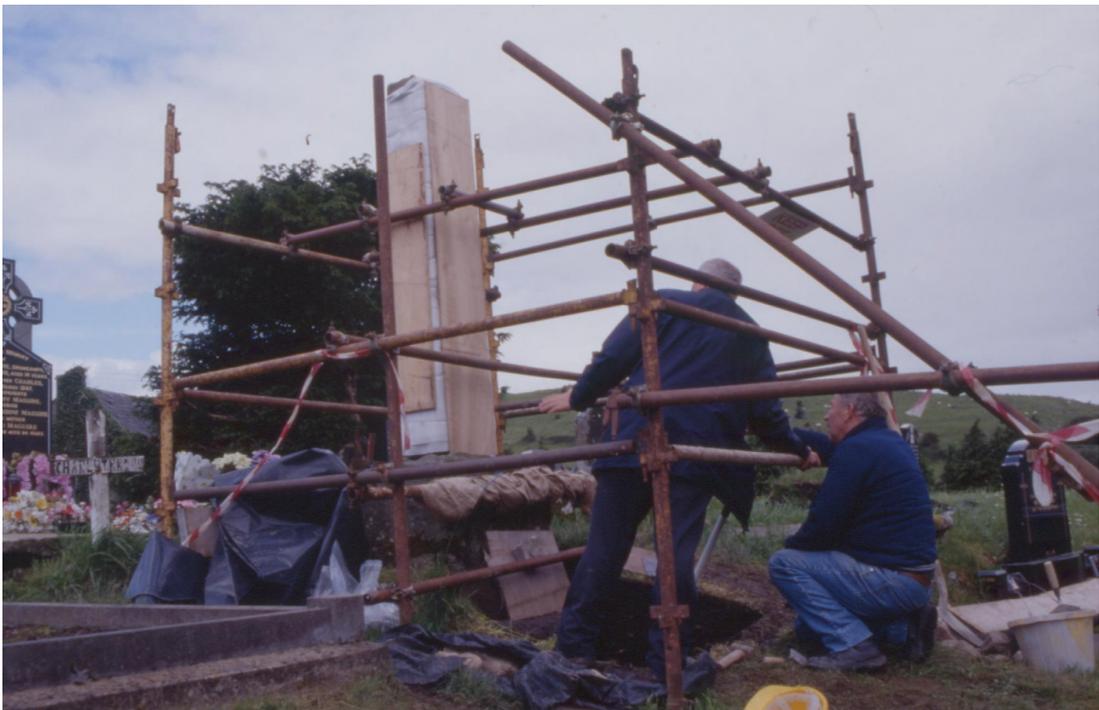
Plate Seven: Engineering work to correct the High Cross's tilt in progress.

4.2.3 As the decades passed the foundation of the High Cross began to compact and the monument began to develop a pronounced eastward lean. An attempt was made by the parishioners to arrest this process in 1985; the topsoil and dark brown humic layer (Context Nos. 1 and 2) were dug into and a cap of clay (Context Nos. 5 and 11) laid down. The clay cap also included a gully (Context No. 6) to enable sub-surface water to escape from around the monument. A series of medium sized stones were also put in place at this time to provide additional support to the eastern side of the High Cross (stones marked as “a” to “e” on Figure 2). This work, however, was unsuccessful in its objective and the cross continued to tilt, thereby necessitating the engineering programme and archaeological excavation of early Summer 2002.
