Data Structure Report: No. 16.

Monitoring at Nendrum, Mahee Island,
Co. Down 2003

**Data Structure Report: Nendrum, Mahee Island, County Down
2003**

Philip Macdonald

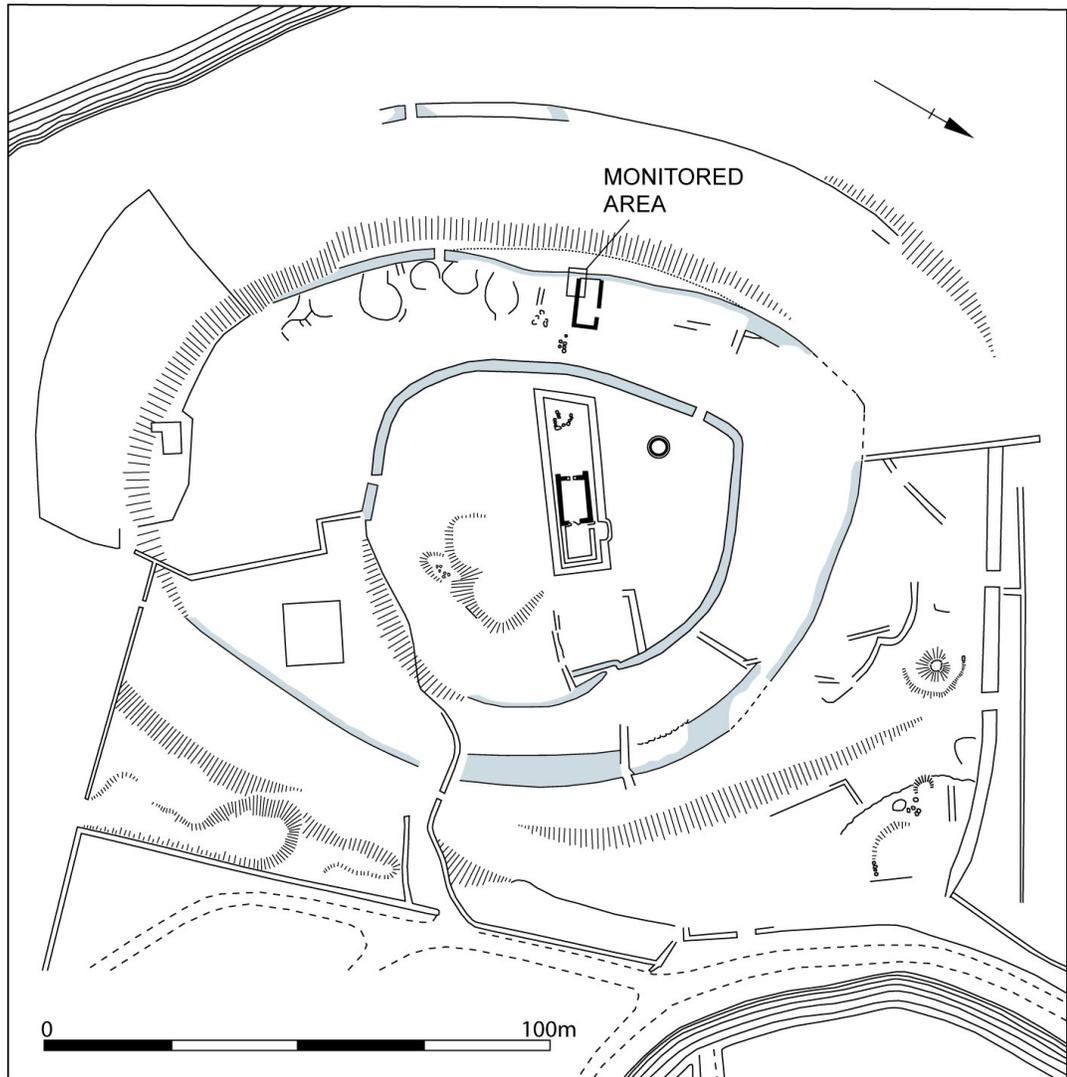
Figure Two: Plan of the Early Christian monastic site of Nendrum showing the monitored area (after Archaeological Survey of County Down 1966, fig.191).

2.2.3 The site at Nendrum is defined by three large concentric cashels, largely rebuilt by Lawlor, of dry-stone walling (Figure Two). The inner cashel contains the remains of a rectangular gabled church, a round tower and a graveyard, while the second cashel contains the so-called monastic school or workshop and further burials. The exposed pit, over which the

replacement safety grill was fitted, is located immediately adjacent to the second cashel wall on the western side of the site. It is partially overlain by the southern wall of the 'monastic school' building. Apparently predating the 'monastic school', the pit is c.0.95 metres by c.0.80 metres in dimension and c.1.9 metres deep. The pit's sides are revetted by stones and Lawlor suggested that it may have been partially arched over the top (Lawlor 1925, 104). Although it was excavated by both Lawlor (who recorded that its base contained 'a deep layer of fire remains, and a few fragments of animal bones' cf. Lawlor 1925, 104), and Thomas (see Matthews 1995, 66, fig.28.4) the precise date and function of the pit remains uncertain.

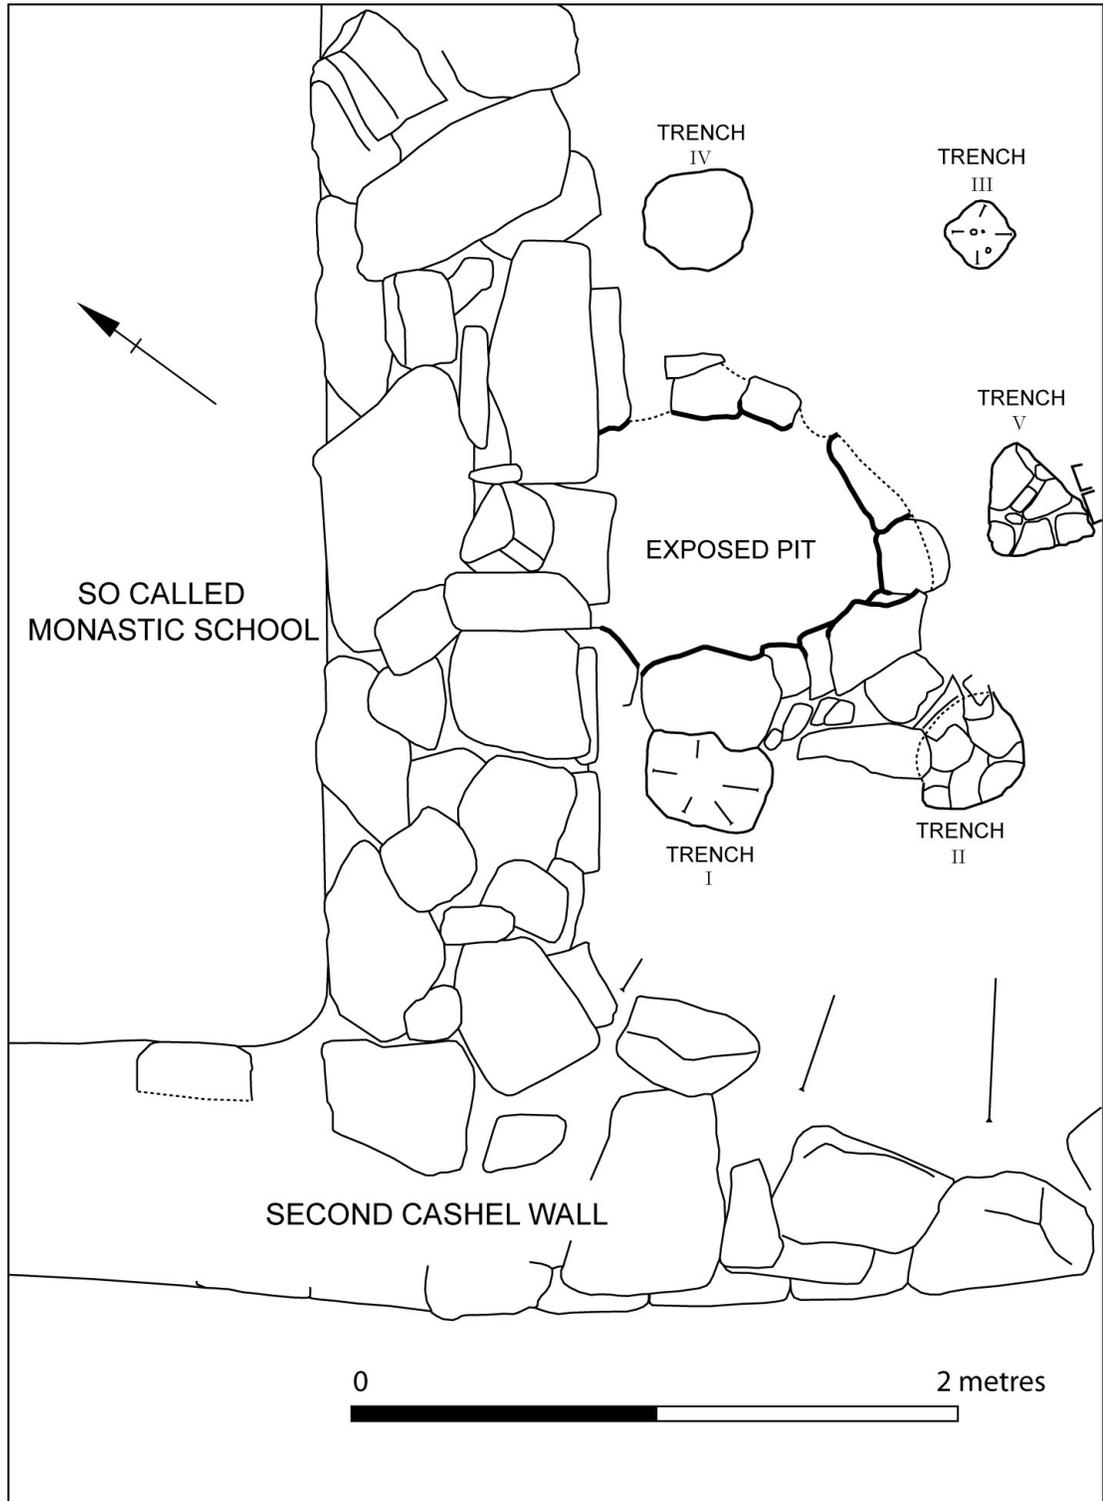
Figure Three: Plan of monitored area illustrating location of Trenches I – V (Scale 1:20)

3.1.1 Installing the new safety grill over the exposed pit involved the excavation of five small, irregular-shaped holes in the area immediately adjacent to the pit (labelled Trenches I to V) (Figure Three). These holes/trenches formed sockets into which the bolts of the safety grill's frame were concreted (see Table Two for the dimensions of the holes).

- 3.2.2 Trench I was a sub-rectangular shaped hole located on the western edge of the exposed pit. It measured 0.42 metres (north-south) by 0.36 metres (east-west) in dimension and was excavated to a depth of 0.14 metres. The matted vegetation (Context No.101) which formed the upper layer in this hole/trench consisted largely of grass and general weeds and was c.0.03 metres thick. It overlay a deposit of loose stones (Context No.102) which formed a layer one stone, or c.0.08 metres, thick which physically butted against the stone edging around the exposed pit. Underlying the layer of stones was a mid brown silty loam (Context No.103) of which only the upper c.0.03 metres was excavated.

- 3.2.3 Trench II was a sub-circular shaped hole located adjacent to the southwestern edge of the exposed pit. It measured 0.36 metres (north-south) by 0.38 metres (east-west) in dimension and was excavated to a depth of 0.15 metres. The matted vegetation (Context No.201), which formed the upper layer in this hole/trench consisted of mainly grass and general weeds and was c.0.03 metres thick. It overlay a deposit of loose stones (Context No.202) which was at least three layers of stone thick, although only the uppermost layer of stone was removed.

- 3.2.4 Trench III was a sub-rectangular shaped hole located adjacent to the southeastern edge of the exposed pit. It measured 0.24 metres (north-south) by 0.23 metres (east-west) in dimension and was excavated to a depth of 0.14 metres. The matted vegetation (Context No.301), which formed the upper layer in this hole/trench consisted of mainly grass and common weeds and was c.0.03 metres thick. It overlay a deposit of loose stones (Context No.302) which formed a layer one stone, or c.0.11 metres, thick. Underlying the deposit of loose stones was a mid brown silty loam (Context No.303) which was not excavated.

- 3.2.5 Trench IV was a sub-circular shaped hole located adjacent to the eastern edge of the exposed pit. It measured 0.36 metres (north-south) by 0.36 metres (east-west) in dimension and was excavated to a depth of 0.16 metres. The matted vegetation (Context No.401) which formed the upper layer in this hole/trench consisted largely of grass and general weeds and was c.0.03 metres thick. It overlay a deposit of loose stones (Context No.402) which formed a layer one stone, or c.0.10 metres, thick. A fragment of bone was recovered from the deposit of loose stones (Small Find No.1001). It was not possible to ascertain whether this deposit butted against the stone edging around the exposed pit. Underlying the layer of stones was a mid brown silty loam (Context No.403) of which only the upper c.0.03 metres was excavated.

3.2.6 Trench V was a sub-triangular shaped hole located adjacent to the southern edge of the exposed pit. It measured 0.35 metres (north-south) by 0.38 metres (east-west) and was excavated to a depth of 0.14 metres. The matted vegetation (Context No.501), which formed the upper layer in this hole/trench consisted of mainly grass and general weeds and was c.0.04 metres thick. It overlay a deposit of loose stones (Context No.502) which was at least two layers of stone thick, although only the uppermost layer of stone was removed. Two brick-shaped blocks of concrete were incorporated into the southern edge of the deposit of loose stones. A sherd of modern bottle glass was recovered from the deposit of loose stones (Small Find No.1002).

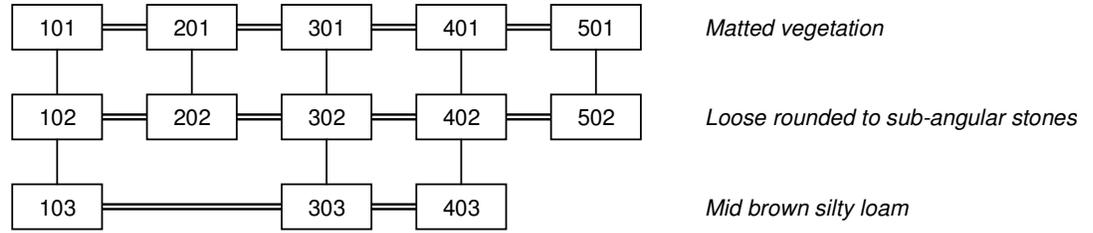
Appendix Two: Harris Matrix

3.2.7 Given the close proximity of the holes/trenches and the similarity in the character of the deposits disturbed in each hole/trench, it is not unreasonable to assume that the deposits of loose stones identified in each hole/trench (Context Nos.102, 202, 302, 402 and 502), and the underlying mid brown silty loams uncovered in Trenches I, III and IV (Context Nos.103, 303 and 403), were all parts of the same two deposits. In addition to these two layers, and the overlying matted vegetation, no other features or deposits were identified during the course of the excavation.

- 4.1 Despite their small size, a tentative interpretation of the stratigraphic sequence exposed in the five holes/trenches is possible. The layer of stones (Context Nos.102, 202, 302, 402 and 502) represents a recent and deliberate deposit presumably intended to form either a path or area of hardstanding around the pit. That the deposit varies in depth suggests that its deposition may have been part of an attempt to level the ground surface around the exposed pit, presumably following either Lawlor's excavations in the 1920's or Thomas's excavations in the 1950's. The overlying matted vegetation is the product of grass and weeds which have grown up through the stones while the underlying mid brown silty loam may represent a buried topsoil or, more probably, the backfill of either Lawlor's or Thomas's excavations.

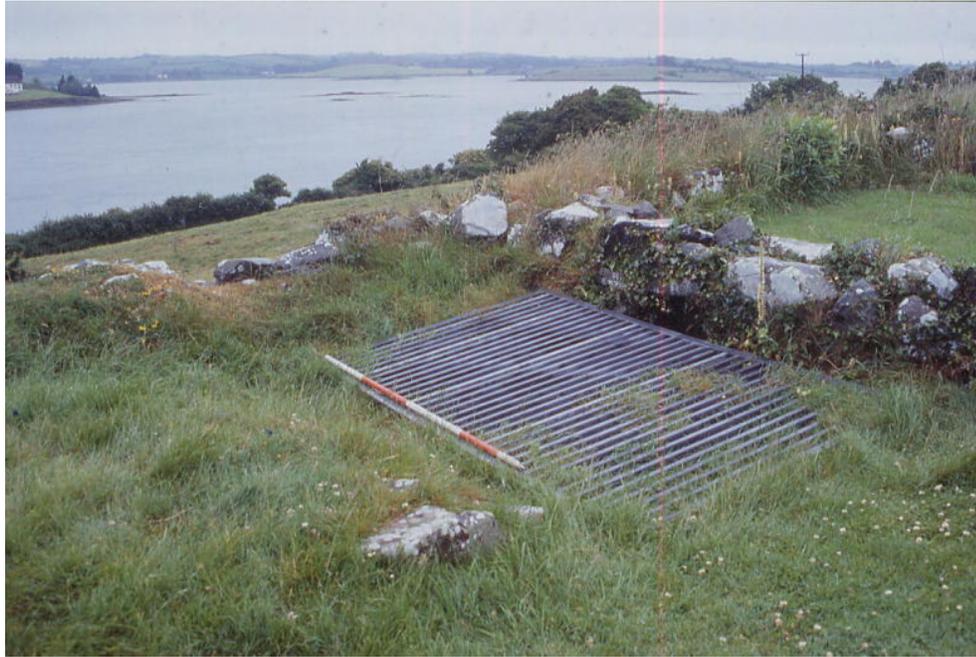
Plate One: The exposed pit prior to the removal of the old safety grill looking west.

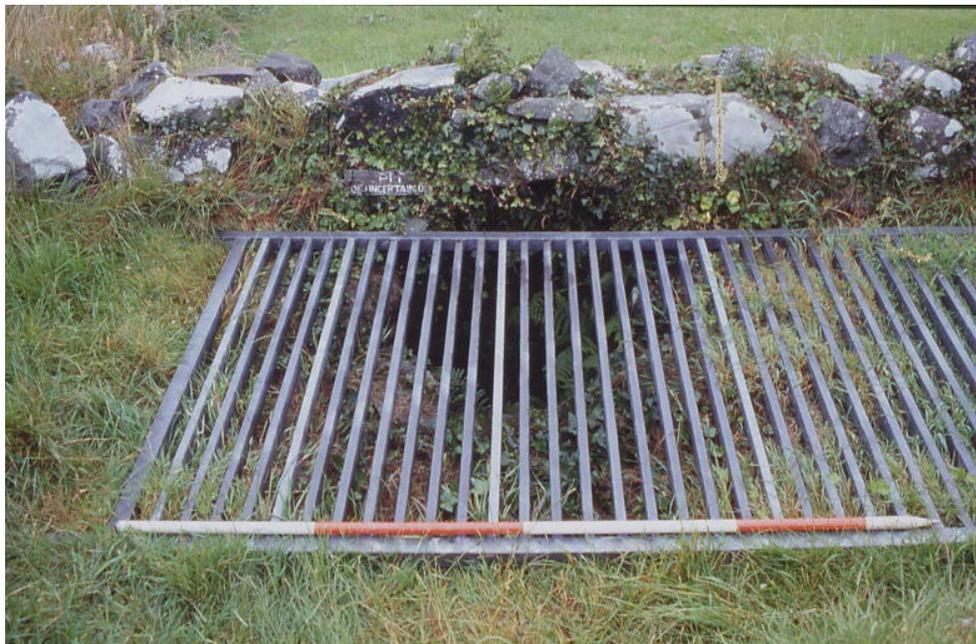
Plate Two: The exposed pit prior to the removal of the old safety grill looking northwest.
