Data Structure Report No. 035

**Malachy's Wall, Bangor Abbey**  
DOW 002:002  
AE/05/01

**Malachy's Wall  
Bangor Abbey, Co. Down**

CAF DSR 035

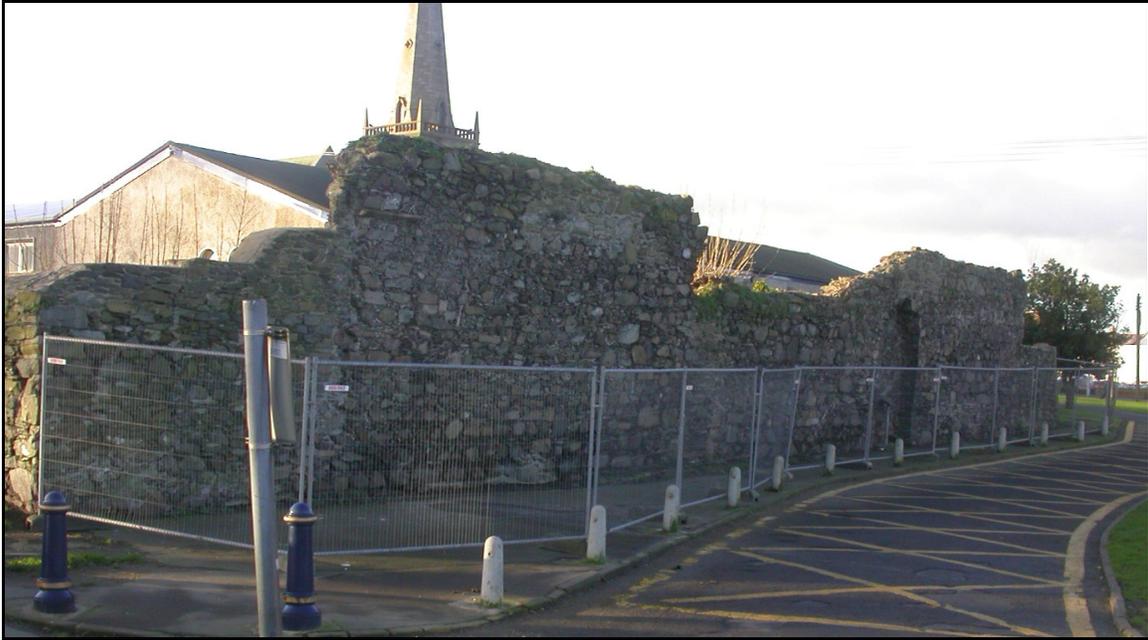
- 3.1.4 The surviving fragment of wall runs approximately east-west for a distance of approximately 37.5 metres (Plate 1). It has been fortified at a number of points along its length with concrete and modern brick, and has been buttressed at both ends (Plate 2) The buttressing accounts for approximately eleven metres of the overall length. Where the wall has not been modified, it is possible to identify a number of the original features as described in the Archaeological Survey of County Down. At the east end of the wall

**Plate 1:** (Above) North face of Malachy's Wall (taken from north- east facing south-west).

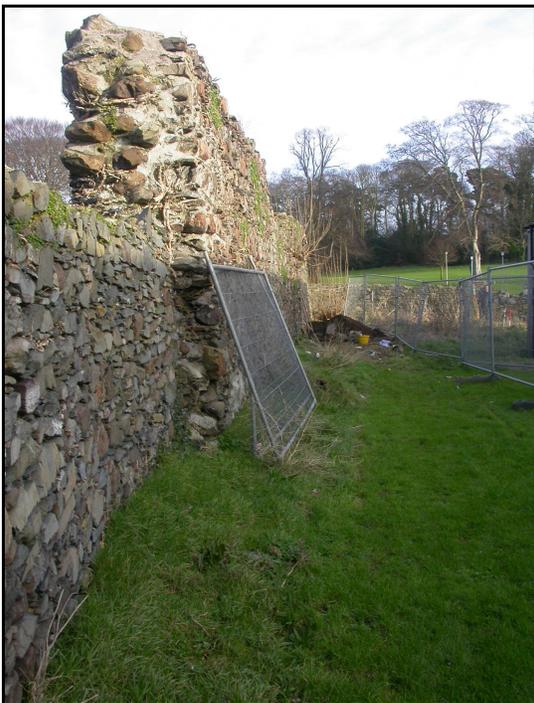
**Plate 2:** (Below left) Modern re-enforcement to west edge of Malachy's Wall (taken from west facing east).

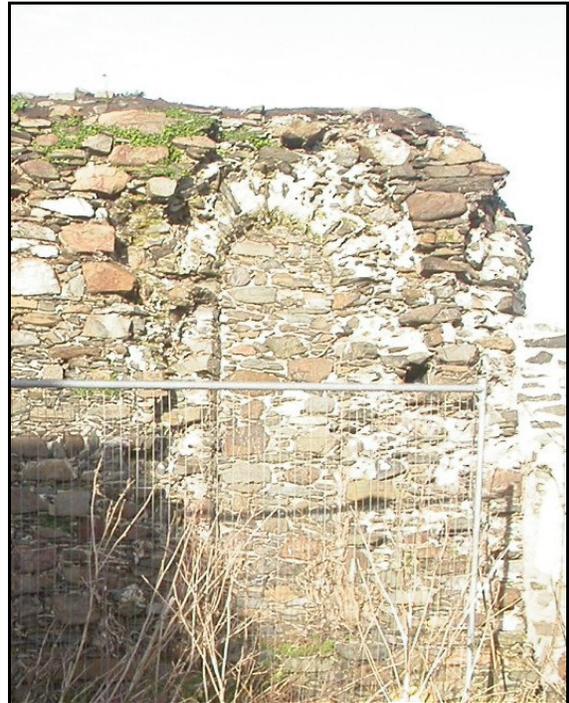
**Plate 3:** (Below right) Lancet window at east of Malachy's Wall (taken from south facing north).

are two bricked-up lancet windows, which have been deprived of dressings (Plate 3). Approximately ten metres to the west is a third lancet window and, further west again is a door from which all of the dressings have been removed with the exception of the base of a roll-moulded jamb (Archaeological Survey of Co. Down 1966, 266). The north face of the wall has been exposed to its base, probably as a result of the construction of the modern road and footpath. The height of the wall varies because of the removal of a considerable amount of material from along its top. However, at its highest point it is approximately 4.74 metres above the level of the ground to the north of the wall. To the south of the wall, the ground level is approximately one metre higher than to the north, owing to a relatively recent accumulation of soil and the deposition of modern debris. The remains of a later structure of approximately square plan butted up against the south face of the wall towards its eastern end.

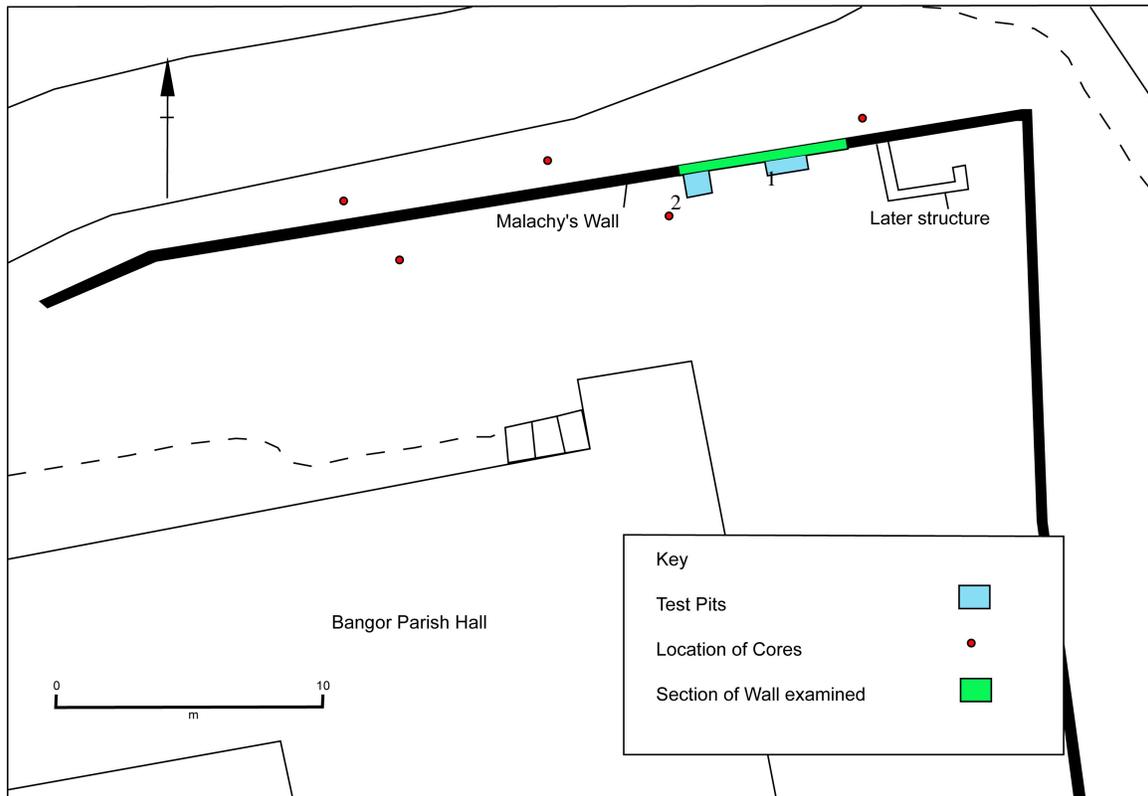
3.2.1 The excavation took place to the south of Malachy's Wall in an area which would probably have been inside the original building (Figure 2). The terrain in this area consisted of an uneven scarp which slopes down to the modern parish hall approximately 20 metres to the south. The hall dates approximately to the 1950s (Rev. R. Nesbitt, pers.comm.). To the north of the wall, the ground surface is lower and has probably been levelled to accommodate a modern roadway. The location of the excavation, which eventually consisted of the insertion of two Test Pits, was determined after consultation with the Structural Engineering Advisory Branch of the Department of Finance and Personnel. It was decided to locate the archaeological investigation along the highest surviving section of the wall that had not been fortified or strengthened in modern times. At the same time, five cores were taken around the wall by the Structural Engineers (Figure 2).

**Figure 2:** Site of 2005 excavation at Malachy's Wall.

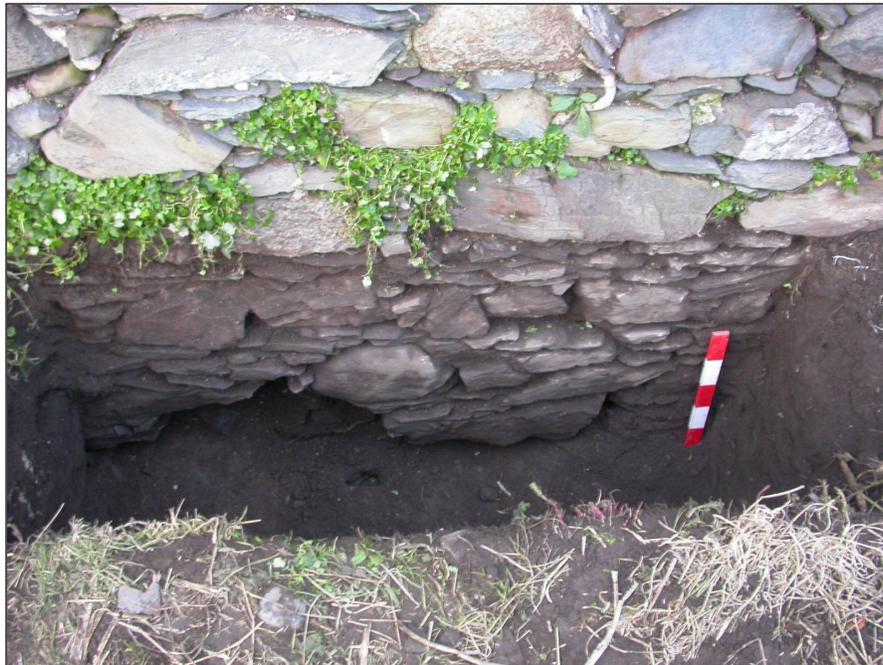
brown clay loam was exposed (Context 102). This loam contained significant quantities of broken glass, bone, glazed pottery and metalwork. Approximately 10% of the material was sampled for further examination. All recognisable finds were modern and the artefacts were evenly distributed throughout the deposit. The base of the wall (Context 107) was exposed during excavation of this fill. The base was initially noted at a depth of 0.6 metres, but in other places was substantially lower, reaching a maximum depth of 0.9 metres. The clayey loam (Context 102) butted up against the wall along the base and extended into voids beneath the wall for approximately 0.3 metres. The soil abutting the wall was removed in order to define the base of the wall. Inspection suggested that a number of larger stones had been removed from the base of the wall at some stage (Plate 4).

**Plate 4:** Test Pit 1 facing north.

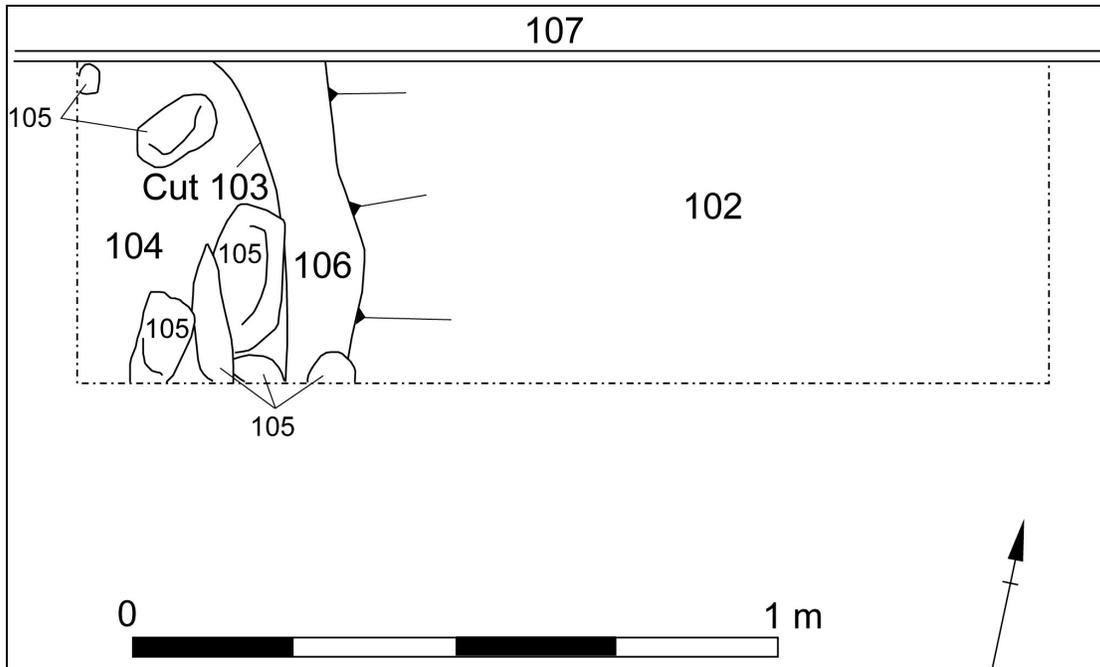
**Figure 3:** Base of Test Pit 1.

3.3.2.3. Figure 3 is a plan of the base of Test Pit 1. The dark brown clayey loam (Context 102) still covered the majority of the area and its maximum depth in the east of the Test Pit was not ascertained. The suspension of the investigation at this stage also prevented the resolution of a notable feature in the west end of the Test Pit. A line of mid brown gravel-rich loam (Context 104) extended from the south of the trench across to the north, where it coincided with a gap in the base of the wall. Set into this material were five slates arranged in a line, which defined the edge of this feature (Context 105). The feature was cut into the orangey-brown loam (Context 106) upon which the wall had been built. Two fragments of bone extended from the base of the southern edge of the Test Pit in line with this feature. However, any possible association between these bones and the cut feature was not investigated during the excavation.

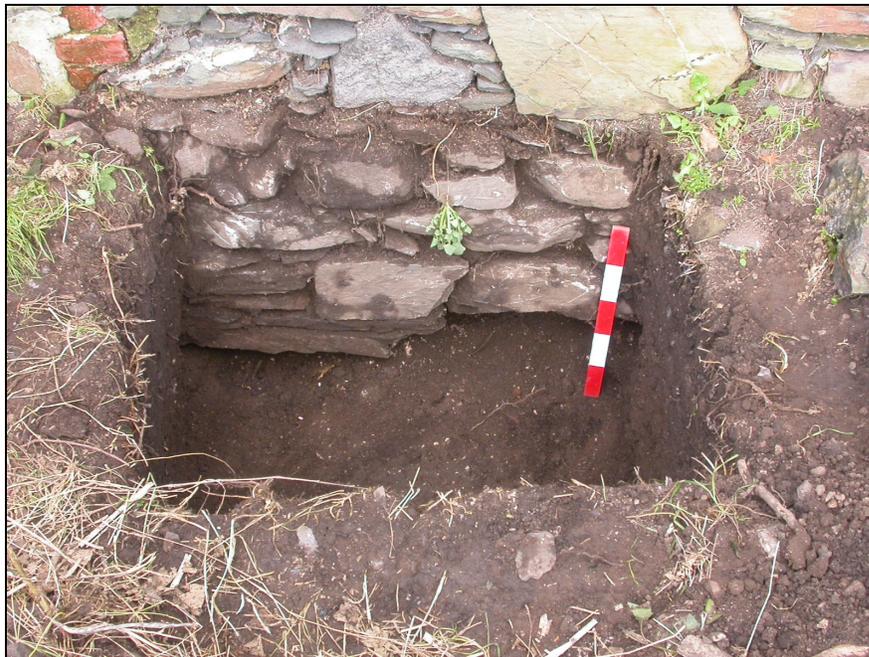
the surface on which the wall was built had been truncated. The only support for the wall was represented by the deep but loose deposit of relatively modern date (Context 102). In order to ascertain whether this was characteristic of the state of the wall elsewhere along its base, it was decided to open up a second Test Pit, 2.1 metres to the west. Test Pit 2 measured 1 metres (east-west) x 0.8 metres (north-south). A loose accumulation of stones and modern rubbish/rubble was removed to reveal a ground surface slightly lower than at Test Pit 1. The stratigraphy in the upper part of the pit replicated that of Test Pit 1. Removal of a shallow sod (Context 201) revealed a dark clay loamy (Context 202) similar to that found in Test Pit 1 (i.e. Context 102) which contained a comparable assemblage of human bone, modern glass, pottery and metalwork. As in Test Pit 1, a representative sample of the artefactual material, this time 5% was taken for examination. The base of the wall was exposed at a depth of 0.65 metres and, as in Test Pit 1, the modern deposit (Context 202) was found to extend into voids beneath the wall for up to 0.4 metres beneath. The base of the wall uncovered in Test Pit 2 was uneven, again suggesting that some of the stone had been removed or dislodged (Plate 5).

**Plate 5:** Test Pit 2 (facing north).

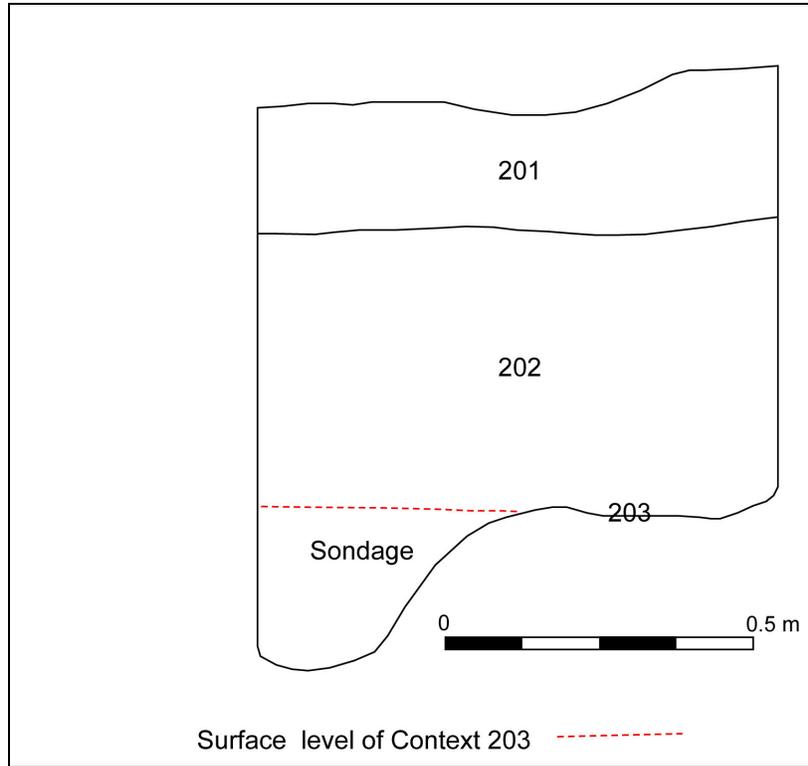
3.3.3.2 The dark clay loam (Context 202) was removed so that the base of the wall could be properly defined. At a depth of 0.8 metres, the clayey loam was found to overly a gravel-rich soil with mortar inclusions (Context 203). This deposit was not excavated, however, a *sondage* was excavated in the south-west corner of the Test Pit to assess the depth of the natural subsoil (Figure 4). Metal artefacts

and modern glazed pottery were noted within the layer. The natural subsoil was a boulder clay (Context 205) and it occurred at a depth of approximately 1.0 metres, that is 0.35 metres below the base of the wall.

**Figure 4:** East-facing section from Test Pit 2, showing position and depth of *sondage*.

- 4.1 The excavation provided valuable information regarding the construction of Malachy's Wall. The sondage dug in Test Pit 2 indicated that the subsoil occurred 0.35 metres below the base of the wall. Therefore, when it was built, there was no effort to set the wall into the subsoil. No evidence of a foundation cut for the wall was recognised, although the truncation of the orangey-brown loam (Context 106) to a depth below the base of the wall would probably have destroyed any such evidence if it existed.

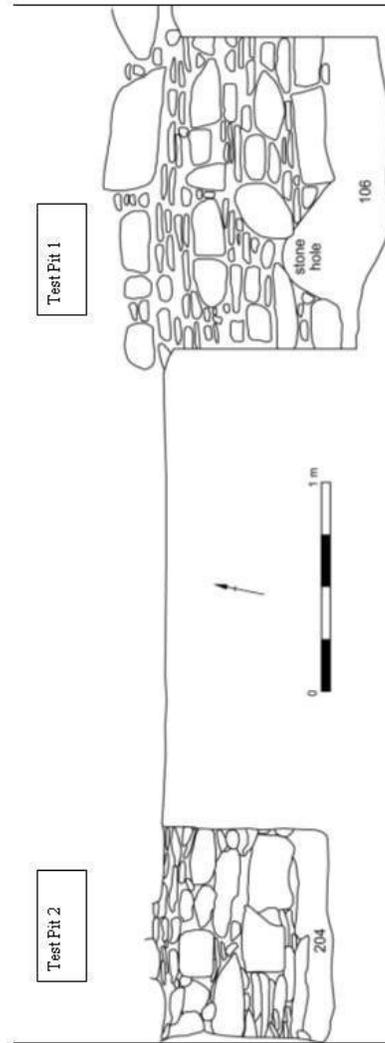
- 4.3.1 It was not possible to ascertain whether the removal of the basal stones occurred in association with the truncation of the construction surface or at an earlier date. However, only the modern clayey loam (Contexts 102 and 202) was excavated from the voids created by the removal of the stones, so these stones were probably removed when the surface material was disturbed. The activity, which resulted in the truncation of the archaeological deposits, was demonstrably modern. The deep clay deposits (Contexts 102 and 202) were homogenous and contained modern finds throughout. This was graphically illustrated in Test Pit 1, where a modern fire-grate (Small Find 1001) was

Figure 6: Excavations of portions of Malachy's Wall (south face) uncovered during the excavation

found wedged into the void beneath the wall. The depth of this material was 0.95 metres at the western end of Test Pit 1, but it extended deeper at the east end of the pit. No archaeologically significant layers occurred above this material in the stratigraphy; only a shallow sod (Contexts 101 and 201) overlay it. It is therefore reasonable to suggest that the deposition of this material was responsible for the uneven scarping to the south of the wall which creates the height differential between the two sides of the wall (Context 107). The uniform nature and depth of the deposit suggests that it was deposited as the result of a large scale exercise, perhaps as spoil associated with the development of the town hall or car-park in the 1950s.

- 4.6 The modern construction activity has had a negative effect on the stability of the wall. Any possible foundation cut has been overcut to a level below the base of the wall, while any the deposits which would have accumulated over the centuries against the base have been stripped away. They have been replaced by a single modern deposit (Contexts 102 and 202) of relatively loose consistency which probably provides significantly less support along the southern base of the wall than the earlier material which has been removed.

5.1.1 The aim of this excavation was to inform the most appropriate strategy for the future conservation of Malachy's Wall. The excavation has highlighted the tenuous condition of the base of the wall and the urgent need for its preservation. All further decisions in this respect of the conservation of the wall will be taken by the Environment and Heritage Service: Protecting Historic Monuments in consultation with the Structural Engineering Advisory Branch, Department of Finance and Personnel.

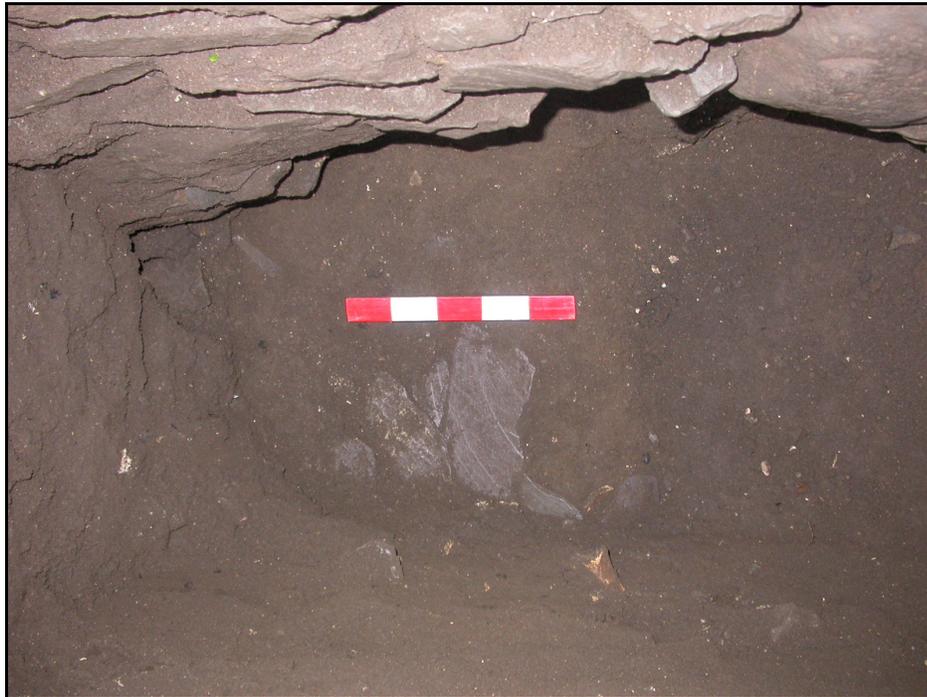
- 4.4 This modern activity destroyed any record of archaeological activity on the site post-dating the construction of the wall, including any floor levels or "occupation" deposits associated with the building. The only feature of potential archaeological interest recorded during the excavation of the Test Pits was an apparent cut (Context 103) into the possible construction surface (Context 106) at the west end of Test Pit 1. Its fill (Context 104) was of a darker colour than the surrounding orangey soil (Context 106) and it was lined with five slates (Context 105). The feature is shown in plate 5 below.

**Plate 6:** Cut Feature (Context 103) at west end of Test Pit 1.

- 4.5 It was not possible to identify any stratigraphic relationship between this feature and Malachy's Wall – it extended into the void beneath the wall created by the removal of the basal stones, but, without excavation, it was impossible to verify whether it pre-dated the erection of the wall or was associated with the activity represented by the later removal of the stones. The presence of possible human bone in association with the feature prompted suggestions that this was the base of a slate-lined burial that had been disturbed by later activity. Stone-lined graves are a common Early Christian burial custom in the British Isles (Thomas 1971, 49), but slate-lined graves are less so. At Caherlehillian, Co. Kerry, Sheehan noted such a feature in an Early Medieval context (Sheehan 1999, 112). However, on the balance of existing evidence the interpretation of the feature as a grave is problematic. Fragments of human bone occurred throughout the modern deposit (Contexts 102 and 202) overlying the cut, and the bones in section might not have been articulated. It is worth noting that the feature was aligned north-south which is at variance with the normative Christian burial rite. It is more likely that the cut represented a ditch for a service pipe or drain, perhaps even associated with the modern construction phase.
