Monitoring Report No. 21

**Castle Espie Road
Ballylighorn
Co. Down**

AE/06/35

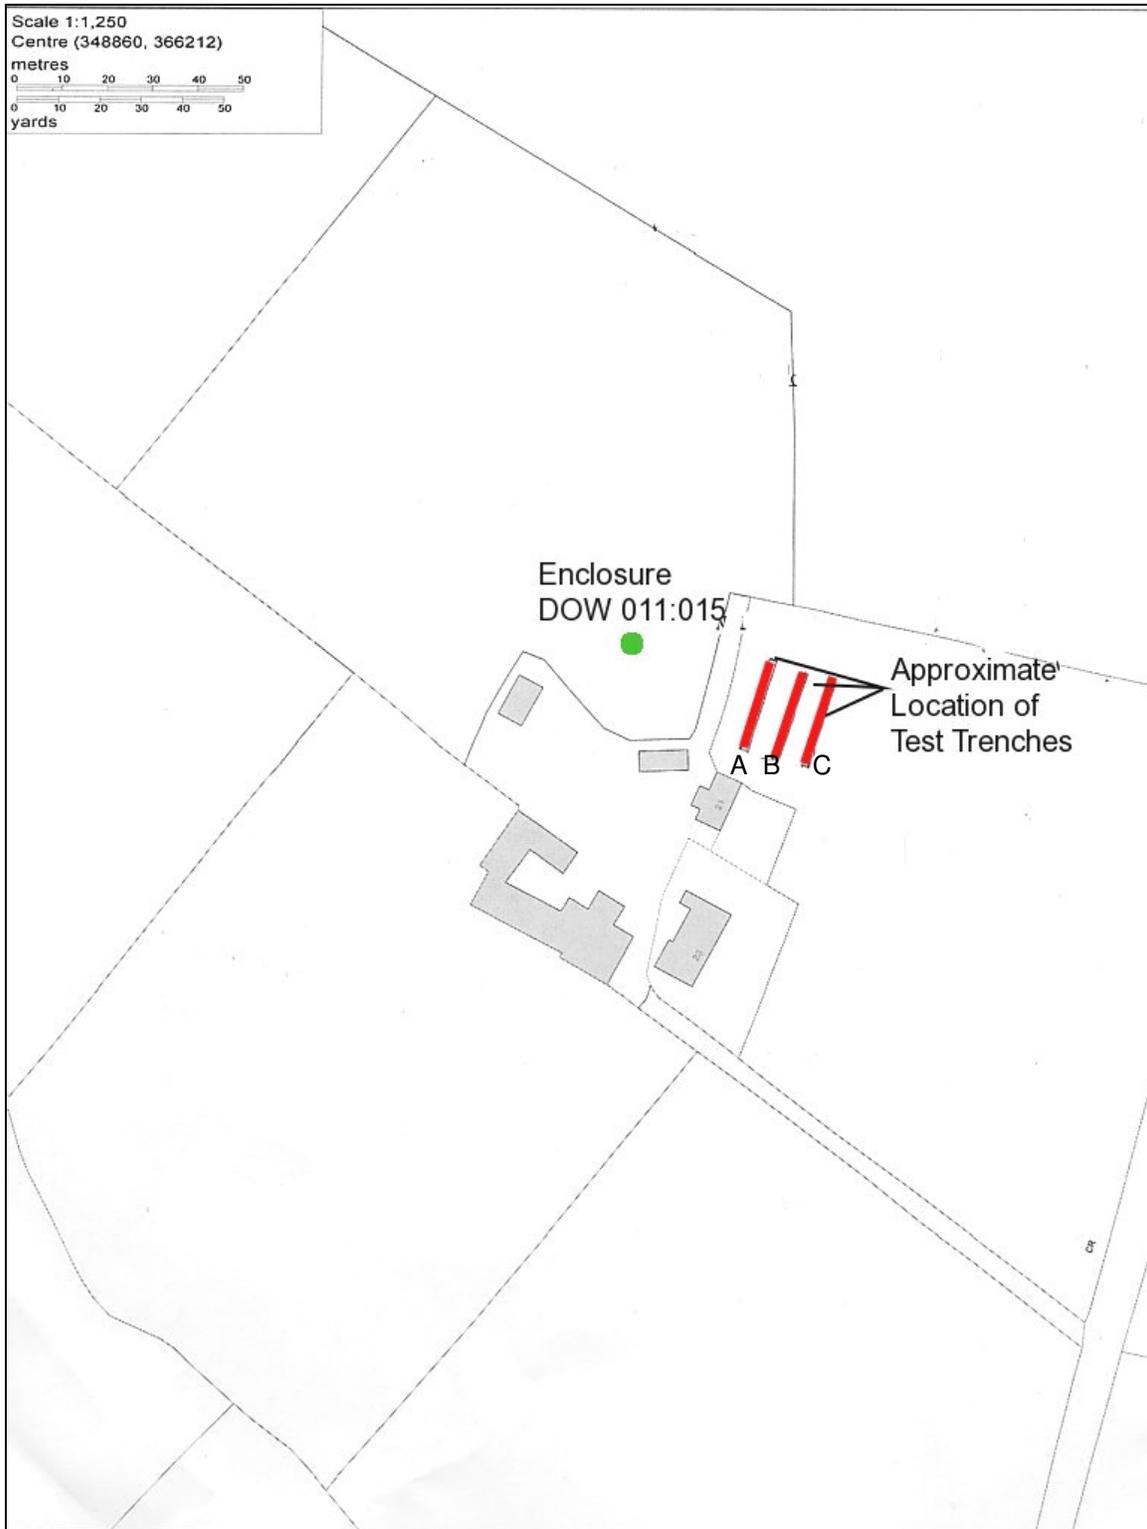
Fig. 3: Location of Enclosure (green circle) and approximate location of test trenches (red).

An archaeological evaluation was requested by EHS: Protecting Historic Monuments to assess the potential impact of the proposed development on any hidden archaeological remains. Monitoring of test trench excavation took place on 23rd February 2006. Three test trenches were excavated (Fig. 3) as requested by the PHM Casework Officer, Gina Baban. All three trenches measured approximately 20m by 2m. The stratigraphy of the test trenches is described below.

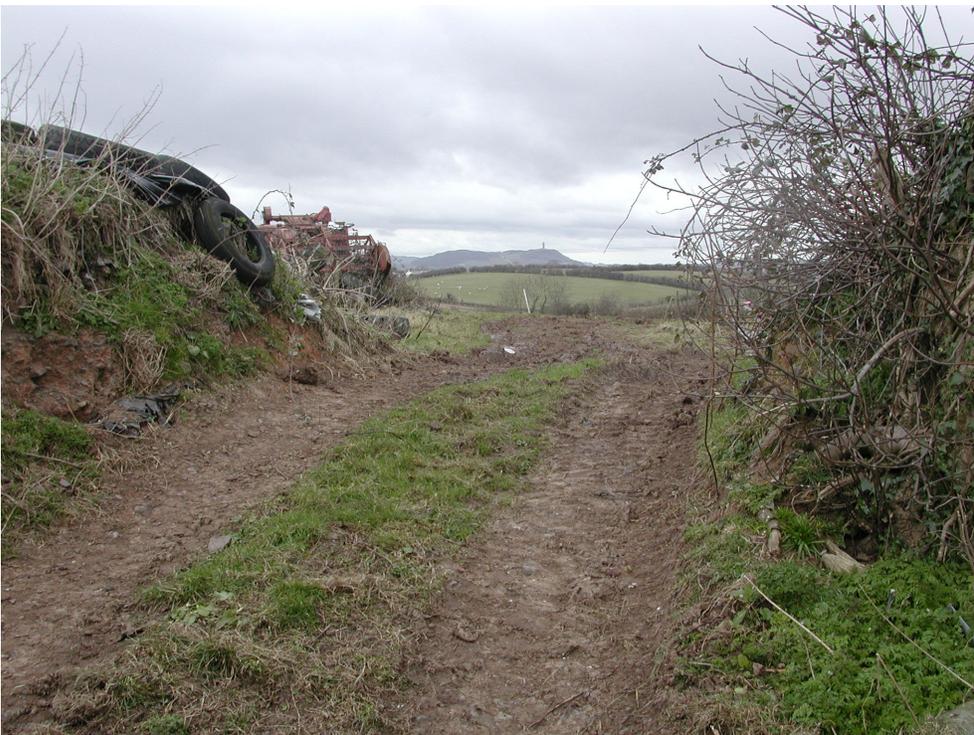
Plate 2: View of farm access cut through bank of enclosure (DOW:011:015), from south.

The proposed development site is located immediately east of an enclosure (DOW:011:015) in Ballyglighorn townland (Fig. 1 and 2). The enclosure is designated 'Fort' on the 1834 OS 6" map, 'Site of Fort' on the 1859 edition and is undesignated on the 3rd and 4th editions. The monument consists of a low mound set off the slope of a hill with scarped sides. It is an elevated site with excellent views towards Strangford Lough (Plate 1). The surface is trampled by cattle and an access for farm machinery cuts across the monument and through what appears to be part of the bank (Plate 2). A track runs straight along the eastern edge of the monument next to the proposed development site.

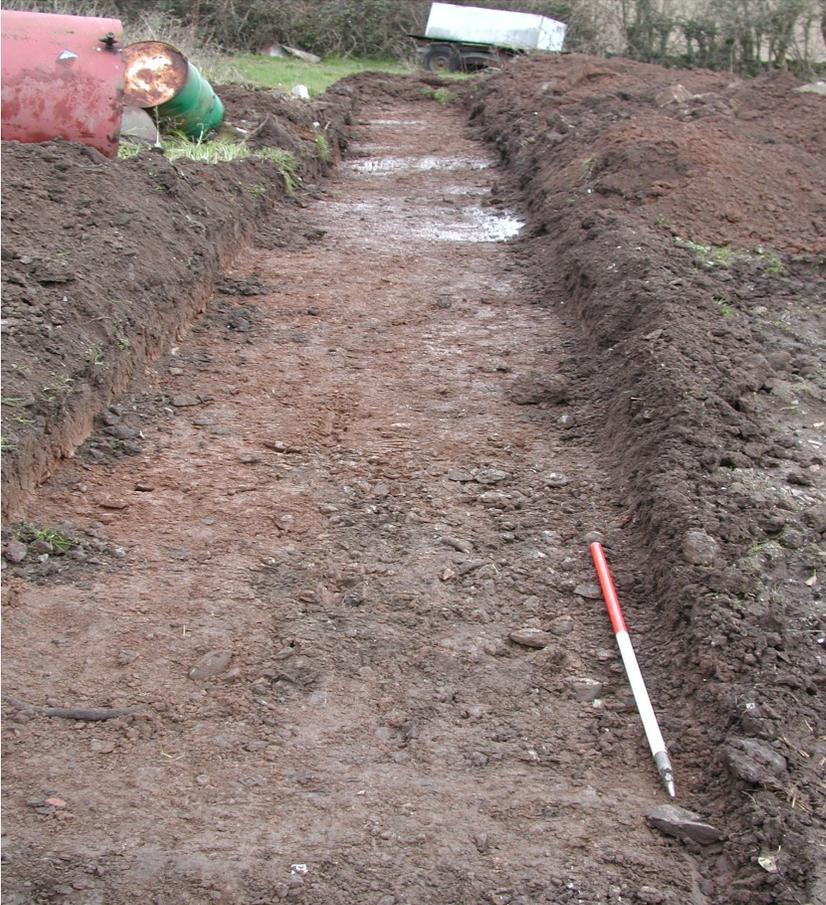
Trench A had a topsoil (C101) with a depth of approximately 0.18m. The topsoil was a uniform moist dark brown sandy silt intermixed with modern farm waste and rubble including brick and baling plastic. Underlying C101 was an eluviation layer (C102) consisting of orange brown silty clay. It was present at a depth of between 0.18m and 0.26m below normal ground level. The subsoil (C103) was an orange brown silty clay with frequent stone inclusions and was located at a depth of approximately 0.26m (Plates 3 and 4).

Plate 3: View of Trench A from south after excavation to surface of subsoil (C103).

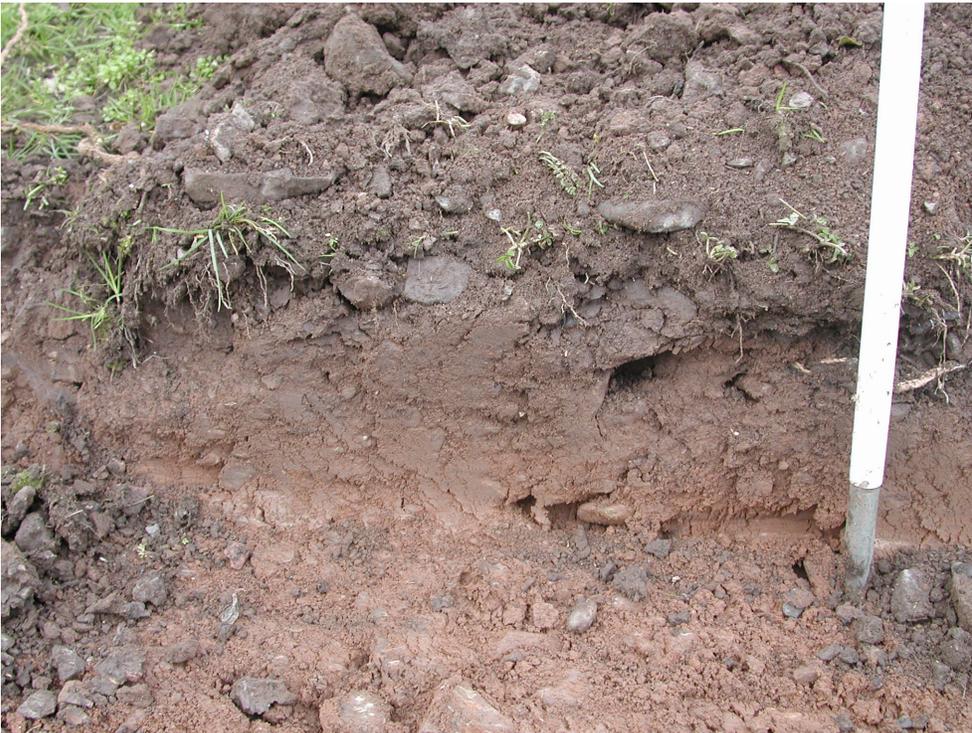
Plate 4: View of east-facing section in Trench A after excavation to surface of subsoil (C103).

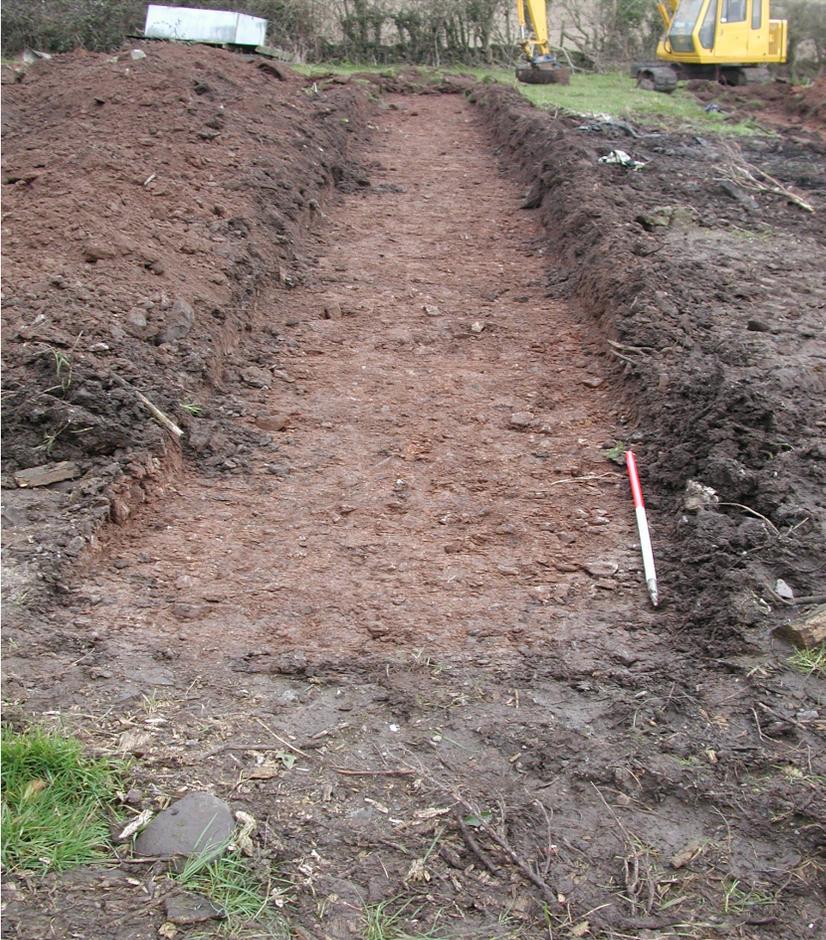
In Trench B the topsoil (C101) had an average depth of 0.14m. The eluviation layer (C102) was located at between 0.14m and 0.24m below ground level and overlay the subsoil (C103) (Plates 5 and 6).

Plate 5: View of Trench B from south after excavation to surface of subsoil (C103).

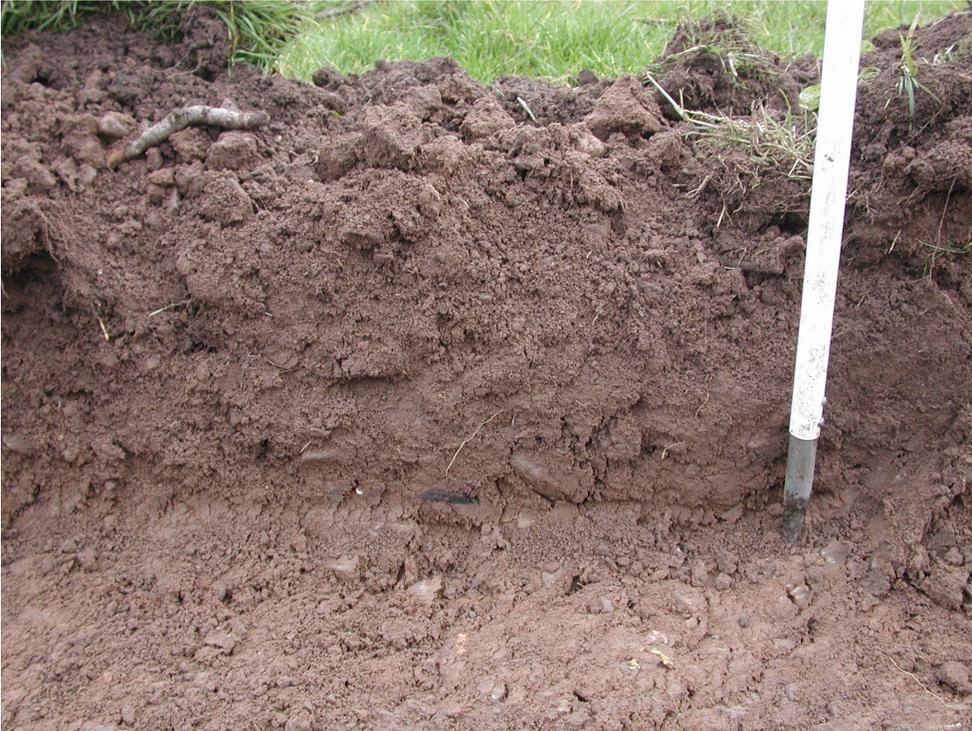
Plate 6: View of west-facing section in Trench B after excavation to surface of subsoil (C103).

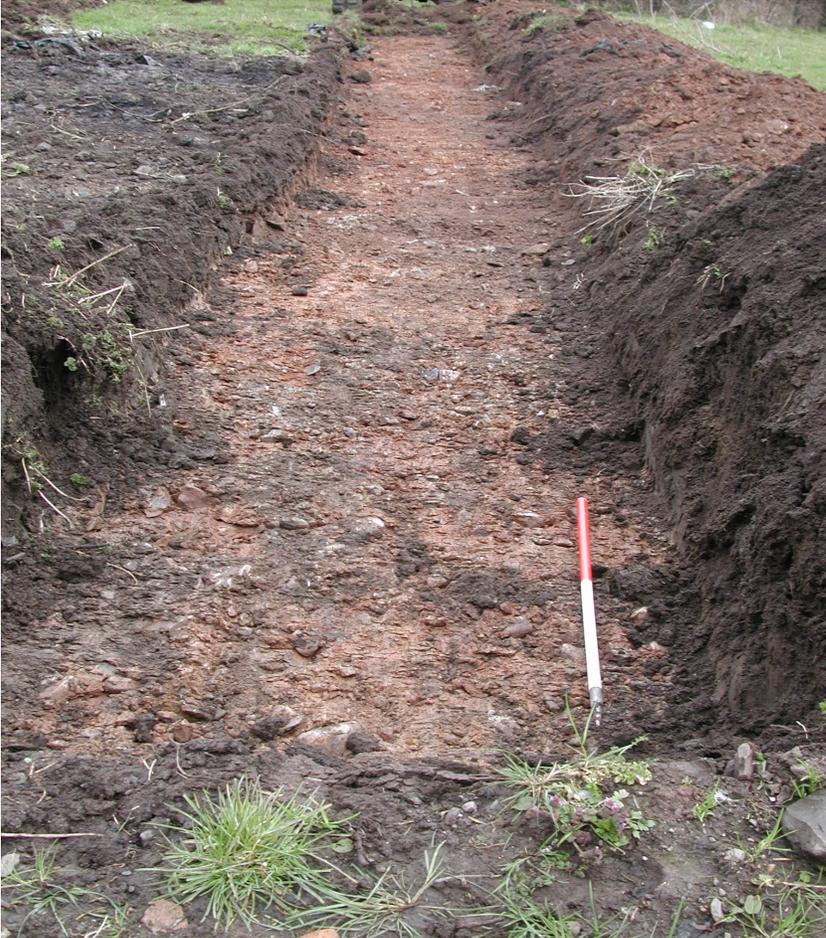
The topsoil (C101) in Trench C had a depth of approximately 0.16m. Underlying this, the eluviation layer (C102) was present between 0.16m and 0.28m and overlay the subsoil (C103) (Plates 7 and 8).

Plate 7: View of Trench C from south after excavation to surface of subsoil (C103).

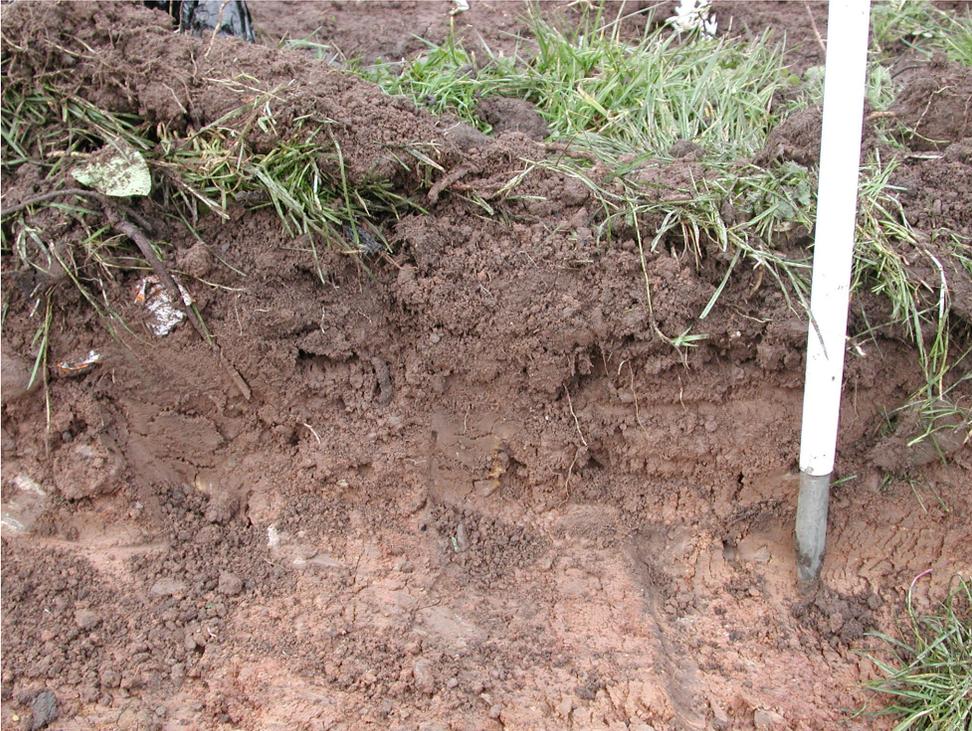
Plate 8: View of west-facing section in Trench C after excavation to surface of subsoil (C103).
