Evaluation/Monitoring Report No. 85

210m north-west of 15 Bonds Road Dorsey Silverbridge County Armagh

LICENCE NO.: AE/07/30

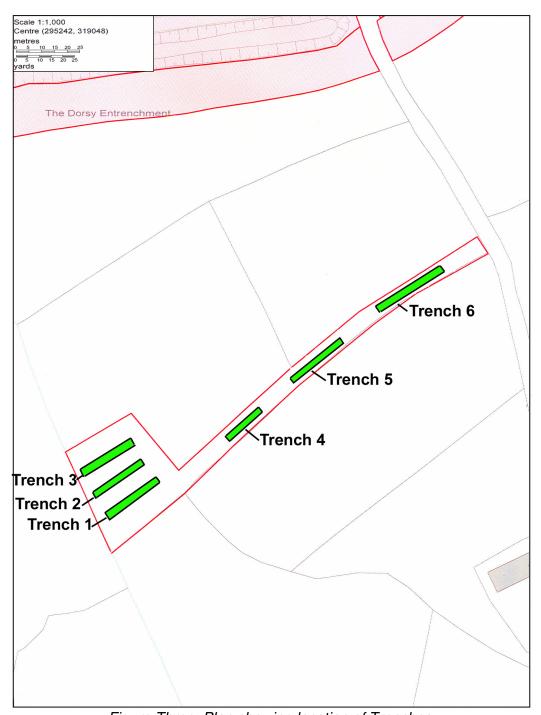
Figure Three: Plan showing location of Trenches.

The evaluation consisted of the archaeological supervision of six mechanically-excavated test trenches. The trenches varied between 18-20m in length by 2m in width and their positions are illustrated in Figure Three. All six test trenches were excavated to the subsoil which consisted of an orangey yellow gravely boulder clay.

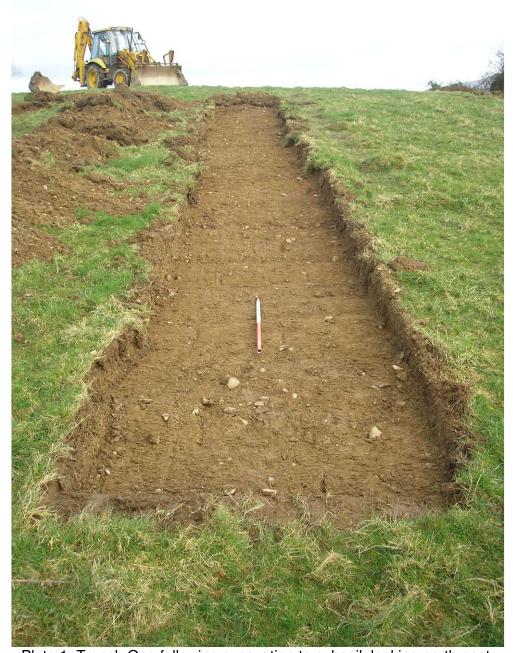
Plate 1: Trench One following excavation to subsoil, looking north-east.

Trench One was located parallel to the south-eastern boundary of the application site (Fig. 3). Trench One measured 19m by 2m and was aligned approximately south-west/north-east. Trench One was excavated to the surface of the subsoil (Plate 1).

The sod and topsoil layer in Trench One (Context No. 101) consisted of mid to dark brown, silty clay loam. The layer contained occasional sub-rounded stone inclusions (average size: $20 \times 20 \times 10$ mm). The layer was around 0.2m thick. Below the sod and topsoil layer (Context No. 101) was a compact, mid to dark brown, sandy loam cultivation soil (Context No. 102) which was 0.1m thick. The cultivation soil contained frequent sub-rounded stone inclusions (average size: $40 \times 30 \times 20$ mm).

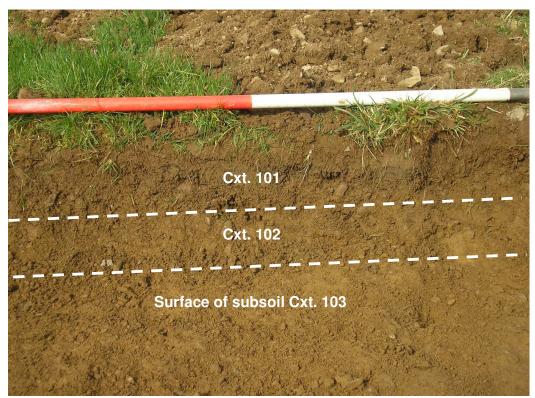
Plate 2: South-east facing section Trench One

The cultivation soil in Trench One (Context No. 102) directly overlay the natural subsoil (Context No. 103) (Plate 2). The subsoil in Trench One (Context No. 103) was an orangey yellow gravely clay with frequent inclusions of small rounded and sub-angular stones (average size 50mm x 30mm x 10mm) as well as larger angular stones (average size 100mm x 80mm x 50mm), and was encountered at an average depth of 0.3m.

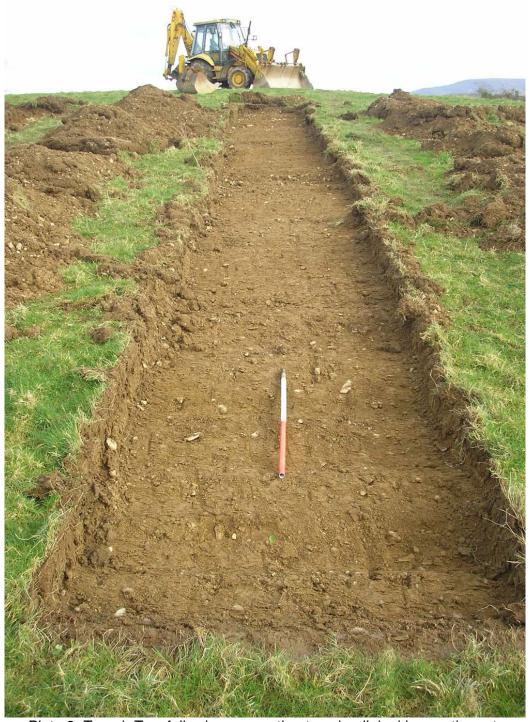
Plate 3: Trench Two following excavation to subsoil, looking north-east.

Trench Two was positioned approximately 5m to the north-west of Trench One and was aligned south-west/north-east (Fig. 3). The trench was 18m long and 2m wide, and was excavated to the surface of the subsoil (Plate 3).

The sod and topsoil layer in Trench Two (Context No. 201) consisted of mid to dark brown, silty clay loam. The layer contained occasional sub-rounded stone inclusions (average size: $20 \times 20 \times 10$ mm). The layer was around 0.2m thick. Below the sod and topsoil layer (Context No. 201) was a compact, mid to dark brown, sandy loam cultivation soil (Context No. 202) which was 0.15m thick. The cultivation soil contained frequent sub-rounded stone inclusions (average size: $40 \times 30 \times 20$ mm).

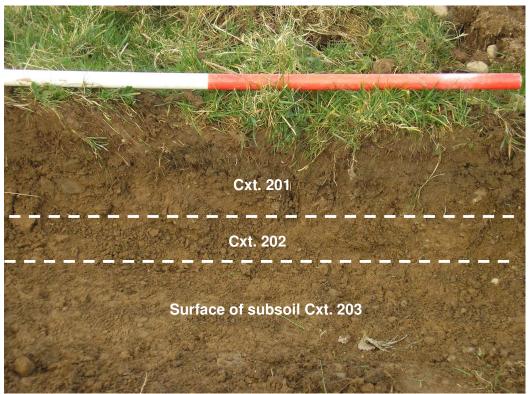
Plate 4: South-east facing section Trench Two.

The cultivation soil in Trench Two (Context No. 202) directly overlay the natural subsoil (Context No. 203) (Plate 4). The subsoil in Trench Two (Context No. 203) was an orangey yellow gravely clay with frequent inclusions of small rounded and sub-angular stones (average size 50mm x 30mm x 10mm) as well as larger angular stones (average size 100mm x 80mm x 50mm), and was encountered at an average depth of 0.35m.

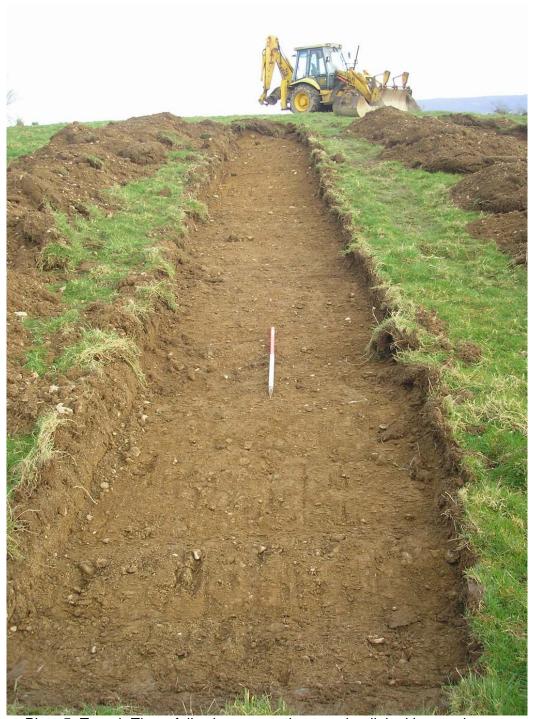
Plate 5: Trench Three following excavation to subsoil, looking north-east.

Trench Three was positioned approximately 10m to the north-west of, and parallel to, Trench Two and measured 20m in length by 2m in width (Fig. 3). The trench was excavated to the surface of the natural subsoil (Plate 5).

The sod and topsoil layer in Trench Three (Context No. 301) consisted of mid brown, silty clay loam. The layer contained occasional sub-rounded stone inclusions (average size: $20 \times 20 \times 10$ mm). The layer was approximately 0.1m thick. Below the sod and topsoil layer (Context No. 301) was a compact, mid to dark brown, sandy loam cultivation soil (Context No. 302) which was 0.2m thick. The cultivation soil contained frequent sub-rounded stone inclusions (average size: $40 \times 30 \times 20$ mm).

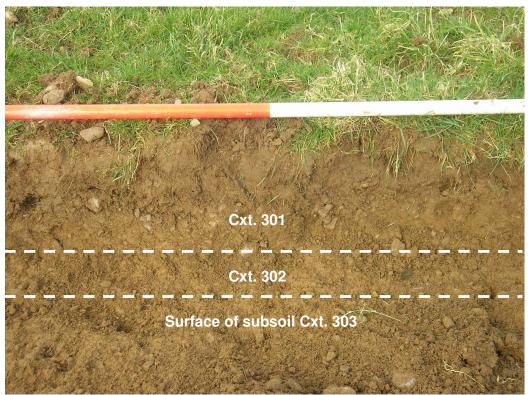
Plate 6: South-east facing section Trench Three.

The cultivation soil in Trench Three (Context No. 302) directly overlay the natural subsoil (Context No. 303) (Plate 6). The subsoil in Trench Three (Context No. 303) was an orangey yellow gravely clay with occasional inclusions of small rounded and sub-angular stones (average size 50mm x 30mm x 10mm) as well as larger angular stones (average size 100mm x 80mm x 50mm), and was encountered at an average depth of 0.3m.

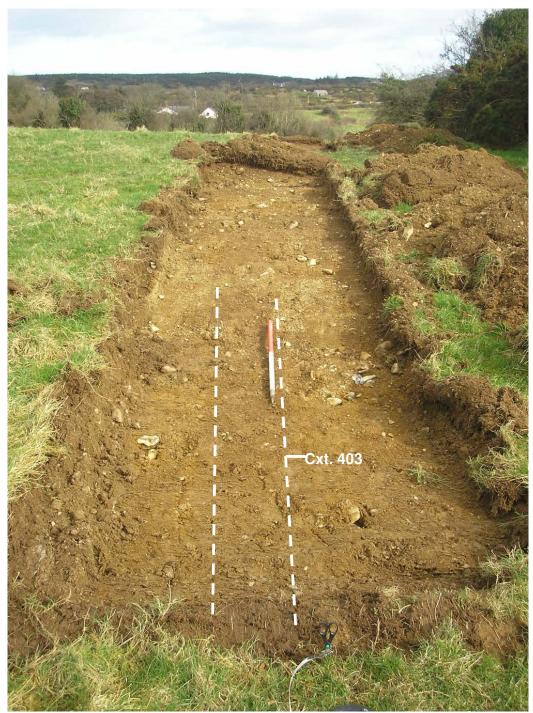
Plate 7: Trench Four following excavation to subsoil, looking north-east.

Trench Four was positioned approximately 10m to the north-east of Trench One along the proposed access route for the new dwelling. It measured 12m in length by 2m in width (Fig. 3), and was excavated to the surface of the natural subsoil (Plate 7).

The sod and topsoil layer in Trench Four (Context No. 401) consisted of light to mid brown, silty loam. The layer contained occasional inclusions of sub-rounded stones (average size: 20 x 20 x 10mm). The layer was approximately 0.1m thick. Below the sod and topsoil layer (Context No. 401) was a compact, mid to dark brown, sandy loam cultivation soil (Context No. 402) which was 0.08m thick. The

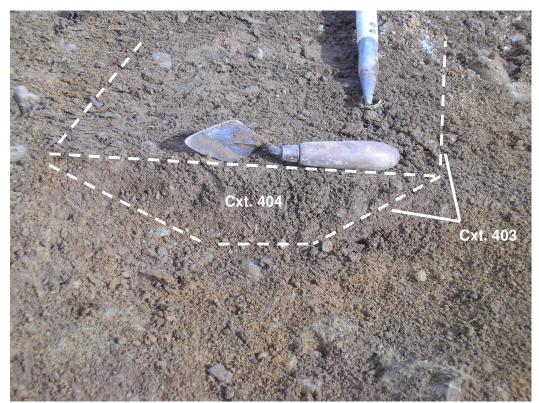
Plate 8: Cutting across agricultural feature Cxt. 403.

Upon removal of the cultivation soil (Context No. 402) a linear feature (Context No. 403) was noticed roughly aligned east-west at the south-western most end of the trench. A small cutting was excavated across this feature to ascertain its archaeological potential. The feature was found to be shallow (0.05m deep) with a flattish base and gently sloping sides. The fill of this feature (Context No. 404) consisted of a light to mid brown sandy loam which contained occasional occurrences of small rounded stones (average size: 30mm x 20mm x 20mm). This feature is interpreted as being the result of an agricultural process, possibly ploughing or spade cultivation (Plate 8).

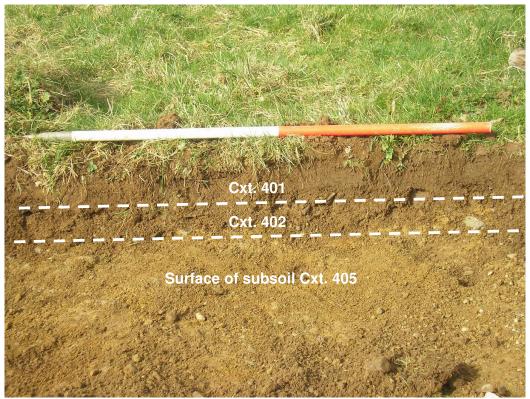
Plate 9: South-east facing section Trench Four.

The cultivation soil in Trench Four (Context No. 402) overlay the natural subsoil (Context No. 405) (Plate 9). The subsoil in Trench Four (Context No. 403) was an orangey yellow gravely clay with occasional inclusions of small rounded and sub-angular stones (average size 50mm x 30mm x 10mm) as well as larger angular stones (average size 100mm x 80mm x 50mm), and was encountered at an average depth of 0.2m.

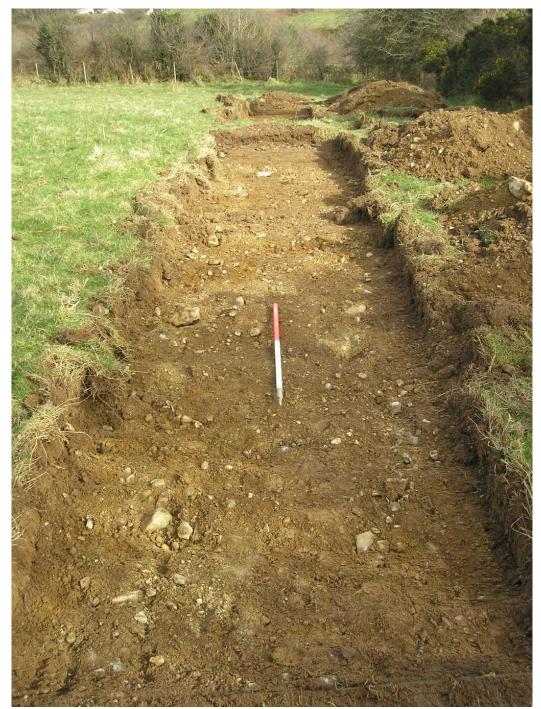
Plate 10: Trench Five following excavation to subsoil, looking north-east

Trench Five was located approximately 5m to the north-east of Trench Four along the proposed access route for the new dwelling (Fig. 3). Trench Five measured 17m by 2m and was aligned approximately south-west/north-east. Trench Five was excavated to the surface of the subsoil (Plate 10).

The sod and topsoil layer in Trench Five (Context No. 501) consisted of mid to dark brown, silty clay loam. The layer contained occasional sub-rounded stone inclusions (average size: $20 \times 20 \times 10$ mm). The layer was around 0.2m thick. Below the sod and topsoil layer (Context No. 501) was a compact, mid to dark brown, sandy loam cultivation soil (Context No. 502) which was 0.1m thick. The cultivation soil contained frequent sub-rounded stone inclusions (average size: $40 \times 30 \times 20$ mm).

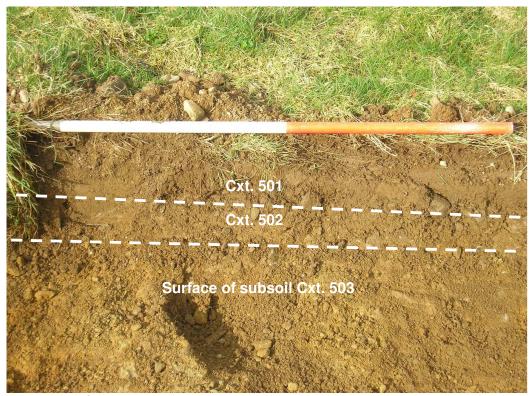
Plate 11: South-east facing section Trench Five. NB depression at base of picture occurred when a stone was removed by the mechanical digger.

The cultivation soil in Trench Five (Context No. 502) directly overlay the natural subsoil (Context No. 503) (Plate 11). The subsoil in Trench Five (Context No. 503) was an orangey yellow gravely clay with frequent inclusions of small rounded and sub-angular stones (average size 50mm x 30mm x 10mm) as well as larger angular stones (average size 100mm x 80mm x 50mm), and was encountered at an average depth of 0.3m.

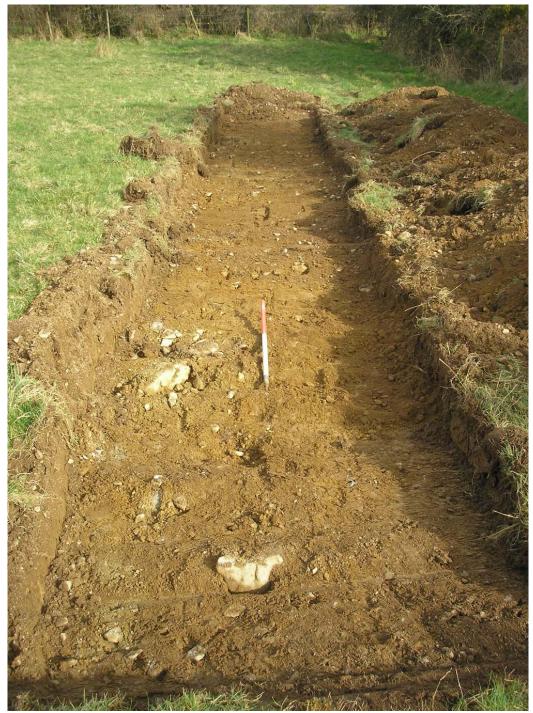
Plate 12: Trench Six following excavation to subsoil, looking north-east

Trench Six was positioned approximately 5m to the north-east of Trench Six and was aligned south-west/north-east (Fig. 3). The trench was 18m long and 2m wide, and was excavated to the surface of the subsoil (Plate 12).

The sod and topsoil layer in Trench Six (Context No. 601) consisted of mid to dark brown, silty clay loam. The layer contained occasional sub-rounded stone inclusions (average size: $20 \times 20 \times 10$ mm). The layer was around 0.15m thick. Below the sod and topsoil layer (Context No. 601) was a compact, mid to dark brown, sandy loam cultivation soil (Context No. 602) which was 0.1m thick. The cultivation soil contained frequent sub-rounded stone inclusions (average size: $40 \times 30 \times 20$ mm).

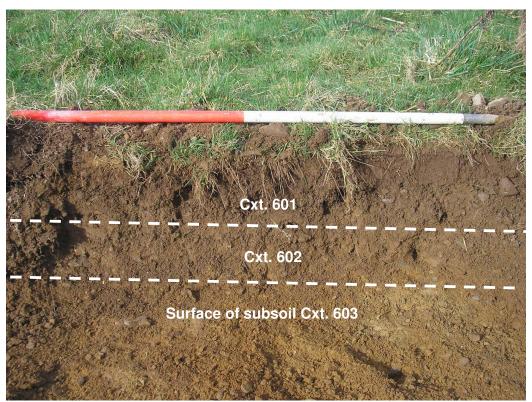
Plate 13: South-east facing section Trench Six.

The cultivation soil in Trench Six (Context No. 602) directly overlay the natural subsoil (Context No. 603) (Plate 13). The subsoil in Trench Six (Context No. 603) was an orangey yellow gravely clay with frequent inclusions of small rounded and sub-angular stones (average size 50mm x 30mm x 10mm) as well as larger angular stones (average size 100mm x 80mm x 50mm), and was encountered at an average depth of 0.25m.
