# **Evaluation/Monitoring Report No. 120**

SITE 100M NORTH OF 117 BANN ROAD MAGHERAMAYO CASTLEWELLAN CO. DOWN

LICENCE NO.: AE/07/54

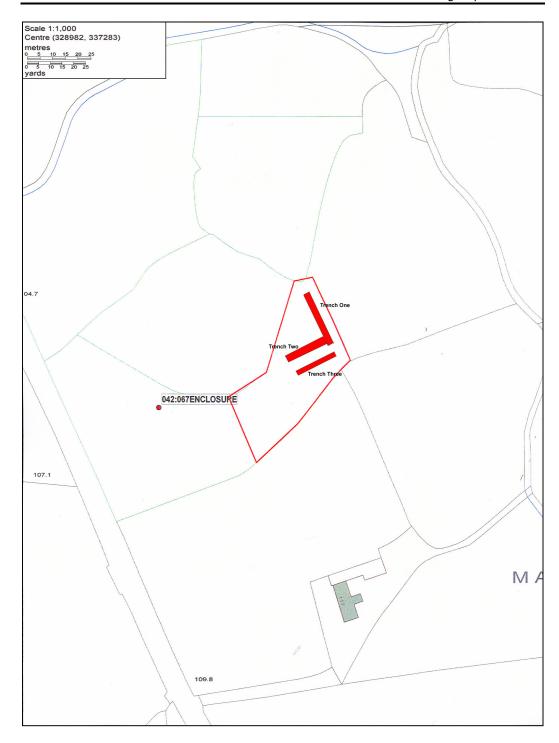
Figure Three: Detailed map showing position of trenches (coloured red) in relation to the enclosure site (DOW 042:067).

The original research design for this evaluation stipulated the excavation of three test trenches measuring between 30m and 20m in length in the area of the proposed development. However, the excavated trenches measured between 15m and 20m due to the presence of a large field clearance cairn in the northern area of the application site (Figure Three). All three test trenches were excavated to the subsoil which consisted of an orange glacially derived sandy clay. The surface of the subsoil was encountered at a depth of around 0.3m.

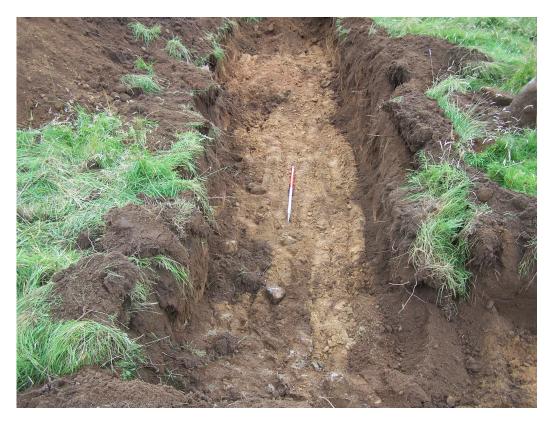
Trench One was located parallel to the southern boundary of the application site. Trench One was approximately 2m wide and 20m long and was aligned approximately north-west/south-east (Plate One). The trench was excavated to the surface of the natural subsoil.

Plate One: Trench One following excavation to the surface of the natural subsoil (Context No. 103), looking south-east.

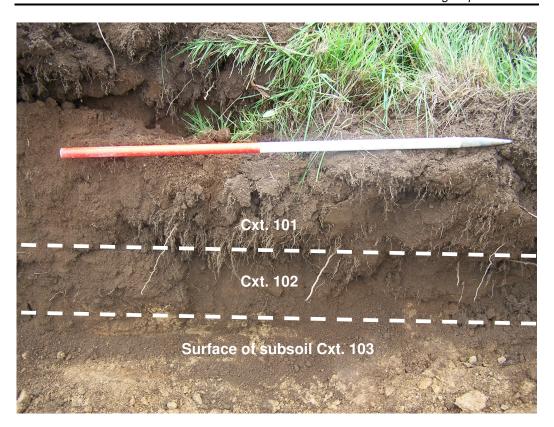
The sod and topsoil layer in Trench One (Context No. 101) consisted of loose, light to mid brown, sandy loam. The layer contained occasional subrounded stone inclusions (average size: 20 x 20 x 10mm). The layer was around 0.1m thick. Below the sod and topsoil layer (Context No. 101) was a compact, mid to dark brown, sandy loam cultivation soil (Context No. 102) which was 0.2m thick. The cultivation soil contained frequent sub-rounded stone inclusions (average size: 40 x 30 x 20mm). There were no finds recovered from this trench. The cultivation soil (Context No. 102) directly overlay the natural subsoil (Context No. 103) (Plate Two).

The subsoil in Trench One (Context No. 103) was an orange sandy boulder clay with occasional inclusions of medium to large angular stones and large boulders, and was encountered at a depth of around 0.3m.

Plate Two: South-west facing section of Trench One.

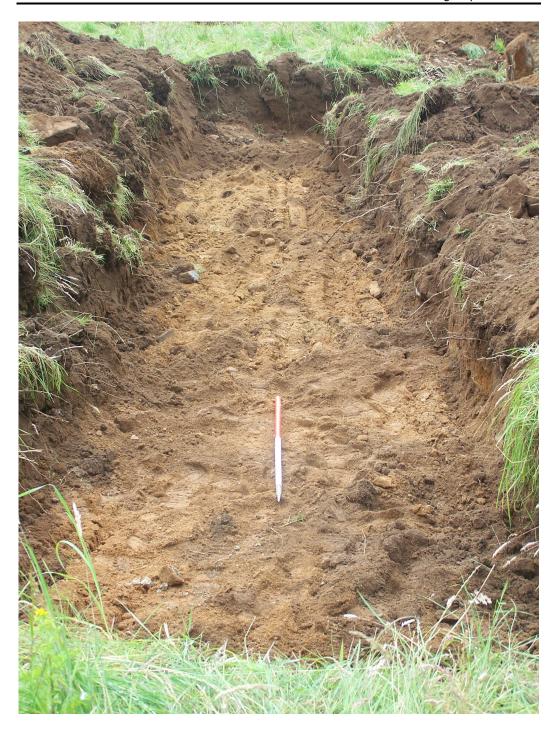
Trench Two was positioned perpendicular to the south-eastern end of Trench One. The trench was aligned roughly east/west. The trench was 2m wide and 17m long and was excavated to the surface of the subsoil (Plate Three).

Plate Three: Trench Two following excavation to the surface of the natural subsoil (Context No. 203), looking north-east.

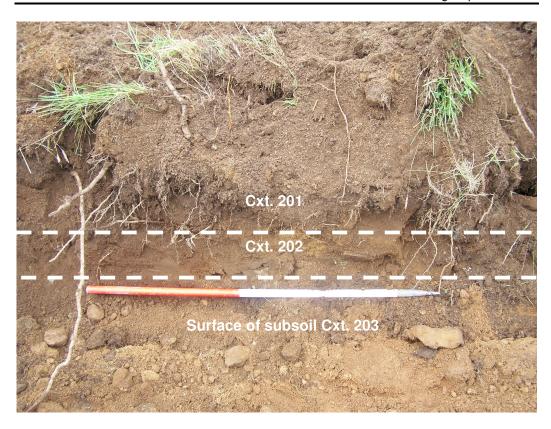
The sod and topsoil layer in Trench Two (Context No. 201) consisted of a loose to slightly compact, light to mid brown, sandy loam. The layer contained infrequent sub-rounded stone inclusions (average size:  $30 \times 20 \times 10$ mm). This layer was on average 0.13m thick.

Below the sod and topsoil layer (Context No. 201) was a cultivation soil of compact, mid brown, sandy loam (Context No. 202) that contained frequent subrounded stone inclusions (average size: 30 x 20 x 10mm) and which was 0.2m thick. The cultivation soil (Context No. 202) directly overlay the natural subsoil (Context No. 203) (Plate Four).

The subsoil in Trench Two (Context No. 203) was an orange compact boulder clay with occasional inclusions of medium to large angular stone, and was encountered at a depth of around 0.33m.

Plate Four: North-west facing section of Trench Two.

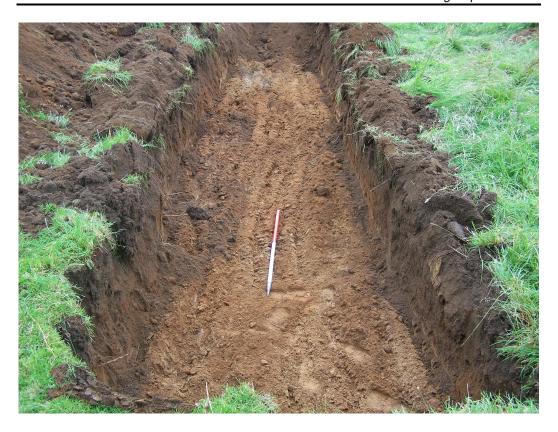
Trench Three was positioned parallel to and approximately 3m to the southeast of Trench Two. The trench was 2m wide and 15m long and was excavated to the surface of the natural subsoil (Plate Five).

Plate Five: Trench Three following excavation to the surface of the natural subsoil (Context No. 203), looking north-east.

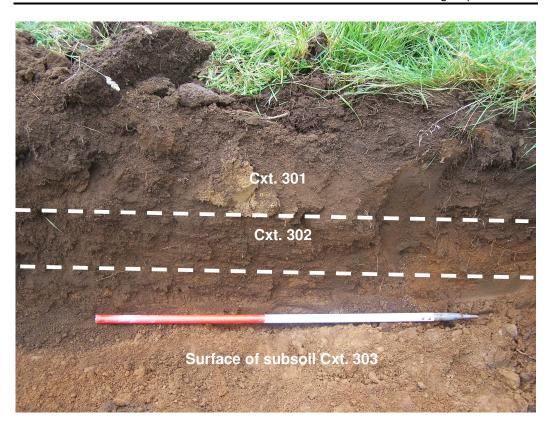
The sod and topsoil layer in Trench Three (Context No. 301) consisted of a loose to slightly compact, light to mid brown, sandy loam. The layer contained infrequent sub-rounded stone inclusions (average size:  $30 \times 20 \times 10$ mm). This layer was on average 0.15m thick.

Below the sod and topsoil layer (Context No. 301) was a cultivation soil of compact, mid brown, sandy loam (Context No. 302) that contained frequent subrounded stone inclusions (average size: 30 x 20 x 10mm) and which was 0.2m thick. The cultivation soil (Context No. 302) directly overlay the natural subsoil (Context No. 303) (Plate Six).

The subsoil in Trench Three (Context No. 303) was an orange compact boulder clay with occasional inclusions of medium to large angular stone, and was encountered at a depth of around 0.35m.

Plate Six: North-west facing section of Trench Three.

The three test trenches excavated at the application site contained nothing of archaeological significance. It is not thought that the development will impact upon previously unrecorded archaeological remains. It is therefore recommended that no further archaeological fieldwork is carried out. No publication is required save for a short summary in the annual *'Excavations'* bulletin.
