**Evaluation/Monitoring Report No. 130**

**Crevinish Castle  
Kesh  
County Fermanagh**

**LICENCE NO.: AE/07/151**

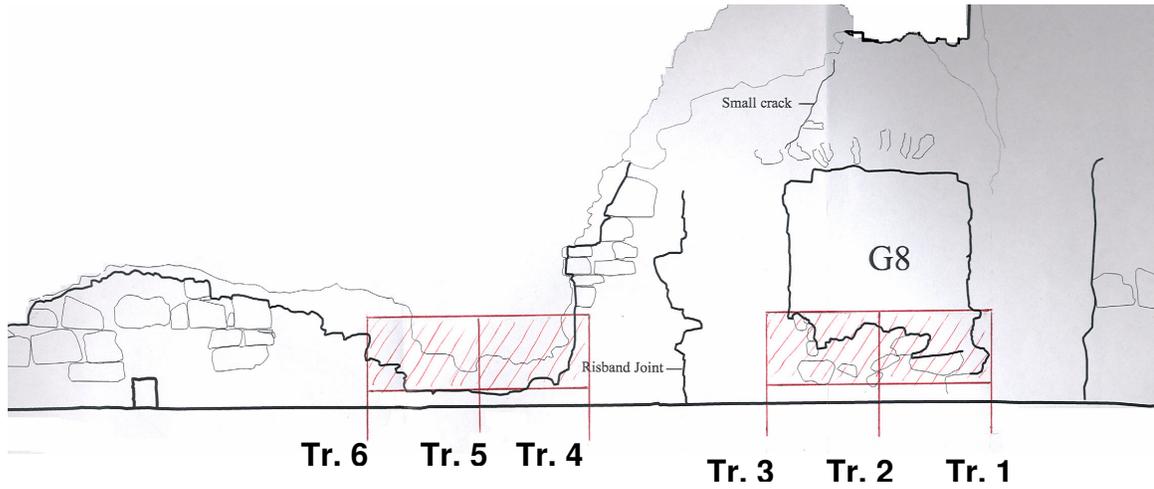
Figure Four: Location of the trenches (Provided by the EHS).

The six trenches were excavated along the southern wall of the castle in an effort to hamper access to a collapsed portion of the wall and a large window (Figure Four). Each trench measured 0.3m x 0.3m and was excavated to a depth of 0.4m. Excavation ceased at this level and the trenches were lined with a semi-permeable membrane prior to concrete being poured in.

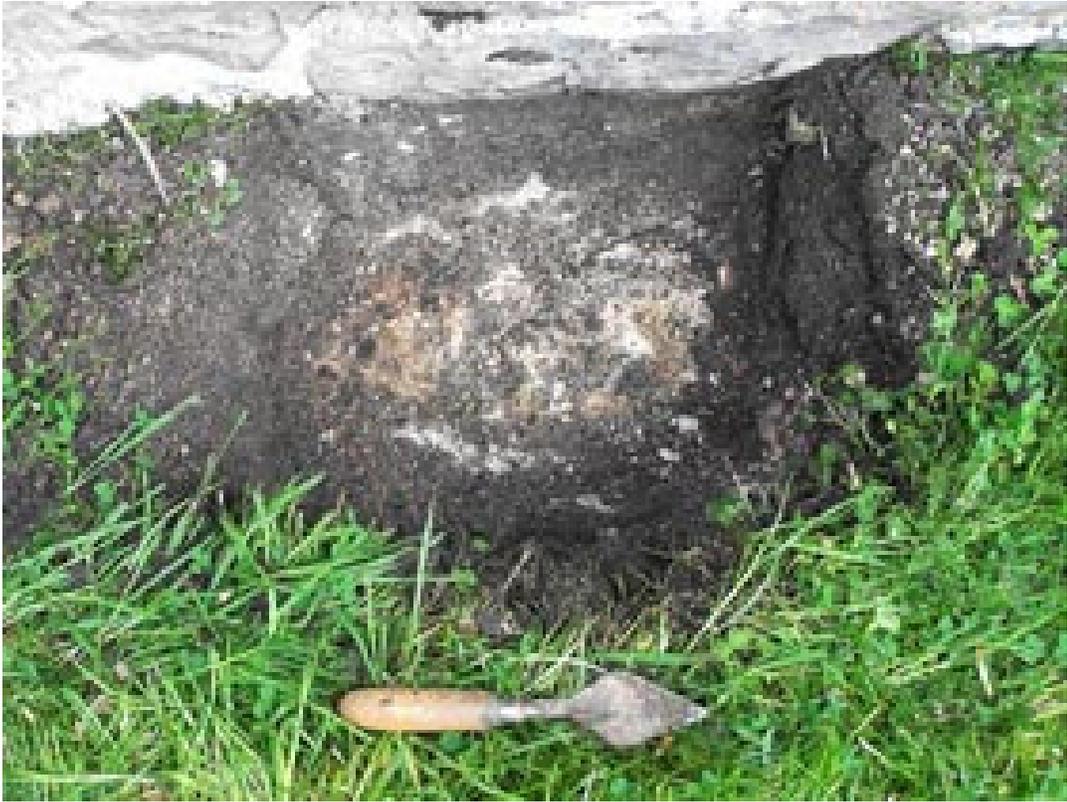
Plate One: Trench 1 showing surface of mortared stone (Context No. 102)

The sod and topsoil in this trench (Context No. 101) consisted of a light to mid brown gritty loam with frequent inclusions of small angular stones and pebbles (average size 20mm x 50mm x 60mm). This deposit was approximately 0.25m deep. Directly below the sod and topsoil (Context No. 101) compact mortared stone (Context No. 102) was encountered (Plate One). Due to the proximity of the excavation to the southern wall of the castle, the mortared stone (Context No. 102) may represent a plinth that the wall was built upon (Billy Silcock *pers comm.*). Excavation continued into this layer (Context No. 102) for a further 0.15m where excavation ceased at an overall depth of 0.4m.

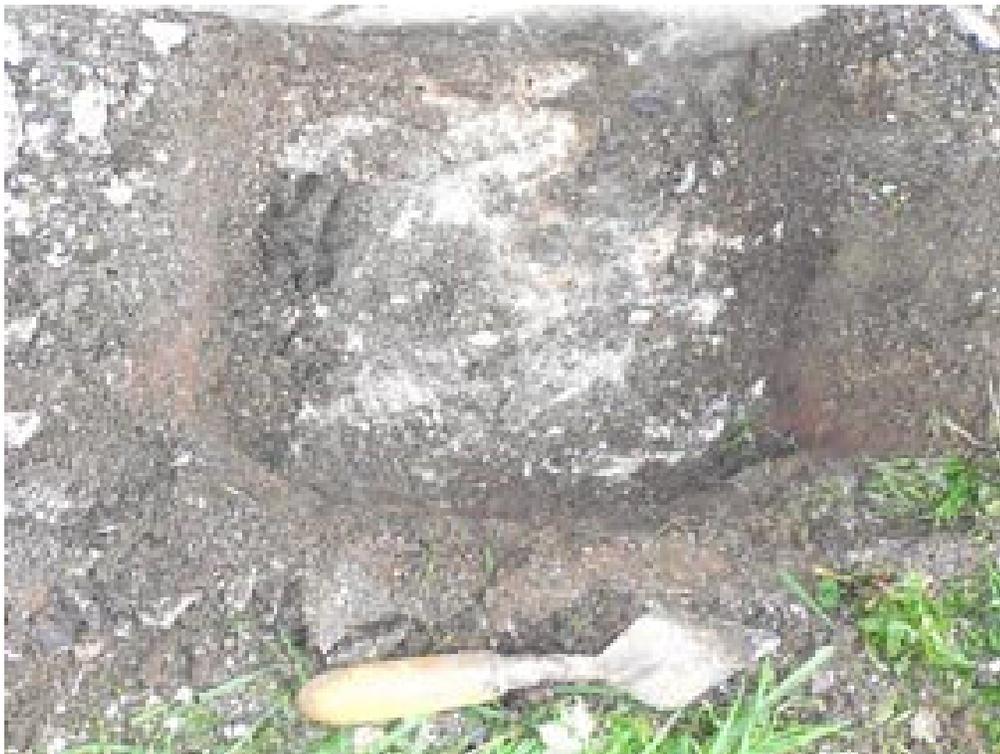
Plate Two: Trench Two Showing surface of mortared stone (Context No. 202).

The sod and topsoil in this trench (Context No. 201) consisted of a light to mid brown gritty loam with frequent inclusions of small angular stones and pebbles (average size 20mm x 50mm x 60mm). This deposit was approximately 0.20m deep. Directly below the sod and topsoil (Context No. 201) compact mortared stone (Context No. 202) was encountered (Plate Two). Due to the proximity of the excavation to the southern wall of the castle, the mortared stone (Context No. 202) may represent a plinth that the wall was built upon (Billy Silcock *pers comm.*). Excavation continued into this layer (Context No. 202) for a further 0.20m where excavation ceased at an overall depth of 0.4m.

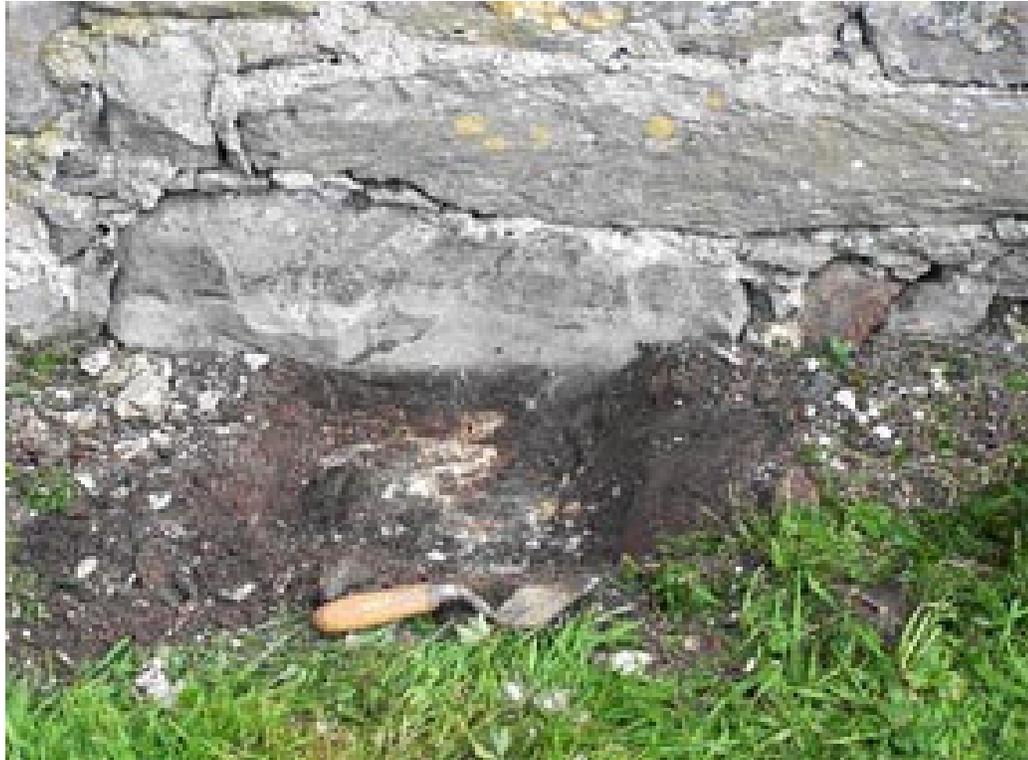
Plate Three: Trench Three showing surface of mortared stone (Context No. 303).

The sod and topsoil in this trench (Context No. 301) consisted of a light to mid brown gritty loam with frequent inclusions of small angular stones and pebbles (average size 20mm x 50mm x 60mm). This deposit was approximately 0.25m deep. Directly below the sod and topsoil (Context No. 301) compact mortared stone (Context No. 302) was encountered (Plate Three). Due to the proximity of the excavation to the southern wall of the castle, the mortared stone (Context No. 302) may represent a plinth that the wall was built upon (Billy Silcock *pers comm.*). Excavation continued into this layer (Context No. 302) for a further 0.15m where excavation ceased at an overall depth of 0.4m.

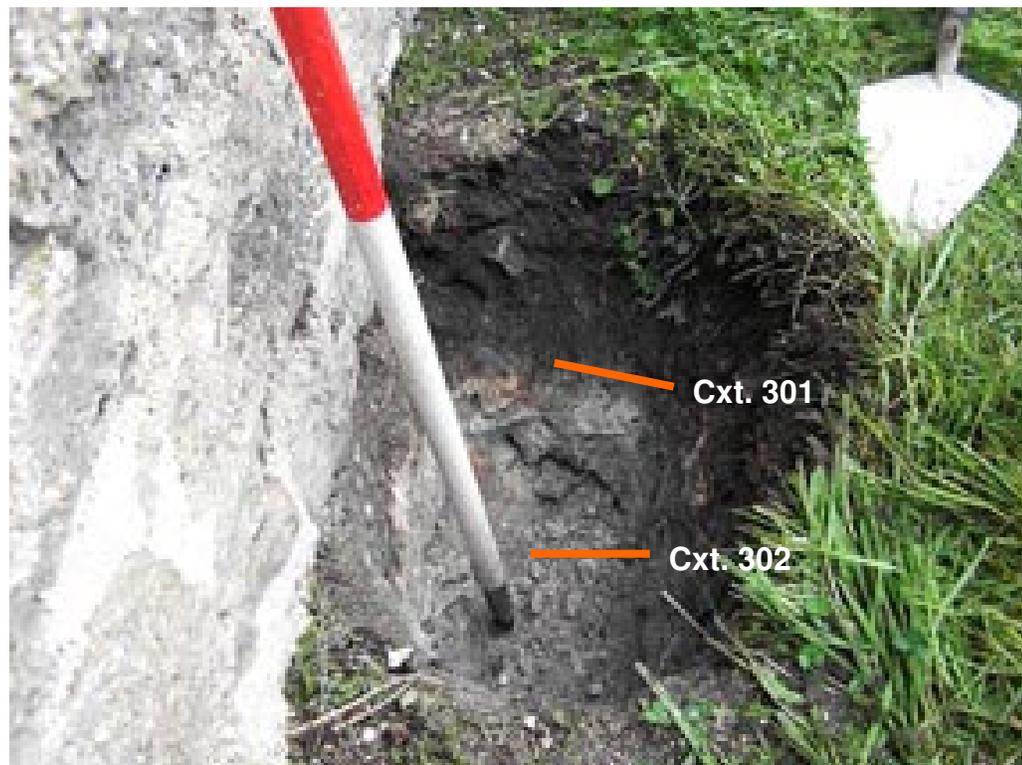
Plate Four: Trench Three showing stratigraphic sequence encountered in the excavation.

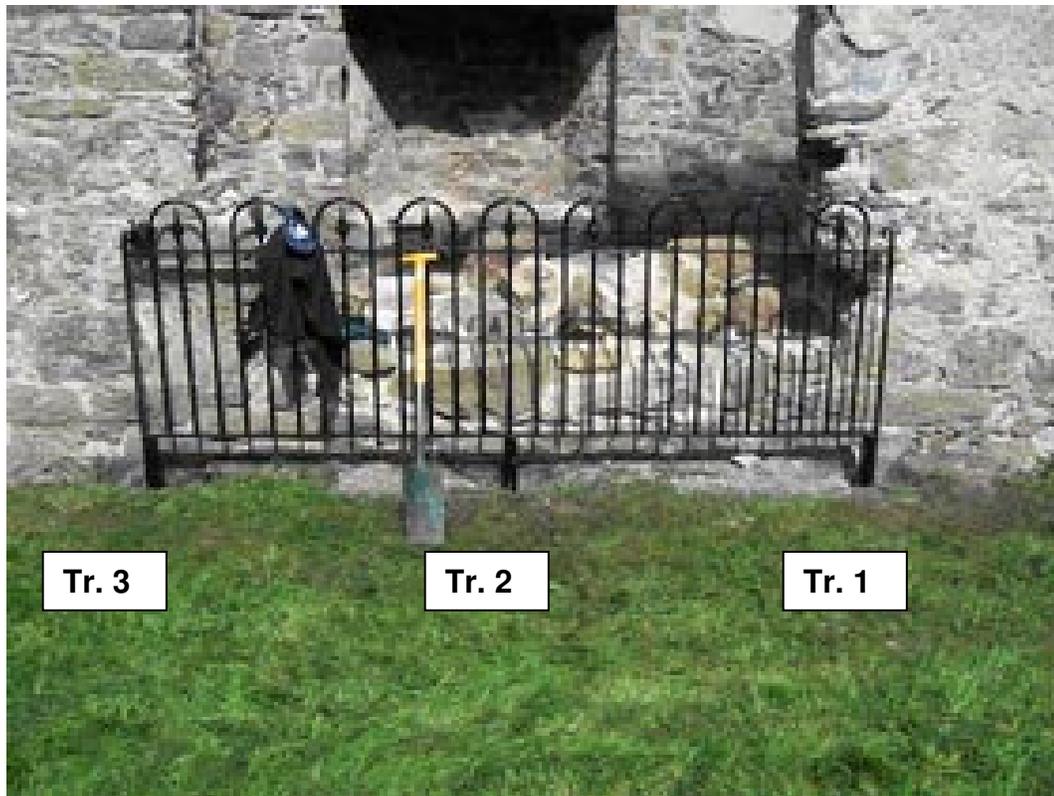
Plate Five: The easternmost guardrail, looking north.

Trench One was the easternmost trench excavated (Plate Five). The trench measured 0.3m x 0.3m and was excavated to a depth of 0.4m.

Trench Two was positioned approximately 2m to the west of Trench One (Plate Five). The trench measured 0.3m x 0.3m and was excavated to a depth of 0.4m.

Trench Three was positioned approximately 2m to the west of Trench Two (Plate Five). The trench measured 0.3m x 0.3m and was excavated to a depth of 0.4m.

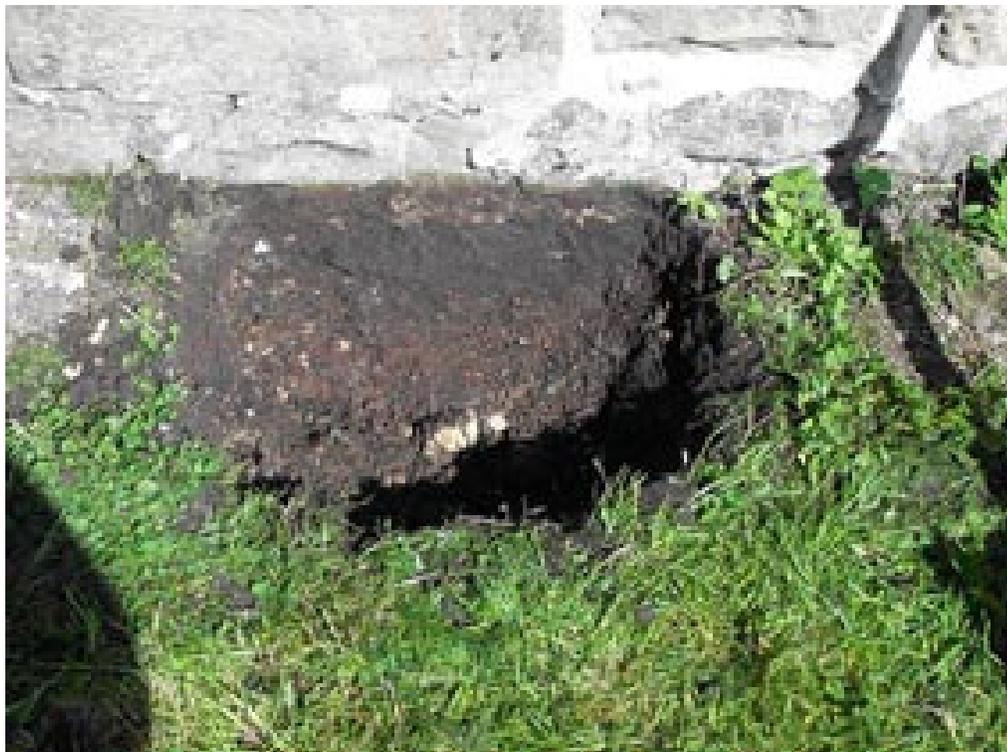
Plate Six: Trench Four following excavation to a depth of 0.4m.

Trench Four was positioned approximately 3.5m to the west of Trench Three and provided the easternmost footing for the railing guarding the collapsed section of wall (Plate Nine). The trench measured 0.3m x 0.3m and was excavated to a depth of 0.4m (Plate Six).

The sod and topsoil in this trench (Context No. 401) consisted of a light to mid brown gritty loam with frequent inclusions of small angular stones and pebbles (average size 20mm x 50mm x 60mm). This deposit was approximately 0.25m deep. Directly below the sod and topsoil (Context No. 401) was a layer of loose gritty soil with frequent inclusions of medium to large rounded and sub-angular stones (average size: 50mm x 80mm x 120mm) (Context No. 402). Excavation continued into this layer (Context No. 402) for a further 0.15m where excavation ceased at an overall depth of 0.4m.

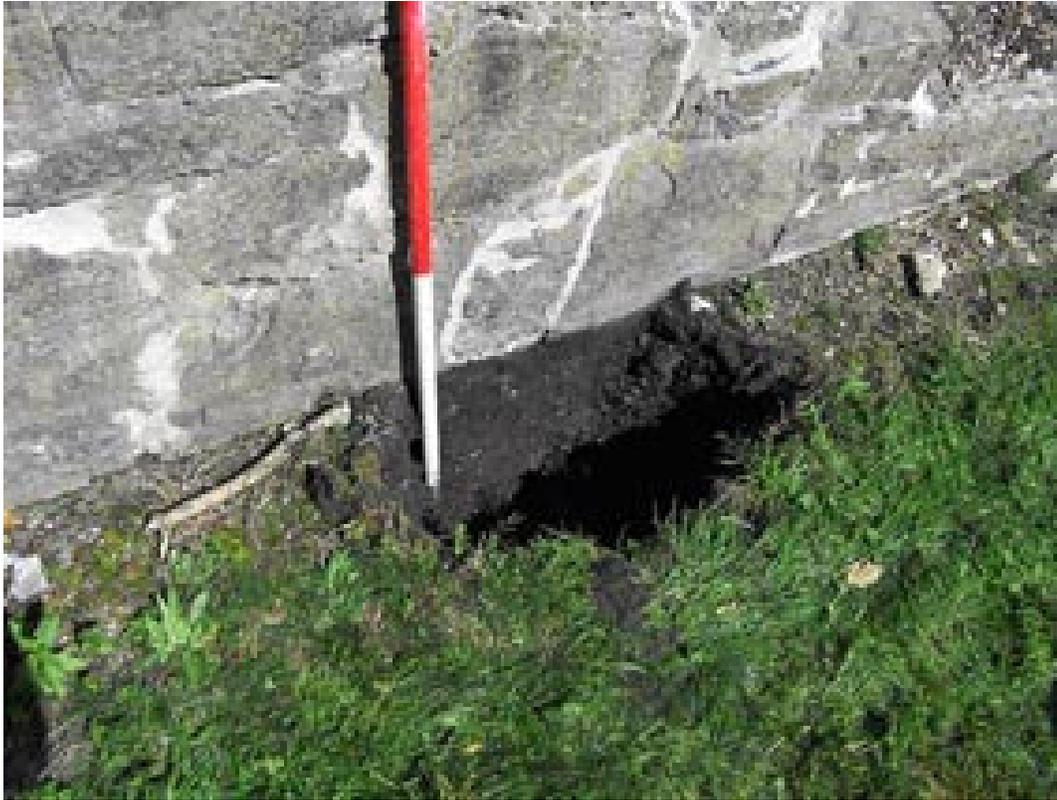
Plate Seven: Trench Five following excavation to depth of 0.4m.

Trench Five was positioned approximately 2m to the west of Trench Four (Plate Nine). The trench measured 0.3m x 0.3m and was excavated to a depth of 0.4m (Plate Seven).

The sod and topsoil in this trench (Context No. 501) consisted of a light to mid brown gritty loam with frequent inclusions of small angular stones and pebbles (average size 20mm x 50mm x 60mm). This deposit was approximately 0.25m deep. Directly below the sod and topsoil (Context No. 501) was a layer of loose gritty soil with frequent inclusions of medium to large rounded and sub-angular stones (average size: 50mm x 80mm x 120mm) (Context No. 502). Excavation continued into this layer (Context No. 502) for a further 0.15m where excavation ceased at an overall depth of 0.4m.

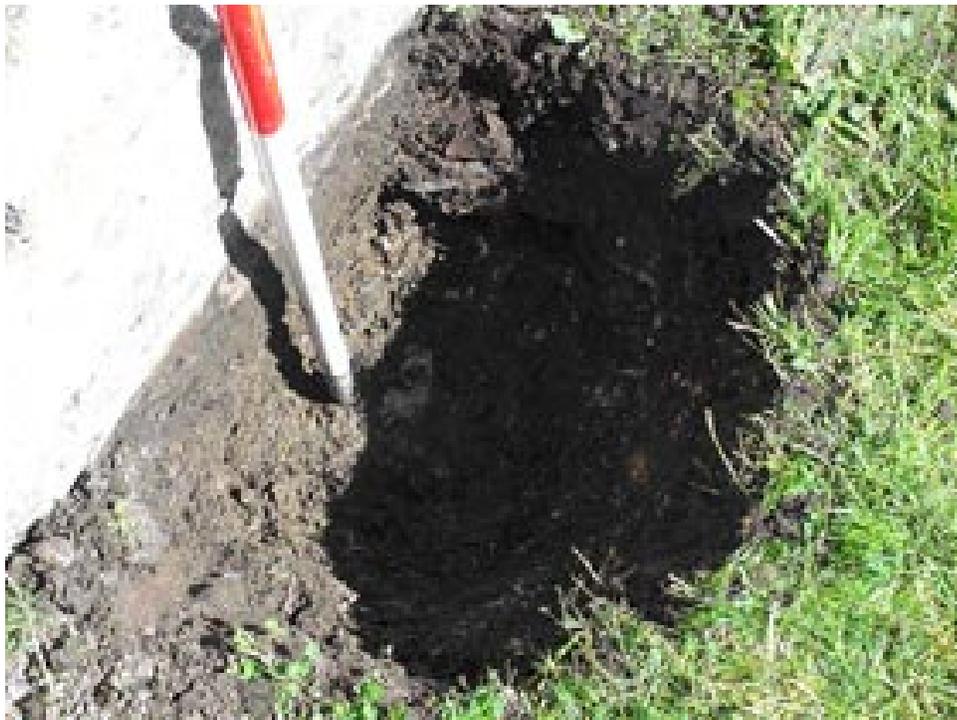
Plate Eight: Trench Six following excavation to a depth of 0.4m.

Trench Six was positioned approximately 2m to the west of Trench Five (Plate Nine). The trench measured 0.3m x 0.3m and was excavated to a depth of 0.4m (Plate Eight).

The sod and topsoil in this trench (Context No. 601) consisted of a light to mid brown gritty loam with frequent inclusions of small angular stones and pebbles (average size 20mm x 50mm x 60mm). This deposit was approximately 0.25m deep. Directly below the sod and topsoil (Context No. 601) was a layer of loose gritty soil with frequent inclusions of medium to large rounded and sub-angular stones (average size: 50mm x 80mm x 120mm) (Context No. 602). Excavation continued into this layer (Context No. 602) for a further 0.15m where excavation ceased at an overall depth of 0.4m.

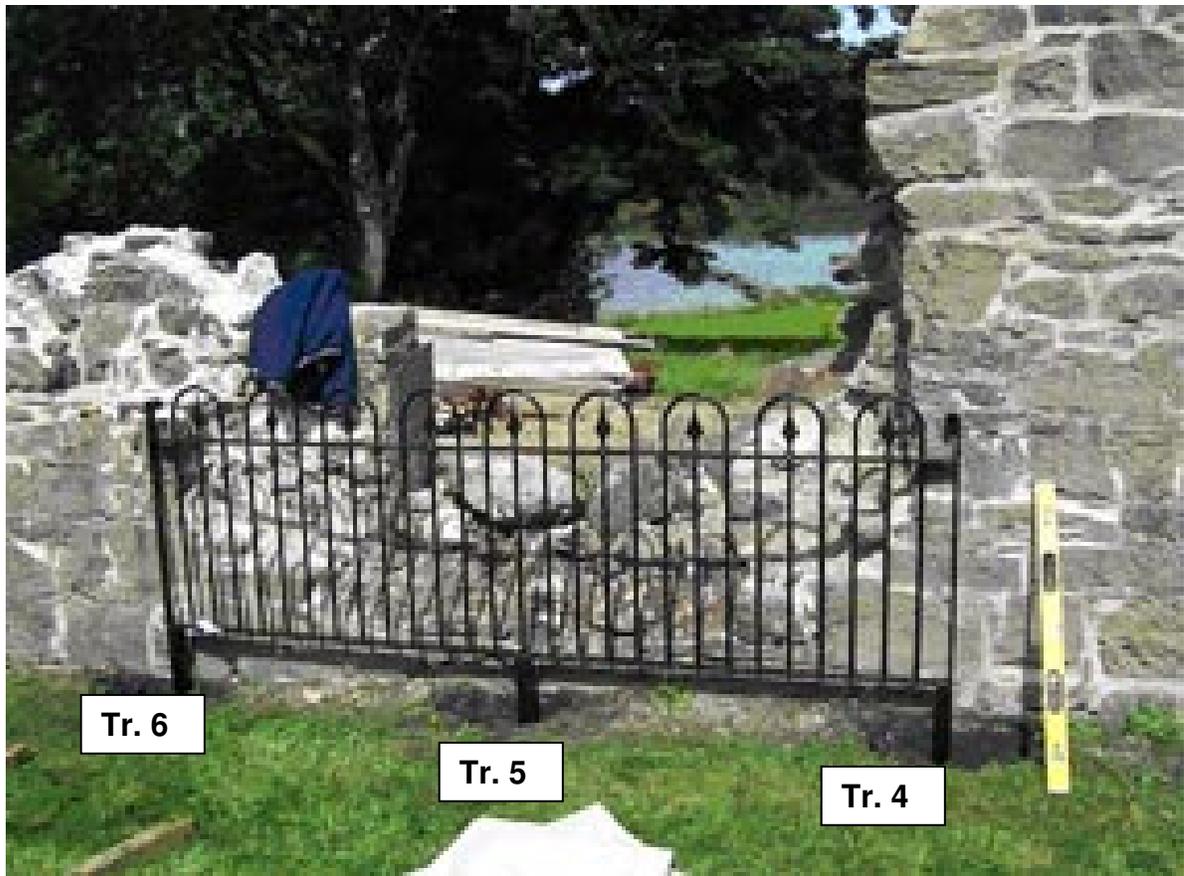
Plate Nine: The westernmost guardrail, looking north.

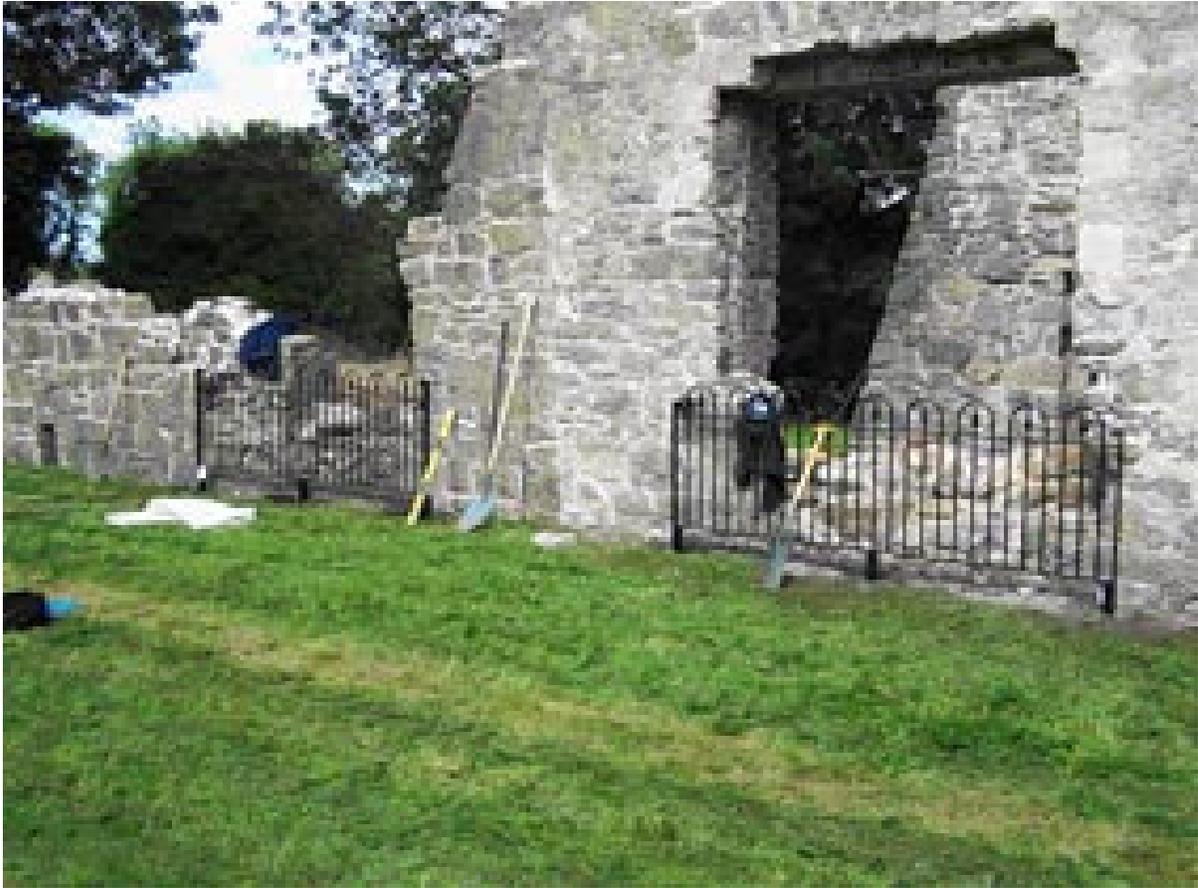
Plate Ten: Positions of the guardrails, looking north-west.
