## **Monitoring Report No. 139**

**St. Mary's Church of Ireland  
Comber  
Co. Down**

**LICENCE NO.: AE/07/145**

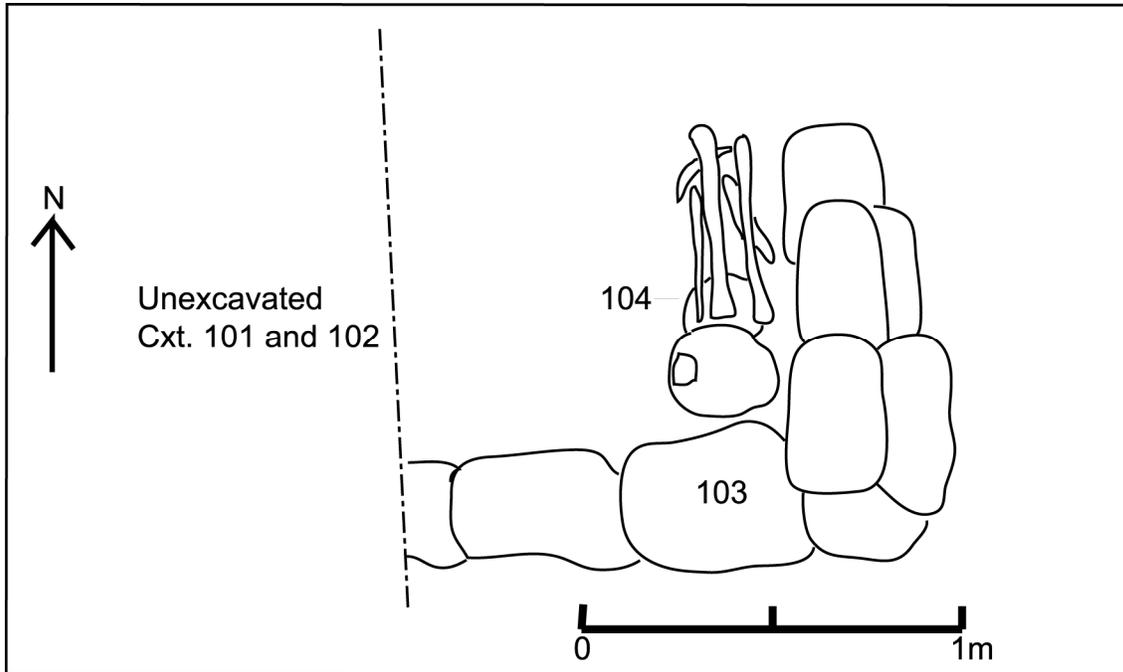
Figure 1: Schematic plan of 'curated' cache of human bones (Context No. 104) within the foundations of the choir vestry constructed in the early twentieth century.

Following the removal of the foundations for the 1970 (Context No. 102) choir vestry, more foundation stones (Context No. 103) were observed approximately 0.3m to the north of the 1970 foundations (Context No. 102). These foundations (Context No. 103) comprised quite large sub-rectangular sandstone blocks (average size: 0.4m x 0.35m) which were bonded together with lime mortar. This feature has been interpreted as the remains of the foundations of the first choir vestry constructed in the early twentieth century (Rev. J. Barry *pers. comm.*). A cache of curated human bones (Context No. 104) was recovered from the western corner of these foundations (Figure 1 and Plate 3). Provisional analysis of this assemblage indicates that at least four adults are represented. One complete cranium was recovered in this assemblage. This cranium represents a male, and due to the fusion of the spheno-occipital synchondrosis, it is estimated that the person was at least 25 years old at the time of death. Other pathologies evident of this assemblage are areas of eburnation (polishing of the joints) on some of the long bones. This also suggests that the assemblage represents adult burials (Clare McGranaghan *pers. comm.*).

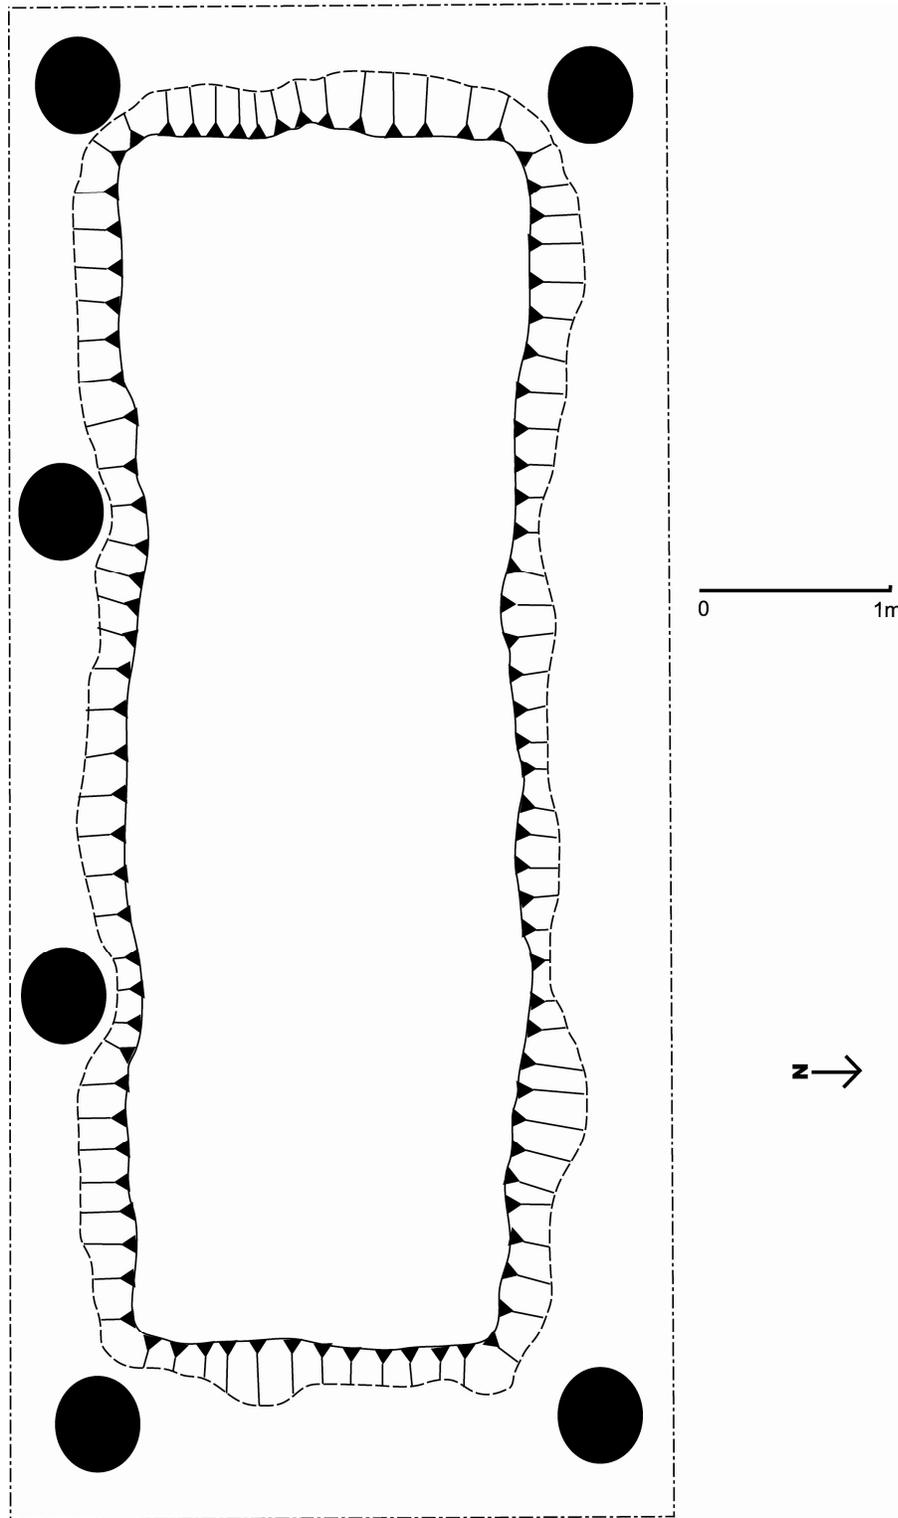
Figure 2: Post excavation plan following excavation of the strip foundations around the piles (shaded black).

Following the driving of the steel piles, strip foundations were mechanically excavated around and in between them. The maximum depth that these strip foundations reached was 0.7m below the present ground surface, effectively excavating approximately 0.3-0.4m into the graveyard soil (Context No. 105). A large assemblage of disarticulated human bone was recovered from the foundation slots, and is currently being processed at Queen's University Belfast.

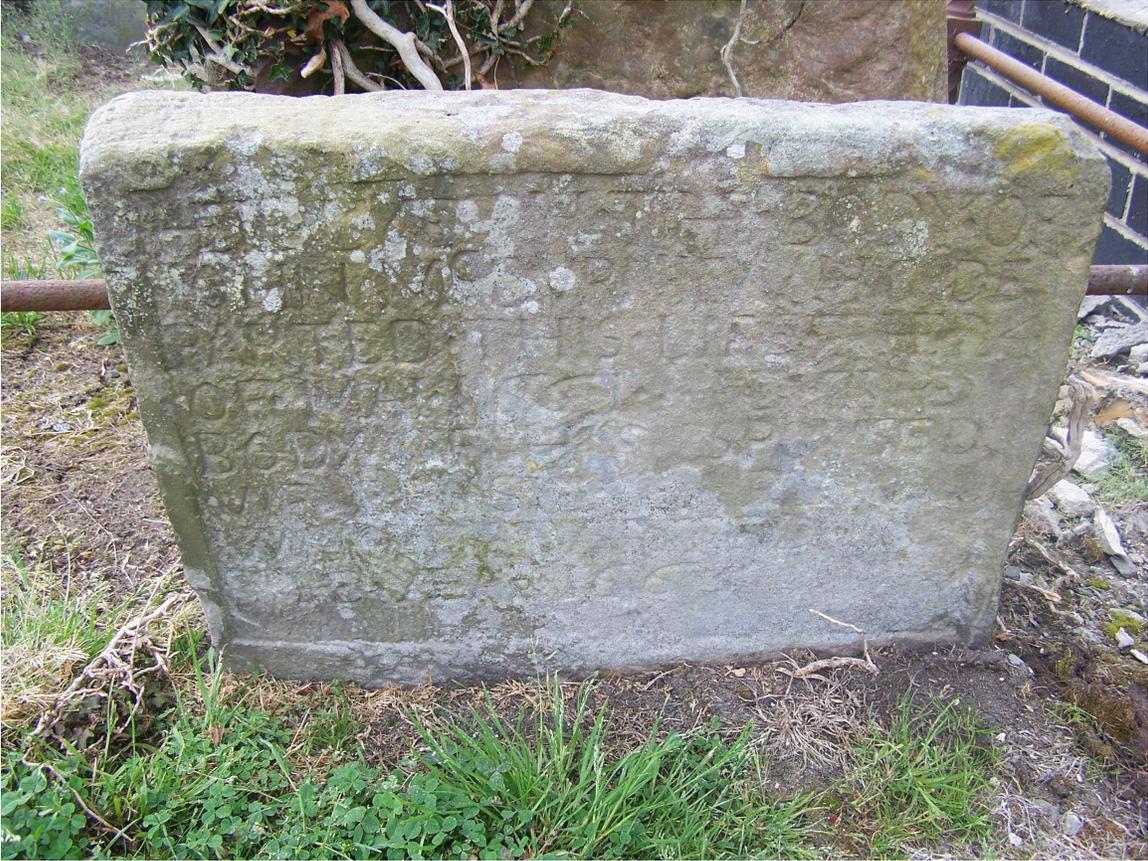
Plate 1: Seventeenth-century headstone, earliest inscription dates to 1661.

That the site of St. Mary's is located directly within the confines of the Cistercian Abbey is unfortunately speculative, as no *in situ* structural elements have been excavated. Medieval cut stones (complete with mason's mark) have been incorporated into the northern boundary wall of the present graveyard (Plate 6), and dressed stone, presumably from a door or window arch, have been found in the vicinity of the Church (Rev. J. Barry *pers. comm.*). Following the dissolution of the monasteries between 1536 and 1540, the abbey at Comber was left in a ruinous state, the stones of which were incorporated into the construction of Meeting House which was constructed on the site in the early seventeenth century (Mc Erlean et al 2002, 289). The existence of this structure is testified by the presence of headstones dating

to the seventeenth century, as well as a fragment of green-glazed seventeenth-century roof tile (identified by Ruairi O'Baoill) discovered during this archaeological investigation.

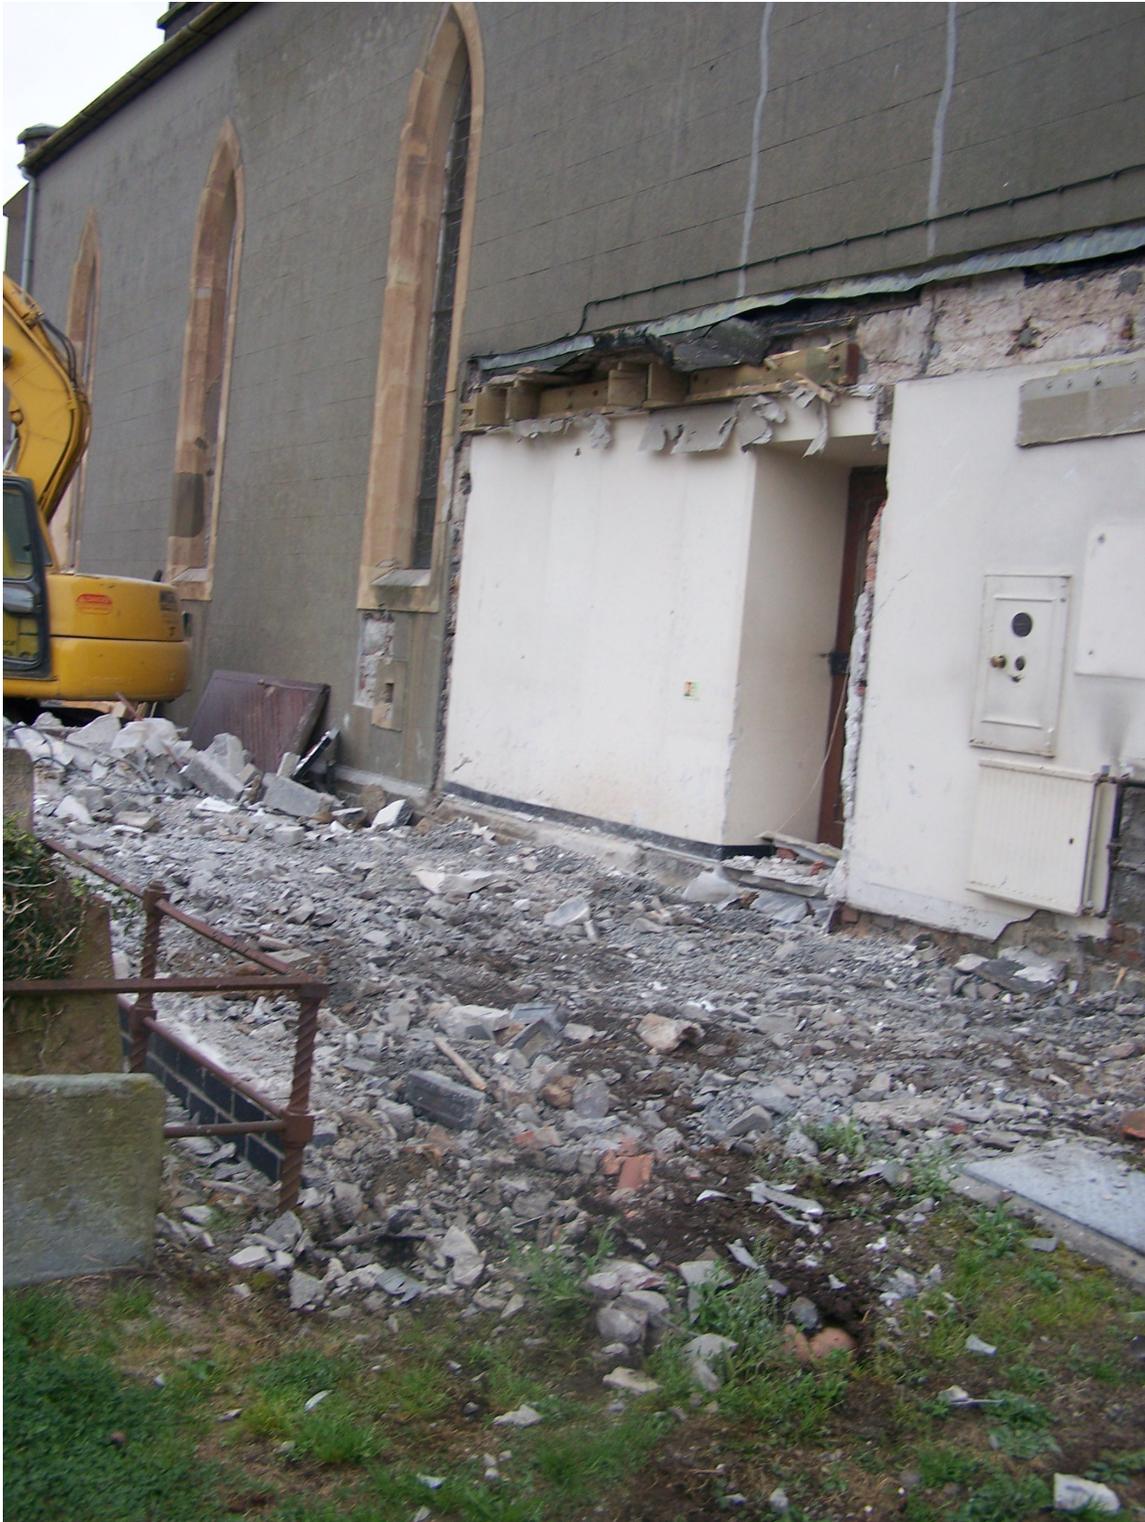
Plate 2: Evaluation area following demolition of choir vestry, looking north-west.

The rubble associated with the demolition of the choir vestry was designated Context No. 101 and was the uppermost strata excavated during the monitoring exercise. The foundations of the 1970 Choir Vestry were exposed following the removal of the rubble demolition layer (Context No.101). These were observed as a course of concrete blocks running parallel to the southern wall of the present church, and were assigned Context No. 102.

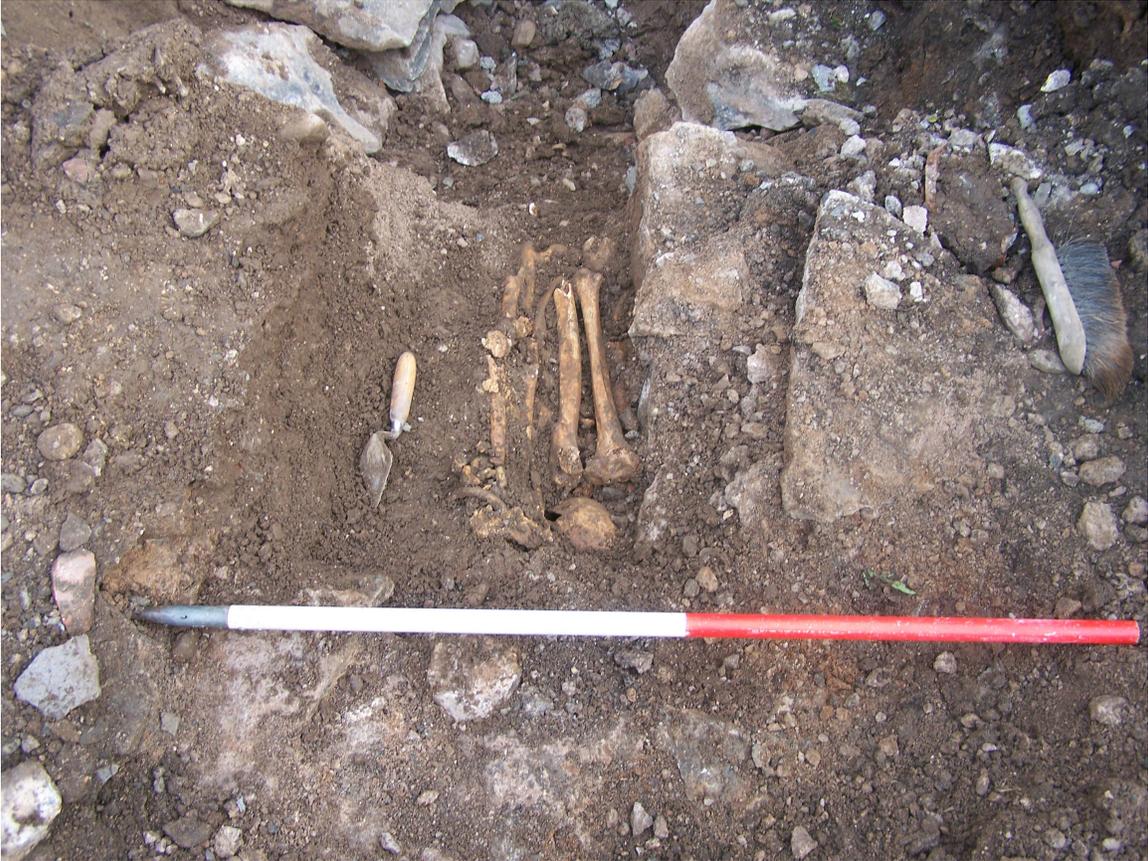
Plate 3: Curated disarticulated human bones (Context No. 104) cached in corner of early twentieth-century choir vestry foundations.

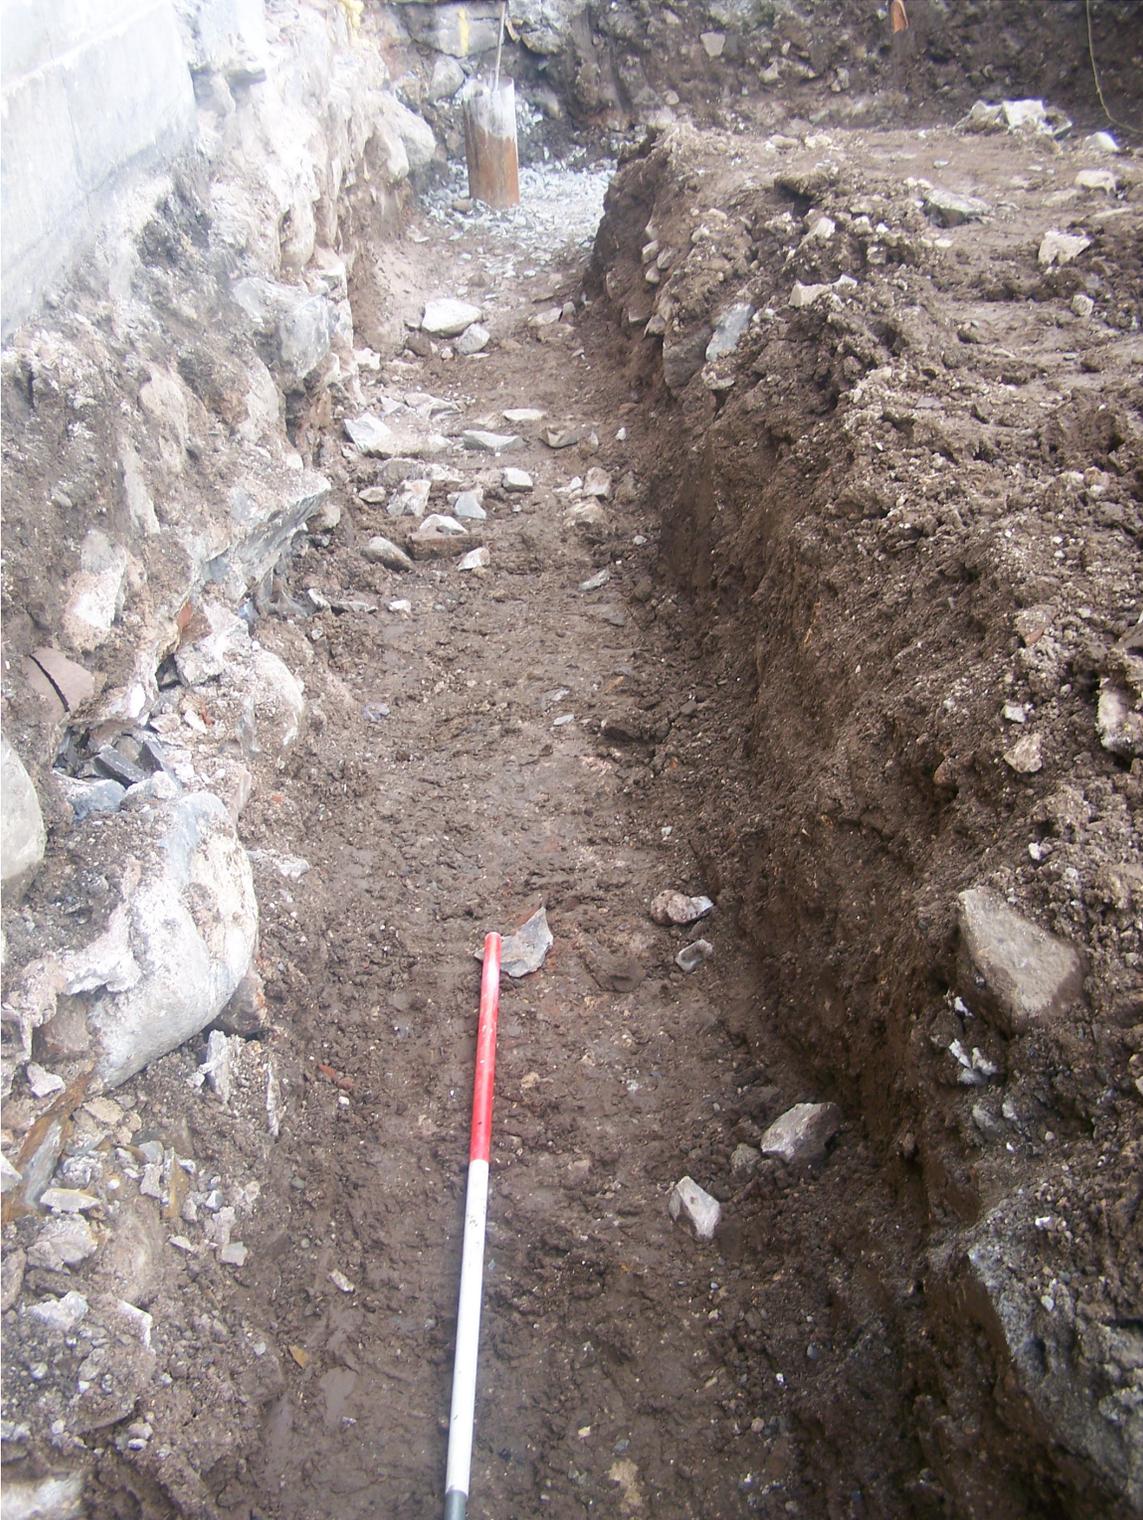
Plate 4: Northern strip foundation showing graveyard soil (Context No. 105) and foundations of the present church (to left of the picture).

The foundations of the choir vestries (Context Nos. 102 and 103), as well as the foundations for the present church (Context No. 106) were excavated into a dark grey sticky clay (Context No. 105). This deposit was interpreted as a graveyard soil, primarily due to the humic consistency as well as the presence of a large assemblage of disarticulated bone. The original research design for this project stipulated the

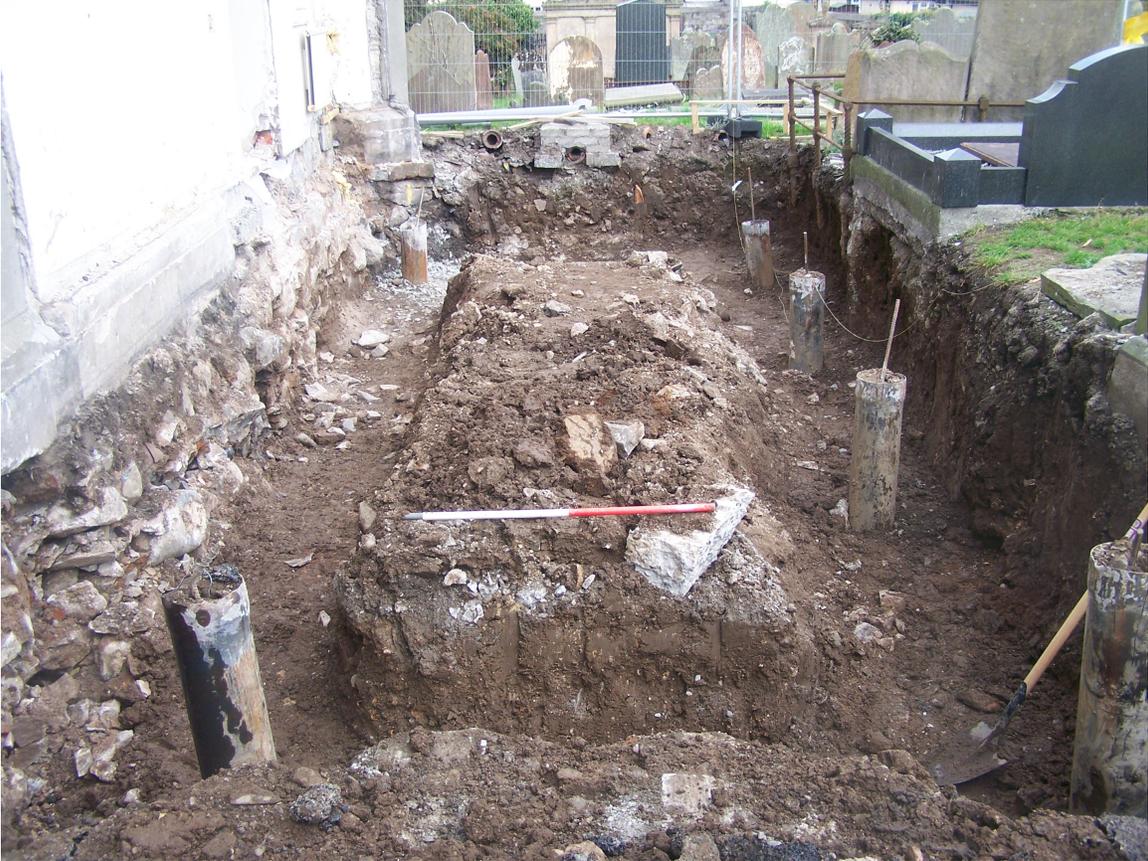
Plate 5: Evaluation area following excavation of the strip foundations around the piles, looking east.

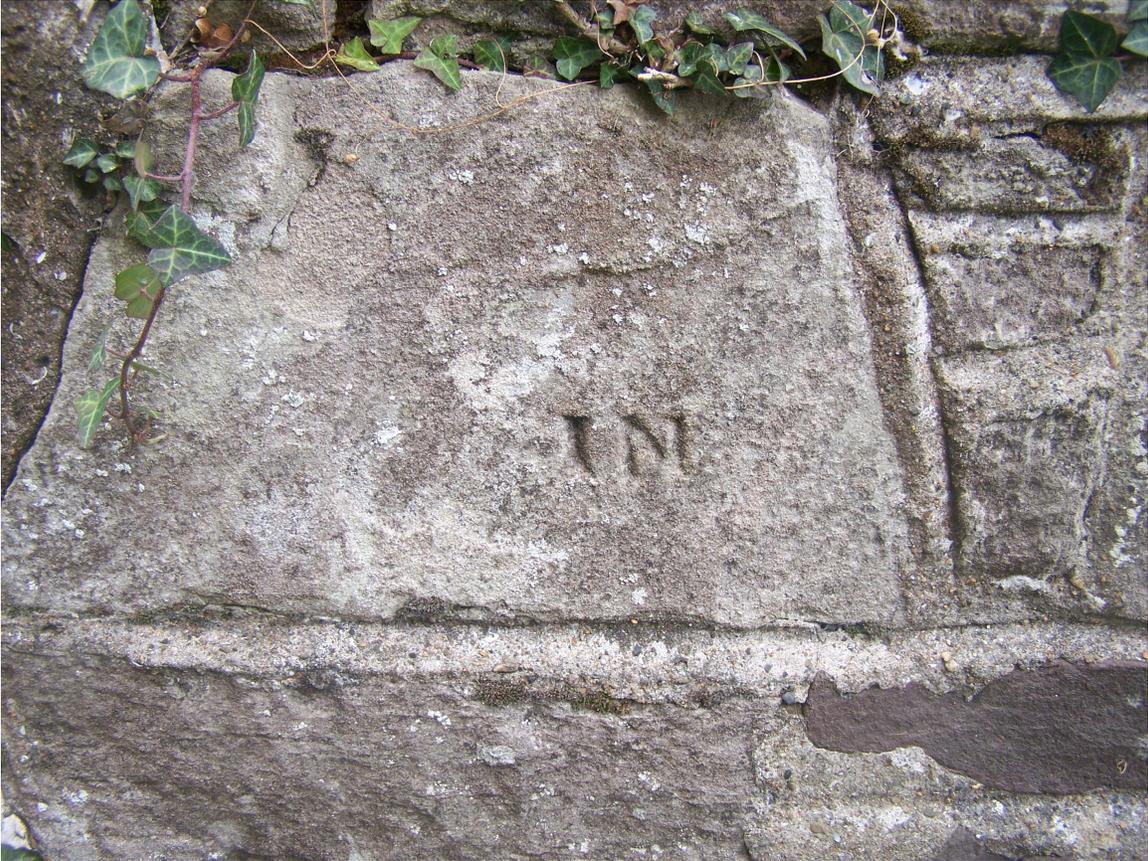
Plate 6: Dressed stone incorporated into the northern boundary wall of the churchyard. The SMR states that this is possibly a medieval dressed stone with mason's mark (DOW 010:026).
