Evaluation/Monitoring Report No. 142

**The Cottage
High Street
Cushendall
County Antrim**

LICENCE NO.: AE/07/167

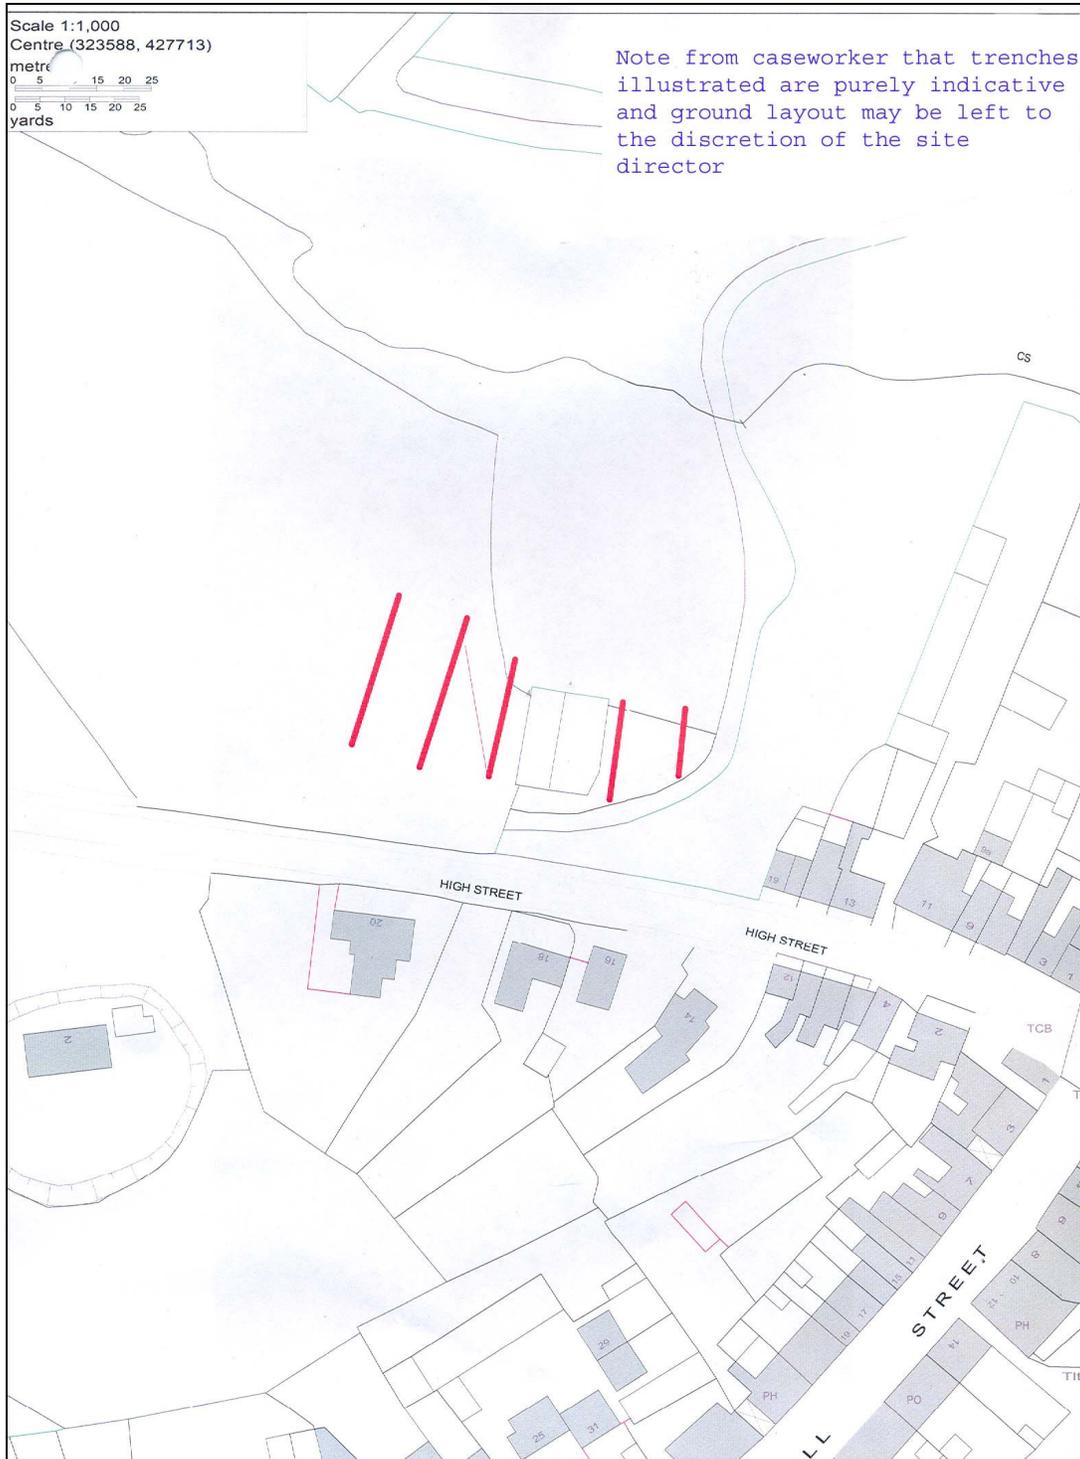
Fig. 3: Map of development site (provided by EHS) showing proposed trench layout. Trenches highlighted in red.

The evaluation consisted of the archaeological supervision of five mechanically excavated test trenches, the location of which was left to the discretion of the site director (Figs. 3 and 5). Two of the trenches were positioned to the back and front of the stable block, and three more to investigate the area of landscaping that were considered of potential archaeological significance. All five test trenches were excavated to the glacial subsoil level, which was noted across site as a stony orange/red boulder clay (Context Nos. 105, 206, 306, 415, 513). Whilst the immediate area surrounding the development site was heavily overgrown, the developer requested that the mature trees were not damaged significantly as part of the evaluation.

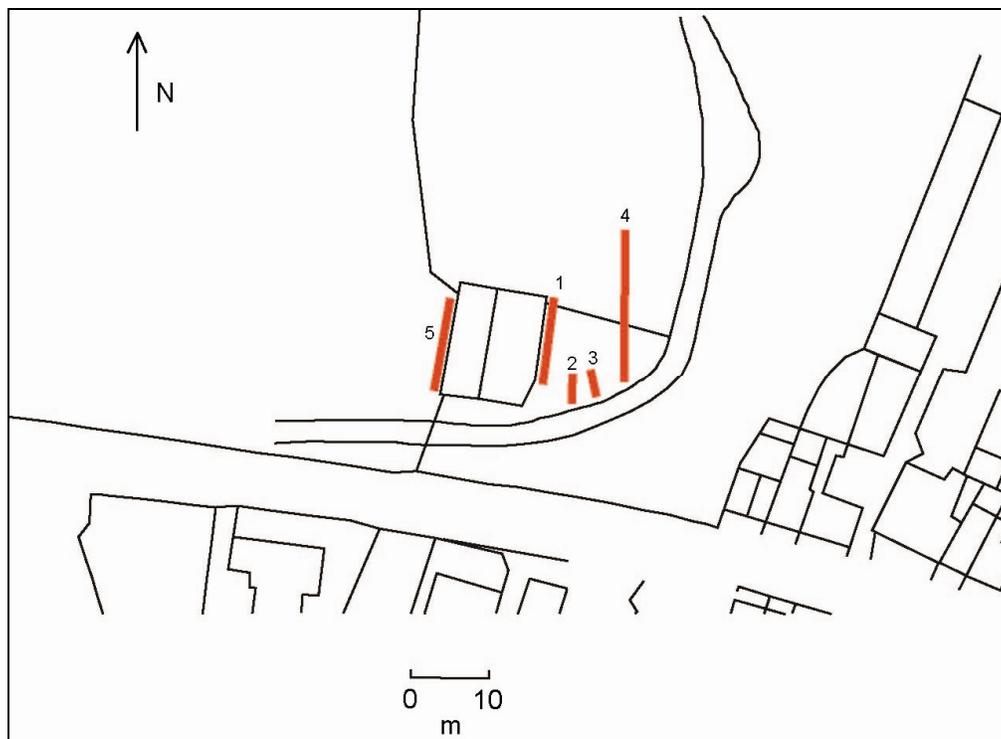
Fig. 5: Location of evaluation trenches. Trenches highlighted in red and numbered.

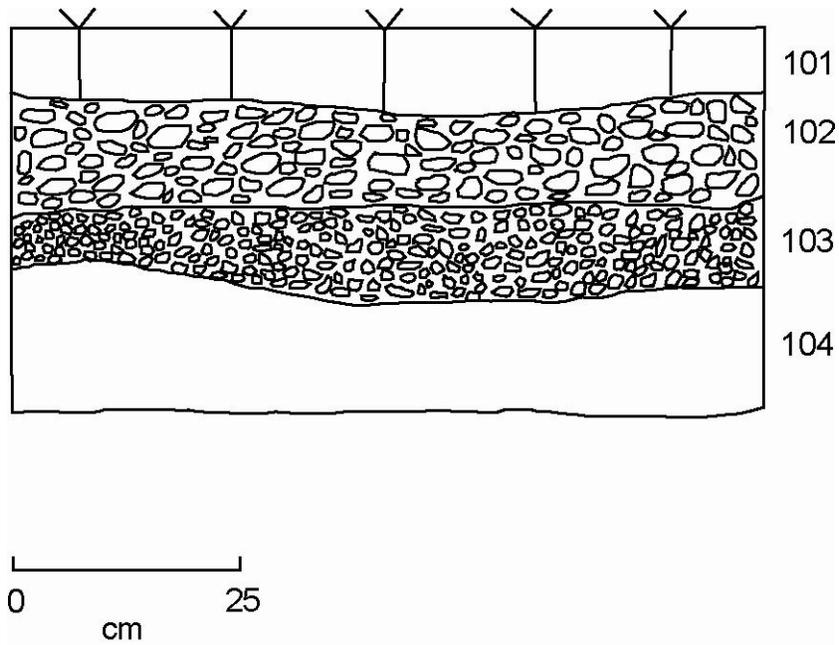
Fig. 6: Section drawing from Trench 1 showing gravel pathway. Context Nos. labeled beside layers.

The trench was positioned approximately 1 metre from the yard wall of the stable block running NNW – SSW, 1 metre in width and 15 metres in length. Upon removal of the vegetation cover (Plate 5) the topsoil layer (Context No. 101) was excavated, consisting of a black humic friable sandy clay with frequent organic inclusions. This layer had a maximum depth of 0.11 metres, and ran the length of the trench. Underlying the humic topsoil was a layer of hard packed gravel (Context No. 102; Plate 6)), consisting of stones approximately 30 x 10 x 10 mm. The layer of gravel showed areas of black staining which has been interpreted as due to tree roots (Plate 7), although it was noted that these did not penetrate the level of the gravel, suggesting that it had been hard packed shortly after its deposition. Under the gravel layer a finer layer of small stones (Context No. 103) had been deposited (average size 10 x 10 x 10 mm), ranging in depth from 0.05 - 0.10 metres in depth. The fine stone deposit represented by Context No. 103 is considered to be a leveling deposit laid over the grey sandy cultivation soil (Context No. 104; depth ranging from 0.20 – 0.15 metres), although the excavator noted that the grey coloration may be attributable to leaching of color from the overlying gravel layers of Context No. 102 and 103. No finds were recovered from this trench. For Trench 1 section see Fig. 6. The subsoil (Context No. 105) in Trench was recorded as a stony orange/red boulder clay (Plate 8).

The gravel layers uncovered in Trench 1 (Context Nos. 102 and 103) are considered to be the packed gravel of estate paths that were constructed after the enlargement of the estate (connecting the stable block to the enlarged house on the site of the original early 19th century Turnly Cottage). The stony deposits (Context Nos. 203 and 303) in Trenches 2 and 3 are considered to be further instances of the estate paths shown on the 1906 map (Figs. 13-15). The brick lined drain that was uncovered in Trenches 3 and 4 is considered to have been laid prior to the installation of these pathways and subsequently disturbed with the path construction (Although the section of drain in Trench 4 was noticeably better preserved). The piece of late nineteenth century ceramic drain uncovered in Trench 2 is considered to be part of landscaping deposits brought in to form the cultivation soil of this area (although the composition of the soil would suggest that it had been obtained in the vicinity).

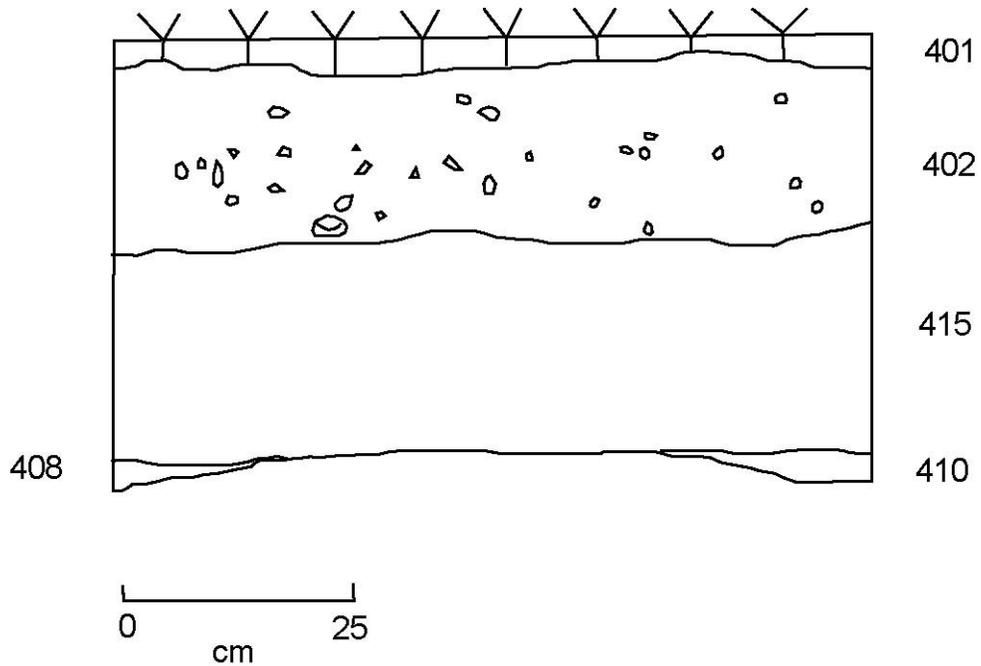
Fig. 7: Section drawing from Trench 4 showing cultivation furrows. Context Nos. labelled beside layers.

In the lower area to the NE of the stable block, the removal of the cultivation soil revealed a layer of orange brown clay (Context No. 415; maximum depth 0.15 metres) extending to the base of the slope. Underlying Context No. 415 the truncated remains of two cultivation furrows were denoted Context Nos. 408 and 410 (the former being the southernmost), and their fills Context Nos. 409 and 411 respectively. The fills (Context Nos. 409 and 411) were archaeologically excavated, and confirmed that the features had been heavily truncated, the maximum depths approximately 0.03 metres in depth (Fig. 7). No finds were recovered from the cultivation furrows. To the south of the two truncated cultivation furrows a field drain was noted on the same orientation. The cut of the drainage channel (Context No. 406) was filled with a waterlogged dark brown clay containing large angular stones (Context No. 407; average size 60 x 60 x 50 mm). A piece of clay pipe stem (Small Finds No. 2) and some late nineteenth century glazed ceramic (Small Finds No. 3) were recovered when the cultivation soil (Context No. 402) was removed from the top of the field drain (Context No. 406 and 407). The removal of the cultivation soil (Context No. 402) revealed an orange/red stony boulder clay (Context No. 415; Plate 14)

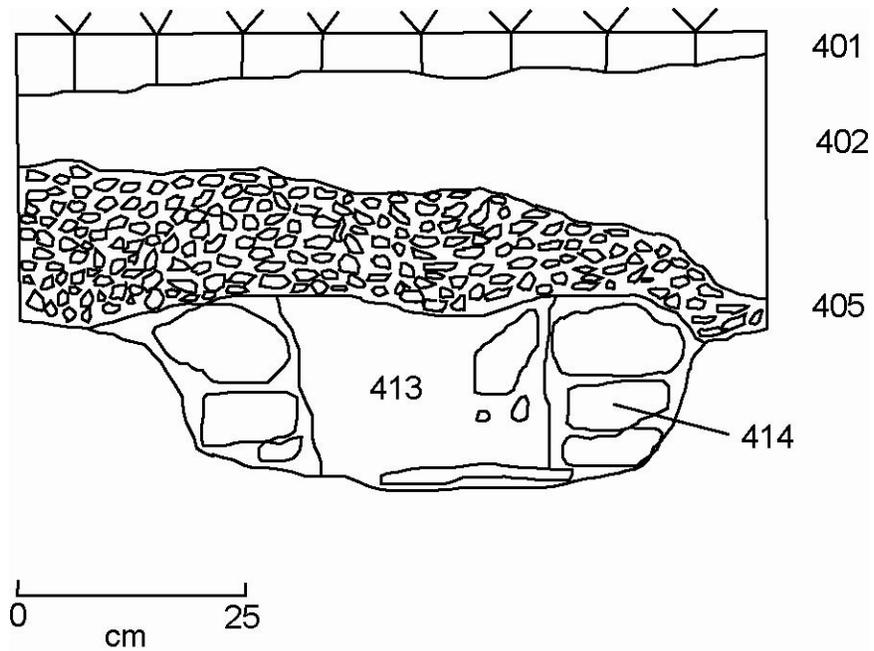
Fig. 8: Section drawing from Trench 4 showing brick lined drainage channel.
Context Nos. labeled beside layers.

This trench was located running N – S, extending across a ridge and a slope to the NE of the stable block. Given the proximity of the Court McMartin medieval fortification, it was excavated to establish if the ridge was natural or a deliberate construction. The trench was 1 metre wide x 20 metres in length. After the removal of the vegetation, a black humic topsoil (Context No. 401) was exposed, with a maximum depth of 0.08 metres in the northern end of the trench. Underlying the humic topsoil (Context No. 401) was an orange/brown sandy clay cultivation soil (Context No. 402) that ran the length of the trench (maximum depth 0.10 metres). At the southern extremity of the trench a modern cut (Context No. 403) contained large stones (Context No. 404) surrounding a modern section of yellow plastic drainage piping. The removal of the cultivation soil level (Context No. 402) revealed a hard packed stony deposit (Context No. 405; similar in size to Context Nos. 203 and 303) which had been truncated at its northern end by Context No. 403. Underlying the stony deposit (Context No. 405; Plate 11) was a brick lined drain (Plate 12), set in a cut (Context No. 412). The drainage channel was filled with a dark brown clay fill (Context No. 413; homogenous to Context No. 305). The brick lining (Context No. 414) did not show signs of mortaring. The base of the drainage channel was lined with broken pieces of hand split slate (Fig. 8).

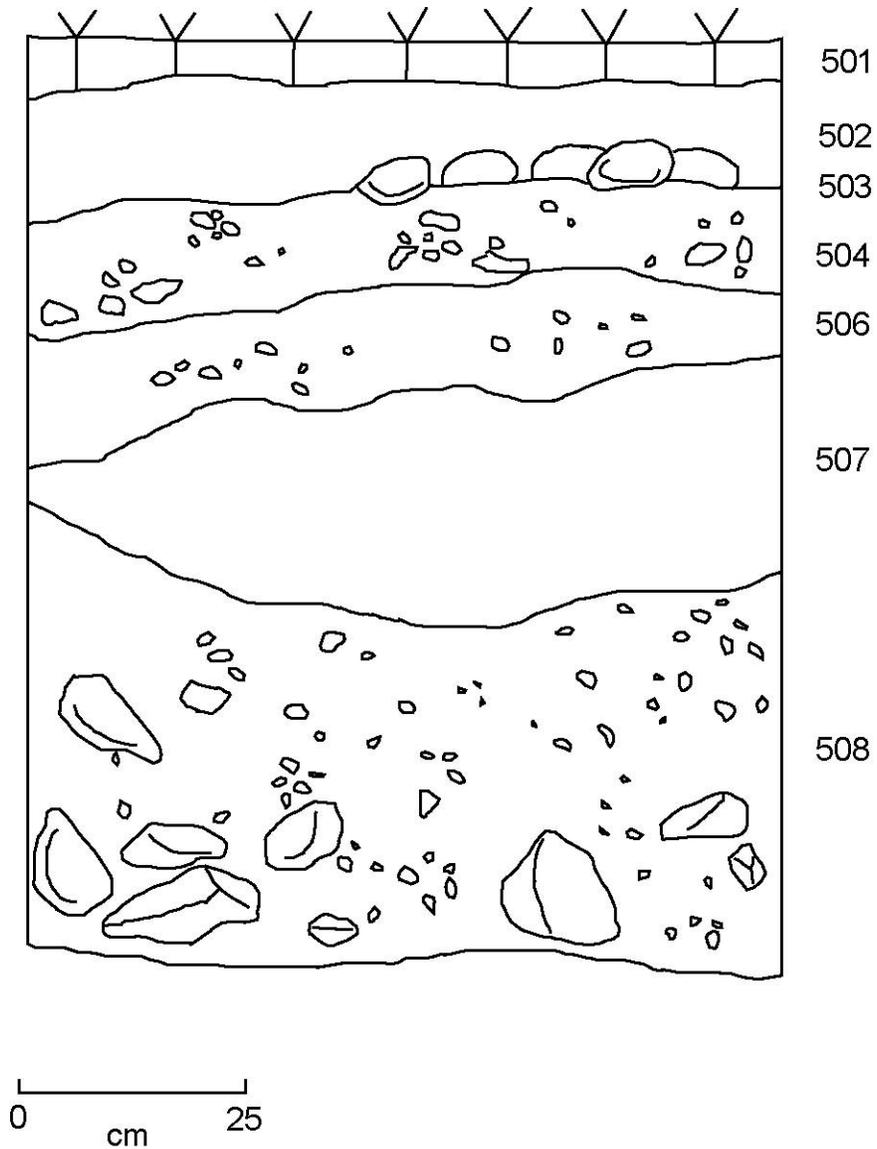
Fig. 9: Section drawing from Trench 5. Context Nos. labelled beside layers.

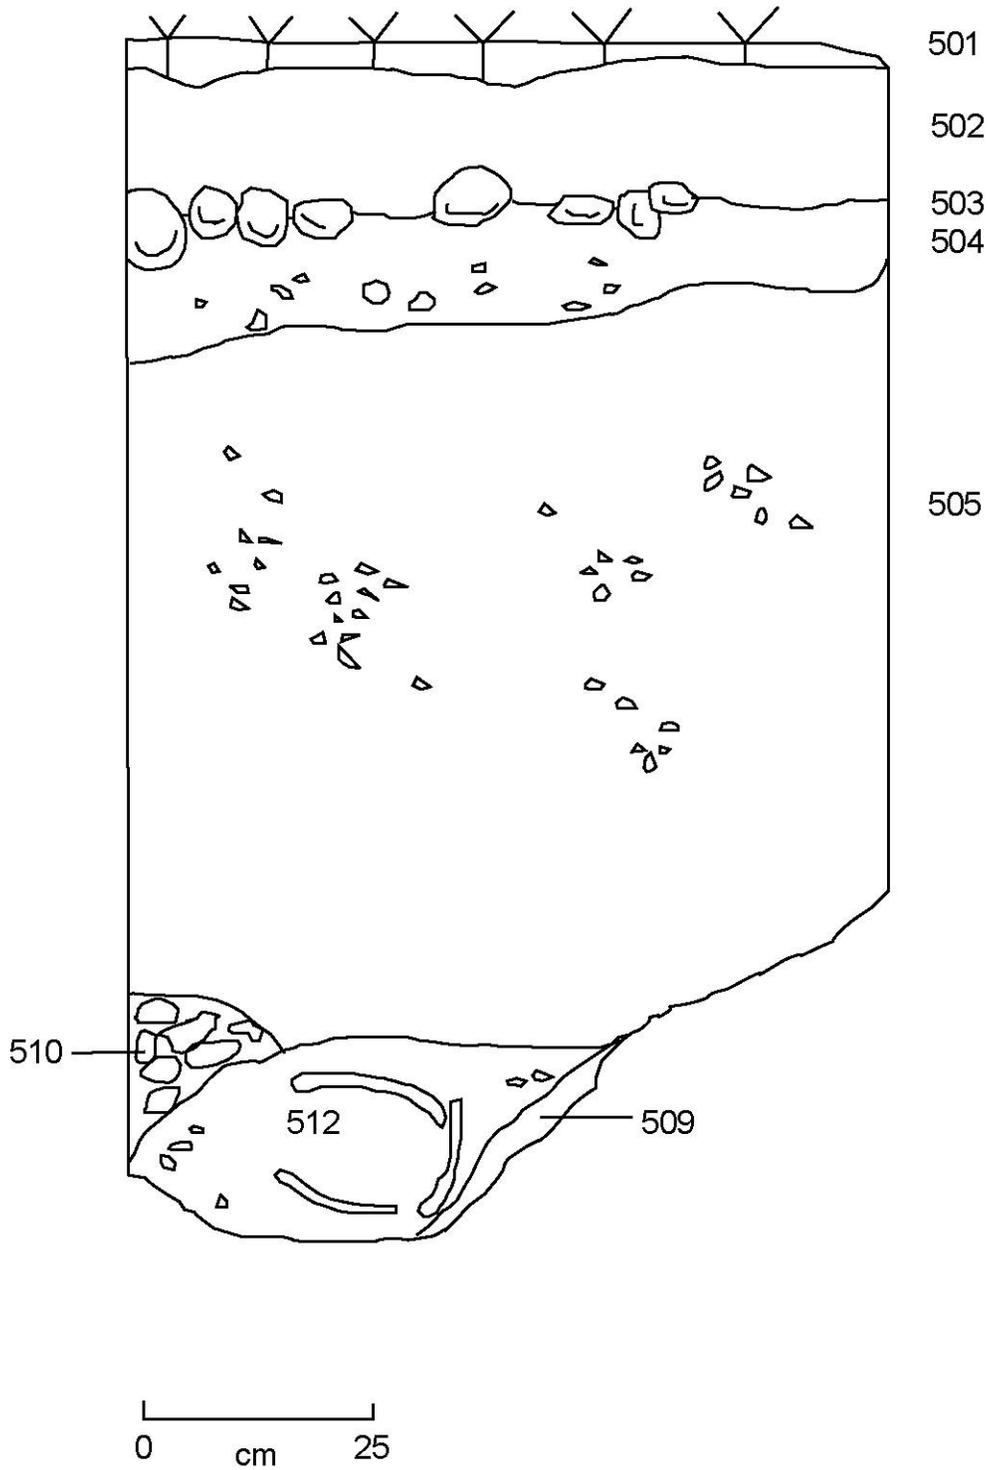
Fig. 10: Section drawing from Trench 5. Context Nos. labelled beside layers.

Plate 19: Close up of 19th century ceramic drain underneath the leveling deposit (Context No. 505). Note the yellow clay sealing the drainage channel (Context No. 509). See Fig.10 for section drawing.

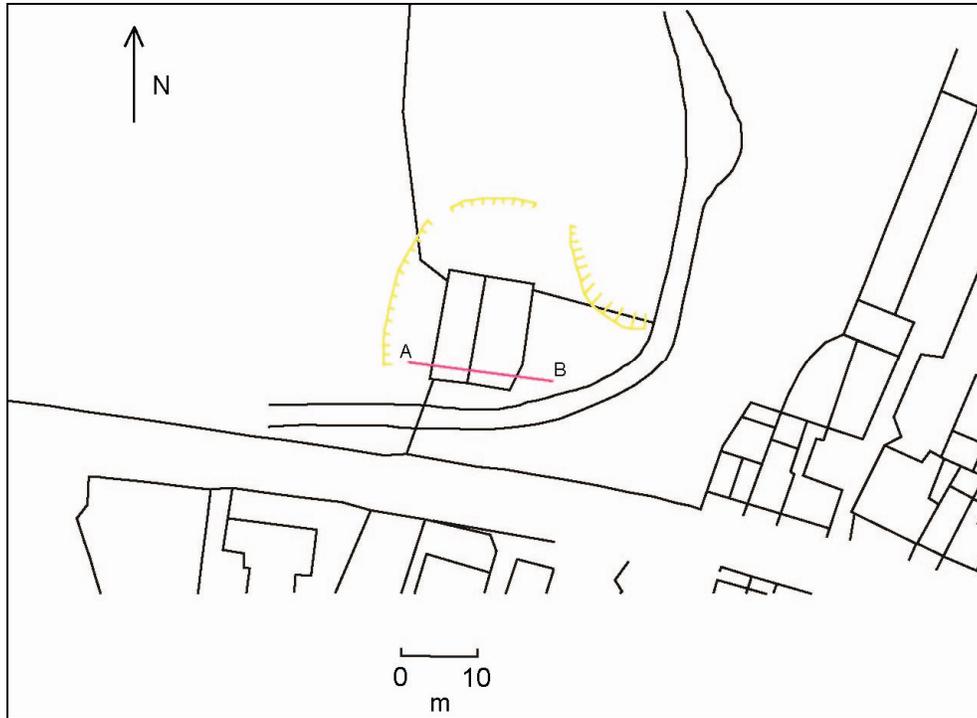
Fig. 11: Map of development site showing topography surrounding stables building (shown in yellow). Transect through topography shown in pink (line A-B).

The removal of the cultivation soil (Context No. 402) from the ridge and the slope that led to the lower area (NE of the stable block) revealed that it a step, approximately 0.50 metres in width, cut into the stony boulder clay (Context No. 415). The drop in elevation from the ridge to the base of the lower step was approximately 1 metre, and could be followed in a curve that ran adjacent to the front wall of the stable block (Fig. 11).

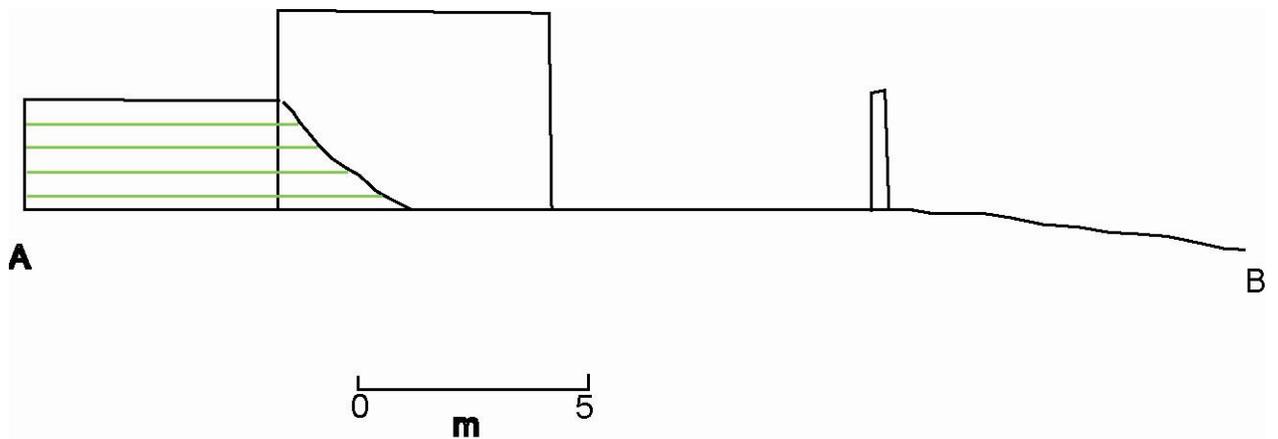
Fig. 12: Transect (line A-B) through topography surrounding stables building. The leveling deposit to the rear of the stables is highlighted in striped green.

Context No. 505 probably is representative of leveling deposit that was laid down behind the original stable building (on top of the original ground surface and the drainage pipe represented by Context No. 509 cut; Fig 12). The late nineteenth century and possible early twentieth century bowl fragments (Small Finds Nos. 8 and 9) would seem to suggest that the leveling was completed by the early 1900s. The back building would then have been constructed, and a sandy layer with some small stone inclusions (Context No. 504) was laid as a base to a layer of cobbles that do not appear to have been bonded substantially, suggesting that the surface was not designed to bear heavy traffic use.

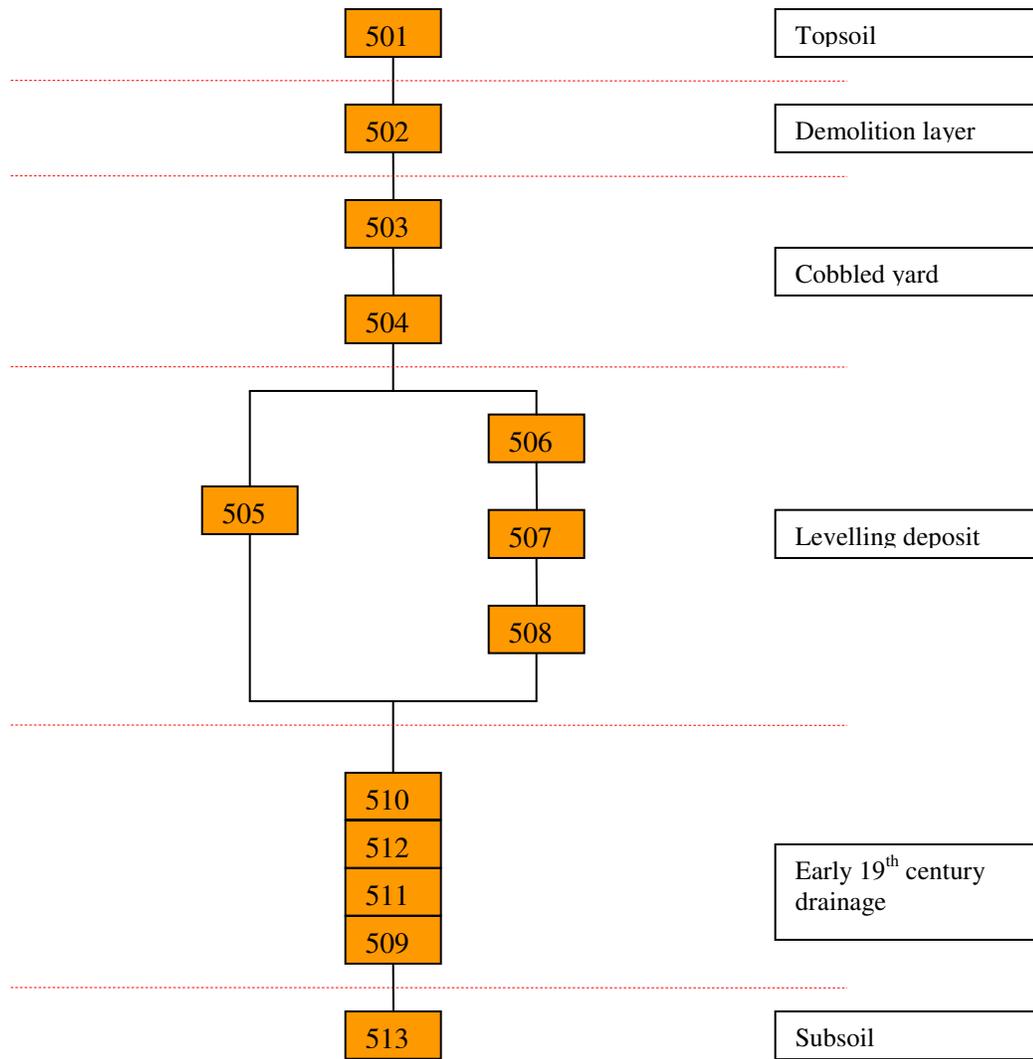
Fig. 16: Harris Matrix Trench 5 showing proposed phases of activity

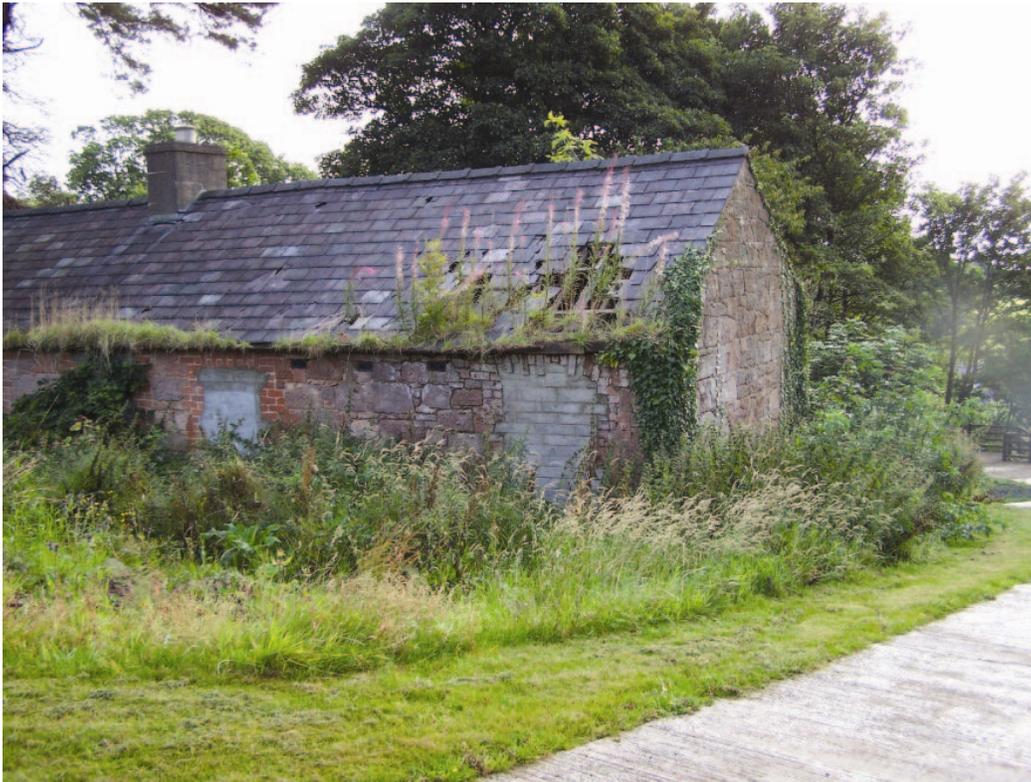
Plate 1: Vegetation growth surrounding the stable block building. Looking northeast.

The development site is located in the town of Cushendall, Co. Antrim (Fig. 1), lying on the periphery of the Cushendall Area of Archaeological Potential, and within the Local Landscape Policy Area (Northern Area Plan 2016). The proposed development site lies within a triangle of land adjacent to 19 High Street (Fig. 2), part of a nineteenth and twentieth century estate complex known as 'The Cottage'. The site is delineated on the southern edge by a modern concrete pathway that connects to High Street, and runs through a public park to the west of the development site. The development site lies near the summit of a hill on a relatively flat area of land. The immediate area surrounding the stable block is heavily overgrown with trees and scrub vegetation (Plates 1 and 2).

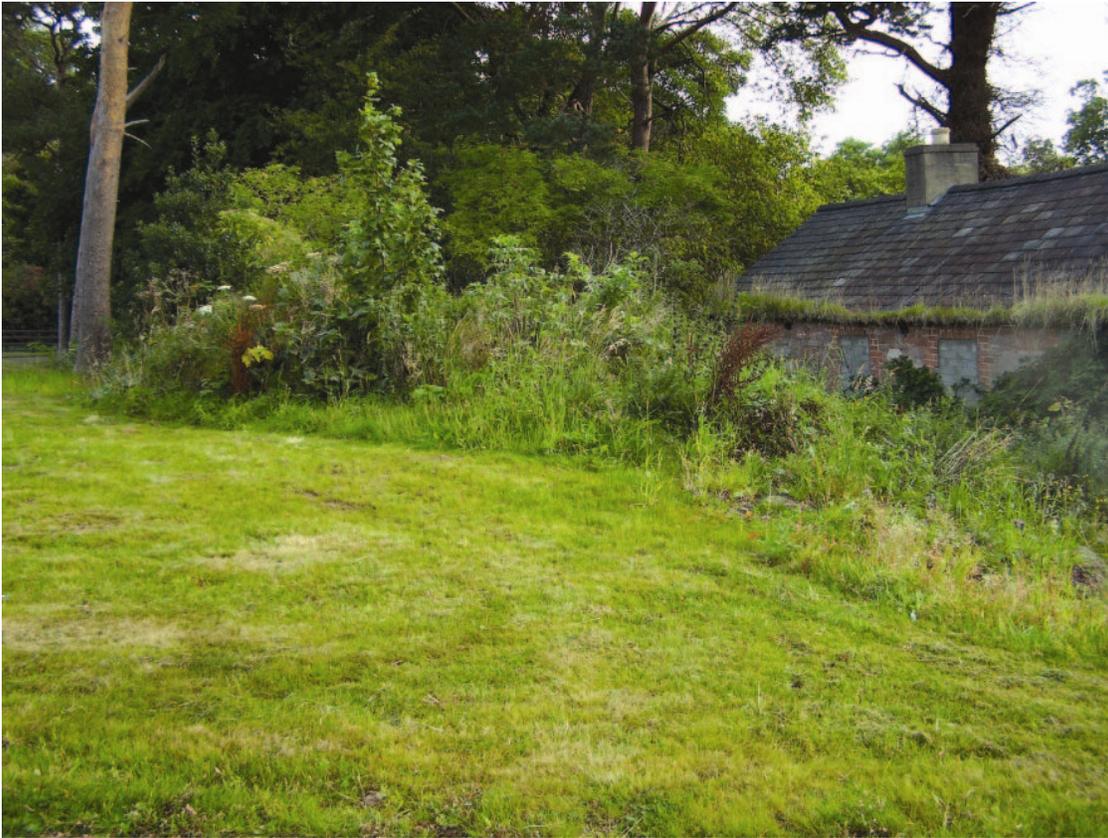
Plate 2: Vegetation growth surrounding the stable block building. Looking northnortheast. Note the public park area abutting the back of the property.

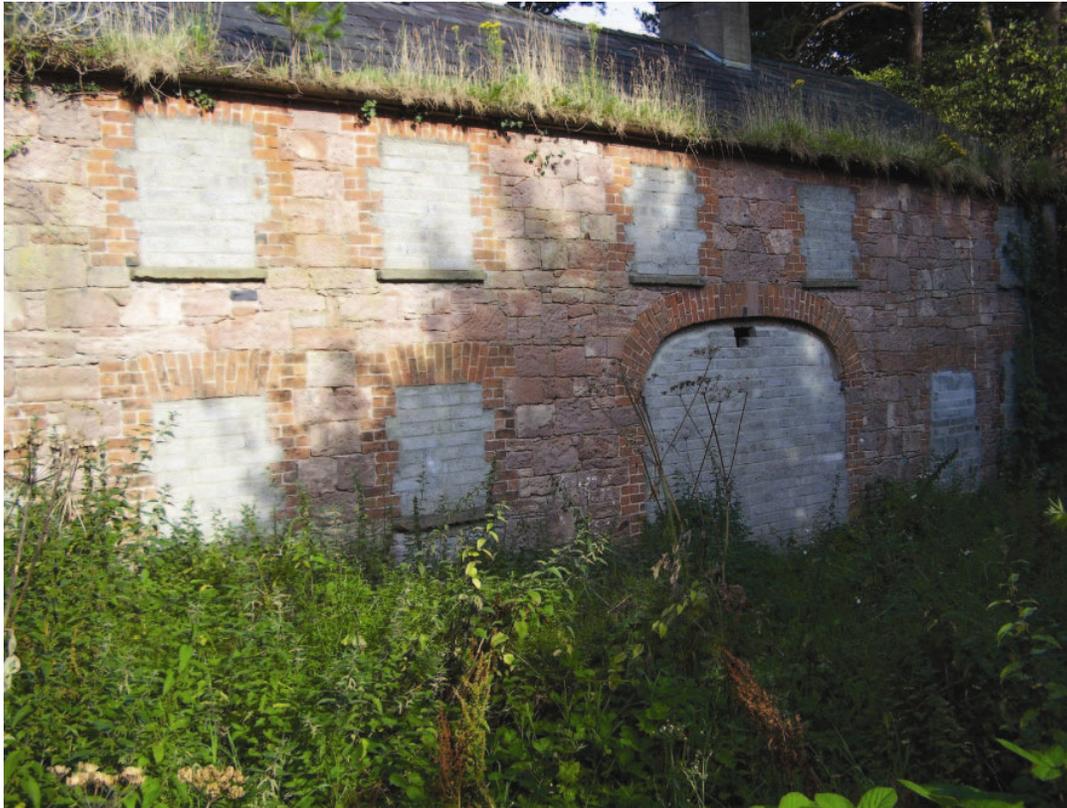
Plate 3: Vegetation growth surrounding the stable block building. Looking northwest.

The evaluation took place as part of the planning application for the restoration of the stable block (Plates 3 and 4) and the construction of new business accommodation, and was requested by Adrian McAleenan (Caseworker with Environment and Heritage Service: Built Heritage) due to the proximity of the development site to the medieval fortification of Court McMartin (ANT 020:018), and the possibility that there may be previously unrecorded remains associated with this site.

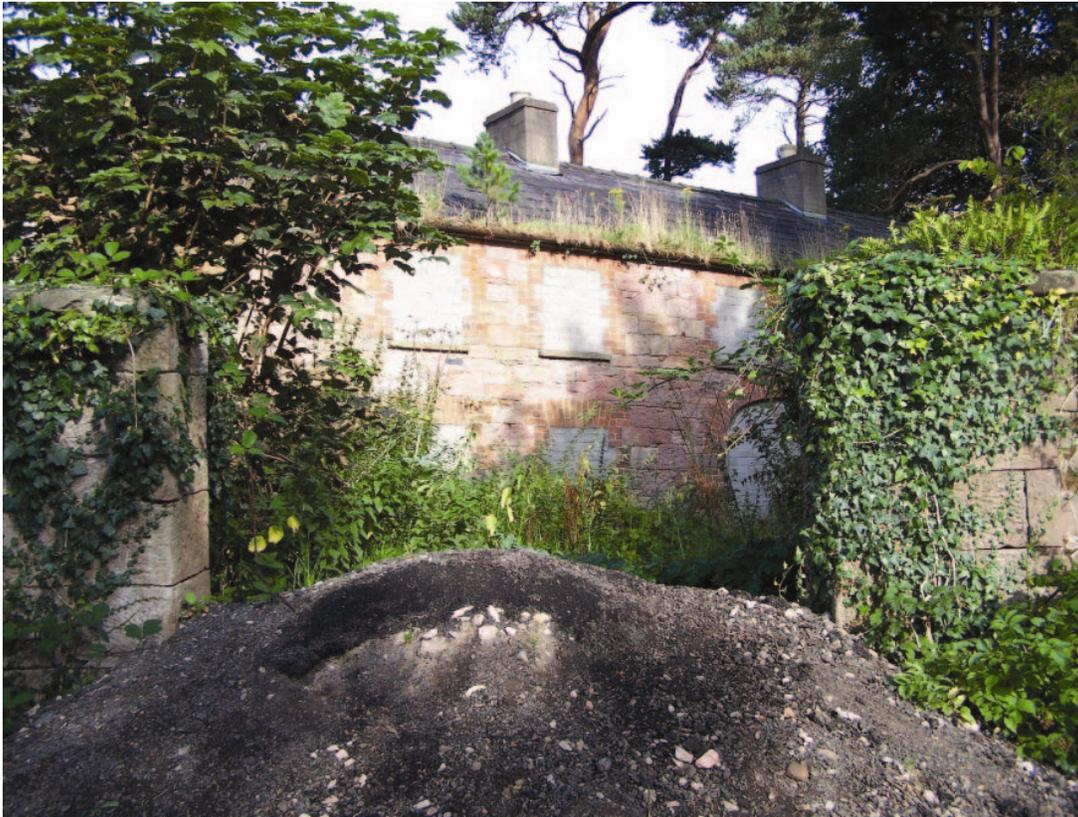
Plate 4: Vegetation growth surrounding the stable block building. Looking northwest.

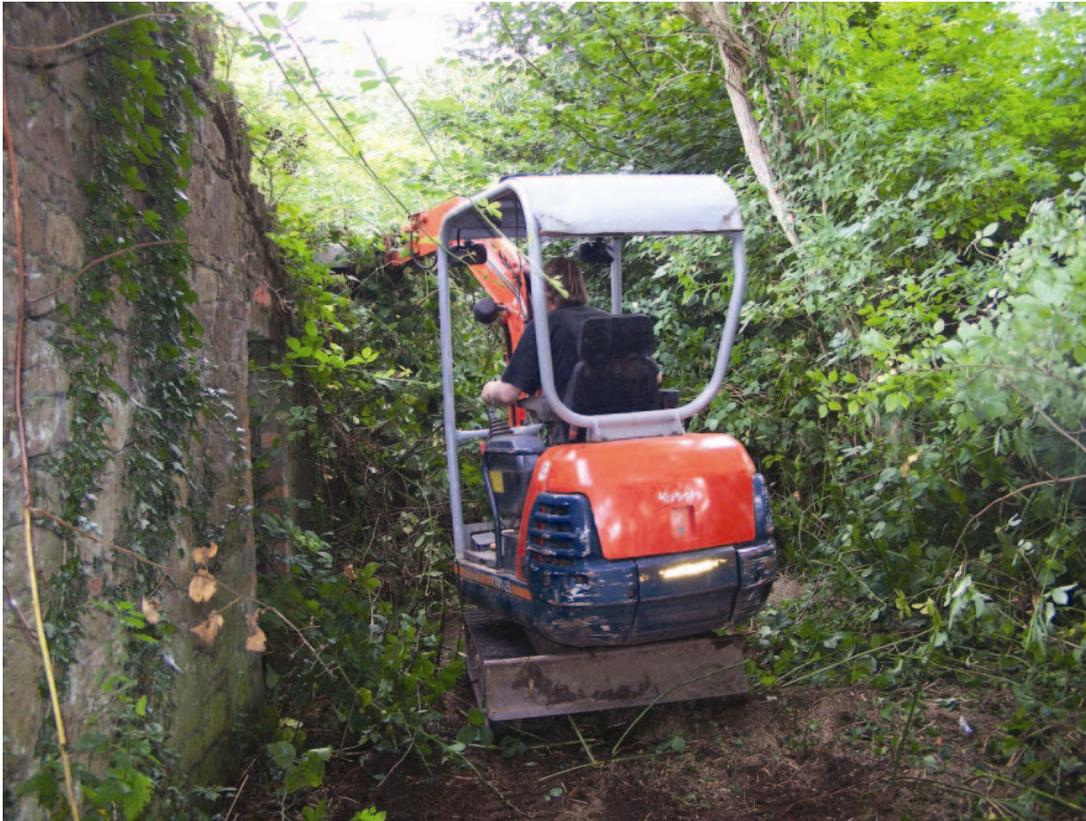
Plate 5: Clearing the vegetation from the front of the stable block yard wall.
Looking north.

A section of stone wall collapse in the area outside the stable block (Plate 5) prompted the positioning of a test trench to investigate if any structures existed in this area. The test trench was 1 metre wide x 5 metres long, running N – S from the modern concrete path. After the removal of the vegetation cover a black humic topsoil was uncovered (Context No. 201; maximum depth 0.08 metres) which contained frequent organic inclusions. Underlying the humic topsoil (Context No. 201) an orange sandy clay cultivation soil was uncovered (Context No. 202; maximum depth 0.10 metres), which in the southern end of the trench overlay a stony deposit (Context 203), comprising stones similar in size to the gravel of Context No. 102. In the northern end of the trench, set into the cultivation soil (Context No. 202) a dark clay feature with some gravel inclusions was interpreted as the base of a tree bowl that had been truncated (Plate 10). Throughout the cultivation soil pieces of late 19th century/early 20th century ceramic drainage pipe were uncovered (Small Finds No. 1). Upon removal of the cultivation soil (Context No. 202), it was noted that the stony gravel deposit had a distinct edge that ran diagonally SW – NE, approximately 0.70 metres at maximum width. Abutting this layer was an area of dark orange sandy clay with frequent gravel inclusions (Context No. 205), which is considered to be the original interface between the gravel bed of Context No. 203 and the cultivation soil of Context No. 202. The subsoil in Trench 2 (Context No. 206) was recorded as a stony orange/red boulder clay.

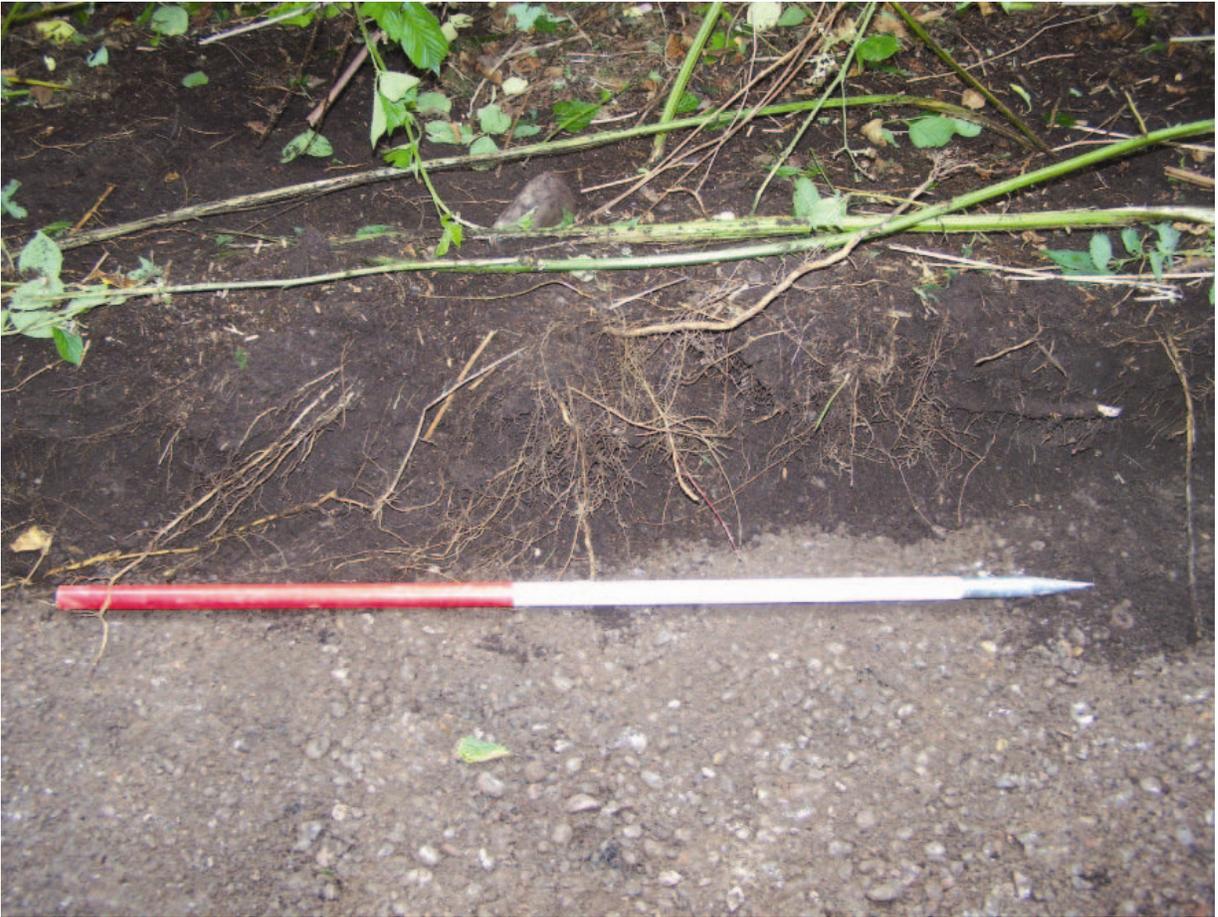
Plate 6: Trench 1 after the removal of the humic topsoil (Context No. 101), revealing the hard packed gravel layer (Context No. 102). Looking west

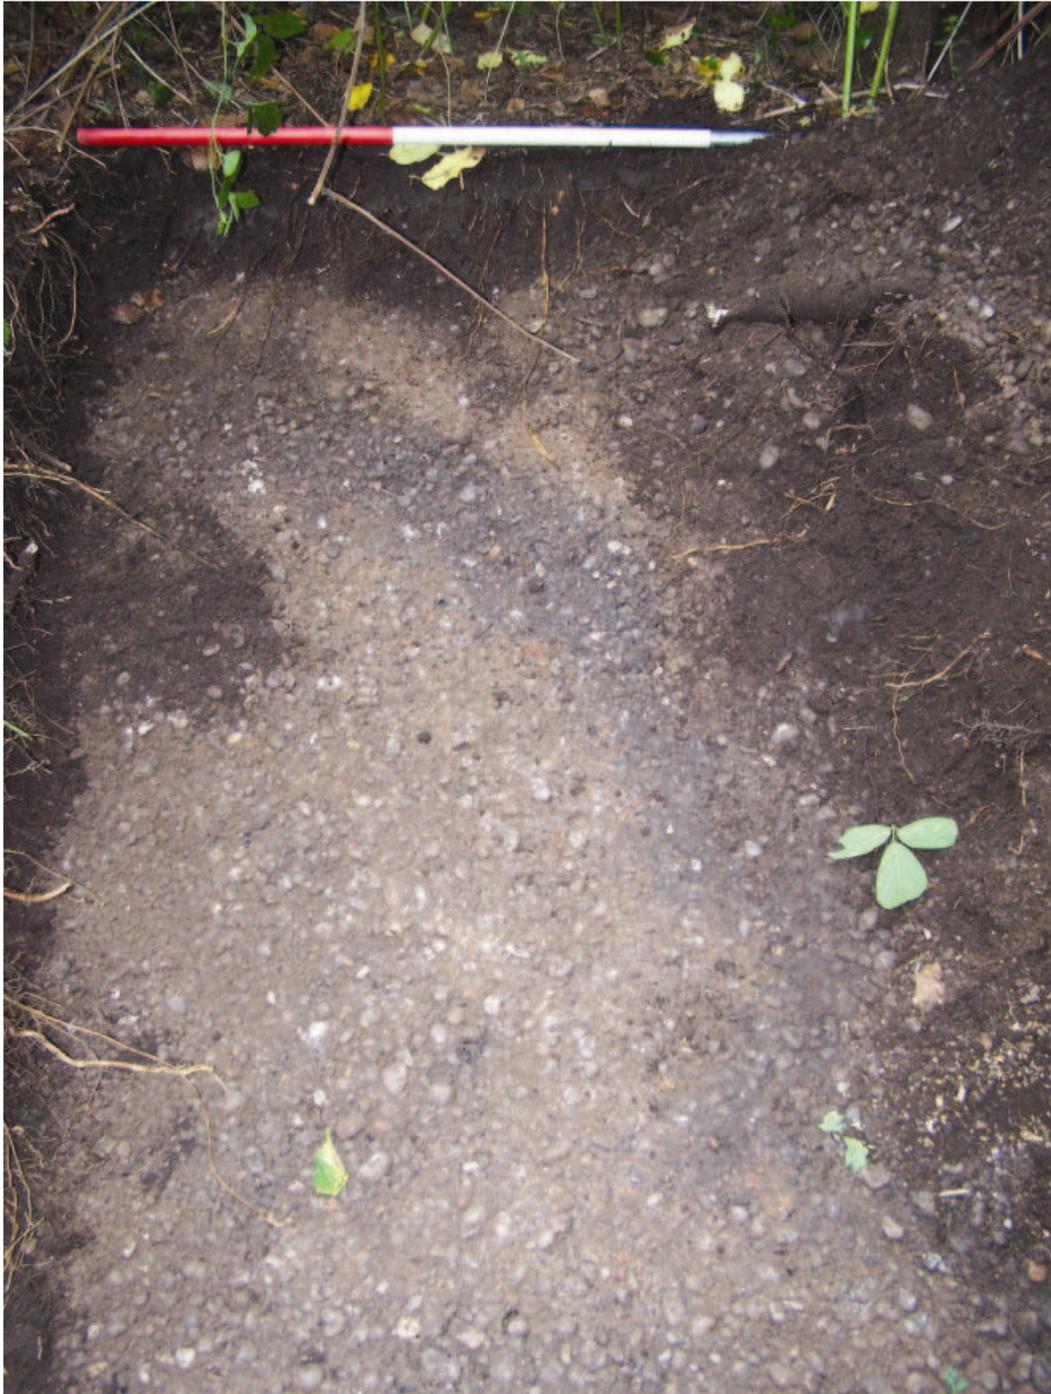
Plate 7: Staining on top of the hard packed gravel layer (Context No. 102) in Trench 1. Looking north.

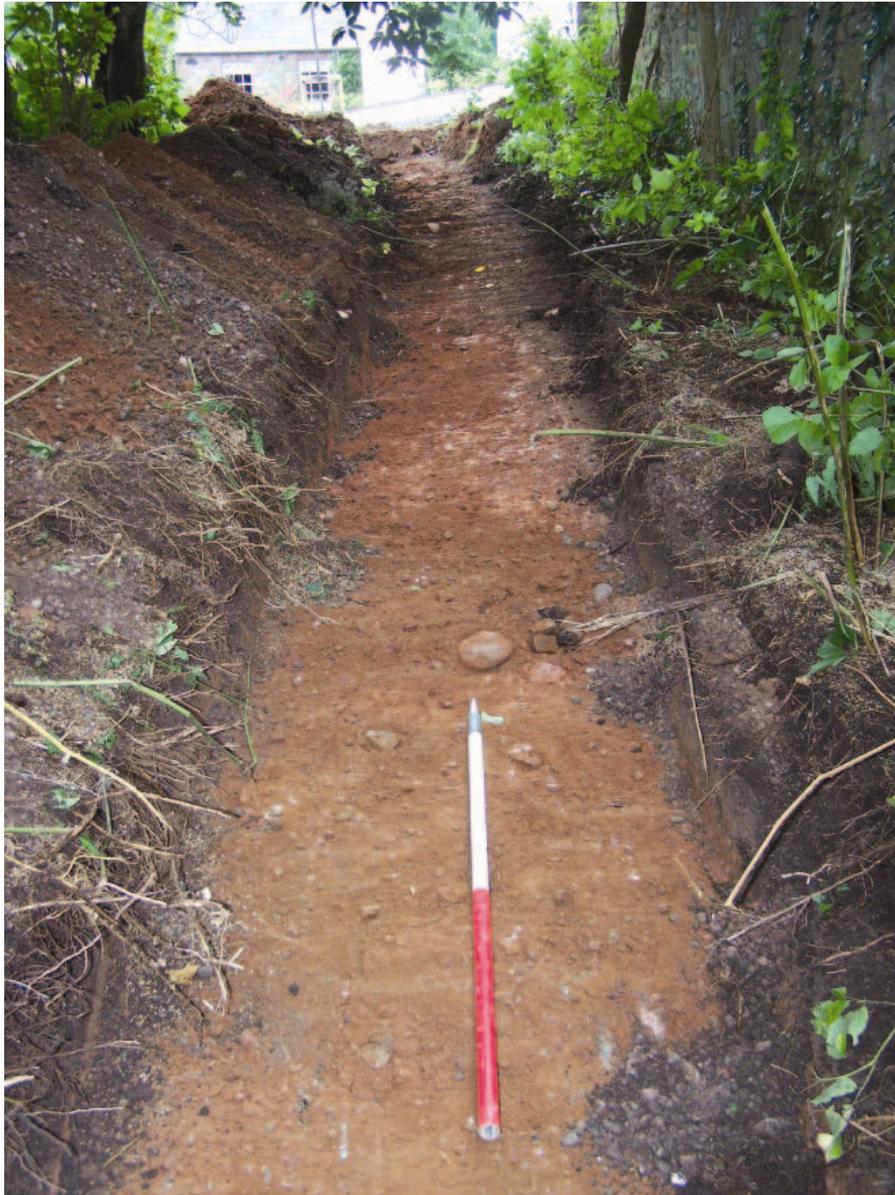
Plate 8: Trench 1 following the removal of the humic topsoil (Context No. 101), gravel deposits (Context 102 and 103) and cultivation soil (Context 105). Looking south.

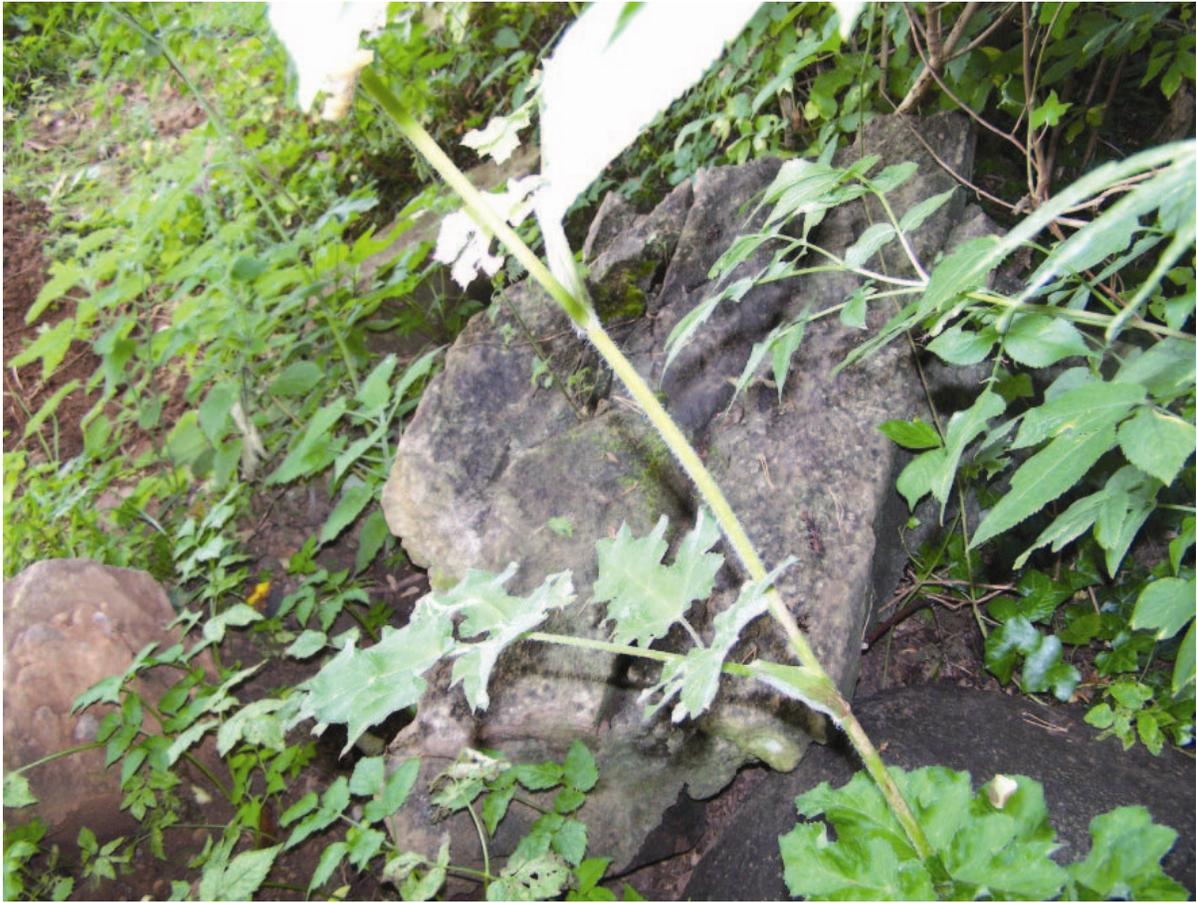
Plate 9 Section of stone wall collapse at northern end of Trench 2. Looking west.

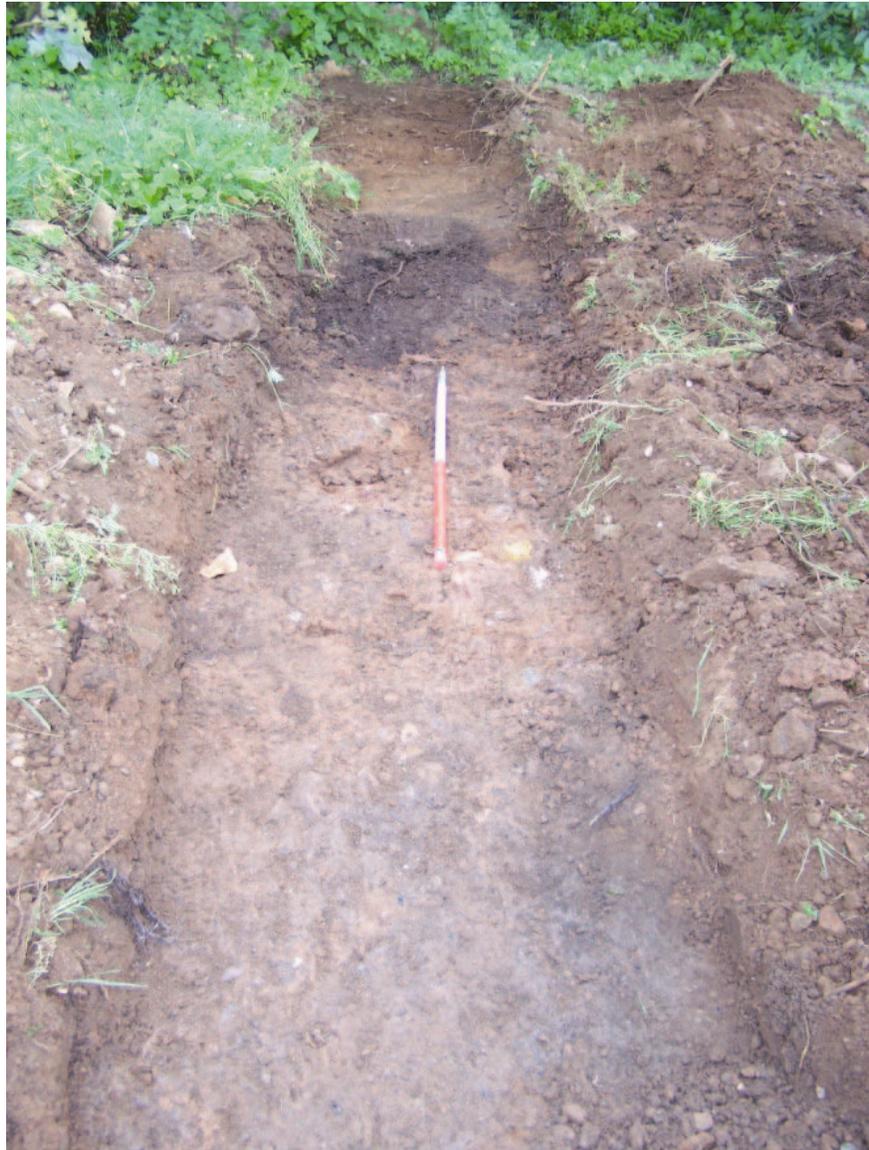
Plate 10: Trench 2 showing the truncated tree bowl at northern end of trench.
Looking north.
