Evaluation/Monitoring Report No. 142

**The Cottage
High Street
Cushendall
County Antrim**

LICENCE NO.: AE/07/167

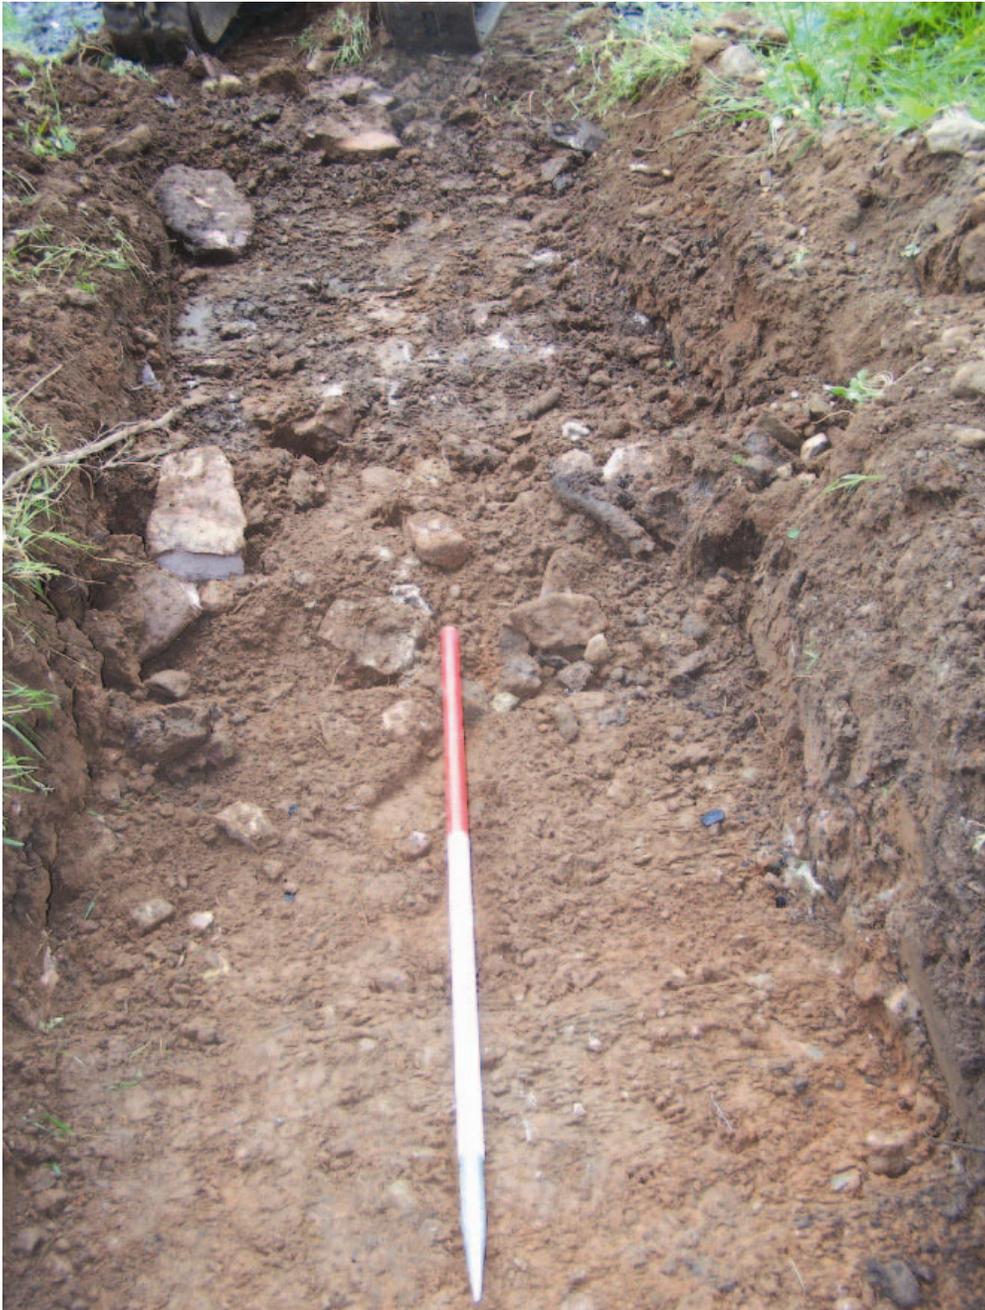
Plate 11: Trench 4 showing the stony deposit (Context No. 404) at southern end of trench. Looking south.

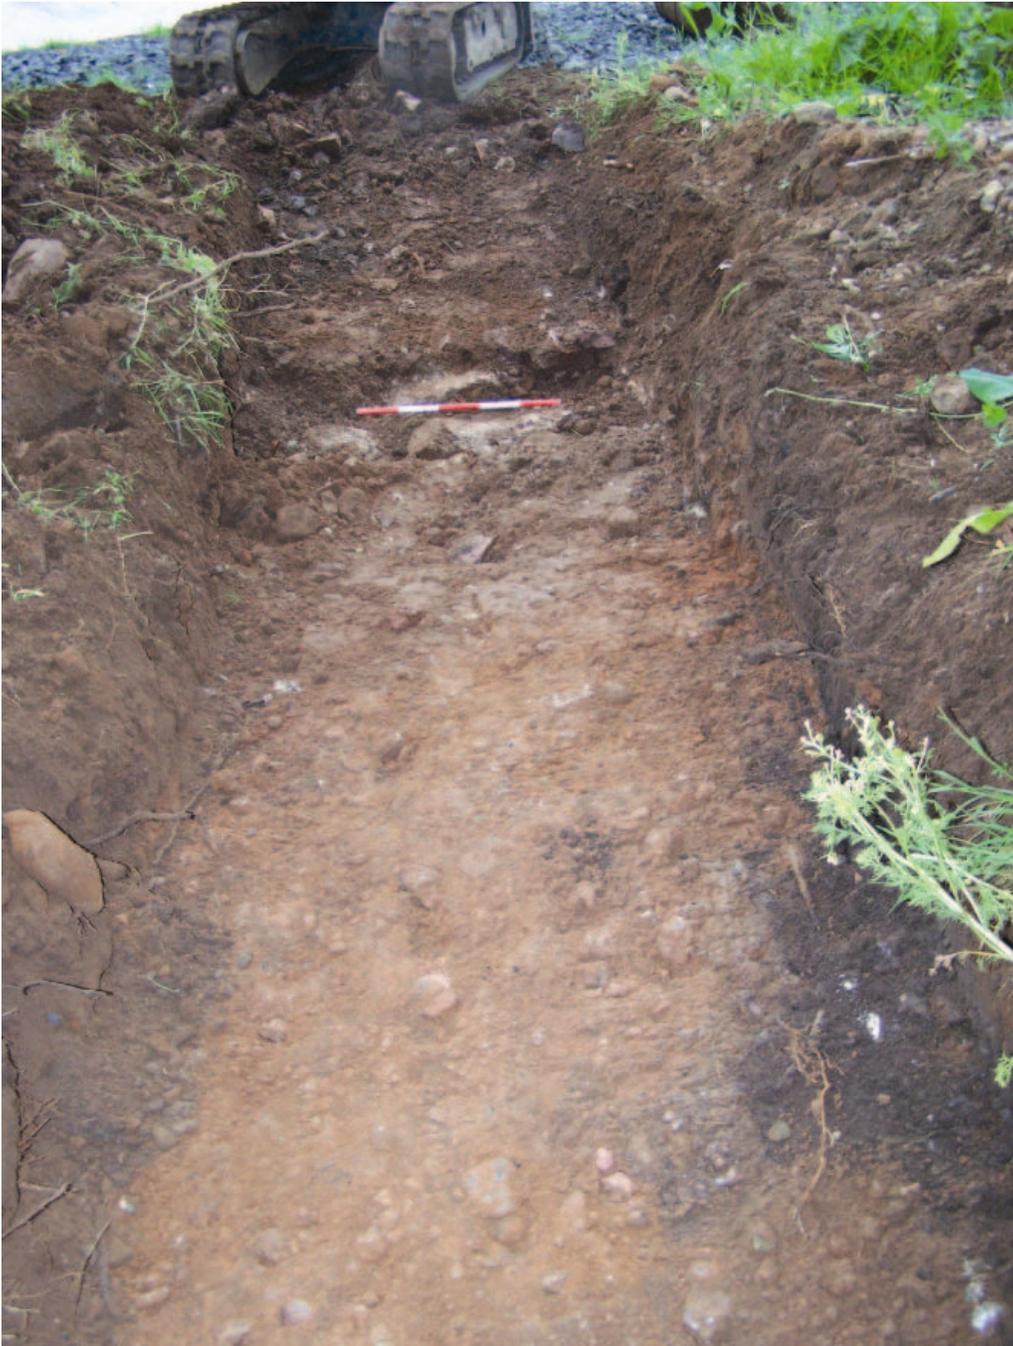
Plate 12: Trench 4 showing the brick lined drain uncovered under the stony deposit (Context No. 404). The scale beside the drain is 50cm in length. Looking south.

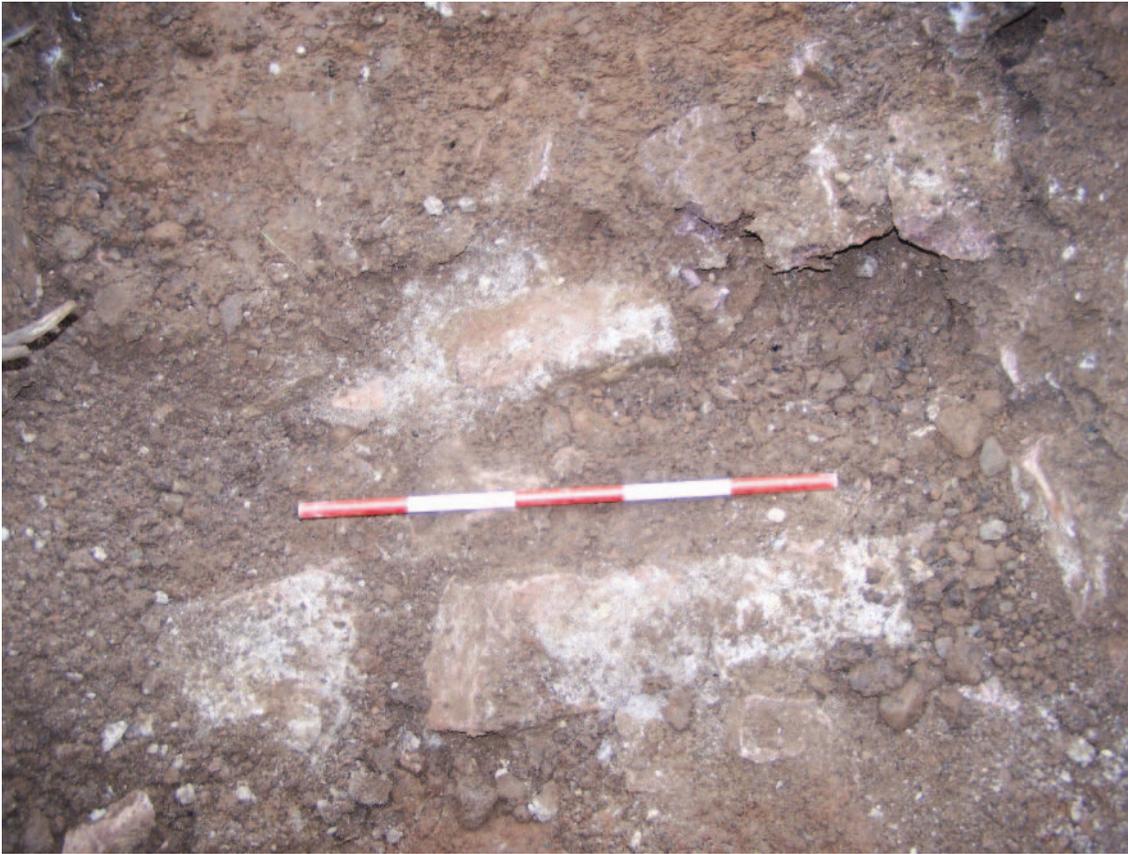
Plate 13 Close up of the brick lined drain in Trench 4 after the removal of stony deposit (Context No. 404).

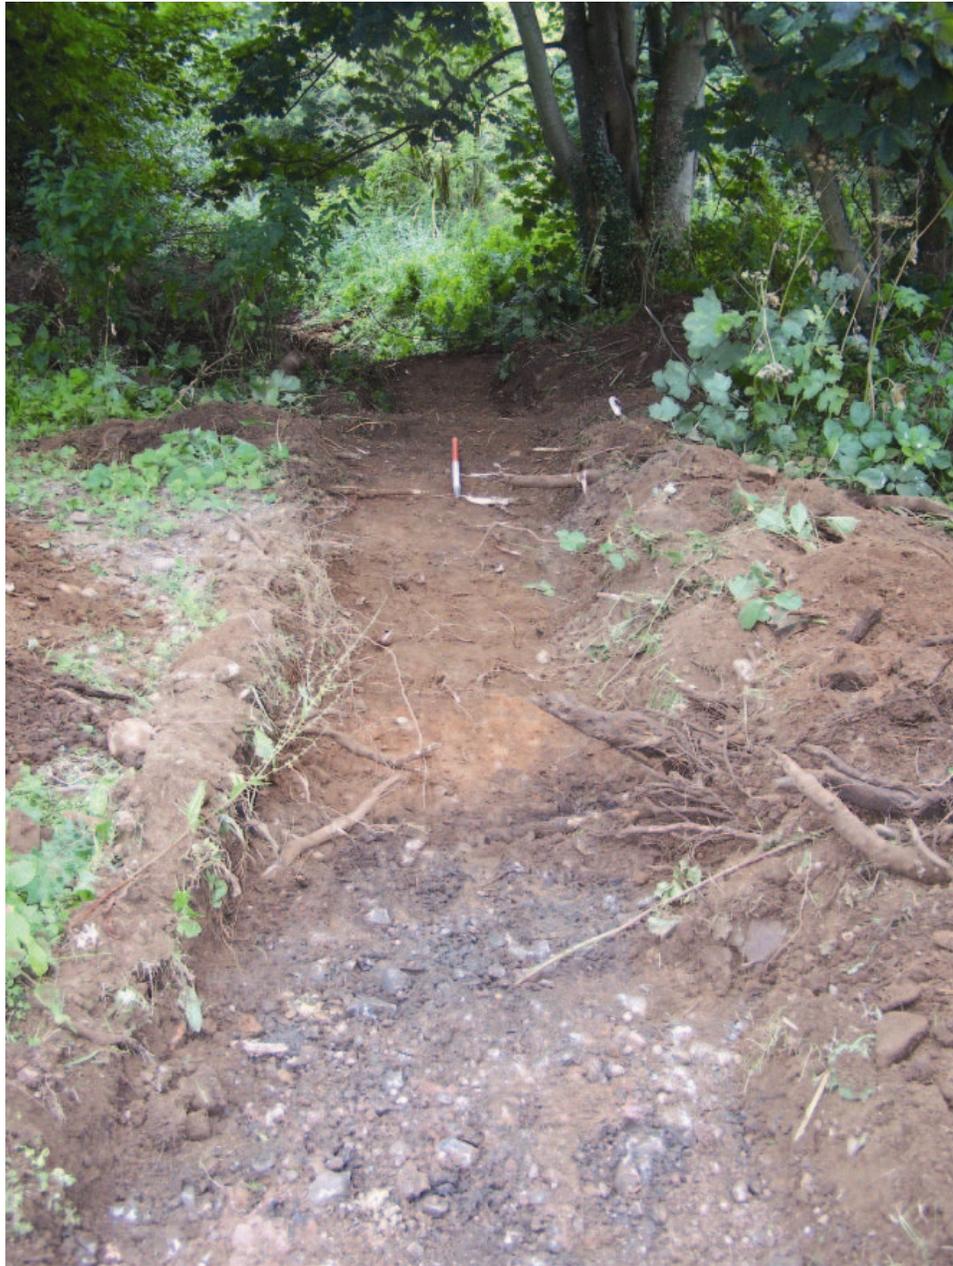
Plate 14 Trench 4 looking north towards the ridge.

In the lower area to the NE of the stable block, the removal of the cultivation soil revealed a layer of orange brown clay (Context No. 415; maximum depth 0.15 metres) extending to the base of the slope. Underlying Context No. 415 the truncated remains of two cultivation furrows were denoted Context Nos. 408 and 410 (the former being the southernmost), and their fills Context Nos. 409 and 411 respectively. The fills (Context Nos. 409 and 411) were archaeologically excavated, and confirmed that the features had been heavily truncated, the maximum depths approximately 0.03 metres in depth (Fig. 7). No finds were recovered from the cultivation furrows. To the south of the two truncated cultivation furrows a field drain was noted on the same orientation. The cut of the drainage channel (Context No. 406) was filled with a waterlogged dark brown clay containing large angular stones (Context No. 407; average size 60 x 60 x 50 mm). A piece of clay pipe stem (Small Finds No. 2) and some late nineteenth century glazed ceramic (Small Finds No. 3) were recovered when the cultivation soil (Context No. 402) was removed from the top of the field drain (Context No. 406 and 407). The removal of the cultivation soil (Context No. 402) revealed an orange/red stony boulder clay (Context No. 415; Plate 14)

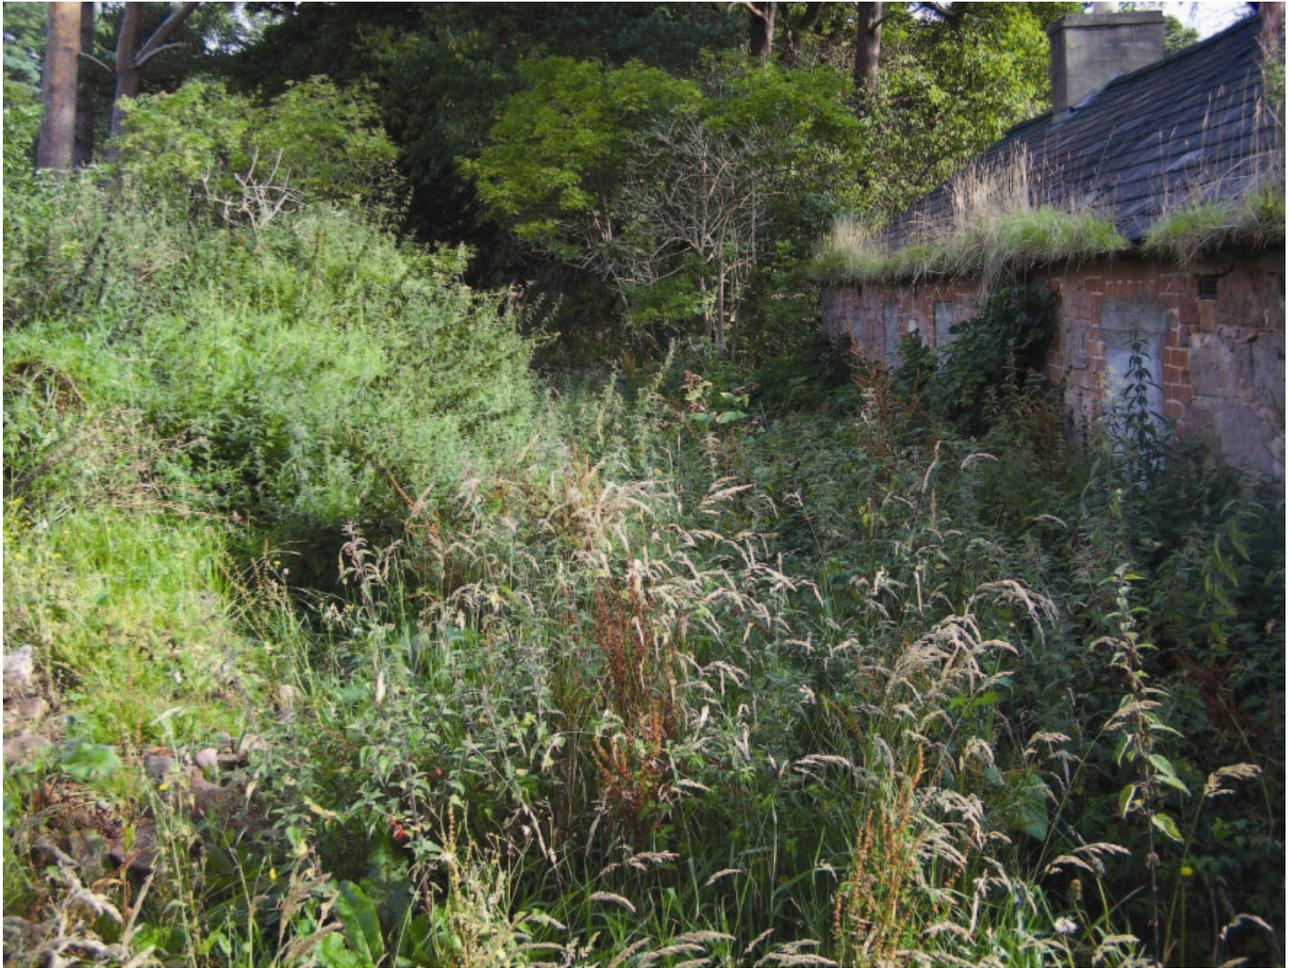
Plate 15 Close up of the vegetation surrounding the back of the stable block, looking northeast.

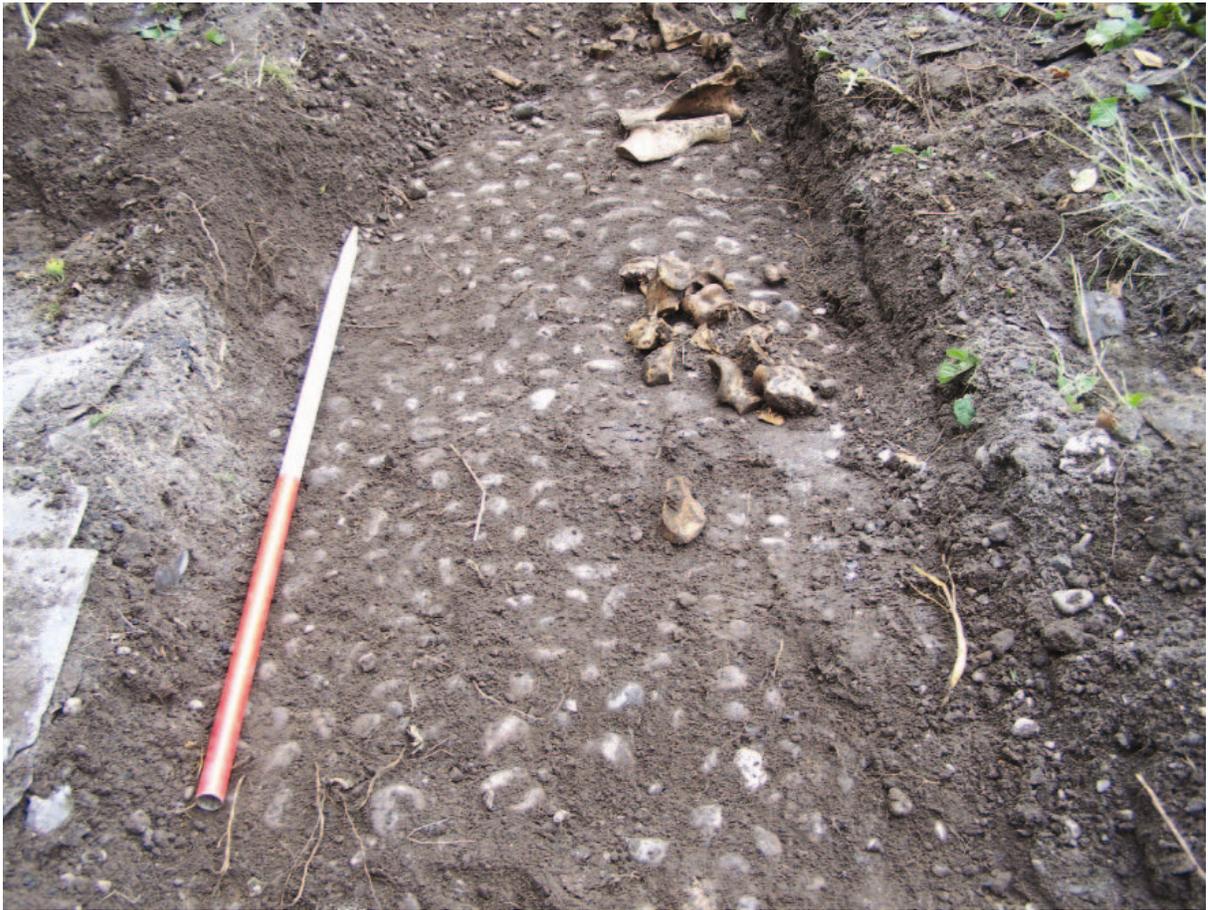
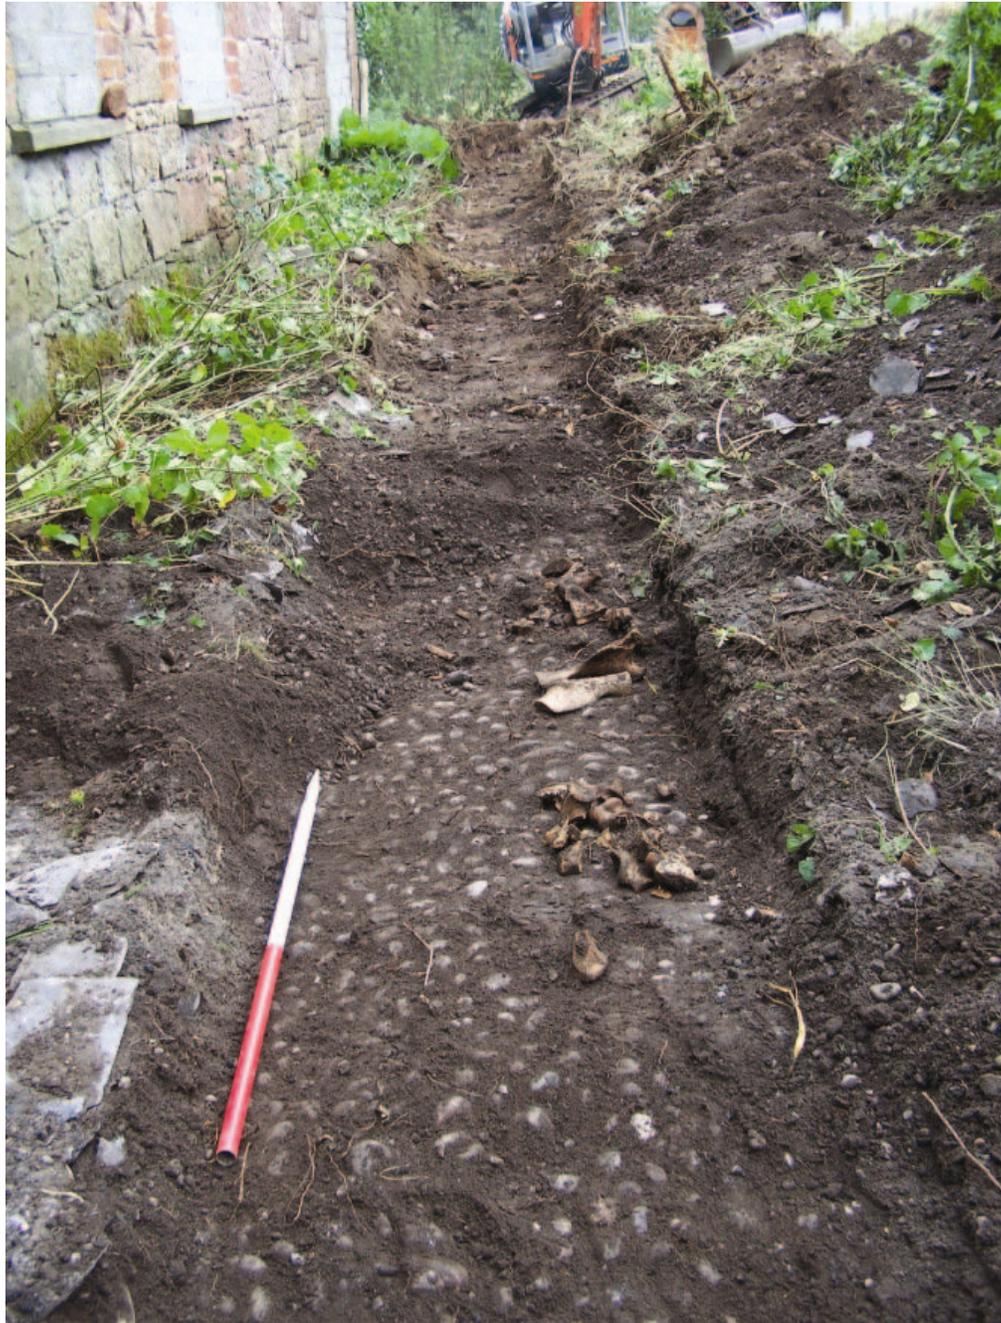
Plate 16: Bone deposit on top of cobbled surface (Context No. 503), Trench 5.
Looking south.

Plate 17: Bone deposit on top of cobbled surface (Context No. 503), Trench 5. Looking south.

The trench was positioned 0.50 metres from the base of the stable building wall (running SSW – NNE). The trench was 1 metre wide x 12 metres long. At the northern extremity of the trench a modern concrete drain access had been constructed. The removal of the vegetation revealed a dark brown/black topsoil layer (Context No. 501; maximum depth 0.05 metres) that had noticeable organic inclusions. This layer overlay a grey/ mottled black sandy layer (Context No. 502; maximum depth 0.13 metres) that the excavator noted had inclusions of ash and black material such as soot. In the upper surface of Context No. 502 two pieces of a late nineteenth/early twentieth century fire backing were recovered (Small Finds Nos. 4 and 5). At the base of this layer (Context No. 502) a piece of fired earthenware tile was recovered, overlying a layer of disturbed cobbles (Context No. 503; rounded cobbles of average size 40 x 30 x 30 mm). The excavator noted that the cobbles were not fixed unto a surface with mortar, and appeared to be just pressed into the underlying layer (Context No. 504; maximum depth 0.11 metres), a light grey sandy layer with frequent inclusions of small stones (approximately 20 x 10 x 10 mm). Lying directly on the surface of the cobbles was a number of animal bones that exhibited cut marks from a saw (see Bone Report; Plate 16, 17 and 25).

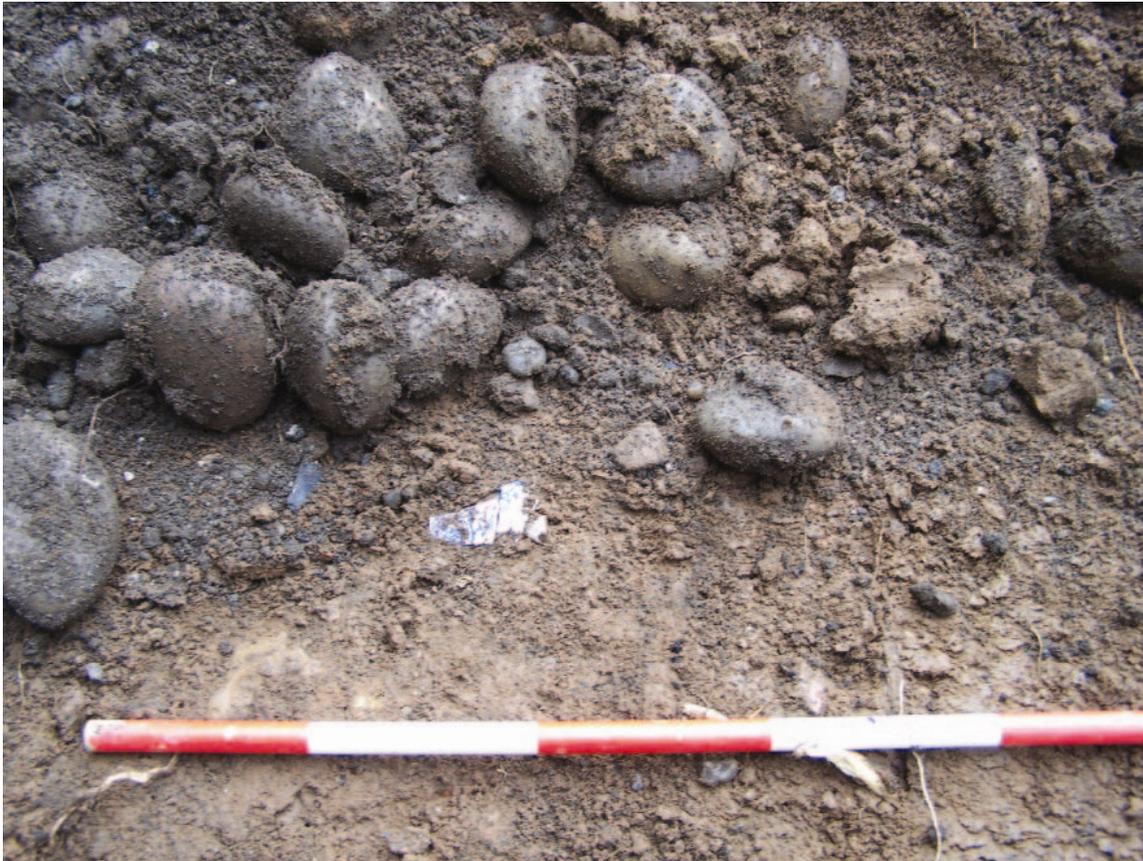
Plate 18: Closeup of the removal of the cobbled surface (Context No. 503), and underlying light grey sandy layer (Context No. 504), revealing the leveling deposit (Context No. 505) with inclusions of 19th century glazed ceramic. Scale is 50 cm in length.

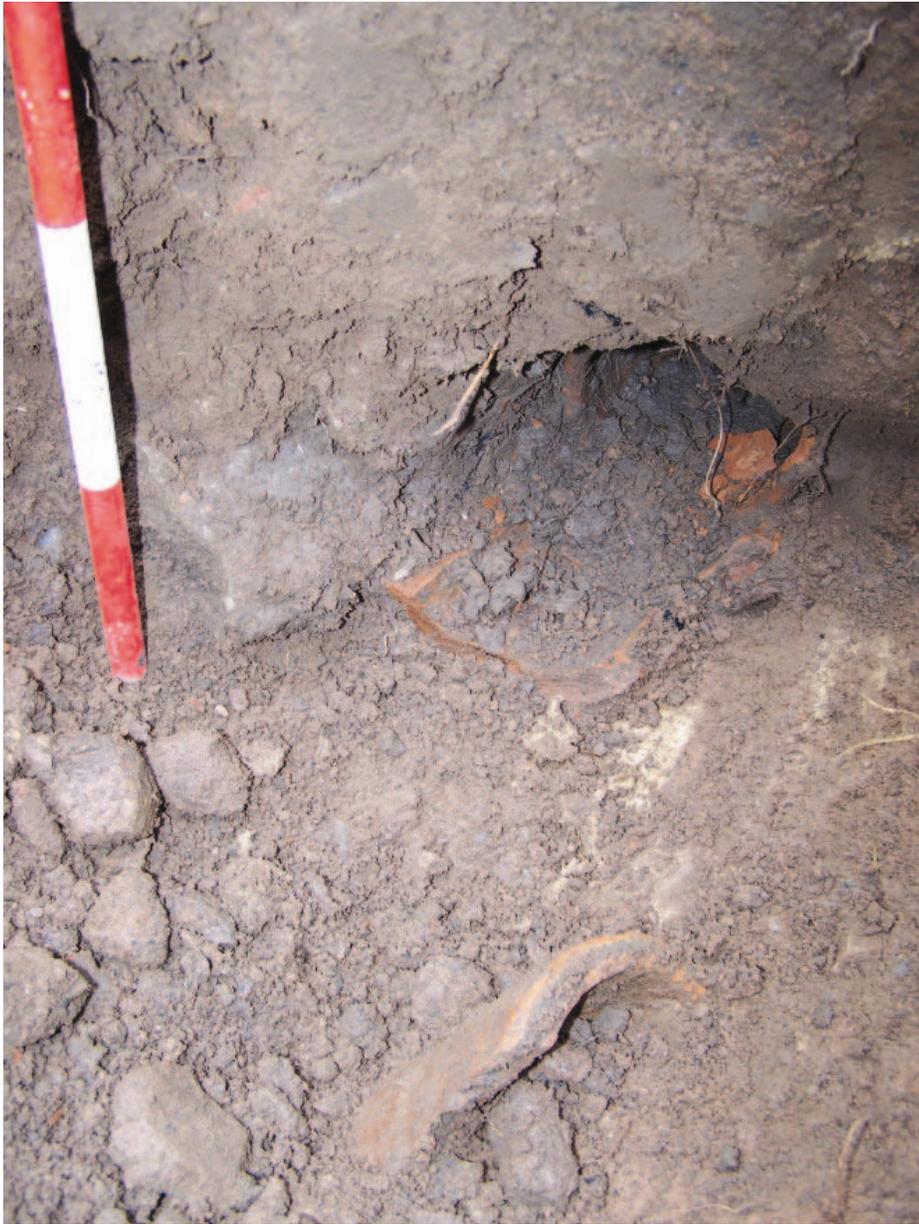
Plate 19: Close up of 19th century ceramic drain underneath the leveling deposit (Context No. 505). Note the yellow clay sealing the drainage channel (Context No. 509). See Fig.10 for section drawing.

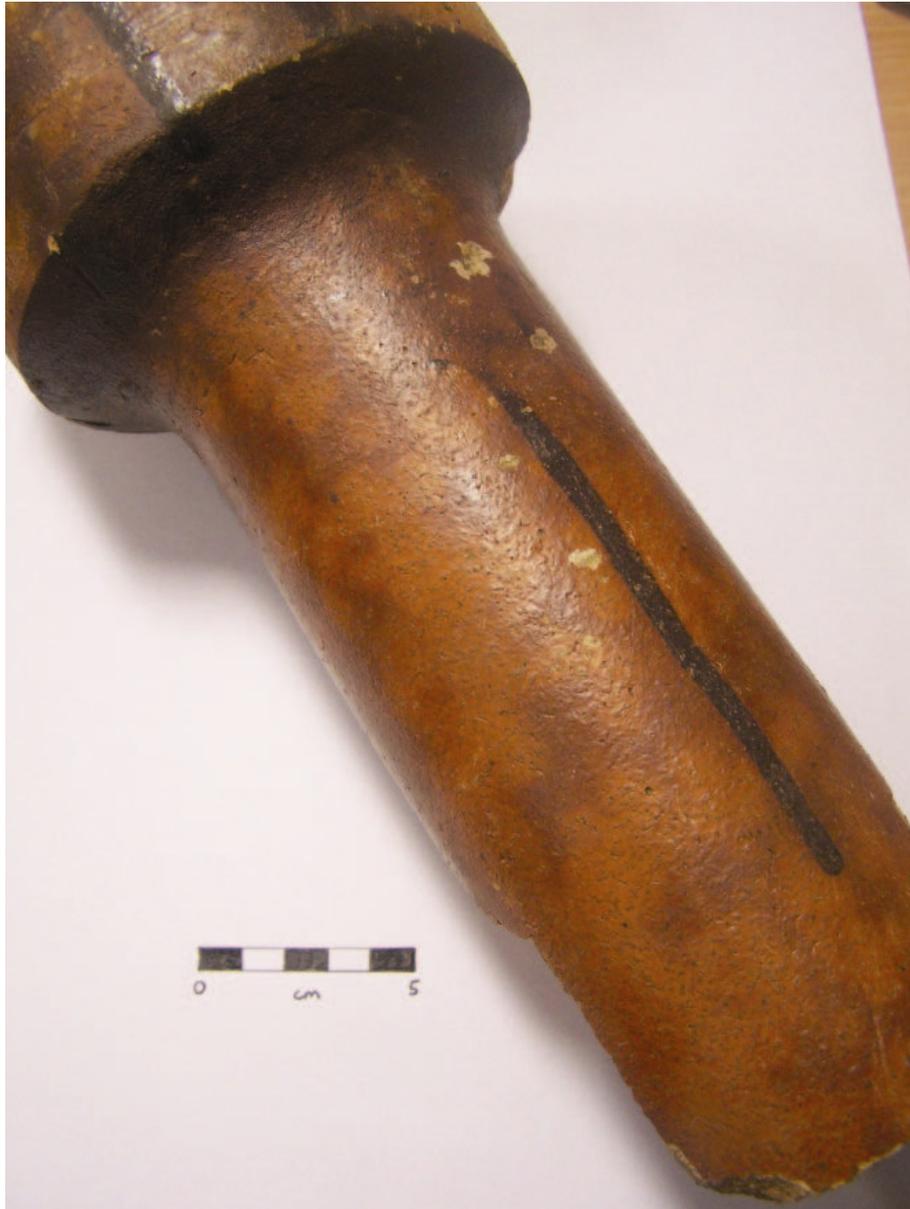
Plate 21: Small Find No. 1. Late 19th century glazed ceramic drain.

No structural remains were uncovered in the trench, and only the late 19th/early 20th ceramic drainage pipe was uncovered (Small Finds No. 1; Plate 21).

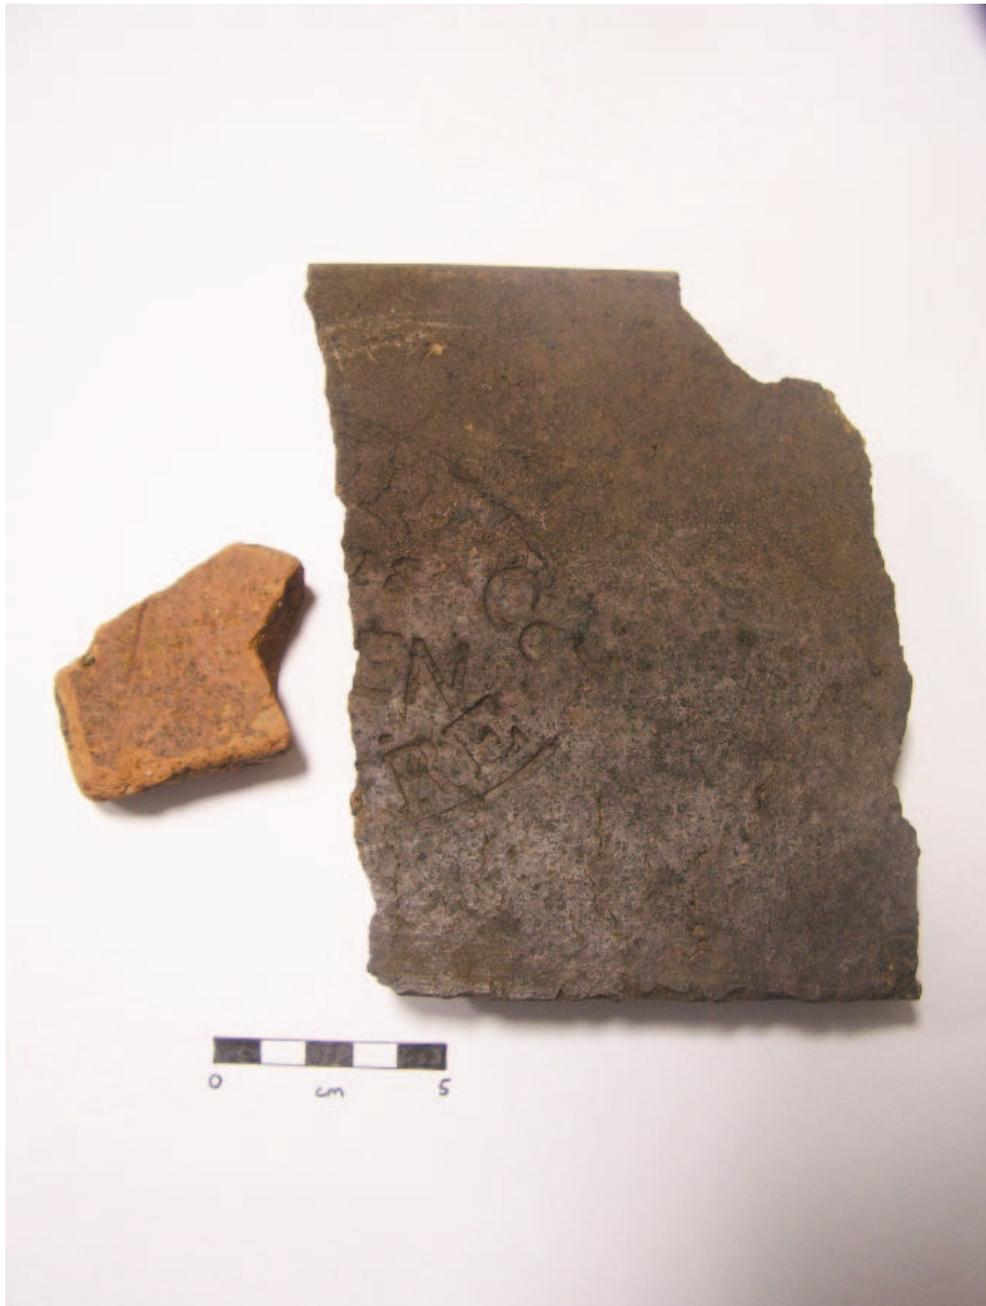
Plate 22: Fired 19th century earthenware tile (Small Find No. 6), and 19th century fire backing (Small Find No. 5), left to right.

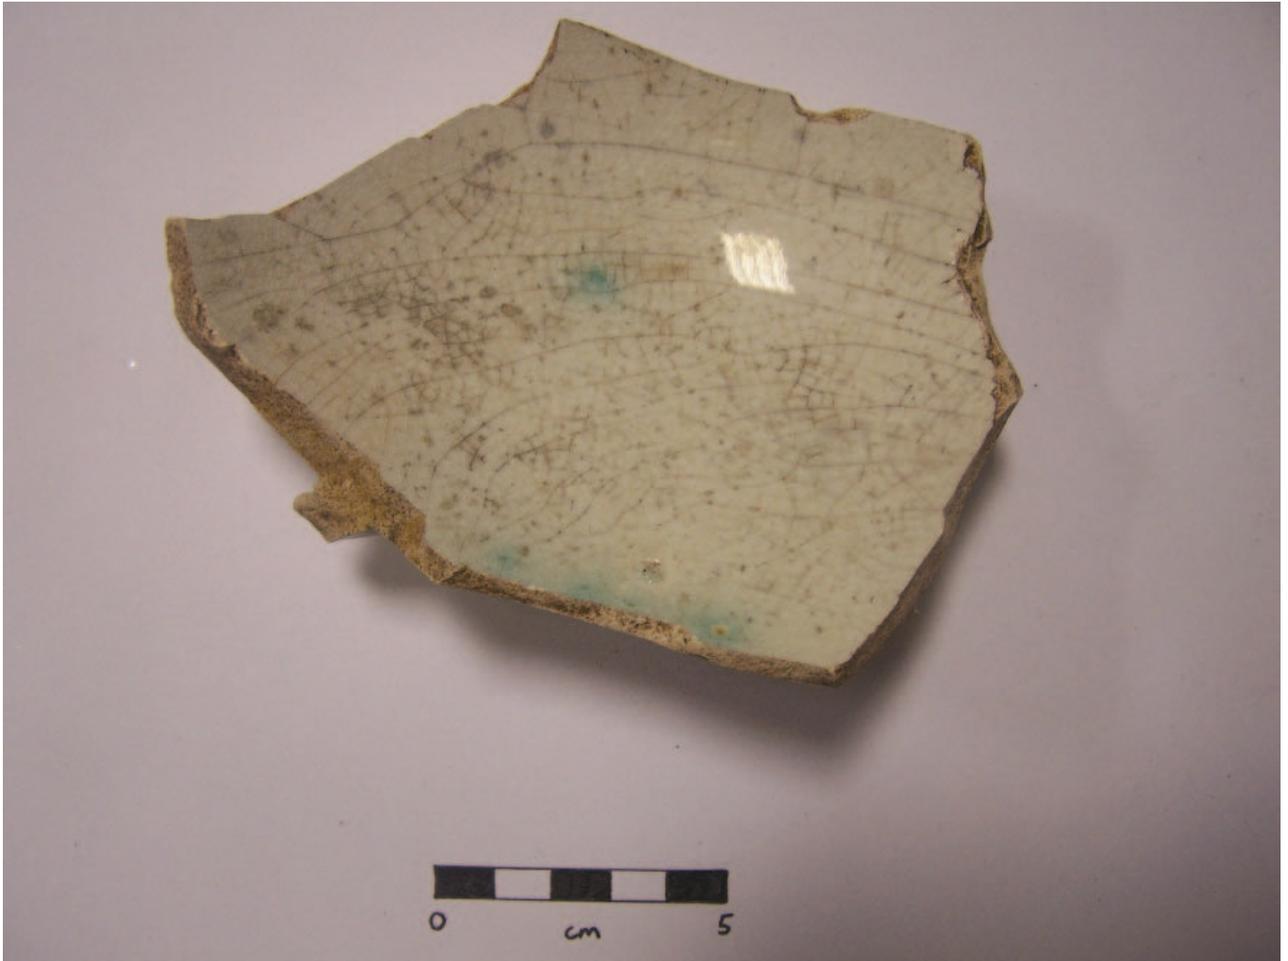
Plate 23: Piece of late 19th century 'Belfastware' glazed ceramic footed bowl
(Small Find No. 20).

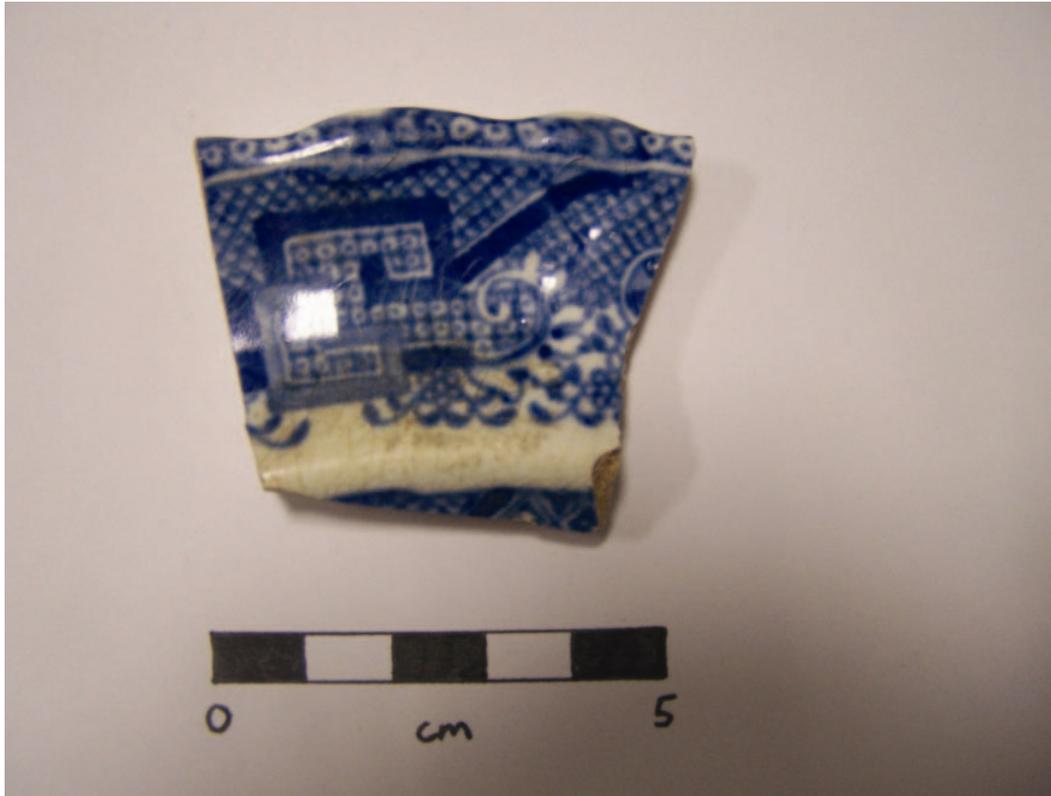
Plate 24: Early to mid 19th century glazed ceramic (Small Find No. 15). Note the smudging of the design at the rim of the piece, a common problem in early examples of underglaze transfer printing.

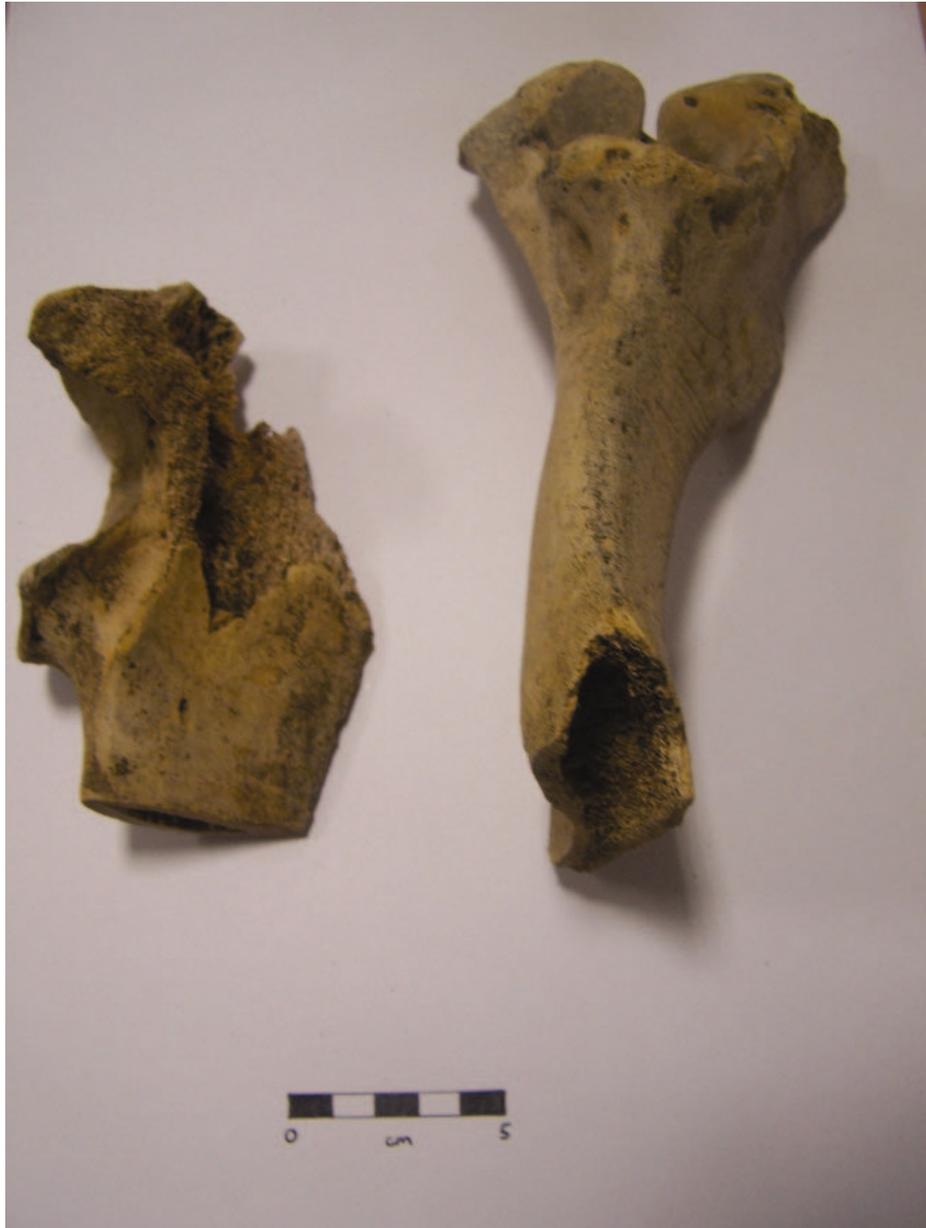
Plate 25: Bones from the deposit on top of cobbled surface (Trench 5; Context No. 503). Note the bone saw marks on the end of the bones facing camera. See Bone Report for details.

The bones primarily represent cattle remains (approx. 30 epiphyses) with a couple of sheep bones also present and the majority had been butchered with a saw. The cattle bones comprised almost the full range of skeletal elements with the notable exception of the lower limb bones (metapodials and phalanges), ribs and the majority of vertebrate though a single atlas, axis and sacrum were present. The most common element was the pelvis and a minimum of six cattle were represented. The pelvises (os innominata) were all fused while many of the epiphyses of the limb bones were unfused indicating the slaughter of animals aged between 1 and 3-3½ years old (after Silver 1969). The bones probably represent the waste from a butcher, the lower limbs having been removed elsewhere at the point of slaughter and the ribs and vertebrae being left with the meat 'on the bone'. Sheep was represented by part of a skull and horncore (sawn through) and a radius.
