**Evaluation/Monitoring Report No. 153**

**PORTAFERRY LIFEBOAT STATION  
BALLYPHILIP  
PORTAFERRY  
CO. DOWN**

**LICENCE NO.: AE/07/256**

An archaeological investigation was carried out at the site of the current Lifeboat Station in Portaferry, Co. Down. The archaeological investigation was requested due to the proximity of the development site to Portaferry Castle (DOW 032:003). The investigation was carried out in two phases; Phase 1 being the mechanical excavation of three test trenches to assess the presence and survival of any archaeological strata, and Phase 2 being the monitoring of the mechanical excavation of the footprint of the proposed replacement Lifeboat Station. In both cases, the area investigated was excavated to the surface of the natural bedrock. The archaeological investigation showed that a substantial degree of modern disturbance has occurred at the site. Nothing of archaeological significance was observed during the exercise. It is recommended that no further archaeological mitigation is necessary at the application site.

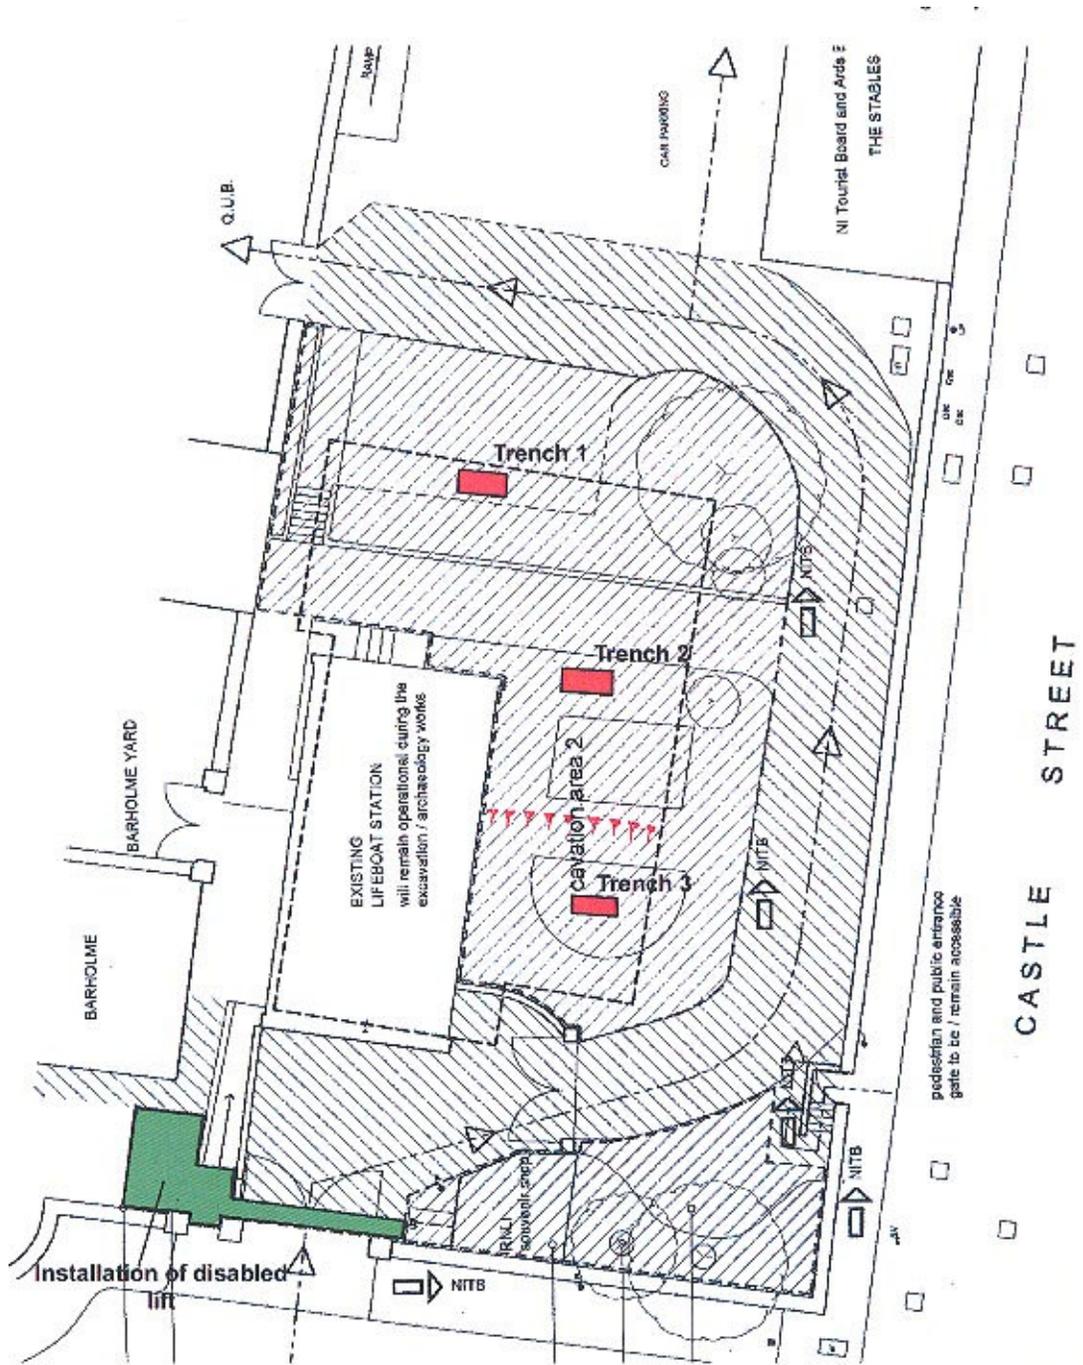
Figure Two: Detailed location map showing development area and the location of the Phase One Test Trenches (coloured red)

Three test trenches, each measuring approximately 2m x 2m were mechanically excavated to the surface of the natural bedrock. The trenches were located in the landscaped area and their positions are illustrated in Figure Two. Phase One of the archaeological programme of works was undertaken between the 15<sup>th</sup> and 16<sup>th</sup> January 2008.

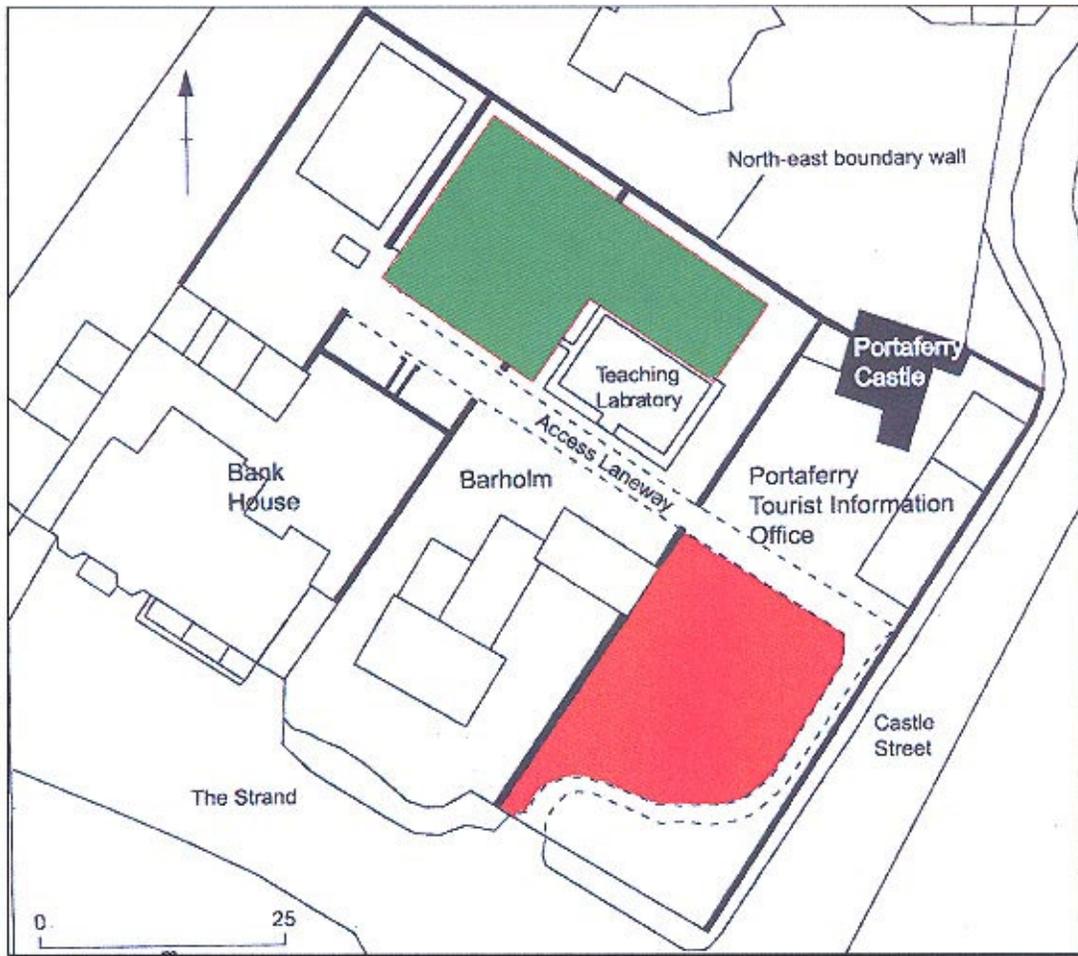
Figure Three: Map of the development area showing location of 2008 investigation (shaded red) in relation to Portaferry Castle (DOW 032:003) and McHugh's investigation in 2005 (shaded green)

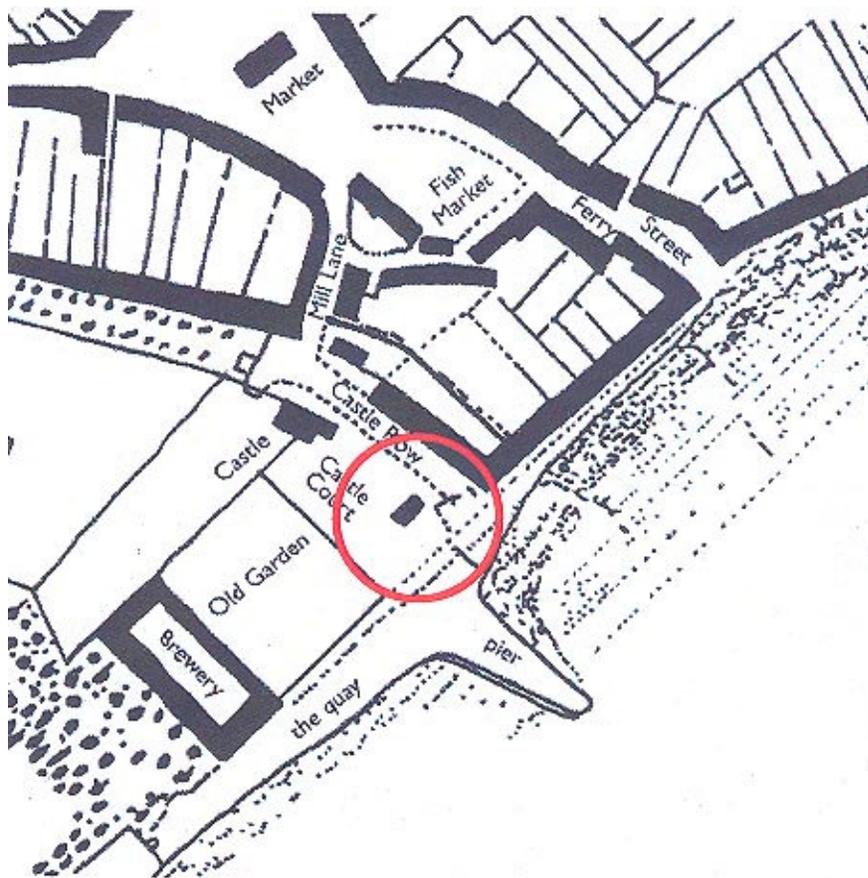
Figure Four: O'Hare's map of 1799 showing 'Castle Court', the 'Castle' and an upstanding building towards the east of Castle Court (circled in red) (McErlean et al 2002, fig 9.6). No trace of this building was encountered during the archaeological investigation.

A dual-phased archaeological investigation was undertaken in advance of the construction of a new Lifeboat Station in Ballyphilip, Portaferry, Co. Down (Figure One). The site is in the centre of the town of Portaferry, directly opposite the slip and ferry terminal. The application site is bounded on the north-east and south-east by a mortared stone wall and on the west by the Barholm self-catering accommodation. Prior to the investigation the current Lifeboat Station, as well as landscaped shrub area, existed on site. The landscaped area was approximately 1.5m above the current street level, indicating that a substantial episode(s) of dumping had occurred on site. Portaferry Castle (DOW 032:003), a seventeenth century fortification built by the savage family, lies approximately 25m to the north-east of the development site, which is known as 'Castle Court' in Patrick O'Hare's map of 1799 (Figure Four).

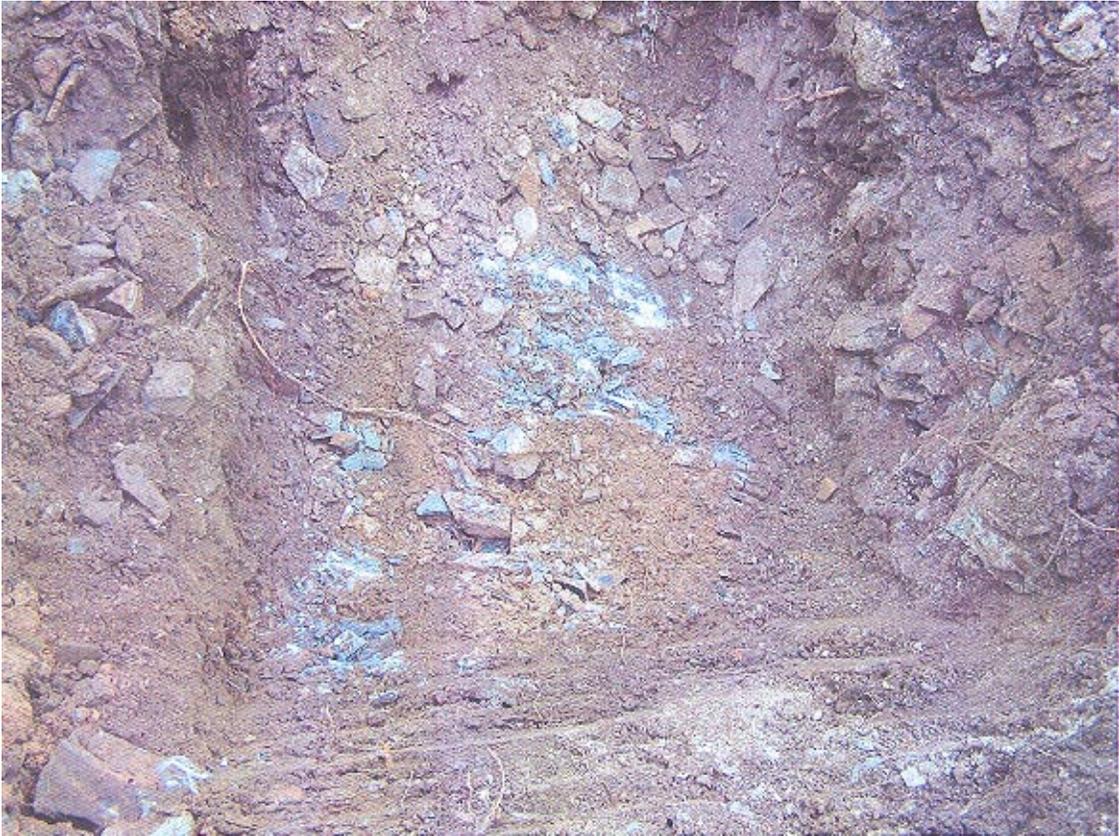
Plate One: Surface of natural shale bedrock in Test Trench Two (Context No. 206), looking east

Test Trench Two was located approximately 6m to the south of Test Trench One and measured approximately 2m x 2m. The trench was mechanically excavated to the surface of the natural bedrock (Context No. 206) which was encountered at a depth of 2.2m.

The rubble and mortar deposit (Context No. 202) also overlay another deposit of rubble within a matrix of mid brown sandy loam (Context No. 204). This deposit (Context No. 204) was similar in appearance to the upper rubble layer (Context No. 202) although a paucity of mortar was observed. The mid-brown sandy loam (Context No. 204) was on average 1.1m thick and overlay thin isolated spreads of mottled orange clay (Context No. 205) suggested that this deposit was the remains of heavily truncated subsoil, only surviving in isolated pockets of the undulating bedrock (Context No. 206).

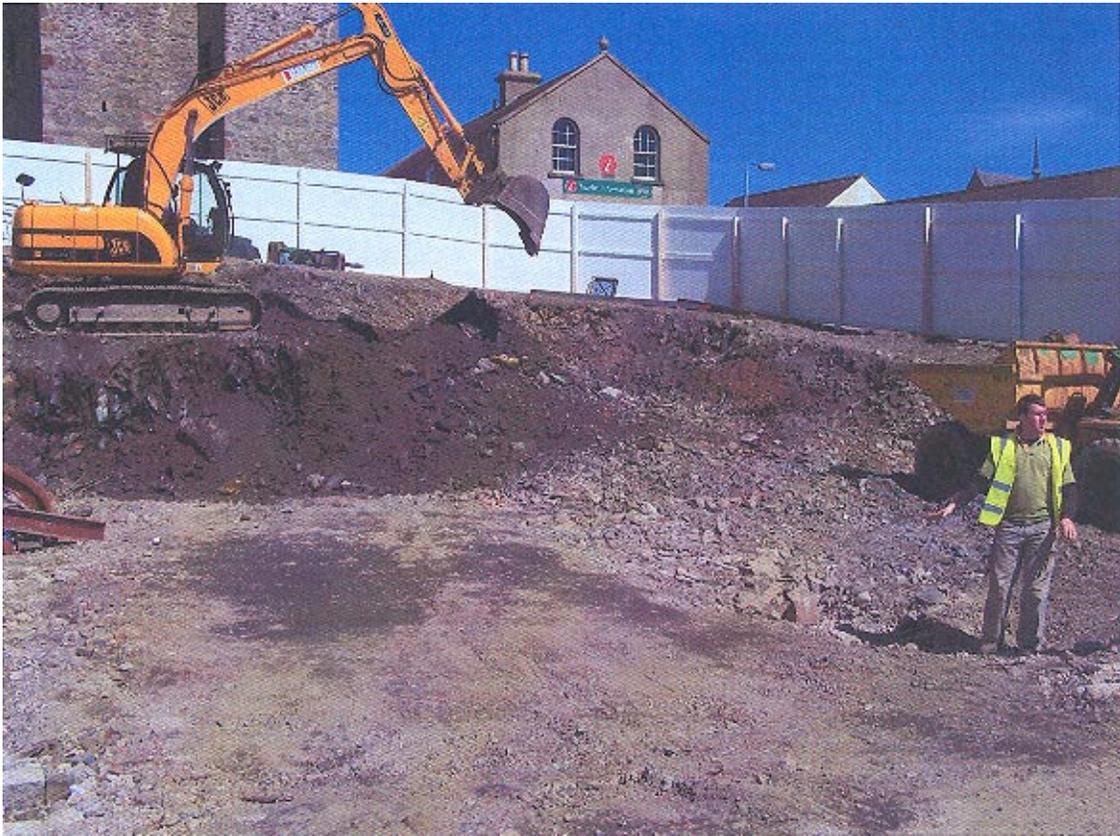
Plate Two: Phase Two monitoring of the mechanical excavation of the development site, looking north-east.

The current Lifeboat Station was demolished and the concrete floor lifted. This was found to be sitting on a relatively thin layer (0.2m thick) of hardcore. The mechanical removal of this hardcore layer was monitored to the surface of the natural bedrock. It became clear that the area had been heavily truncated, with a terrace being excavated into the bedrock slope to accommodate the Lifeboat Station in the 1980s (Avery 2007). Numerous old and existing service pipes were observed during the Phase Two monitoring, testifying the degree of truncation and disturbance that had been carried out on site prior to this archaeological investigation. Nothing of archaeological significance was encountered during the monitoring that would have implications on the development of the new Lifeboat Station.

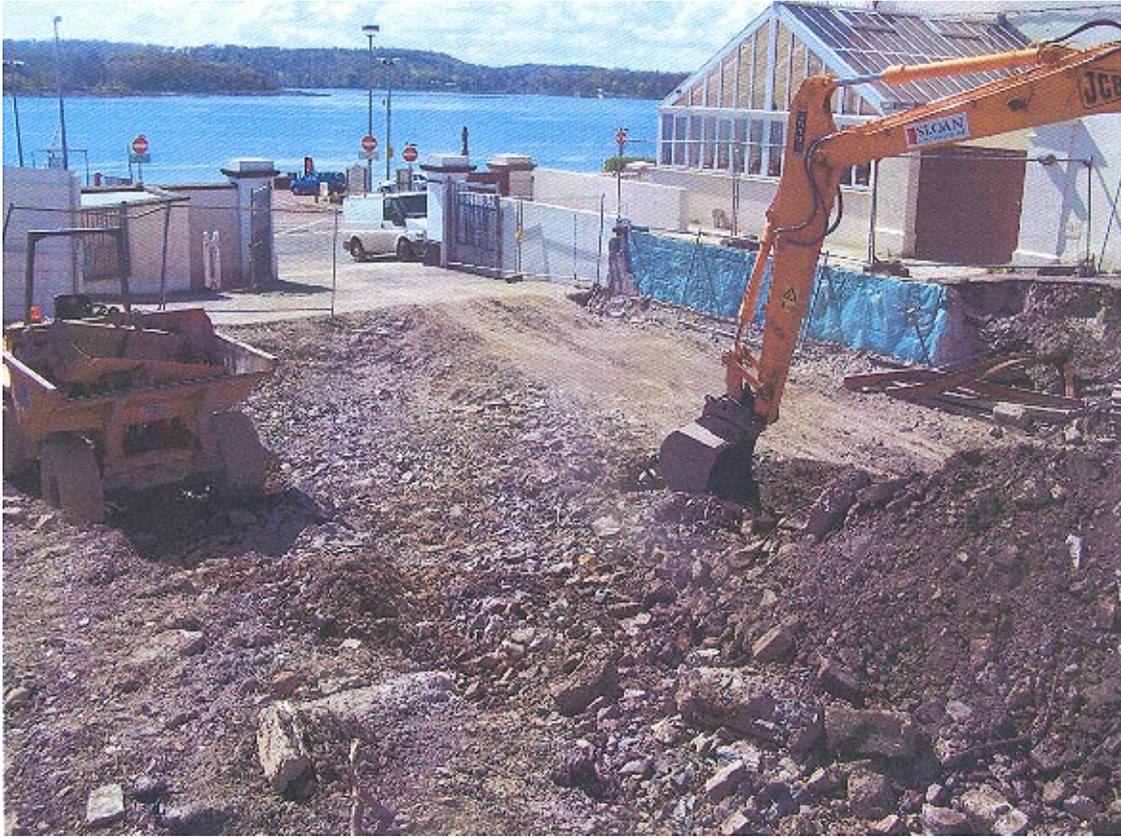
Plate Three: Phase Two mechanical excavation of the development site, looking south-west.
