Evaluation/Monitoring Report No. 157

**REPLACEMENT DWELLING AT 74 DUNOVER ROAD
TULLYKEVIN
BALLYWALTER
CO. DOWN**

LICENCE NO.: AE/08/128

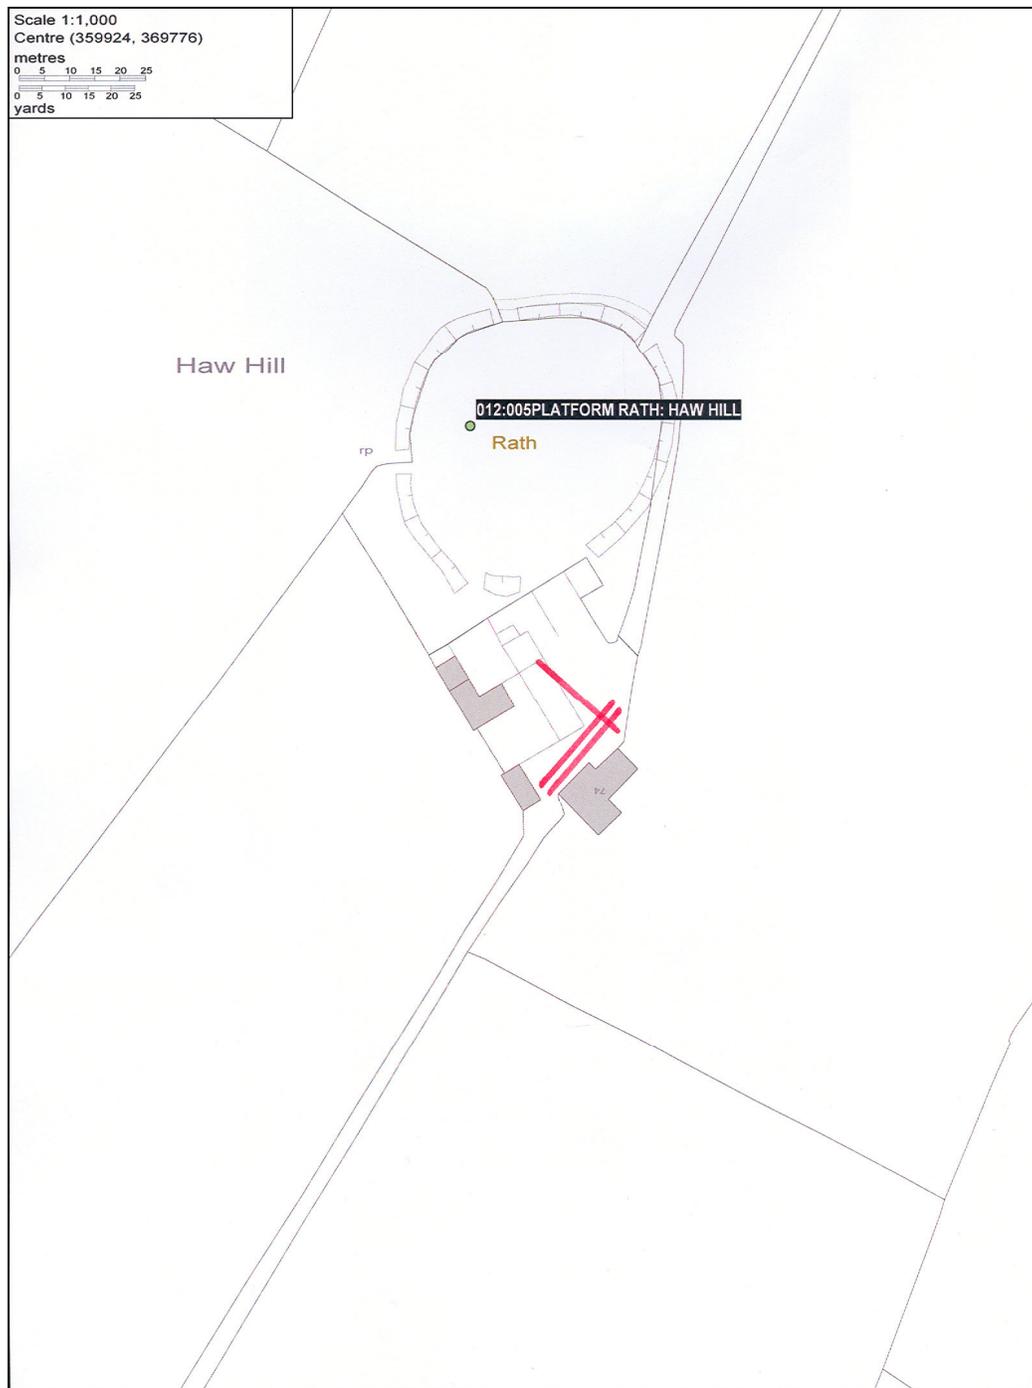
Figure Three: Proposed location of test trenches.

Three trenches were mechanically opened across the proposed location for the replacement dwelling. The trenches were approximately 2m wide and ranged in length from 15m to 18m. All three test trenches were excavated to the subsoil which consisted of an orange glacially derived boulder clay. The stratigraphy encountered in Trenches One and Two was very shallow (0.05m). Information provided by the landowner indicates that this truncation was carried out relatively recently to remove rubble that had collapsed from the dilapidated outbuildings. The surface of the subsoil was encountered at a depth of around 0.3m in Trench Three.

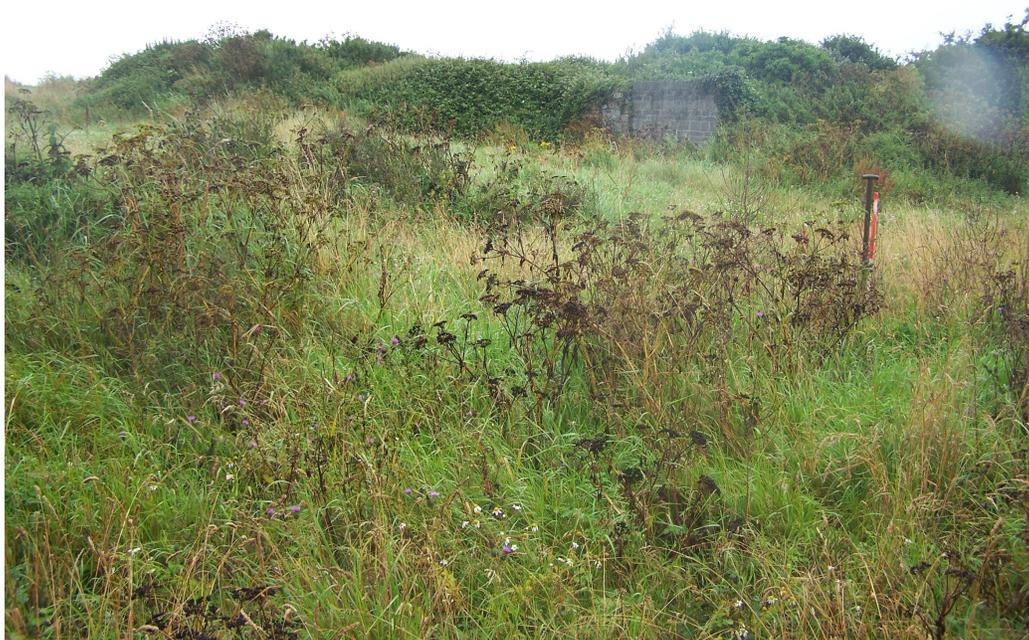
Plate One: Proposed location of replacement dwelling with rath (DOW 012:005) in the background, looking north-east.

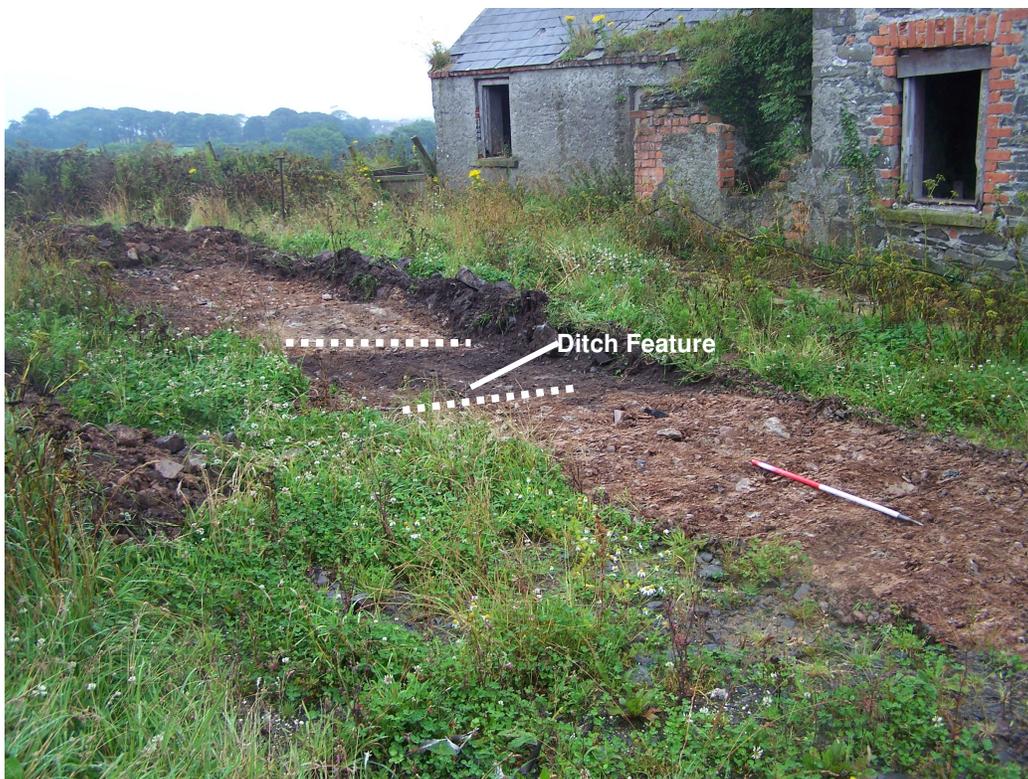
Trench One was located parallel to the northern wall of the previous dwelling. Trench One was approximately 2m wide and 15m long and was aligned approximately south-west/north-east. The trench was excavated to the surface of the natural subsoil which was encountered at an average depth of 0.05m.

The topsoil (Context No. 101) in this trench was very thin (0.05m). This area had been severely truncated in the recent past, as rubble from the extant outbuilding had been cleared away by the landowner. Upon removal of the topsoil (Context No. 101) a negative feature was observed cutting the natural subsoil (Context No. 102). This feature was aligned roughly north/south and was approximately 1.6m in width. The fill of the feature (Context No. 103) consisted of a compact silty clay that had frequent inclusions of small rounded and sub-angular stones (average size: 40mm x 50mm x 30mm) and larger angular rocks (60mm x 90mm x 110mm). A small cutting was excavated into the fill (Context No. 103) of the feature to assess its archaeological potential. Forty sherds of souterrain ware pottery (provisionally identified by Cormac McSparron) were recovered from the fill (Context No. 103), along with charcoal and burnt bone. Excavation ceased following the identification of the feature as being of archaeological significance.

The cut of the feature (Context No. 104) consisted of steep sloping sides. However the feature was not excavated to the base of the cut (Context No. 104) at this stage.

Plate Two: Trench One following excavation to the surface of the natural subsoil (Context No. 102) looking south-east. Ditch feature (Context No. 103) can be seen about the middle of the trench.

It is recommended that the proposed area of the replacement dwelling should be mechanically stripped to the surface of the natural subsoil, and any archaeologically significant features or deposits excavated and recorded prior to the development proceeding. It would also be beneficial to excavate a section of the rath ditch (Context No. 305) to provide a comparison of stratigraphy and chronology.

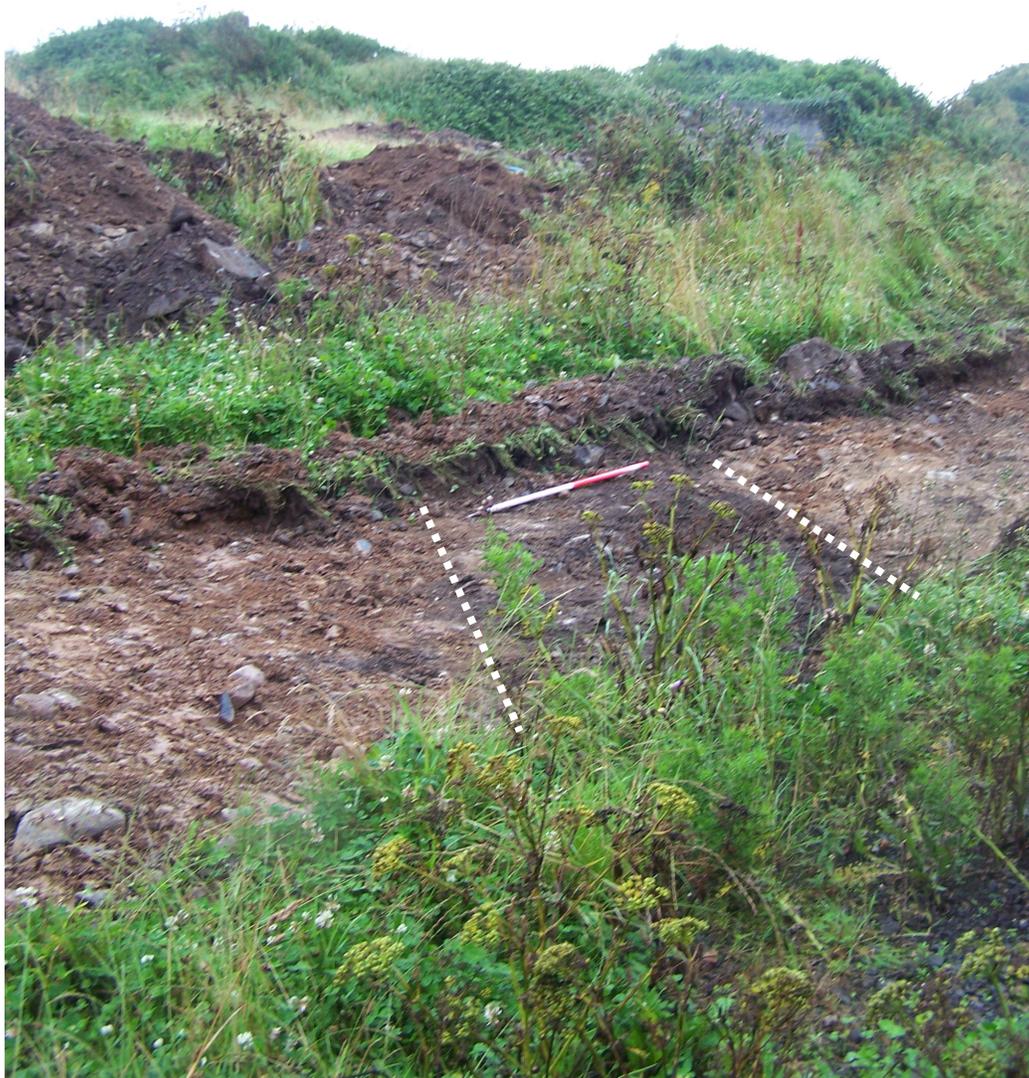
Plate Three: Trench One showing ditch feature (Context No. 103), looking north-east towards the rath (DOW 012:005).

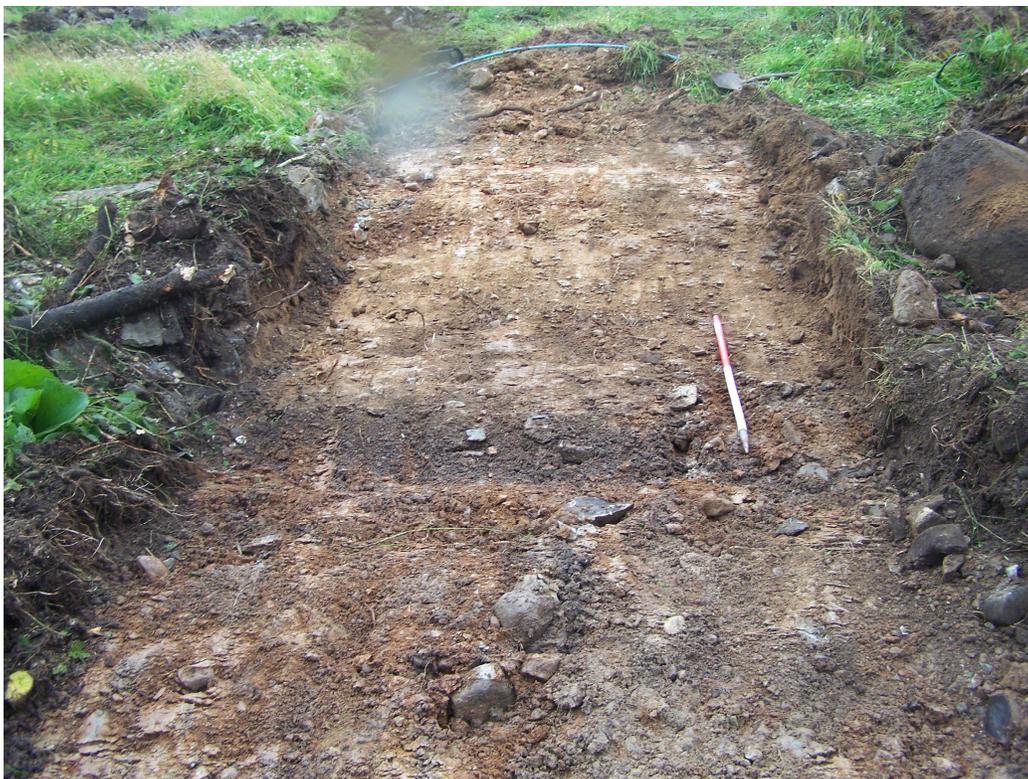
The sod and topsoil layer in Trench Two (Context No. 201) consisted of a loose to slightly compact, light to mid brown, sandy loam. The layer contained infrequent sub-rounded stone inclusions (average size: 30 x 20 x 10mm). This layer was on average 0.08m thick.

The sod and topsoil layer in Trench Two (Context No. 201) directly overlay the natural subsoil (Context No. 202). It is assumed that the shallow nature of this deposit (Context No. 201) represents the same truncation encountered in Trench One. A continuation of the ditch encountered in Trench One (Context No. 104) was observed in Trench Two. However, in Trench Two the main fill of the feature (Context No. 204) was overlain by a thin spread of redeposited natural subsoil (Context No. 203). As the feature was investigated in Trench One and found to be of archaeological potential, it was not investigated in Trench Two at this stage.

Plate Four: Trench Two following excavation to the surface of the natural subsoil (Context No. 202) showing the continuation of the ditch feature encountered in Trench One, looking east.

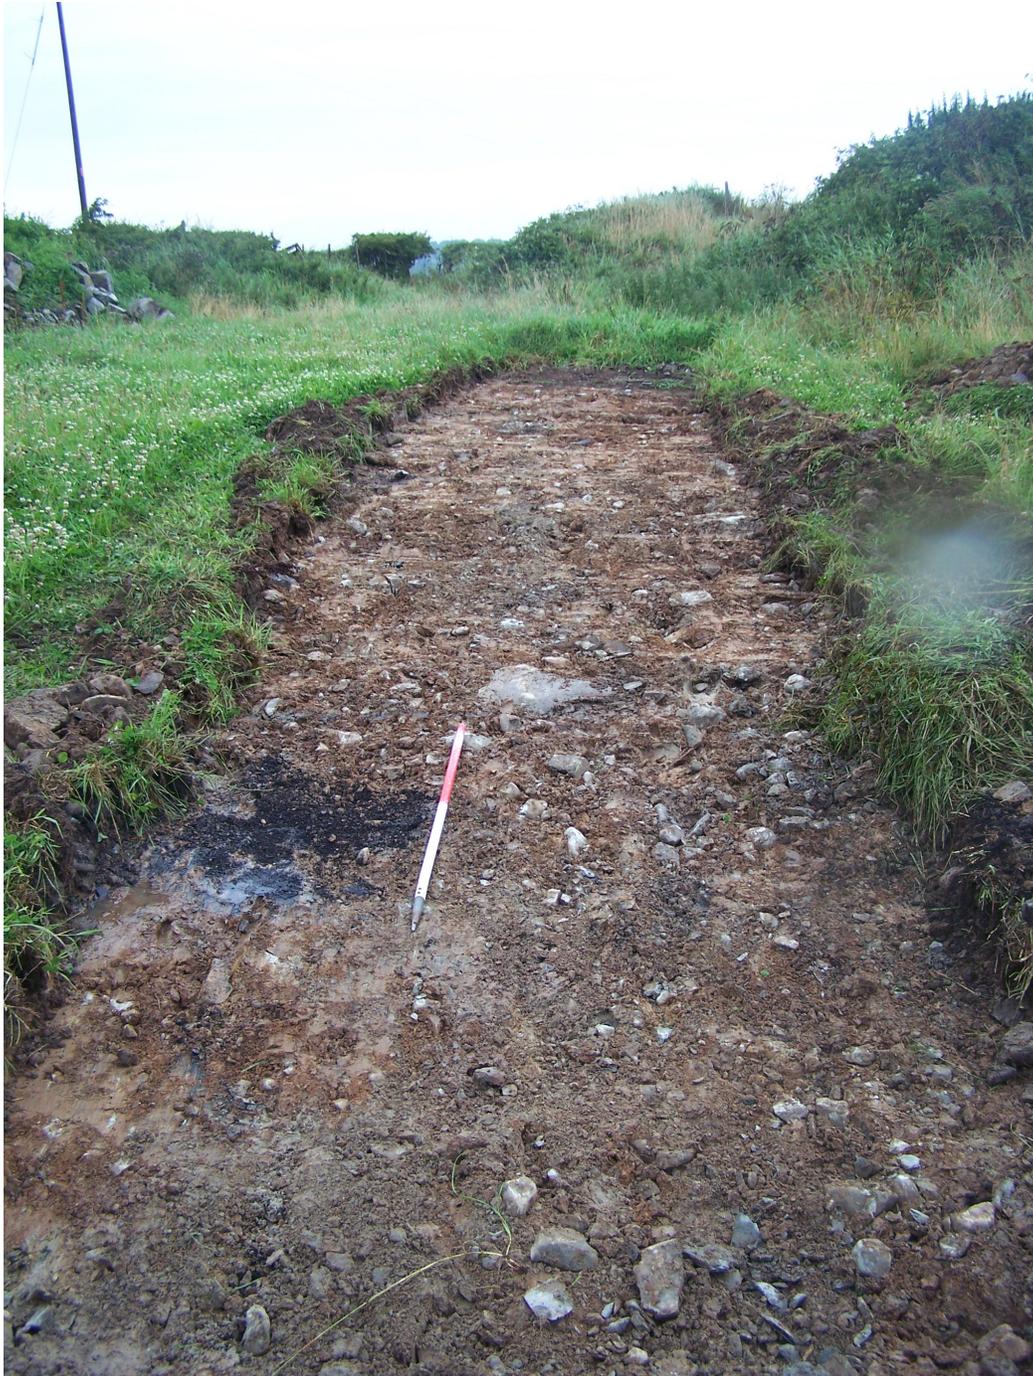
Trench Three was positioned approximately 15m north of Trench Two and was aligned roughly north-south. The trench measured roughly 18m in length by 2m in width and was excavated to the surface of the natural subsoil (Context No. 303) which was encountered at a depth of around 0.3m.

The sod and topsoil layer in Trench Three (Context No. 301) consisted of a loose to slightly compact, light to mid brown, sandy loam. The layer contained infrequent sub-rounded stone inclusions (average size: 30 x 20 x 10mm). This layer was on average 0.25m thick.

Below the sod and topsoil layer (Context No. 301) was a thin cultivation soil of compact, mid brown, sandy loam (Context No. 302) that contained frequent sub-rounded stone inclusions (average size: 30 x 20 x 10mm) and which was 0.05m thick. The cultivation soil (Context No. 302) directly overlay the natural subsoil (Context No. 303).

Plate Five: Trench Three following excavation to the surface of the natural subsoil (Context No. 303), looking north with the rath in the background.

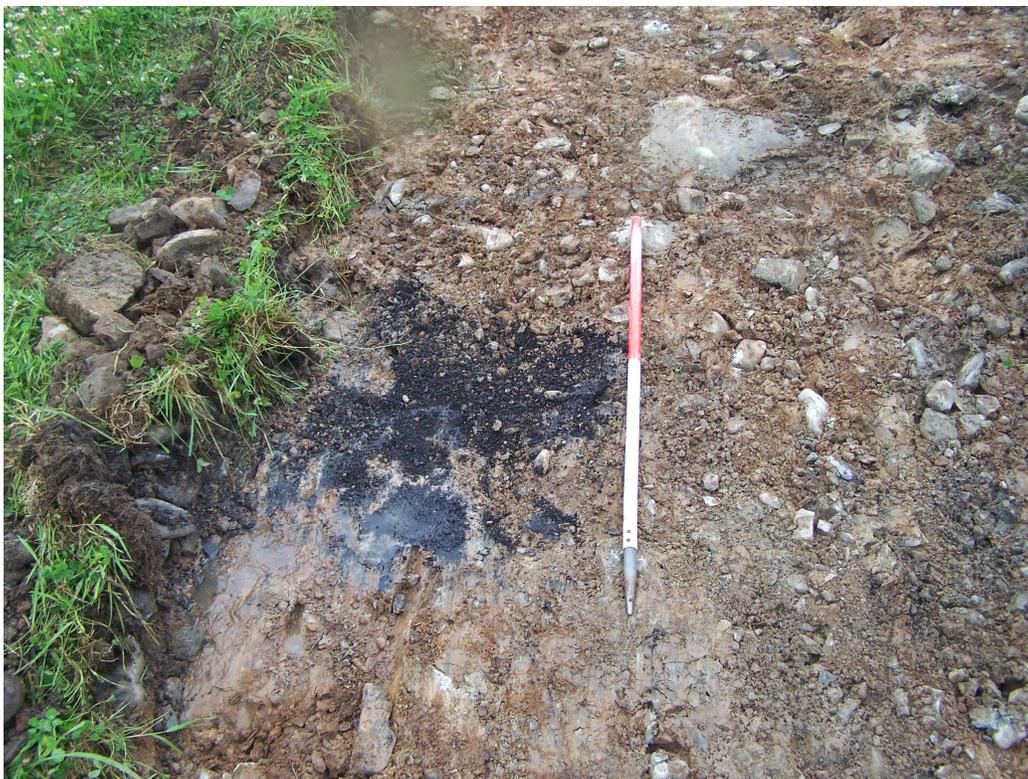
Following the removal of the thin cultivation soil (Context No. 302) some features of archaeological potential were observed. An isolated patch of charcoal (Context No. 304) was observed approximately 4m from the southern edge of the trench. The northern edge of the trench was positioned approximately 1.5m from the base of the bank of the rath (DOW 012:005). A curvilinear ditch (Context No. 305) was observed in this area that appeared to be respecting the arc of the bank of the rath. Although the feature (Context No. 305) was not archaeologically

Plate Six: Charcoal spread (Context No. 304) in Trench Three, looking north.

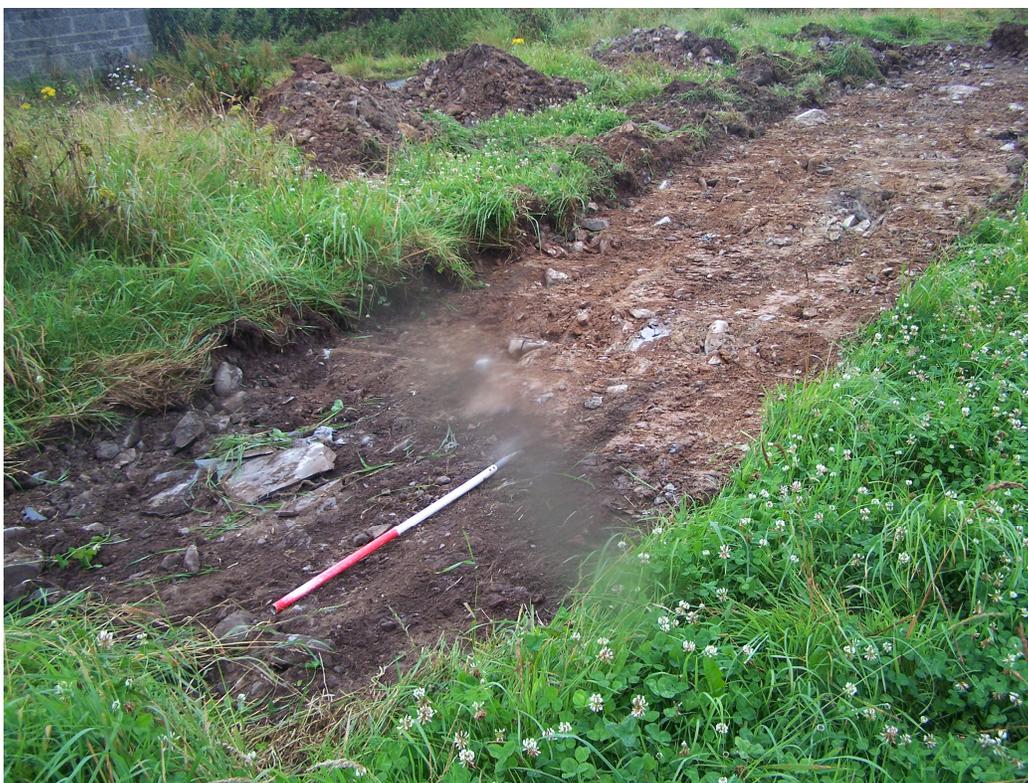
investigated, it is assumed that it represents the silted up/filled in ditch of the rath itself.

Plate Seven: Rath ditch (Context No. 305) looking north-east, taken from the bank of the rath.
