Evaluation Report No. 164

**Carrickfergus Castle
Carrickfergus
Co. Antrim
License No. AE/08/115**

Cormac McSparron

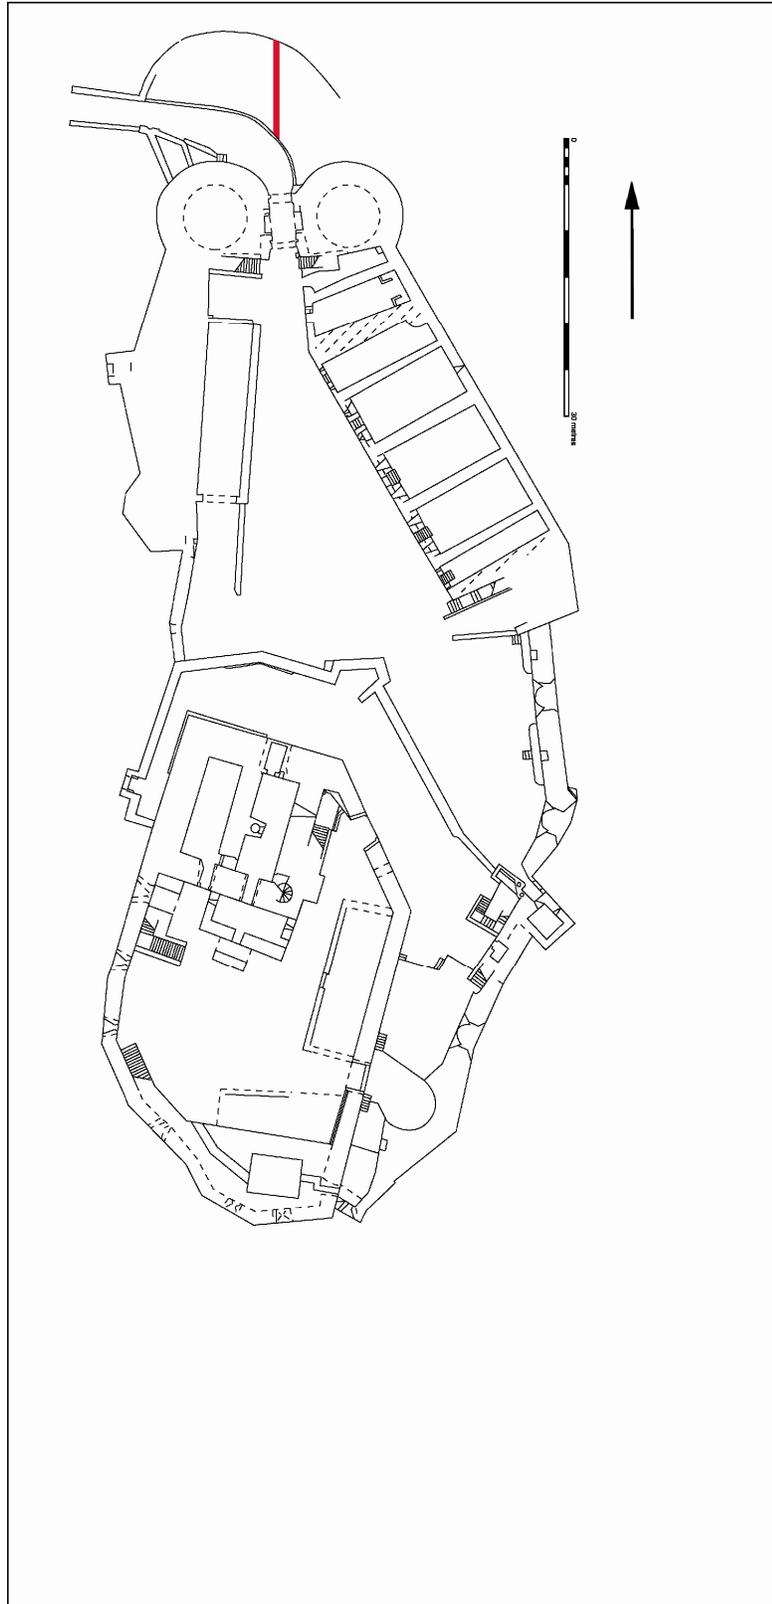
Figure 1: Plan of Carrickfergus Castle showing location (in red) of line of pipe replacement.

The evaluation consisted of the archaeological supervision of: Trench 1 a manually excavated stretch of trench 3m long, by 0.5m wide and 0.7m deep, running north from the edge of the entrance footpath at the front of the gatehouse, down a grassy slope towards the Marine Highway; and Trench 2 a mechanically excavated trench 3m long by 1.15m wide and 1.5m deep, in line with the first stretch of trench, at the bottom of the grassy slope (figure 1 & 2).

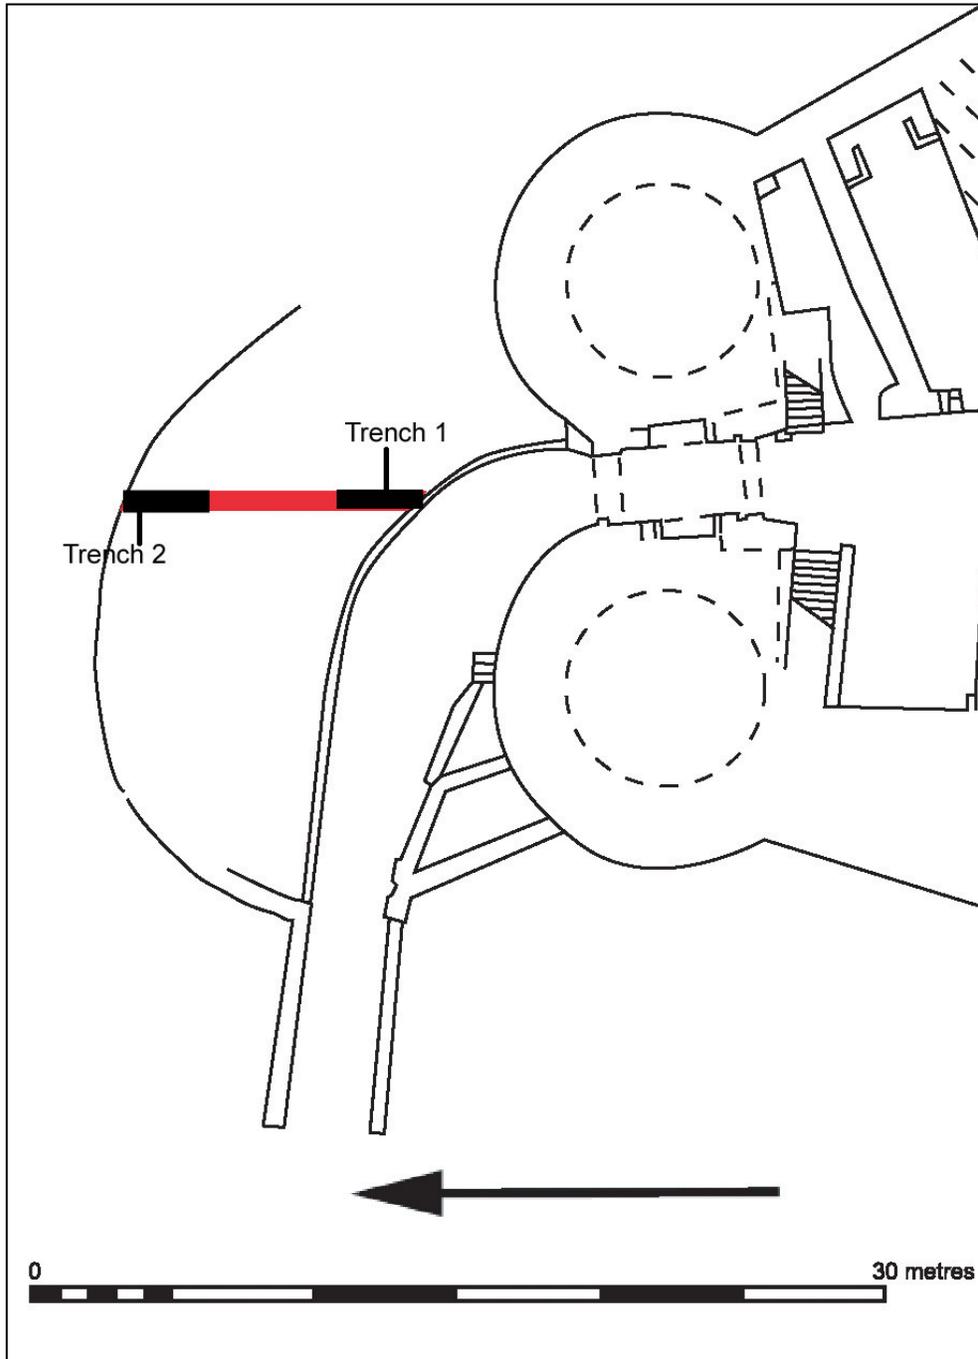
Figure 2: Detailed location map showing Trench 1 and Trench 2.

Trench 1 This trench was 3m long by 0.5m wide and 0.7m deep. It ran north from the edge of the entrance footpath at the castle, down a steep grassy slope. (figure 2 and plate 1). The sod in this trench was above a clay / loam topsoil layer, which was itself situated on a made-up layer of building rubble, modern rubbish and warning tape for electrical service cables. The pre-existing pipe, dating from the 1960's, was found at the base of this trench. No archaeological artefacts or strata were uncovered during the excavation of this trench. At no stage was subsoil uncovered during the excavation.

Trench 2 Due to engineering difficulties it was necessary to excavate a larger trench at the base of the slope (figure 2). This trench was 3m long, 1.15m wide and 1.5m deep. Its south end was situated 4.5m north of Trench 1, which it was in line with. The excavation of this trench cut through a number of modern rubble and earth fills (C. 1, 2, 3 and 4) and a modern, concrete block built, manhole (C.6) (figure 3, plate 2 & 4). In addition however an older stone built wall was revealed in section (C. 5) (figure 3, plate 2, 3, 4 & 5). It was constructed from dressed basalt blocks bonded with mortar. Although the wall had clearly been buried for several decades at least the mortar between the basalt blocks was intact and in good condition, possibly indicative of the wall having been re-pointed not long before its burial and modern sand and cement mortar having been utilized. Excavation of this trench was not deep enough to uncover the base of this wall fragment and only relatively modern strata were disturbed making it impossible to judge, from stratigraphy alone, the antiquity of this masonry.

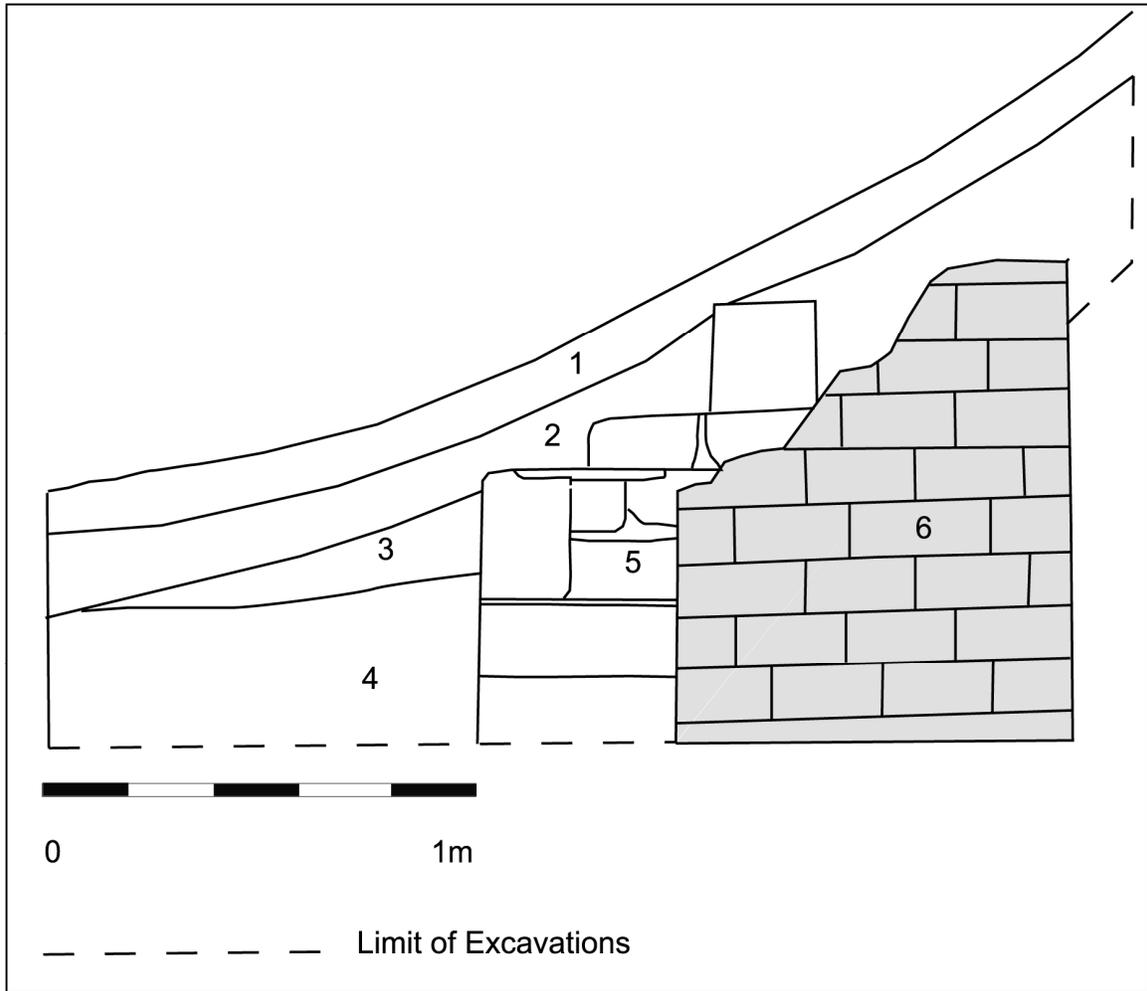
Figure 3: Section drawing of east face of Trench 2, showing modern concrete block manhole wall (6), basalt block wall (5) and modern rubble and soil layers (1),(2),(3) and (4).

The manually excavated Trench 1 revealed nothing of archaeological interest. The mechanically excavated Trench 2 although it did not actually remove any archaeological strata, structures or artefacts did reveal a very well constructed dressed basalt block wall. This is an unexpected discovery. The area had apparently been reduced to bedrock by Dudley Waterman during his excavations at the front of the gatehouse in 1950 (Waterman 1952). It is possible however that Waterman would not have reported the finding of relatively modern masonry. A photograph from the NIEA archive suggests a possible explanation. Plate 4 and 5 show Carrickfergus castle in the early 20th century. If the height of the serviceman in the bottom left of the photo is taken to be approximately 1.8m, the masonry pier at the base of the staircase can be estimated as being 18m due north of the door of the castle, approximately the same position as the masonry uncovered in October 2008. This does not of course prove that the wall is not older, nevertheless the regular cut stone masonry is different in character from the medieval

walls and revetments uncovered by Dudley Waterman and on balance a nineteenth or early twentieth century origin for this wall is perhaps most likely.

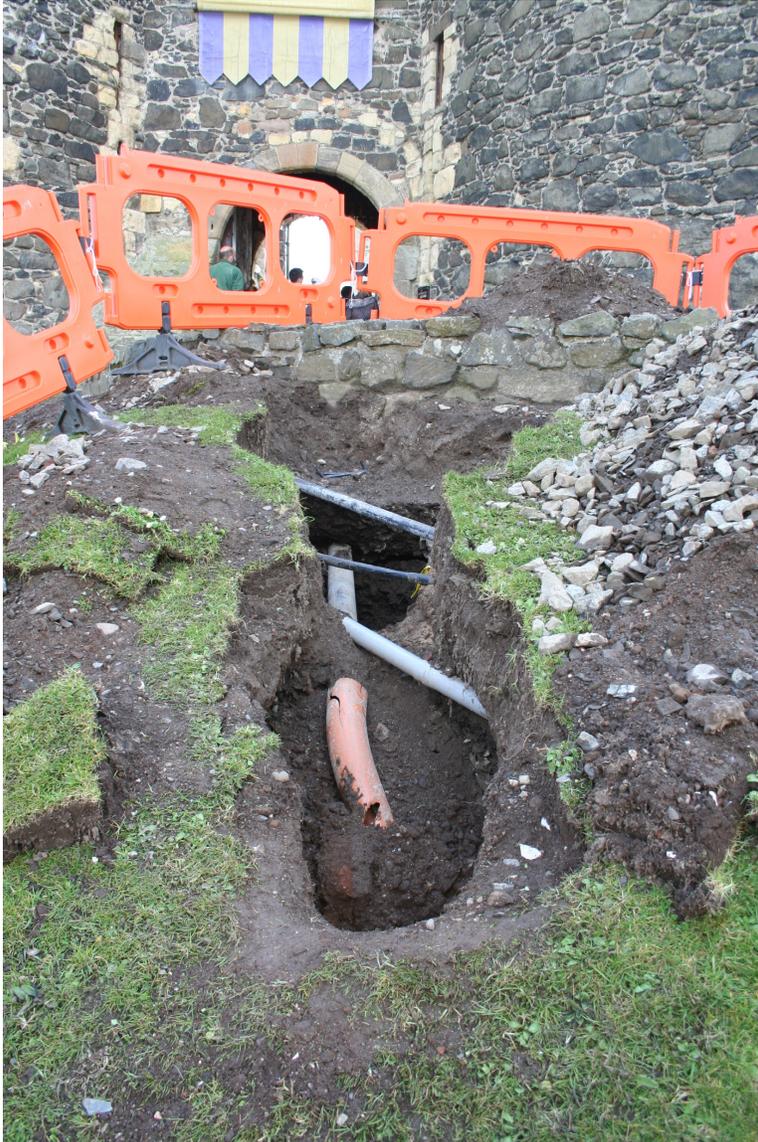
Plate 1: Trench 1 from the north showing existing services.

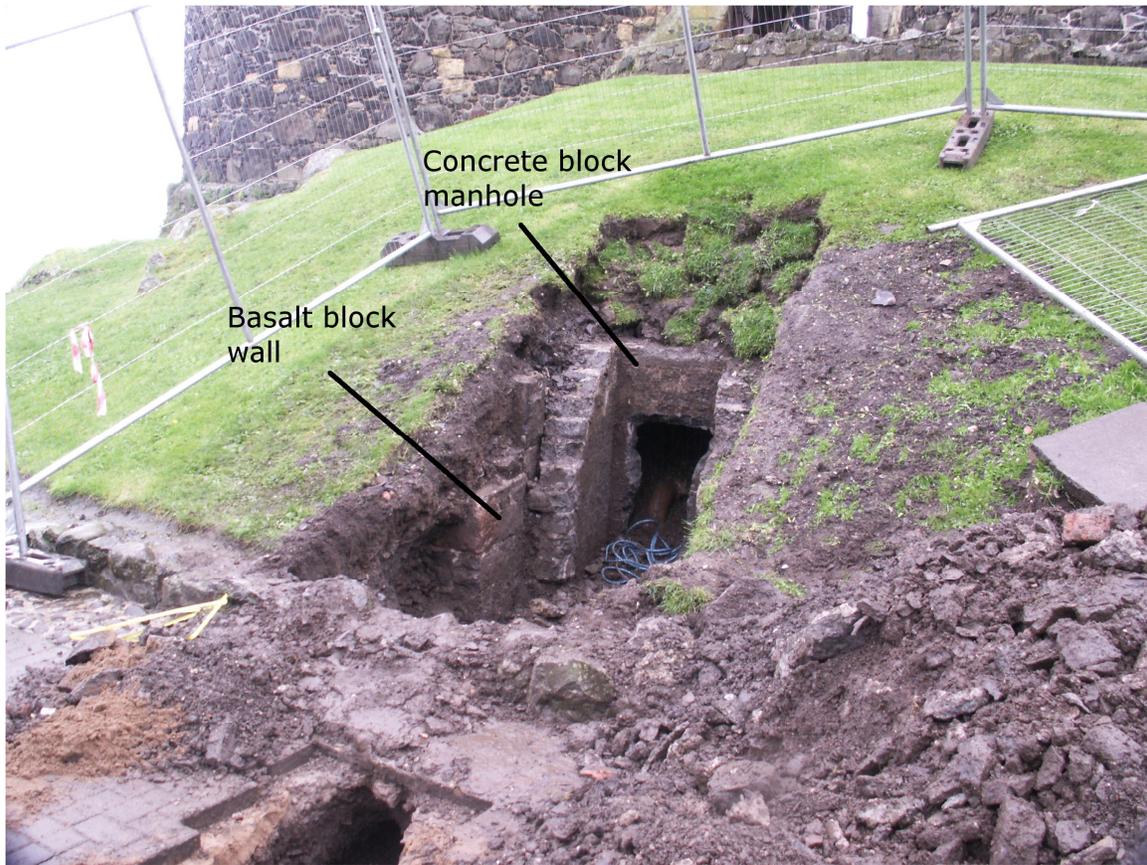
Plate 2: Trench 2 from the northwest showing concrete block manhole wall (6) and basalt block wall (5).

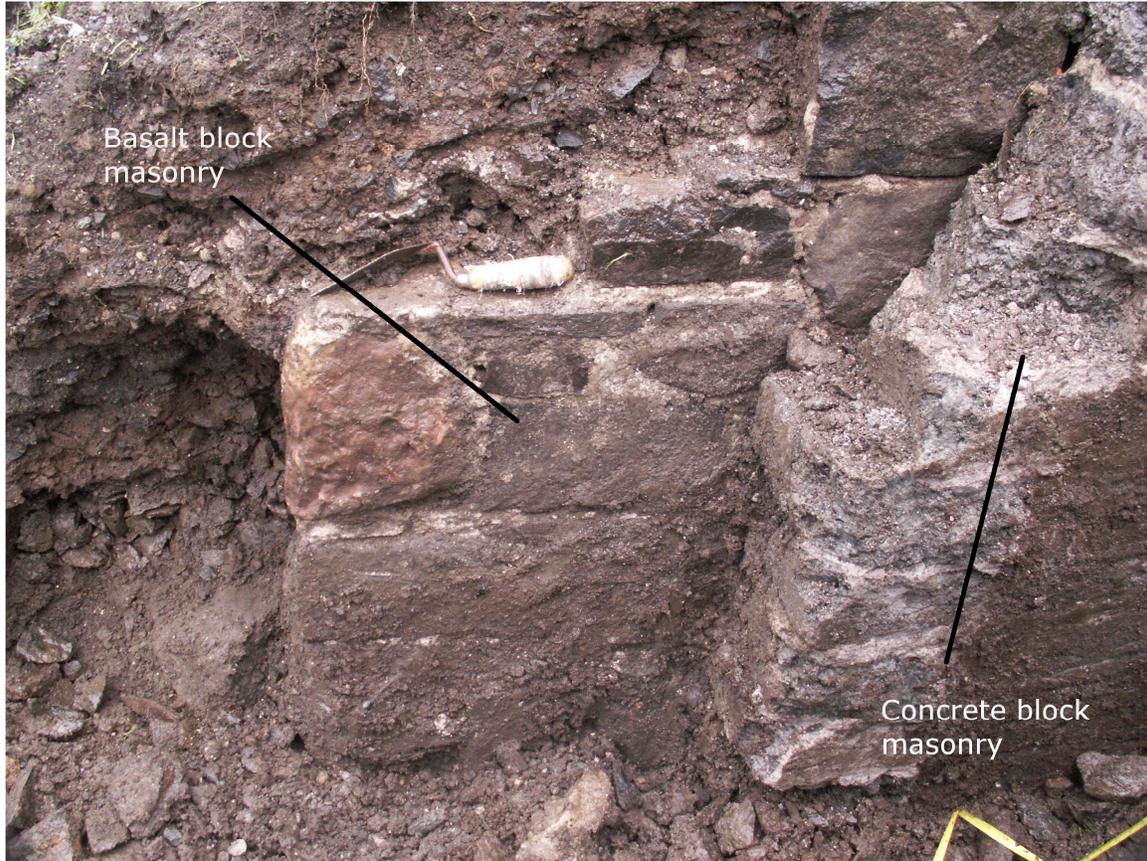
Plate 3: Photo of section of Trench 2 showing concrete block masonry (6) and basalt block masonry (5).

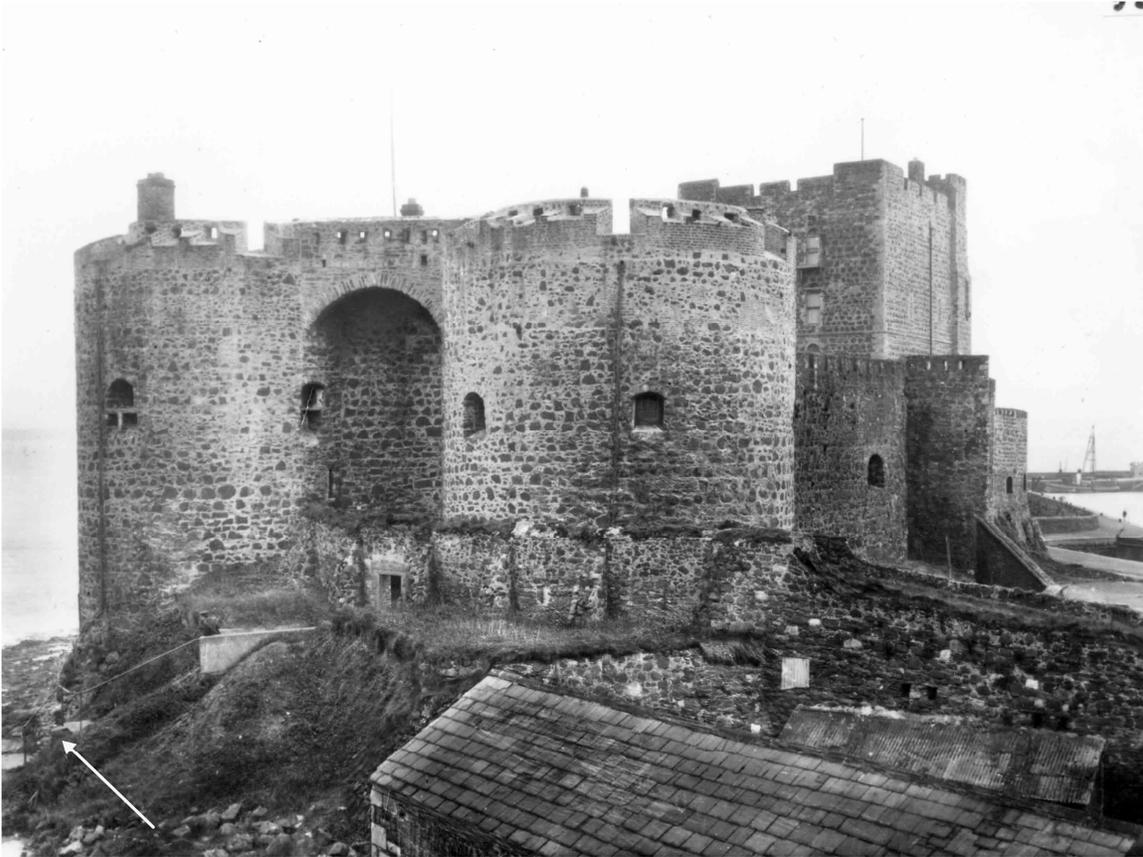
Plate 4: Early 20th century photograph of Carrickfergus Castle showing possible masonry pier (arrowed) at the base of a staircase with metal handrail.

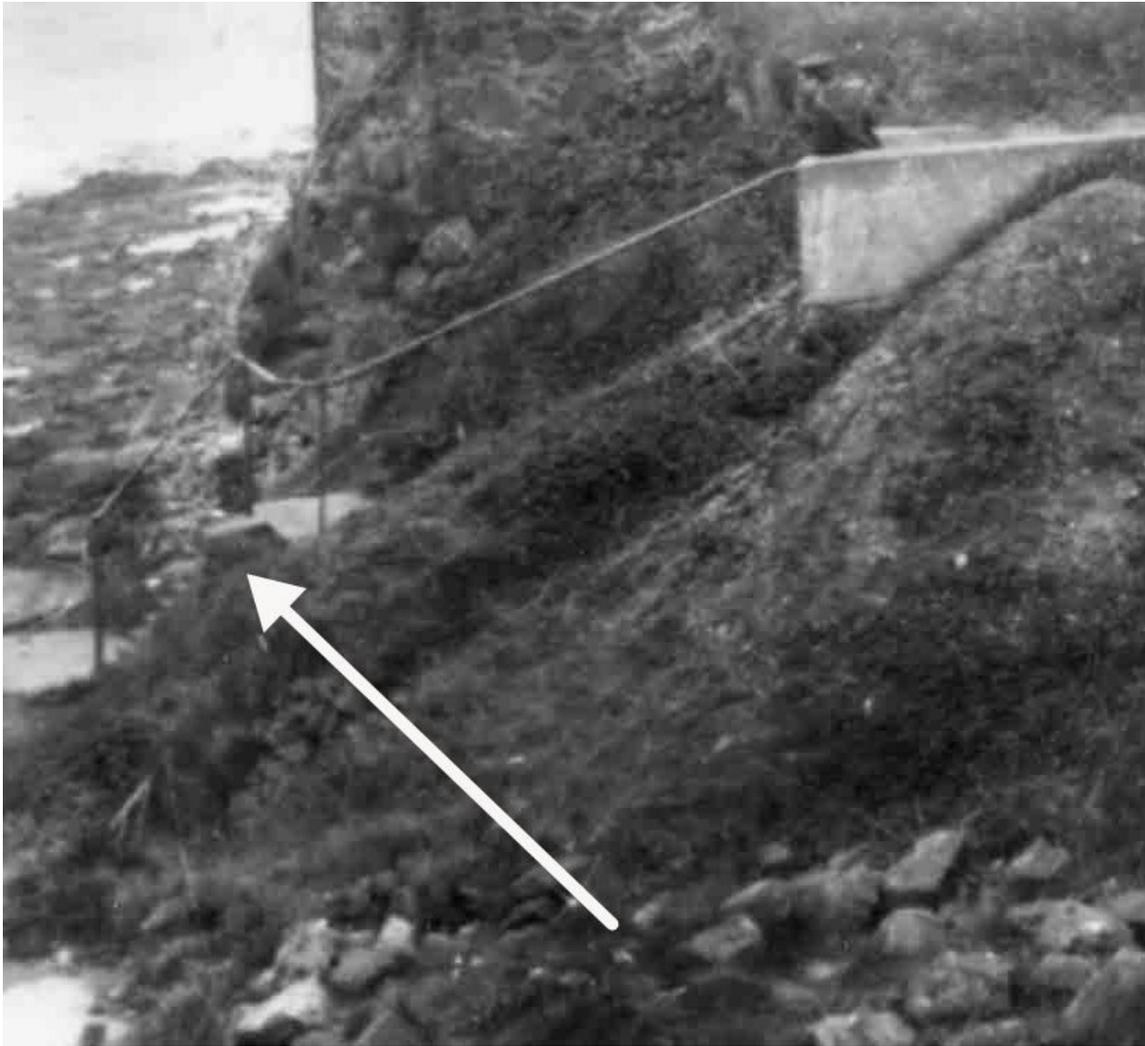
Plate 5: Detail of Plate 5 showing possible masonry pier (arrowed).
