CAF Data Structure Report No. 66
Investigations at Tully Castle, Co. Fermanagh
AE/09/82

Investigations at Tully Castle, Co. Fermanagh

CAF DSR 066

Licence No: AE/09/82

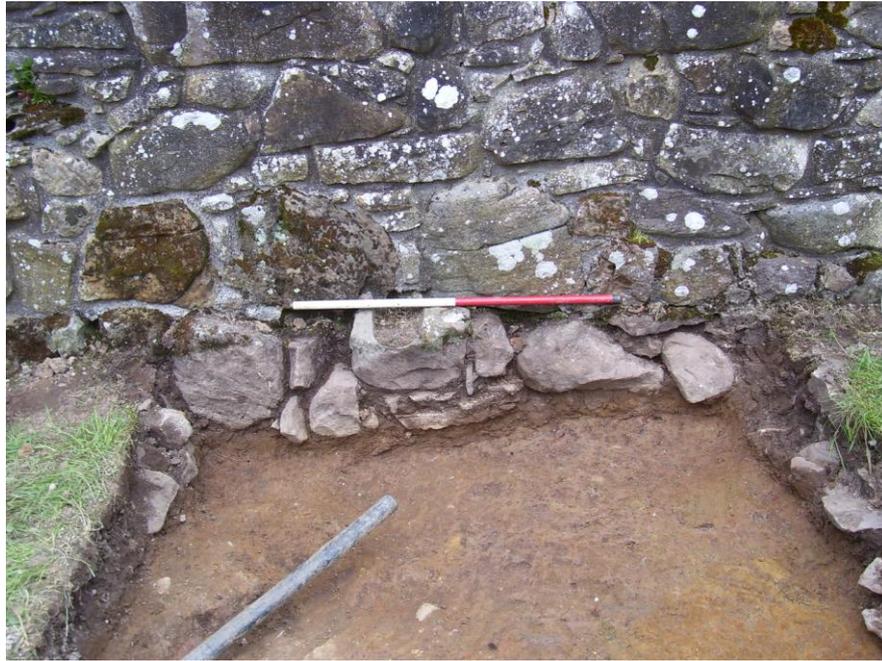
Plate 2: Close-up photograph showing eastern bawn wall foundation (context 106) built directly upon subsoil in Trench 1

- 3.3.4 The base of the bawn wall (context 106) was found at a depth of 0.3m with the protruding stones that were visible prior to the excavation being the only course of foundation stones. The stones measured up to 0.5m in diameter were very roughly hewn at best, in some cases they were simply un-worked boulders. No mortar was visible between the stones although it is presumed that any mortar present would have been 'washed out' over time. The foundation stones protruded out from the bawn wall for up to 0.2m, providing a slightly wider base on top of which the main wall was built. Unlike the foundation, the stones within the bawn wall proper were well-faced, but laid in random rubble courses, although later restoration work had obscured it somewhat.

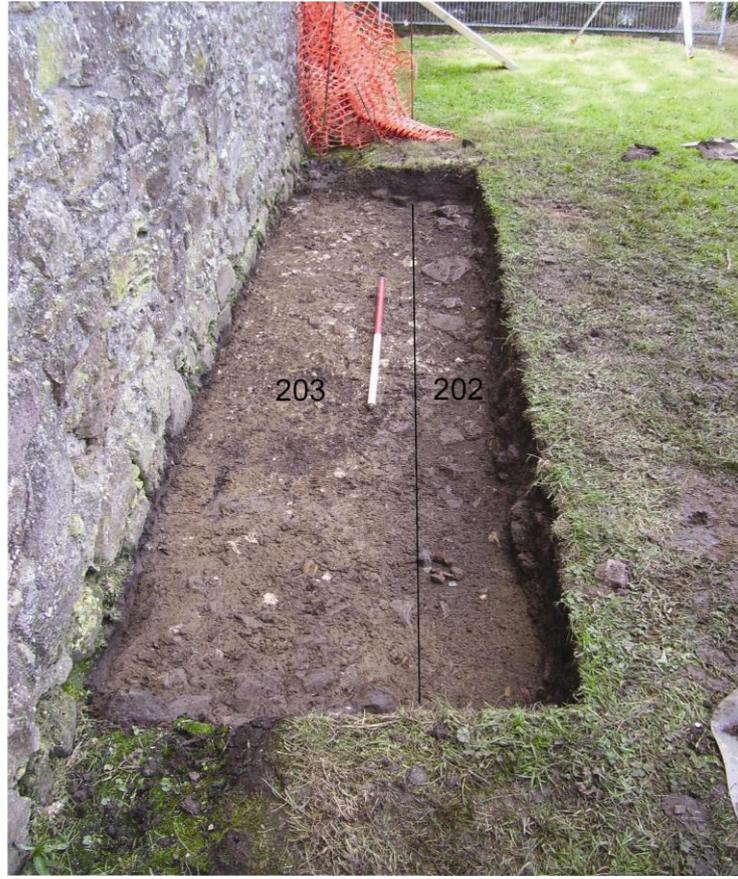
Plate 3: Pre-excitation photograph of Trench 2 showing mortar fragments pressed into surface of relict topsoil (context 203), with unexcavated drain (contexts 202/204) running down northern (right) side of trench

- 4.2 The earliest evidence for activity on the site was the construction of the main castle building. This was dug into a pre-existing topsoil horizon (contexts 107, 203, 304, 407, 508, 604, 708, 805) that was uncovered in Trenches 2 to 8, which were excavated adjacent to the northern wall of the castle in advance of the insertion of the drainage pipe. This horizon, overlying the natural geology, would presumably have been the ground level concurrent with the construction of the castle. The mortar fragments found in Trench 2 pressed into this surface (context 203) were perhaps the result of construction activity.

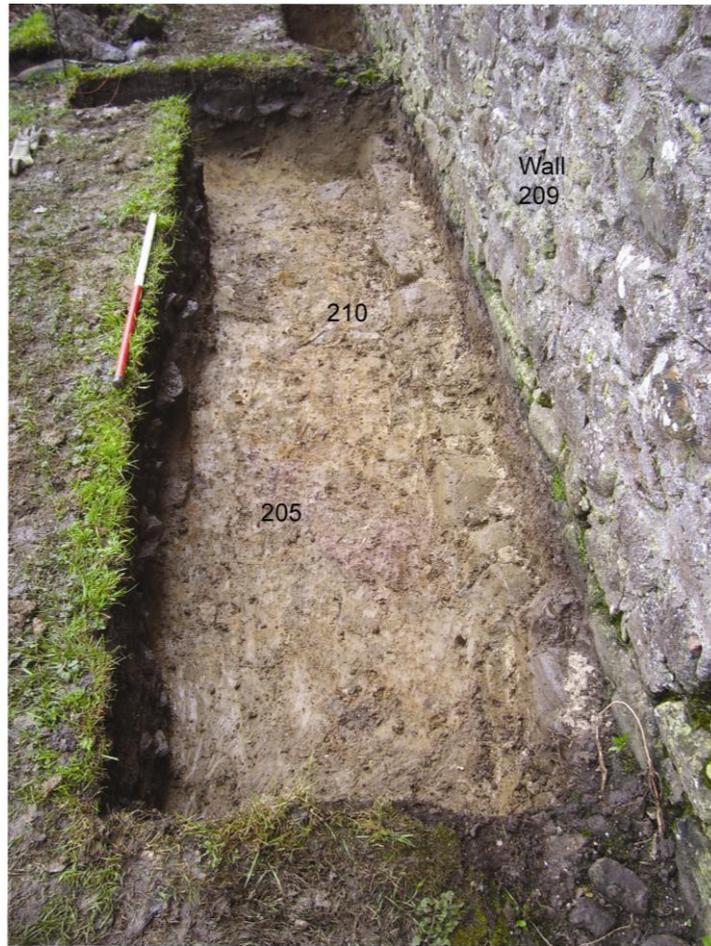
Plate 4: Post-excavation photograph of Trench 2 showing natural subsoil (context 205) and foundation plinth (context 210) projecting from base of northern castle wall (context 209)

- 3.4.1 The foundation cut for the castle wall (context 208) was uncovered at the southern edge of the trench, its outer edge located 0.2m out from the base of the castle wall (context 209). It proved to be impossible to fully excavate this cut due to the nature of the construction of the castle. The foundation cut was excavated to a depth of 0.2m where the foundation of the castle was encountered (context 210). The foundation consisted of a mortared stone plinth found to run the entire length of the trench (Plate 4). It projected out from the base of the castle wall for 0.18m, almost to the edge of the foundation cut. It was not possible to excavate the foundation cut any further below this point due to the presence of the plinth. The foundation plinth was constructed from un-hewn stones and boulders, which formed a level surface on which the northern wall of the castle was then built. The stones of the plinth, none of which appeared to be worked, measured a maximum of 0.35m by 0.30m by 0.25m. The northern castle wall was built directly on this plinth and also consisted of roughly-hewn stones. The stones within the wall measured 0.35m by 0.30m in size and were laid in irregular courses. The upper 0.2m of the foundation cut was filled with a soft and pliable light brown sandy clay (context 207).

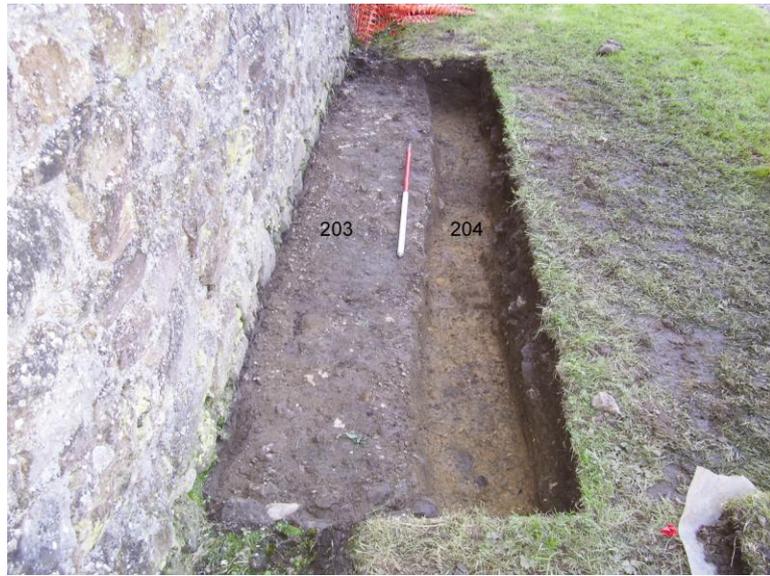
Plate 5: Post-excavation photograph of drain (context 204) in Trench 2

- 3.4.2 The second feature cut into the relict topsoil in Trench 2 (context 203) was a small linear drain (context 204), found at the eastern edge of the trench, with the southern edge 0.6m

to the north of the castle wall. This drain ran from east to west across the trench, parallel to the castle wall, and when first excavated the northern edge was found to lie beyond the limits of the trench. In order to ascertain the full width of the drain a small 0.6m wide projection was excavated at the eastern end of the trench. When excavated, it was revealed that the drain was a maximum of 0.6m wide and 0.2m deep. The edges were found to be steeply sloping to a flattish base that sloped gently from east to west (Plate 5). A single fill was excavated from within the drain (context 202). It consisted of dark grey silty clay with moderate charcoal flecking. A number of window glass fragments (FN 013), some possible glass vessel fragments (FN 014), a single small strip of window lead (FN 009), along with some animal bone (FN 015), some with signs of butchery, a clay pipe stem (FN 010), fragments of corroded iron (FN 011) and a sherd of possible earthenware ridge tile (FN 012) were all recovered from the fill of the drain.

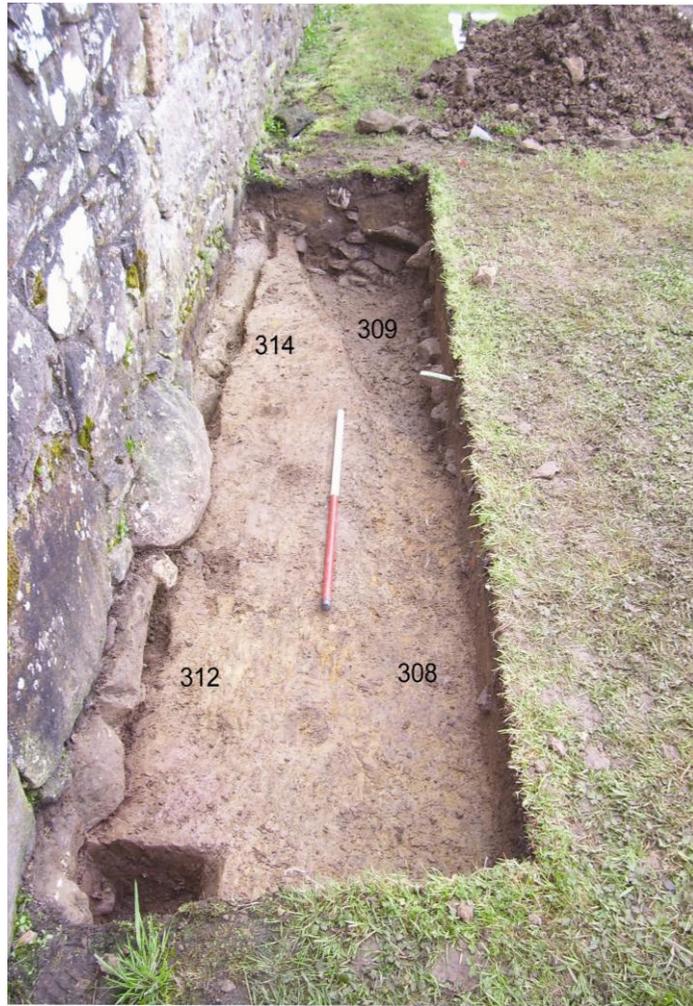
Plate 6: Post-excavation photograph of Trench 3 showing foundation cuts (contexts 312/314), drain (context 308) and soakaway (context 309)

- 3.5.2 The probable earliest feature cutting the relict topsoil was the foundation cut (context 314) for the castle wall. Exposed by excavation it measured at least 0.2m wide and 0.15m deep, although full excavation was not possible. It was filled with a whitish grey clay (context 315). The wall foundation (context 317), a small plinth, projected 0.1m out from the base of the main castle wall (context 306). This plinth consisted of a mixture of well-laid, mortar-bonded stones, along with un-hewn boulders. The main castle wall was built directly upon this. The lowest quoin stone exhibited a series of diagonal tool marks (Plate 7).

- 3.5.3 After the construction of the castle wall, the bawn wall (context 305) was built, clearly butted up against the former. The foundation cut (context 312) for the bawn wall was also excavated, and was found to be 0.15m wide and 0.15m deep. Unlike the castle wall there were no real foundation stones; rather the foundation cut was excavated to subsoil level, upon which the wall was built directly. Infilling the foundation cut was a greyish white sandy clay (context 313).

- 3.5.4 A small drain was also found to be cut into the relict topsoil (context 304) on the northern side of the trench. This drain (context 308) is most likely a continuation of that uncovered in Trench 2 (context 203). It ran beyond the limits of the trench to the east but had been disturbed by the digging of a later soakaway (context 309) at the western end of the trench. The surviving part of the drain was 1.67m long (east/west), 0.47m wide (north/south) and 0.15m deep. The edges sloped fairly steeply to a flattish base which then sloped gradually to the west. The single fill of the drain (context 307) was a soft and friable greyish brown clay silt which contained some window glass (FN 028), a small strip of window leading (FN 026), butchered animal bone (FN 029), some burnt bone (FN 031), fragments of corroded iron (FN 032), a clay pipe stem (FN 027), a fragment of a possible glass bottle stopper (FN 024) and several sherds of brown glazed earthenware pottery (FN 025).

- 3.5.5 Some time after the drain had become fully silted-up, a large soakaway (context 309), was dug through it at the western end of the trench. This soakaway extended beyond both the northern and western edges of the trench. Within the trench it had dimensions of 2.34m (east/west) by 0.8m wide (north/south) and 0.4m deep. The edges of the soakaway were very steep, almost vertical in places and it had a flat base. Originally the soakaway had been filled with stone (context 318), the voids in which later silted up with soft dark brownish grey silt (context 310). The stones within the soakaway were mostly large, rounded, natural boulders- possibly obtained through field clearance- measuring up to 0.3m in diameter. The upper fill of the soakaway (context 311) was a soft and sticky light grey clay with a number of small stones within it.

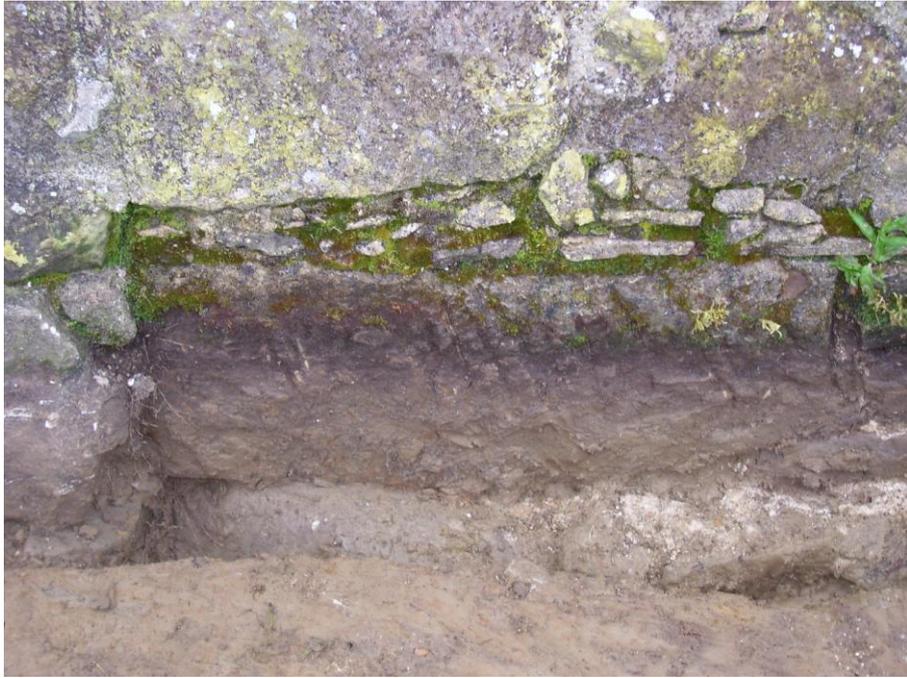
Plate 7: View of quoin stone with diagonal tool marks at base of northern castle wall (context 306) in Trench 3

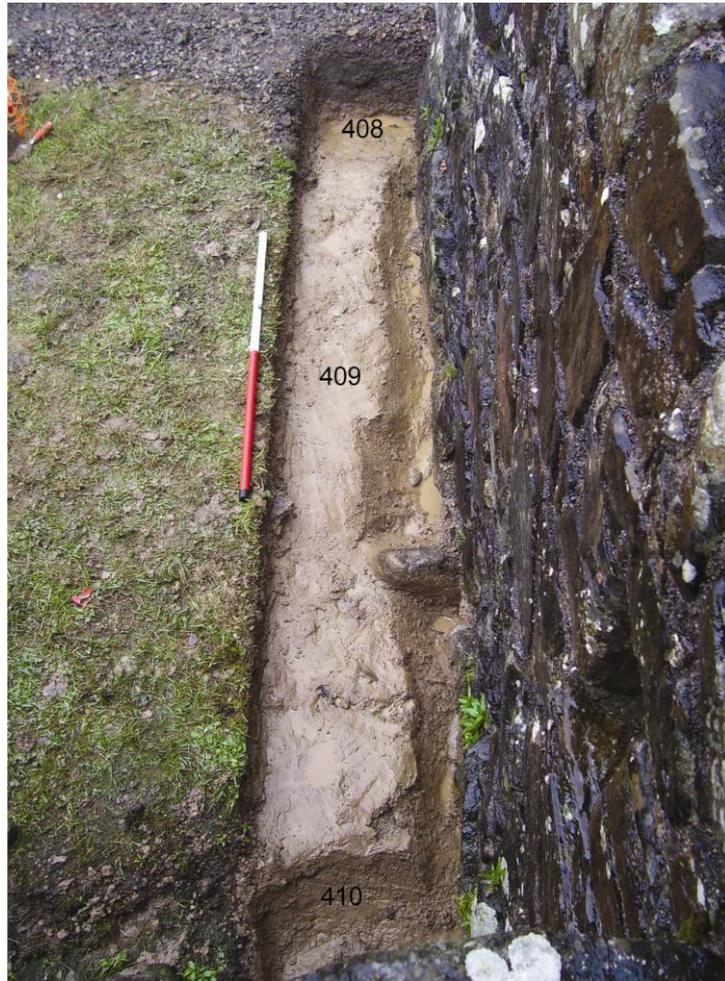
Plate 8: Post-excavation photograph of Trench 4 showing foundation cuts for flanker wall (context 409), bawn wall (context 410) and cut (context 408)

- 3.6.2 The excavated foundation cut for the flanker wall was found to be 0.2m wide by 0.2m deep with a steeply sloping edge. The base of the flanker wall was built directly upon the subsoil, with only the lowermost course of stone within the foundation cut. Infilling the foundation cut was a light brown sandy clay (context 403).

- 3.6.3 The foundation cut for the bawn wall was located at the southern end of the trench. It was not possible to determine the relationship between the bawn and flanker wall due to the later restoration, although it is likely that they were contemporary. The foundation cut for the bawn wall measured 0.25m wide, with a depth of 0.2m, and again the bawn wall was built directly upon the subsoil with almost no foundations. Infilling the foundation cut was a light brown sandy clay (context 406).

- 3.6.4 At the northern end of the trench was a small cut feature (context 408) which had been dug through the foundation cut (context 409) for the flanker and into the subsoil. It was exposed in the trench for 0.55m (north/south), by 0.5m wide (east/west), and continued to both the north and west, with the eastern edge formed by the flanker wall, although it may also have continued to run along the outer face of the northern wall of the flanker. The only exposed edge of the cut, the southern edge, sloped gently to a flat base, some 0.2m in depth. A single fill was excavated from the feature (context 402). This was a mottled grey brown silty clay with some orange clay inclusions.

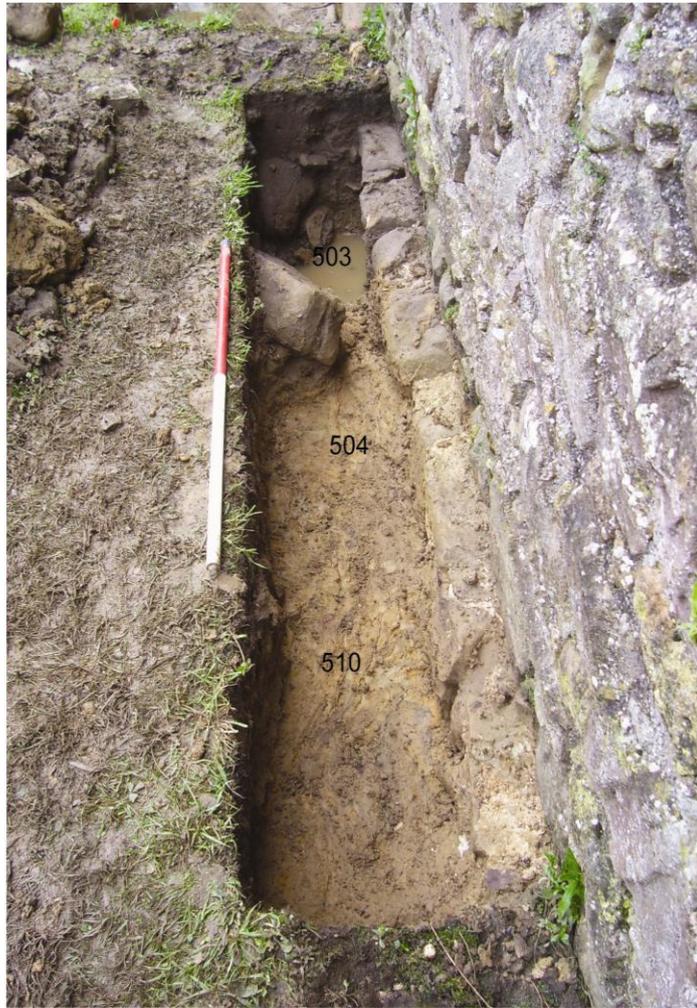
Plate 9: Post-excavation photograph of Trench 5 showing subsoil (context 510), foundation plinth (context 504) and excavated soakaway (context 503)

504) for the castle wall was uncovered. This foundation plinth comprised of well set stone, mortared together to form a level base for the castle wall. Above this plinth the foundation cut was filled with a light brown sandy clay (context 512).

- 3.7.4 At the eastern end of the trench a continuation of the soakaway found in Trench 3 was uncovered (context 309). In Trench 5 this soakaway (context 503) had maximum exposed dimensions of 0.75m (east/west) by 0.4m (north/south), was 0.45m in depth, and continued beyond the trench to the north and east. The southern edge of the soakaway was vertical, formed where it had been dug against the face of the foundation plinth (context 504). The western edge was steeply sloped, being almost vertical, while the base was flat. On the base of the soakaway was a 0.14m thick layer of grey clay silt (context 506). Above this was the main fill of the soakaway, comprising of field-cleared stones (context 507) intermingled with a dark brown sandy clay (context 502). The main fill also contained several sherds of black-glazed earthenware pottery and white ceramic (FN 033), two sherds of green bottle glass (FN 034) and a fragment of red brick (FN035). Overlying the uppermost fill of the soakaway was a thin lens of yellow clay (context 505), probably re-deposited subsoil.

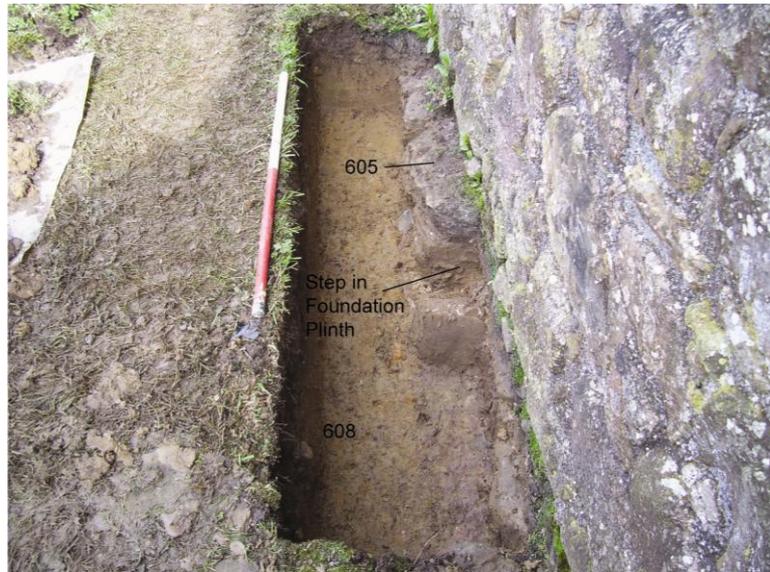
Plate 10: Post-excavation photograph of Trench 6 showing subsoil (context 608) and stepped foundation plinth (context 605)

this was constructed from hewn, mortar-bonded stones lain in random courses. The stones within the wall measured up to 0.4m by 0.3m. Infilling the foundation cut was a light brown sandy clay (context 607).

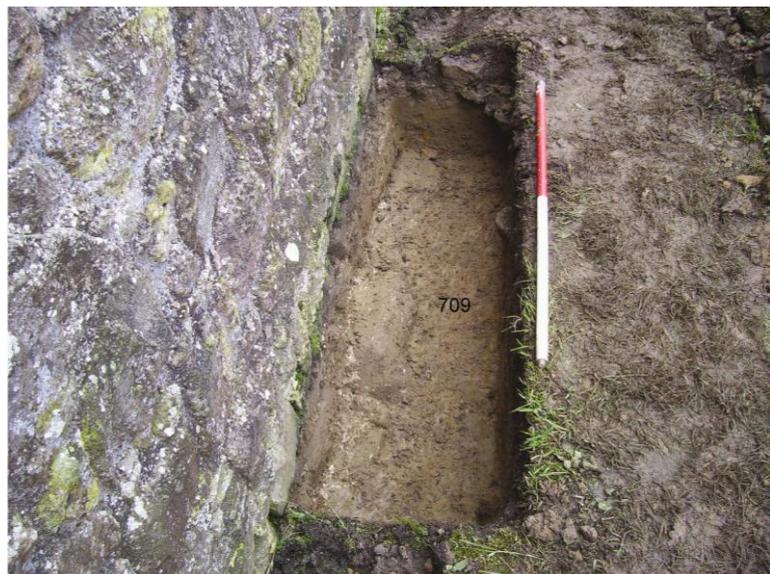
Plate 11: Post-excavation photograph of Trench 7 showing subsoil (context 706) and foundation plinth (context 709)

3.9.1 Trench 7 measured 1.5m long (east/west) and 0.5m wide (north/south). It was 0.5m east of Trench 2 and 0.5m west of Trench 6 (Figures 11 and 13). It was excavated to the subsoil (context 706), which was found at a maximum depth of 0.5m (Plate 11). In this trench the subsoil consisted of a compact yellow clay.

3.9.2 Overlying the subsoil was a relict topsoil (context 703), a grey brown silty clay measuring 0.3m in thickness. This layer was cut through by the foundations (context 707) for the castle wall (context 710). The foundation cut was 0.15m out from the face of the castle wall and was excavated to a depth of 0.45m where the top of the foundation plinth (context 709) was uncovered. The plinth was similar to that found in other trenches.

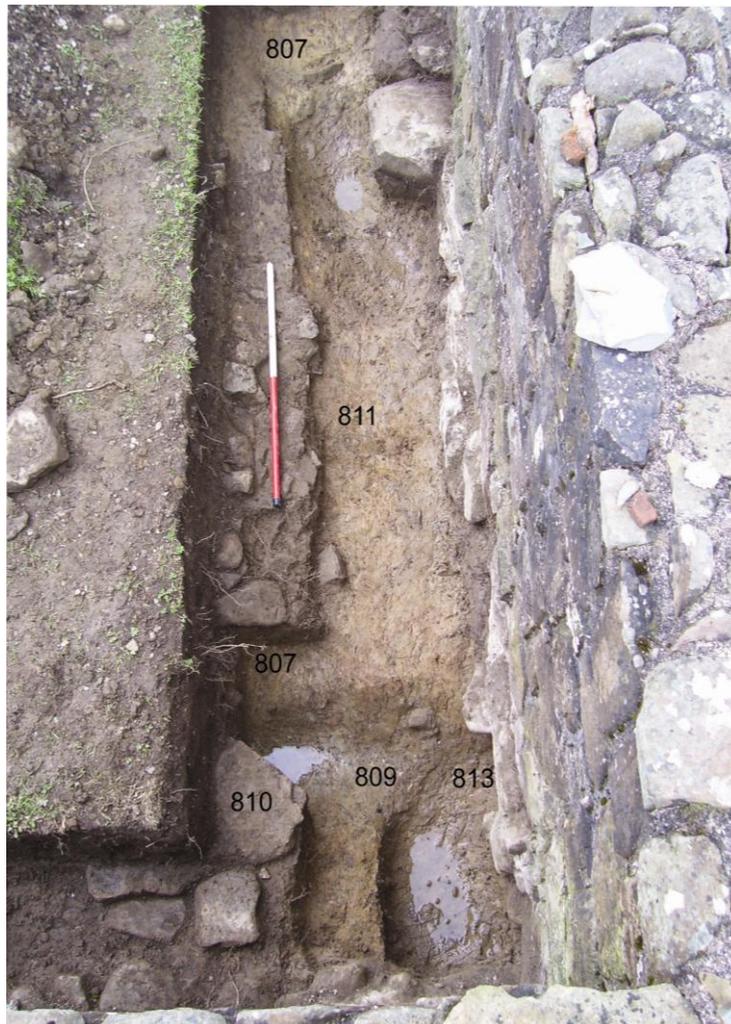
Plate 12: Post-excavation photograph of Trench 8 showing remains of stone surface (contexts 810/811) and drains (contexts 807, 809 and 813)

- 3.10.8 Overlying the infilled drains was a moderately compact dark brown clay loam (context 812) forming a bedding layer for a rough stone surface (contexts 810 and 811). Context 811 comprised of small rounded stones, almost cobble like, forming an uneven surface, while to the west of this was a surface of larger well-set flat stones (context 810). Both these contexts represent a surface lain over the area after both the castle and drains had fallen out of use.
