CAF Data Structure Report No. 67
Phase 1 Excavation at Antrim Bastion Wall
Townparks
Antrim
Co. Antrim
AE/08/204

**Report on Phase 1 Excavations
Antrim Bastion Wall, Townparks, Antrim
County Antrim**

**CAF DSR 067
Licence Number: AE/08/204
SMR No: ANT 050:183
Grid Ref: J 1464 8675**

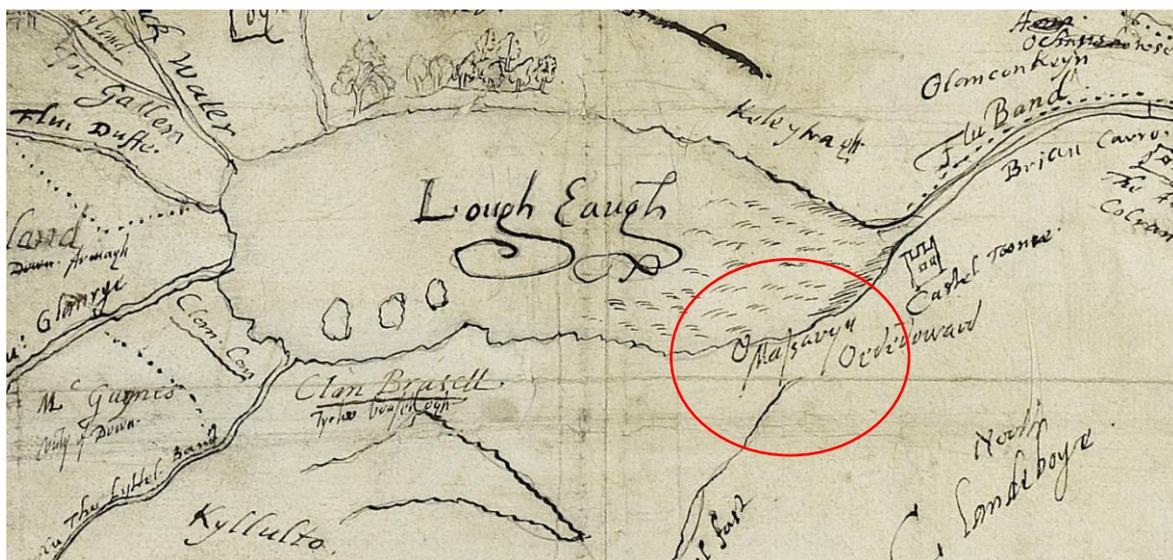
Figure 3: Extract from unknown map dating to 1587 and showing 'Mafsaryn' (circled in red)

2.4.2.1 The earliest map examined dated from c.1580 and shows the province of Ulster with annotations by Burgley (PRONI T1493/6: Swift 1999, 31). No structures are recorded at Antrim, although 'Massreyne' is shown as a heavily wooded area. A second map, dated to 1587 records Lough Neagh as 'Lough Eaugh' and also has 'Mafsaryn' labelled but shows no structures within the area (PRONI T1493/51: Figure 3).

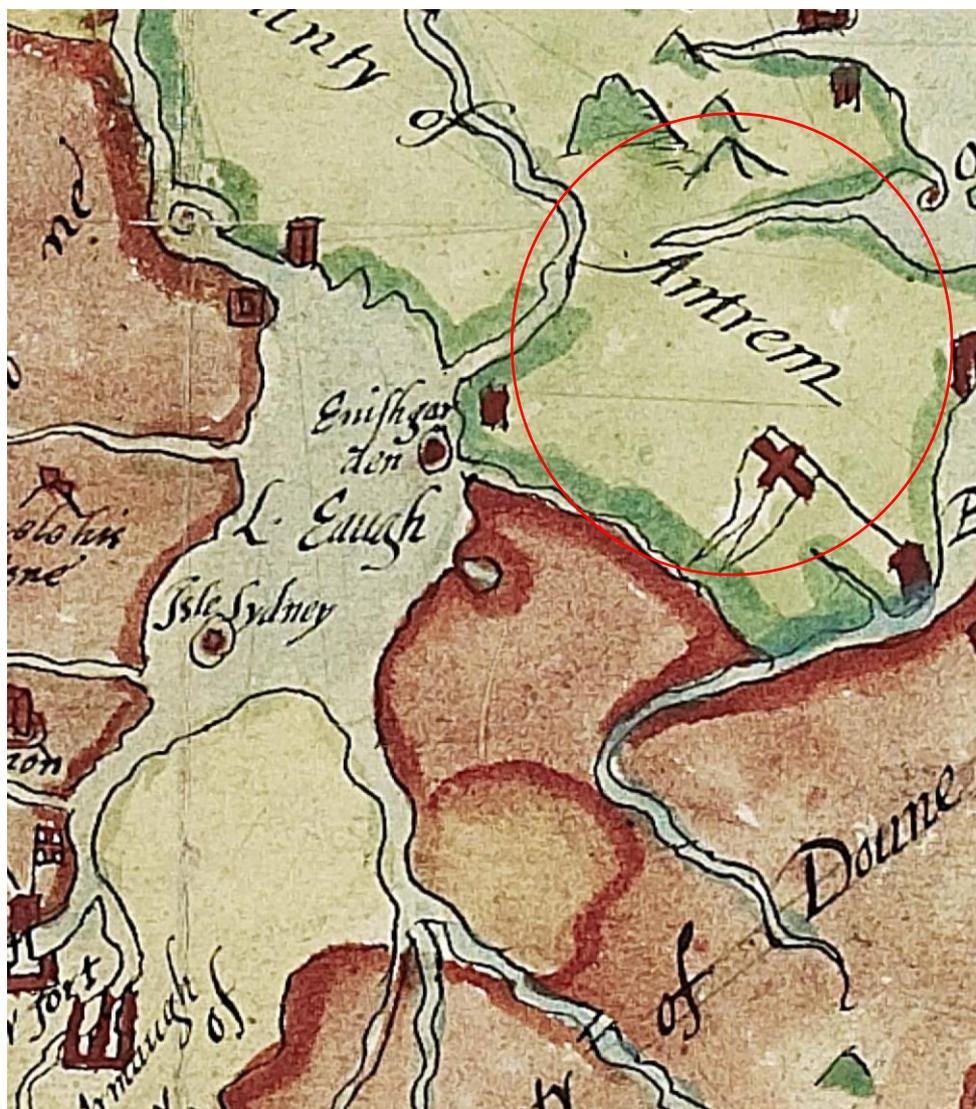
Figure 4: Map by Jobson dating to 1598 and showing 'Antrem' (circled in red)

2.4.2.2 A series of maps dated to 1590 and drawn by Francis Jobson show the area of Lough Neagh, including Antrim, in generally similar details (PRONI T 1668/15, /16, /17). On all of these maps a castle is depicted on the northern bank of the Six Mile Water, between it and the River Main. It is labelled variously as 'Edendoaghcarrick' (T 1668/15), 'Edendufcarick' (T 1668/16) and 'Edendufcarigge' (T 1668/17) and while its location is comparable to that for the late 16th-Century fort and Antrim Castle, it is actually Shane's Castle (ANT 049:029). The location of the friary at Massereene is recorded on two of the maps, although buildings are only shown on one map (T1668:17). On this map the friary is sited on the northern bank of the Six Mile Water, to the east of 'Edendufcarigge'. It is simply labelled as '8' with the key to the side of the map denoting this as 'M:Mafarina'. On the other map (T1668:15) buildings are recorded at Massereene on the southern bank of the Six Mile Water, while on the northern shore, west of 'Edendoaghcarrick' the remains of Steeple are also shown. At Massereene, also on this map, two unroofed buildings are shown, one of them labelled as 'M:Mafarina', the second, further to the west may also have the same label but it is unclear. The remains of the Early Christian monastic foundation at Steeple is shown as a single, unroofed structure labelled as 'T:Antrym'. A further map by Jobson from 1598 (Figure 4), a map of Ulster, shows Lough Neagh with various fortifications around its shoreline. Close to Antrim, there is a structure recorded to the north of a river, presumably the Six Mile Water. Although indistinct it appears to be labelled as 'Enifhgarden', and in common with the

previous maps most likely represents Shane's Castle. No further structures are recorded with the vicinity.

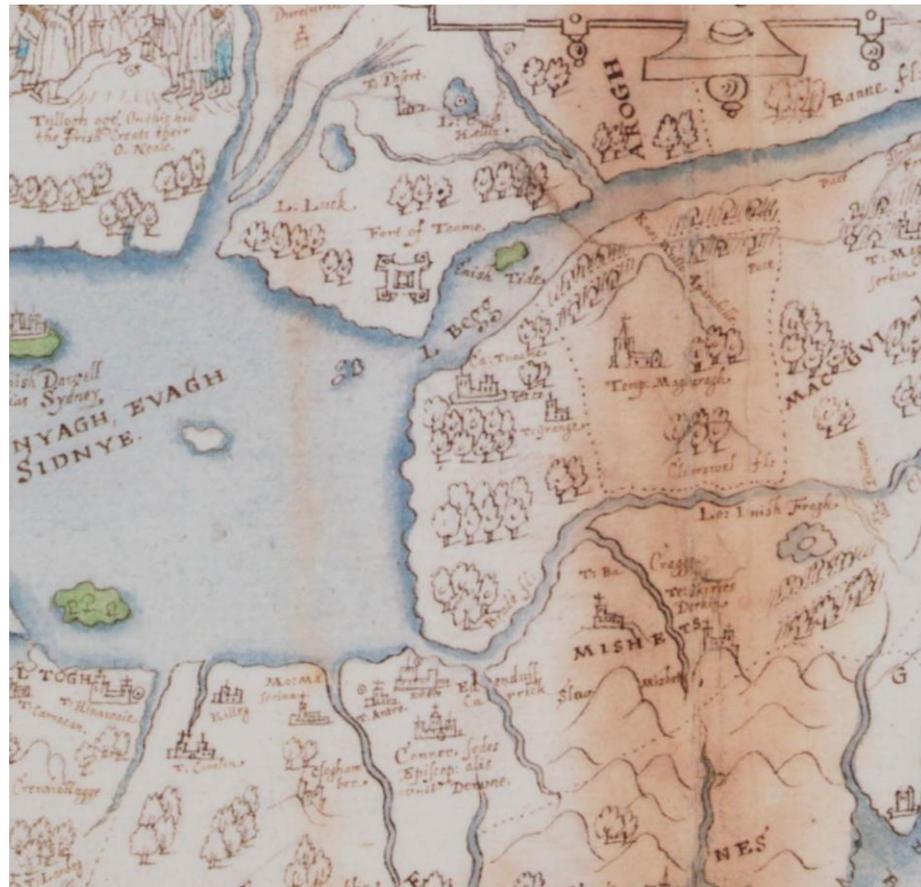
Figure 5: Bartlett map dating to 1601 and showing various features in the vicinity of Antrim

2.4.3.2 A map of southeast Ulster from 1601 by Bartlett (Figure 5) records structures at Antrim but not the fort, one on either side of the Six Mile Water. To the south of the river, labelled as 'Mo:Maserina' (Massereene Friary?) is structure shown as a single large building with a tower at the southern end surmounted by a cross, surrounded by a possible enclosure. To the north of the river is T:Antrim (?) (Temple Antrim/Steeple) shown as a towered structure also with a cross. To the west of this is a small circular feature that may be the Anglo-Norman motte but is unclear. Further north is Shane's Castle, labelled as 'Edenduffcarrick'.

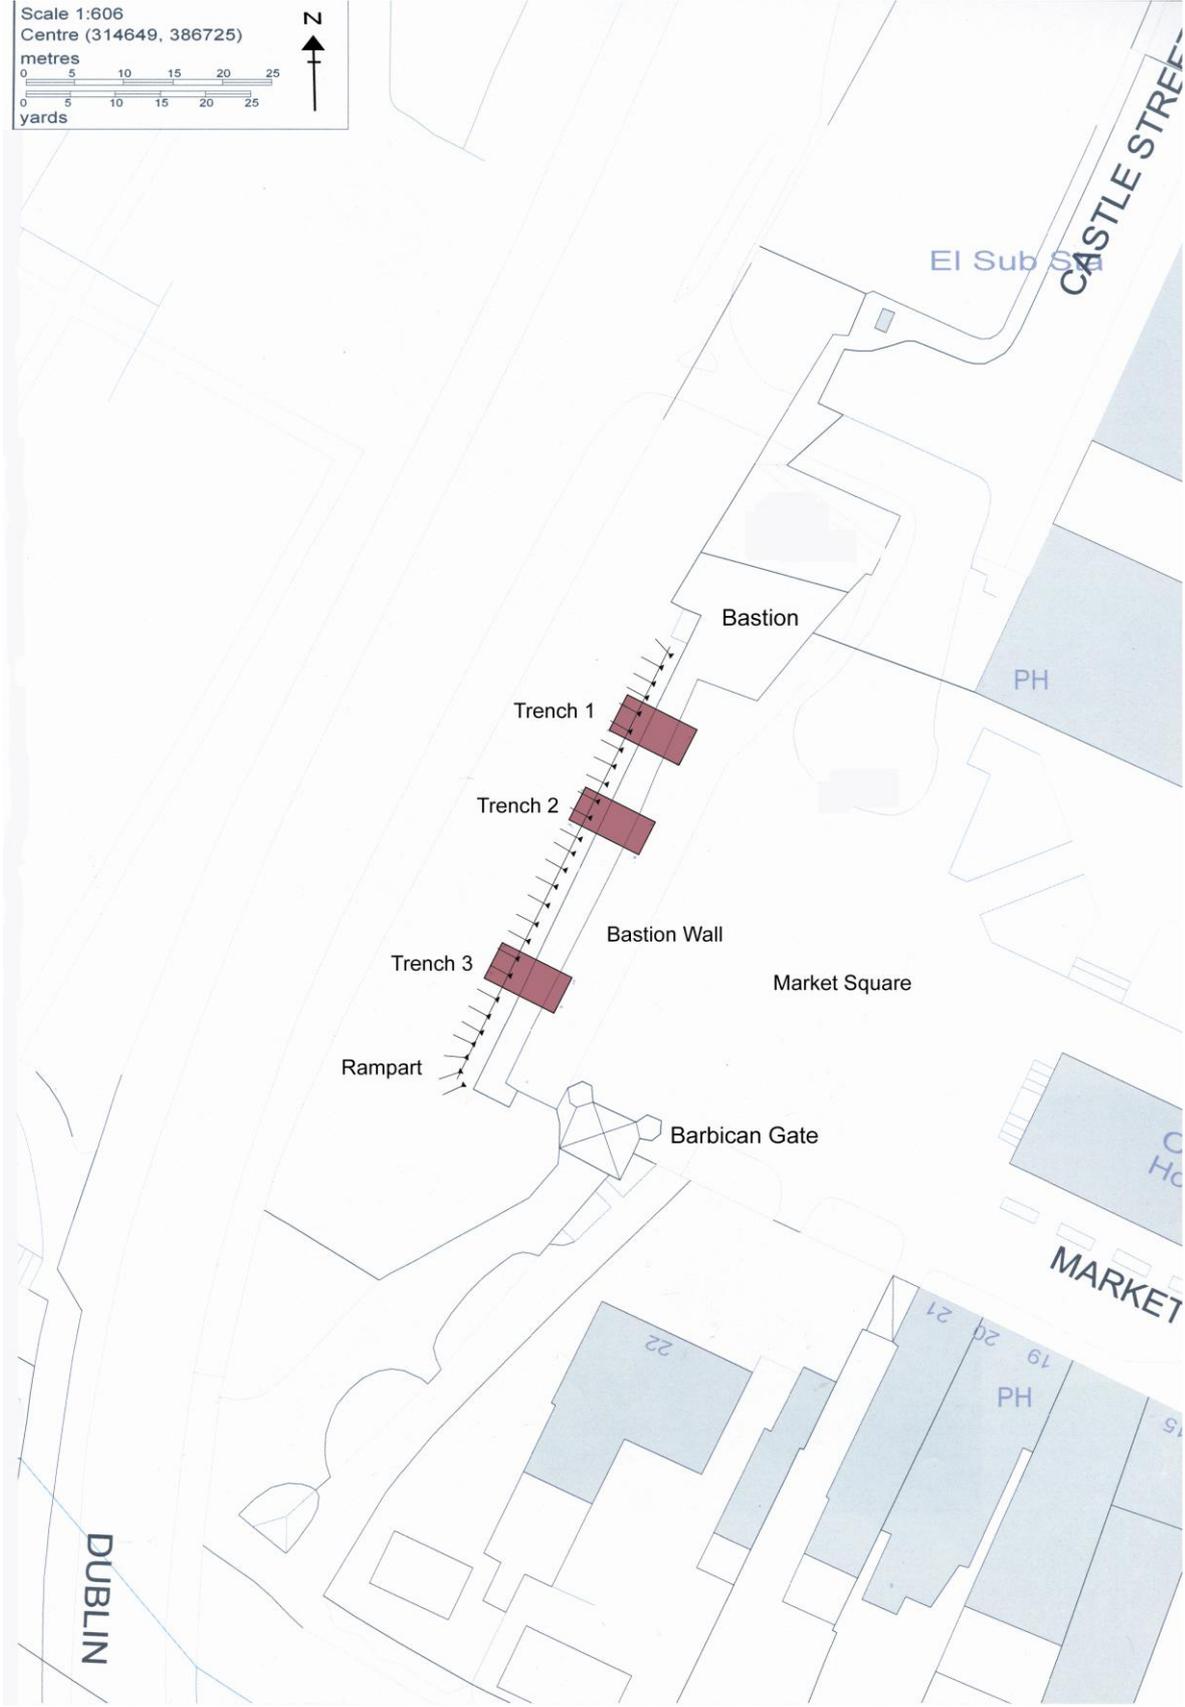
Figure 9: Location of trenches on site

- 3.1.3 Three trenches were excavated on site, each one orientated approximately east-west across the line of the bastion wall. The trenches were numbered 1-3, from north to south (Figure 9). Each trench was further sub-divided into 'east' and 'west', with the bastion wall running through the middle. The deposits on either side of each trench were given a unique context number even where there was a possibility that they may have extended into both sides of the trench. The reason for this was that the foundation of the bastion wall remained in place during the excavation and the deposits below could not be excavated and while it was possible to infer that deposits on either side of the wall were the same, this was impossible to substantiate. Reference is made in the text to such deposits.

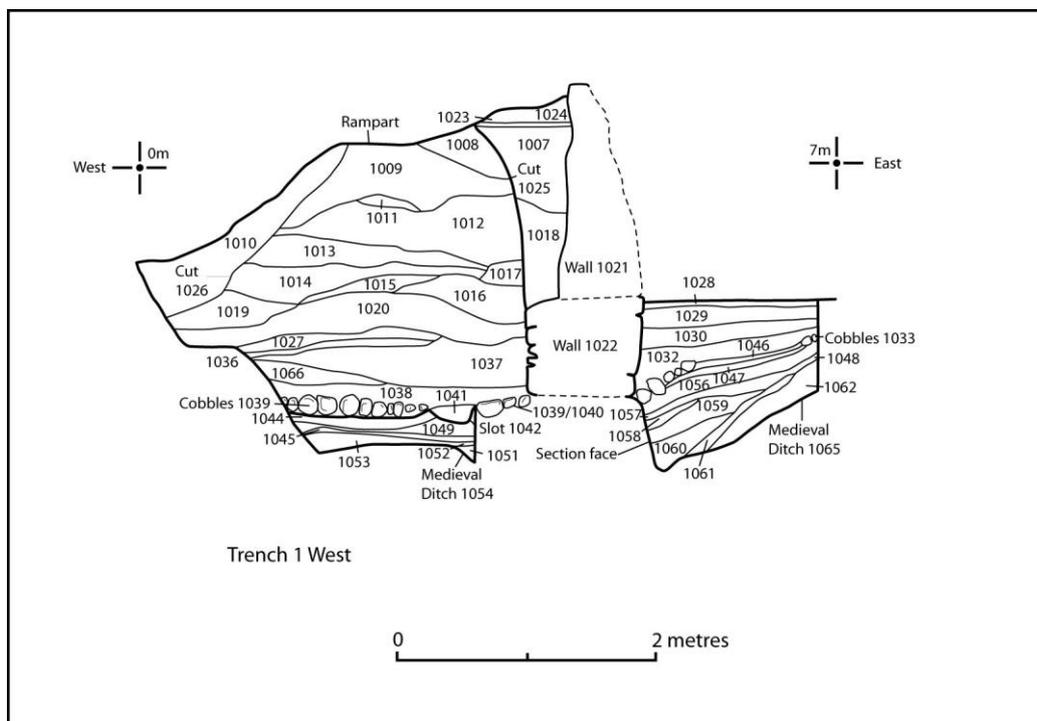
Figure 10: South-facing section of Trench 1

3.4.1.1 Trench 1 was located approximately 6.0m south of the bastion at the northern extent of the collapse. Trench 1 East was located to the east of the bastion wall and Trench 1 West to

the west (Figures 10 and 11). Both trenches were positioned as close to the bastion as was safely possible.

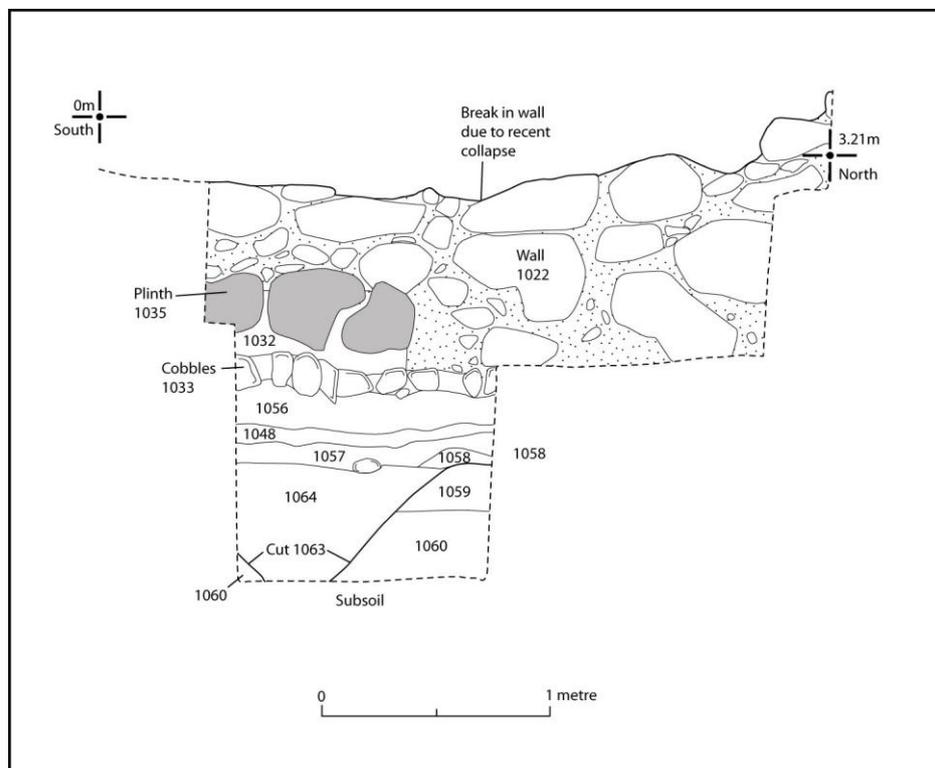
Figure 11: East-facing section of Trench 1 East

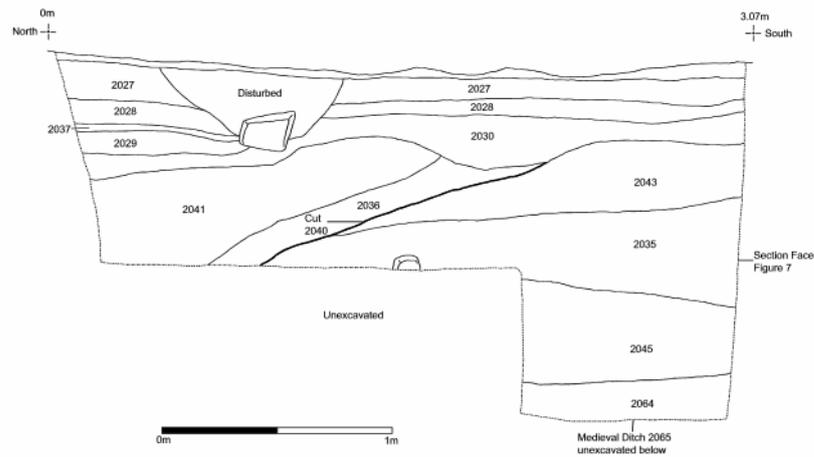
Figure 13: West-facing section of Trench 2 East

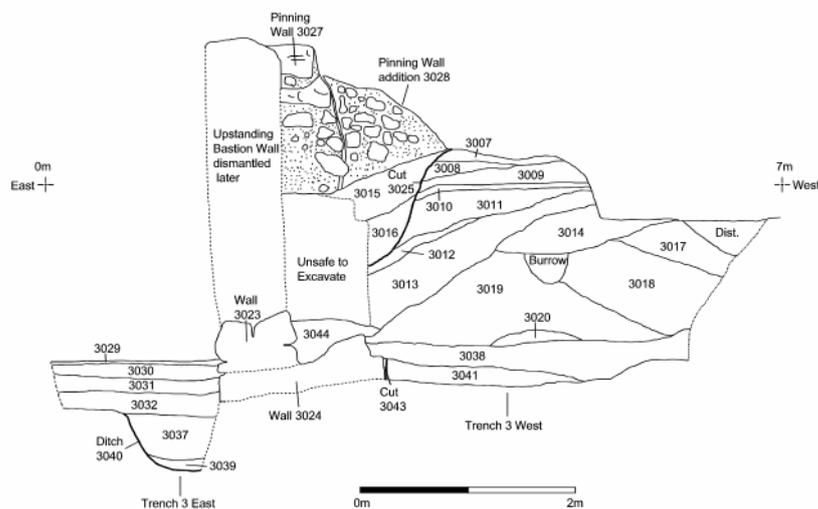
Figure 14: North-facing section of Trench 3

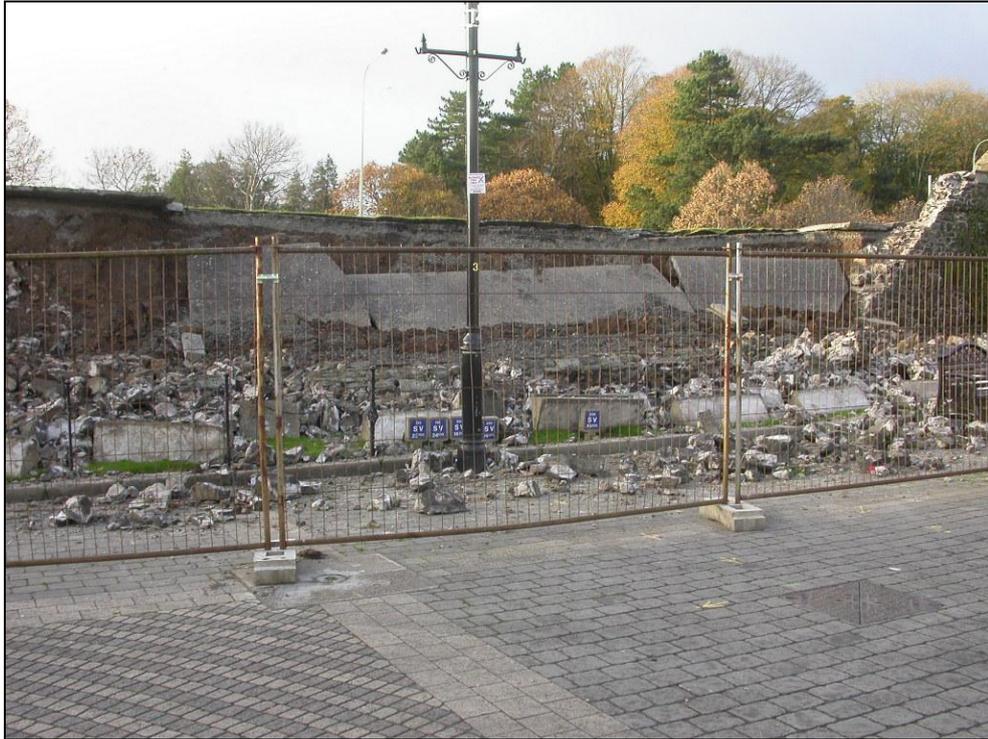
Plate 1: View of collapsed section of bastion wall, looking north-east from Market Square

2.7.1 Following the collapse of a 19m section of the 17th-Century bastion wall (ANT 050:183) on Saturday 11th October 2008 (Plate 1) it was decided by Antrim Borough Council, following discussions with NIEA, that the remaining upstanding section of the bastion wall, along with a portion of the rampart, would be removed to make the site safe prior to the re-construction of the wall. In order for the wall to be re-built it was deemed necessary to examine the original foundation levels to determine their condition and suitability to support a re-constructed wall. In light of these factors NIEA requested that an archaeological evaluation be carried out as part of the repair and consolidation work to be undertaken by the council. It was intended that this would help inform future decisions about the site by both the council and NIEA.

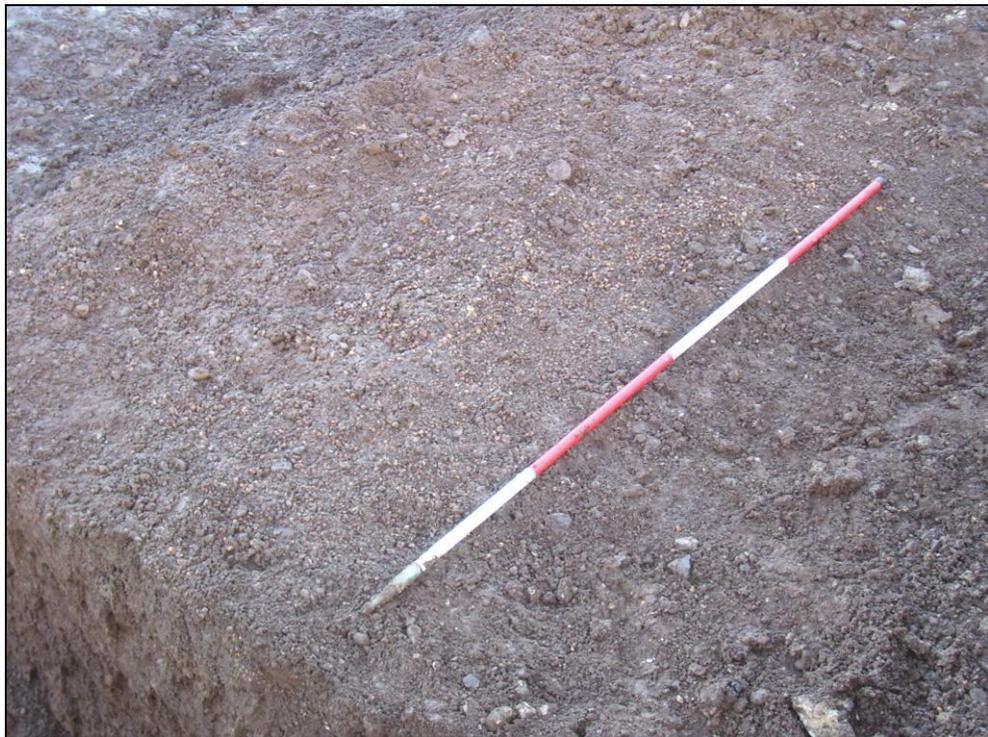
Plate 2: Remains of gravel pathway (context 3007) on top of rampart following removal of 19th- to 20th-Century overburden, looking north-east

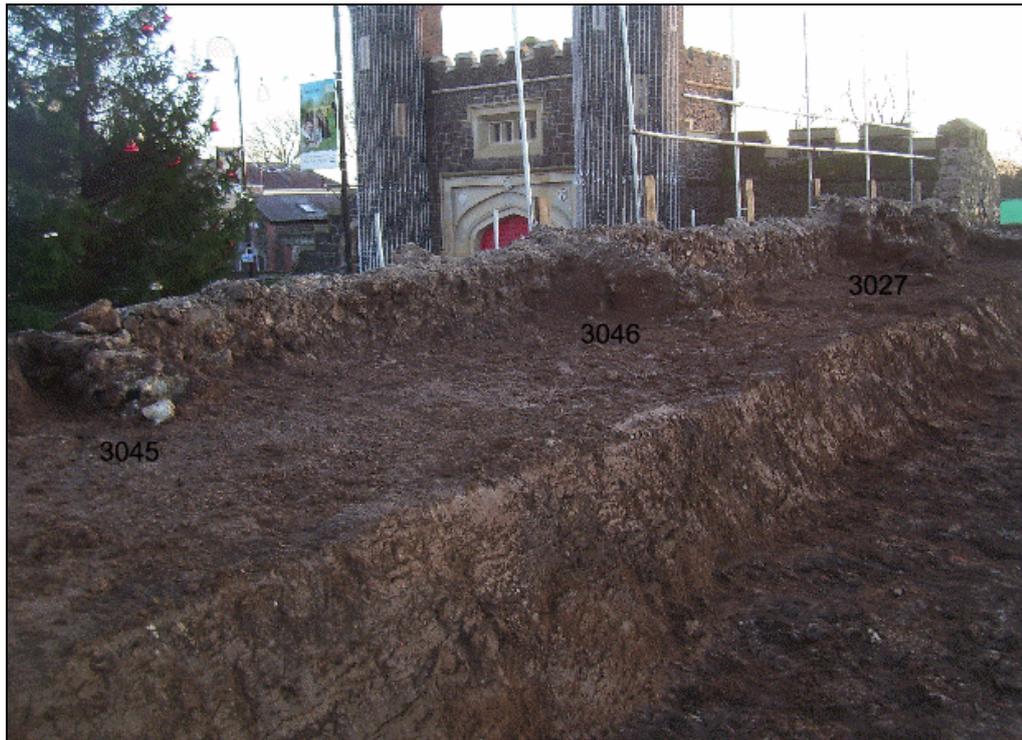
Plate 3: View of pinning walls (contexts 3027, 3045 and 3046) running from bastion wall into rampart, looking south-east towards Barbican gate

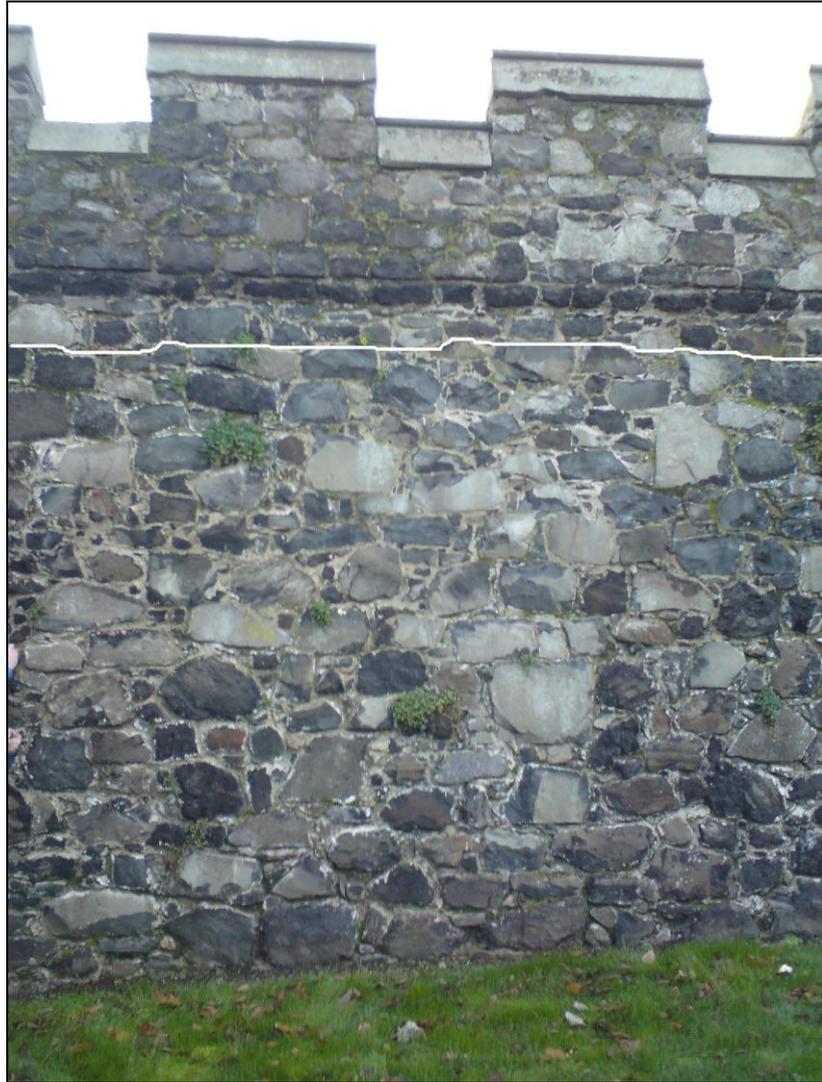
Plate 4: Upstanding section of bastion wall prior to dismantling. Line separates 19th-Century additions, including corbelling and parapet, from the earlier bastion wall below

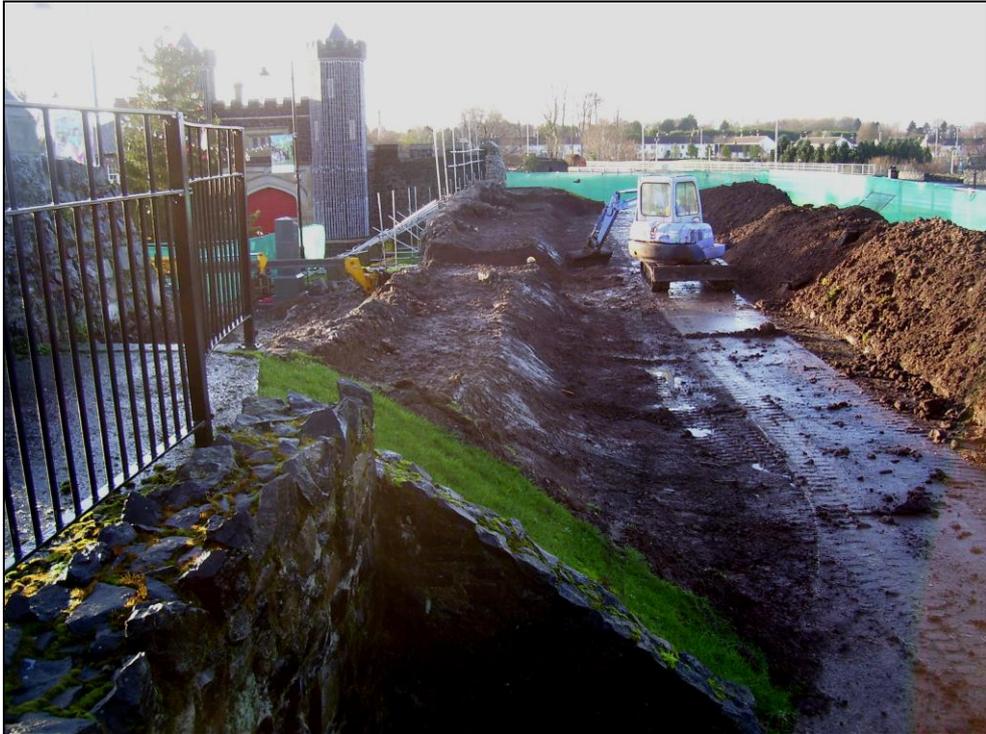
Plate 5: View of rampart after removal of 19th- to 20th-Century overburden, looking southwest

3.3.4 The surviving elements of the 17th- to 18th-Century rampart (Plate 5) were recorded once the 19th- to 20th-Century overburden was removed, and prior to three mechanically excavated trenches being investigated. The rampart measured up to 2.0m in depth, was almost 1.8m wide at the top and was found to be a minimum of 4.2m at the base which continued beyond the limit of the trenches. The top was flat and it had a steeply sloping western edge, although some evidence suggested this may have been scarped slightly when the modern clay deposits were dumped on the top. The rampart was made up of a series of dumped re-deposited subsoil layers that were archaeologically sterile. There was no evidence to suggest that there was any preparatory work done prior to the rampart construction. It was built directly upon the underlying topsoil surface and there was nothing to suggest that there was any sort of shoring or revetment used to relieve the pressure and weight on the bastion wall.

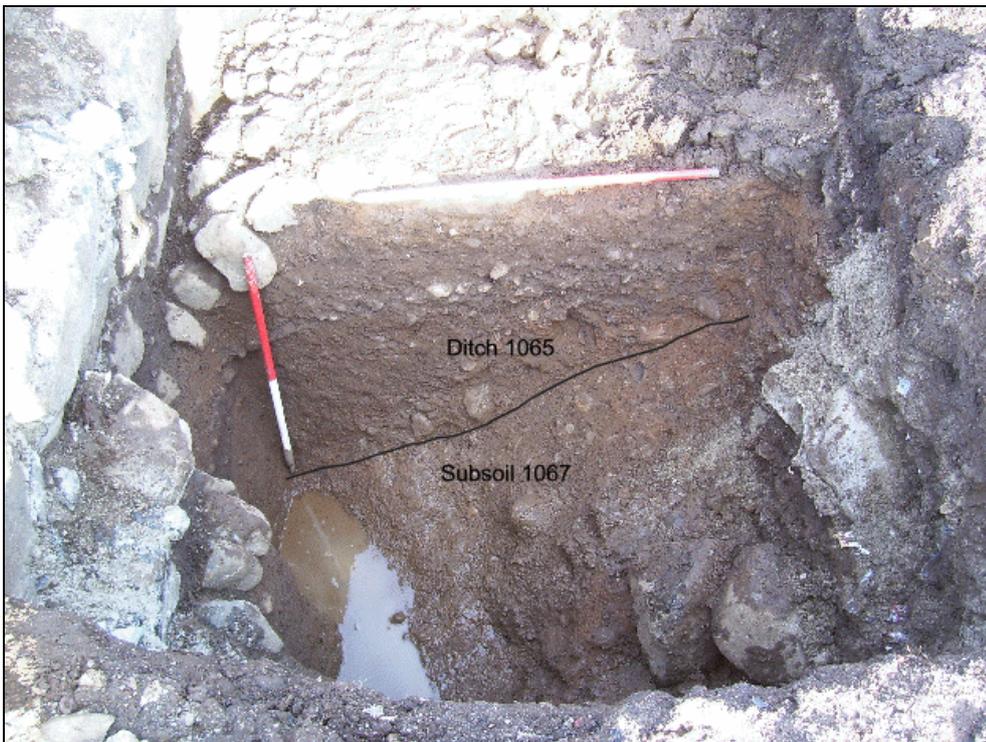
Plate 6: Post-excavation photograph of Trench 1 East showing Medieval ditch (context 1065), looking north-east

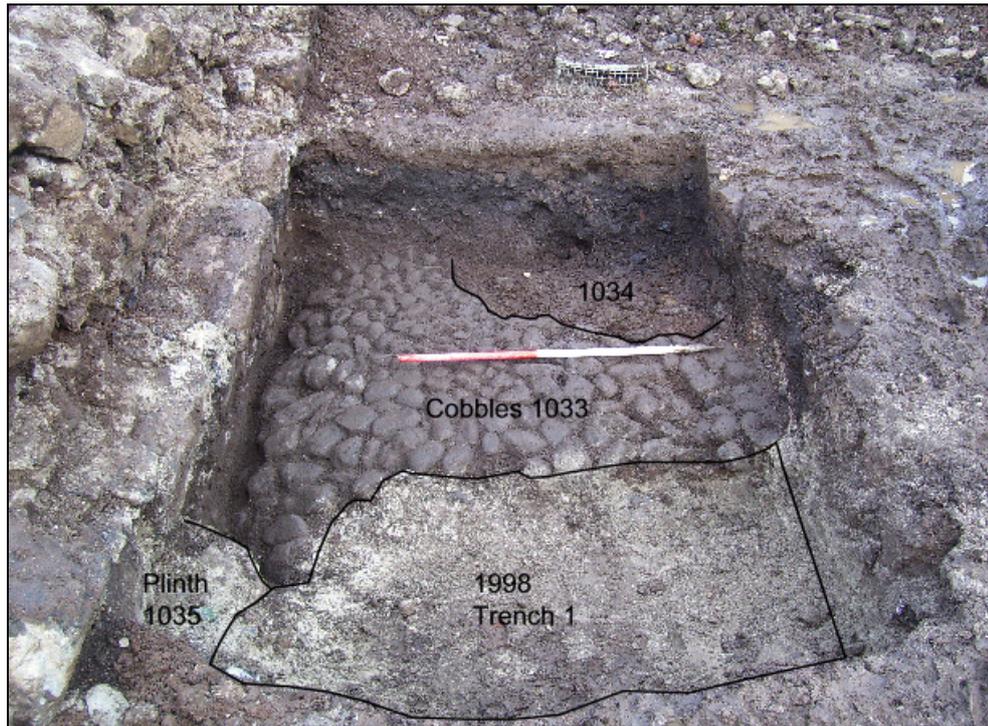
Plate 7: Pre-excitation photograph of Trench 1 East showing cobbles (context 1033), 1998 excavation Trench 1 and pit (context 1034), looking north-east

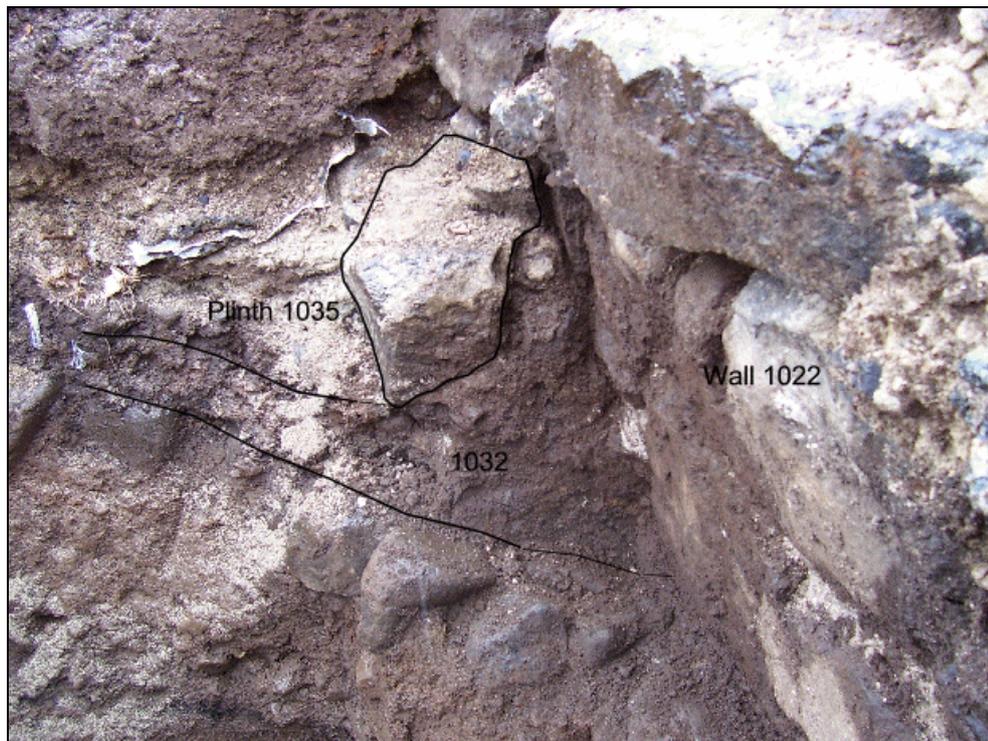
Plate 8: View of plinth (context 1035) after removal of stone, looking south-west

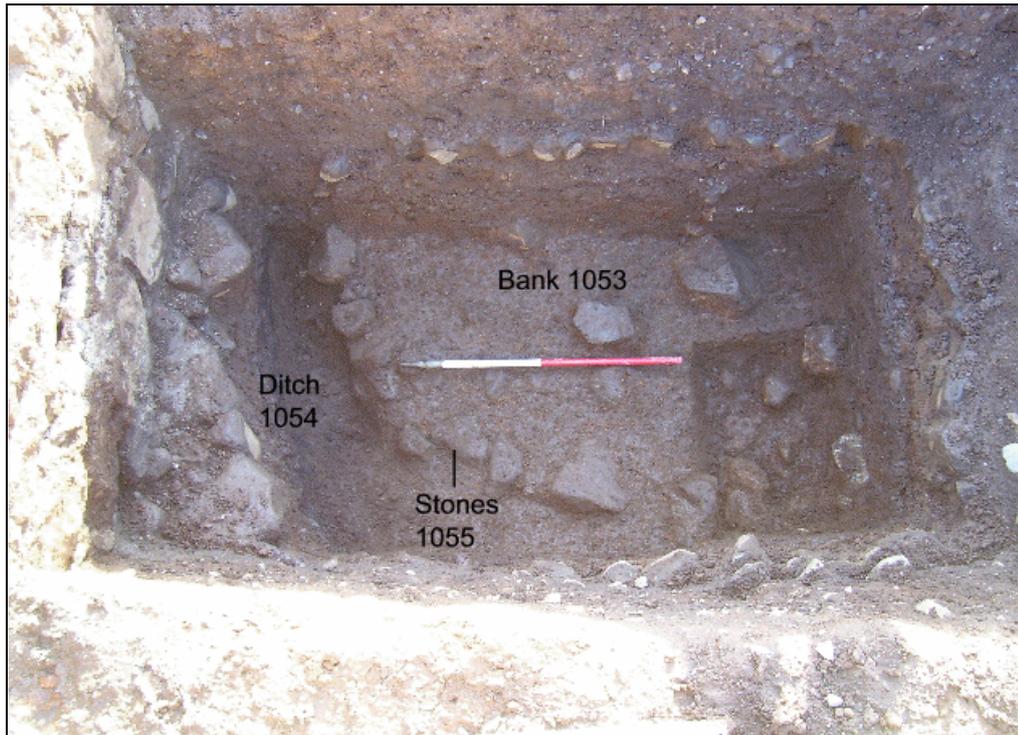
Plate 9: View of possible bank (context 1053) and curving setting of stones (context 1055) in Trench 1 West, looking south-west

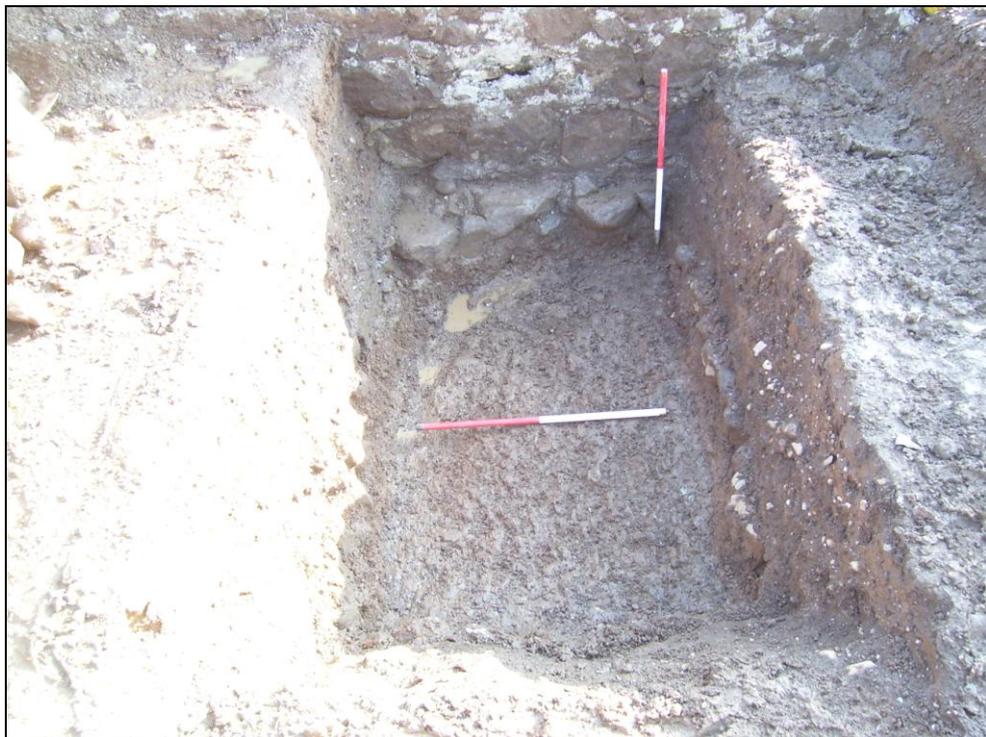
Plate 10: Metal surface (context 1045) in Trench 1 West, looking south-east

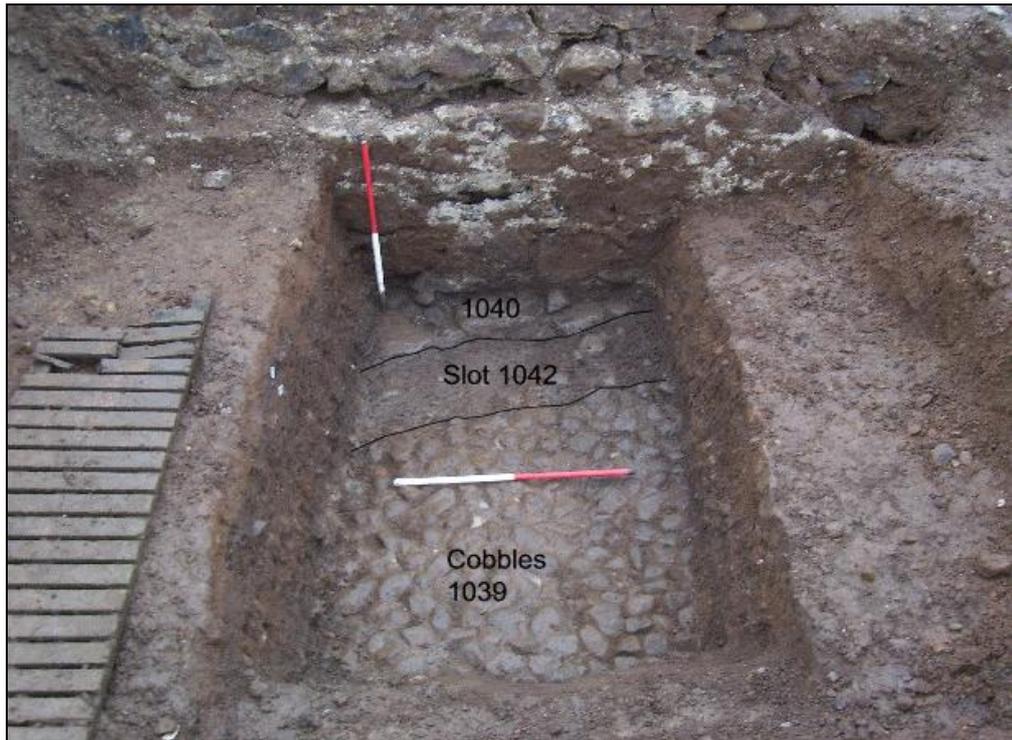
Plate 11: View of cobbled surface (context 1039) and unexcavated slot (context 1042) in Trench 1 West, looking south-east

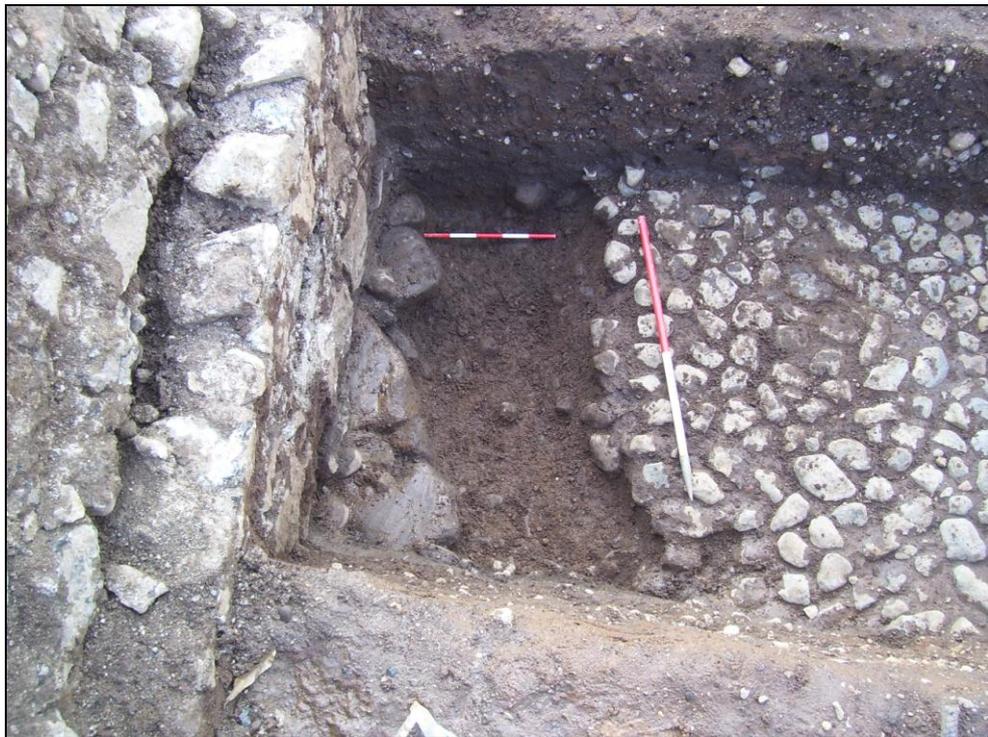
Plate 12: Post-excavation photograph of slot (context 1042), looking south-west

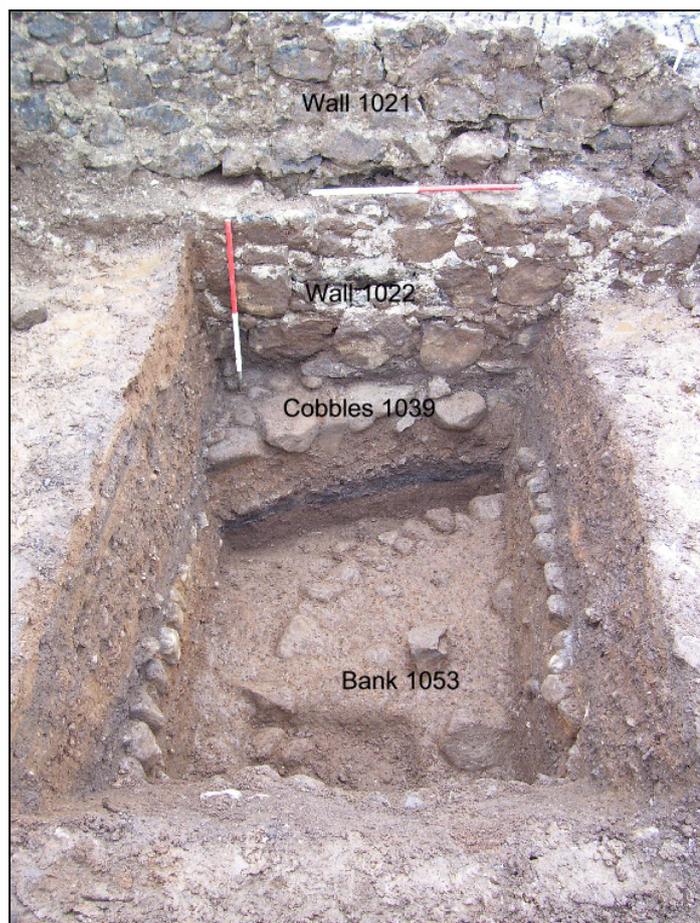
Plate 13: View of western face of original bastion wall (context 1022) built directly upon cobbles (context 1039), looking south-east

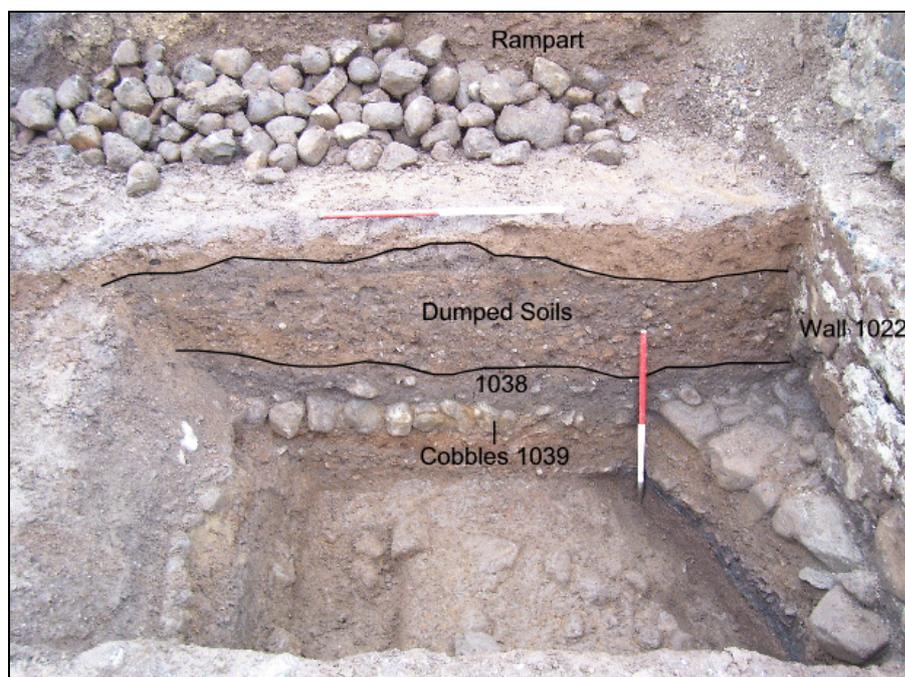
Plate 14: South-facing section of Trench 1 West showing buried soil (context 1038) above cobbles (context 1039) and below dumped soils (contexts 1027, 1026, 1037 and 1066), looking north

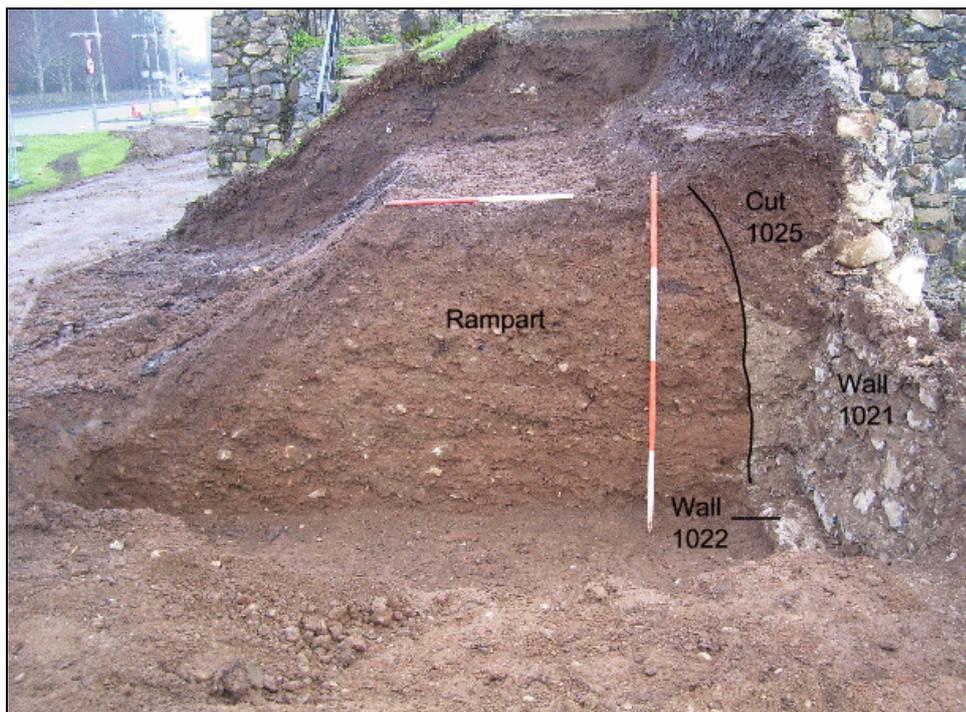
Plate 15: South-west-facing section of rampart after removal of 19th- to 20th-Century overburden. The foundation cut (context 1025) for the re-built bastion (context 1021) wall can be seen at right hand side, looking north-east

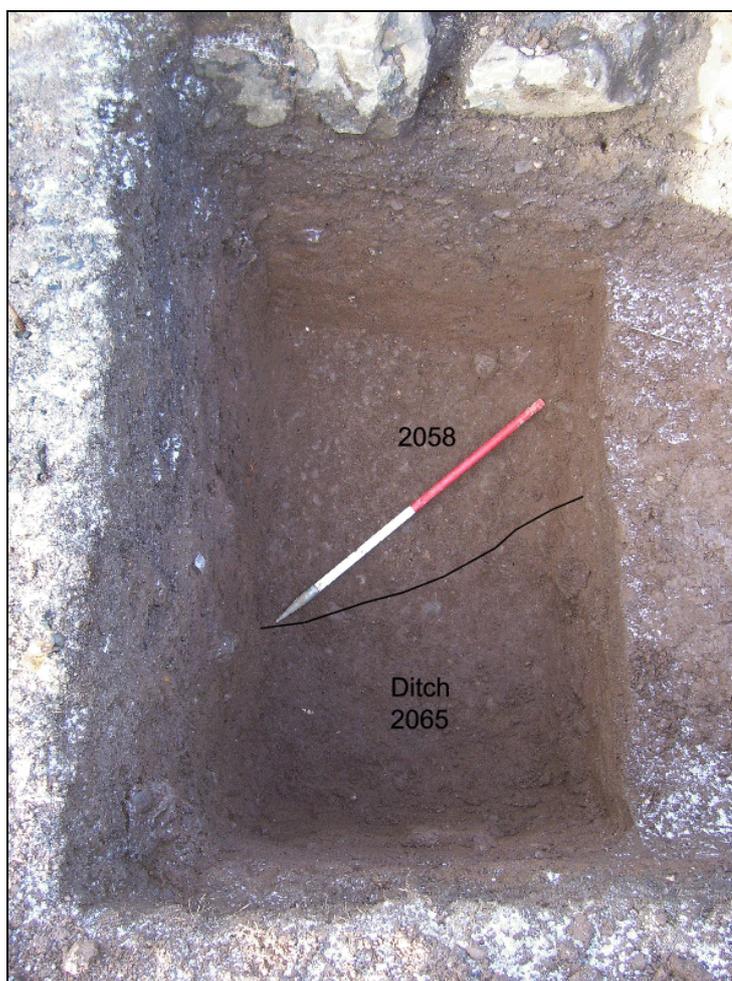
Plate 16: View of metalled surface (context 2058) and excavated portion of medieval ditch (context 2065) in Trench 2 East, looking north-west

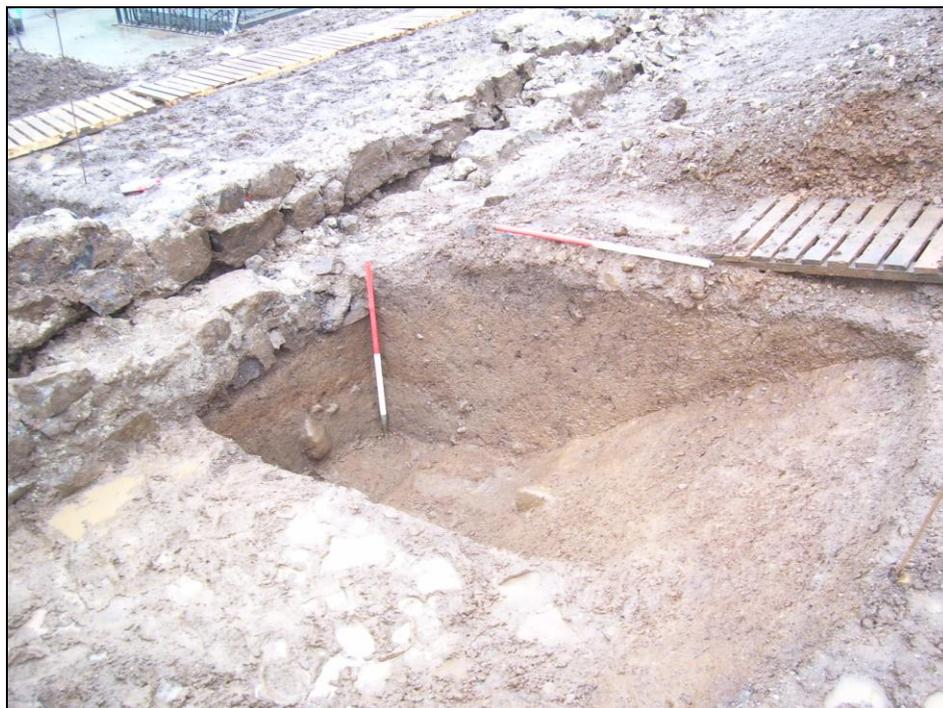
Plate 17: Post-excitation photo of scarp (context 2053) in Trench 2 West, looking south

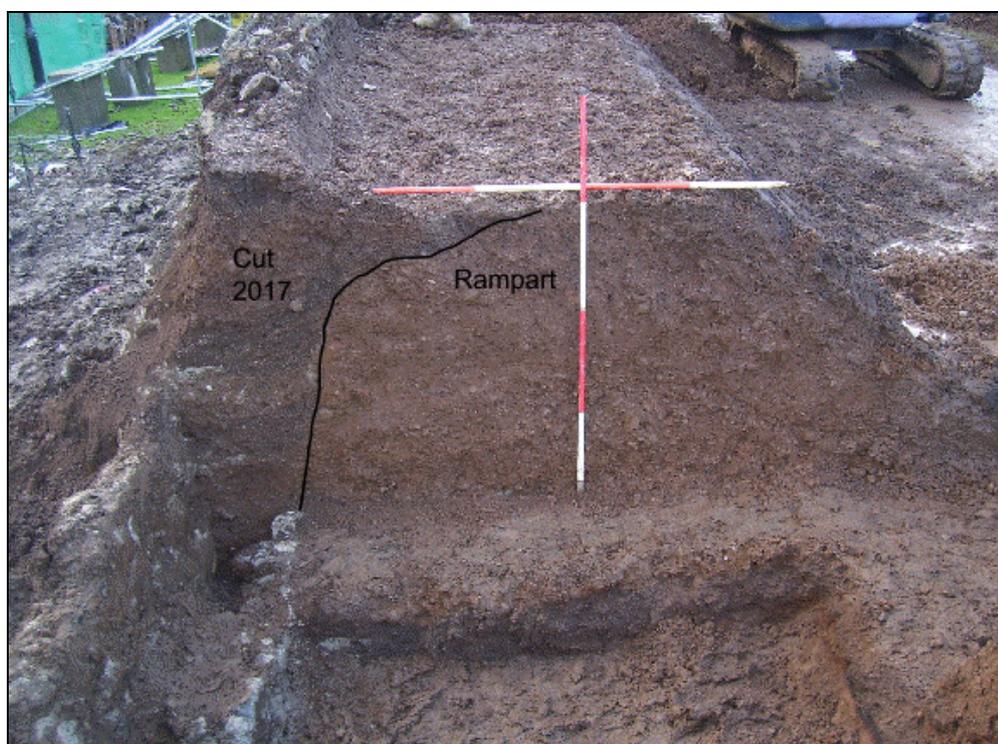
Plate 18: North-east-facing section of rampart (context 2006) in Trench 2 West after removal of 19th- to 20th-Century overburden. The foundation cut (context 2017) for the re-built bastion wall can be seen at left hand side, looking south-west

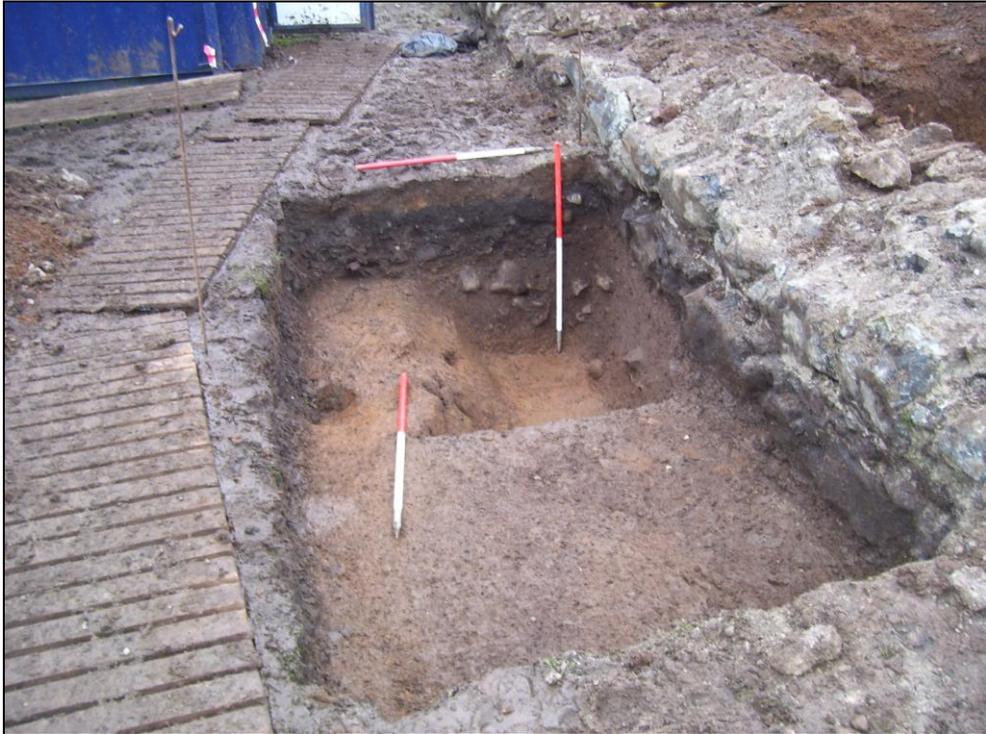
Plate 19: Post-excavation photo of 17th-Century ditch (context 3040) in Trench 3 East, looking south-west
