CAF Data Structure Report No. 67
Phase 1 Excavation at Antrim Bastion Wall
Townparks
Antrim
Co. Antrim
AE/08/204

**Report on Phase 1 Excavations
Antrim Bastion Wall, Townparks, Antrim
County Antrim**

**CAF DSR 067
Licence Number: AE/08/204
SMR No: ANT 050:183
Grid Ref: J 1464 8675**

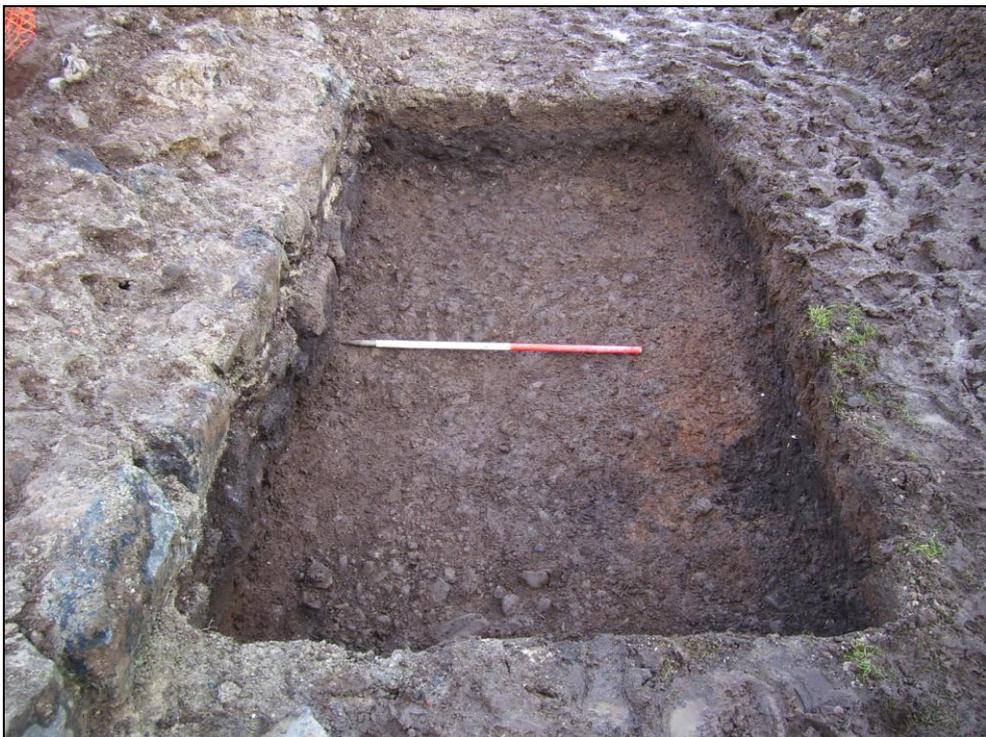
Plate 20: Metalled surface (context 3032) in Trench 3 East, looking north-east

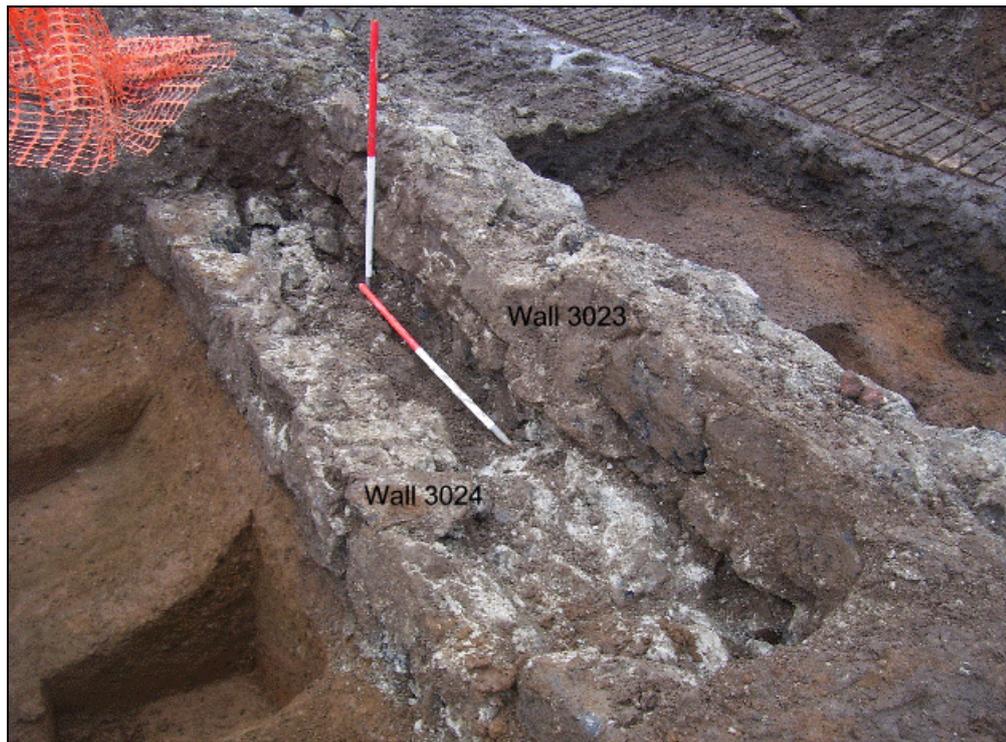
Plate 21: View of rebuilt bastion wall (context 3023) constructed directly on top of original bastion wall (context 3024), looking north-east

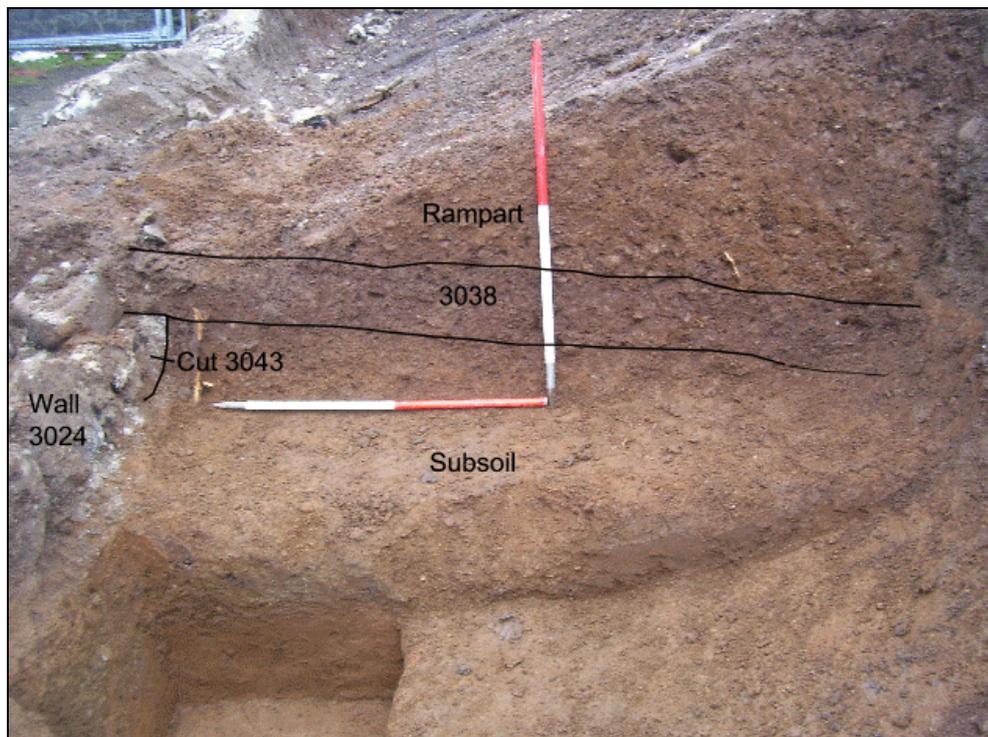
Plate 22: View of buried garden soil (context 3038) found directly below rampart in Trench 3 West, looking south-west

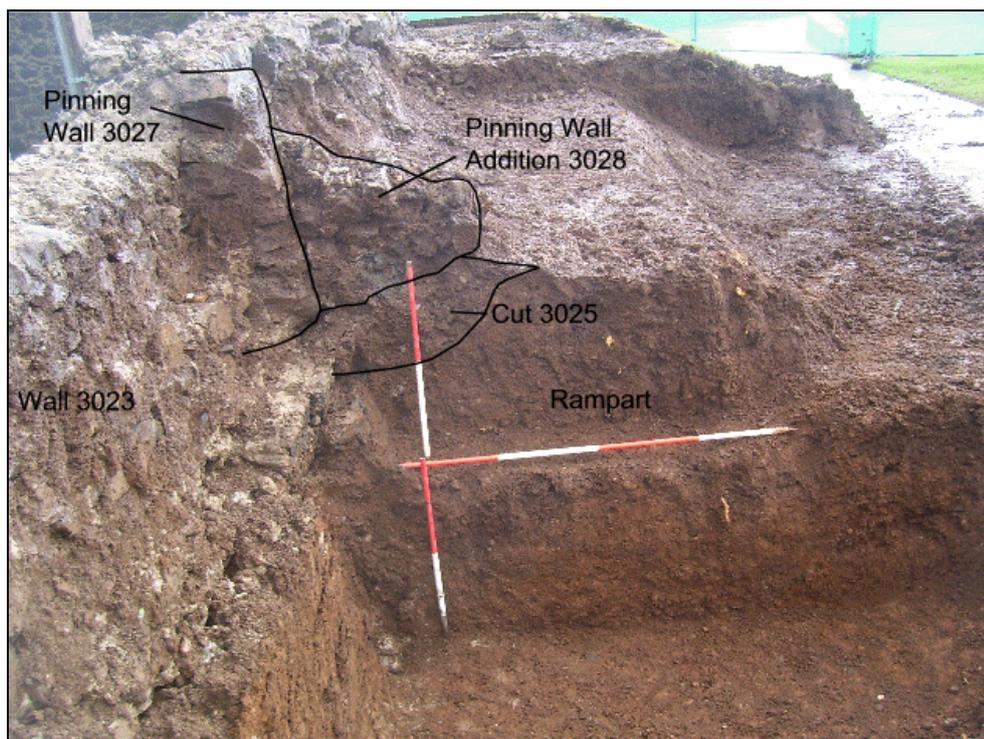
Plate 23: North-east-facing section of rampart in Trench 3 West. Also visible are the upstanding remains of the rebuilt bastion wall (context 3023), pinning wall (context 3027) and pinning wall addition (context 3028) at left hand side, looking south-west
