Monitoring Report No. 196

**Riddell Hall
Queen's University Belfast
Co. Antrim**

AE/10/12

Z/2009/0309/F

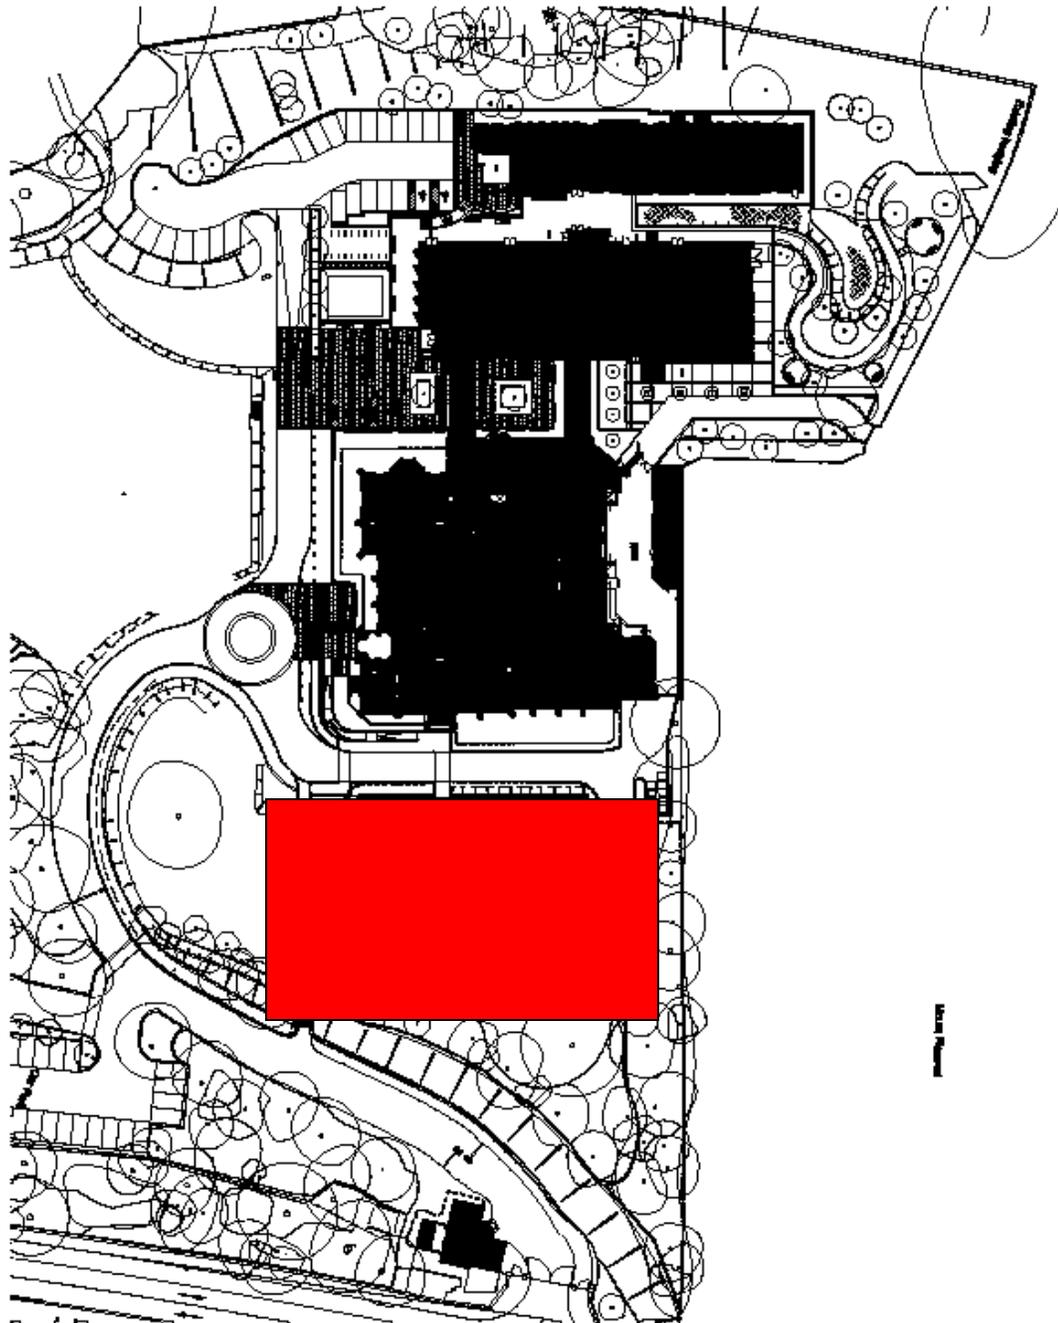
Fig. 2: Plan of the proposed development as provided by Estates Department QUB. The east of the development is at the top of the picture. Also showing is the approximate location of the area that was subject to archaeological mitigation (red box).

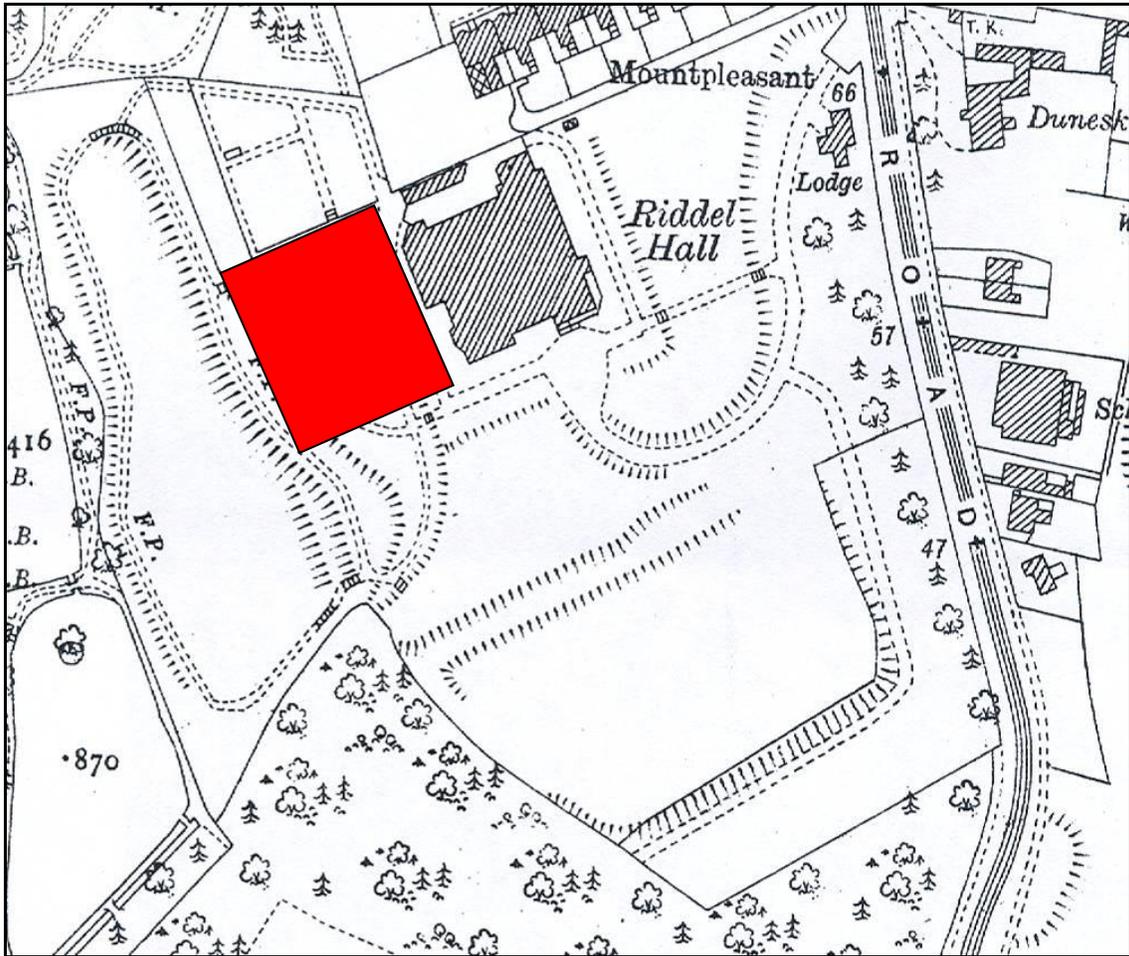
Fig. 3: Area subjected to archaeological evaluation (shaded red).

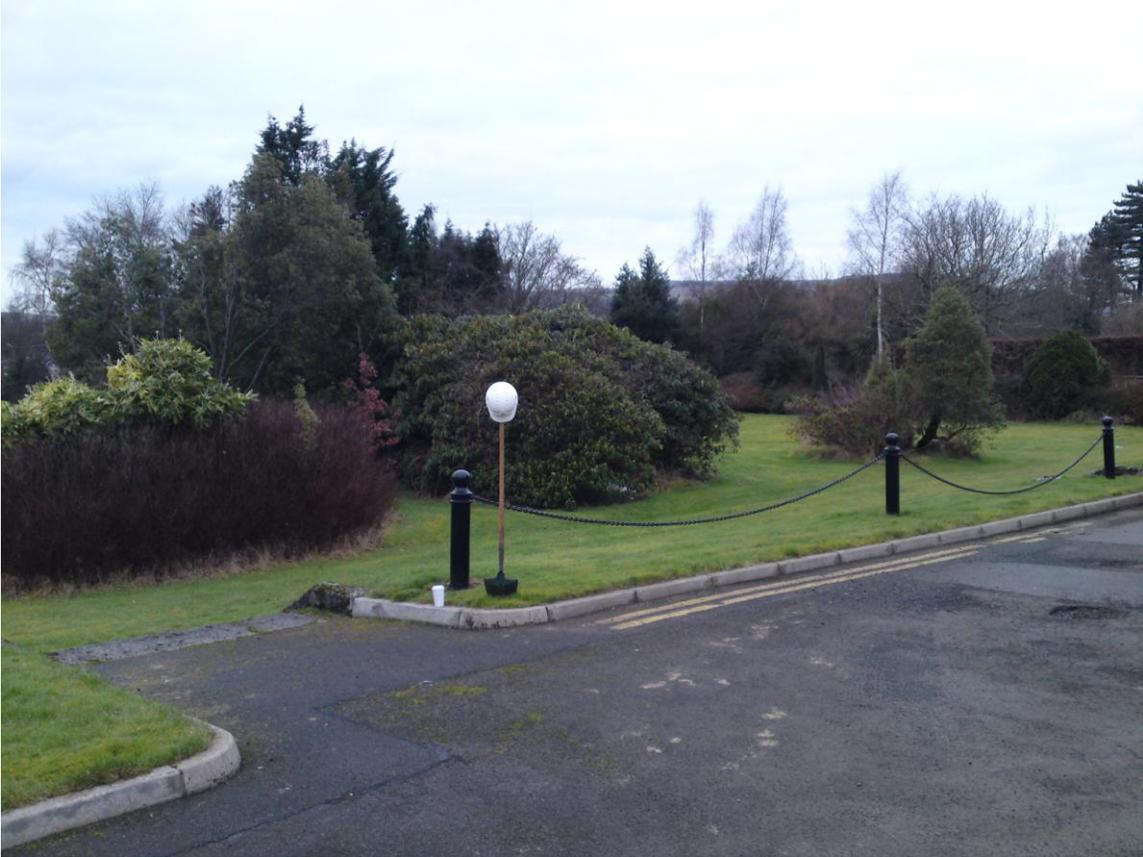
Plate 2: Area to the west of Riddell Hall that was subject to archaeological evaluation, looking north-west.

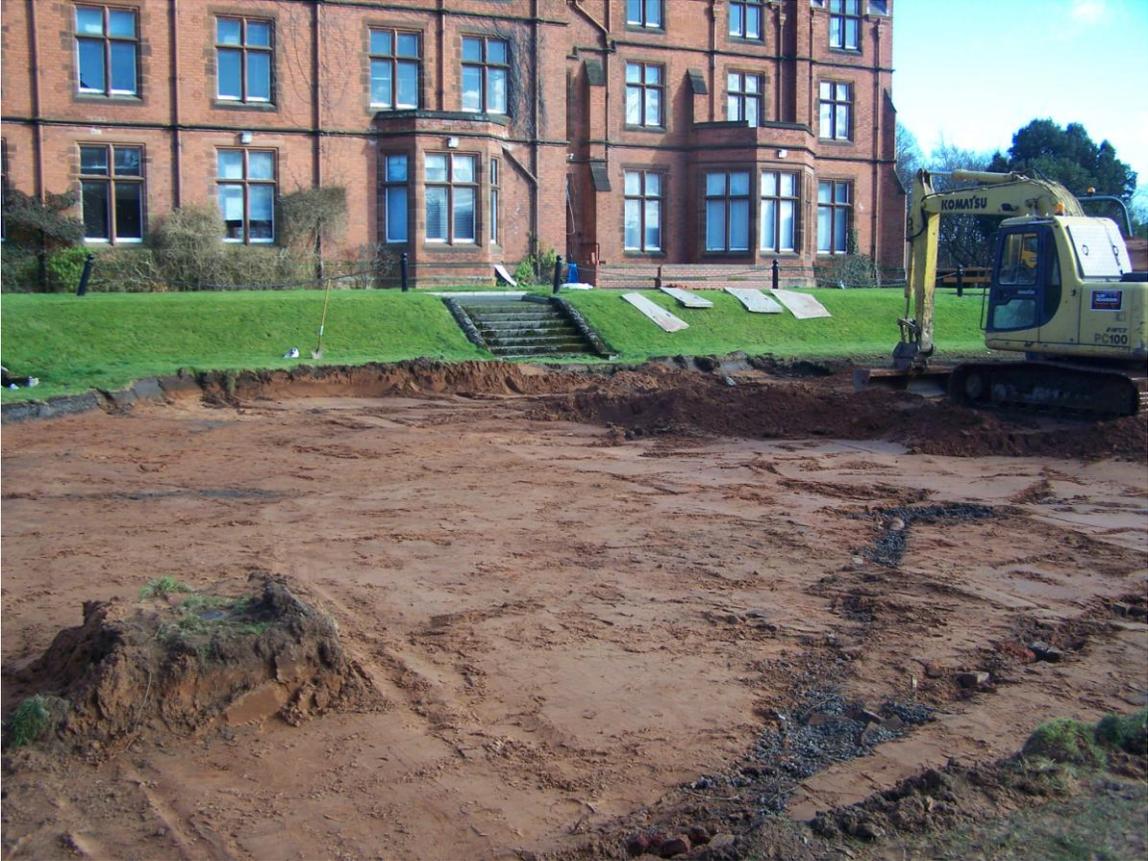
The sod and topsoil in the excavation area (Context No. 101) consisted of a friable mid to dark brown sandy loam. Inclusions of small angular stones (average size: 30mm x 20mm) and larger rounded stones (average size: 60mm x 80mm) were frequent throughout this deposit, as well as brick fragments (of apparent twentieth century date). Various discreet lenses of material including fragments of asphalt were observed within the topsoil deposit (Context No. 101) although were not assigned separate context number due to the topsoil being removed as a single stratigraphic unit. The topsoil (Context No. 101) was on average 0.3m in depth and directly overlay the natural subsoil (Context No. 102) which consisted of an orange red sand.

Four field drains were observed following the removal of the topsoil deposit (Context No. 101), and these were assigned Context Nos. 103, 104, 105 and 106 (see table 1). These drains were observed as linear features of approximately 0.3m wide filled with angular gravel. Due to the apparent modern nature of these features they were not excavated.

Plate 3: Mid- excavation shot showing removal of topsoil (Context No. 101) to the surface of the natural subsoil (Context No. 102), looking south-east. The field drains (Context Nos. 103 and 104) can be seen in the foreground of the picture.

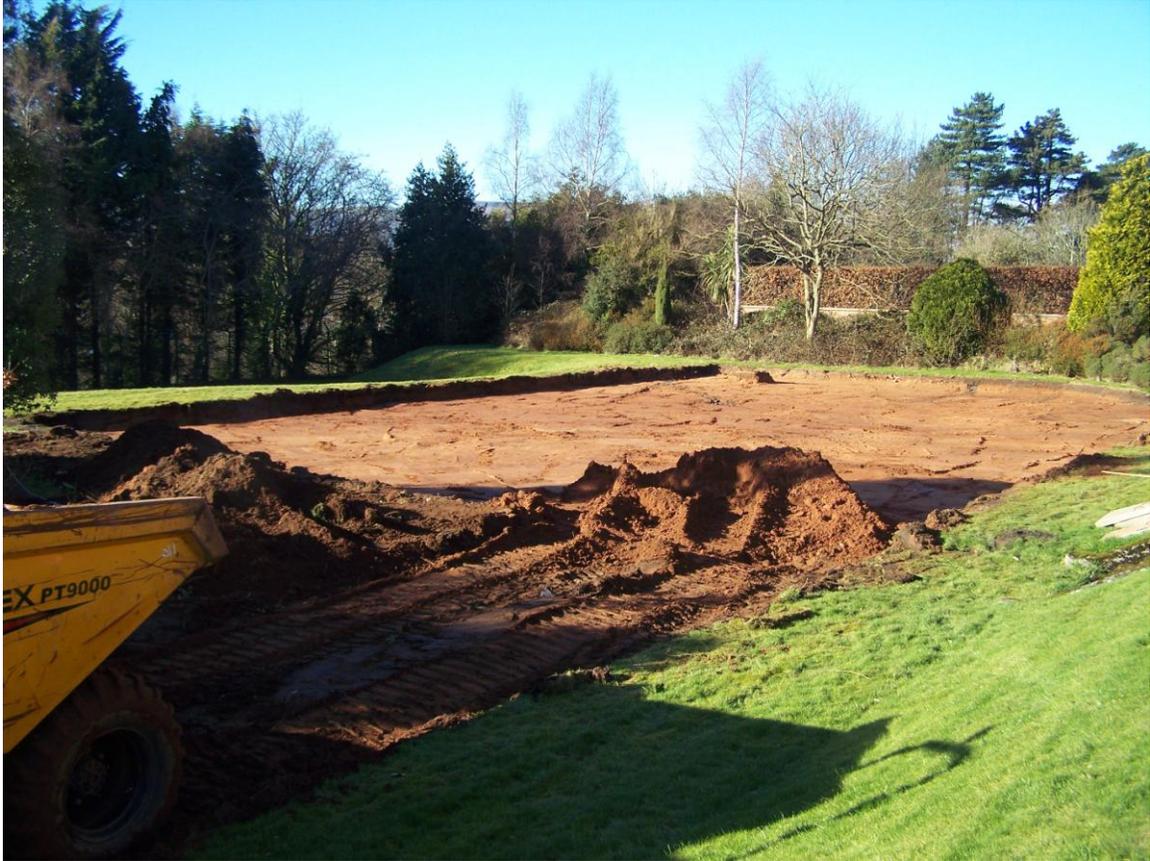
Plate 4: Proposed development area following removal of the topsoil (Context No. 101), looking north-west.

The evaluative test trench excavated in the application area contained nothing of archaeological significance. It is not thought that the redevelopment of Riddell Hall will impact upon previously unrecognised and unrecorded archaeological remains. It is therefore recommended that no further archaeological fieldwork is carried out at the development site. No publication of this work is merited save a short summary in the annual *Excavations Bulletin*.
