Excavation at Blundell's House, Dundrum Castle,
County Down 2009

Data Structure Report: Site Evaluation and Excavation at Blundell's House, Dundrum Castle, County Down 2009

**(CAF DSR 071)
(Licence No. AE/09/36)
(SMR No. DOW 044:006)**

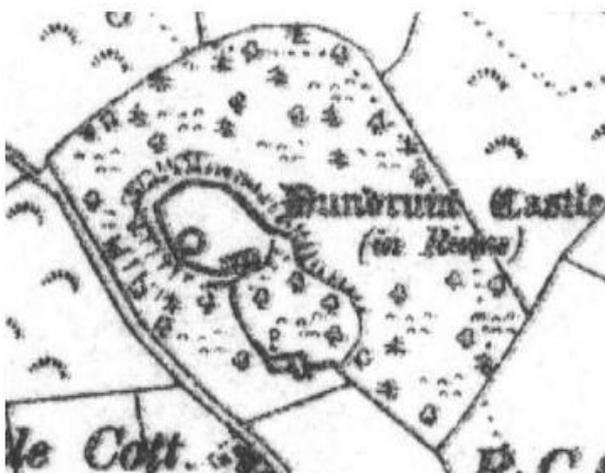
1925

Figure 1: Details of various Ordnance Survey 6" and 1:10000 surveys and revisions of Dundrum Castle and its immediate environs. Top left 1834; top right 1859; bottom left 1925; and bottom right 1931.

2.5.20 Differences between the various Ordnance Survey 6" and 1:10000 surveys (Figure 1) reflect the changes that occurred to Dundrum Castle and its immediate environs whilst the site was part of the Downshire Estates. The nineteenth-century maps show three buildings, each standing within individual garden plots, immediately to the west and southwest of Blundell's House. The maps also show that until at least 1859, access to the upper ward was made from the west via an entrance located where the current toilet block for visitors is presently situated. The first edition map of 1834 also shows that the lower ward was sub-divided by a boundary that ran from the northeastern corner of Blundell's House towards the southeastern angle of the upper ward. This boundary is represented in a number of late eighteenth-century

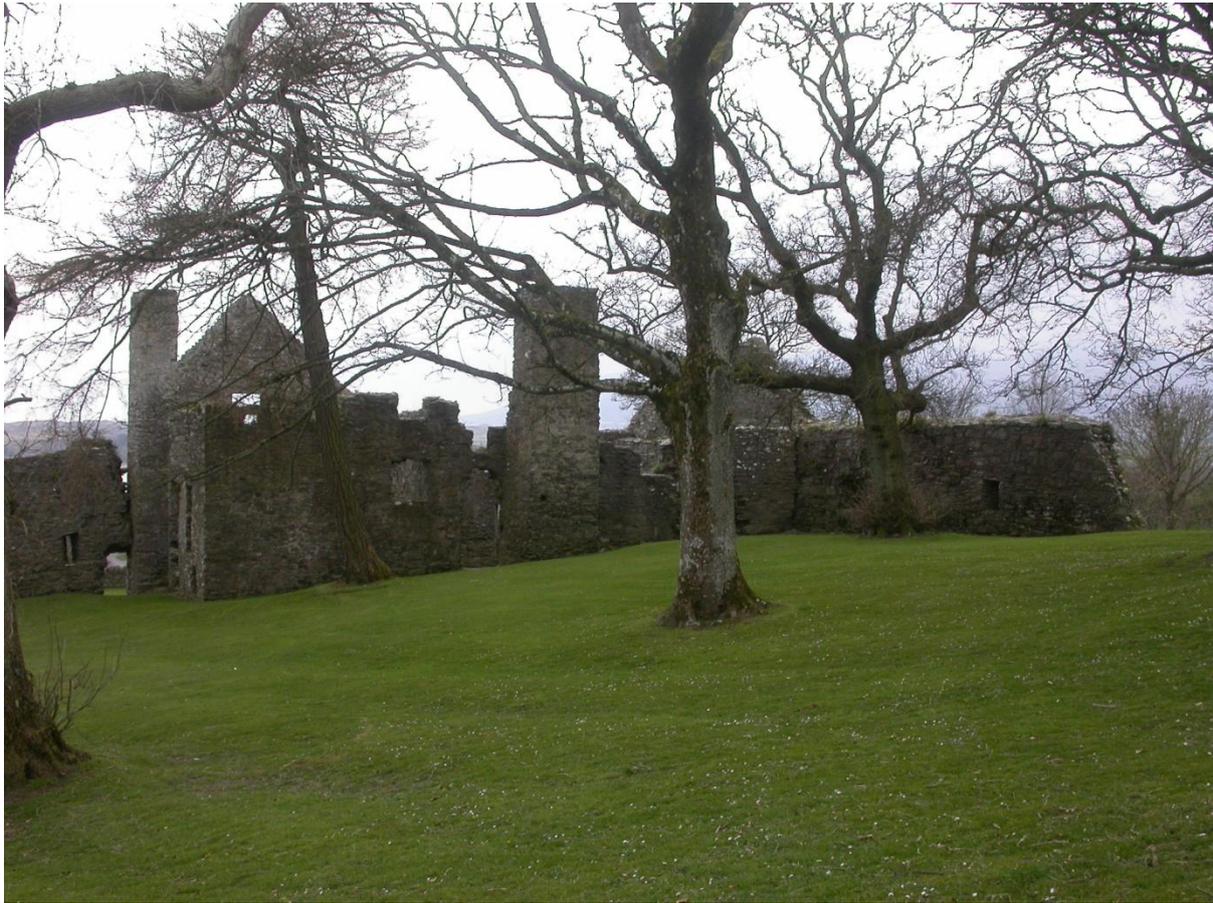
Plate 1: Blundell's House viewed from the same approximately northeast perspective as the Fleming and Thomas illustrations.
Note the evidence for spade cultivation ridges in the foreground.

2.6.7 Fleming's illustration is drawn from a similar approximately southwest-looking perspective to the 1791 engraving, however, this does not necessarily indicate that Fleming's drawing is a copy of the 1791 engraving, or that both images are based upon the same, unidentified original. The perspective chosen by both Fleming and Thomas is undoubtedly the best for representing the ruin in its entirety and, consequently, little significance should be placed upon two different artists choosing the same perspective to draw the remains of Blundell's House. What is of potential significance, however, is that Fleming's sketch shows a number of features which are no longer extant or represented in the 1791 engraving (compare Figure 4 with Figure 3 and Plate 1). Most importantly, Fleming's sketch appears to show a courtyard attached to the north of the surviving ruins. This courtyard has entrances on its northern and eastern sides; the entrance on the northern side having a Romanesque appearance. Fleming's sketch also depicts a relieving arch in the wall above the eastern entrance into the courtyard and a small square window or armorial panel in the courtyard's northern wall. Furthermore, a tall structure apparently rises up from the northeastern corner of this courtyard. Although its position and profile suggests that it might be a confused attempt to render the projecting chimney breast still extant in the northern wall of the building's west wing, the apparent representation of a window within this structure suggests that this was not the case. If accepted as genuine, these features suggest that either Blundell's House was built upon the site of an earlier, medieval structure or that it had a hitherto unrecognised northern extension in which a medieval doorway had been reused. Fleming's sketch also shows dressed stone surviving in the windows of the northern gable of the east wing and the western gable of the west wing. If accurate, this indicates that the dressed stone was not robbed out of the ruin until after the building's roof collapsed or was dismantled. The sketch also apparently shows a lean-to structure attached to the eastern side of the east wing adjacent to the chimney, which is not represented in the 1791 engraving.

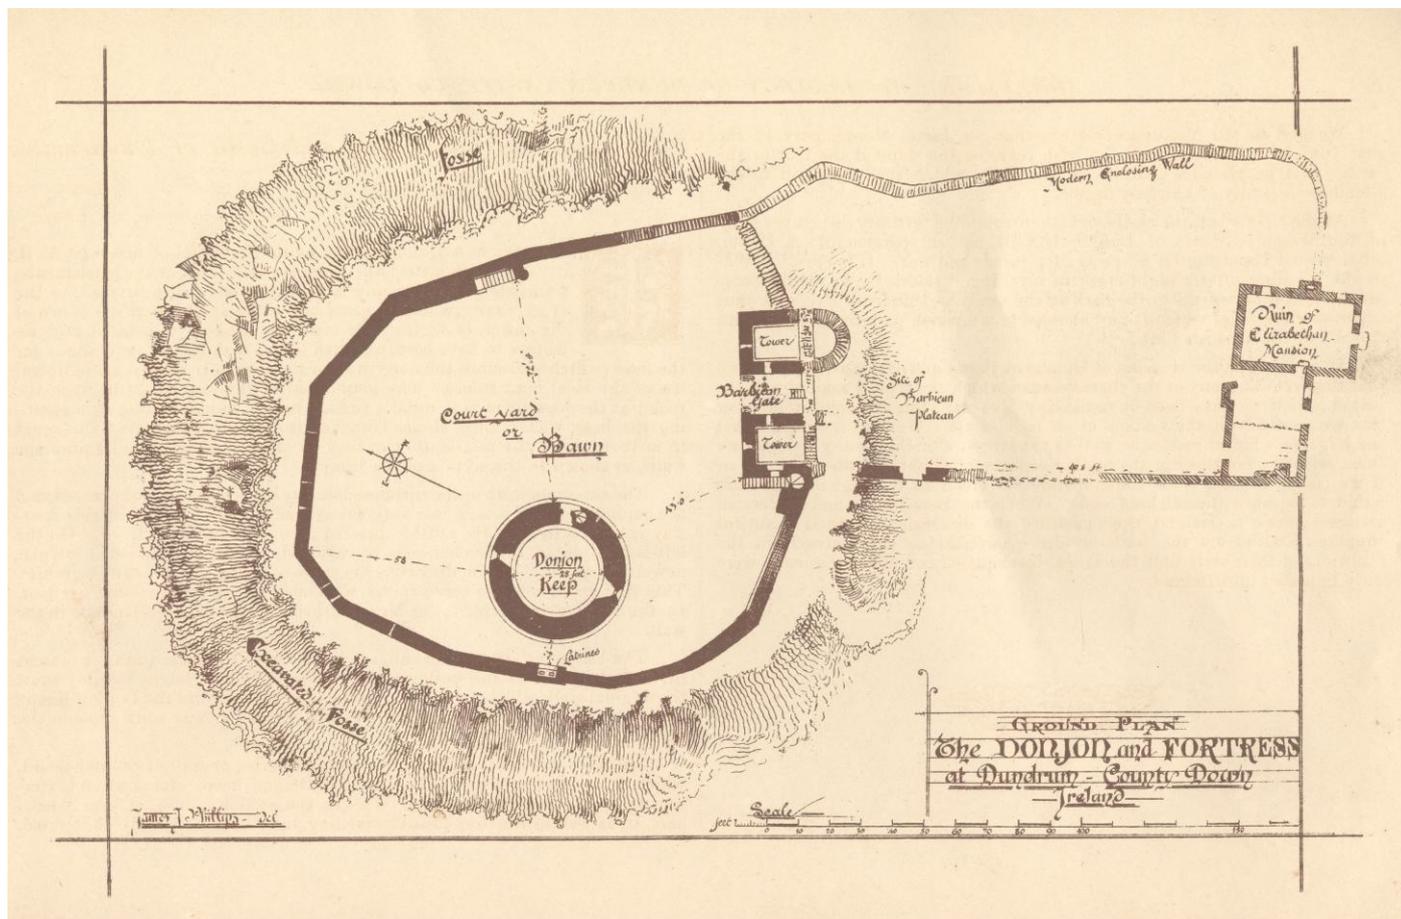
Figure 5: Ground plan of Dundrum Castle and its immediate environs produced by James Phillips (1883, pl. opp.17; 1883-84, pl. opp.160).

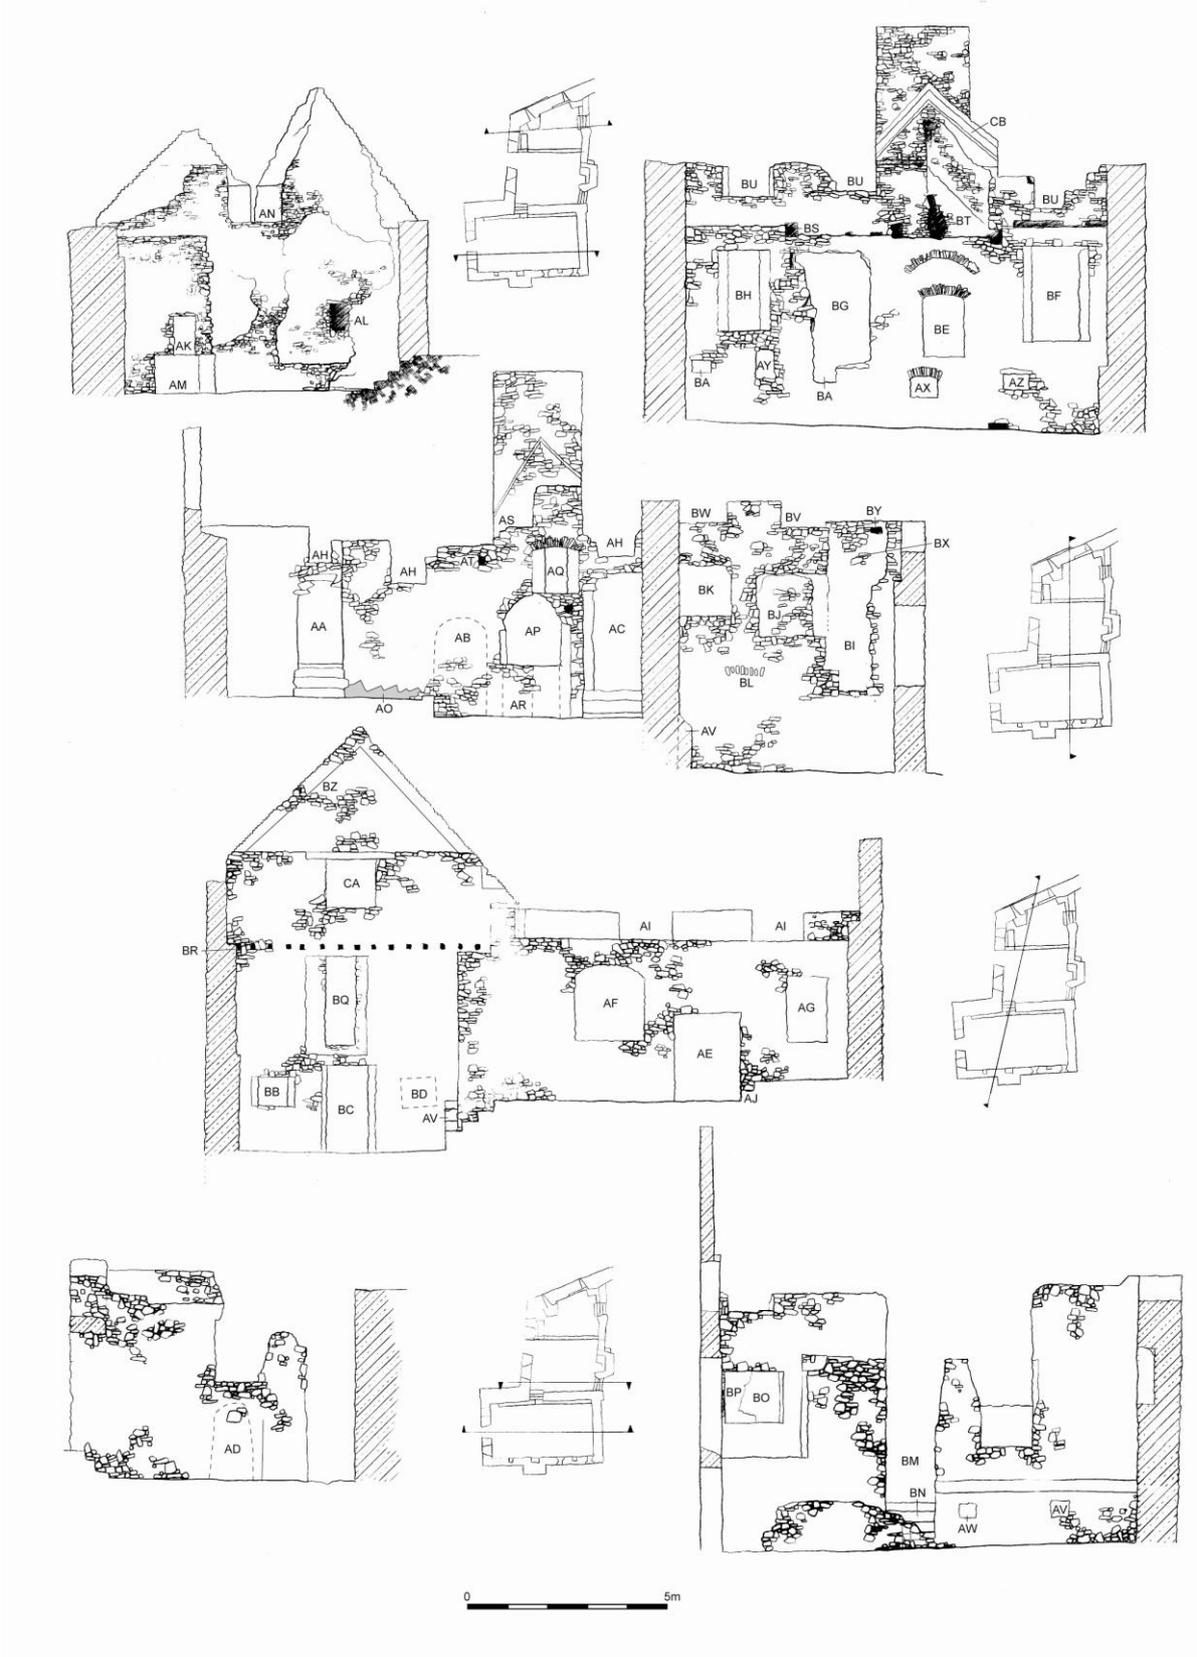
Figure 6: Elevation drawings of the internal walls of Blundell's House, with the principal architectural features annotated. Adapted from an original set of illustrations kindly provided by the Northern Ireland Environment Agency: Built Heritage.

- 2.8.4 The west wing was entered from the lower ward by at least two doorways, one still extant (Figure 6.AA) and the other now blocked (Figure 6.AB). The extant doorway is located close to the point where the north wall joins the curtain wall, whilst the now blocked entrance was located immediately to the west of the projecting chimney breast. The profile of an angled roof is preserved in outline in the harling (i.e. lime coating applied as an external finish) of the western external face of the west wing's projecting chimney, suggesting that the blocked entrance was at some point furnished with a porch. It is uncertain whether these two entrances were contemporary, or whether the extant doorway replaced the blocked entrance. Waterman considered that the present opening in the north wall, located immediately to the east of the projecting chimney breast and adjacent to the east wing (Figure 6.AC; Plate 4), was originally a window on the strength of the survival of a rebate for a wooden frame (Anon. 1966a, 211; see Plate 2). Given the scale of reconstruction work to the walls it is possible, however, that this rebate may have originally formed part of a larger feature which accommodated a doorframe. A blocked opening that extends to ground level, and which was presumably a doorway, is visible in the west wing's eastern wall (Figure 6.AD; Plate 3). The doorway in the southern wall of the west wing (Figure 6.AE) is inserted in a section of the wall identified as modern in date by Waterman (Anon. 1966a, 211). That the internal face of this wall meets in a butt join with the section of curtain wall which forms the western end of Blundell's House, and that the lintel above the doorway itself consists of three narrow, neatly-quarried, joist-like pieces of granite which appear to be either nineteenth or twentieth century in date, is consistent with Waterman's assertion that this wall had been 'recently' rebuilt. That the southern wall and its present day openings are represented in Phillips' plan of the early 1880s (1883, pl. opp.17; 1883-84, pl. opp.160; see Figure 5), indicates that this episode of rebuilding occurred in the nineteenth century. Whether a doorway existed in this wall prior to the reconstruction is impossible to assess in the absence of either any record of this restoration

2.8.6 The lower part of the west wall, which was originally part of the curtain wall, has had two narrow gun loops the southernmost of which (Figure 6.AK; Plate 5) was apparently inserted into it. Not enough of the northern loop (Figure 6.AL) survives to evaluate whether it is an original feature or a later insertion, however, it is reasonable to assume, by analogy with the southern example, that it was also probably inserted. A block of masonry adjacent to the southern gun loop projects into the interior of the west wing (Figure 6.AM; Plate 5). The function of this apparently inserted block of masonry is uncertain, although given its position and the fact that the top of the block is flush with the sill of the loop, it may have been used to support a firearm. The gun loop in the centre of the western gable at attic level (Figure 6.AN) appears to have been an original feature rather than a later insertion. The inner face of the west wing's northern wall is built directly upon a near vertical exposure of bedrock (Figure 6.AO; Plate 4), which presumably forms the back end of a rock-cut terrace upon which the west wing has been constructed. The northern wall of the west wing contains an externally projecting chimney breast that was connected to fireplaces located in both the lower (Figure 6.AP; Plate 4) and upper (Figure 6.AQ; Plate 4) storeys. The lower fireplace has been both raised and reduced in size by the insertion of a block of masonry (Figure 6.AR). The low arch of the upper fireplace survives intact (Plate 4). The profile of a small gabled roof is preserved in outline in the harling of the inner face of the chimney projection on the west wing's northern wall (Figure 6.AS; Plate 4). Similar small, dormer-like gable roofs extending, perpendicular to the main alignment of the roof, towards the inner face of chimney projections are known from the northern wall of Cairsluith Castle, Galloway (RCAHMCS 1914, 151-154, no.282) and Terregles Castle, Dumfries (cf. Maxwell-Irving 2000, fig.344). The function of these, not uncommon, features appears to have been to prevent water gathering at the base of the chimney projection where it emerges from the roof (S.Stevenson pers.comm.). A small opening of uncertain purpose (Figure 6.AT) is present in the northern wall of the upper storey to the west of the fireplace.

- 2.8.10 The ground floor of the east wing contains the remains of a fireplace in its east wall (Figure 6.BE; Plate 8) that is serviced by a projecting chimney breast. The fireplace has, at some point, been reduced in both height and width - presumably to improve its ability to draw smoke. The east wall also contains three openings, probably windows, set in embrasures which extend to floor level. The southernmost window is blocked (Figure 6.BF), the central window badly damaged (Figure 6.BG), and the northernmost window (Figure 6.BH) reduced in width. Waterman plausibly interpreted the secondary feature (Figure 6.BI; Plate 9) at ground floor level in the eastern side of the northern wall as a roughly-inserted fireplace. At ground floor level the northern wall also contains a now blocked central window (Figure 6.BJ; Plate 9) and a smaller window to the west (Figure 6.BK; Plate 9) which butts against the dividing wall between the two wings. Also situated in the north wall at ground floor level, but located approximately 0.4 to 0.5 metres below the level of the windows, are the apparent traces of the relieving arch (Figure 6.BL; Plate 9) whose investigation prompted the location of Trench 2 (see Paragraph 3.1.1). Excavation failed to demonstrate whether this feature was originally related to a barrel vault, stairwell or entrance in the northern part of the east wing. Apart from the already noted blocked opening (Figure 6.AD) in the dividing wall between the two wings (see Paragraph 2.8.4), the east wing's west wall also contains an opening (Figure 6.BM; Plate 6) in the middle of the wall which would originally have enabled egress between the two wings at ground floor level. This

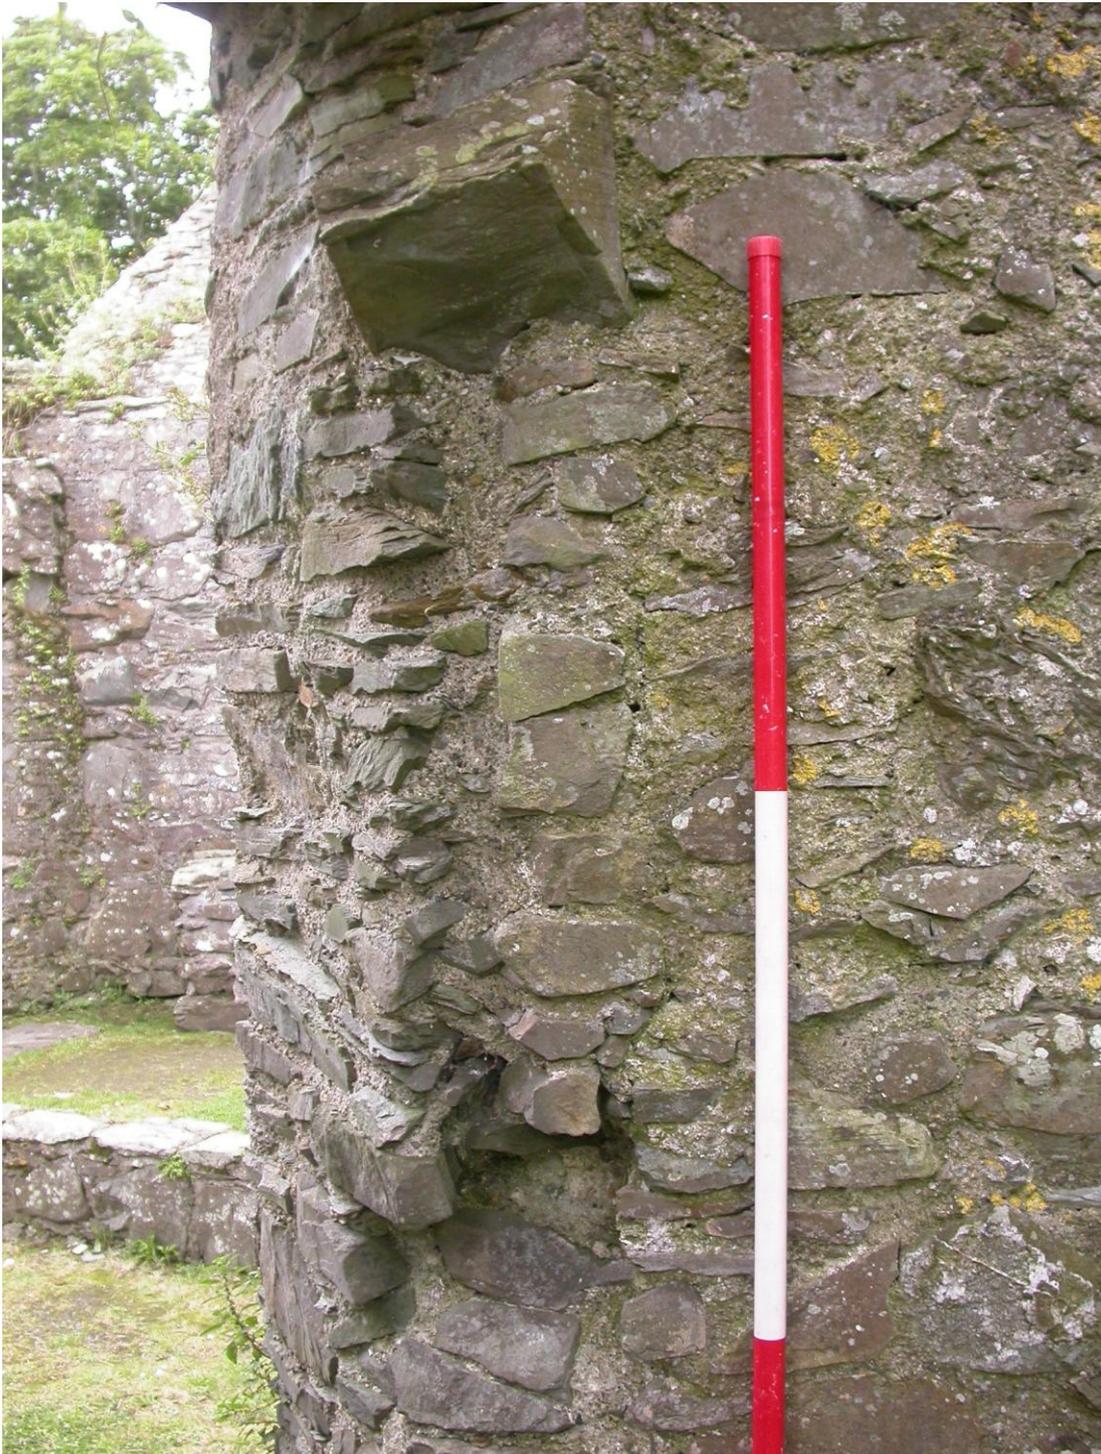
Plate 2: Surviving rebate for a wooden frame preserved in the western edge of the eastern opening in the north wall of the west wing (AC), looking southwest. Scale divisions 0.5 metres.

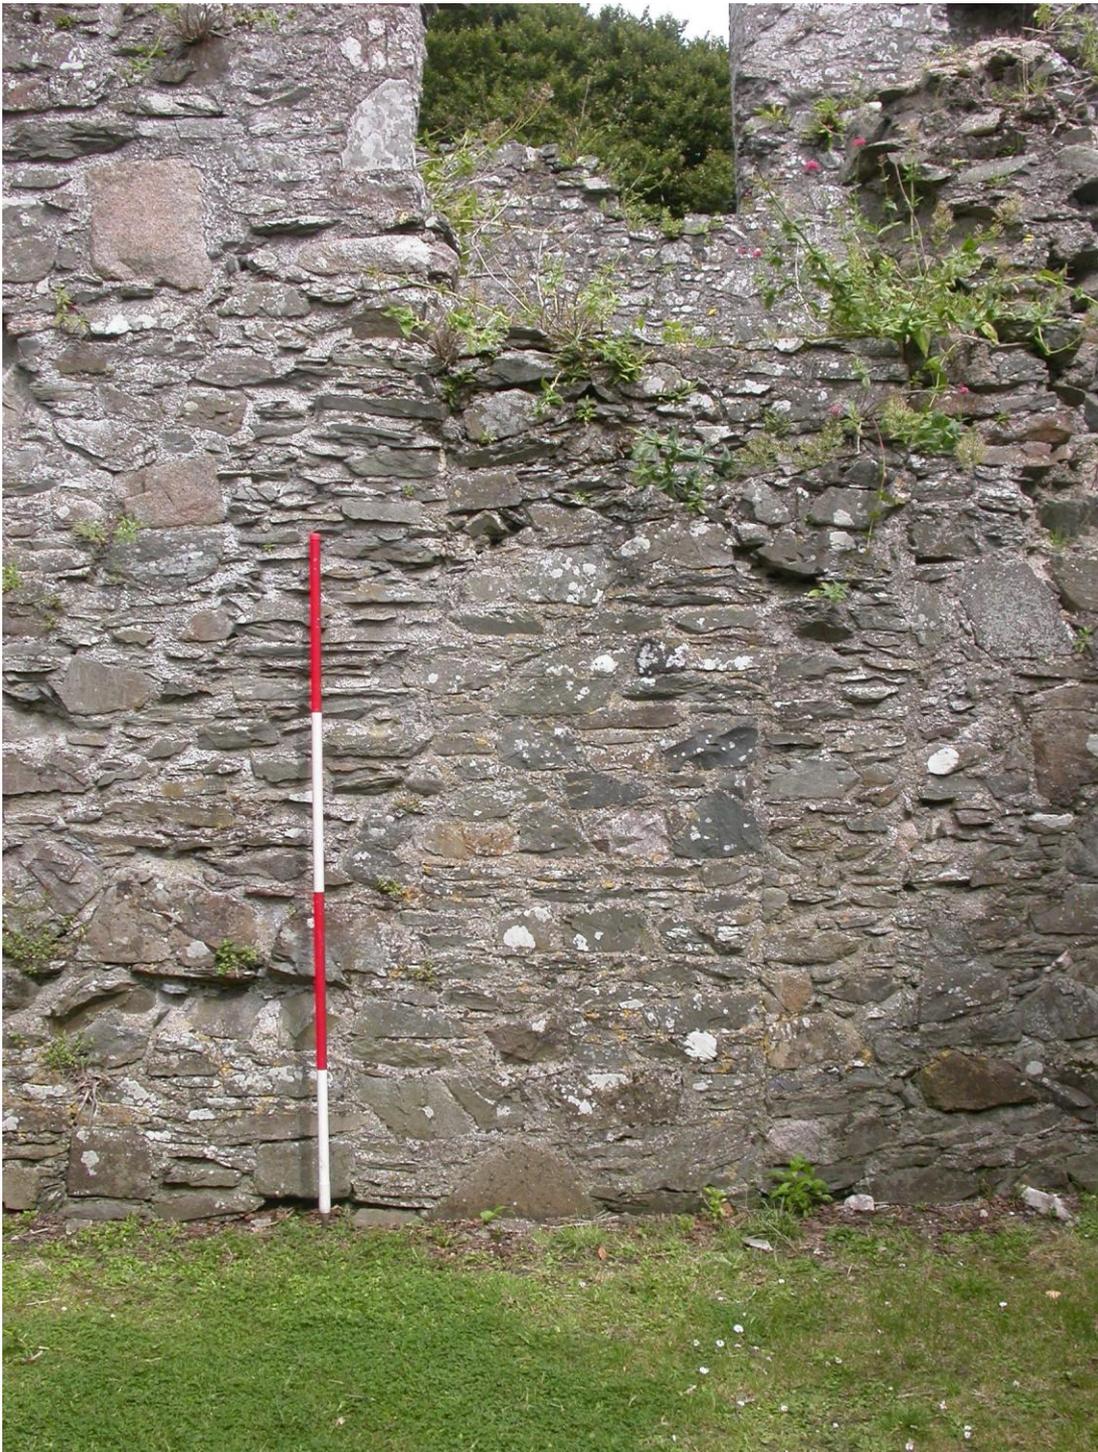
Plate 3: Blocked opening that extends to ground level in the west wing's eastern wall (AD), looking east. Scale 2.0 metres.

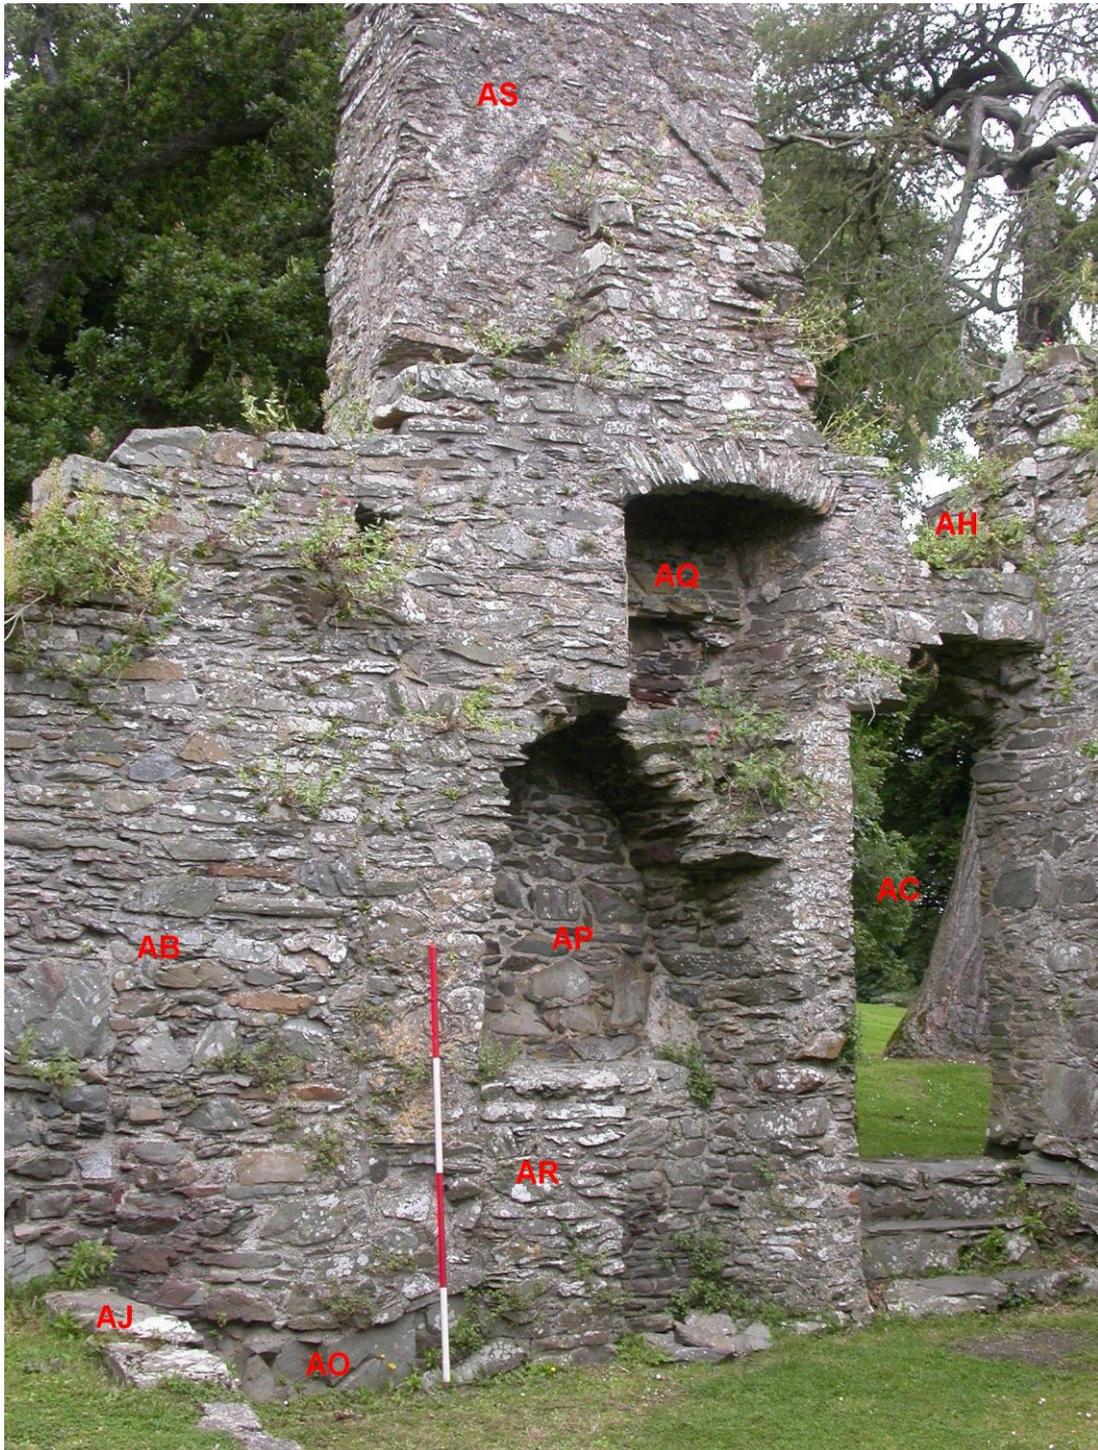
Plate 4: Part of the northern wall of the west wing of Blundell's House, looking northeast. Scale 2.0 metres.
[AB: blocked doorway; AC: window or door frame; AH: splayed window opening; AJ: internal revetment wall; AO: exposed bedrock;
AP: narrowed and raised fireplace; AQ: fireplace; AR: inserted block of masonry; AS: profile of small gabled roof].

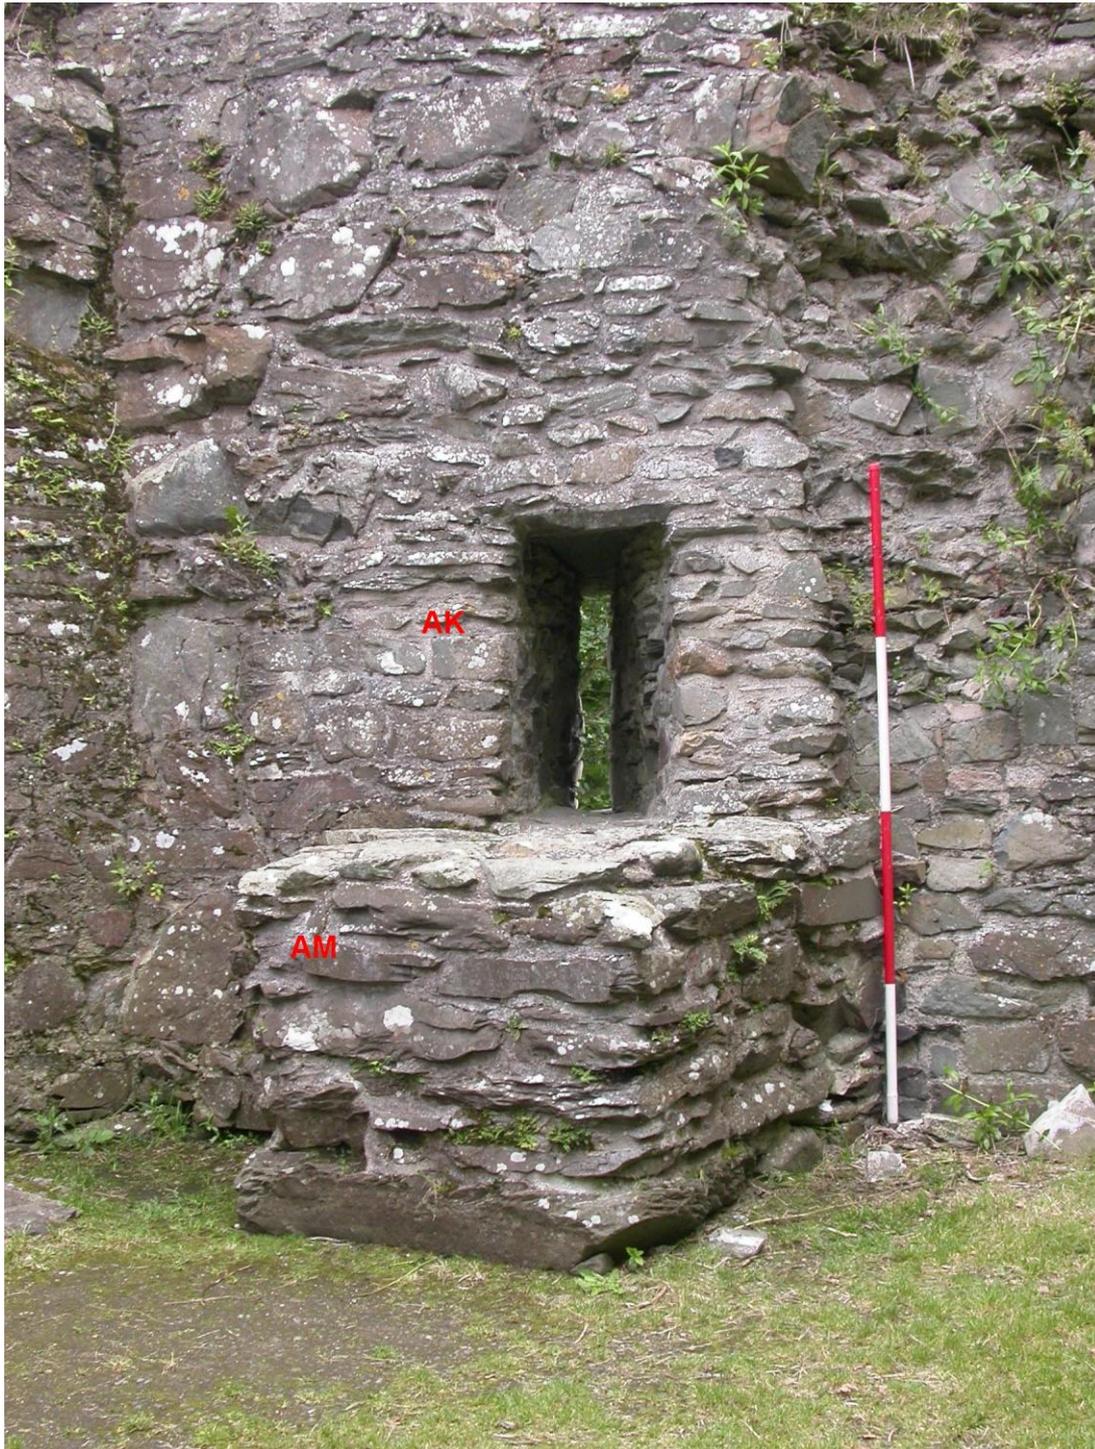
Plate 5: Gun loop (AK), apparently inserted into the lower part of the west wall of the west wing, and associated projecting block of masonry (AM), looking southwest. Scale 2.0 metres.

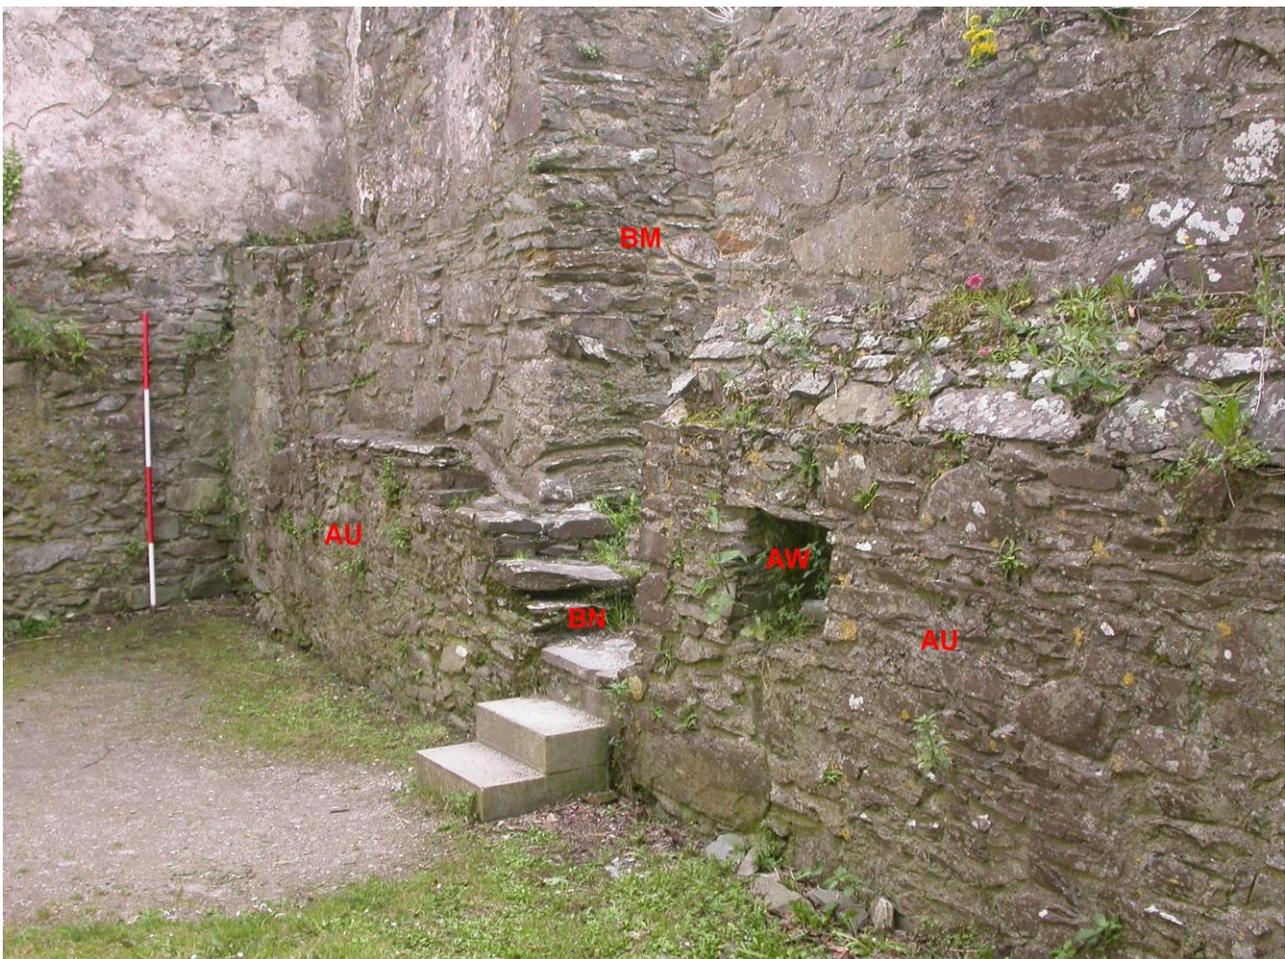
Plate 6: The western wall of the east wing, showing revetment wall that forms the off-set upon the eastern face of the dividing wall between the two wings (AU), the southern cupboard (AV) built into this off-set, the opening (BM) in the middle of the wall which enabled egress between the two wings and the modern cut through this opening (BN), looking southwest. Scale 2.0 metres.

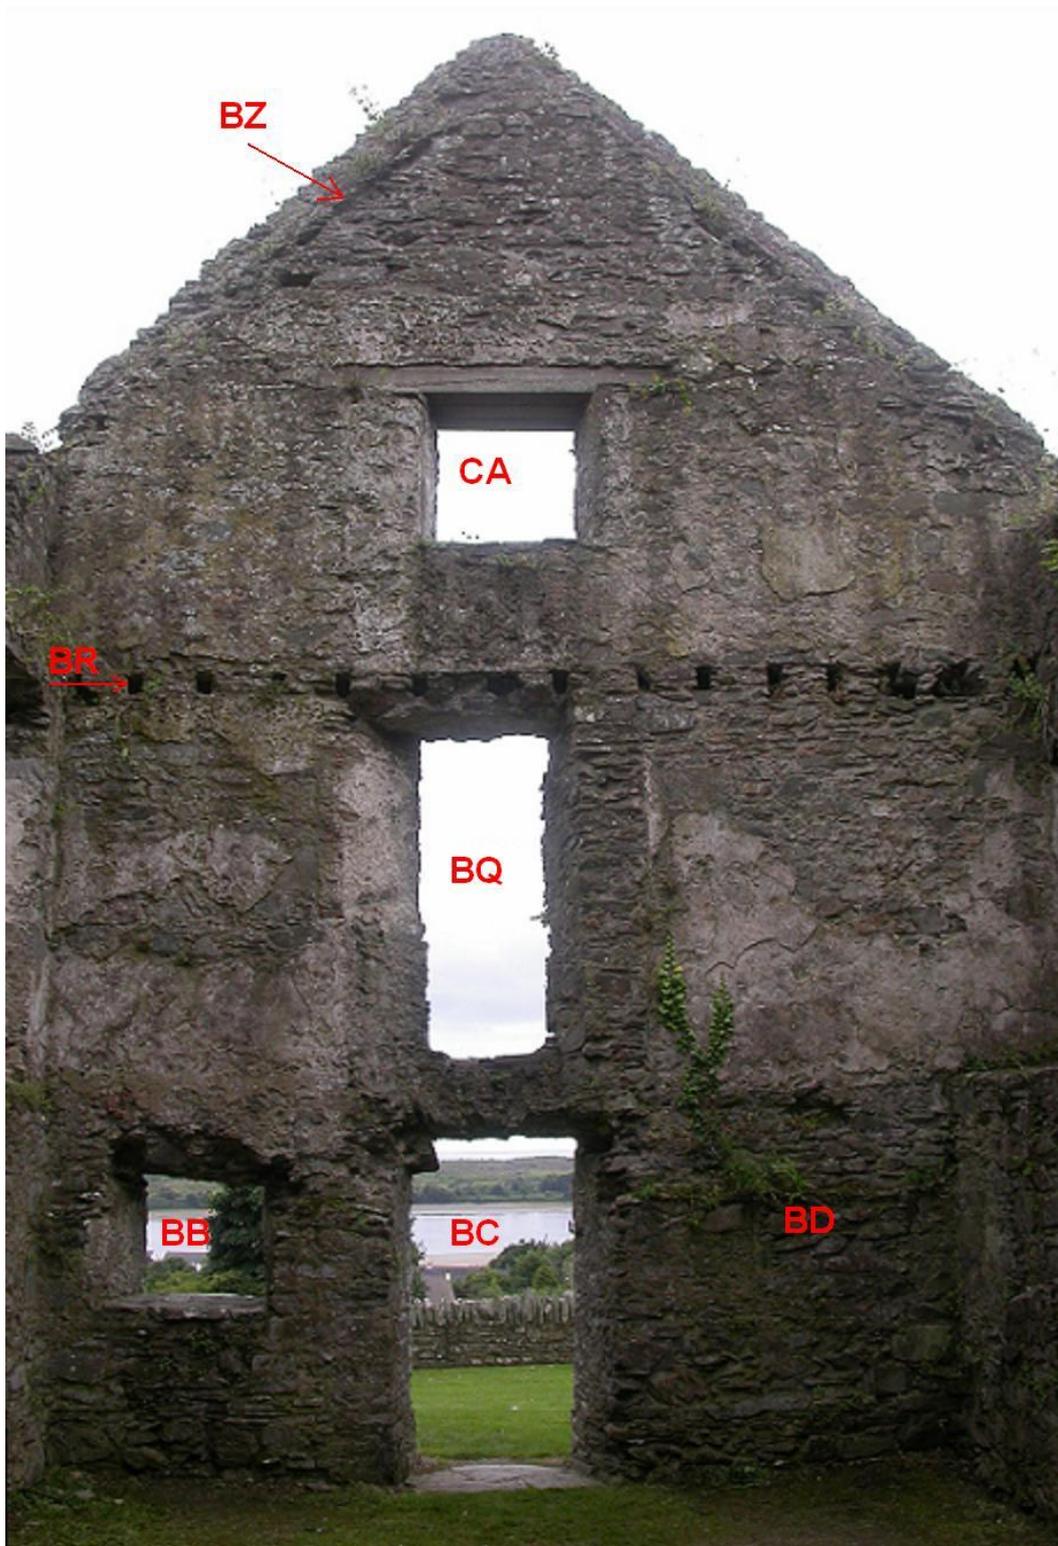
Plate 7: Southern wall of east wing, showing eastern basement window (BB), central basement window apparently extended to form a doorway (BC), blocked western basement window (BD), ground floor opening (BQ), supporting holes for joists (BR), preserved line of roofing 'slates' (BZ) and attic window (CA), looking south.

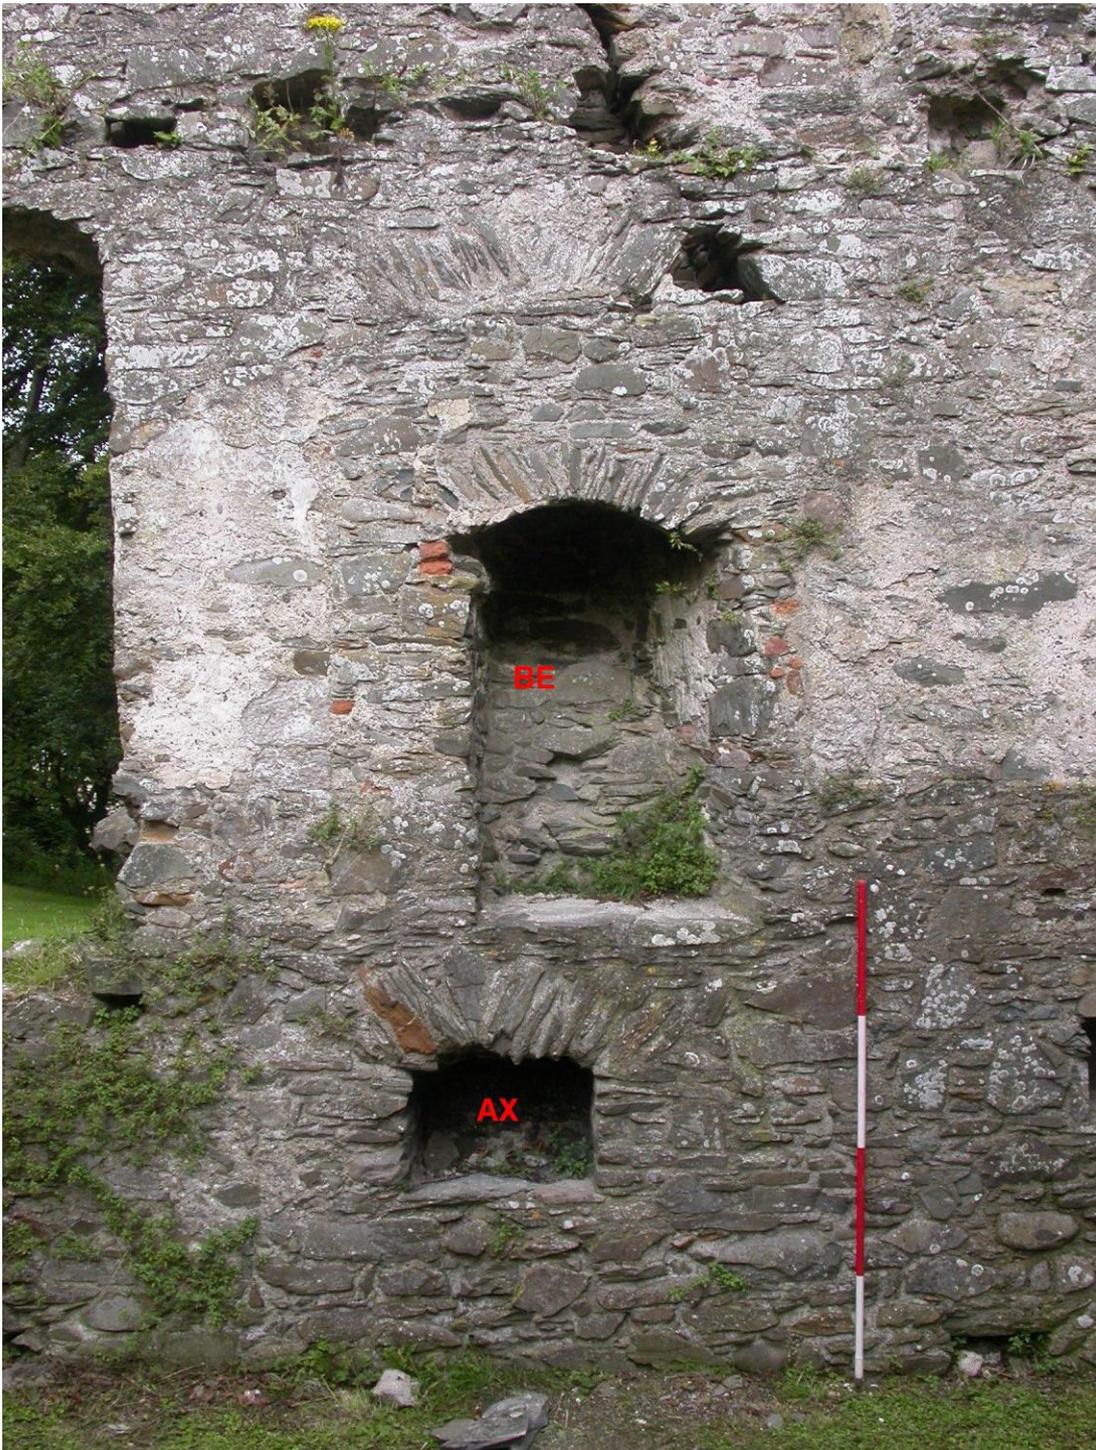
Plate 8: Part of the eastern wall of the east wing, showing internally-blocked fireplace (AX), ground-floor fireplace (BE), looking east. Also visible in the top of the photograph are the supporting holes for the crossbeams that carried the attic floor.

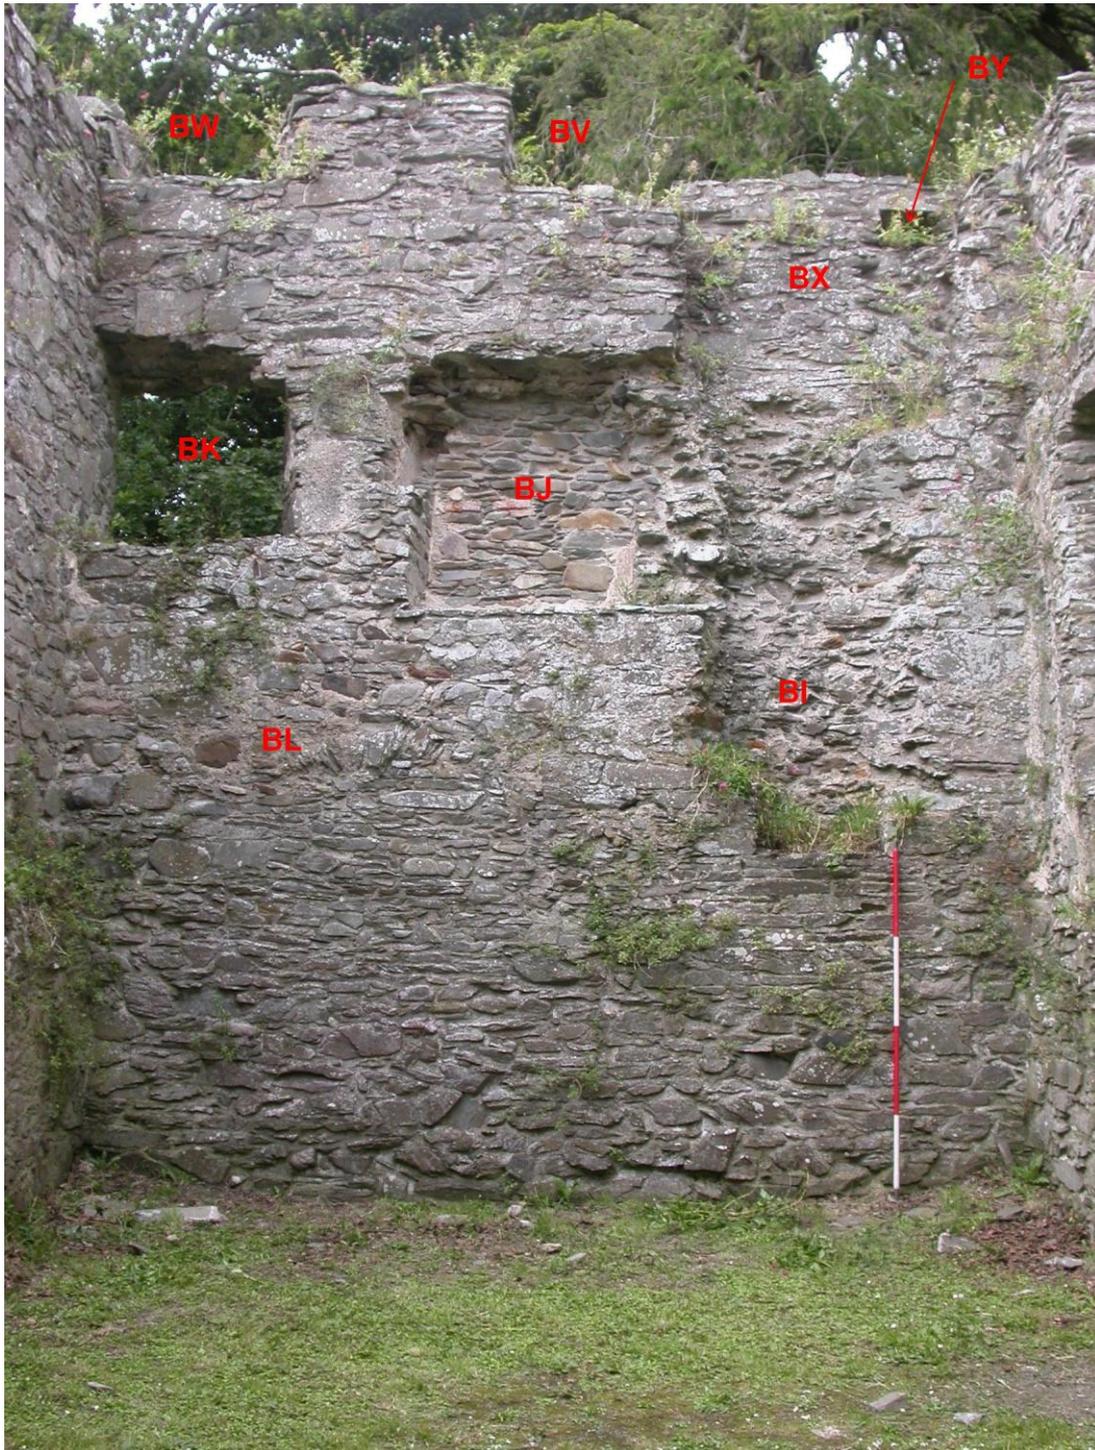
Plate 9: Inner-face of the north wall of the east wing, looking north. Scale 2.0 metres.

[BI: crudely-inserted fireplace; BJ: blocked window; BK: small window; BL: possible relieving arch; BV: window; BW: window; BX: recess of unknown purpose, possibly converted for use as chimney flue; BY: opening of unknown purpose].

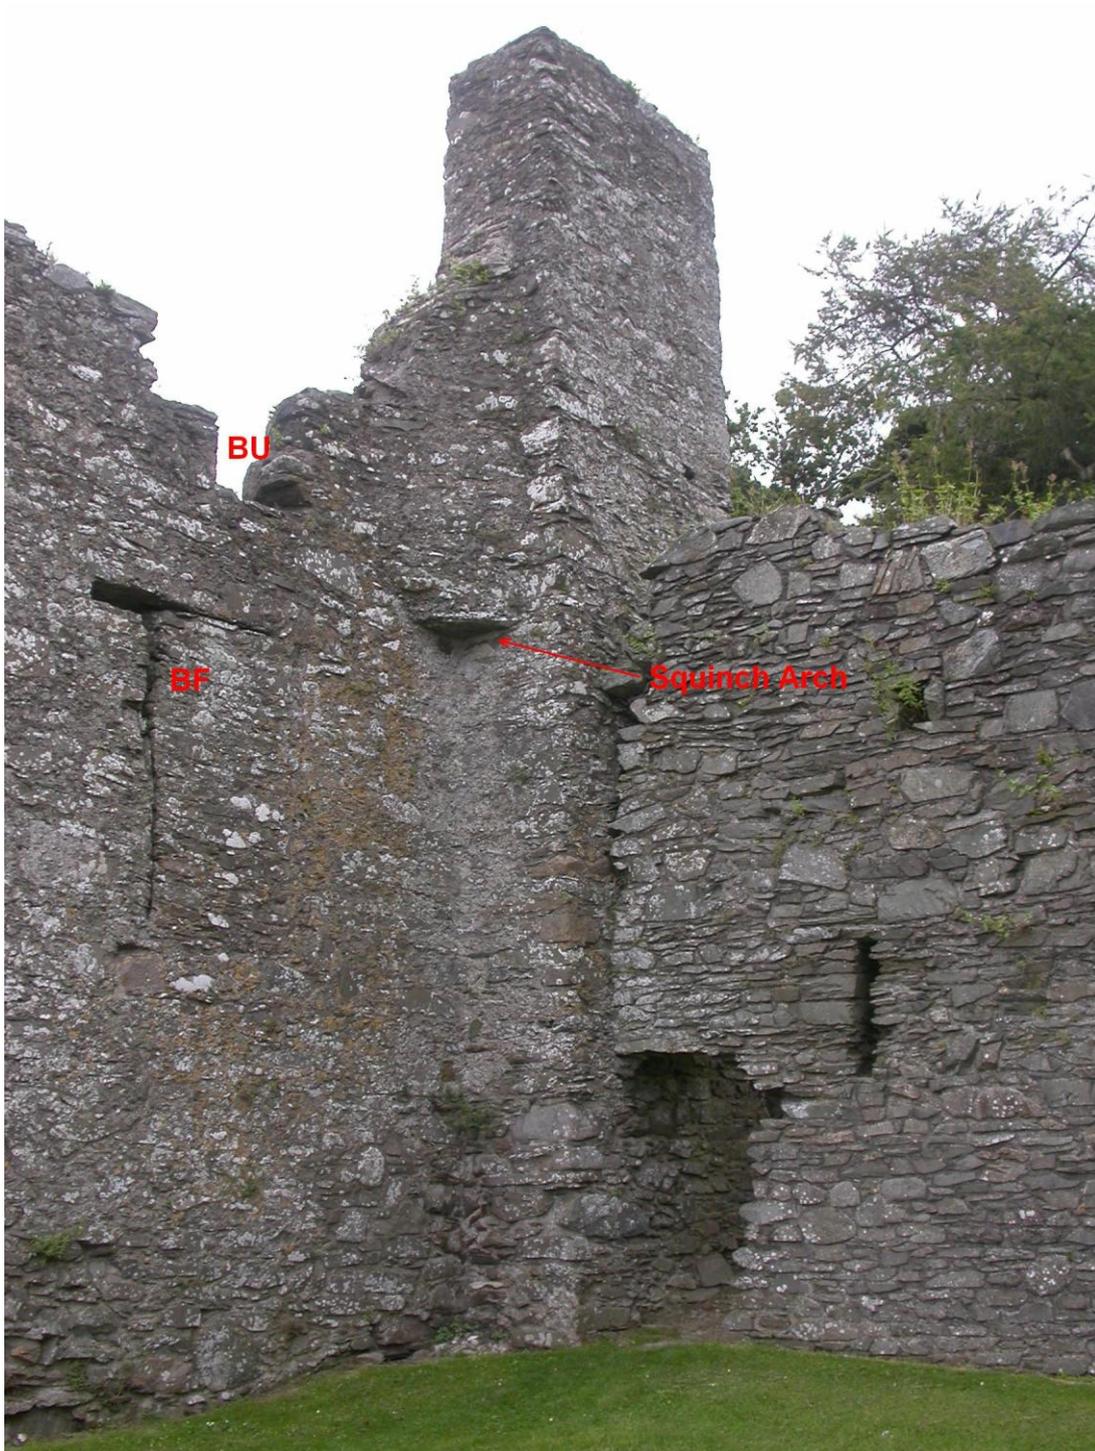
Plate 10: The external face of the eastern wall of the east wing, showing blocked window (BF), attic-floor window (BU) and the squinch arch which bridges the angle between the east wall and the southern face of the chimney, looking northwest.
