Excavation at Blundell's House, Dundrum Castle,
County Down 2009

Data Structure Report: Site Evaluation and Excavation at Blundell's House, Dundrum Castle, County Down 2009

**(CAF DSR 071)
(Licence No. AE/09/36)
(SMR No. DOW 044:006)**

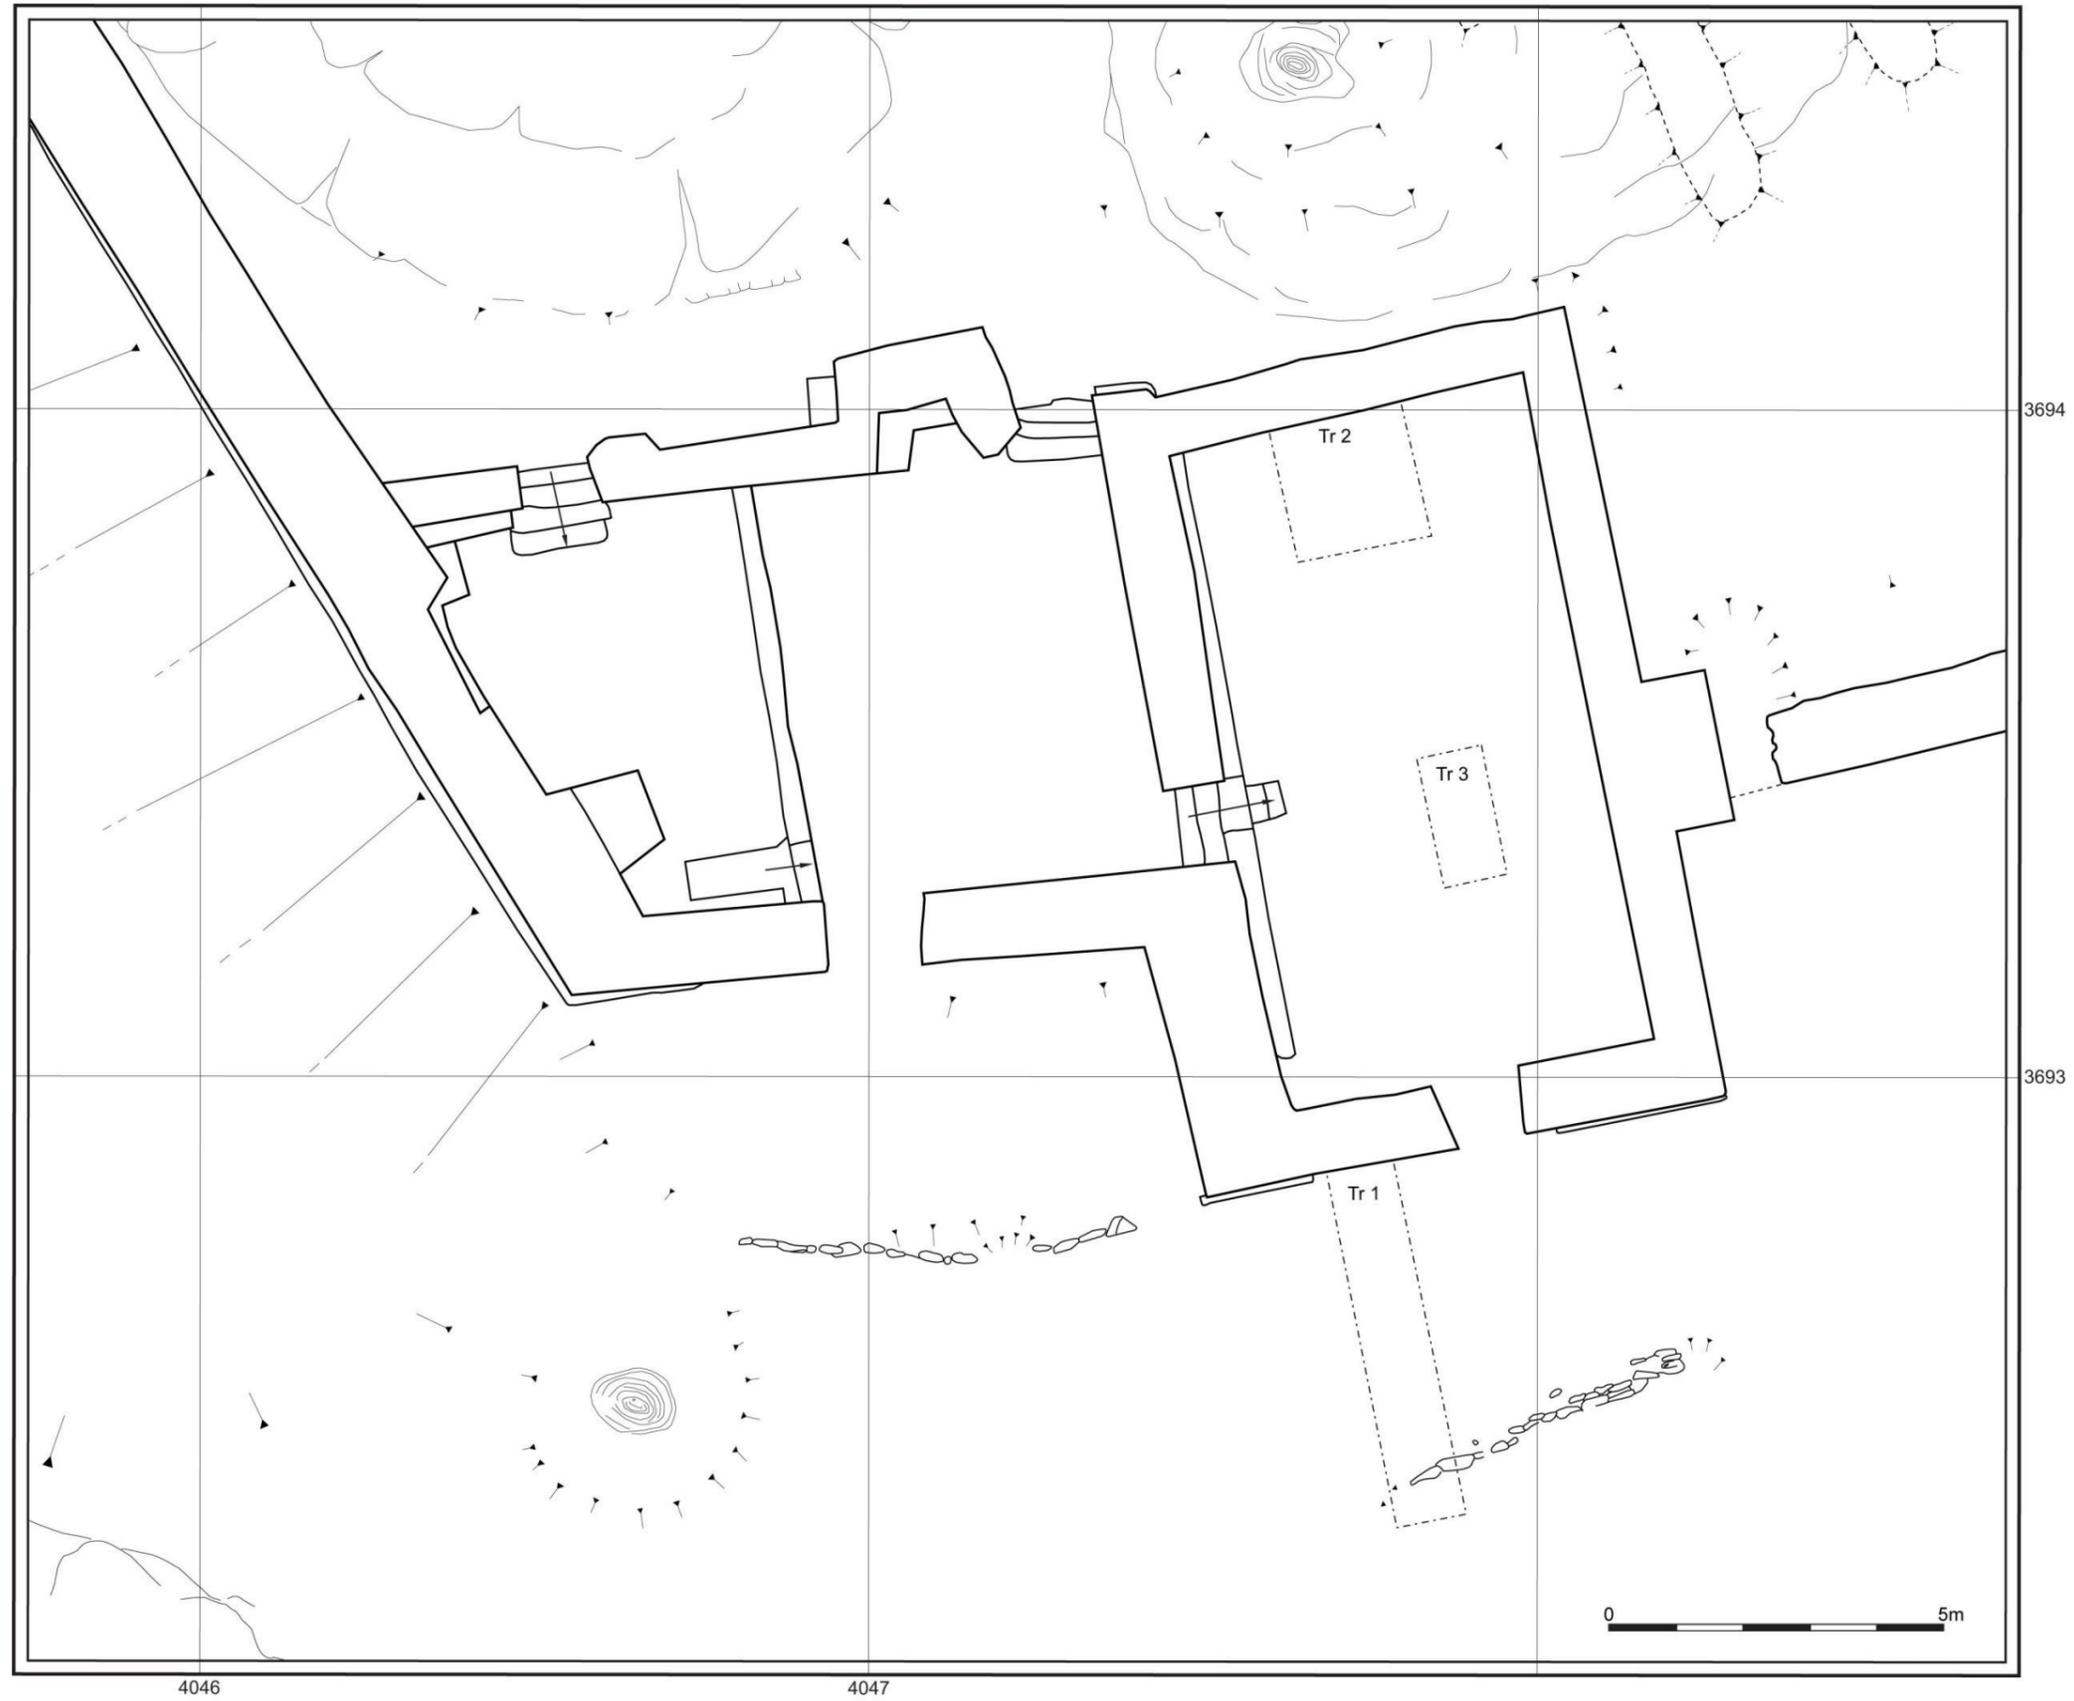
Figure 7: Plan of Blundell's House showing location of excavation trenches.

Trench 1 (length: 5.5 metres; width: 1.0 metre) was intended to investigate both the character of the foundations of Blundell's House and the nature of an apparently collapsed masonry located immediately to the south of the east wing.

Trench 2 (length: 2.0 metres; width: 2.0 metres) was primarily intended to uncover any surviving evidence of a supporting wall whose presence was suggested by the traces of an apparent barrel vault, relieving arch or stairwell preserved in the internal face of the northern wall of the east wing. By extending the trench up to the northern wall of the east wing it was intended to address the question of the building's foundations.

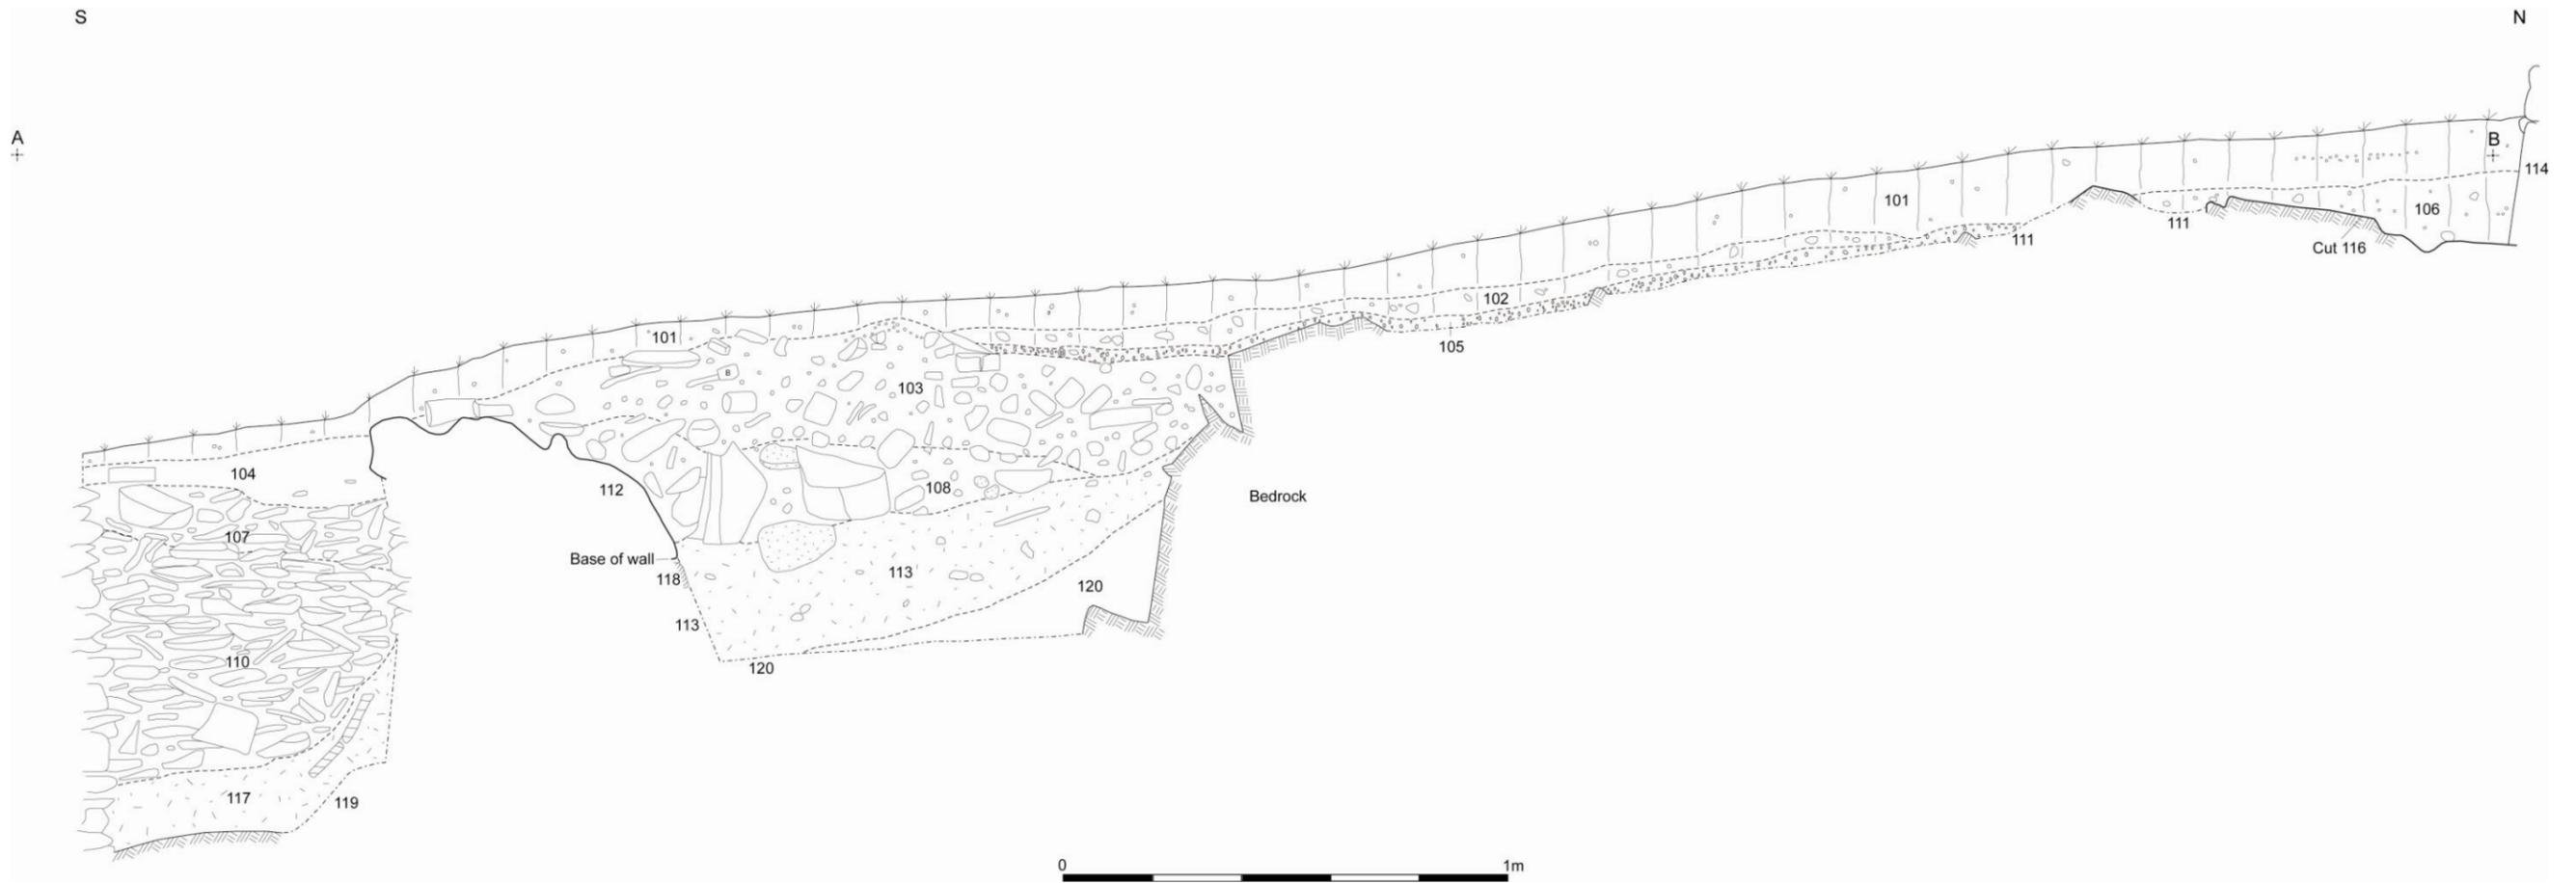
Figure 8: East-facing section of Trench 1.

3.3.4 Following the excavation of the topsoil and other superficial deposits described above (Paragraphs 3.3.2 to 3.3.3), the stratigraphic sequence within Trench 1 divided into two parts. In the southern half of the trench there was a series of dumped deposits (Context Nos.103 and 108) retained by a terrace revetment (Context No.112), and a second series of apparently contemporary dumped deposits (Context Nos.104, 107, 109 and 110) that were located below and to the south of the revetment (Context No.112). These dumped deposits, and the retaining revetment that separated them, formed parts of two adjacent terraces associated with a phase of landscaping that is dated to the last two to three decades of the eighteenth century. In the northern part of the trench immediately adjacent to the east wing there was a sequence of contexts (i.e. Context Nos.115, 121 and 116) associated with the construction of the east wing's southern wall (Context No.114), which is dated on architectural grounds to around the 1630s (see Paragraph 2.9.1). Separating these two sets of contexts was a relatively flat exposure of bedrock and a sterile subsoil made up of shattered bedrock (Context No.111), which extended between 0.65 and 2.95 metres from the northern end of Trench 1.

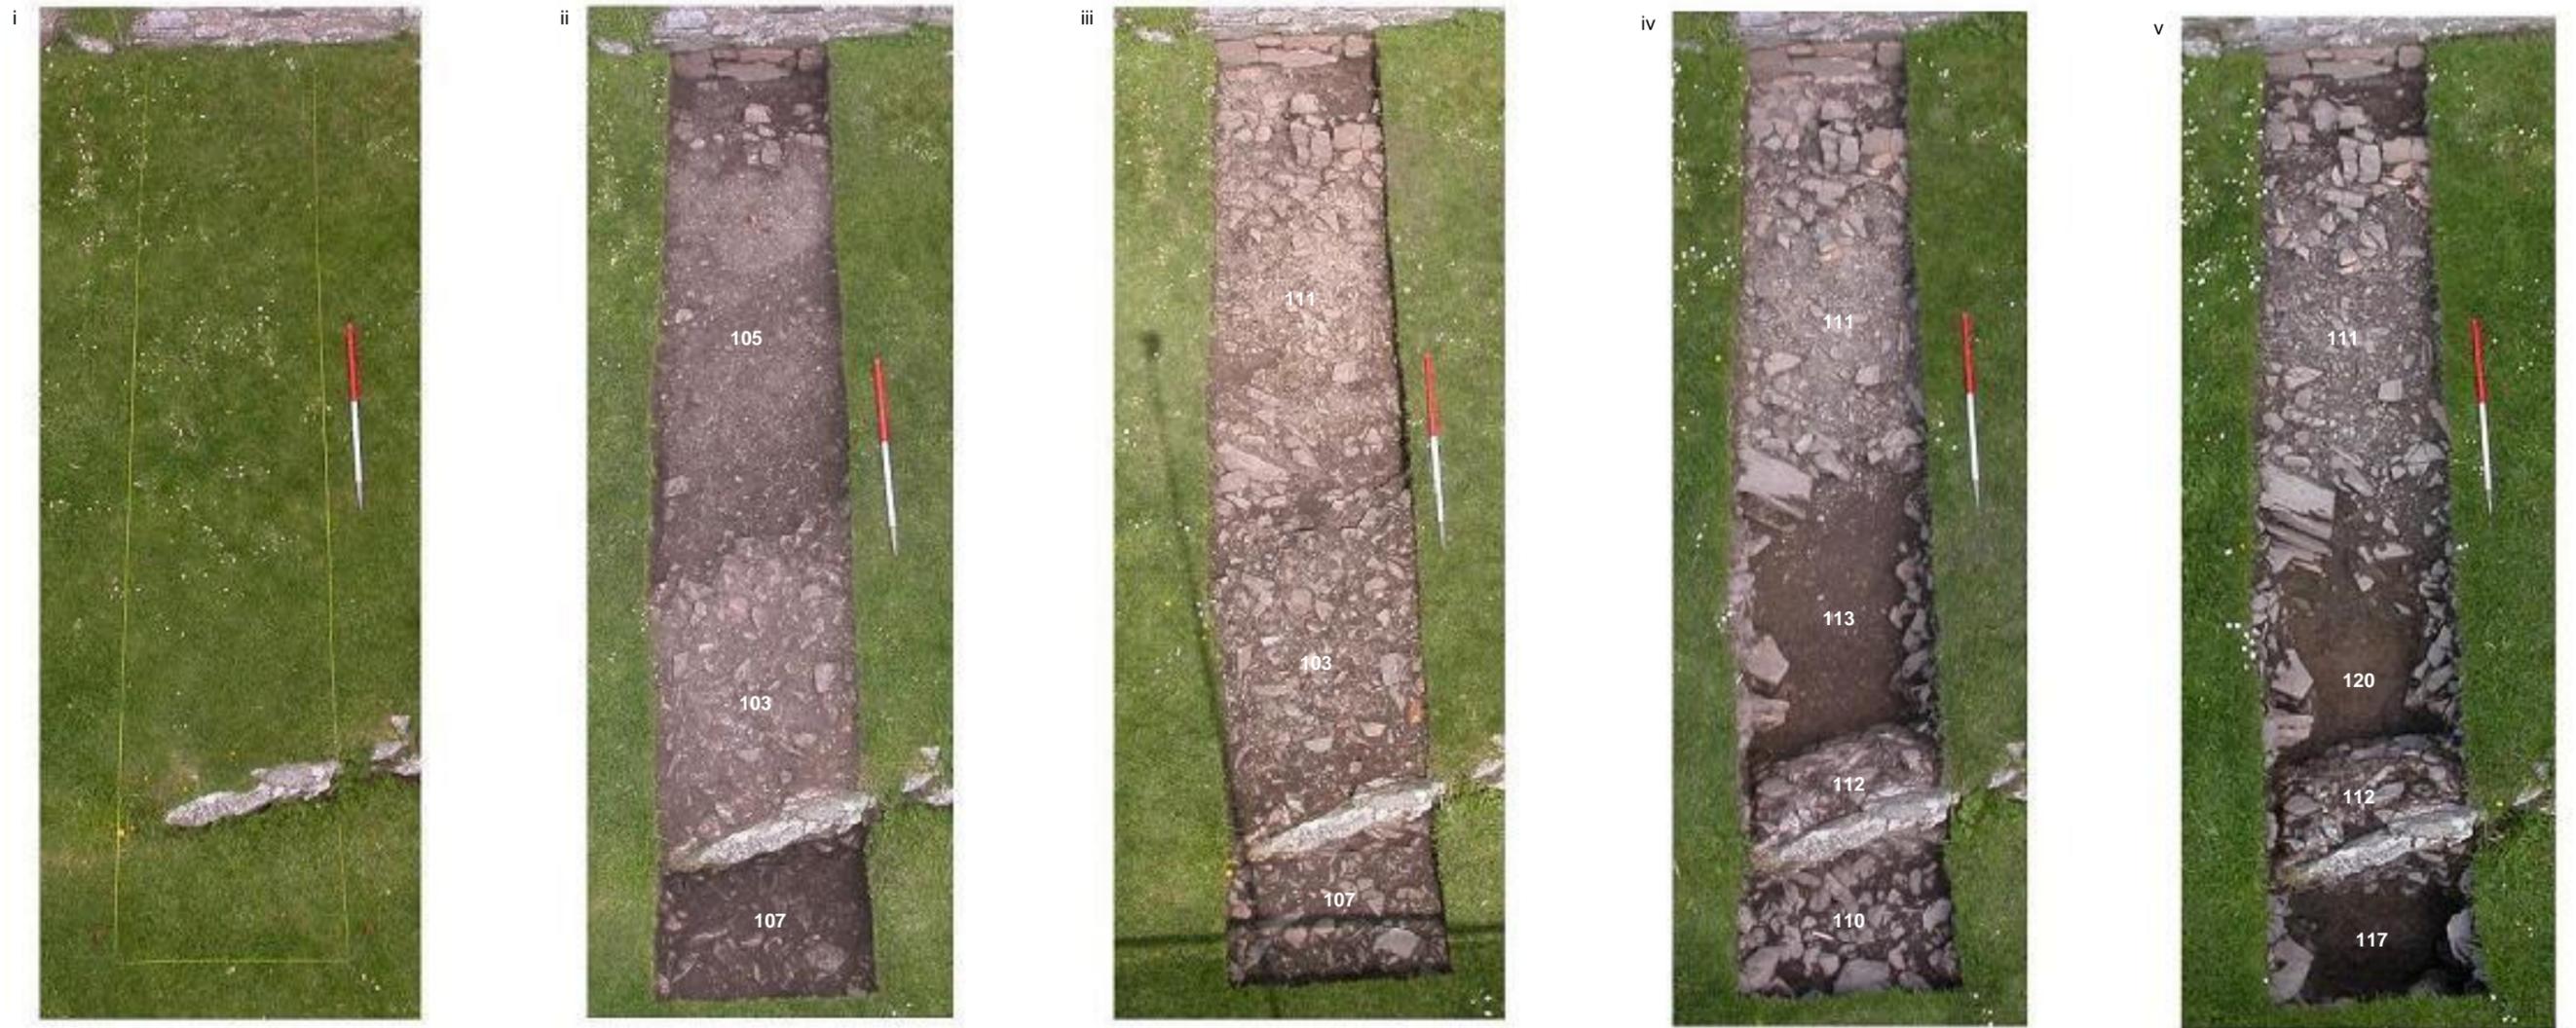
Plate 11: Successive photographs of Trench 1, looking north from an elevated position. From left to right: **i** - Trench 1 prior to excavation; **ii** - following excavation of superficial deposits of topsoil (101), stone-rich humic silty clay loam deposits (102 and 106) and redeposited layer of silty clay loam and clay (104), showing possible levelling deposit of small stones (105) and dumped deposit of stones in silty loam (107 and 103) and mortared stone revetment (112); **iii** - following excavation of the possible levelling deposit of small stones (105), showing dumped deposits of stones in silty loam (107 and 103), mortared stone revetment (112) and natural subsoil (111); **iv** - following excavation of dumped deposit of small stones in a silty loam matrix (109) and dumped deposit of stones with air voids (108), showing dumped deposit of stones with air voids (110), mortared stone revetment (112), mortar-rich, silty loam, buried soil horizon (113) and natural subsoil (111); and **v** - following excavation of dumped deposit of stones with air voids (110) and mortar-rich, silty loam, buried soil horizon(s) (113 and 117), showing natural subsoil (111, 119 and 120) and exposed bedrock. Scale 1.0 metre.

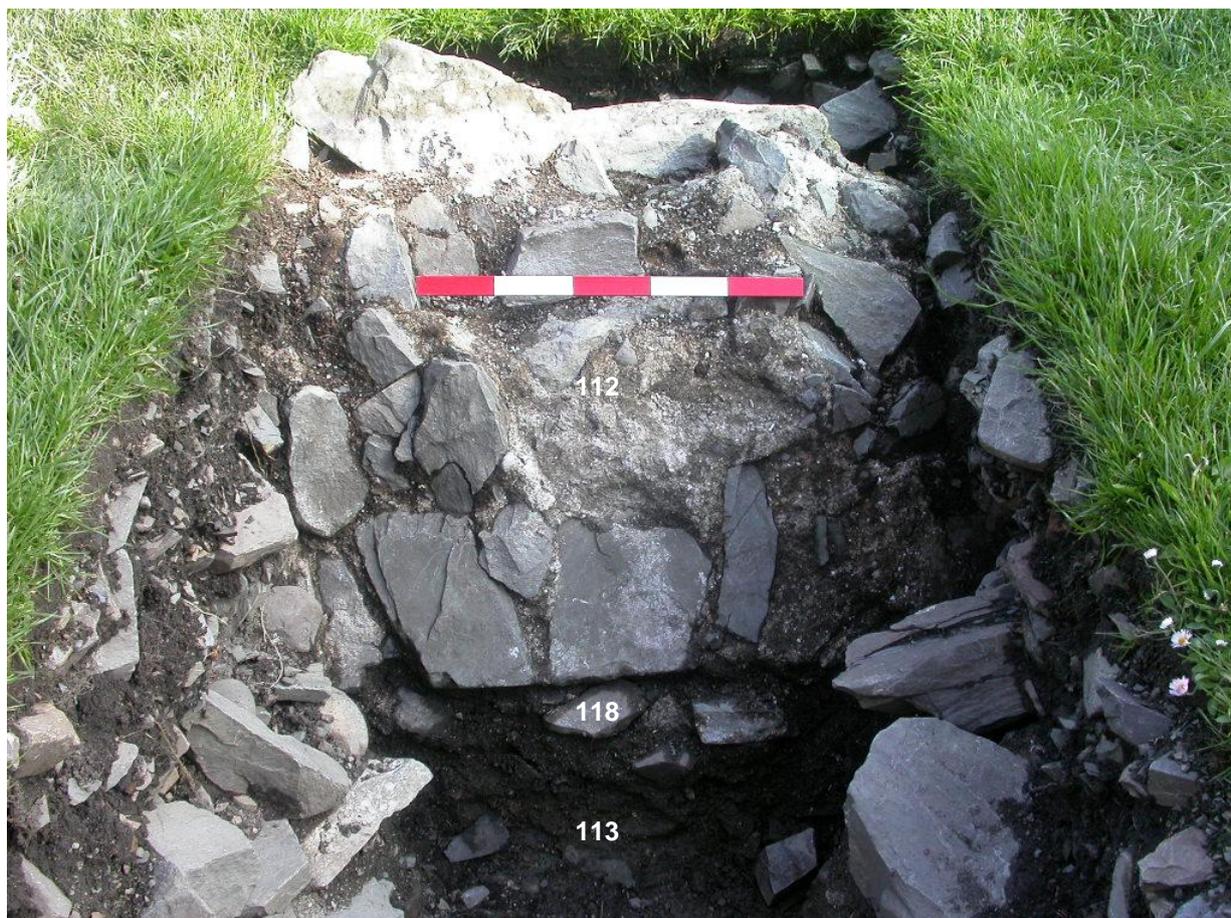
Plate 12: Mortared stone revetment (112), its underlying foundation deposit (118) and the underlying mortar-rich, silty loam, buried soil horizon (113), looking south. Scale 0.5 metres.

- 3.3.6 Prior to excavation, the masonry revetment (Context No.112) was assumed to be either the remains of a collapsed or demolished wall associated with an earlier phase of building on the site of the east wing of Blundell's House, or an exposure of natural bedrock that had been consolidated with lime mortar. Excavation demonstrated, however, that it was an *in situ* revetment and that its exposed surface was finished in a manner intended to resemble a natural outcrop of bedrock. The 'naturalistic' appearance of the revetment was further enhanced by building it at a slight angle, rather than parallel to, the southern wall of the east wing. Today, the revetment is visible on the surface for a distance of 5.0 metres (see Figure 7), although, it may originally have been slightly longer in length. It was constructed at an angle of 45° degrees to the horizontal upon a single foundation course of reused masonry rubble bonded with lime mortar (Context No.118). It stood to a height of 0.40 metres and was at least 0.25 metres thick. Once exposed the revetment's northern side was revealed to have been competently built with a neatly 'faced' appearance. The foundation course (Context No.118) included reused stone with lime mortar adhering to it and isolated lumps of mortar, which were both presumably derived from an episode of collapse or demolition of Blundell's House.

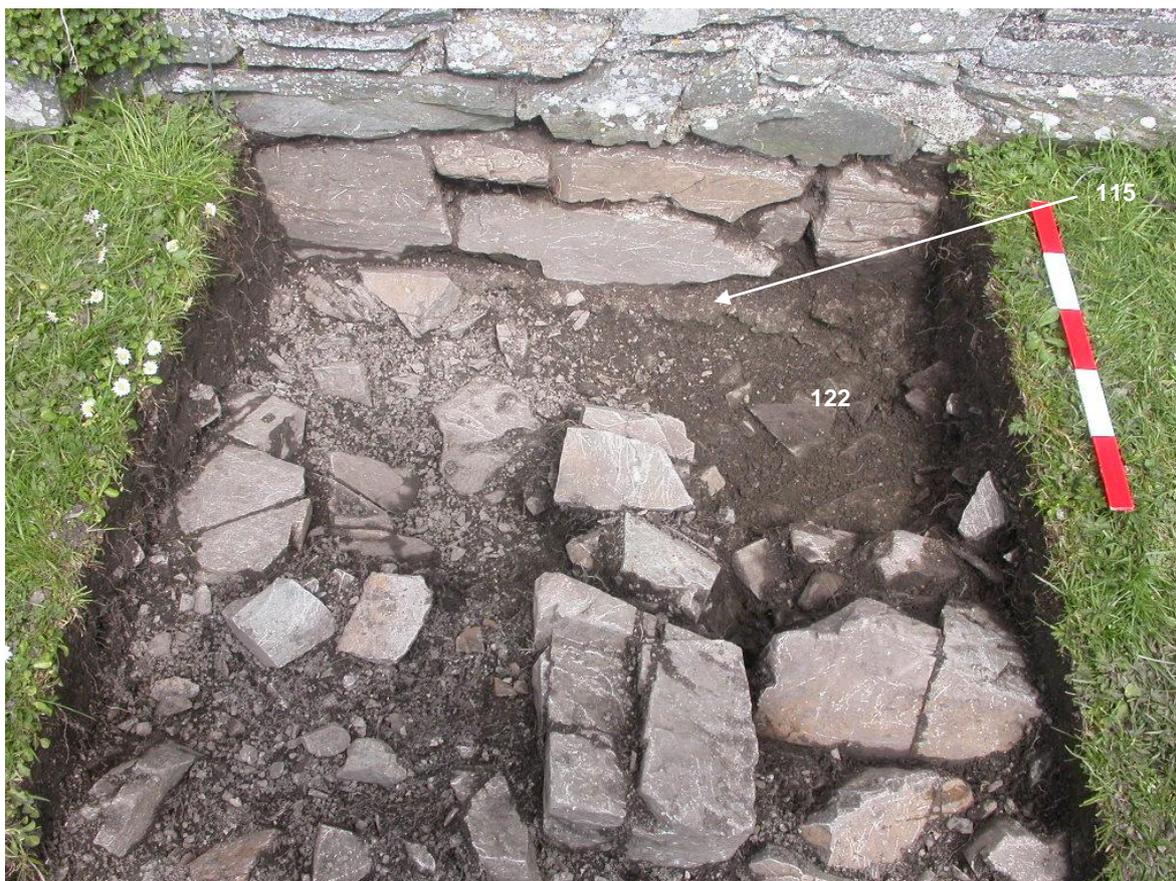
Plate 13: Northern part of Trench 1, following excavation of possible levelling deposit of small stones (105), showing localised deposit of silty clay loam (122) and mortar 'pad' (115) immediately adjacent to southern wall of the east wing of Blundell's House (114), looking north. Scale 0.5 metres.

3.3.12 At the northern end of Trench 1, the excavation of the localised layer of silty clay loam (Context No.122; see Paragraph 3.3.3) exposed an uneven surface in the bedrock (Context No.116) located immediately adjacent to the southern wall of the east wing (Context No.114). Although no tool marks were observed, the surface's proximity to the building, and the fact that it sloped towards the north against the prevailing direction of slope of the bedrock, suggested that it was artificial and represented the southern edge of a bedrock-cut terrace that the east wing of Blundell's House was built upon. The southern edge of this cut began 0.65 metres from the building's southern wall and had a maximum exposed depth of 0.11 metres. Of the east wing's southern wall, only a single course of masonry extended approximately 0.3 metres below the modern ground surface. This course of stone was built directly on to either the bedrock cut surface (Context No.116) or, where the surface of the bedrock was slightly deeper on the eastern side of the trench, upon a thin pad of lime mortar (Context No.115; maximum depth 0.03 metres) laid directly over a thin foundation course of otherwise unbonded stones (Context No.121; maximum depth also 0.03 metres). A number of the stones in this foundation course had relict traces of lime mortar adhering to them suggesting that they were derived from the collapsed or demolished remains of an earlier wall. It is possible that the localised deposit of silty clay loam (Context No.122) that filled the eastern part of the cut (Context No.116) was an original backfill, however, in the absence of any finds from the deposit this is impossible to verify. As the southern wall of the east wing is dated on architectural grounds to around the 1630s (see Paragraph 2.9.1), it is reasonable to assume that this date can be extended to the terrace cut through the bedrock (Context No.116) and the lime mortar pad (Context No.115) and associated foundation course (Context No.121). There is no evidence to suggest that the terrace may have been cut to accommodate an earlier structure constructed on the site of the east wing.

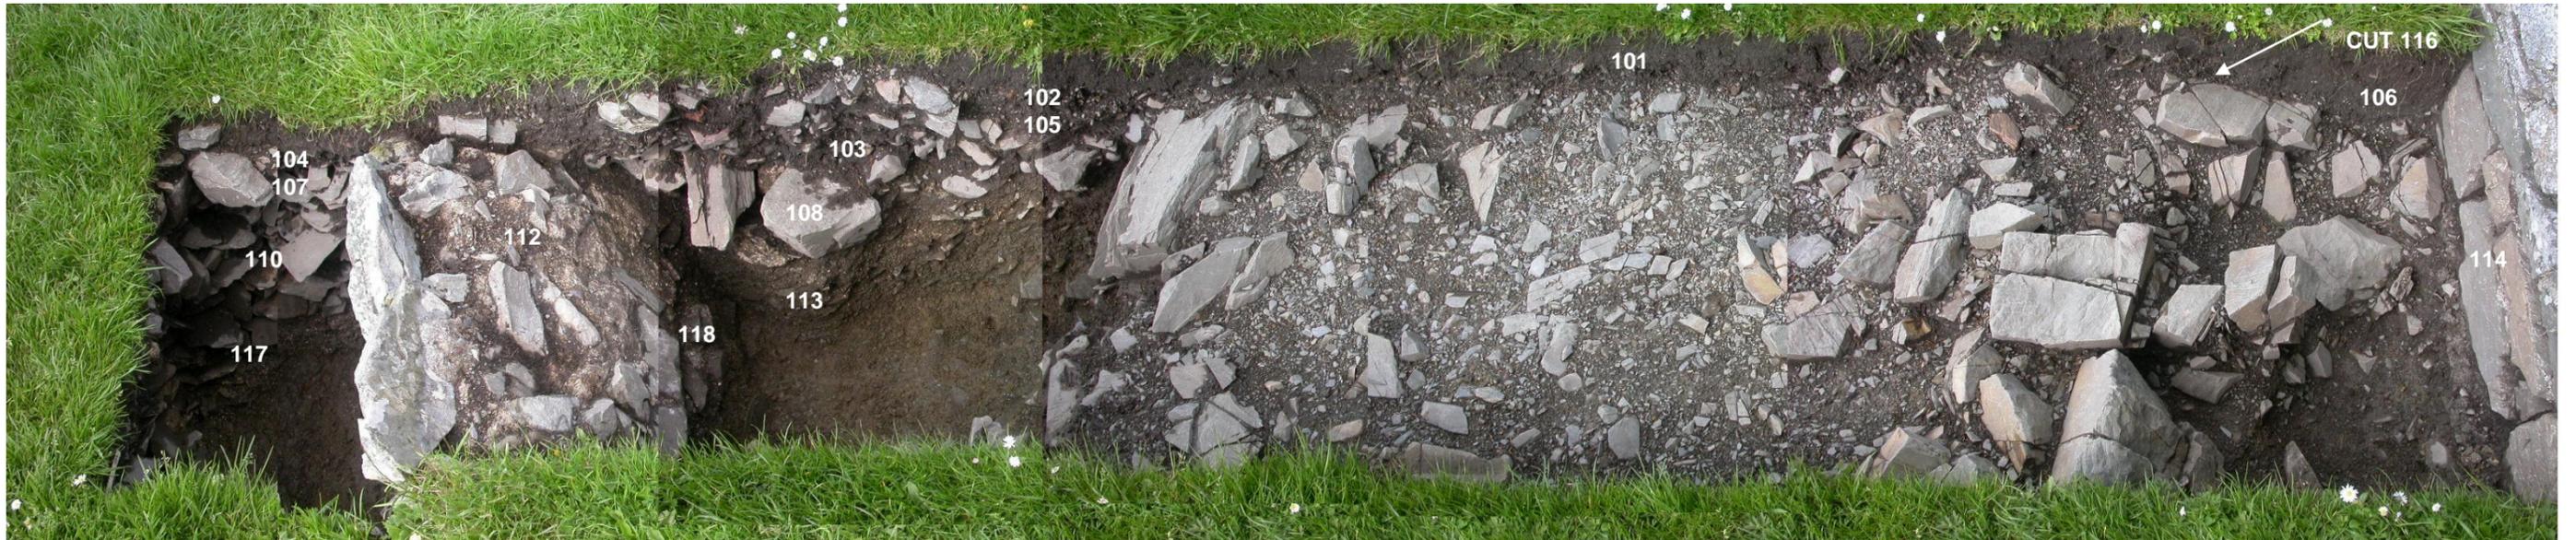
Plate 14: East-facing section of Trench 1 (photographic montage).

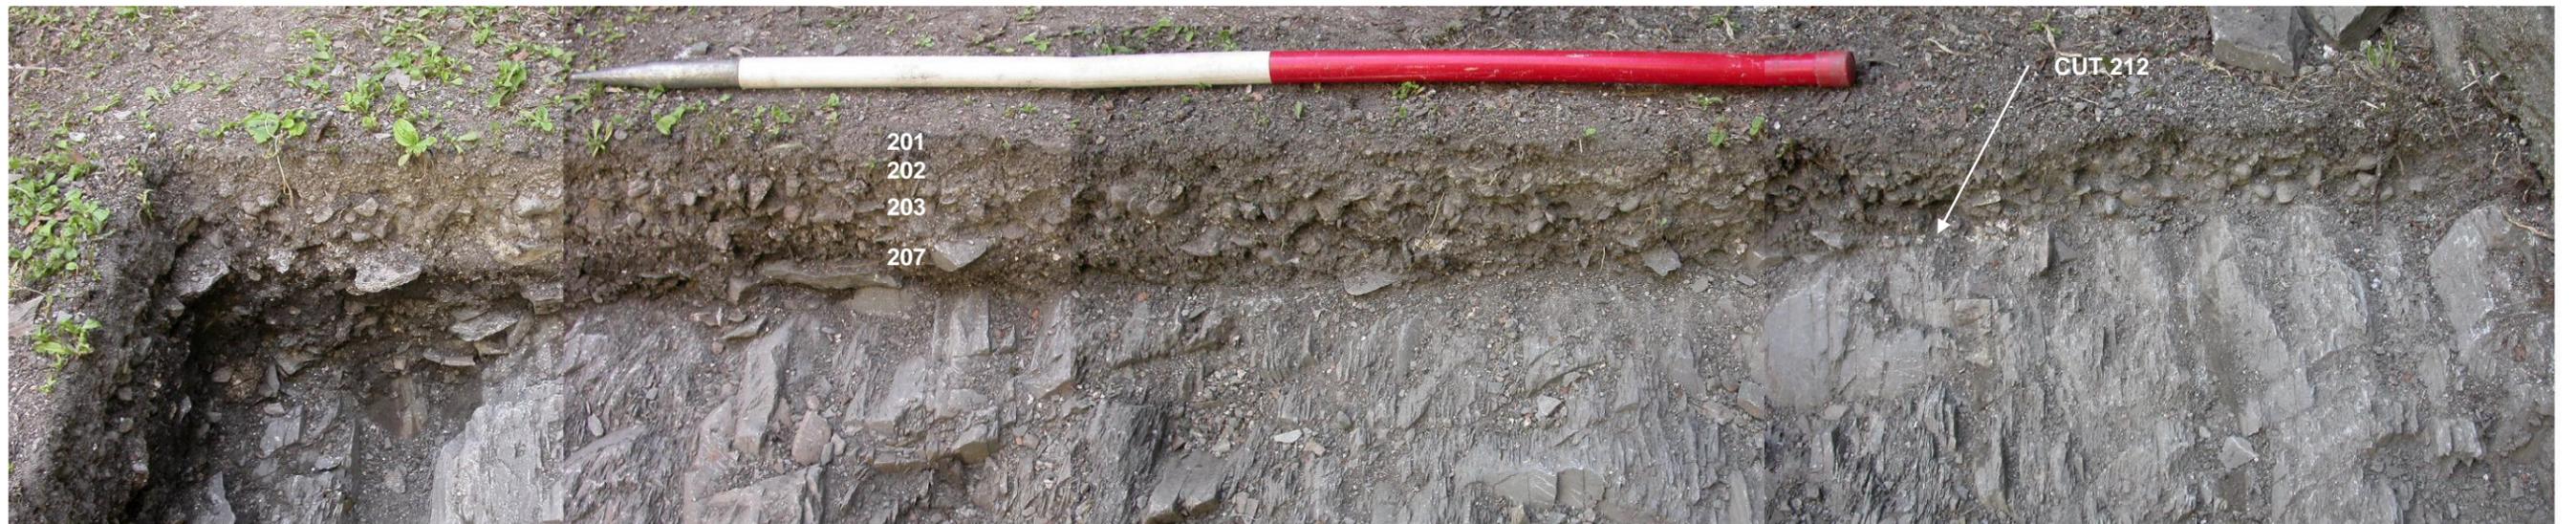
Plate 15: East-facing section of Trench 2 (photographic montage). Scale 1.0 metre.

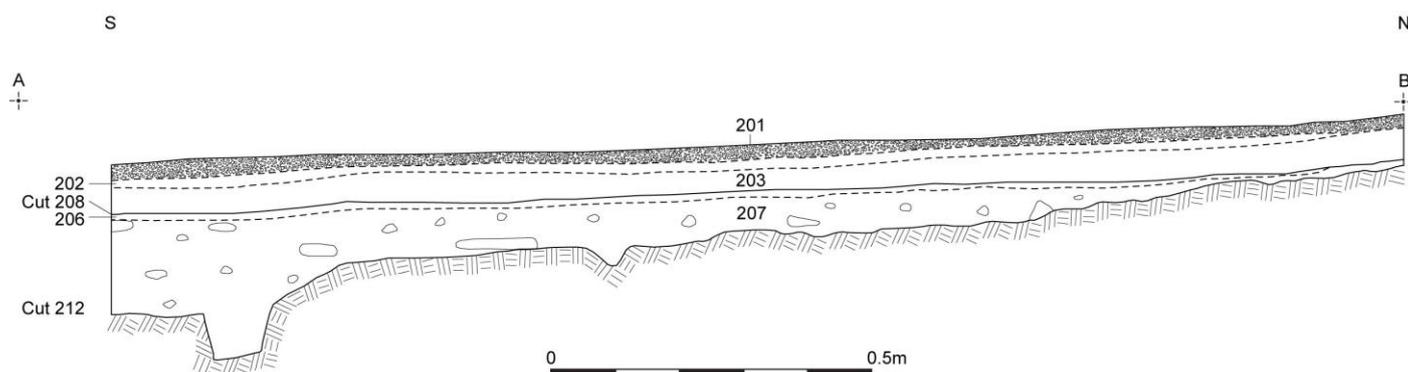
Figure 9: East-facing section of Trench 2.

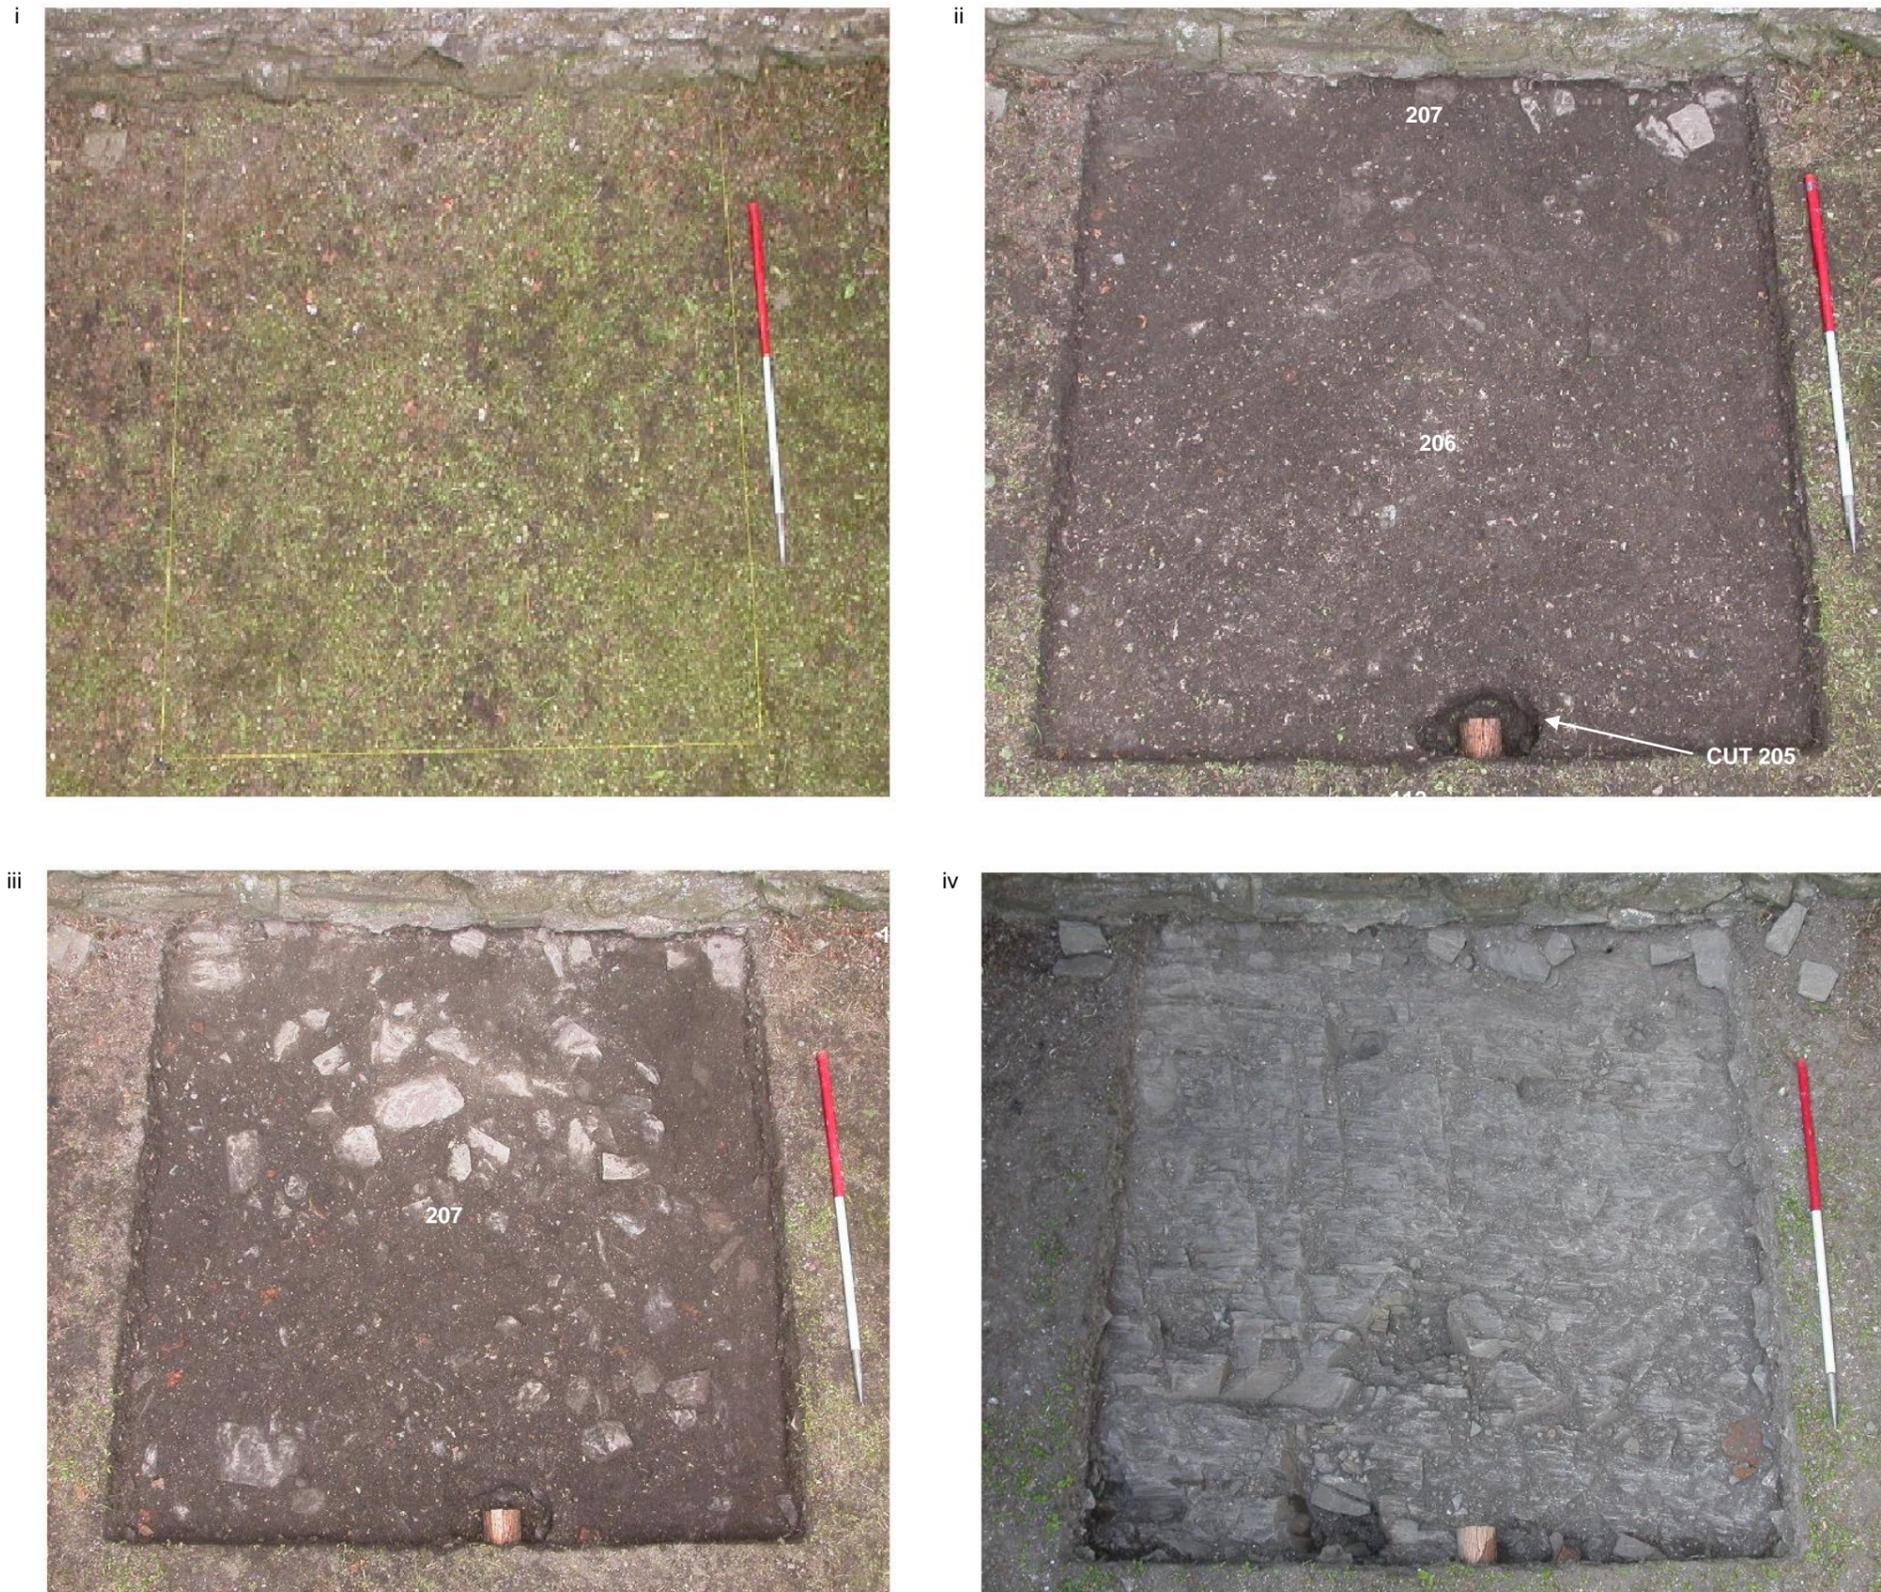
Plate 16: Successive photographs of Trench 2, looking north from an elevated position. From left to right: **i** - Trench 2 prior to excavation; **ii** - following excavation of north-south aligned drain (204/205), showing horizontal discontinuity (208), north-south aligned drain cut (204), mortar-rich clay loam (206) and mixed clay loam (207); **iii** - following excavation of mortar-rich clay loam (206), showing mixed clay loam (207); and **iv** - following excavation of mixed clay loam (207), showing rock-cut terrace upon which the east wing of Blundell's House built (212). Scale 1.0 metre.

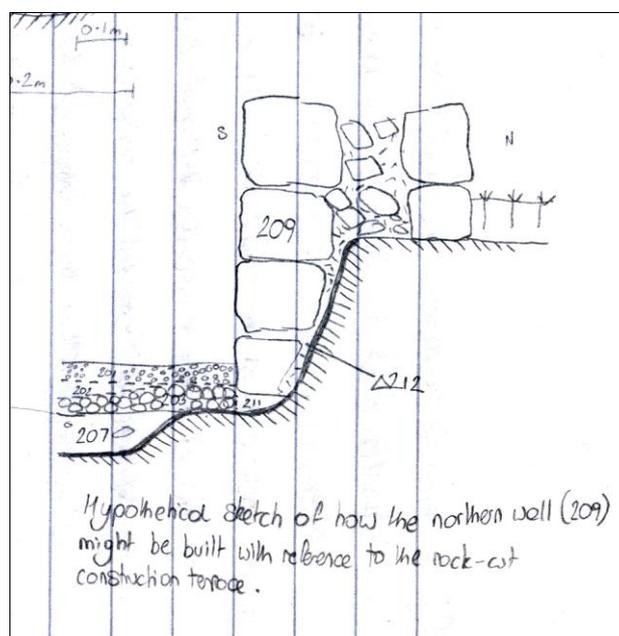
Figure 10: Sketch section representing how the northern wall of the east wing (209) was constructed with reference to the rock-cut terrace (212) (taken from the director's site notebook).

3.4.7 Removal of the mixed medium brown clay loam (Context No.207) exposed the weathered surface of the underlying bedrock (Context No.212). This surface was notably flat and uniform throughout the trench, except for its northern edge where it began to rise immediately adjacent to the northern wall (Context No.209) of the east wing. Although no tool marks were observed, the uniformity of the bedrock surface and the significant drop of 0.8 metres in level between the modern ground surface to the north of the east wing and the surface of the bedrock exposed in Trench 2 immediately adjacent to the north wall, indicates that the bedrock had been quarried to create a terrace upon which the east wing was built. Although flat, this surface was not horizontal - it sloped consistently to the south across the length of Trench 2 (from 53.05 to 52.94 metres OD) and presumably the whole length of the east wing.

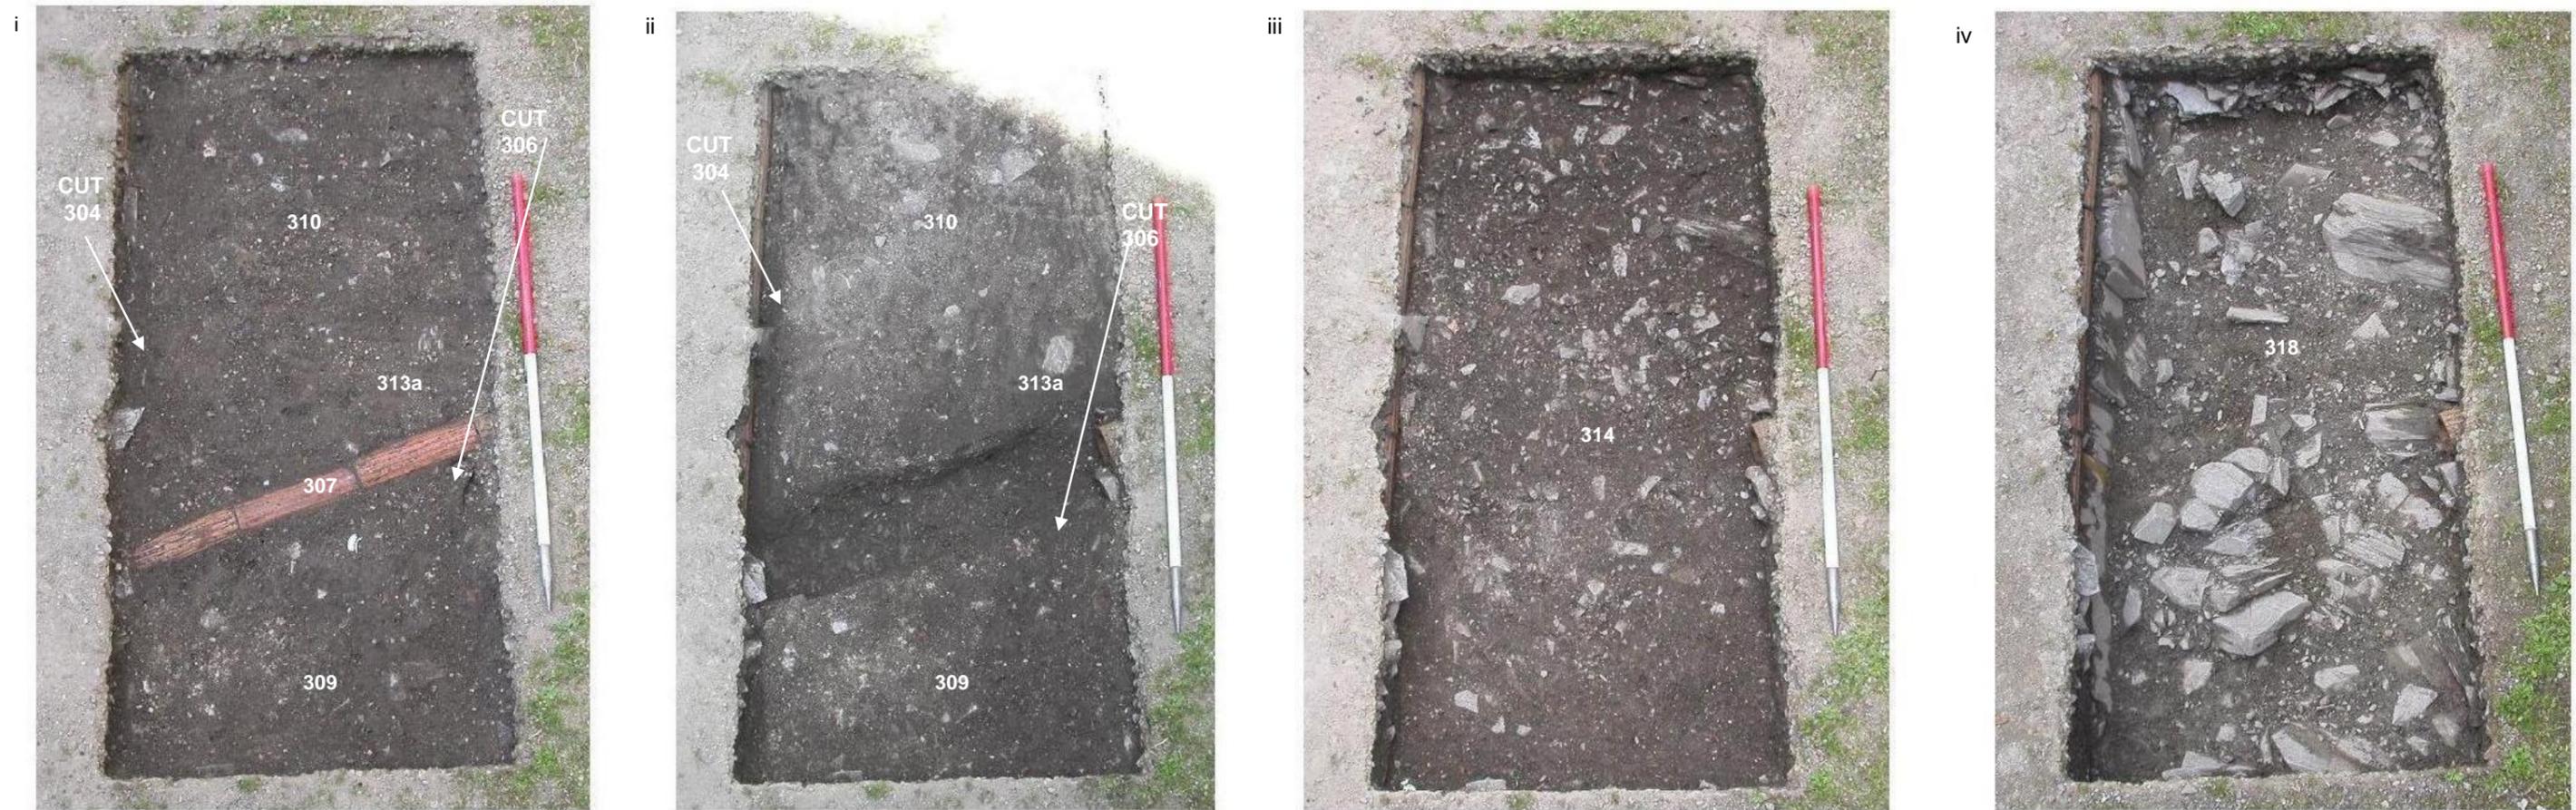
Plate 17: Successive photographs of Trench 3, looking north from an elevated position. From left to right: **i** - following the excavation of aggregate levelling deposit (303), showing drains (304/305 and 306/307) cut into horizontal discontinuity (312) and silty loam deposits (313a and 309) and mortar-rich silty clay loam (310); **ii** - following excavation of drains (304 and 306) cut into horizontal discontinuity (312) and showing silty loam deposits (313a and 309), mortar-rich silty clay loam (310) and exposed in the base of the excavated drain (306) a medium brown clay loam (316); **iii** - following the excavation of medium brown clay loam (316), showing horizontal discontinuity associated with removal of the basement's floor (319) and the mortar-flecked silty loam (314); and **iv** - completion of excavation, showing the surface of the natural subsoil (318) and rock-cut terrace upon which the east wing of Blundell's House built (317). Scale 1.0 metres.

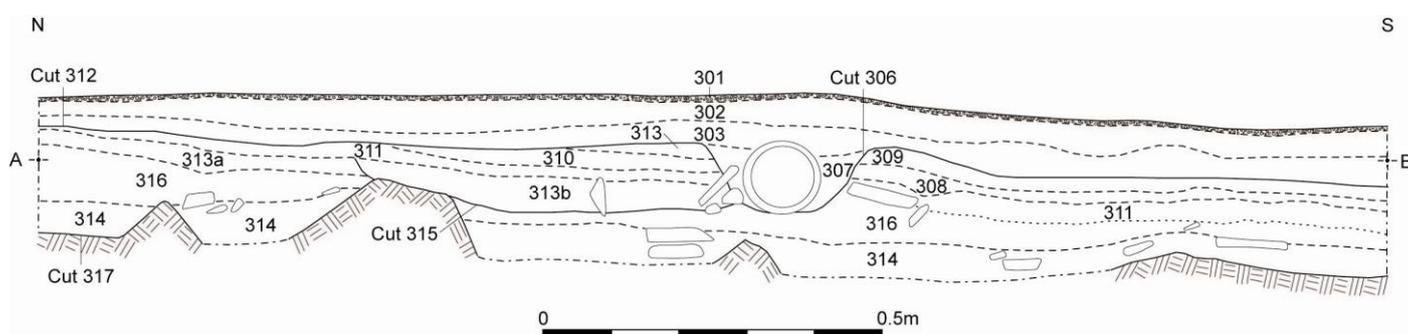
Figure 11: West-facing section of Trench 3.
