Excavation at Blundell's House, Dundrum Castle,
County Down 2009

Data Structure Report: Site Evaluation and Excavation at Blundell's House, Dundrum Castle, County Down 2009

**(CAF DSR 071)
(Licence No. AE/09/36)
(SMR No. DOW 044:006)**

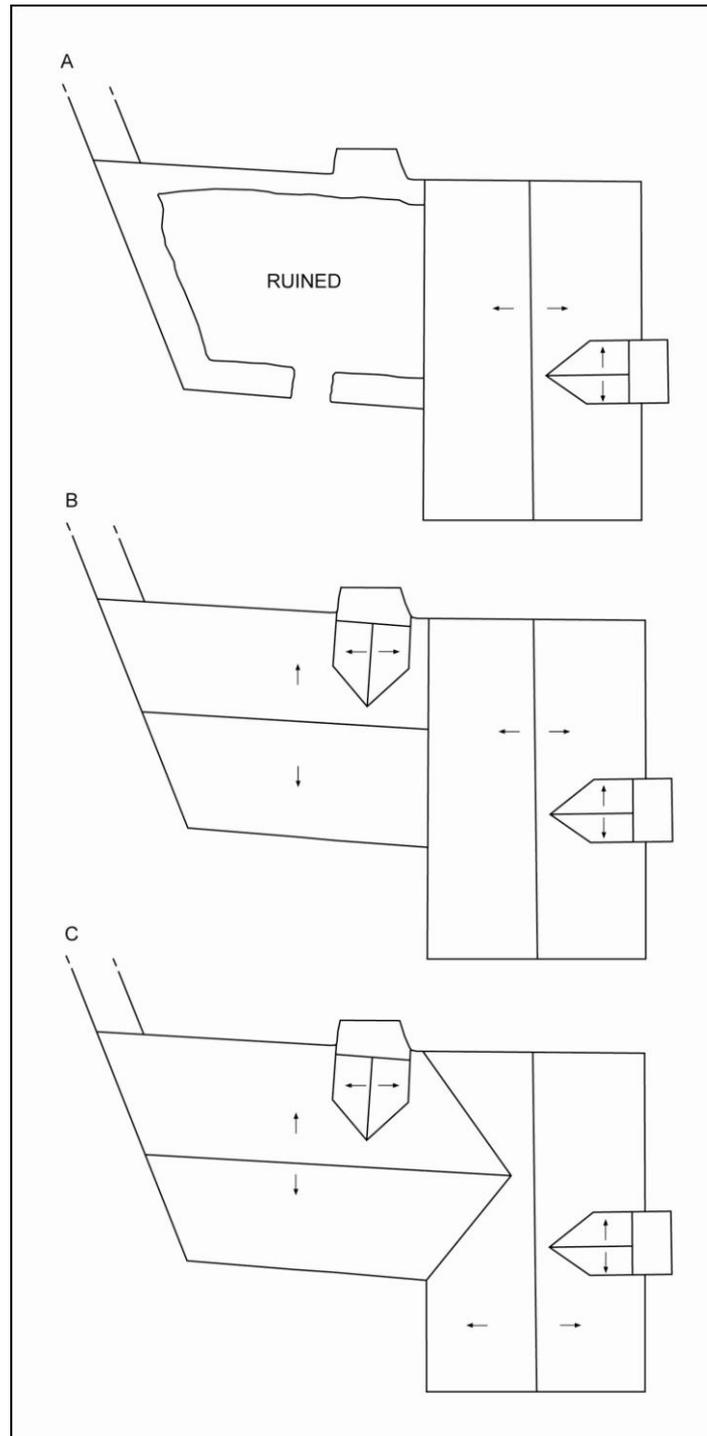
Figure 12: Three conjectural plans of the roofing arrangements for the final phase of Blundell's House.

4.2.3 In terms of the arrangement of the roof of the final phase of construction at Blundell's House, the above conjectures and observations are consistent with three possibilities (Figure 12). Firstly, the 'west wing' could have been partly demolished either prior to, or during, the construction of the east wing. As noted above (see Paragraph 2.6.4), study of one late eighteenth-century image of the site indicates that the fabric of the west wing was in a considerably poorer state of repair than that of the east wing, suggesting that the west wing may have been slighted or fallen into ruin either prior to the construction of the east wing, or whilst the east wing was still occupied (Figure 12.A). Given the architectural pretension exhibited by the triangular pediments which probably contained armorials and relief sculptures in the east wing's southern wall, it seems unlikely that its builders would have left an adjoining ruin standing next to the newly built east wing. Consequently, this first possibility is unlikely to be correct. The second possibility is that the west wing was still inhabited when the east wing was built, but that the roof of the west wing was not extended so as to be physically joined with that of the east wing (Figure 12.B). Such an arrangement would enable the west wing to be abandoned and become a ruin without compromising the structural integrity of the east wing. Thirdly, the west wing was still inhabited when the east wing was built and the west wing's roof was extended to join the roof of the east wing at a right-angle creating two valleys on the western side of the east wing's gabled roof (Figure 12.C). This third possibility would have required some modification of the western side of the east wing's roof if the building's west wing was allowed to become a ruin prior to the desertion of the east wing.

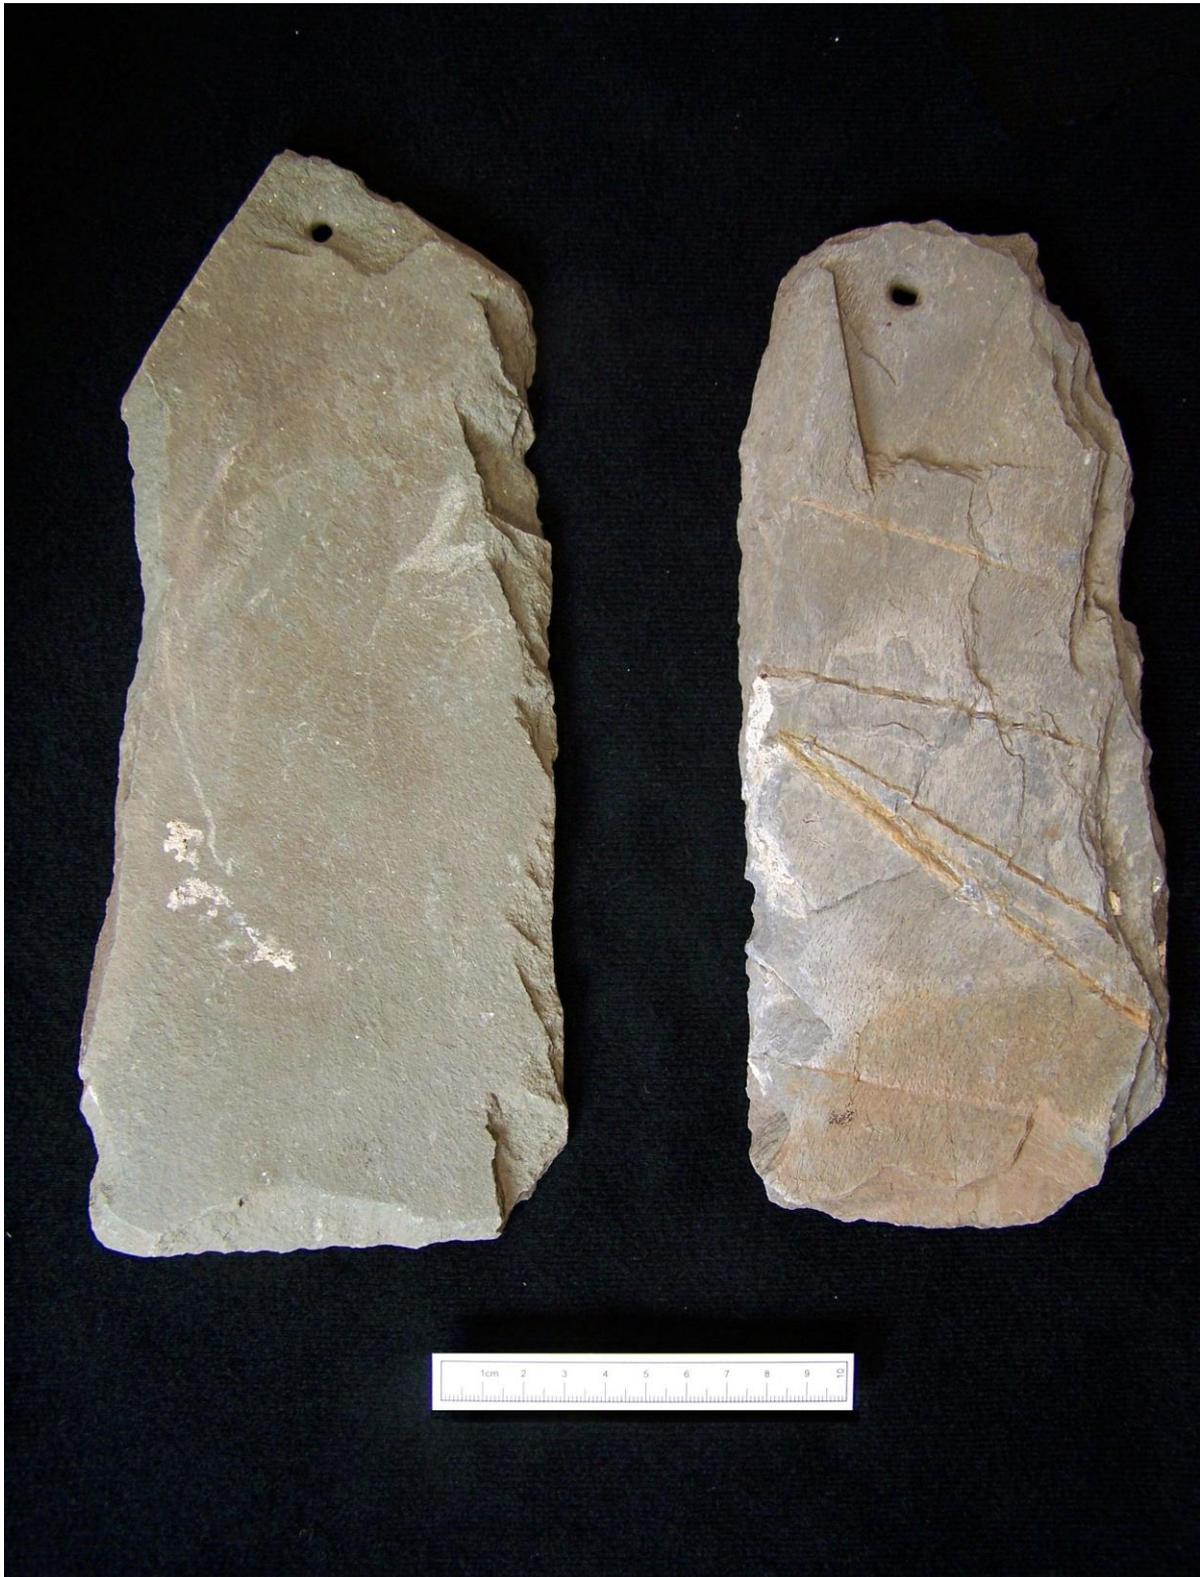
Plate 18: The backs of two near complete roofing 'slates' that taper towards their heads (left: Small Find No.1077; right: Small Find No.1070). One of the 'slates' (Small Find No.1077) has pronounced shoulders that form a point giving its head a triangular shape and a crudely-chamfered tail. Scale 10 centimetres.

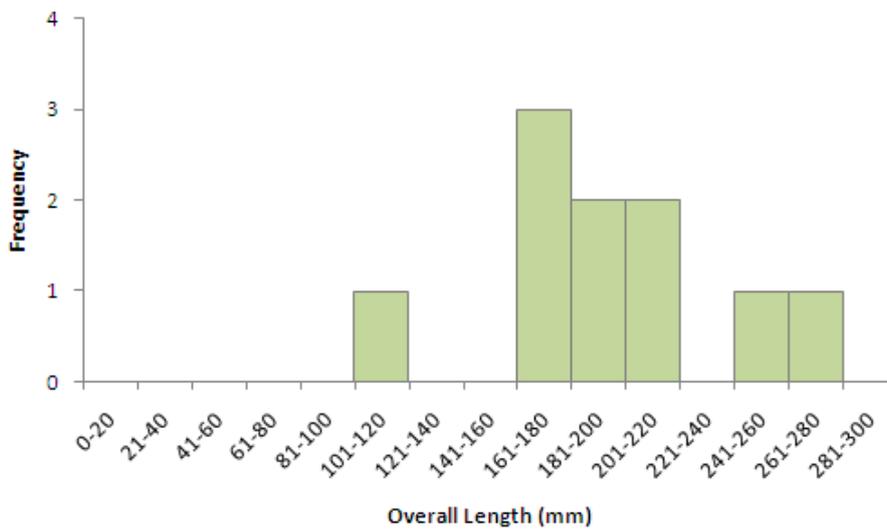
Figure 13: Histogram of the overall length of the 'slates' (sample size 10).

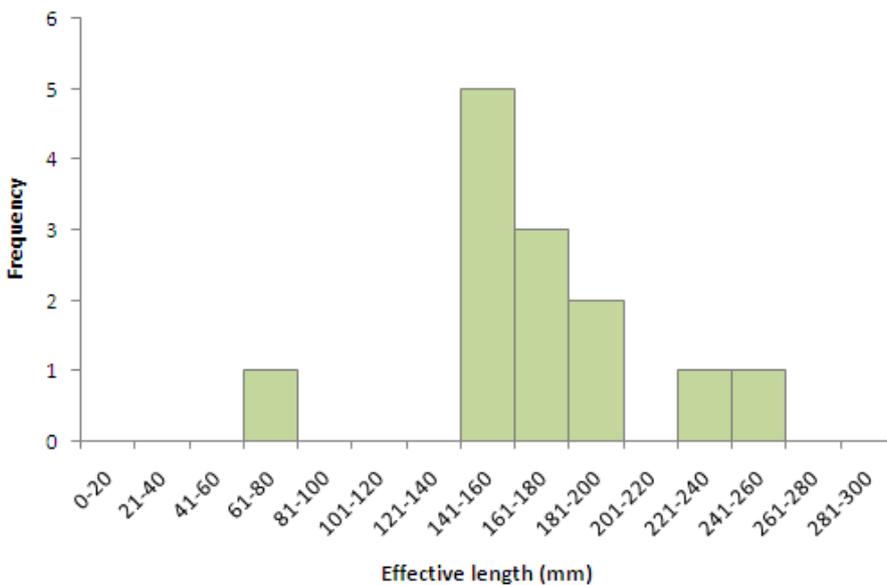
Figure 14: Histogram of the effective length of the 'slates' (sample size 13).

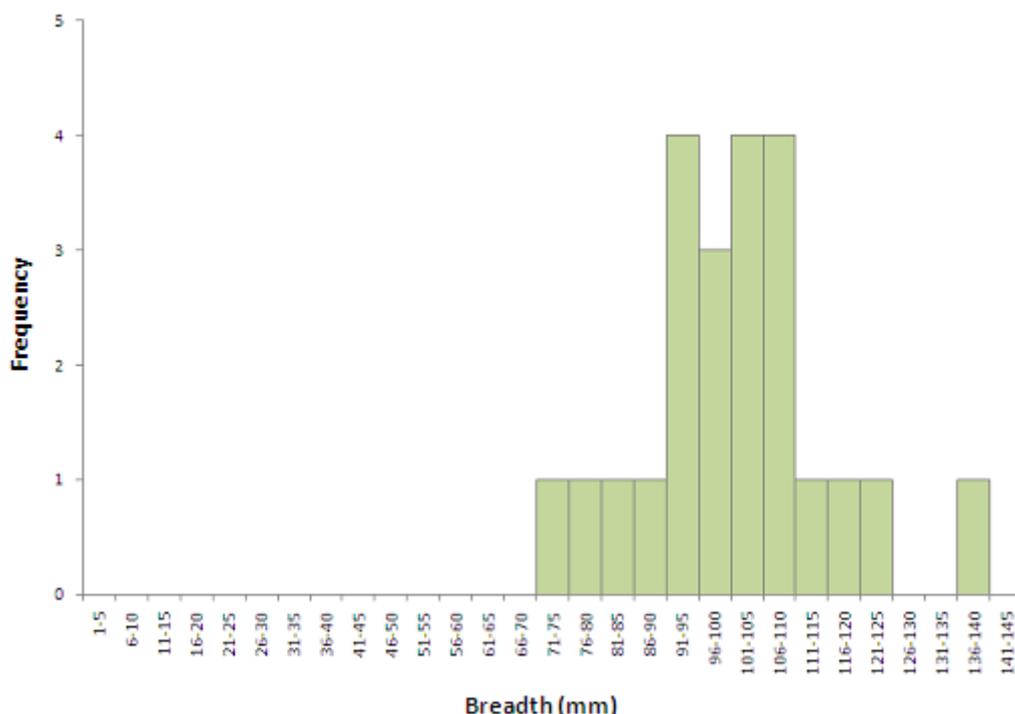
Figure 15: Histogram of the original maximum breadth of the 'slates' (sample size 23).

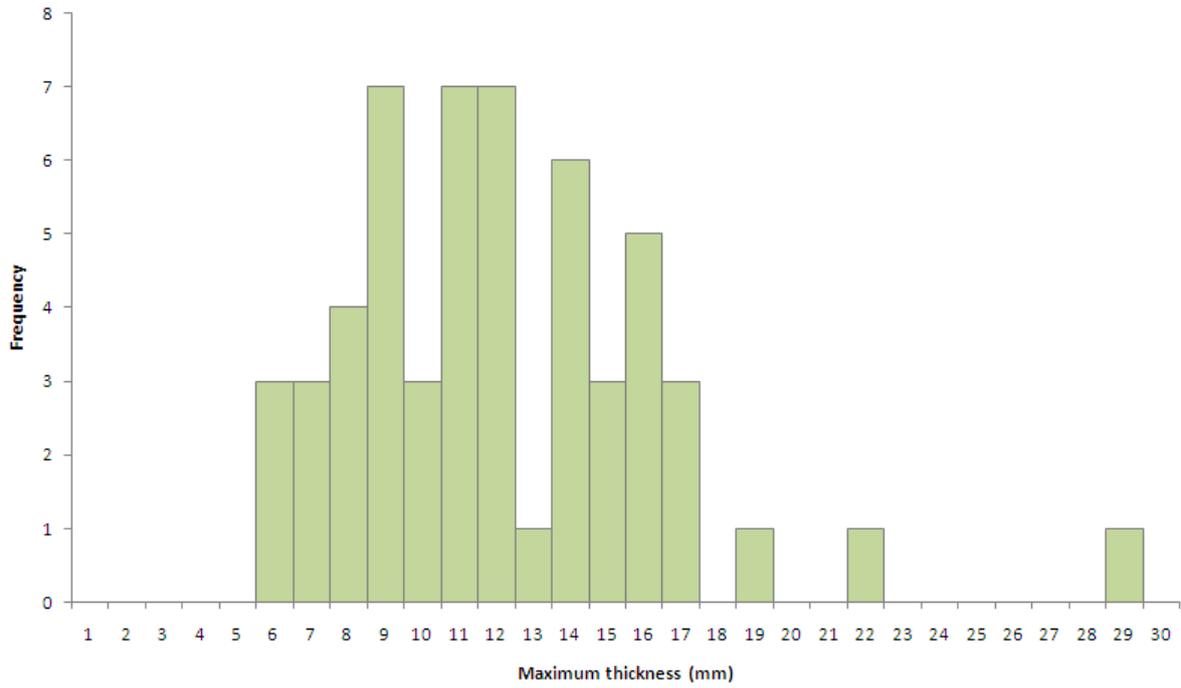
Figure 16: Histogram of the maximum thickness of the 'slates' (sample size 55).

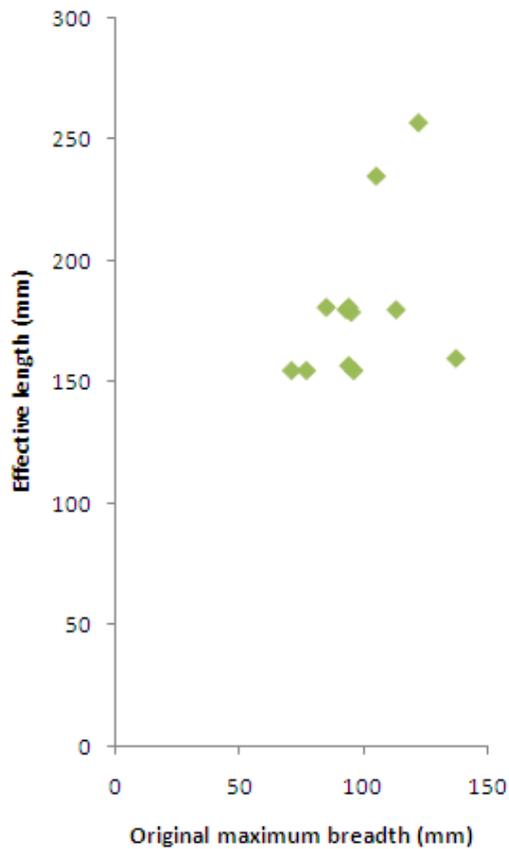
Figure 17: Scattergram comparing effective length against original maximum breadth (sample size 12).

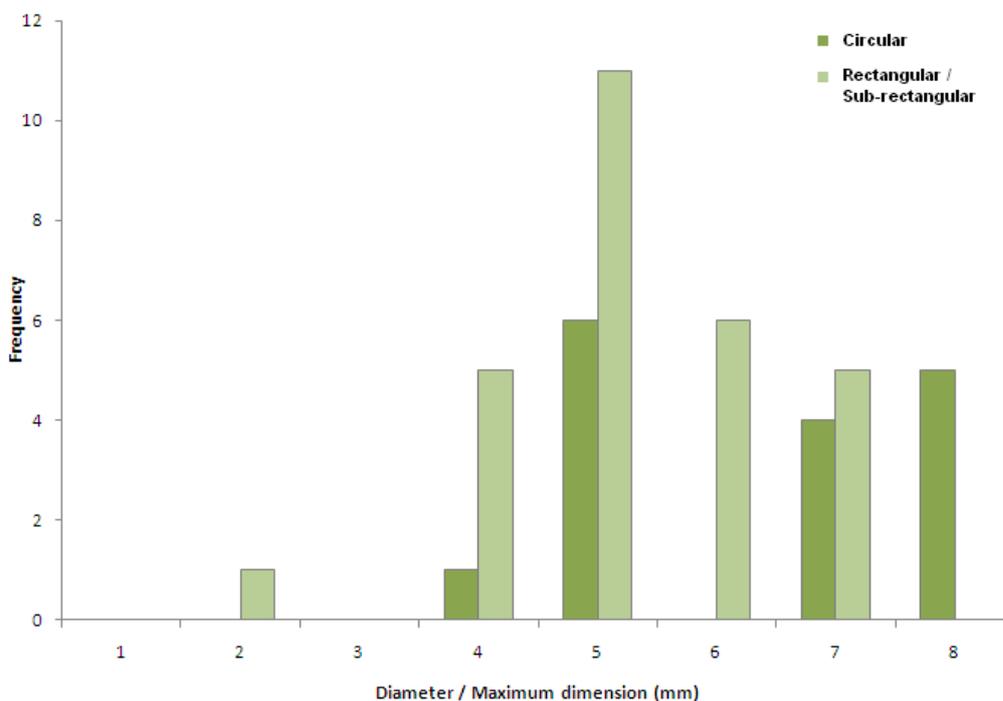
Figure 18: Histogram of the diameter / maximum dimension of the circular (sample size 16) and rectangular / sub-rectangular (sample size 28) fixing holes.

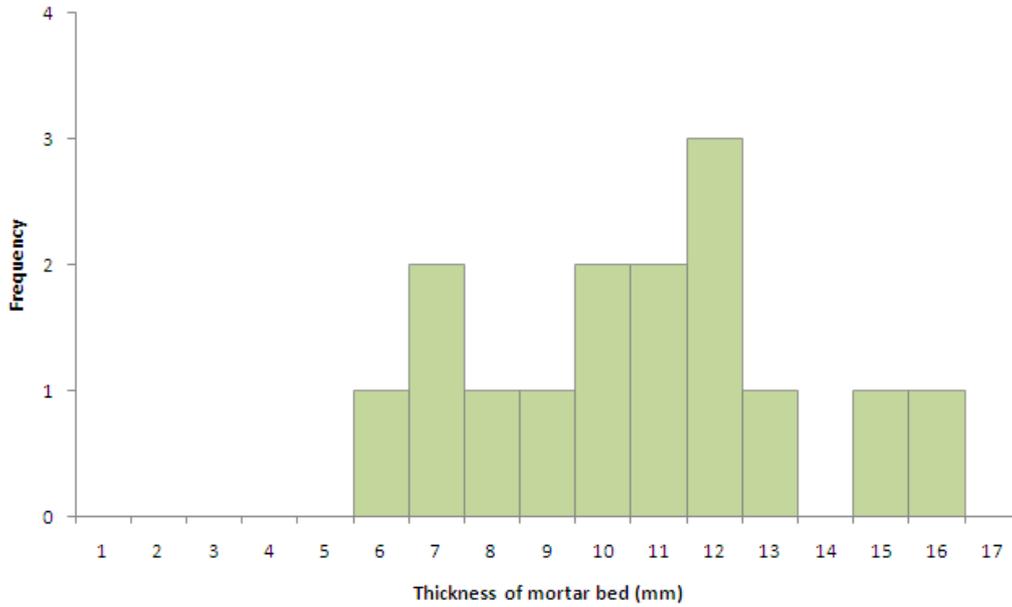
Figure 19: Histogram of the thickness of the mortar beds (sample size 15).

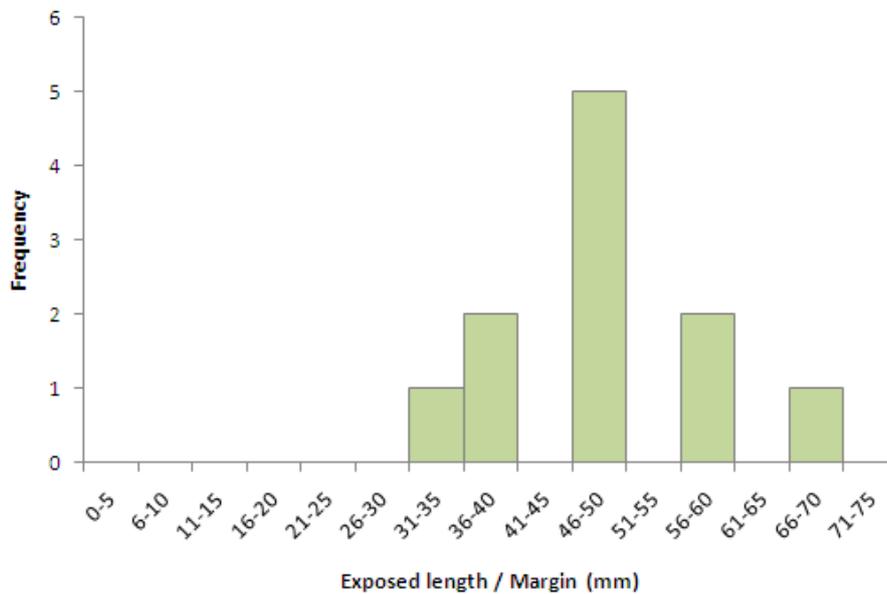
Figure 20: Histogram of the exposed length (margin) of the 'slates' (sample size 11).

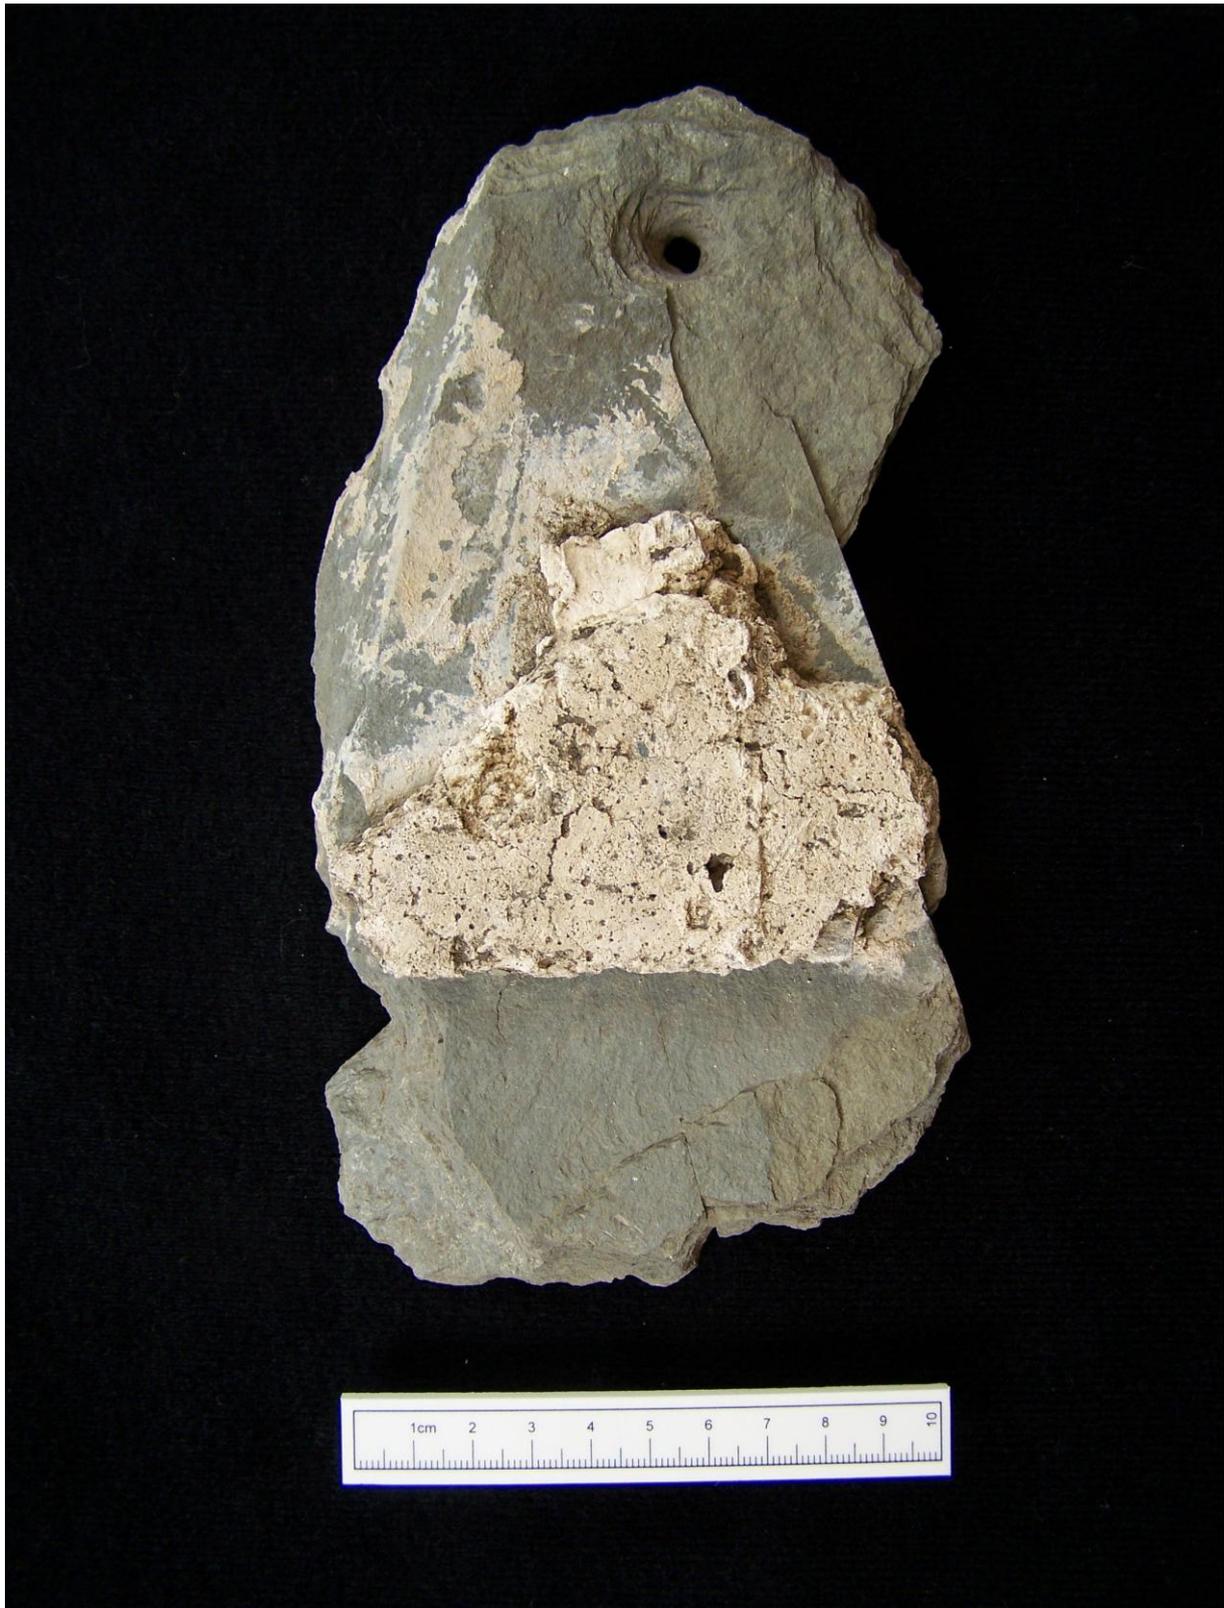
Plate 19: The back of a roofing 'slate' upon which a longitudinal seam is preserved on the surface of the mortar bed (Small Find No.1040). This seam was formed by the mortar squeezing up between the adjoining edges of the two 'slates' laid on to the mortar bed. That it approximately lines up with the centrally-placed fixing hole indicates that the overlying 'slates' formed a near 50% overlap. Scale 10 centimetres.

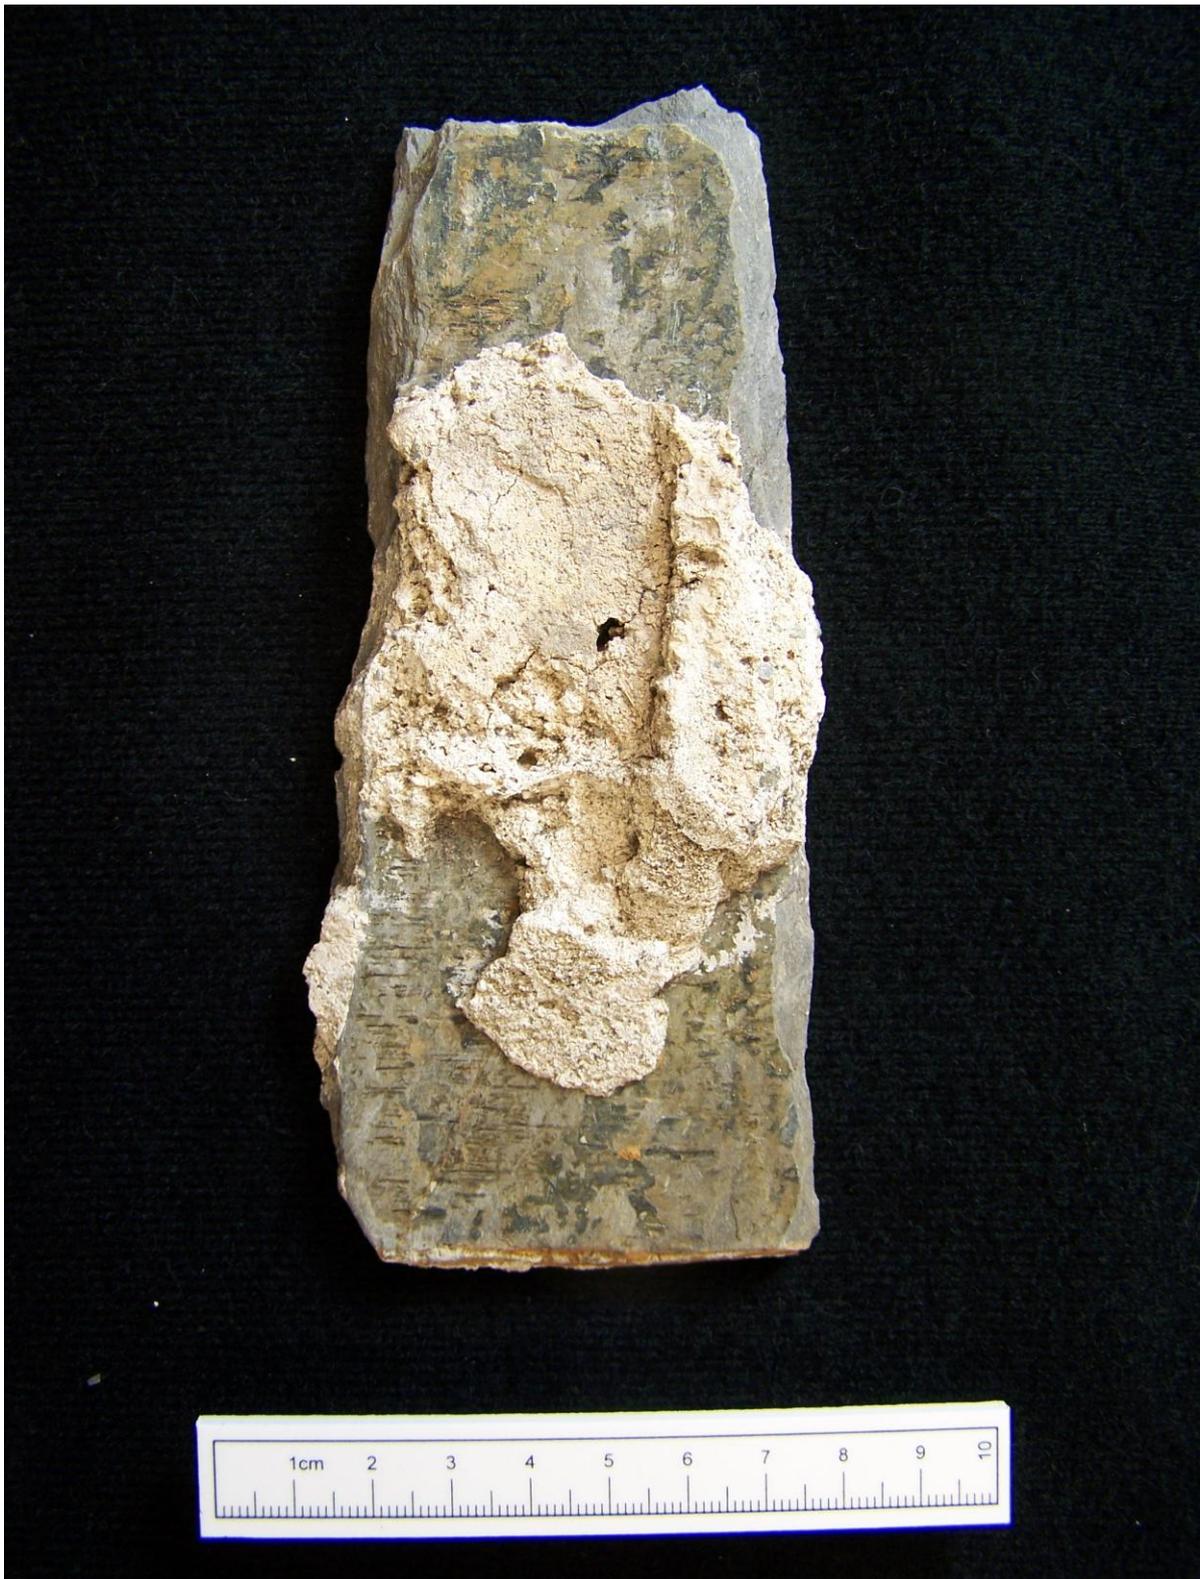
Plate 20: The back of a roofing 'slate' upon which the longitudinal seam is preserved on the surface of the mortar bed (Small Find No.1175). Note that impressions also survive within the mortar bed of the perpendicular seams created by the tails of the overlying 'slates'. That there is a difference of 15mm between the longitudinal position of these perpendicular seams indicates that the courses of the 'slate' roof would not have had a neat or even appearance. A further point of interest are the scored lines which run perpendicular to the length of the 'slate' and appear to be keying for a dark grey substance. Scale 10 centimetres.

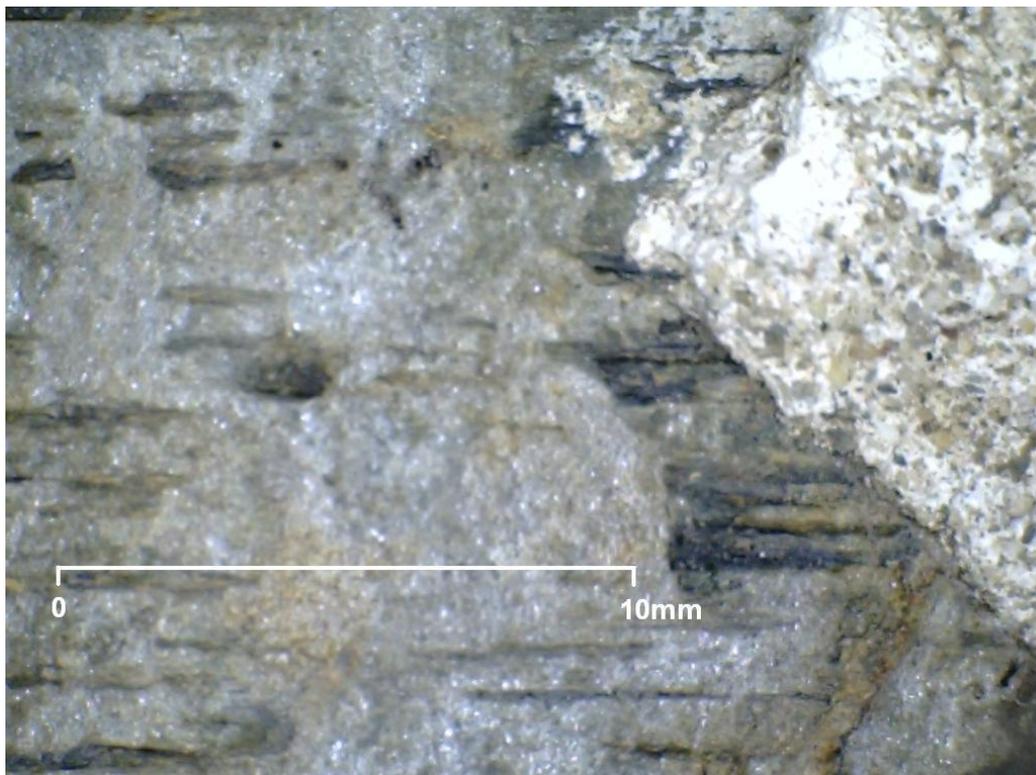
Plate 21: Microscopic image of incised lines filled with dark grey substance on 'slate' (Small Find No. 1175). Note the image shows lines beneath part of the 'slate' that was formerly covered by part of the mortar bed.

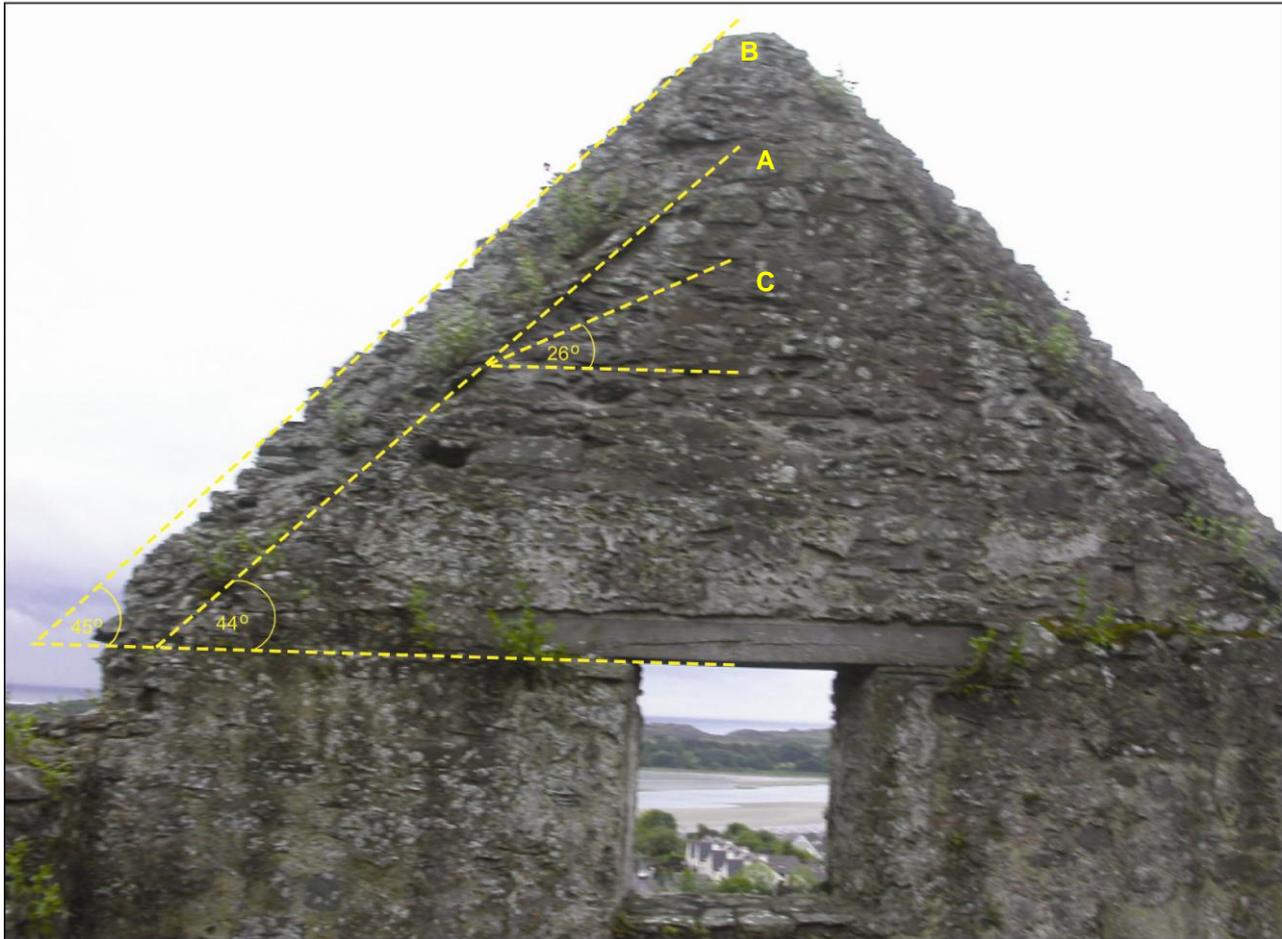
Plate 22: Photographic analysis of the eastern half of the east wing's southern wall. A = 44° angle of the gable to the horizontal (equivalent to the roof's rafter pitch); B = 45° angle of the gabled facade to the horizontal; C = 26° maximum estimated angle of effective pitch of *in situ* 'slates'.

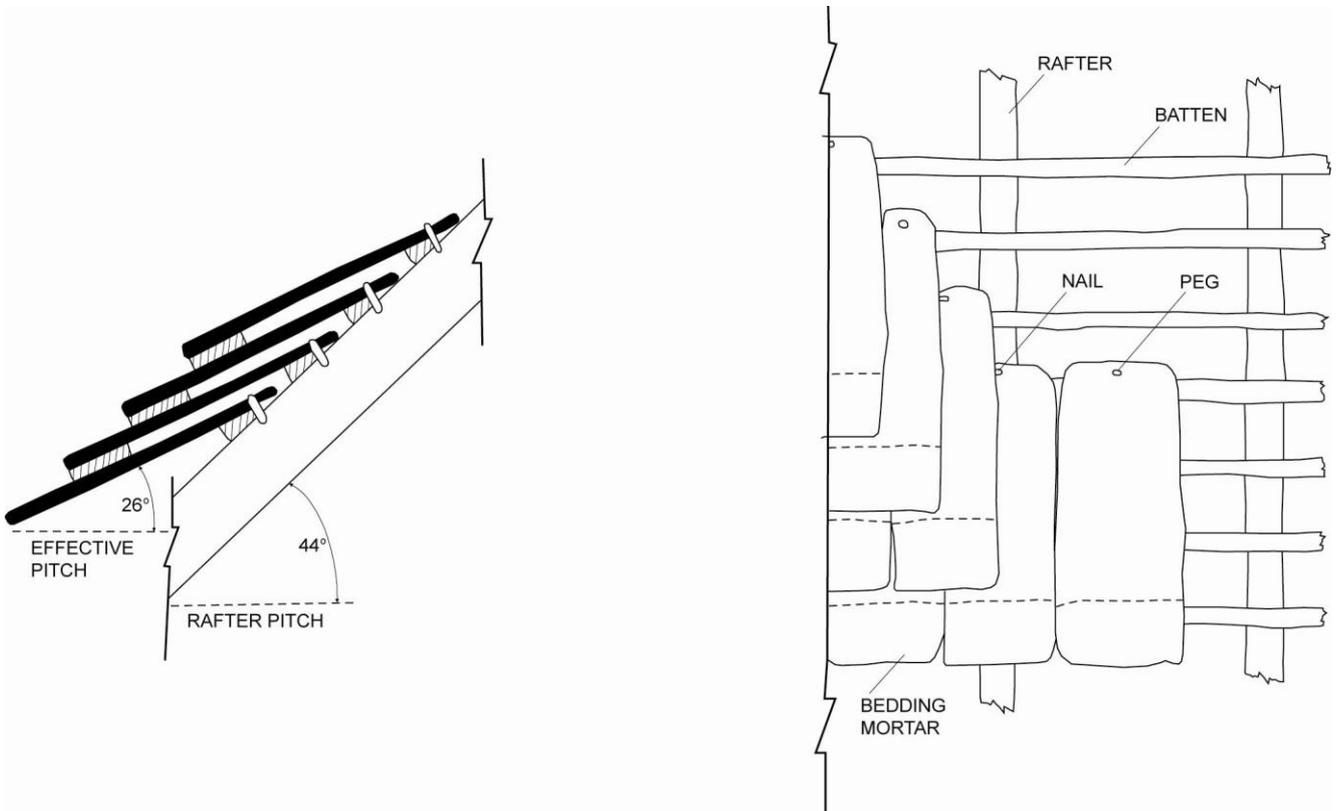
Figure 21: Reconstructed profile and plan of the east wing's roof.
