Monitoring Report No. 203

75m south-east of 35 Woburn Road Ballyrolly Millisle Co. Down

AE/10/118E

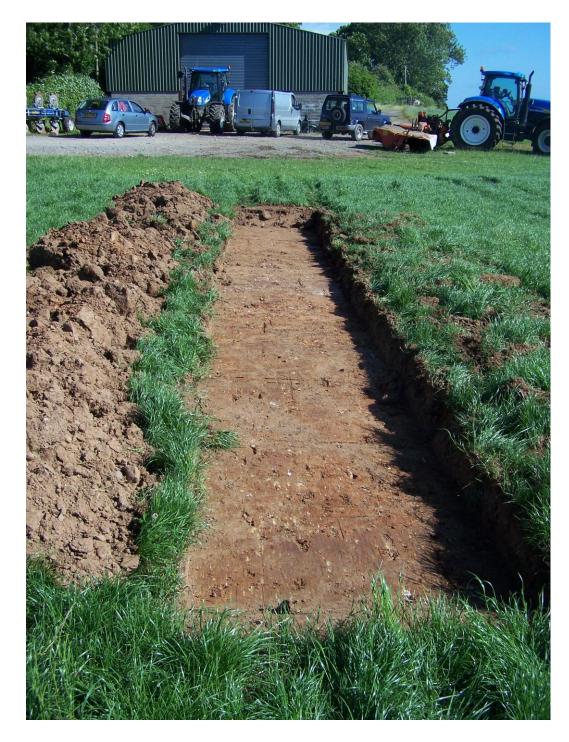
Trench 1 was positioned parallel to the western boundary of the application site and measured approximately 20m by 2m. The trench was aligned roughly north/south and was excavated to the surface of the natural subsoil (Context No. 102) which was encountered at an average depth of 0.3m. A simple stratigraphic sequence was encountered in this trench consisting of topsoil (Context No. 101) directly overlying natural subsoil (Context No. 102).

The sod and topsoil in Trench 1 (Context No. 101) consisted of a mid to dark brown clay loam. This deposit had infrequent inclusions of rounded and angular stones (average size: 30 x 30 x 40mm) and active plant roots were observed within it. The sod and topsoil (Context No. 101) had an average depth of 0.3m and directly overlay the natural subsoil (Context No. 102).

The natural subsoil in Trench 1 (Context No. 102) consisted of yellowish orange gravelly clay. There were no finds or features of an archaeological nature encountered in this trench.

Plate 1: Trench One following excavation to the surface of the natural subsoil (Context No. 102), looking north.

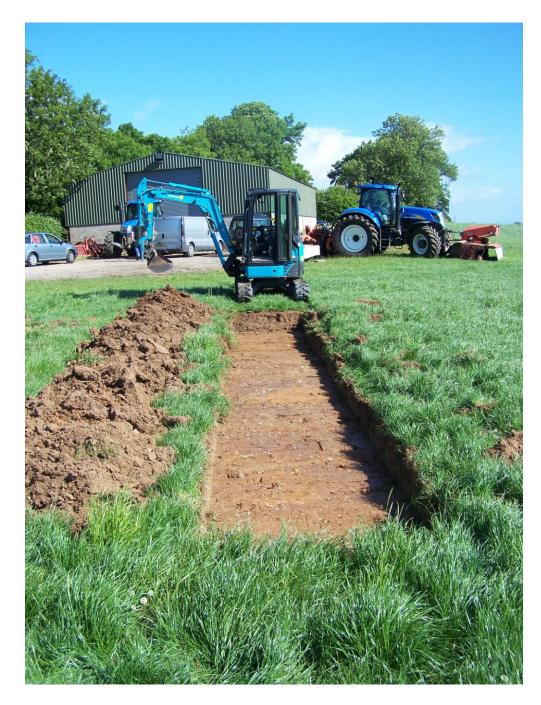
Trench 2 was positioned approximately 4m to the east of Trench 1. The trench was aligned roughly north/south and was excavated to the surface of the natural subsoil (Context No. 202) which was encountered at an average depth of 0.2m. A simple stratigraphic sequence was encountered in this trench.

The sod and topsoil in Trench 2 (Context No. 201) consisted of a mid to dark brown clay loam. This deposit had infrequent inclusions of rounded and angular stones (average size: 30 x 30 x 40mm). The sod and topsoil (Context No. 201) had an average depth of 0.2m and directly overlay the natural subsoil (Context No. 202).

The natural subsoil in Trench 2 (Context No. 202) consisted of yellowish orange gravely clay. There were no finds or features of an archaeological nature encountered in this trench.

Plate 2: Trench Two following excavation to the surface of the natural subsoil (Context No. 202), looking north.

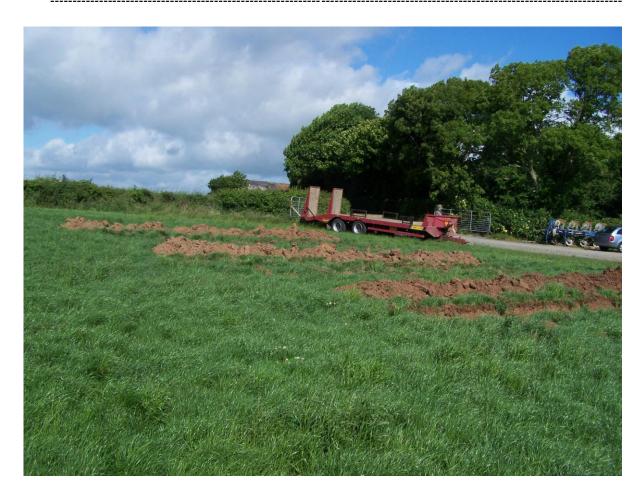
Trench 3 was positioned approximately 2.5mm to the east of Trench 2. The trench was aligned roughly north/south and was excavated to the surface of the natural subsoil (Context No. 302) which was encountered at an average depth of 0.3m. A simple stratigraphic sequence was encountered in this trench.

The sod and topsoil in Trench 3 (Context No. 301) consisted of a mid to dark brown clay loam. This deposit had infrequent inclusions of rounded and angular stones (average size: 30 x 30 x 40mm). The sod and topsoil (Context No. 301) had an average depth of 0.3m and directly overlay the natural subsoil (Context No. 302).

The natural subsoil in Trench 3 (Context No. 302) consisted of yellowish orange gravely clay. There were no finds or features of an archaeological nature encountered in this trench.

Plate 3: Trench Three following excavation to the surface of the natural subsoil (Context No. 302), looking north.
