Evaluation/monitoring Report No. 220

**Carrickfergus Castle
Co. Antrim**

AE/10/202

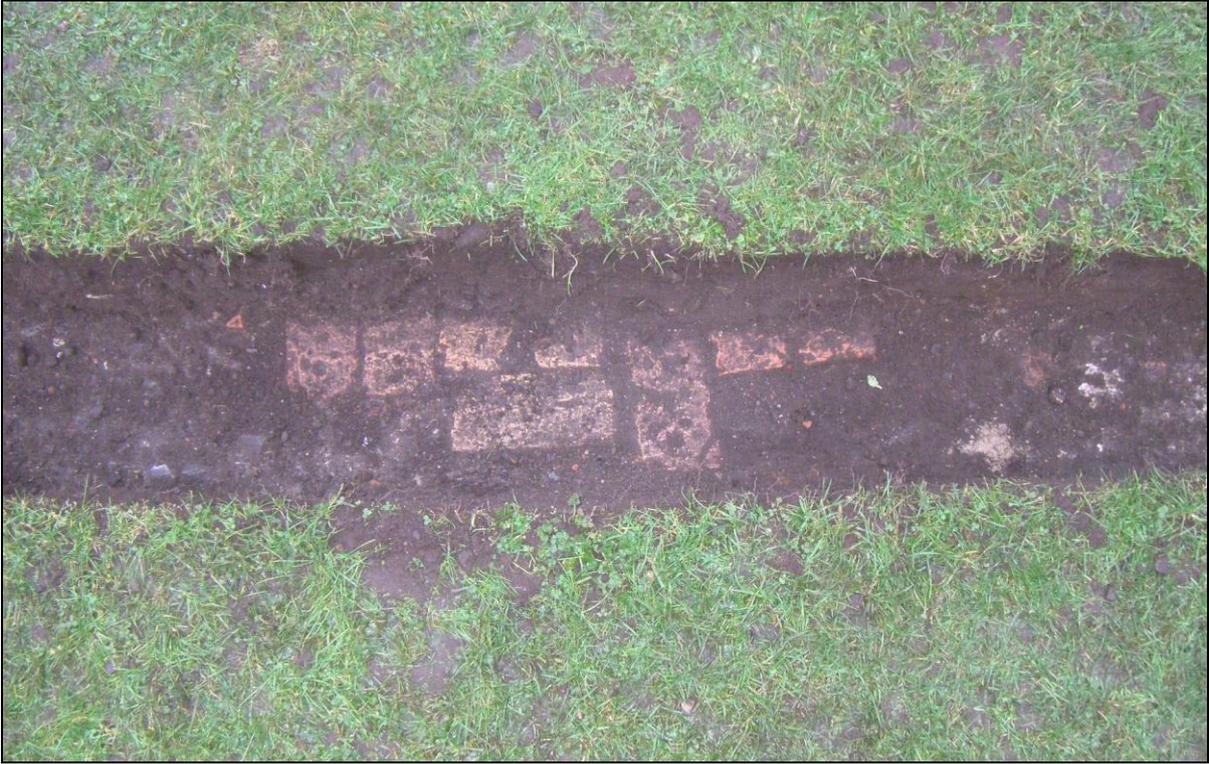
Plate 01: Trench 1: mid-excavation view of brick path C106, looking east

The cobbled surface (Context No. 112) was found to extend at least 4m to the south, with a variety of features placed on it at intervals. The first of these was an un-mortared brick surface (Context No. 106), consisting of eight visible bricks, which extended into the eastern side of the trench. The southern-most of these bricks was found to rest on a deposit of mortar (Context No. 120), which extended across the trench and for 0.4m to the south. This was interpreted as being either a path aligned east/west, or a platform to support the crane associated with raising ammunition and supplies from the tramway tunnel nearby. The restricted size of Trench 1 prevented a more positive identification.

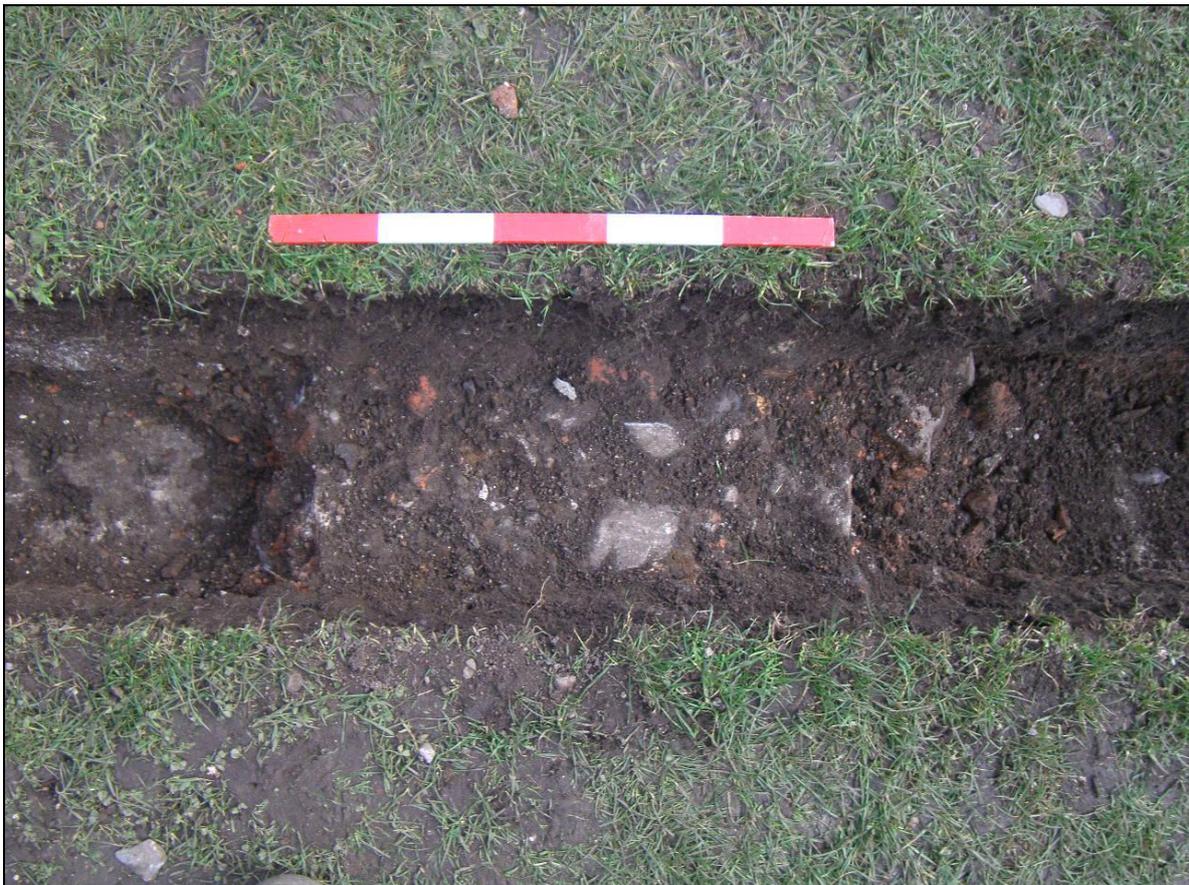
Plate 02: Trench 1: mid-excavation view of dump of cobbles C108

A variety of features were found immediately below Context No. 102. The first of these (Context No. 108) was located between 2.1m and 2.8m from the northern end of the trench. This was a deposit of compacted mortar-rich sandy loam, around a dump of cobble stones, many of which had mortar attached to them. To the south of this, was a layer of orange sand (Context No. 109), averaging 0.05m in depth. This was found to terminate at another deposit of compacted mortar-rich sandy loam (Context No. 110), within which was a deposit of larger rounded stones (approximately 0.02m in diameter). When context No. 109 was removed, it was found to be 0.05m in depth. No finds were recovered from this context. Immediately below Context No. 109, a layer of mortar-rich gravelly loam was present (Context No. 113). This was excavated to a depth of 0.4m at which point the limit of excavation was reached. One piece of bone and a metal object, possibly an iron nail, were recovered. All the deposits and finds in this area were consistent with the excavation, construction and filling in around the brick-built tramway tunnel in the Inner Ward constructed in 1889 (McNeill 1981, 51).

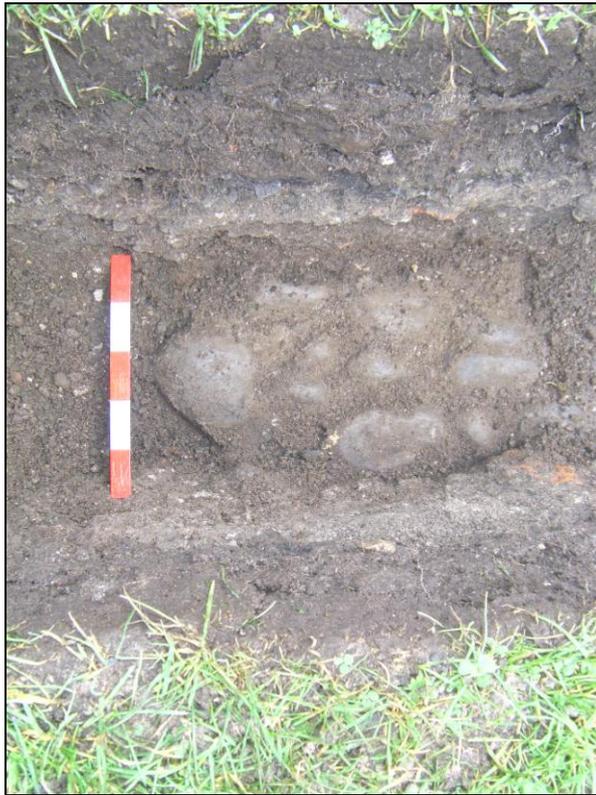
Plate 03: Trench 1: view of cobbled surface C112, with cut C129 to the right

The cobbled surface (Context No. 112) had been cut (Cut No. 129), probably during the construction of the tramway tunnel described above and this point marks the southernmost extent of the disturbance of the Inner Ward associated with these works. The presence immediately above the cobbled surface of cinder-rich (Context No. 126) and mortar-rich (Context No. 127) deposits, similar to Context No. 113 to the south, suggests the cobbled surface was exposed while construction and restoration works connected with the tramway tunnel were taking place. Other features in the remainder of Trench 1 were found to be undisturbed. The original requirement was that the trench be excavated to a depth of 0.5m in order to accommodate a plastic duct for the provision of the electricity supply to the Flash Room Corridor. Due to the presence of these undisturbed archaeological features and in consultation with staff at the castle and Mr Andrew Gault, Inspector at the Northern Ireland Environment Agency: Built Heritage, it was agreed to limit the depth of the excavation at the point where there would be still sufficient depth to accommodate the duct, at around 0.2m to 0.3m.

According to McSkimin (1823, 164), part of the south curtain wall of the castle collapsed in 1754, facilitating the French occupation in 1760 and repairs probably took place in 1761. There is a possibility that the cobbled surface (Context No. 112) may be associated with this repair work, providing a solid surface to the repaired Inner Ward.

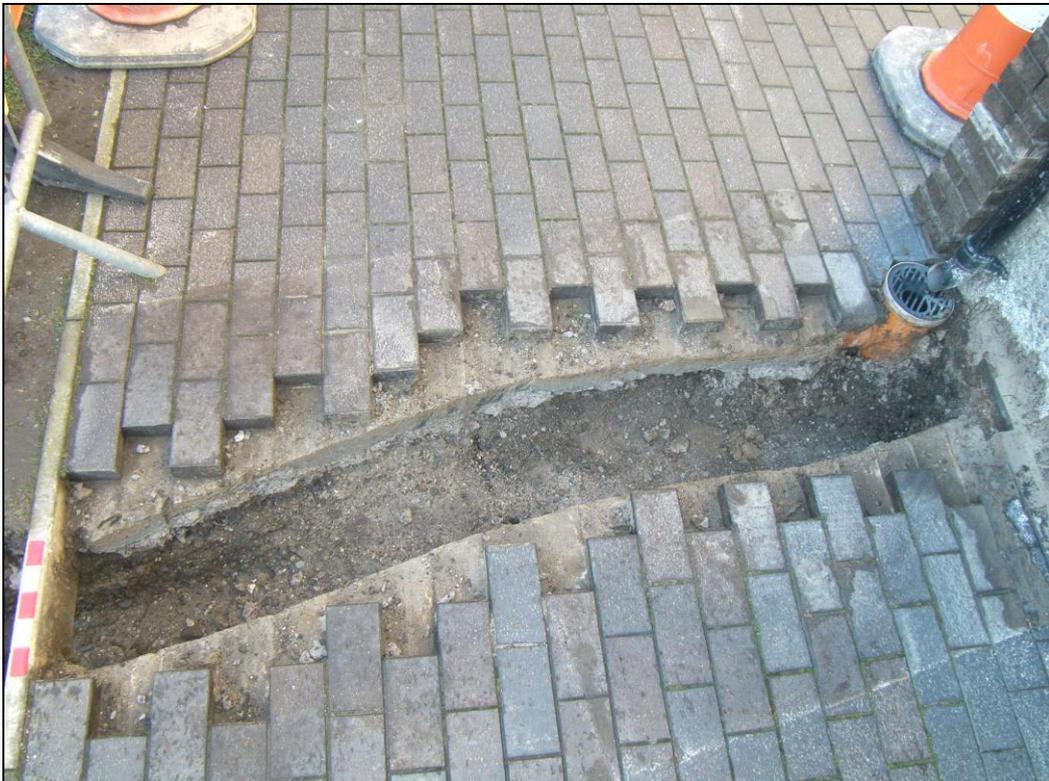
Plate 04: Trench 2: post-excavation view, looking west

Trench 2 was 2.1m in length, aligned north/south and located to the north of Trench 1. It was effectively an extension of Trench 1, being required to connect the existing electricity supply from a source in the keep to the northern end of Trench 1. The stratigraphically latest deposit encountered was a layer of concrete paving blocks (Context No. 201). Immediately below this was a concrete substrate (Context No. 202), along which a trench 0.3m wide had to be cut using an angle grinder. Under this was a concrete foundation layer (Context No. 203), which also had to be cut with an angle grinder before removal by hand. Under this was a clinker and mortar-rich deposit, which was excavated to a depth of 0.4m. Also uncovered were concrete edging (Context No. 206) and an associated concrete foundation (Context No. 205). Nothing of archaeological significance was found in this trench and deposits were consistent with modern disturbance associated with the construction of paving around the Inner Ward.

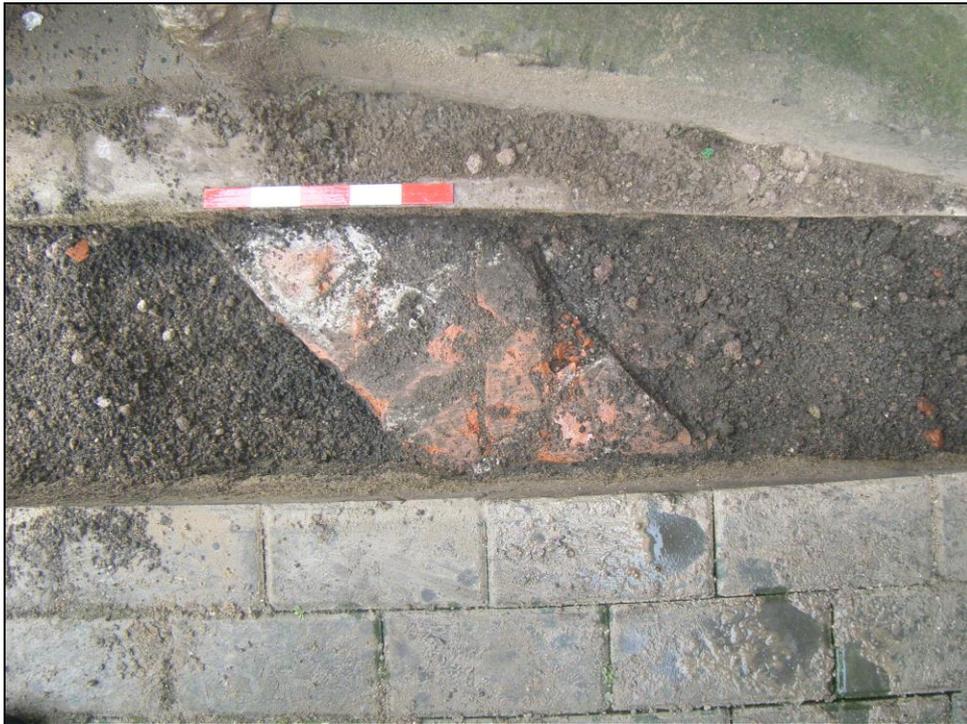
Plate 05: Trench 3: post-excitation view of brick wall C305

Trench 3 was 1.85m in length, aligned north-east/south-west and located to the south of Trench 1, being required to connect the new electricity supply from the southern end of Trench 1 to the Flash Room Corridor. The stratigraphically latest deposit encountered was a concrete door sill (Context No. 301) at the entrance of the Flash Room Corridor. This abutted a layer of concrete paving blocks (Context No. 302). Immediately below this was a concrete substrate (Context No. 303), along which a trench 0.3m wide had to be cut using an angle grinder. Immediately under Context No. 302 was a deposit of mortar-rich gravelly clay (Context No. 307), which had been cut (Cut No. 309) to permit the construction of a mortared brick wall (Context No. 305), 0.3m in width, aligned east/west across the trench. A dark grey gravel-rich clay had later been deposited around the brick wall, probably as part of preparatory levelling in connection with construction of the modern paving. Context No 307 had also been cut (Cut No. 310) to permit the construction of the concrete edging (Context No. 306). A levelling deposit (Context No. 308) had then been added in order to provide a foundation for the concrete substrate (Context No. 303) referred to above. No finds were recovered from this trench. The limited area of Trench 3 militated against a positive interpretation of the brick wall Context No. 305, but its mortared construction and regular shape suggests it was more substantial than a garden feature and may represent the remains of a small building, perhaps associated with the nearby Flash Room to the east.

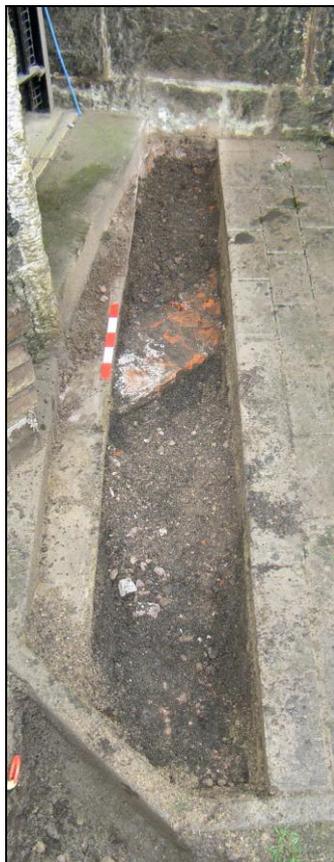
Plate 06: Trench 3: post-excitation view of trench, looking south-west

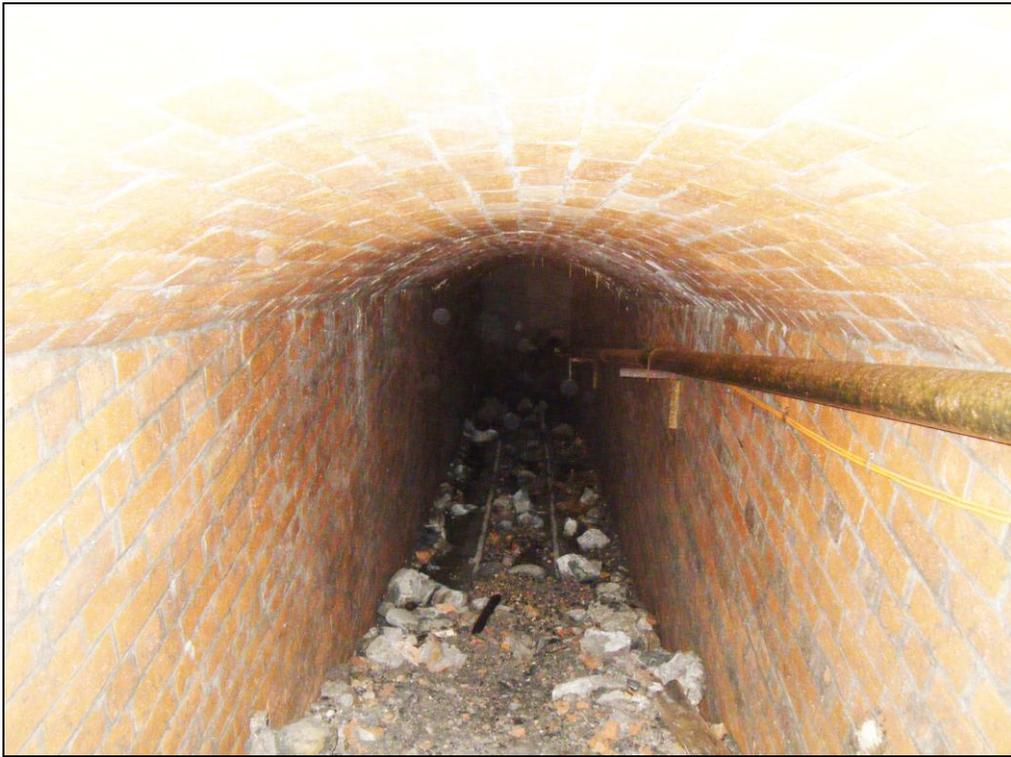
Plate 07: View of interior of access tunnel, looking north-west

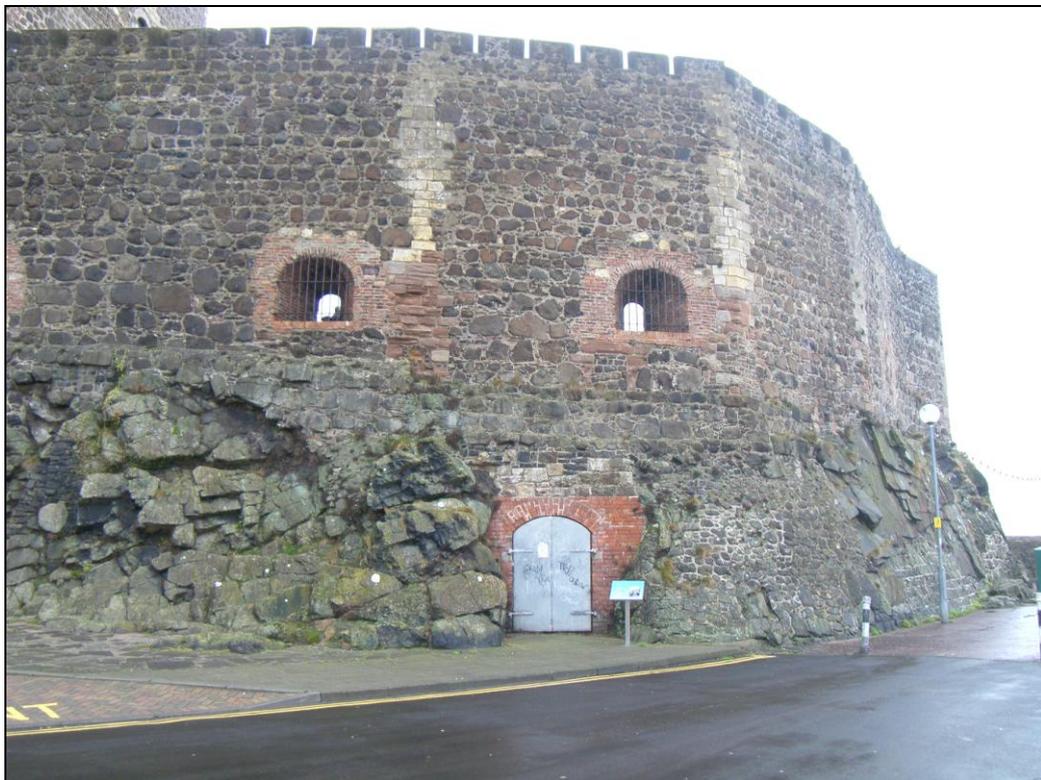
Plate 08: View of external entrance to access tunnel, looking south-east

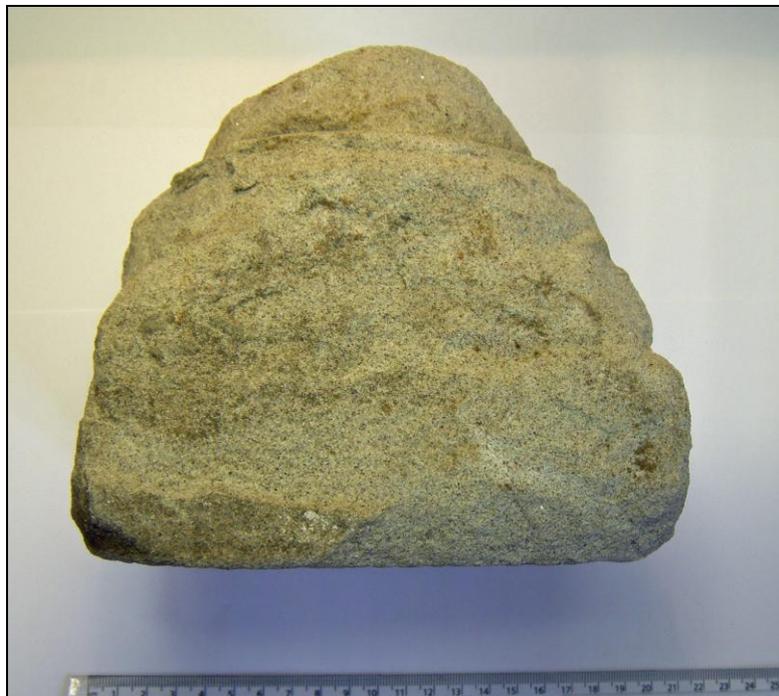
Plate 10: Side view of stone architectural feature

To the south of this brick feature three small areas of mortared stonework (Context No. 118) were uncovered, along with a small mortar-rich surface (Context No. 117). Due to the restricted size of the trench, it was not possible to determine if these were separate features or all part of a larger structure, but their proximity and similar constructional components suggest these were all part of one feature, perhaps wall foundations. This may be the partial remains of the south wall of the building marked *Engine House* on the 1811 map of the Castle (PRO wo 78/1158, cited in McNeill 1981). The only other feature uncovered in this area was a small mortared brick wall (Context No. 103), which consisted of a single row of broken bricks, aligned east/west and which continued across the trench. This was located at the southern end of the trench and probably represented the remains of a small landscaping feature. It was in this area that a moulded stone architectural feature (Small Find No. 1; see Figure 10 and Plates 09 and 10) was uncovered within Context No. 104 and close to Context No. 103. An initial examination of this object was carried out by Dr Tom McNeill,

who concluded (pers. comm.) that it seemed to be similar to four similar stone objects, previously found during work in this area to lay paths around the Inner Ward. He suggested that these might be surviving parts of a post-medieval fireplace that was removed from the Keep.
