## Evaluation/monitoring Report No. 169

Carrickfergus Castle  
Co. Antrim

AE/08/210

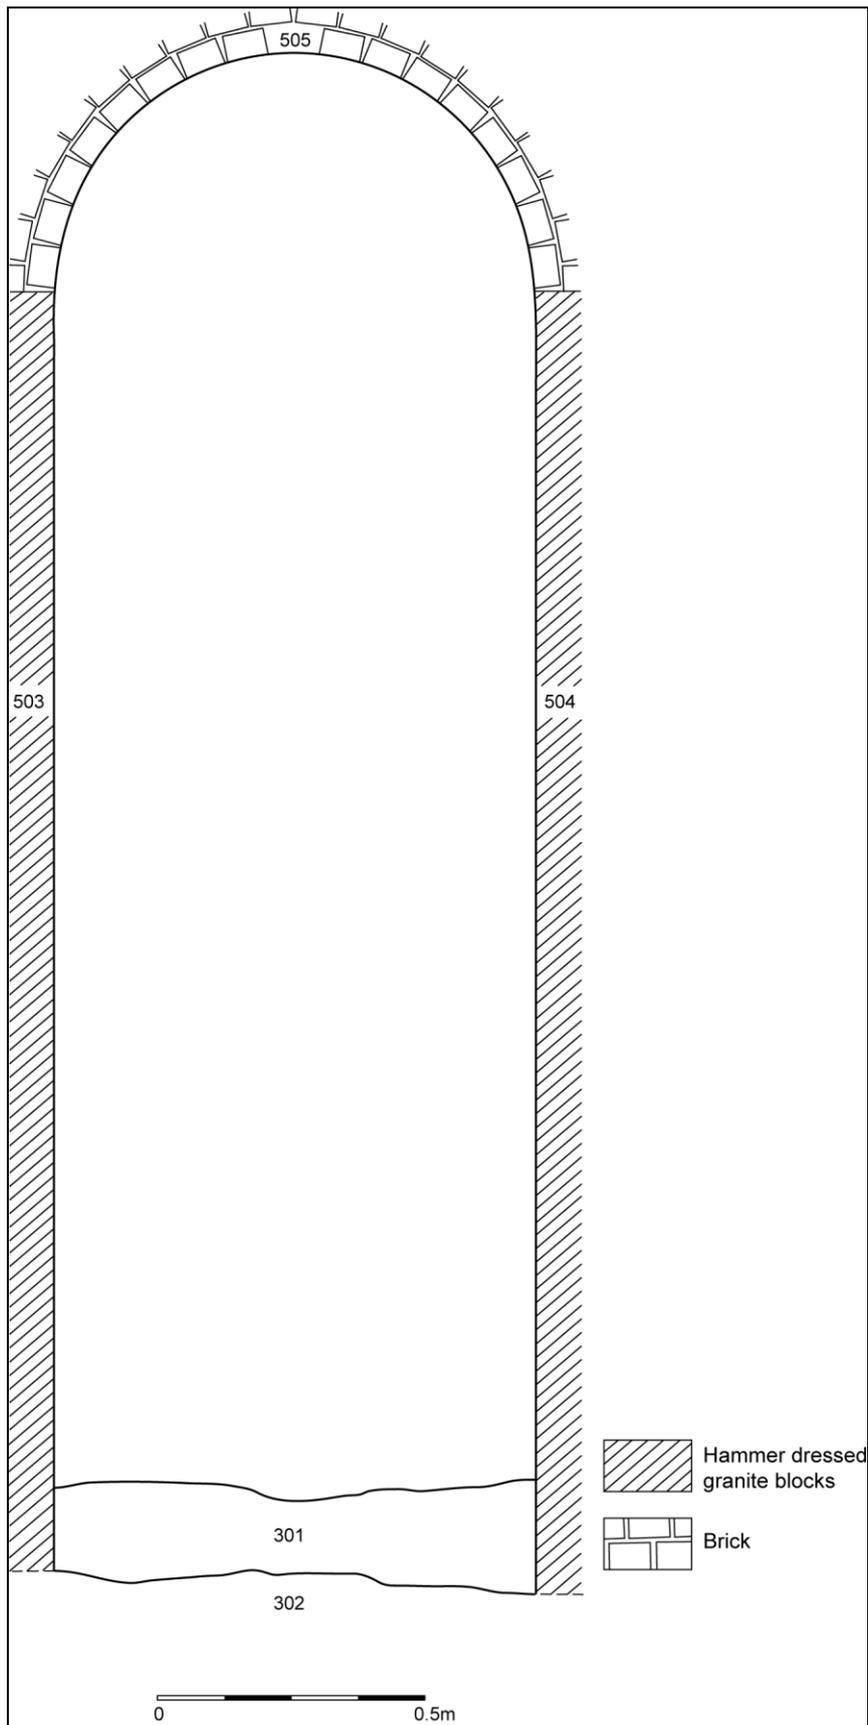
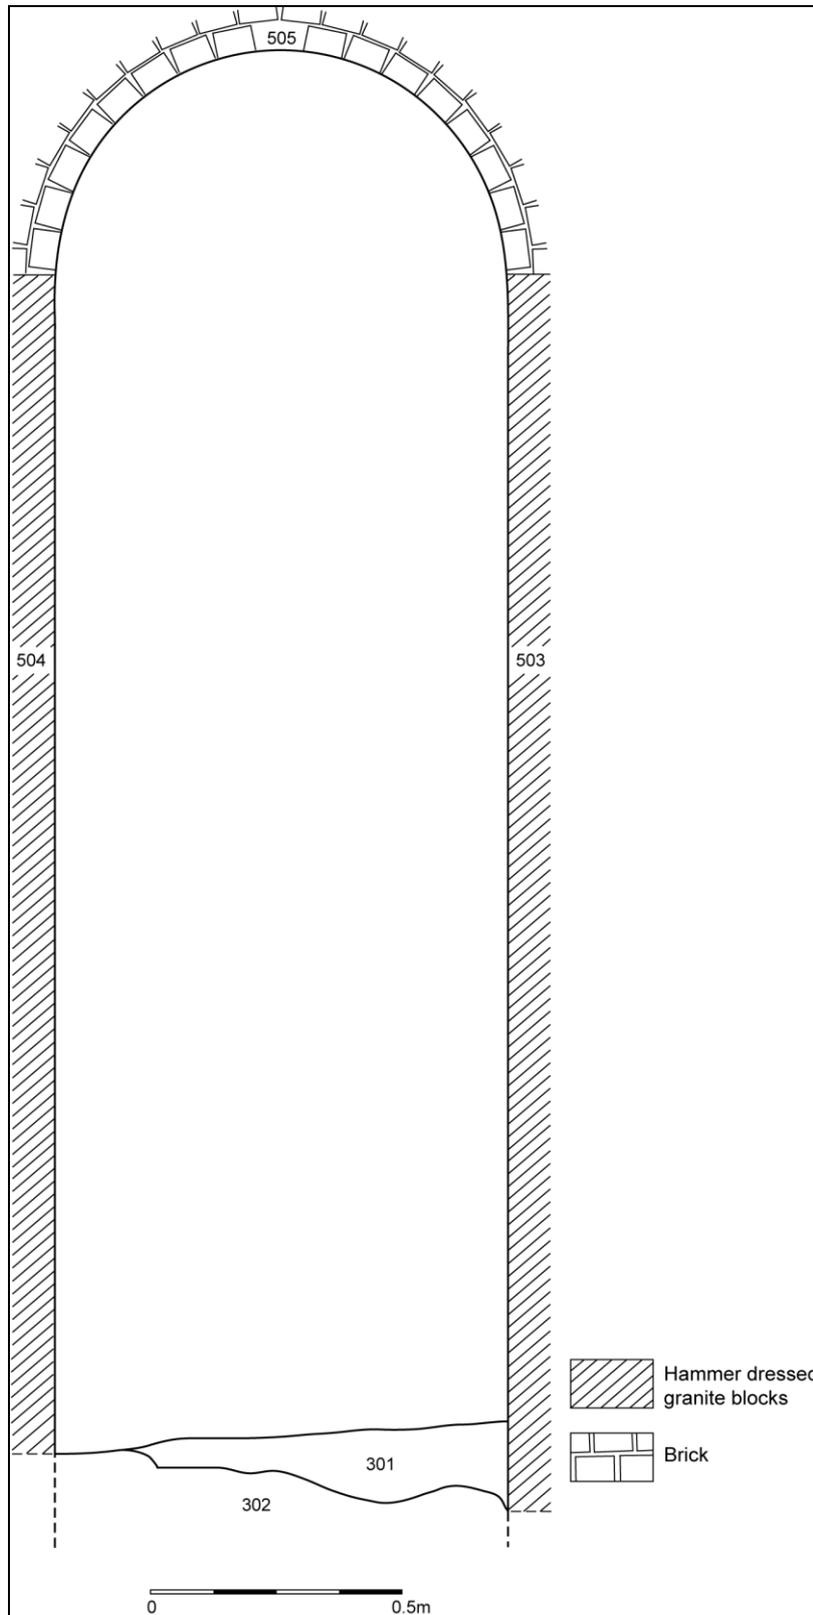
Figure 4: Trench 3 North-west facing section

Figure 5: Trench 3 South-east facing section

Trench 3 was 1.0m north-west/south-east by 0.9m north-east/south-west. The stratigraphically latest deposit encountered consisted of a mid-brown sandy layer (Context No. 301) which was 0.22m in depth. Immediately beneath this was a concrete surface (Context No. 302), which extended across the entire area of Trench 3. Excavation ceased at this point. It was observed that a slightly raised ridge extended centrally across the trench in a north-west/south-east alignment and this was interpreted as marking the position of a sewer pipe underneath, as this corresponded with the alignment of a sewer pipe that extended through trenches 4 and 5, as detailed below. If correctly interpreted, then the trench for the sewer pipe must have been filled in and covered with a layer of concrete (Context No. 302) at this point along the corridor. The sandy deposit (Context No. 301) contained 103 pieces of animal bone, some flint, iron items (possibly nails), 4 sherds of pottery (tentatively identified as medieval and post-medieval), 1 clay pipe fragment, pieces of slate, coal and coke and some shell.

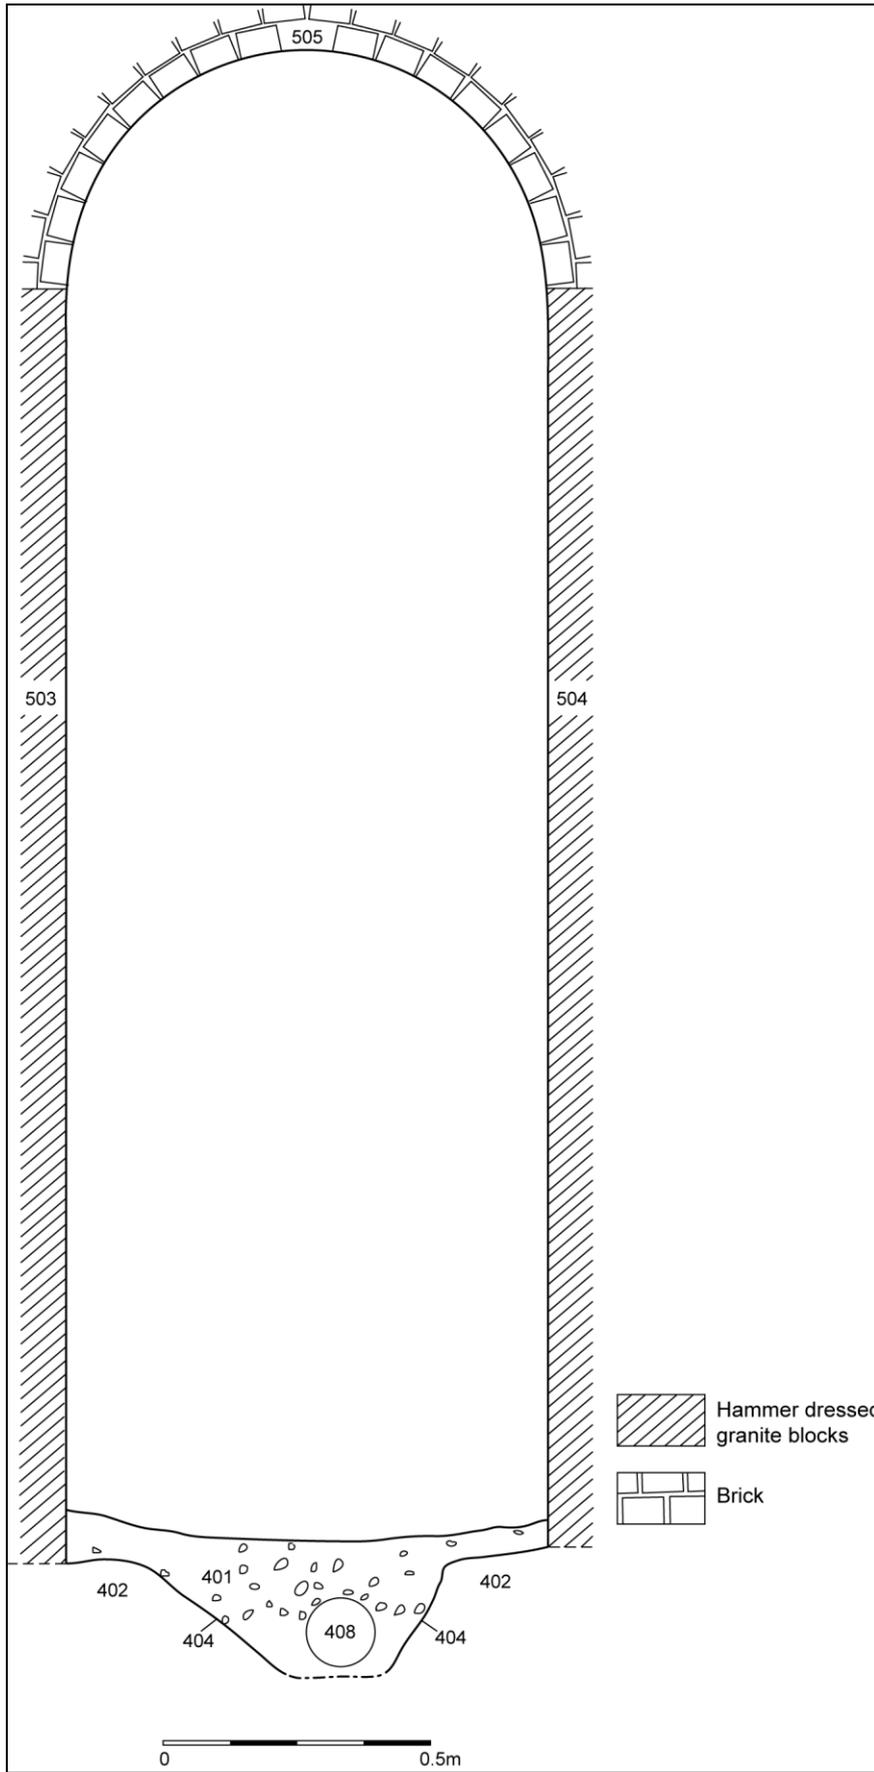
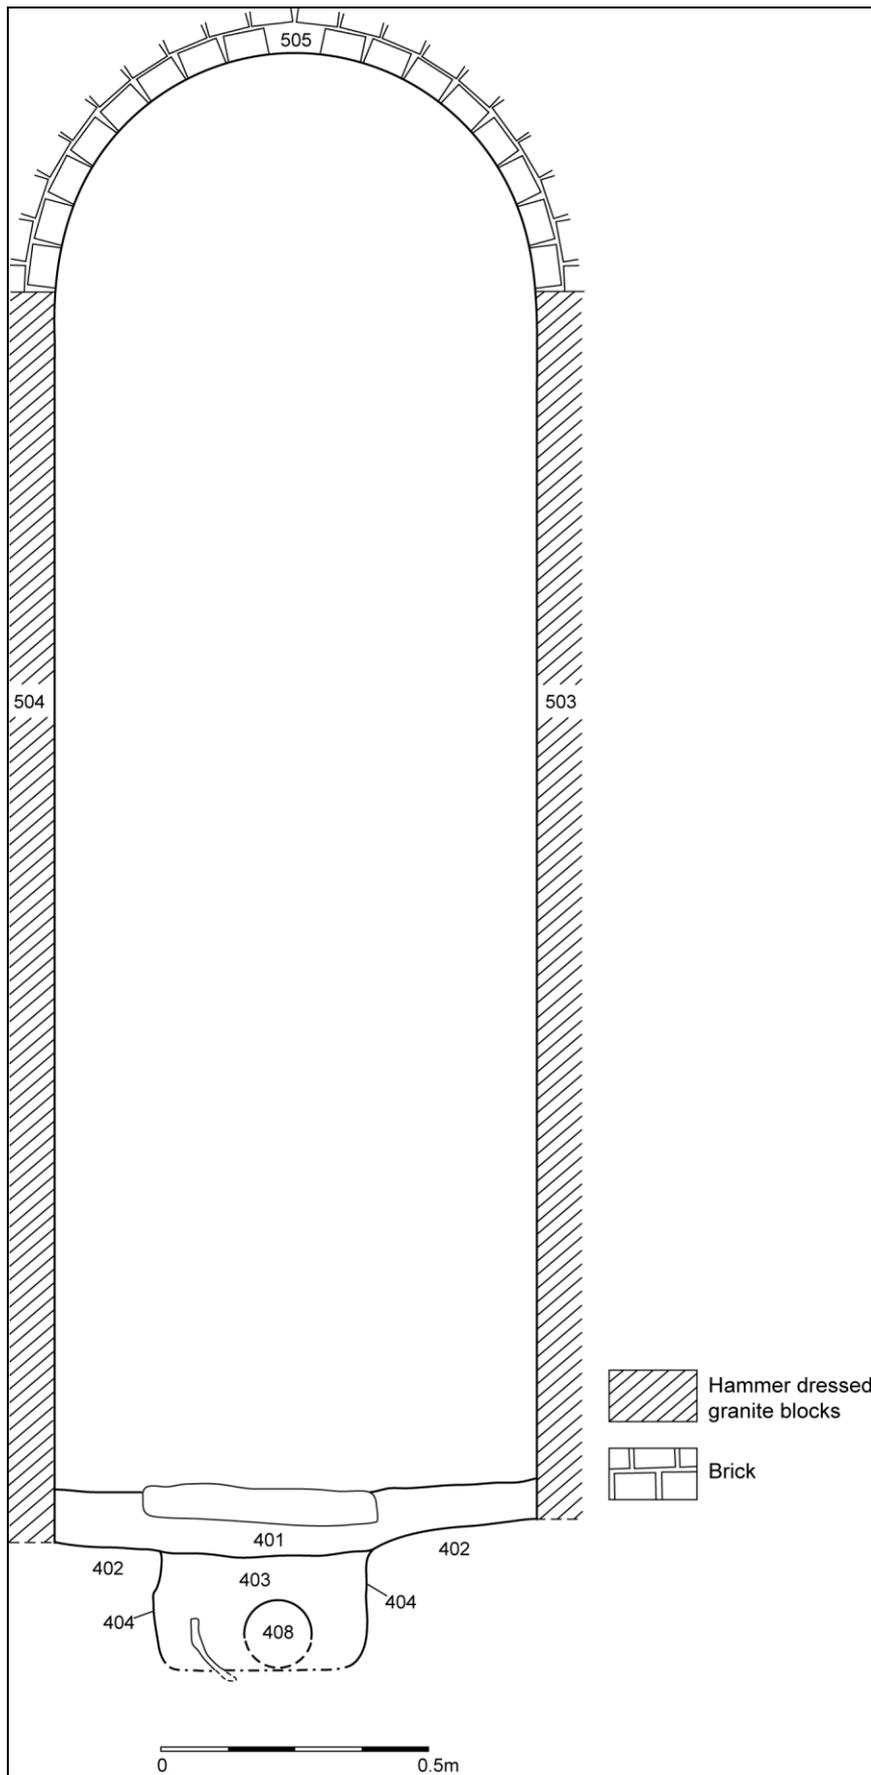
Figure 6: Trench 4 North-west facing section

Figure 7: Trench 4 South-east facing section

Trench 4 was 1.0m north-west/south-east by 0.9m north-east/south-west. The stratigraphically latest deposit encountered consisted of a mid-brown sandy layer (Context No. 401) to a depth of 0.10m, where a layer of concrete (Context No. 402) was encountered on the north-east and south-west edges of the trench, with a dark-brown sandy layer (Context No. 403) in between. When this was removed to a depth of 0.22m, a ceramic sewer pipe (Context No. 408) was uncovered. This was found to extend centrally along the length of the trench and it was clear that the layer of concrete

(Context No. 402) had been cut into in order to provide a trench to accommodate this sewer pipe. The sewer pipe had a maker's stamp impressed on it at regular intervals and most letters were legible. As far as could be ascertained, these letters were [C]ERG[H][O]LIE, N BROWN, PAISLEY. The excavation of Trench 4 was terminated at a depth of 0.32m. The interpretation here was that the concrete wall foundation (Context No. 402) was cut into to provide a trench for sewer pipe (Context No. 408). After this pipe was laid, the trench was in-filled with the dark-brown sandy layer (Context No. 403) to a level flush with the top of the concrete foundation. Context No. 403 was found to contain 37 pieces of animal bone, a sherd of broken sewer pipe, 14 pieces of flint, some iron objects (possibly nails) and some shell. This part of the corridor did not receive a covering layer of concrete, but was instead covered by a mid-brown sandy layer (Context No. 401). This layer contained what appeared to be a military-style button, 2 fragments of clay pipe, metal objects, iron slag, animal bone and teeth, 6 sherds of pottery, slate, wood and paper fragments, flint and shell.

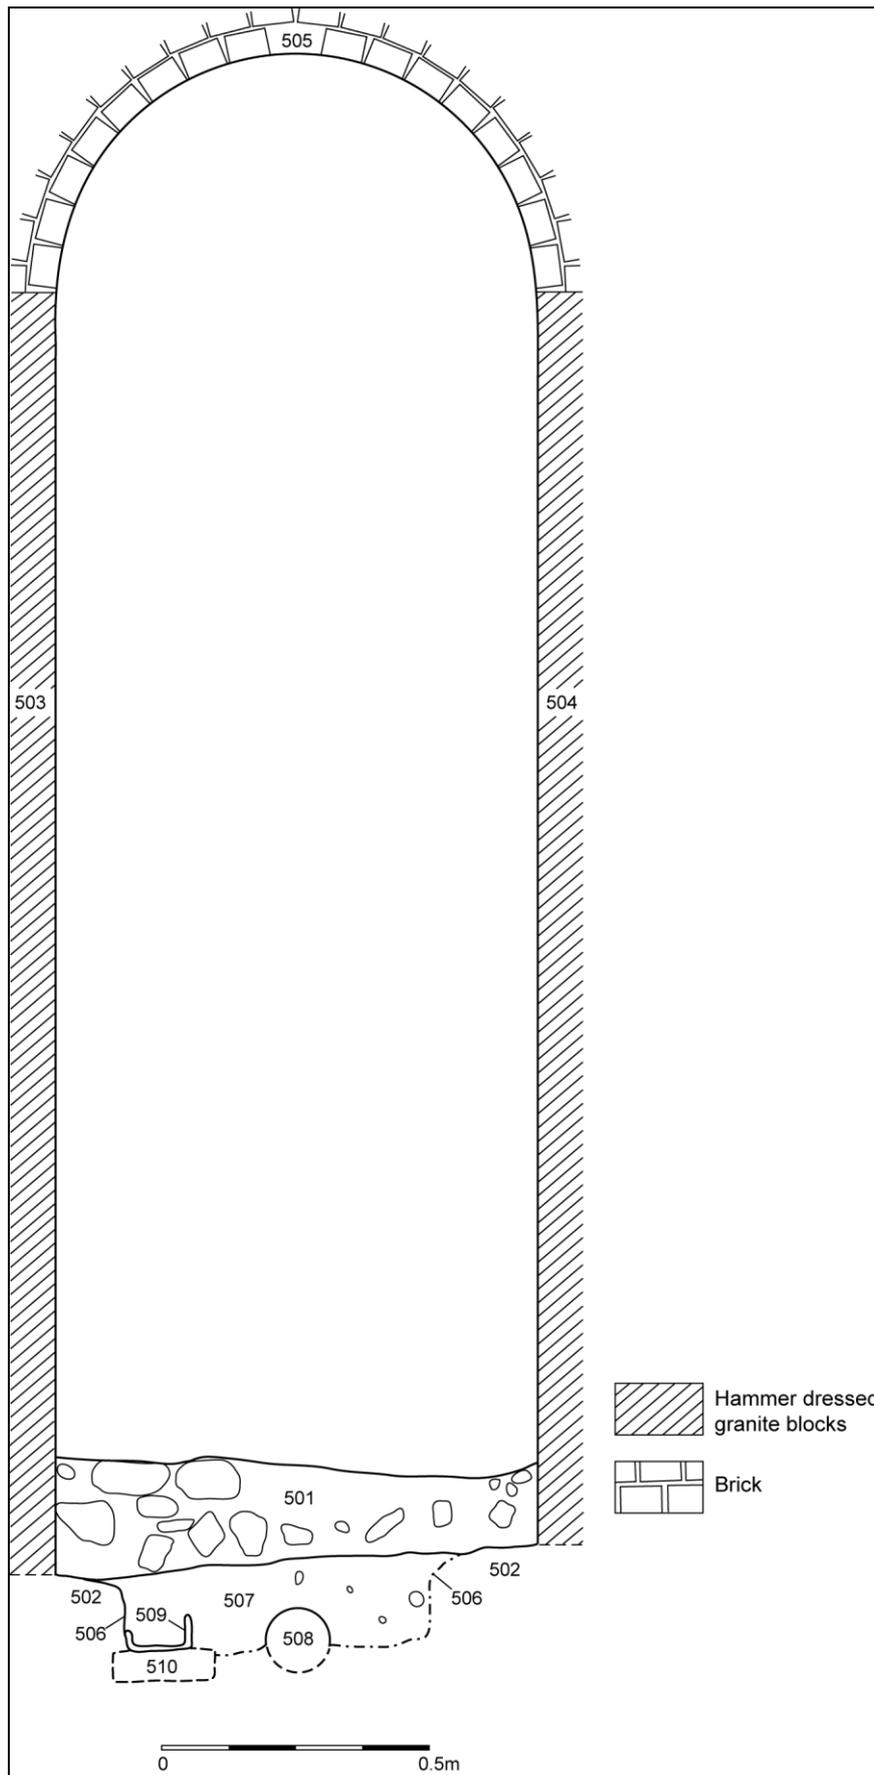
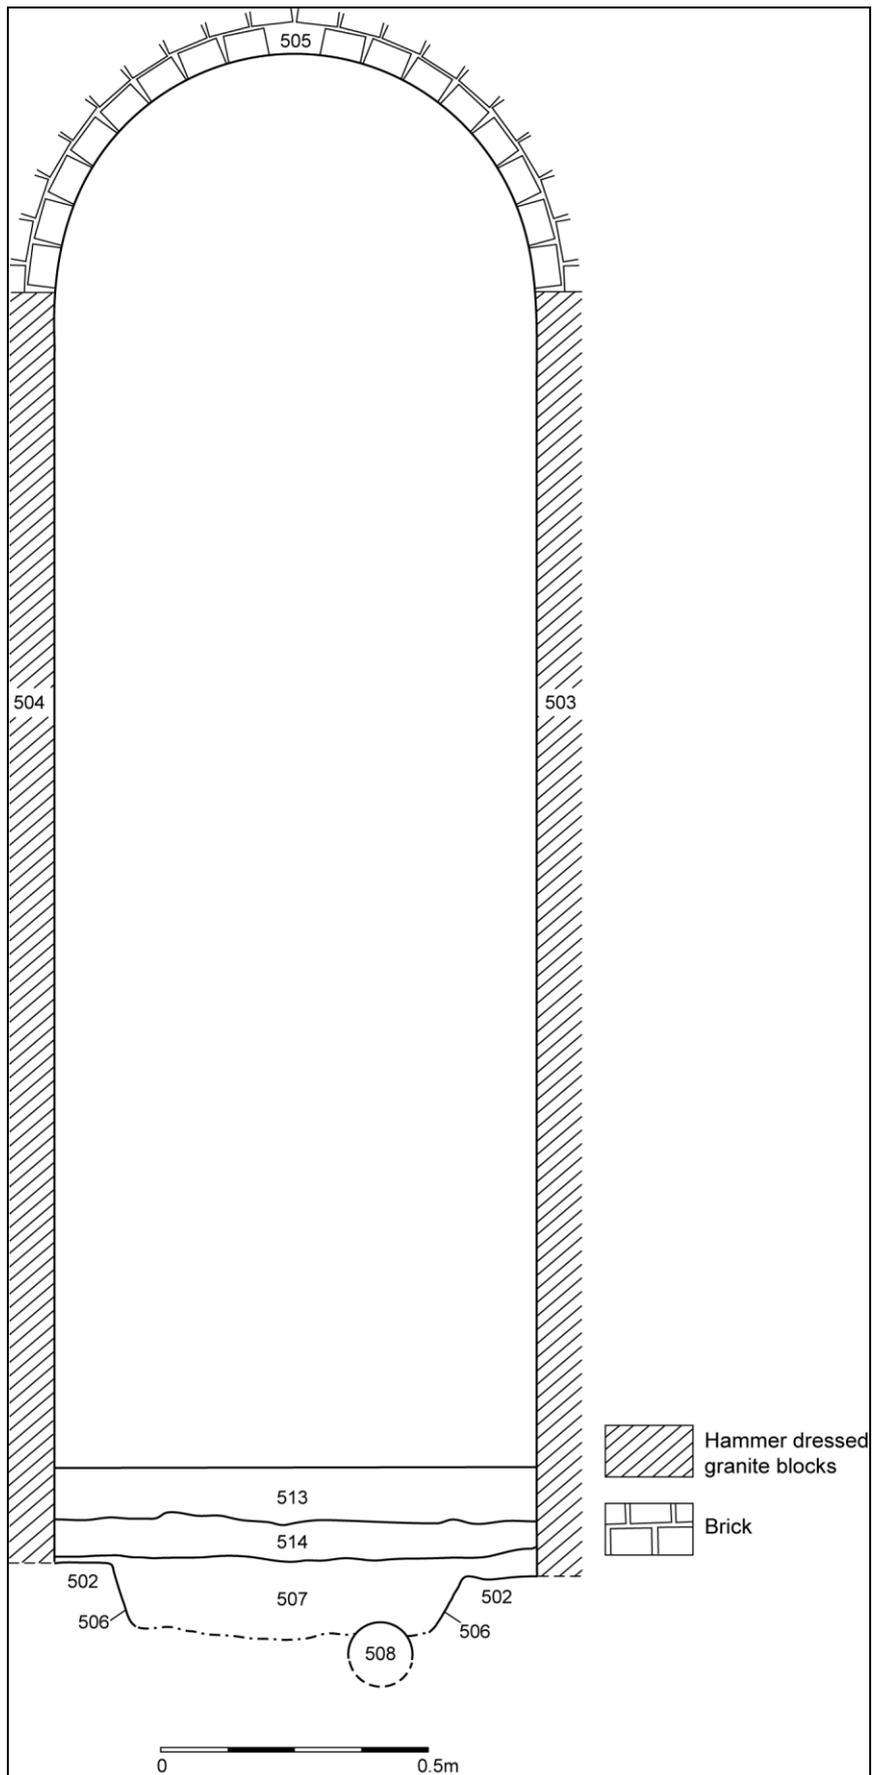
Figure 8: Trench 5 North-west facing section

Figure 9: Trench 5 South-east facing section

Trench 5 was 1.0m south-east/north-west by 0.9m north-east/south-west. It consisted of an upper mid-brown sandy layer (Context No. 501) to a depth of 0.22m, where a layer of concrete (Context No. 502) was encountered on the north-east and south-west edges of the trench, with dark-brown sandy layer (Context No. 507) in between. When Context No. 507 was removed to a depth of 0.15m, a ceramic sewer pipe (Context No. 508) was uncovered, extending centrally along the length of the trench with a north-west/south-east alignment. Levels taken on this sewer pipe indicate the direction of flow to be north-west, towards the Inner Ward. It was clear that the concrete layer (Context No. 502) had been cut to provide a trench to accommodate this sewer pipe. An iron channel (Context No. 509) was also uncovered at the south-east corner of the trench. It was resting on a row of red bricks, mortared together and aligned north-south, extending into the baulk on the south-east side of the trench and under the concrete layer (Context No. 502) to the north-east. The excavation of trench 5 was terminated at a depth of 0.35m. In trench 5, it appears that the concrete foundation (Context No. 502) was set down on top of the existing iron channel (Context No. 509), which does not appear to be associated with either the Flash Room or the Flash Room Corridor. The concrete foundation was itself later cut into to provide a trench for ceramic sewer pipe (Context No. 508) and subsequently in-filled with dark-brown sandy layer (Context No. 507), which contained a number of complete bricks, cobbles, metal objects and slag, a clay pipe fragment, 1 sherd of pottery, some flint and shell and a fragment of slate, pierced with a small hole. This end of the corridor did not receive a covering layer of concrete, but was instead covered by a mid-brown sandy layer (Context No. 501). This layer contained some metal objects, animal bone, slate (1 piece pierced with a small hole), flint and shell.

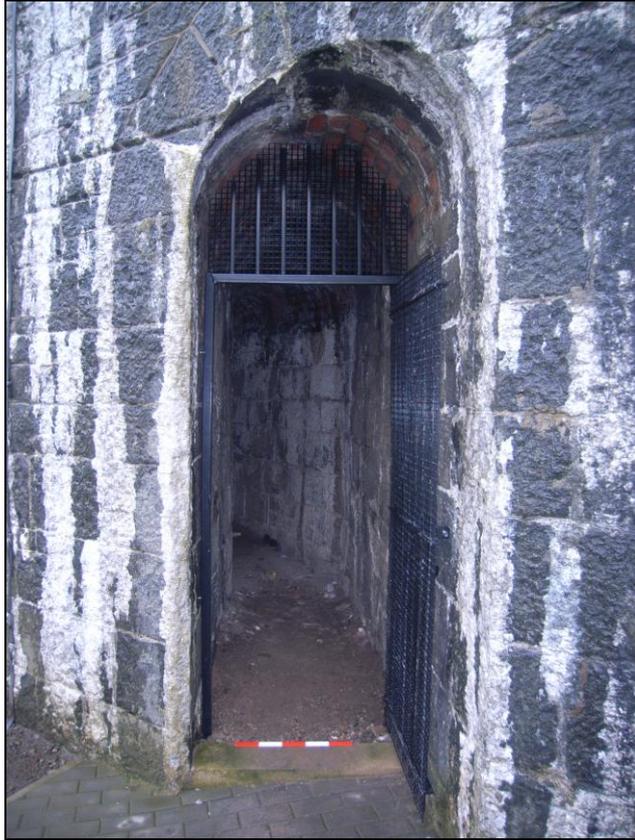
Plate 2: Entrance to Flash Room Corridor, looking south-east

The mid-nineteenth century Flash Room Corridor is entered from the southern end of the Inner Ward, through a modern metal gate and grille (Context No. 511). The corridor here is constructed of hammer-dressed granite blocks (Contexts 503 & 504), with a brick arch (Context No. 505) over and

The most recent works at the north-western end of the corridor included the provision of a concrete foundation (Context No. 514) on which was placed a concrete sill (Context No. 513), both to secure a path of brick pavers laid around the south-west of the Inner Ward. The entrance to the Flash Room

corridor was also provided with a metal gate and grille (Context No. 511), to provide security and keep pigeons out.

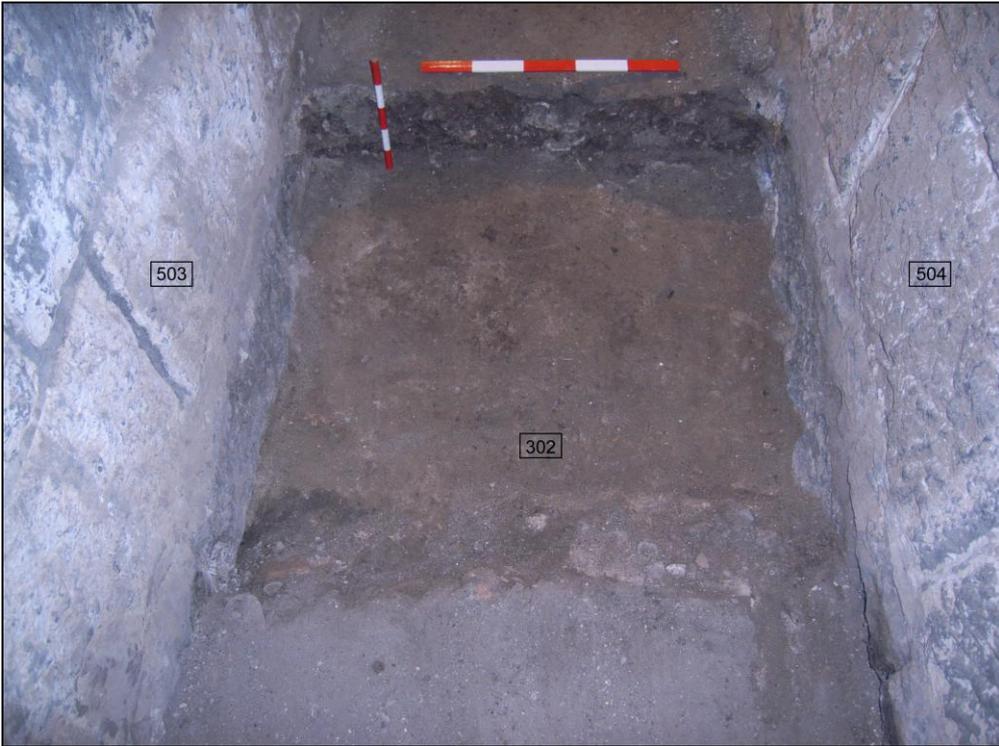
Plate 4: Trench 3 after excavation, looking south-east

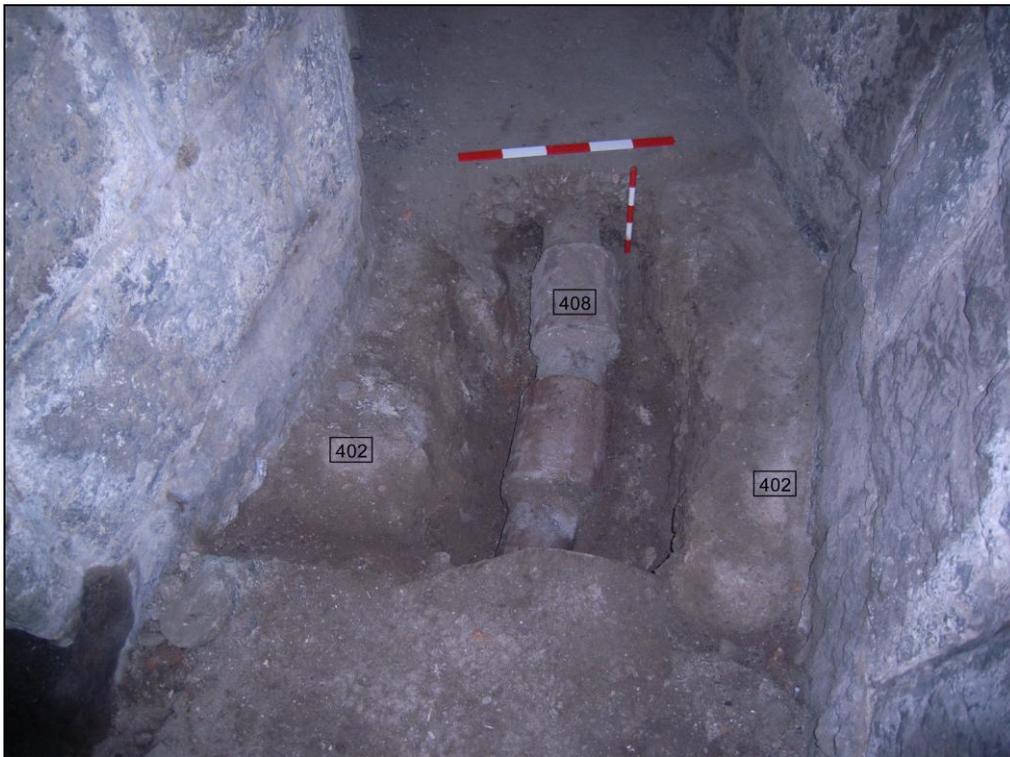
Plate 5: Trench 4 after excavation, looking south-east

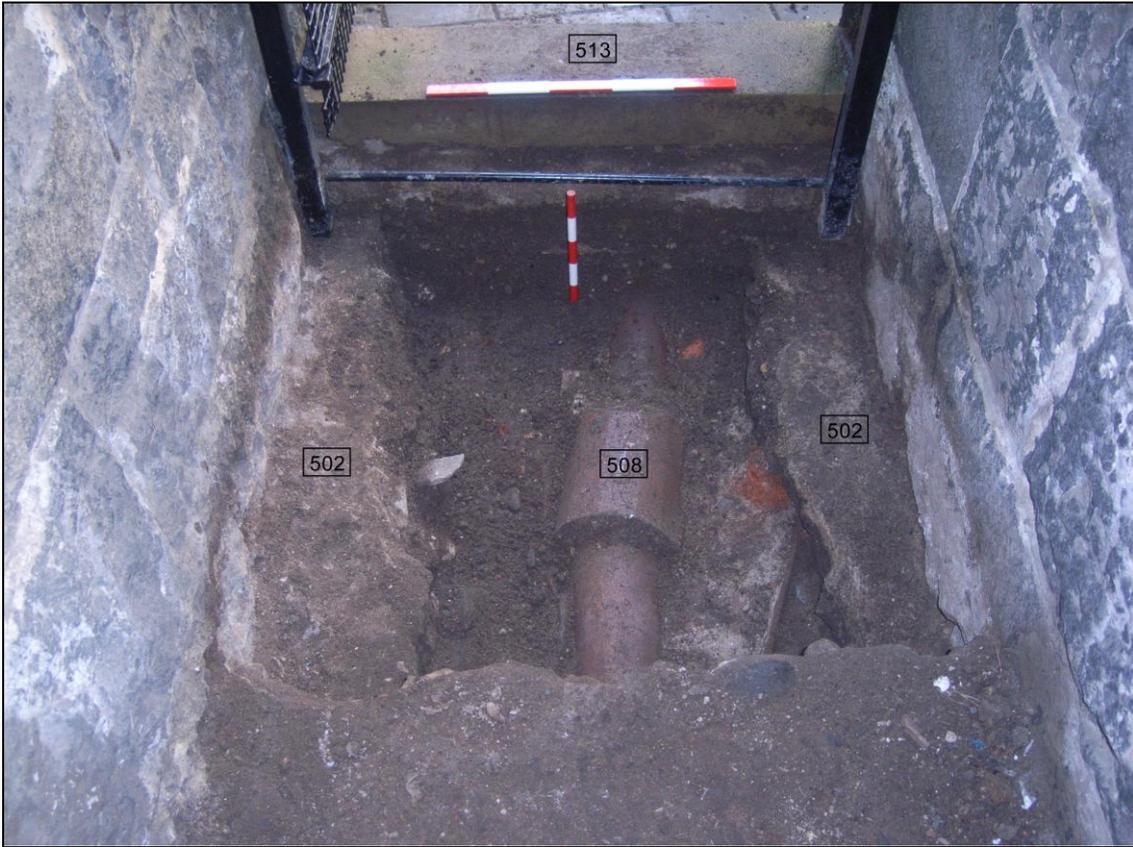
Plate 6: Trench 5 after excavation, looking north-west

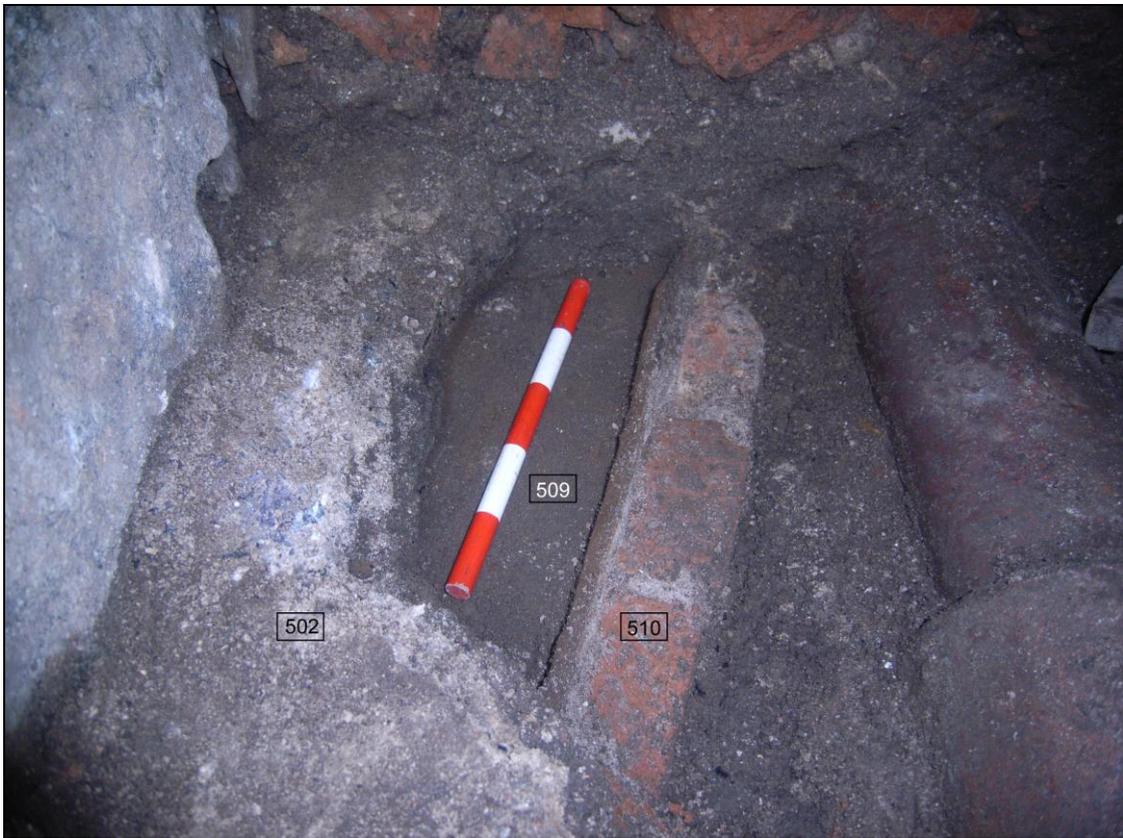
Plate 7: Trench 5, iron channel C 509 and brick foundation C 510, looking south-east

According to McSkimin (1823, 164), part of the south curtain wall of the castle collapsed in 1754, facilitating the French occupation in 1760 and repairs probably took place in 1761. There is a possibility that the iron channel (Context No. 509) may be associated with this repair work, providing a solid platform for bringing stone to the site.
