**Data Structure Report No. 85 (preliminary report)  
Archaeological Excavations at Quoile Castle, Co. Down**

**Archaeological excavations at Quoile Castle, Co. Down  
Preliminary report submitted to NIEA**

**Licence number: AE/11/65  
NISMR: Dow 031: 009  
Grid reference: J 4963 4701**

**December 2011**

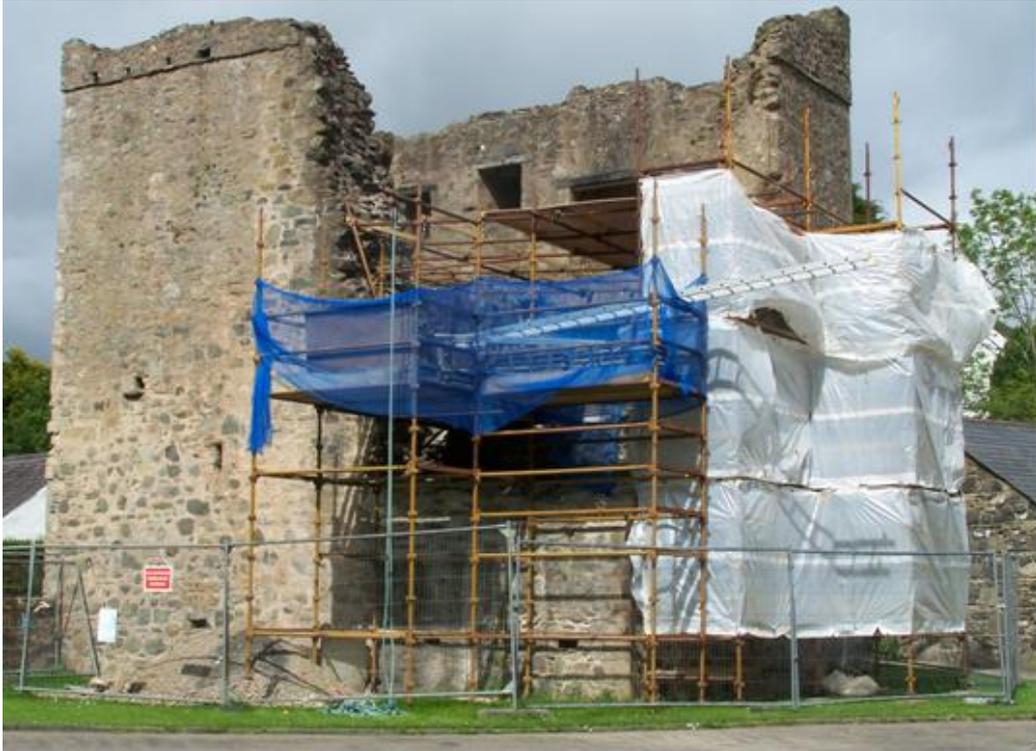
**Plate 1. Quoile Castle, Co. Down. The west and south walls during conservation work, May 2011.**

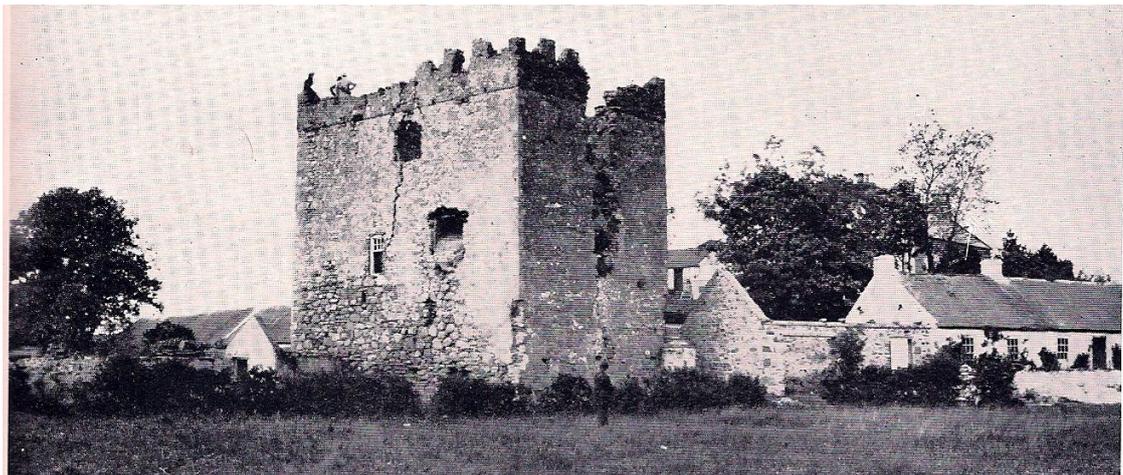
**Plate 2. Quoile Castle, Co. Down. The Welch photograph from *circa* 1900.**

A Welch photograph from *circa* 1900 shows the castle clear of ivy with render on the masonry visible (Plate 2). The photograph also shows a crack in the west wall that later was the cause of the later collapse.

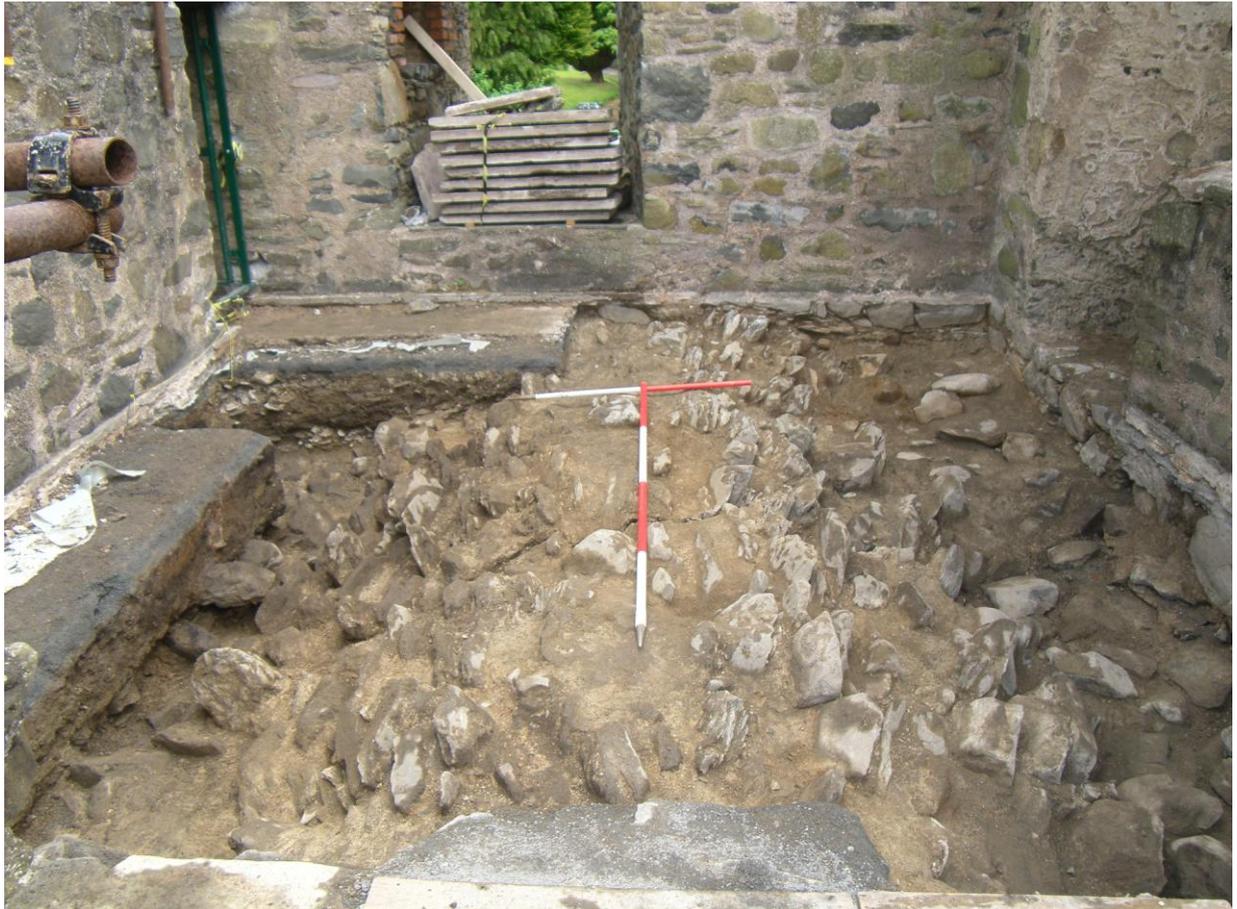
**Plate 3. Quoile Castle, Co. Down. The southern chamber. Exterior surface of the first floor vault fully exposed after excavation. The crack in the vault roof is visible, running left to right across the middle of the photograph. From the west.**

The external surface of the vault roof (C.7/C.107) was constructed of large stones set on end in a heavily-mortared base, and in irregular rows. When uncovered on the excavation the surface was very jagged in appearance and when originally constructed it was clearly not meant to be seen. The mortar on the vault roof was very crumbly and loose.

The excavation showed the roof to be mostly intact, apart from a large crack that runs up the middle of the crown, in a roughly north-south alignment, almost to the western side of the window in the south wall.

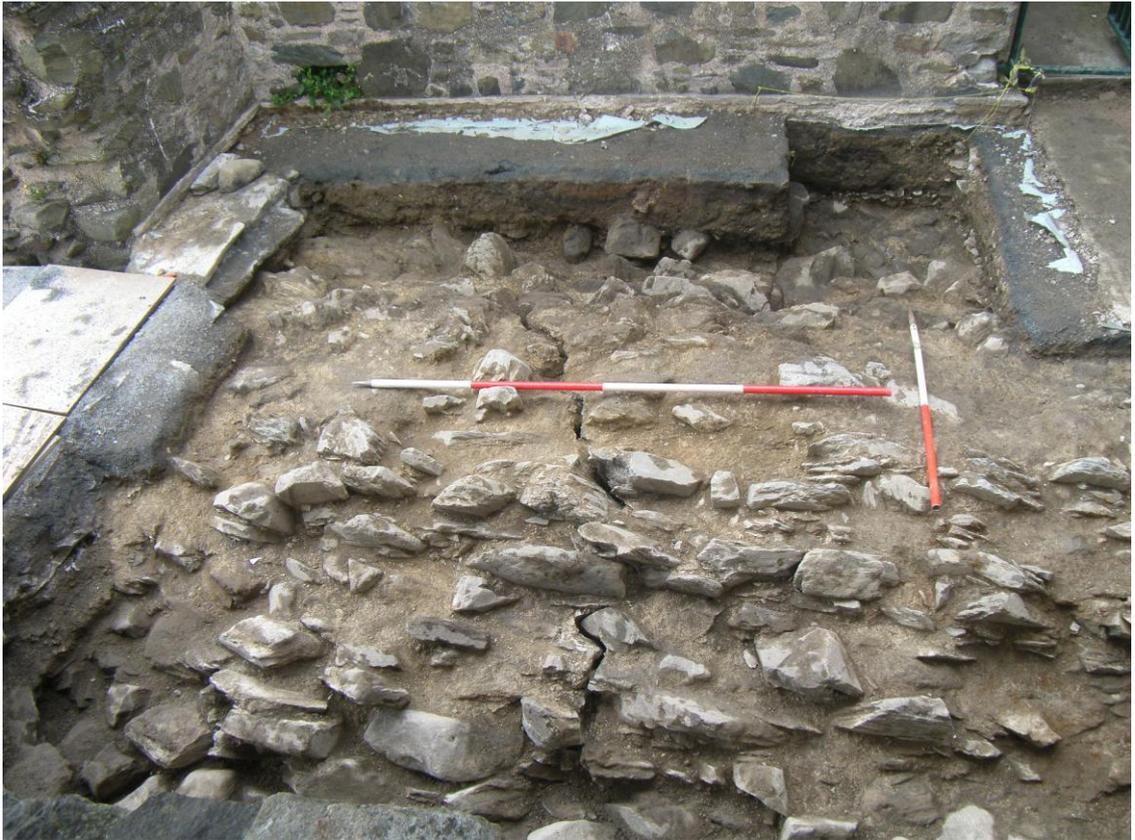
**Plate 4. Quoile Castle, Co. Down. First floor, southern chamber.**  
**Photograph of the fully-excavated vault roof. In the top right of shot, the dividing wall between the northern and southern chambers is clearly shown not to be founded on either early deposits or an earlier wall. Shot taken from south,**

The partition wall between the northern and southern chambers of the first floor was investigated during the 2011 excavation. The wall had no foundation trench and was not founded on any earlier masonry construction. It was discovered to be set on a base of stone slabs and cement and, therefore, appears to be a modern construct, not part of the original castle building.
