CAF Data Structure Report No. 77 (preliminary report)

**Excavations on the Grand Battery at
Carrickfergus Castle**

ANT 052:059

8th December 2011

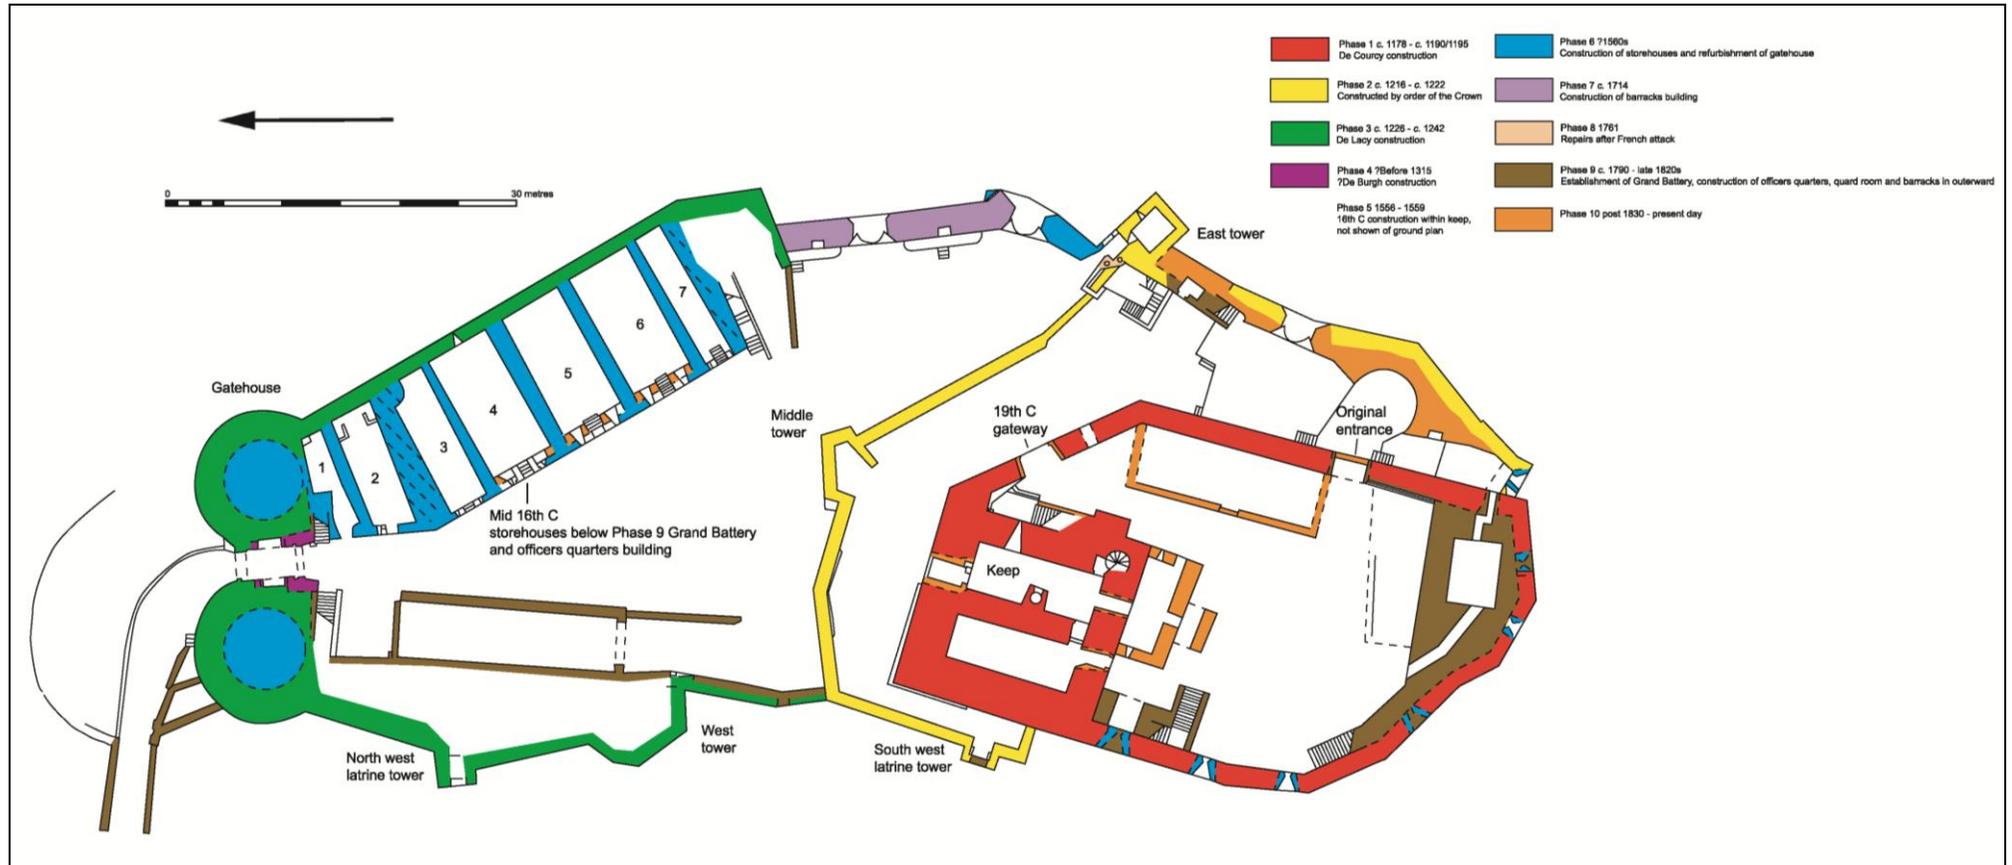
Figure 2 Plan of Carrickfergus Castle showing the main structural phases of development (from Ó Baoill 2008 - after McNeill 1981).

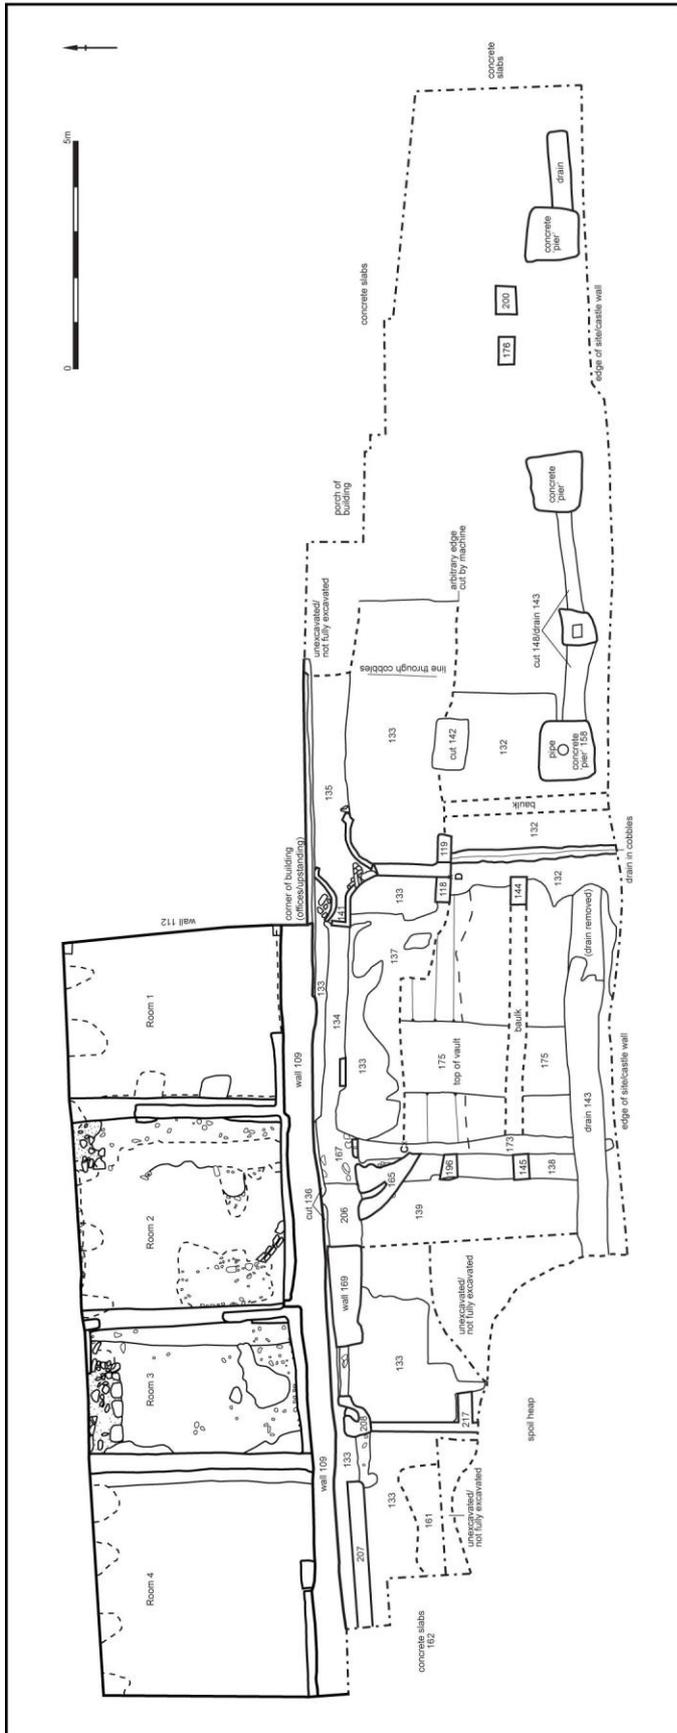
Figure 12: Post-excavation plan of the Grand Battery. The four rooms and southern end of the former Officers' Quarters building is shown in detail in Figure 13. The location of the Vault 5 transect (Figure 15) is marked by points 'C' and 'D'.

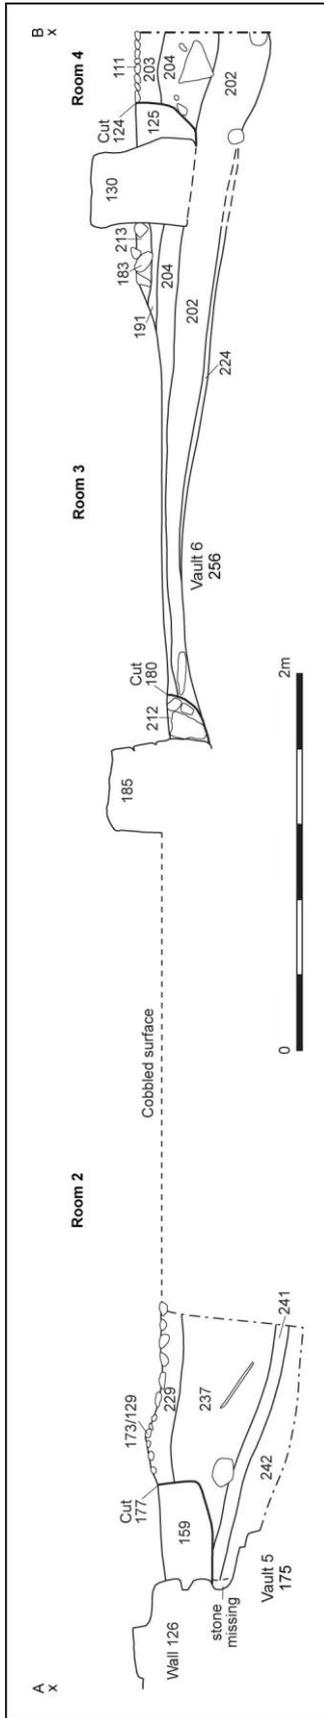
Figure 14: West-facing running section drawing of a series of box-trenches excavated across the western ends of Rooms 4-2 (see Figure 13 for the location of the section).

In Room 3 a section was cut through the western end of cut C.180. This had a gently sloping, U-shaped profile with a width of 0.37m (north-south) south of the wall, and depth of around 0.28m (Figure 14). In addition to the wall, C.185, it had a single fill C.212, a sandy loam containing large angular stones, fragments of brick and decayed mortar. Disturbed cobbles were also present and visible within the top of the fill further to the east. An excavation trench was opened right across the width of Room 3 along its western end (approx.. 2.7m wide) but the northern edge of the cut, C.124 for the subdividing wall between Rooms 3 and 4, wall C.130, was not identifiable. The section was continued into Room 4 for a length of around 0.75m and excavation south of this wall (C.130), through the cut C.124, showed that it had a sloping U-shaped profile, a width of 0.25m (south of the wall) and depth of 0.29m. It had a single fill, C.125, a brown sandy loam containing small stones, brick fragments and animal bone.

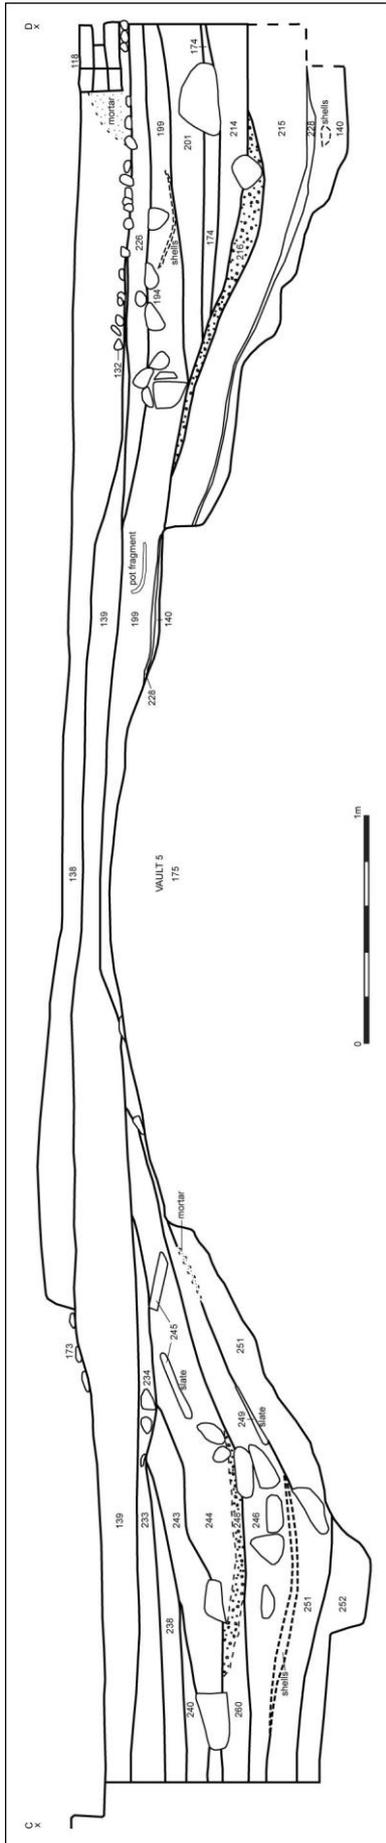
Figure 15: East-facing section drawing of the Vault 5 transect (see Figure 12 for the location of the section).

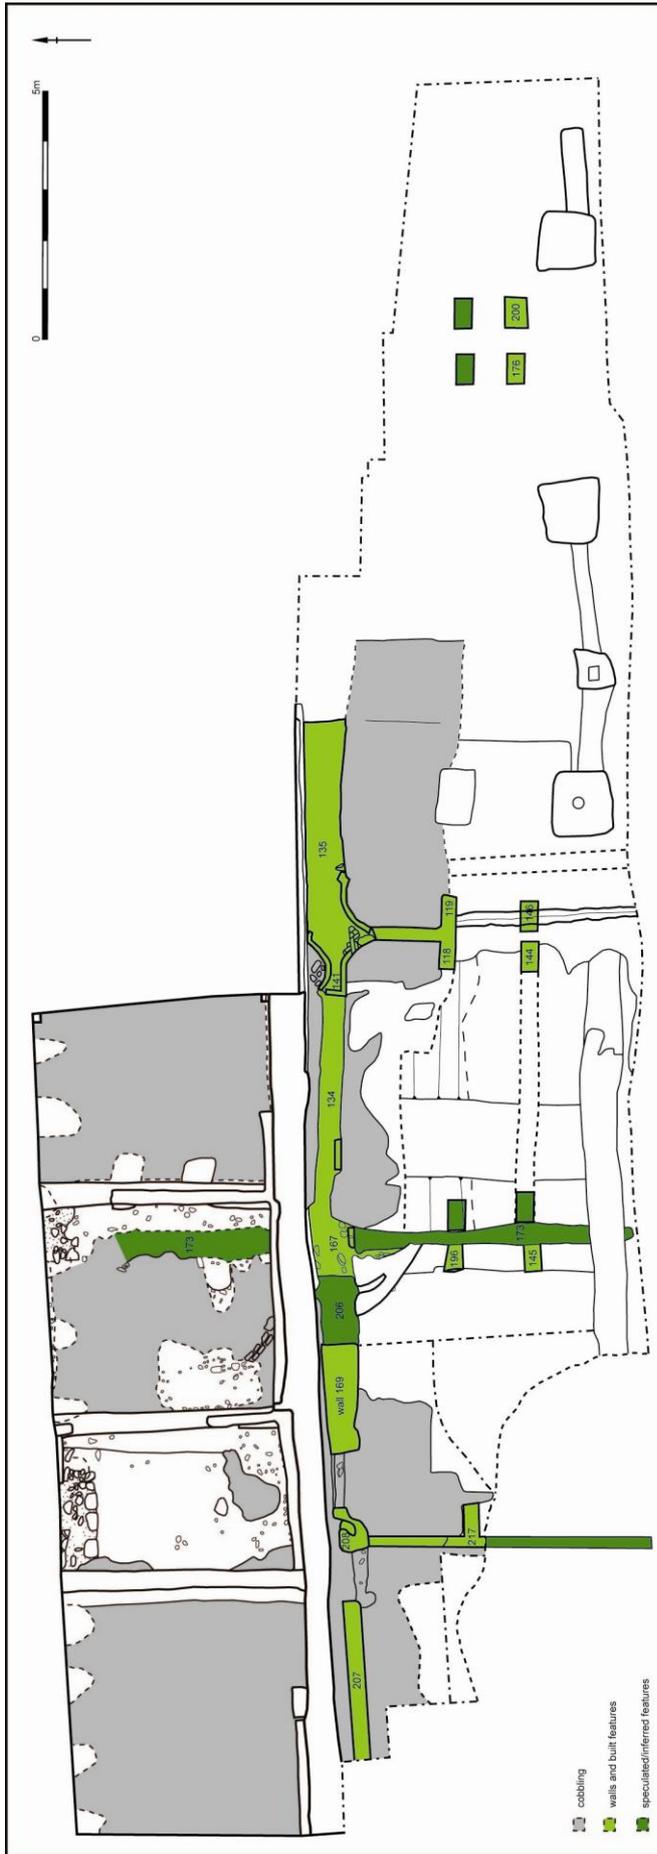
Figure 16: Post-excavation site plan with the surviving remains of the eighteenth-century Infantry Barracks highlighted. Uncertain features and speculated features that may once have existed and been part of the barracks are also added and highlighted.

The nineteenth-century Officers' Quarters building located along the western side of the Grand Battery replaced an earlier Infantry Barracks built in 1715 providing a *terminus ante quem* for the construction of the ground floor vaulted storehouses. No plans, drawings or other illustrations of this building survive though comparisons can be made with a small number of contemporary barracks, surviving and/or documented. There were perhaps enough bits uncovered at Carrickfergus to piece together an idea of the building and to make some suggestions as to its design and layout. It also seems probable that, unlike the later Officers' Quarters building, that the barracks spanned and occupied the full length and width of the Grand Battery.

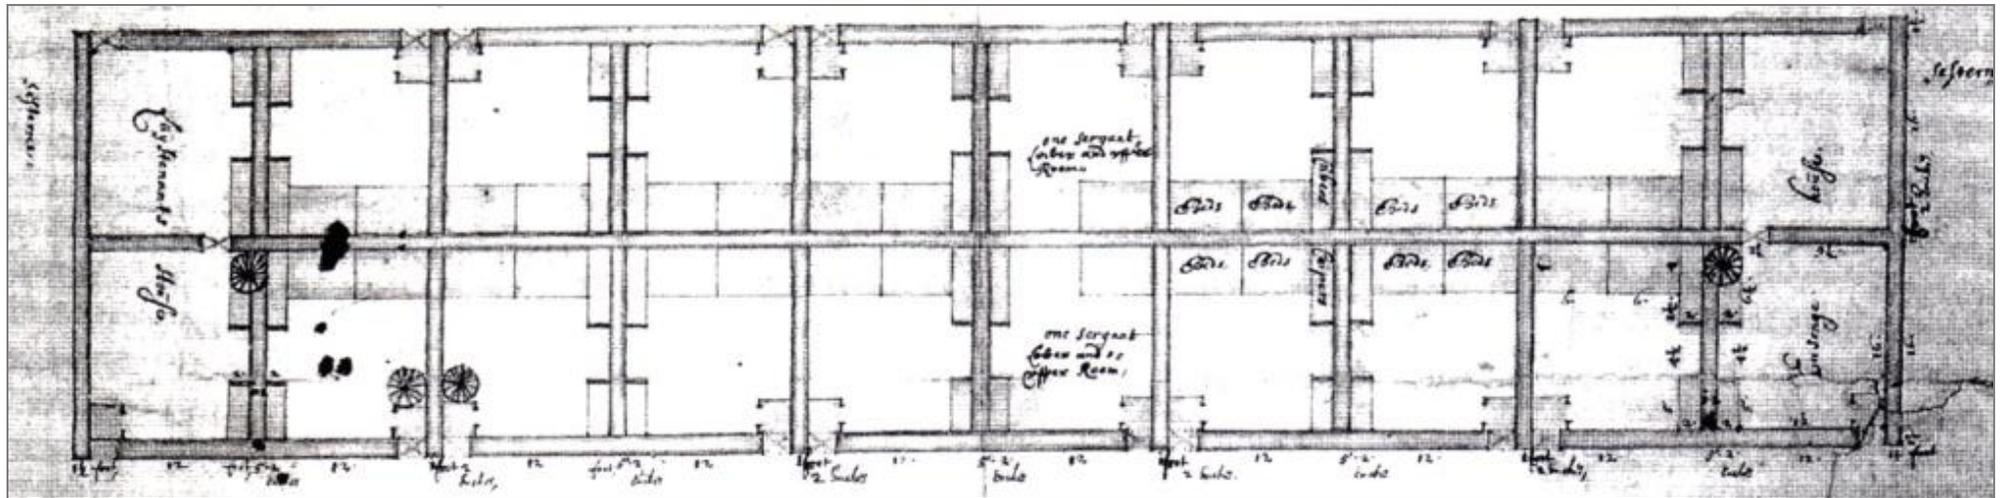
Figure 18 De Gomme's ground-floor plan of the barracks at Portsmouth, circa 1679 (from Douet 1998, 10).

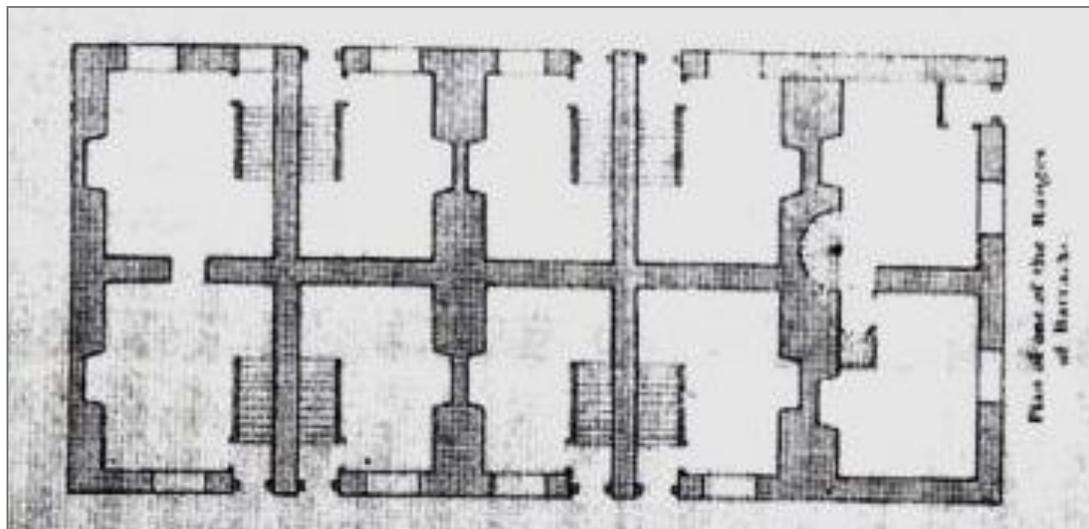
Figure 19 A 1715 plan of de Gomme's barrack range of the 1670s in Plymouth citadel (from Douet 1998, 14).

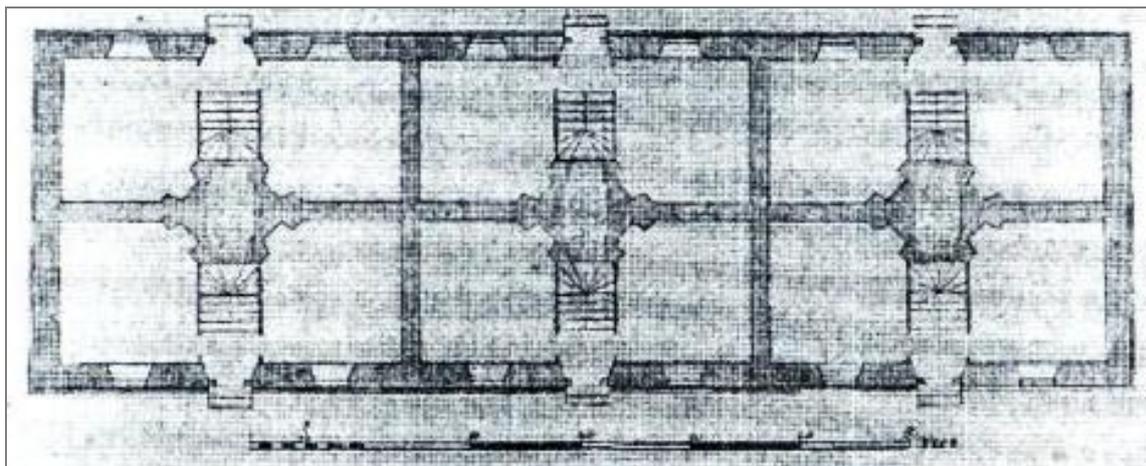
Figure 20 Lily's 1715 plan for a proposed new barracks on St Mary's, Isles of Scilly (from Douet 1998, 17).

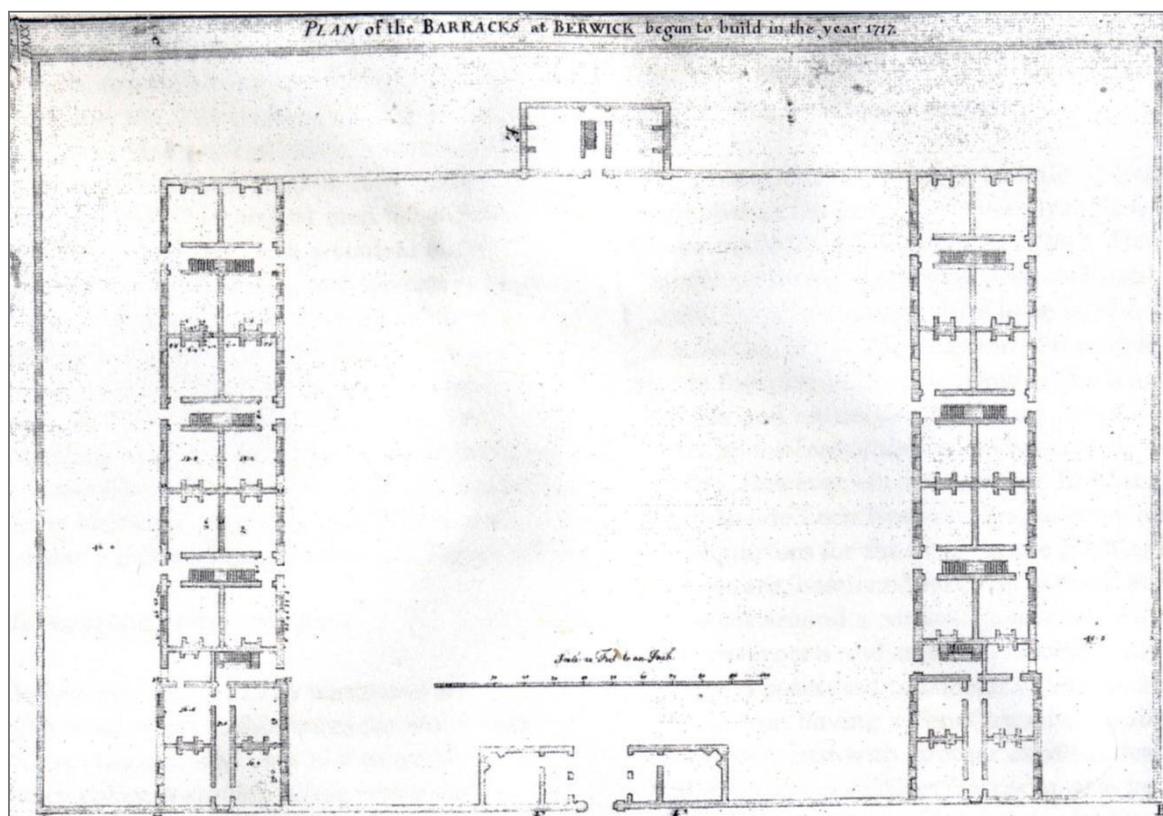
Figure 21 Plan of the barracks at Berwick upon Tweed built in 1717 (from Douet 1998, 19).

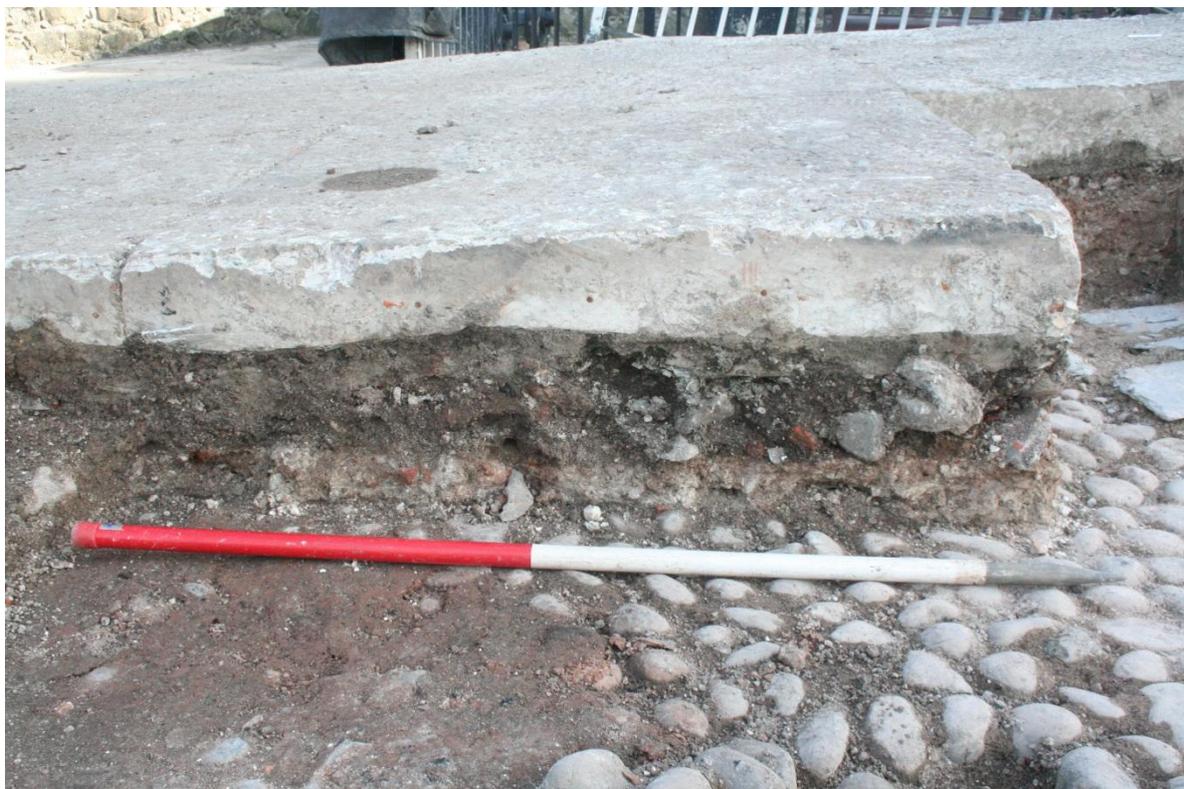
Plate 8 Concrete (C.162) overlying levelling and demolition deposits C.211 and C.209, and clay layer C.161 (over cobbles C.133) at the top of the ramp at the southern end of the Grand Battery (facing south).

A section of the concrete slab (C.162; 0.15m thick with a pebbled surface) survived at the top of the ramp that leads-up from the Outer Ward to the Grand Battery at its southern end. This overlay the levelled surface of the eastern long wall (C.109) of the southern end of the former Officers' Quarters building: the northern 'half' of this building still stands and is currently used as offices. The concrete (C.162) also sealed at least two levelling horizons east of this wall; a heterogeneous dark brown loam and rubble layer, C.211 (0.10m-0.13m thick), containing fragments of broken slate, stone, brick and mortar, and a lower loose, mottled light-brown rubble layer (C.209) with a high concentration of mortar. This deposit (C.209) decreased in thickness eastwards, closer to the east curtain (0.21m-0.06m). Much of these two deposits had been removed or heavily disturbed on arrival on site and were best preserved under the surviving section of concrete (C.162) at the southern end of the Grand Battery. It was unclear if the upper levelling deposit (C.211), which appeared to be a mixed layer of garden soil and building rubble, also extended west of the levelled wall (C.109) of the Officers' Quarters building. It probably dates to 1990 when the garden was replaced with concrete (see Section 2.3). The lower levelling deposit was more representative of a demolition layer and may date to the

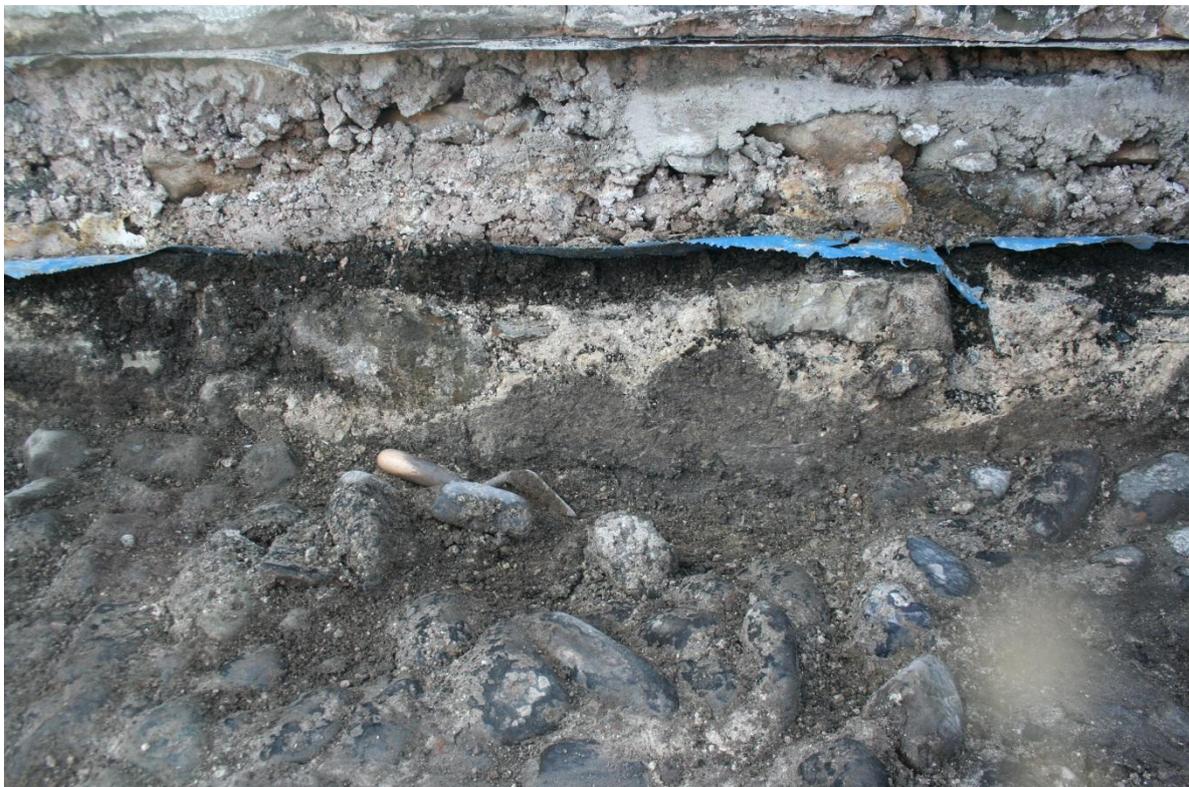
Plate 10 Surviving plaster/render on wall C.220 in Room 4; below tarp (C.105) and contemporary wall infill (C.106).

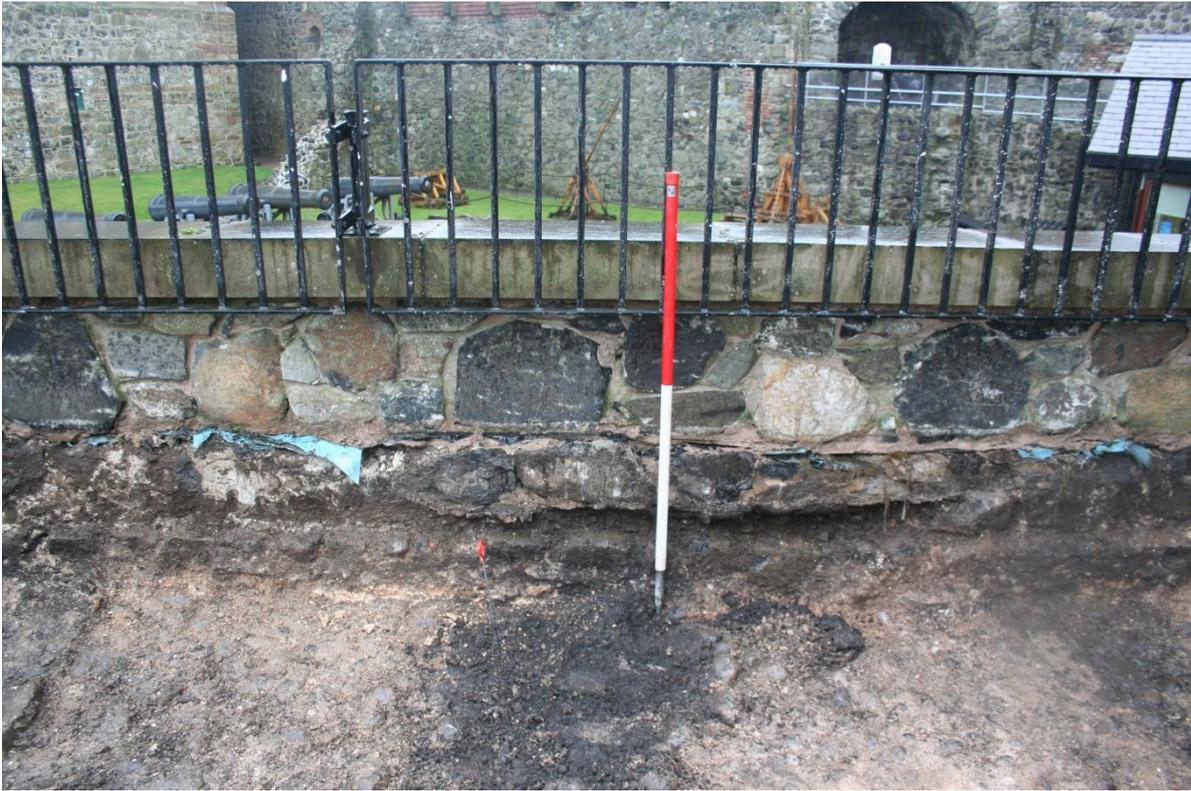
Plate 11 Western wall in Room 1 showing modern wall (C.101-106) with C.105 above C.106 (see Plate 10) and the hedge bed C.118 and fill C.119.

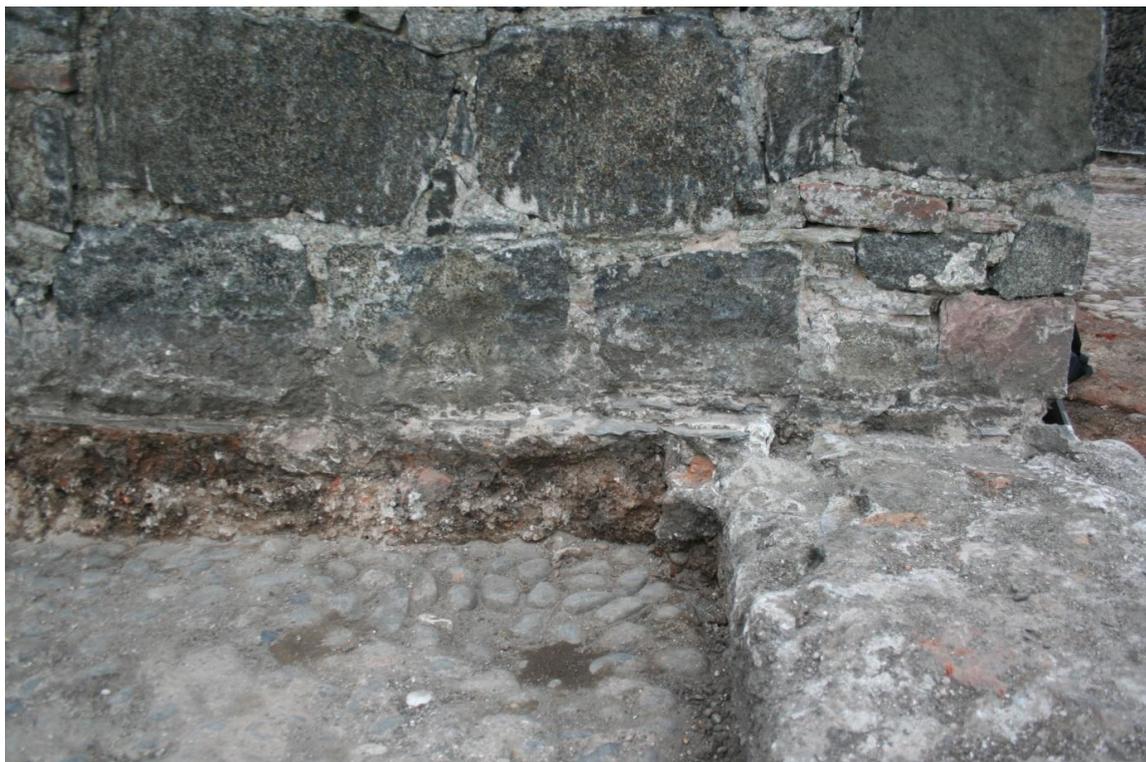
Plate 13 Room 1 wall 187 in the north eastern corner of the room under gable wall C.112 and wall C.109 (right).

Thin brick-built walls also survived along the eastern side of the building set just inside (west) of the eastern long wall C.109 in Rooms 1 (C.187), 2 (C.113) and 3 (C.186). In Room 4, a length of this internal ‘skin’ wall survived set inside wall C.109 but was stone-built (C.123). Remnants of a parallel wall set inside, east of the western long wall C.107/8, also survived in the north-western corner of Room 1 (C.223). These walls, unlike the dividing walls between the rooms aligned east-west, were not set on a stone foundation course. In Room 1, two sections of the wall C.187 survived. Along the south-eastern side of the room two courses of brick, with the bricks set end-on survived for a length of 1.5m (north-south). The top of the wall appeared to be partly capped and bonded to wall C.109 with a layer of mortar/concrete – perhaps this was laid when the site was levelled and reused as a garden. The wall was also bonded at the southern end to the brick partition and skin walls of Room 2, C.120 and C.113. Just a short length, less than one brick length of wall C.187, survived at the north eastern corner of Room 1. The wall, C.187, was built against the western face of wall C.109, and was built above the cobbling (C.155) and the cut and fill of the long wall (C.136 and C.257). A fragment of a parallel brick wall, C.223, survived in the north-western corner of the room (length approx. 0.16m). Again two courses survived (0.15m in height) and the long sides of the bricks were set parallel to wall C.107 to which it is bonded with mortar. The wall is built on the cobbled surface (C.155) and continues under the new gable wall (C.112).

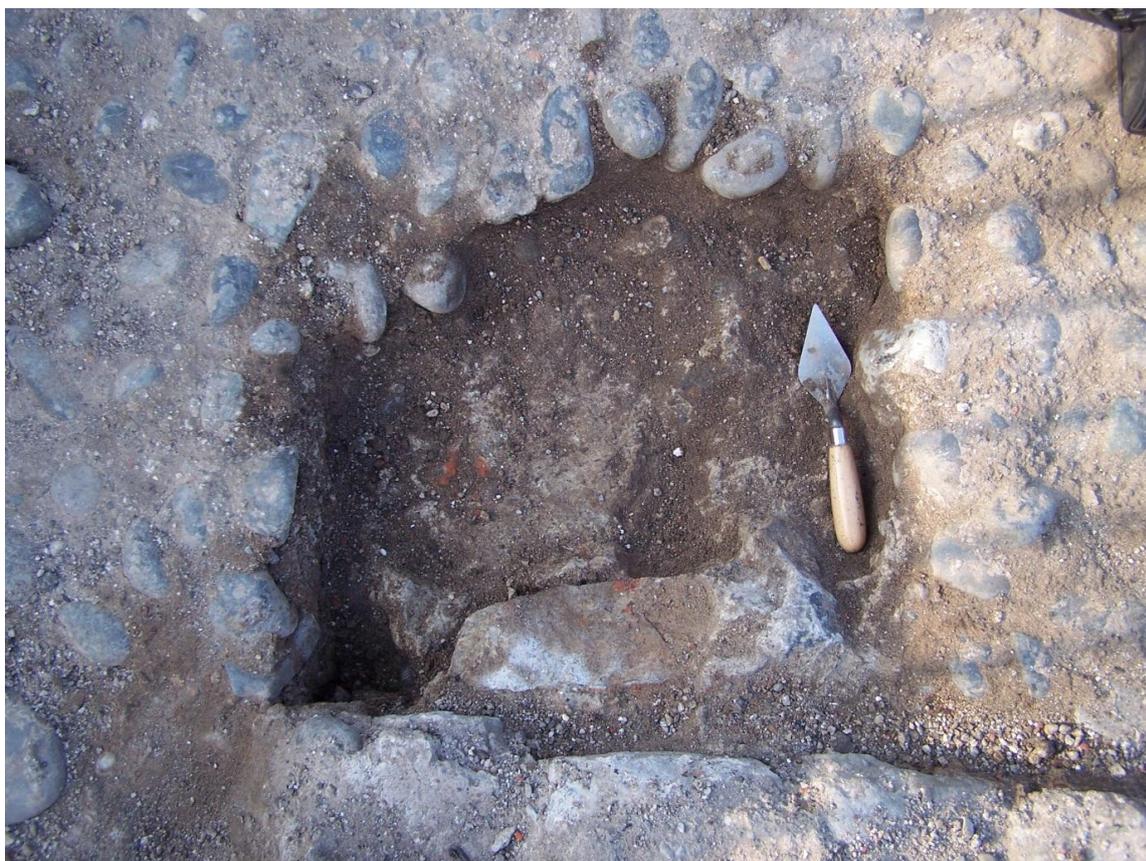
Plate 14 Base of western pier (fireplace?) in Room 1 after removal of demolition debris.

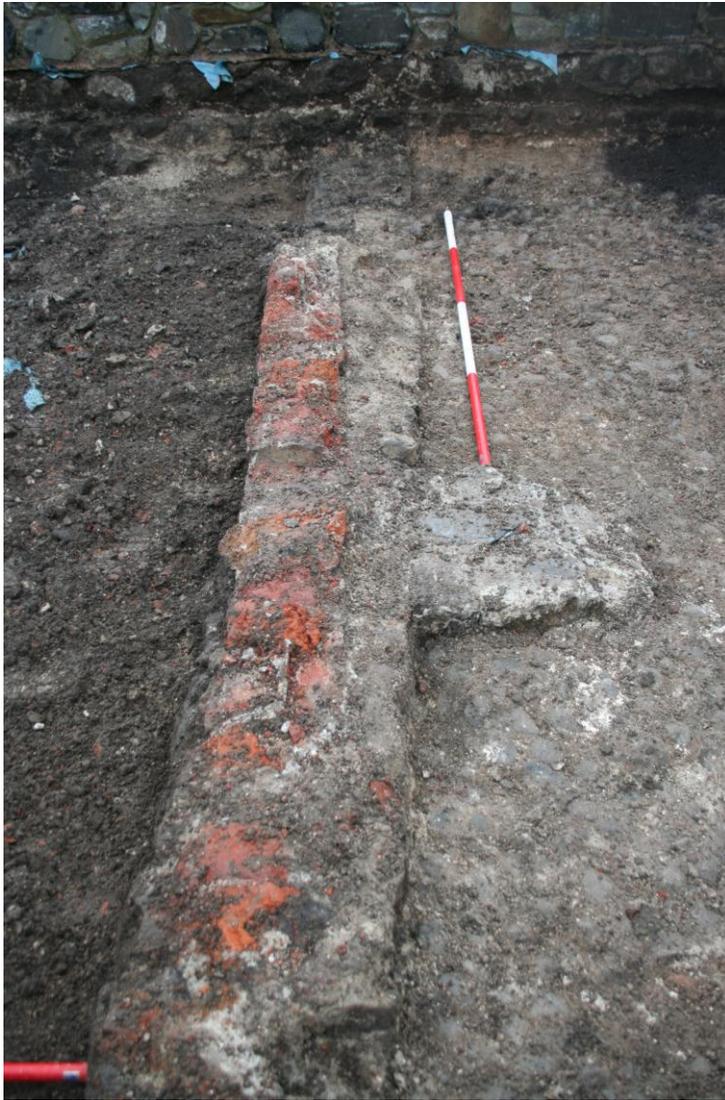
Plate 15 Subdividing wall between Rooms 2 (L) and 1(R), and pier and possible fireplace feature, C.121 & C.122 (facing W).

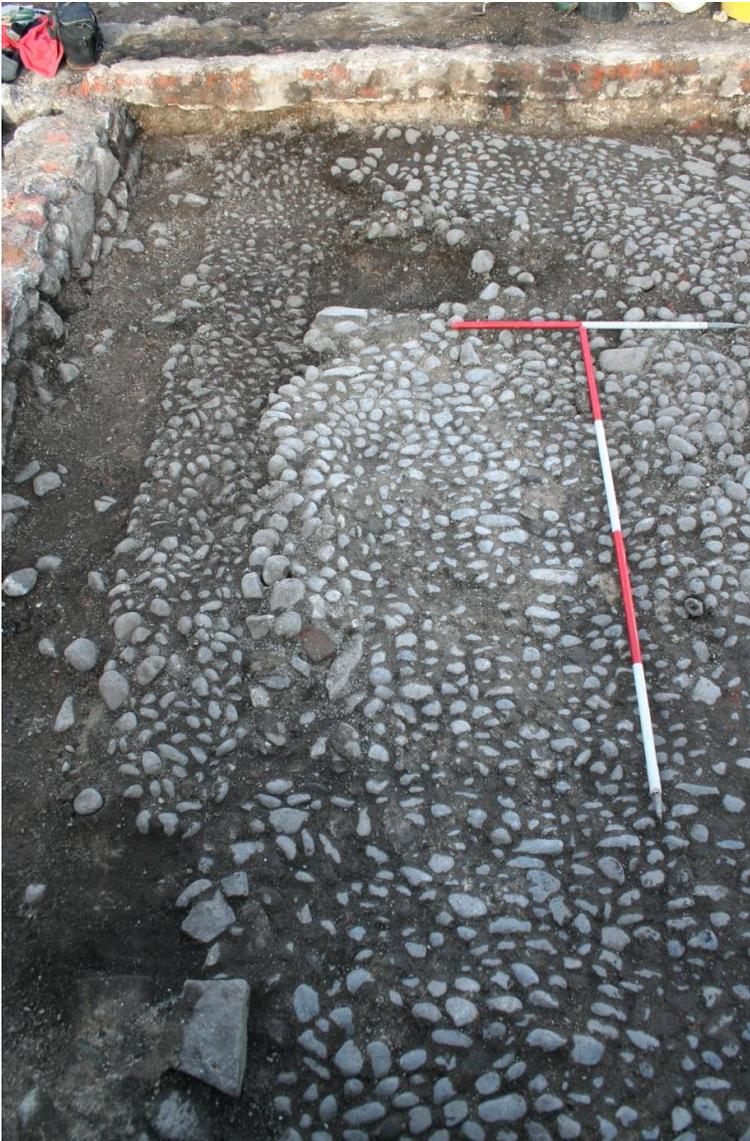
Plate 17 Room 2: cobbling C.173 and c.129 (facing E).

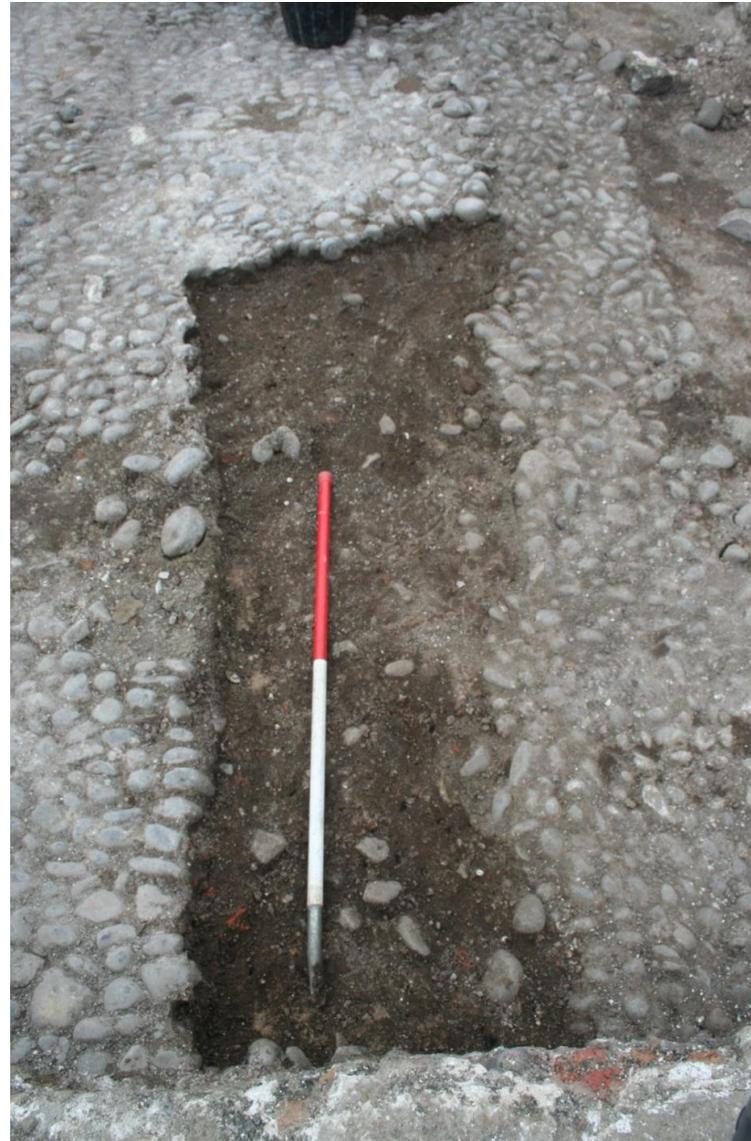
Plate 18 Room 2; cobbling C.129 and C.173 and cut C.254 (extended).

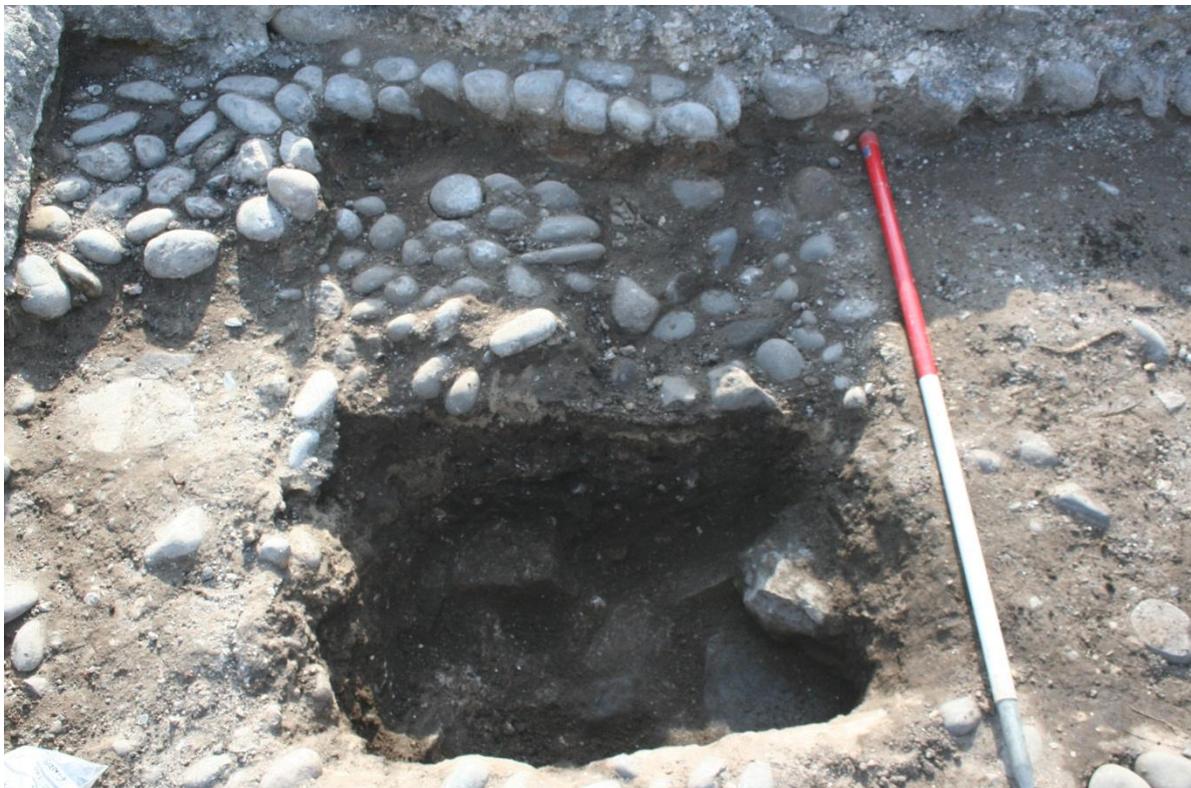
Plate 20 Box section in the south-eastern corner of Room 3 showing the two cobble horizons – C.183 (upper) overlying clay bedding layer, C.213, and lower cobbles, C.190.

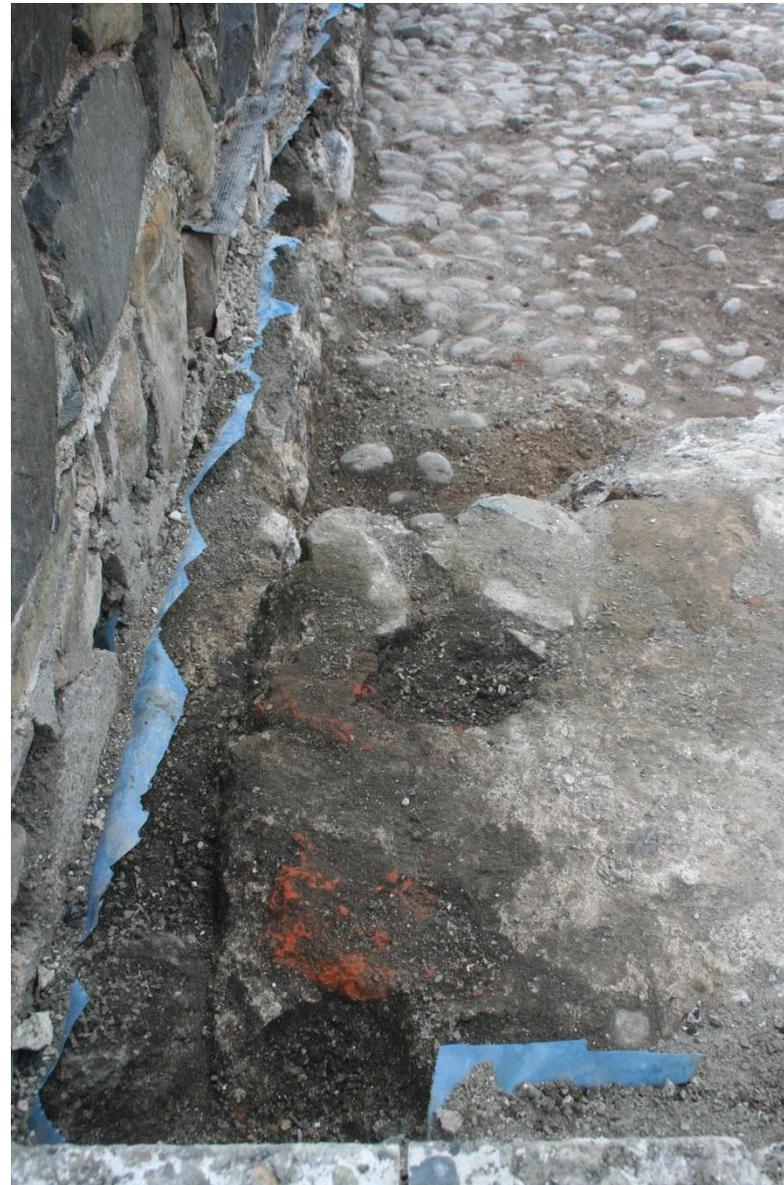
Plate 22 Juncture of southern end of wall C.109 and wall C.220.

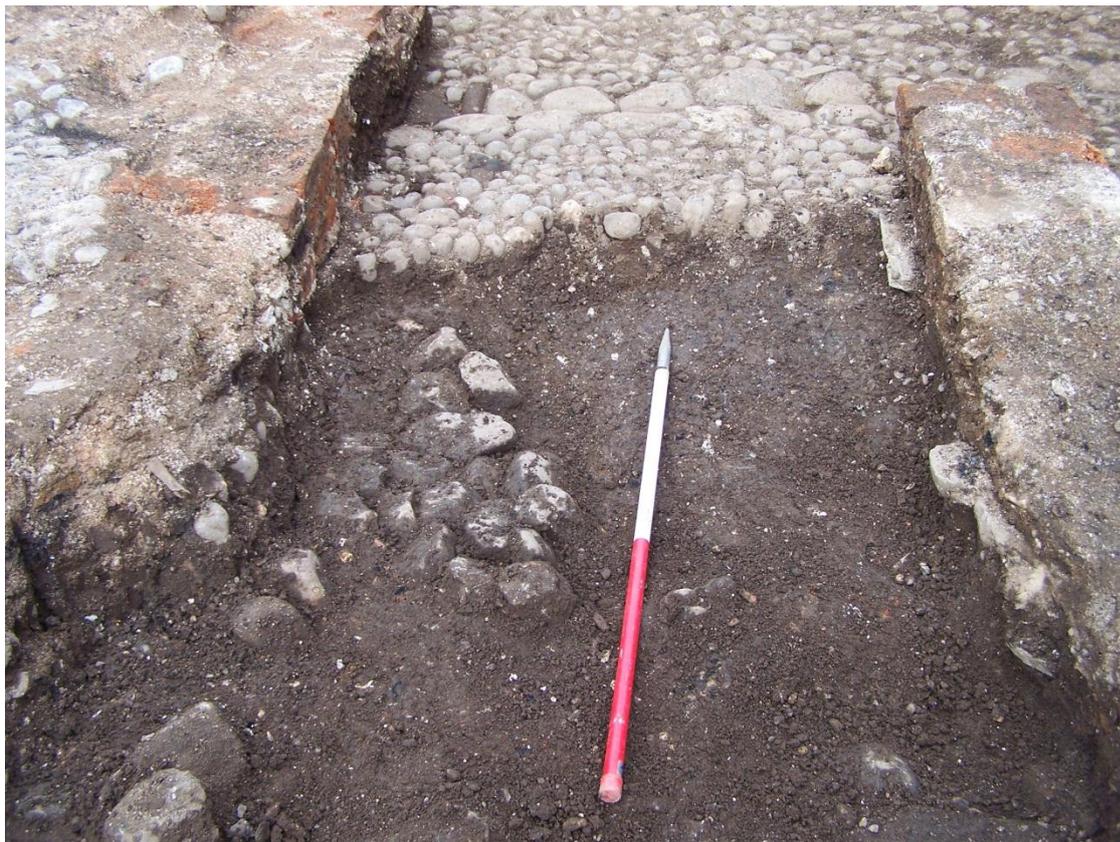
Plate 23 Stone surface, C.194, northern side of Vault 5 transect (facing north).

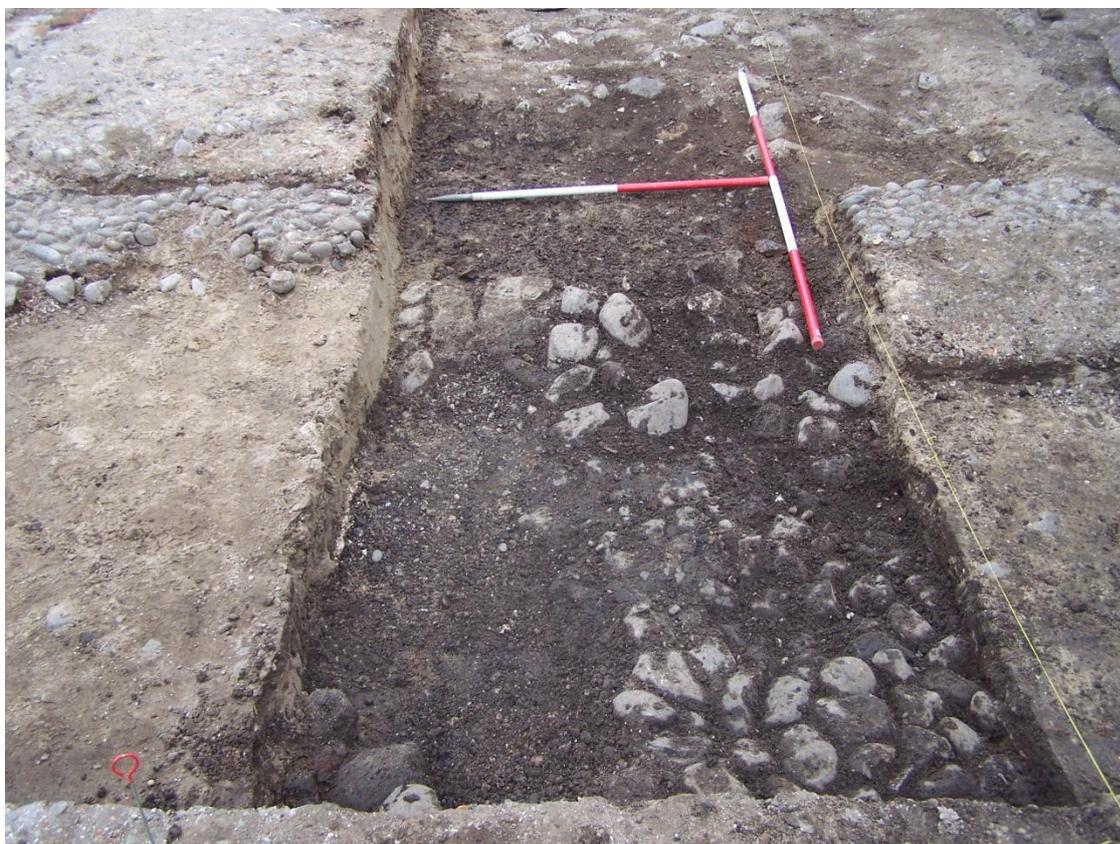
Plate 24 Stone surface, C.234, southern side of Vault 5 transect (facing north).

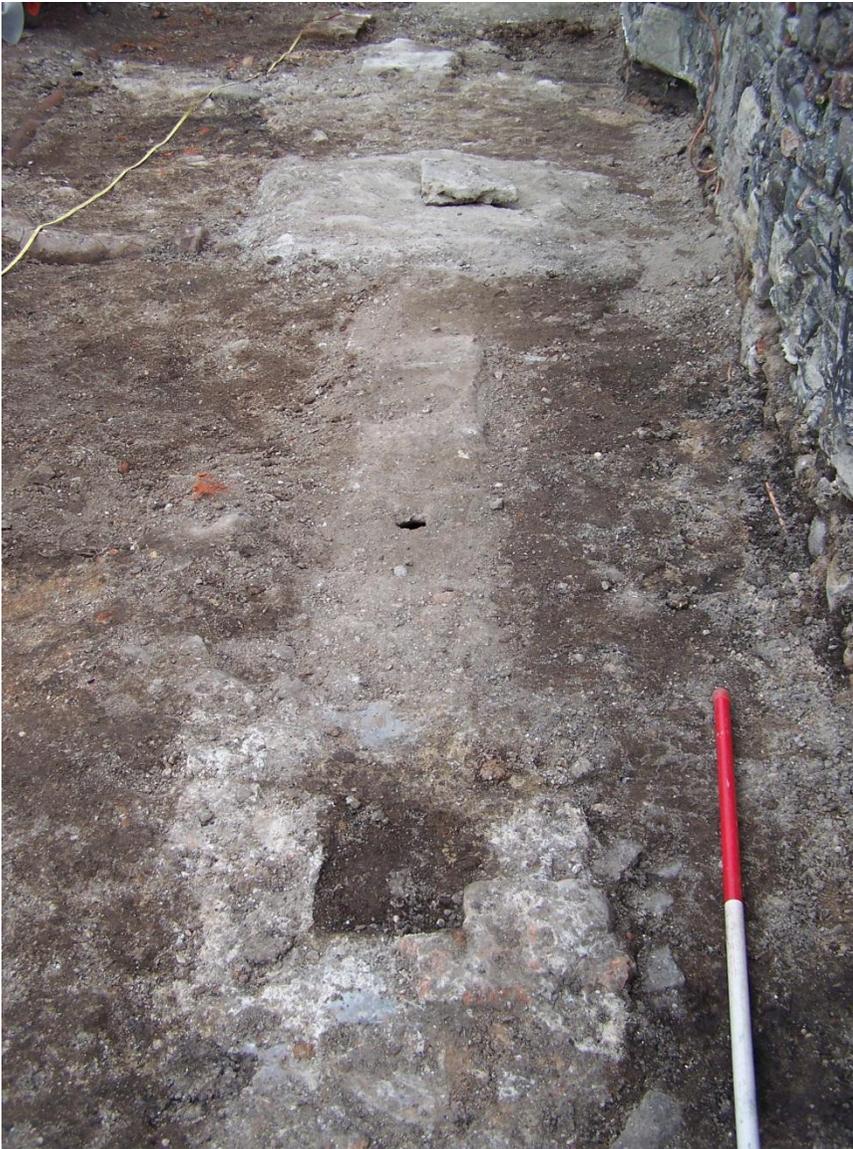
Plate 25 Drain C.143 and integrated vent/access point with concrete pier (C.158) and pipe [covered with a stone] in the background (facing north).

Running along the eastern length of the site, just inside (0.38m west of) the east curtain was a brick-built slate-capped drain bonded with lime mortar (C.143). It ran approximately north-south but not in a true straight line and was discontinuous. A small section was excavated and it was found to have been constructed of two single lines of bricks, set end-on. The gap or channel between these two lines was 0.23m wide while the overall external dimension of the drain measured 0.43m-0.48m wide. The bricks were set into a mortared base and the line of bricks on the western side was 'protected' or supported by an unmortared collection of rounded stones (average size 0.28m x 0.18m). The drain (C.143) and the collection of stones and associated structural debris including mortar and brick fragments forming the fill (C.172), were both set within an irregular linear cut (C.148), approximately 0.88m wide. Both the drain and the fill sat proud of the surviving edges of the top of the cut. The only integrated feature within the drain was a widening out of the drain where it was inset with a square vent or access-point. The drain, as it survived, was discontinuous and no exit points were identified nor were any physical connections discovered between it and other built features on the battery. The cut for the drain (C.148) cut through the top of one of the barrel vaults, Vault 5 (C.175) as well as multiple deposits overlying the vault (C.138, C.132, C.173) while the drain in turn was cut through in multiple locations by air vents, C.157 (see below). The relative surface of the drain was quite high and had been exposed by the machining. It is presumed the drain was sealed by the concrete and also some of the recent levelling deposits of red clay and gravel (C.211) but when it was inserted prior to this and for what purpose is unclear. It predates the early twentieth-century air vents and postdates the seventeenth-century Infantry Barracks. It is possible it dates to the nineteenth-century Officers' Quarters building and may relate to the drainage of the building, waste water and/or effluent.
