CAF Data Structure Report No. 77 (preliminary report)

**Excavations on the Grand Battery at
Carrickfergus Castle**

ANT 052:059

8th December 2011

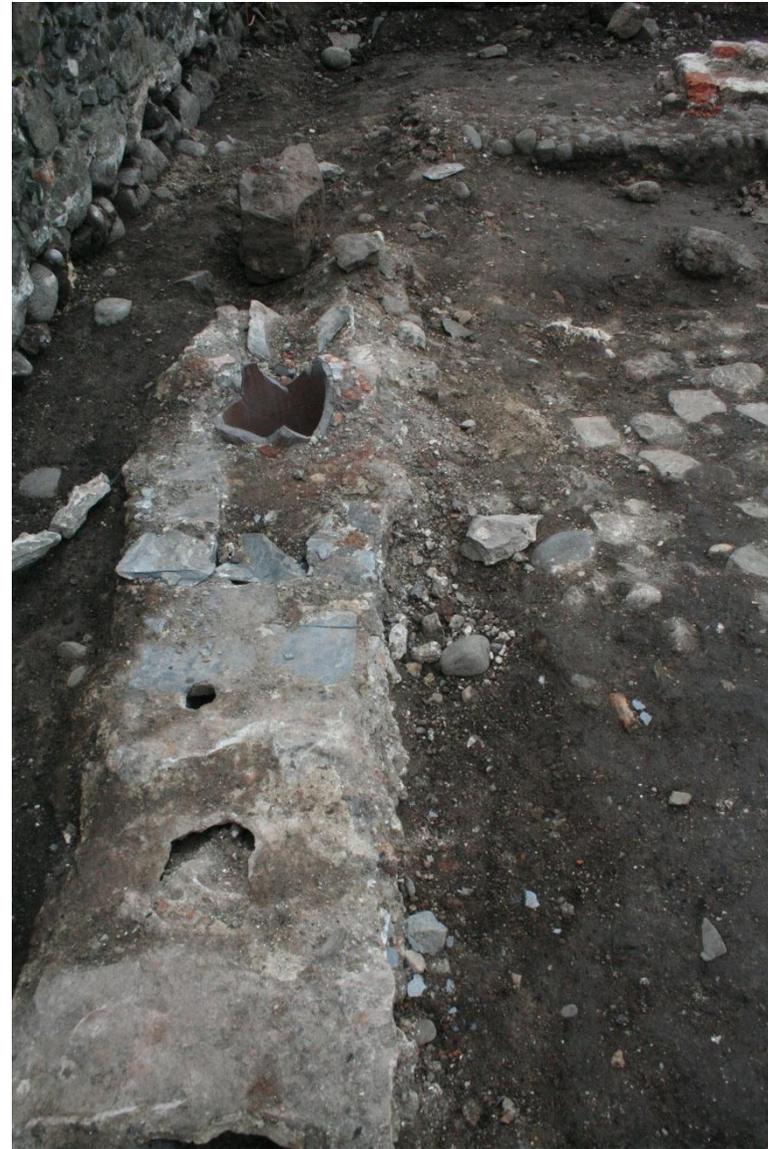
Plate 26 Slate-capped drain (C.143), ceramic pipe (C.127) and top of Vault 5 (facing south).

Running along the eastern length of the site, just inside (0.38m west of) the east curtain was a brick-built slate-capped drain bonded with lime mortar (C.143). It ran approximately north-south but not in a true straight line and was discontinuous. A small section was excavated and it was found to have been constructed of two single lines of bricks, set end-on. The gap or channel between these two lines was 0.23m wide while the overall external dimension of the drain measured 0.43m-0.48m wide. The bricks were set into a mortared base and the line of bricks on the western side was 'protected' or supported by an unmortared collection of rounded stones (average size 0.28m x 0.18m). The drain (C.143) and the collection of stones and associated structural debris including mortar and brick fragments forming the fill (C.172), were both set within an irregular linear cut (C.148), approximately 0.88m wide. Both the drain and the fill sat proud of the surviving edges of the top of the cut. The only integrated feature within the drain was a widening out of the drain where it was inset with a square vent or access-point. The drain, as it survived, was discontinuous and no exit points were identified nor were any physical connections discovered between it and other built features on the battery. The cut for the drain (C.148) cut through the top of one of the barrel vaults, Vault 5 (C.175) as well as multiple deposits overlying the vault (C.138, C.132, C.173) while the drain in turn was cut through in multiple locations by air vents, C.157 (see below). The relative surface of the drain was quite high and had been exposed by the machining. It is presumed the drain was sealed by the concrete and also some of the recent levelling deposits of red clay and gravel (C.211) but when it was inserted prior to this and for what purpose is unclear. It predates the early twentieth-century air vents and postdates the seventeenth-century Infantry Barracks. It is possible it dates to the nineteenth-century Officers' Quarters building and may relate to the drainage of the building, waste water and/or effluent.

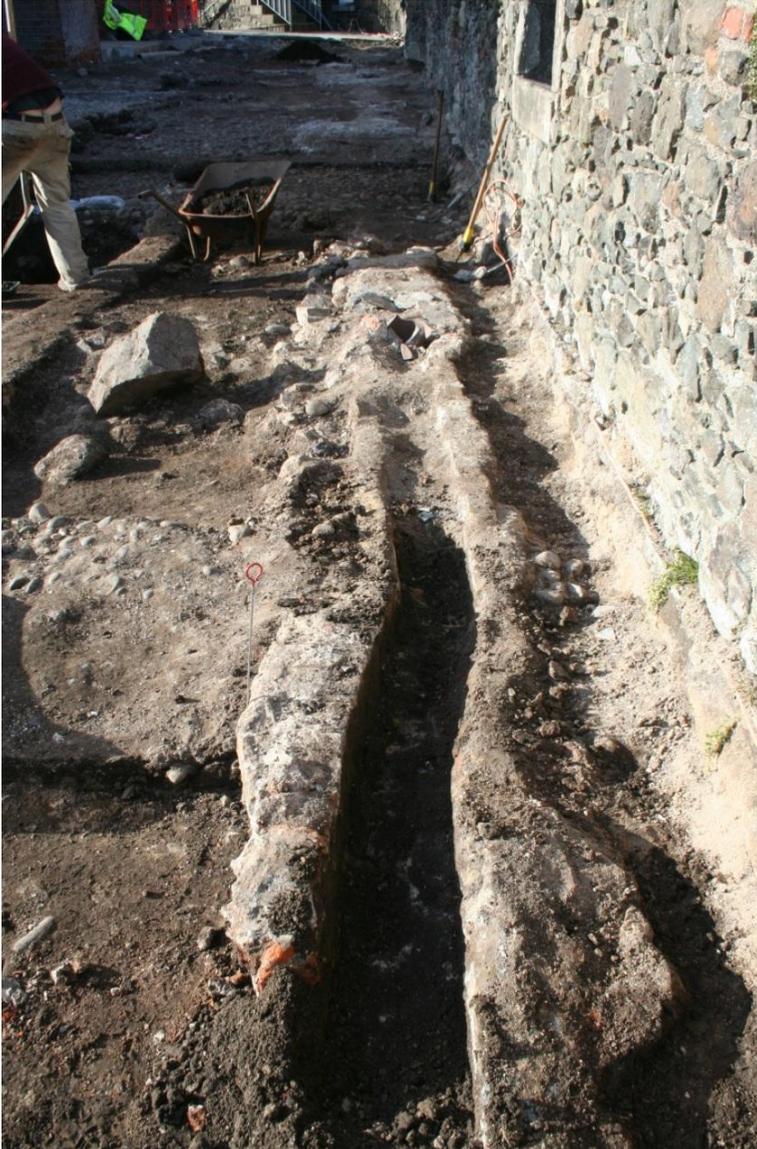
Plate 27 Slate-capped drain C.143 with slates removed (facing north).

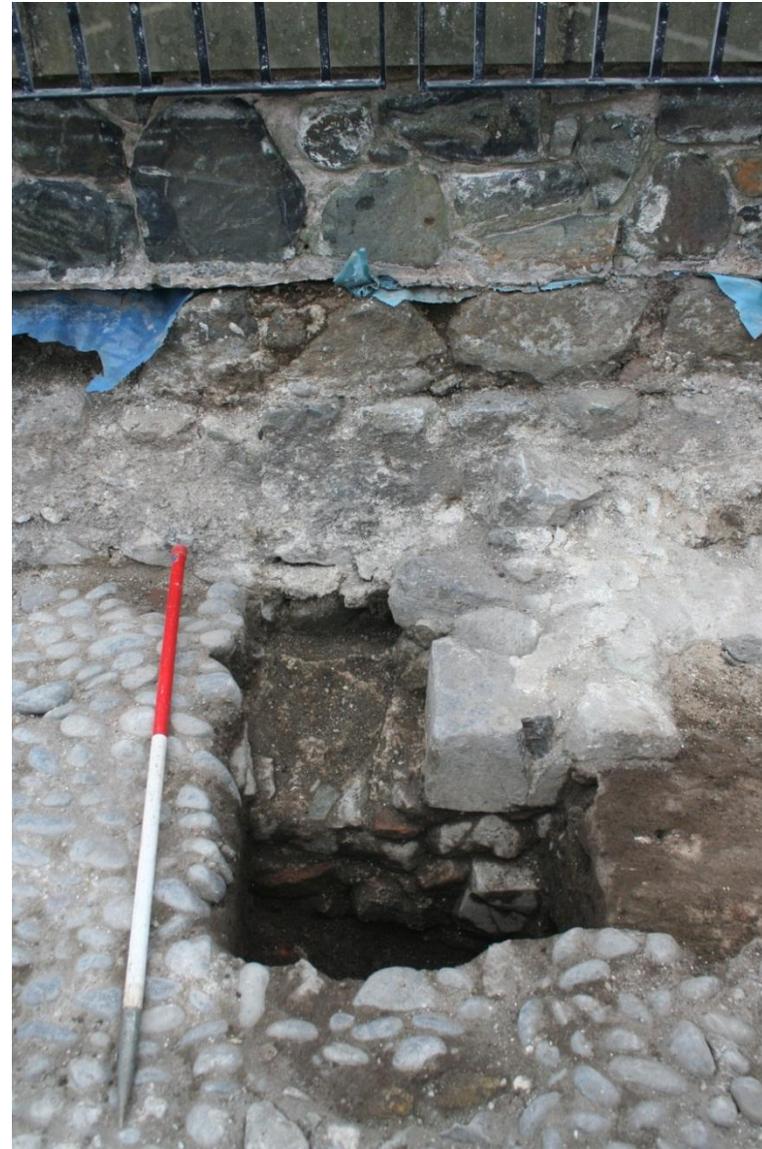
Plate 28 Box-section in the north-western corner of Room 2 showing stone feature C.179 bonded to wall C.107 and both built above wall C.210.

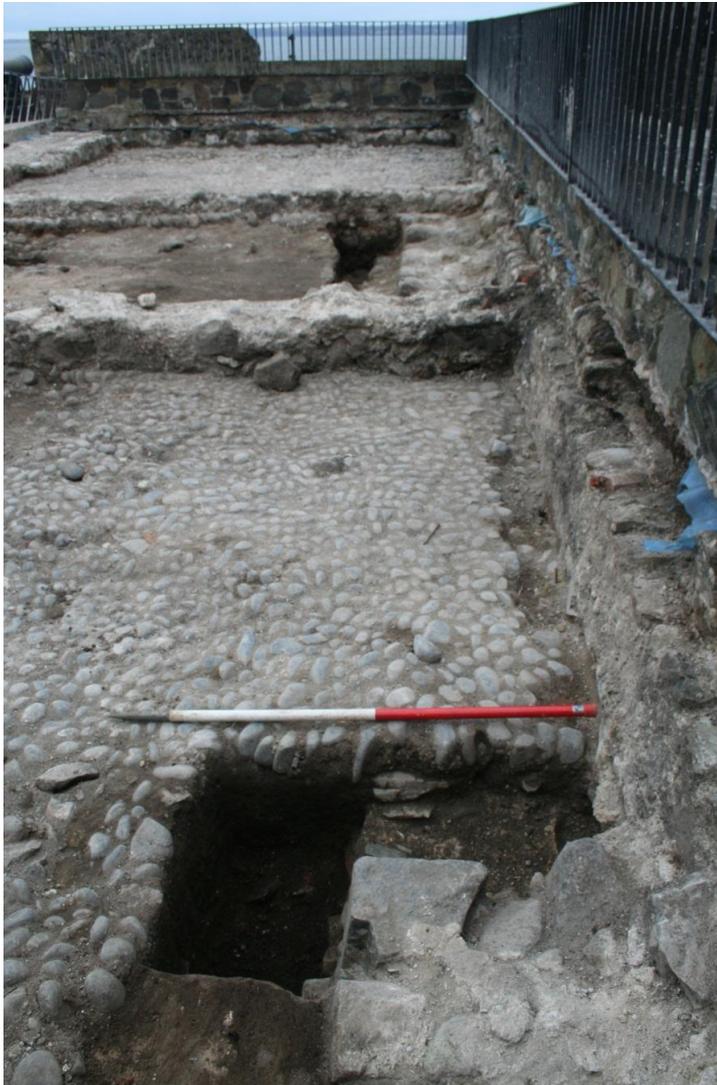
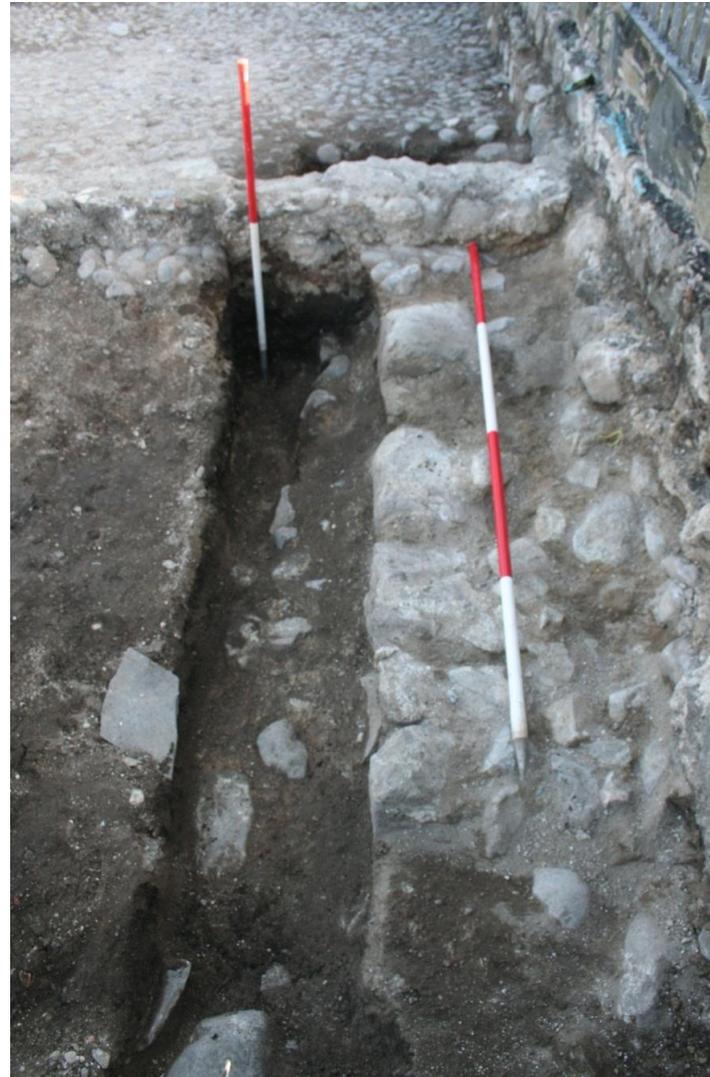
Plate 29 Box section in Room 2 (foreground) and Room 3 (background). **Plate 30** feature C.181 at the western end of Room 3.

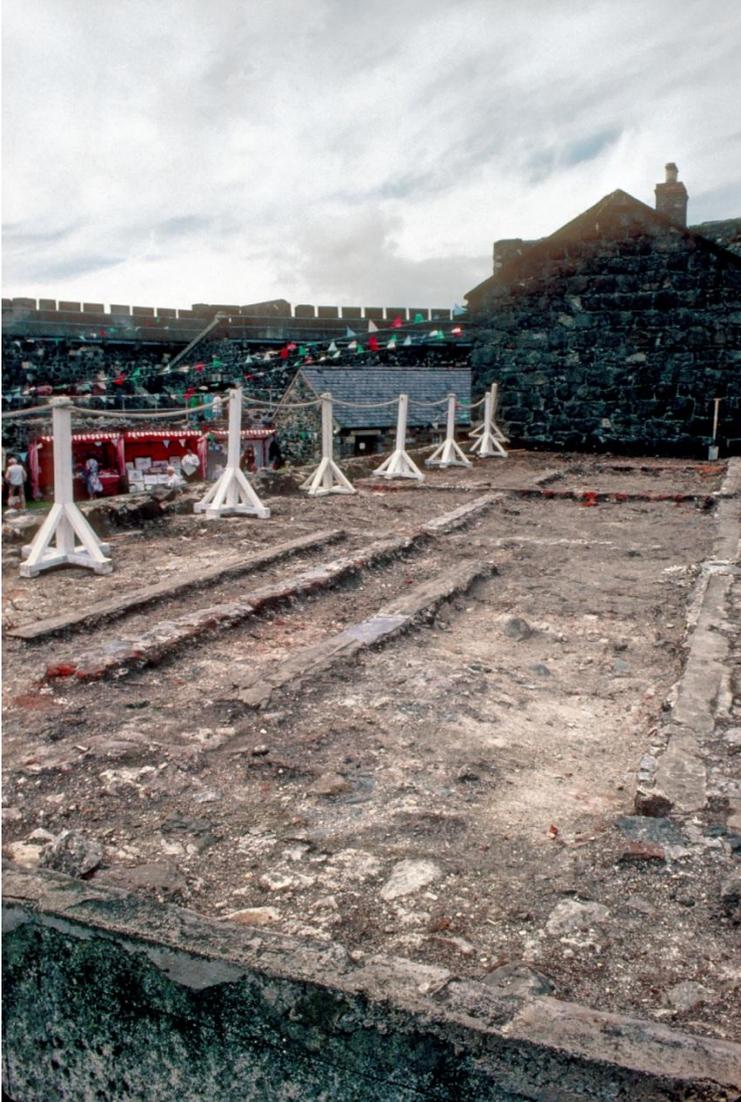
Plate 31 The foundations of the Officers' Barracks and other features exposed when the garden was removed in 1990s (NIEA). The three linear walls set side by side did not survive in 2010 the structure of the inner and outer one apparently with slate is not dissimilar to linear section of feature C.165.

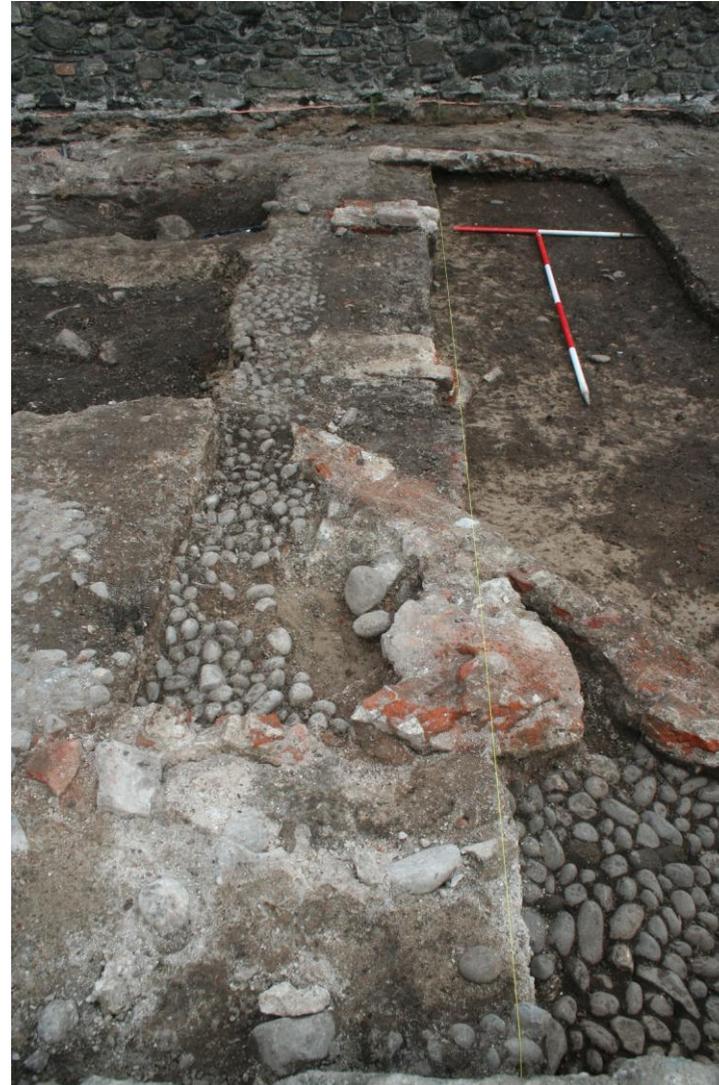
Plate 32 Cobbles C.173 and C.206 and masonry feature C.165.

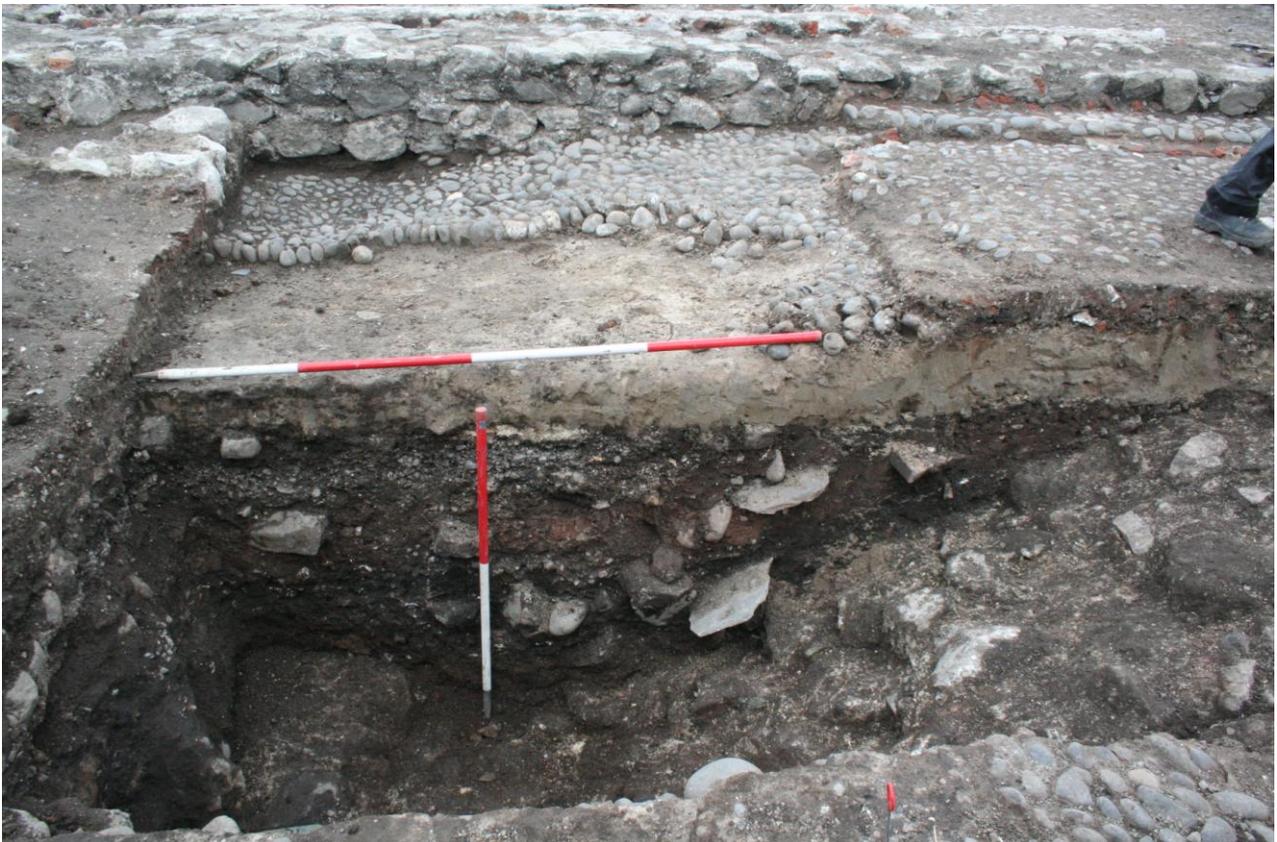
Plate 34 The east-facing section of the Vault 5 transect showing depth of stratigraphy.
