**DATA STRUCTURE REPORT: No. 79  
AE/08/122 and AE/09/101**

**EXCAVATION AT THE SITE OF THE QUEEN ANNE PERIOD MANSION HOUSE, CASTLE  
WARD, STRANGFORD, COUNTY DOWN**

**Data Structure Report: Queen Anne Period Mansion House,  
Castle Ward, Strangford, County Down**  
Emily Murray, Henry Welsh and Malachy Conway  
**Grid Reference J 5735 4995**  
**CAF DSR 079**  
**Licence Nos. AE/08/122 and AE/09/101**  
**SMR No. DOW 031:071**  
**NTSMR 131512**

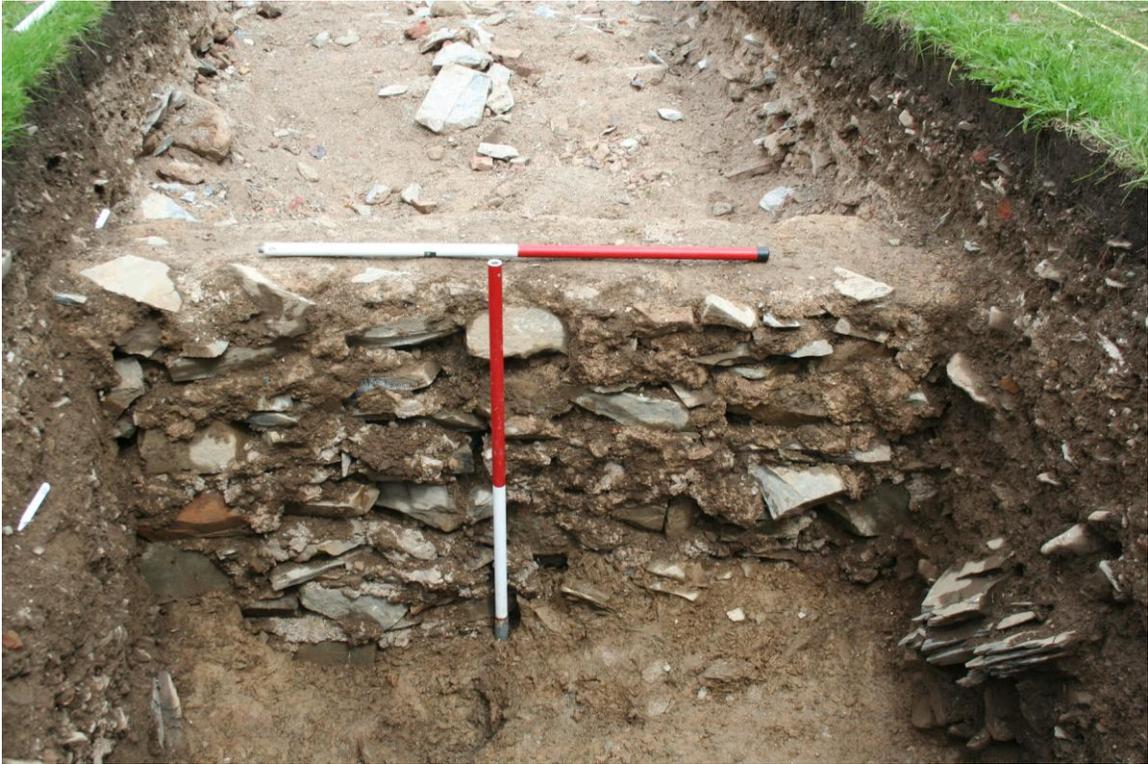
Plate 05: 2008 Trench 1, southern face of cellar wall C.106

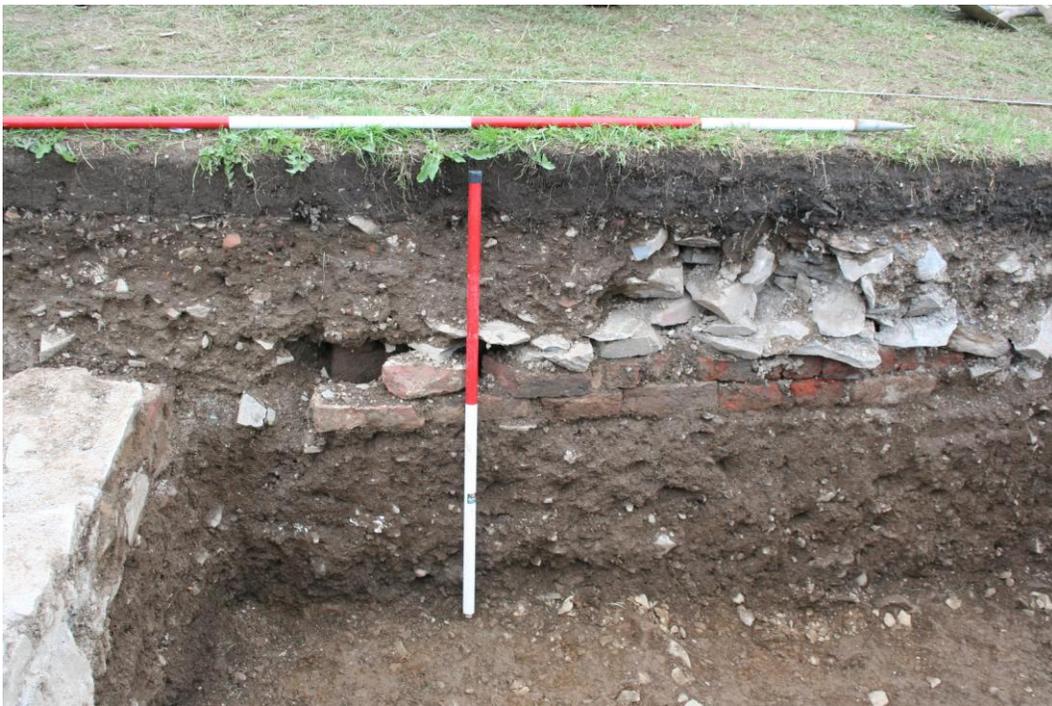
Plate 06: 2008 Trench 1, brick drain (C.133) with capping stones and overlying rubble (west-facing section)

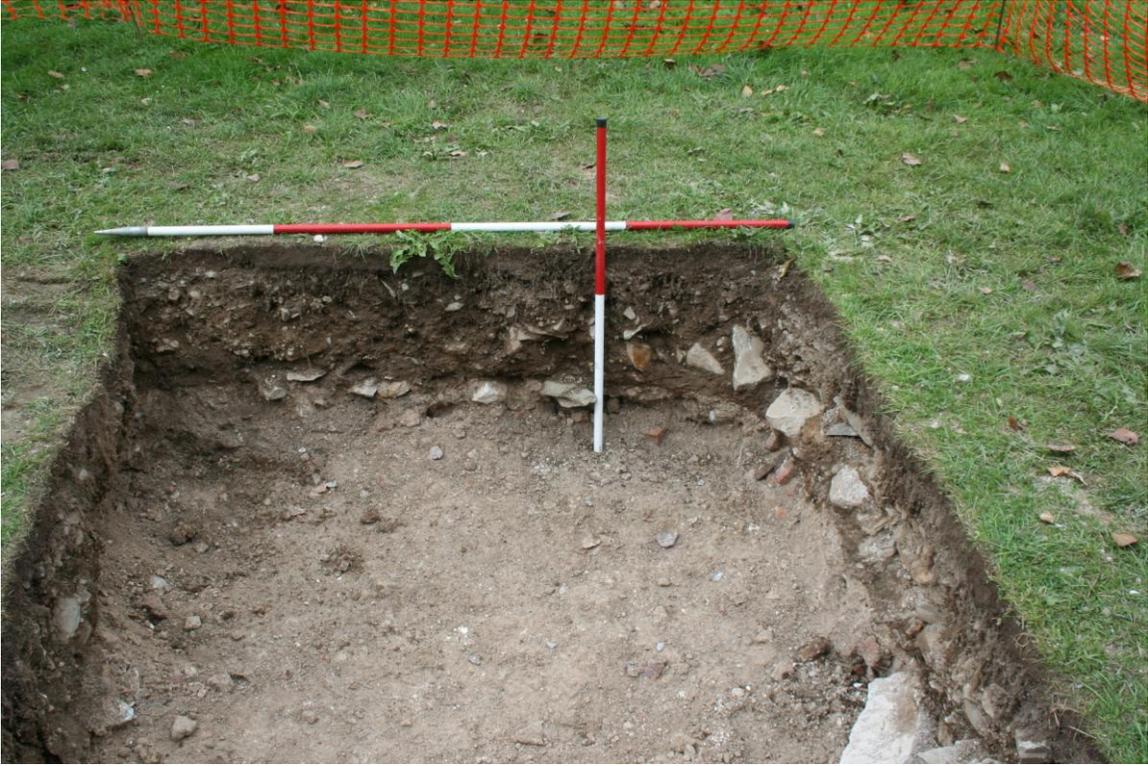
Plate 07: 2008 Trench 3, demolition rubble (bricks, stones, mortar and plaster)

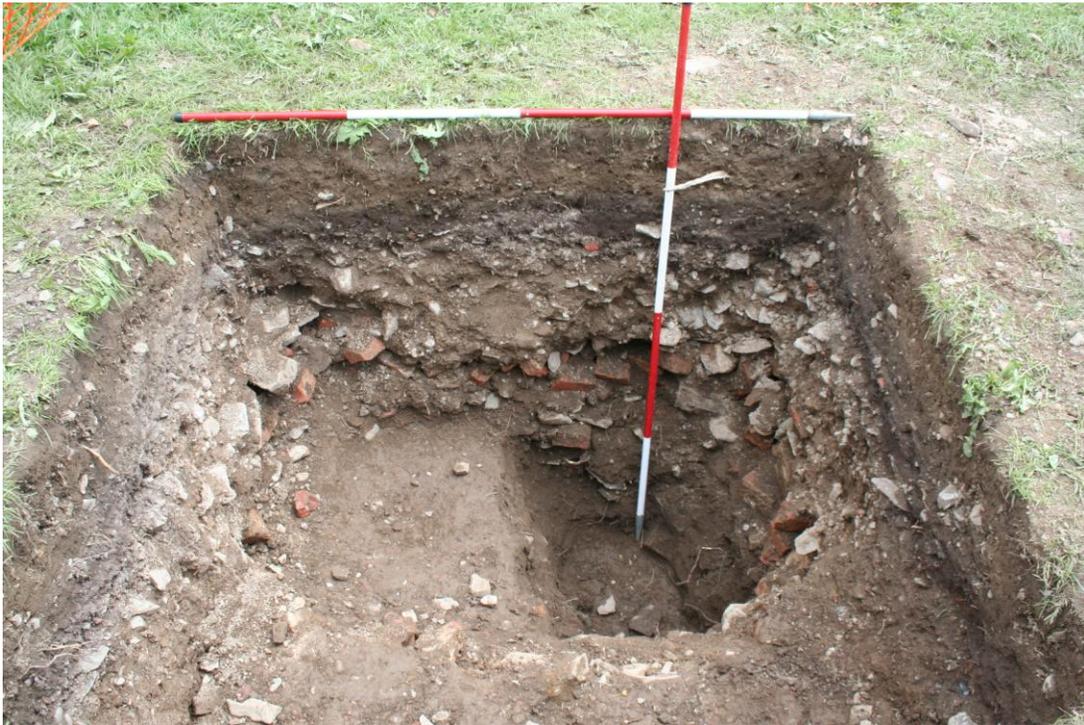
Plate 08: 2008 Trench 4, post-excavation view (looking east) showing rubble and levelling deposits in section

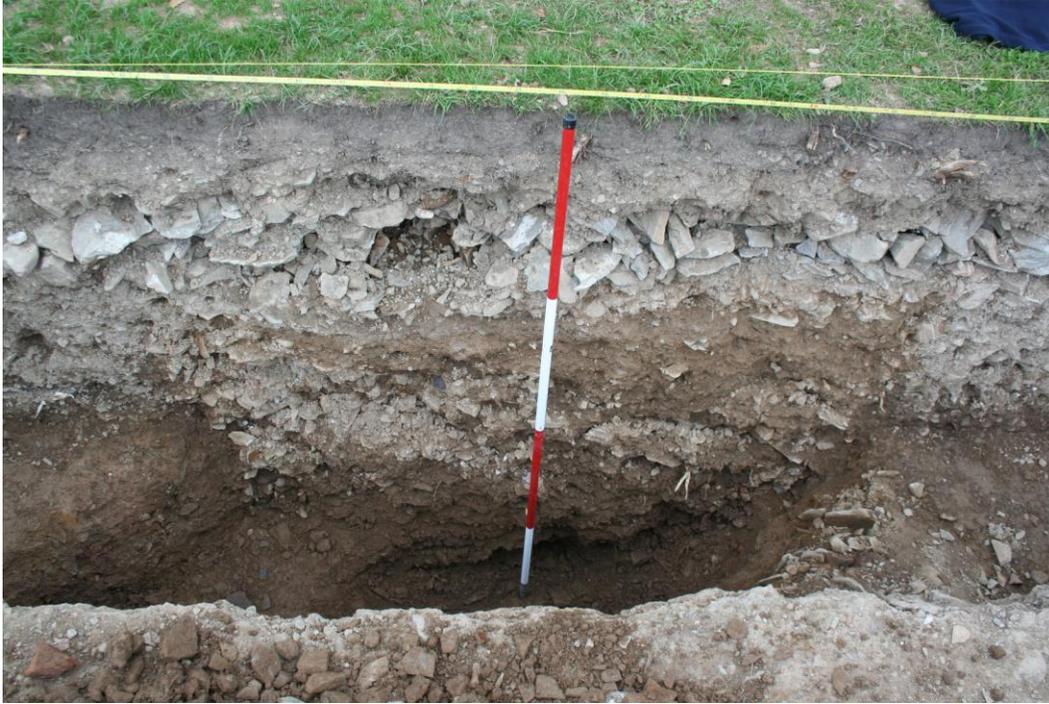
Plate 09: 2008 Trench 1, ditch (C.142) and overlying rubble towards the southern end of the trench (west-facing section)

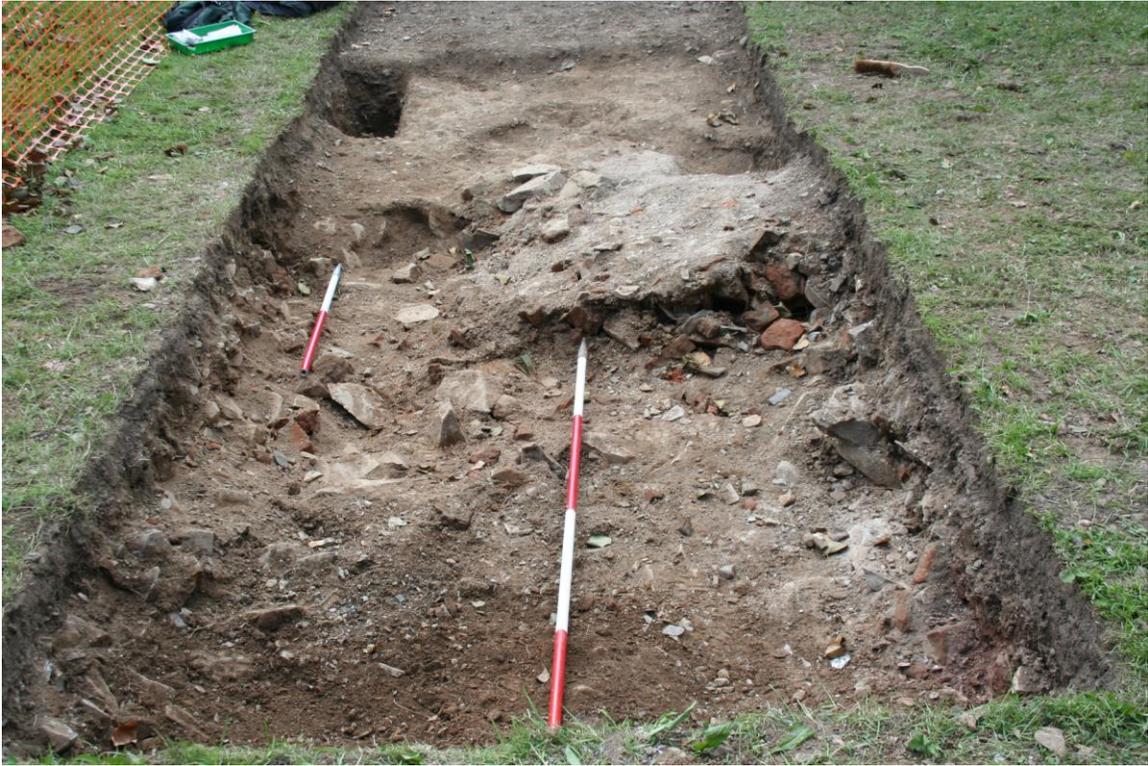
Plate 10: 2008 Trench 2, demolition rubble at the eastern end of the trench (looking west)

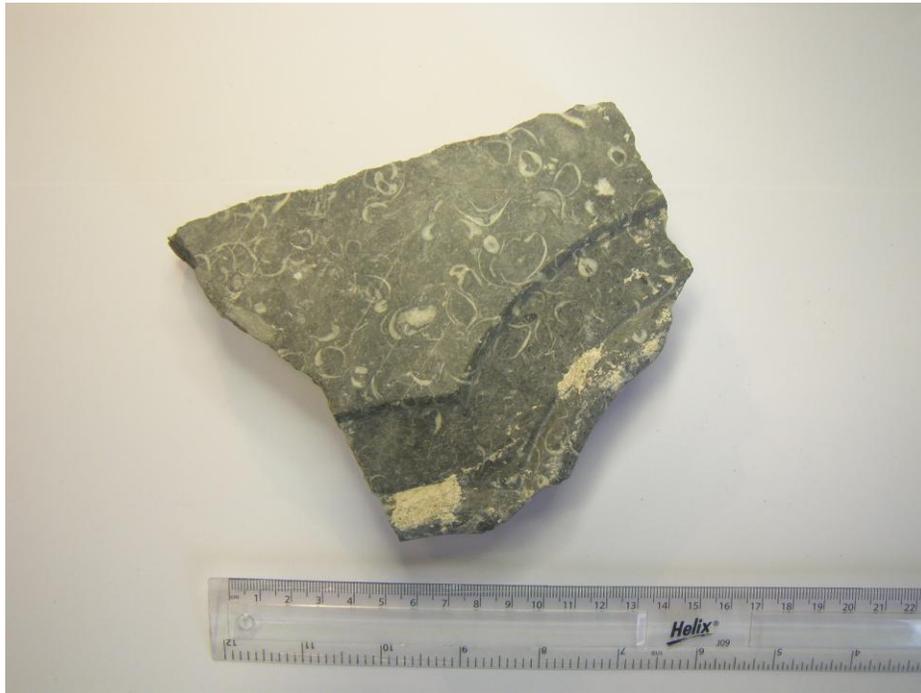
Plate 22: Fragment of moulded oolitic limestone

Two dressed pieces of a bluish stone, identified as oolitic limestone from the Bath area and known commonly as *Bath stone*, were recovered from the spread of demolition rubble in 2008 Trench 1 (C.125). A third small irregular piece with a bevelled edge (approx. dimensions of 66.8mm by 45.4mm and 25.1mm thick) was found in 2008 Trench 2 (C.208). The larger of the two dressed pieces was a square block with one chamfered corner and with approximate dimensions of 140mm by 150mm and 69.1mm thick. The second dressed piece was slightly smaller (98.5mm by 106.8mm and 45.8mm thick). It was faceted on all four sides although on one face the block was not completely cut through and it had a rough edge projecting out beyond the cut face. It has been suggested that dressed stone was probably carved and dressed on site thereby allowing it to be correctly fitted and also limiting the damage that might occur in transit (Craig 2006, 44). It could be suggested that this piece and the small fragment from Trench 2 may be an off-cut. Assuming this material derives from the Queen Anne house it is probable that the stone was employed as dressings for the main building. In the present mansion house Bath stone is the primary building stone employed in the east and west-facing elevations and it is also used in the Temple folly, in the portico and as dressings in the main brick-built body of the building. The earliest reference to the use of Bath stone on the estate is in a letter dated 1739, from a Samuel Campbell in Bath to Michael Ward in which the former discusses the merits of Bristol and Bath stone apparently as a reply to an enquiry from Judge Michael:
