Evaluation/Monitoring Report No. 248

OLD GENERAL HOSPITAL WOODSIDE AVENUE LISNAMALLARD COUNTY TYRONE

LICENCE NO.: AE/12/132E

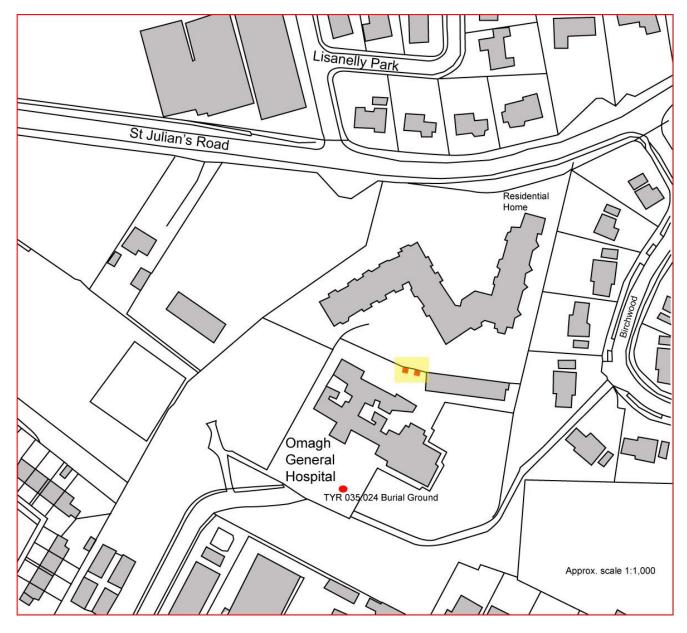
Figure 3: Site plan showing location of test trenches (red rectangles within highlighted area)

The licence application and research design for the site proposed the excavation of two evaluative trenches in the area where the modular building would be connected to services. Two trenches were excavated in this area, each measuring 2.0m by 3.0m (Figure 3). Each was excavated to the surface of brick foundations, a depth of approximately 1.5m.

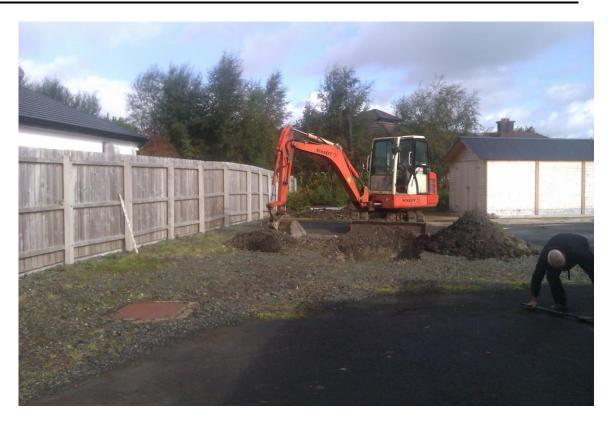
Plate 3: General view of application site during evaluation, looking east

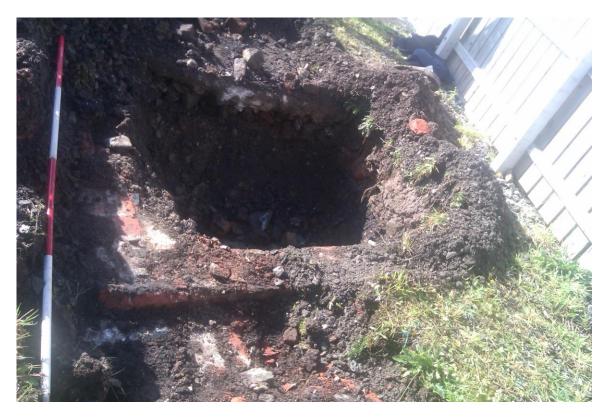
Plate 4: Brick foundations in Trench 1 (C104), looking west

Trench 1 was 2.0m wide and 3.0m long. It was located beside the northernmost side boundary and ran parallel to it. The uppermost deposit in Trench 1 consisted of a gravelly/grassy layer (C101) consisting of angular stones around 100mm long. Below this was a topsoil (C102) consisting of dark grey stony clay loam. It overlay a hardcore

deposit (C103) of angular stones of a mixture of sizes. The hardcore deposit stratigraphically overlay a rubbly deposit (C105) consisting of large stone rubble in a matrix of sandy gravel. This deposit was contained within brick foundations (C104), the corner of which was encountered in the trench. The foundations were 0.3m wide and consisted of angular red bricks. They had been built directly onto a greenish grey boulder clay subsoil (C106). There were no finds associated with the foundations.

Brick foundations were uncovered in both test trenches. It was not possible to date these remains due to the paucity of artefacts. However, examination of Ordnance Survey maps dating between 1854 and 1940 shows no buildings on this part of the site. It is likely, therefore, that the foundations post-date the mid-20th century. After discussion of the remains with NIEA: Built Heritage staff it was decided that no further archaeological mitigation would be carried out due to the limited scale of the development and the fact it would not impinge on the remains. A short summary has been prepared for inclusion in *'Excavations* 2012'.

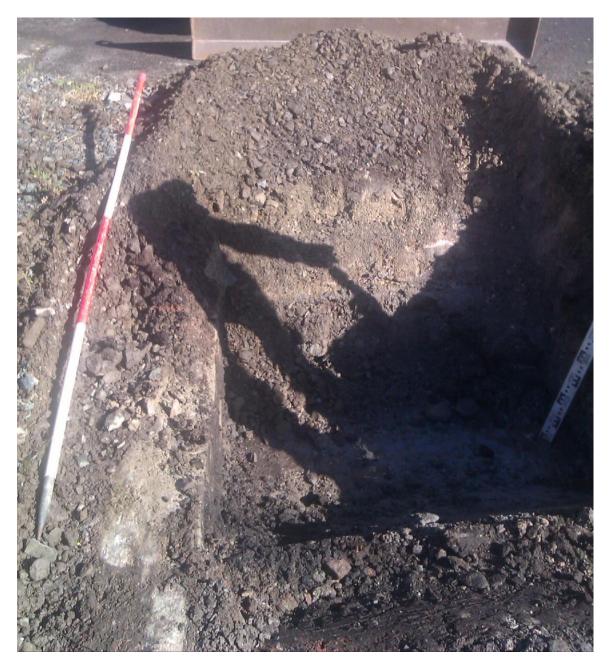
Plate 5: Walls in Trench 2 (C203 & 204), looking east

Trench 2 was located 7.0m to the west of Trench 1 and also ran parallel to the northernmost boundary of the site. The trench was 2.0m wide by 3.0m long. The uppermost deposit in the trench was a gravelly/grassy layer (C201) similar to the uppermost deposit in Trench 1 (C101). Below this was a dark brownish black clay (C202) which contained coarse rubble components including brick and stone. This deposit overlay two walls which were probably part of the same brick foundations encountered in Trench 1. The earlier wall (C203) ran east-west along the edge of the trench. This was overlain by a second wall (C204) which ran perpendicular to the first. The walls had been built directly onto the greyish green boulder clay subsoil (C205). There were no finds associated with the foundations.

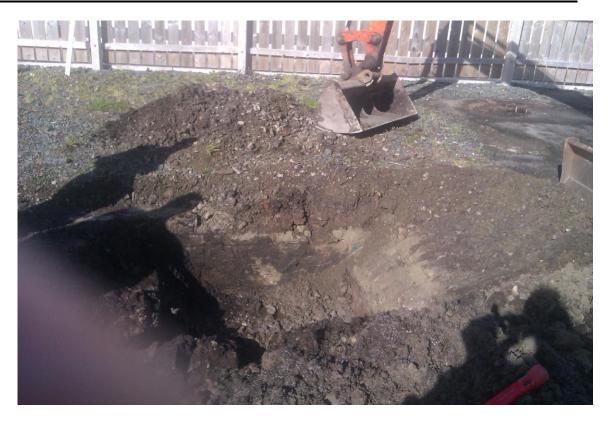
Plate 6: Walls in Trench 2 (C203 & 204, looking north
