**Monitoring Report No. 274**

**Site 285m South-East of 57 Manse Road  
Ballycarry  
Co. Antrim**

**AE/13/151**

**F/2010/0402/O**

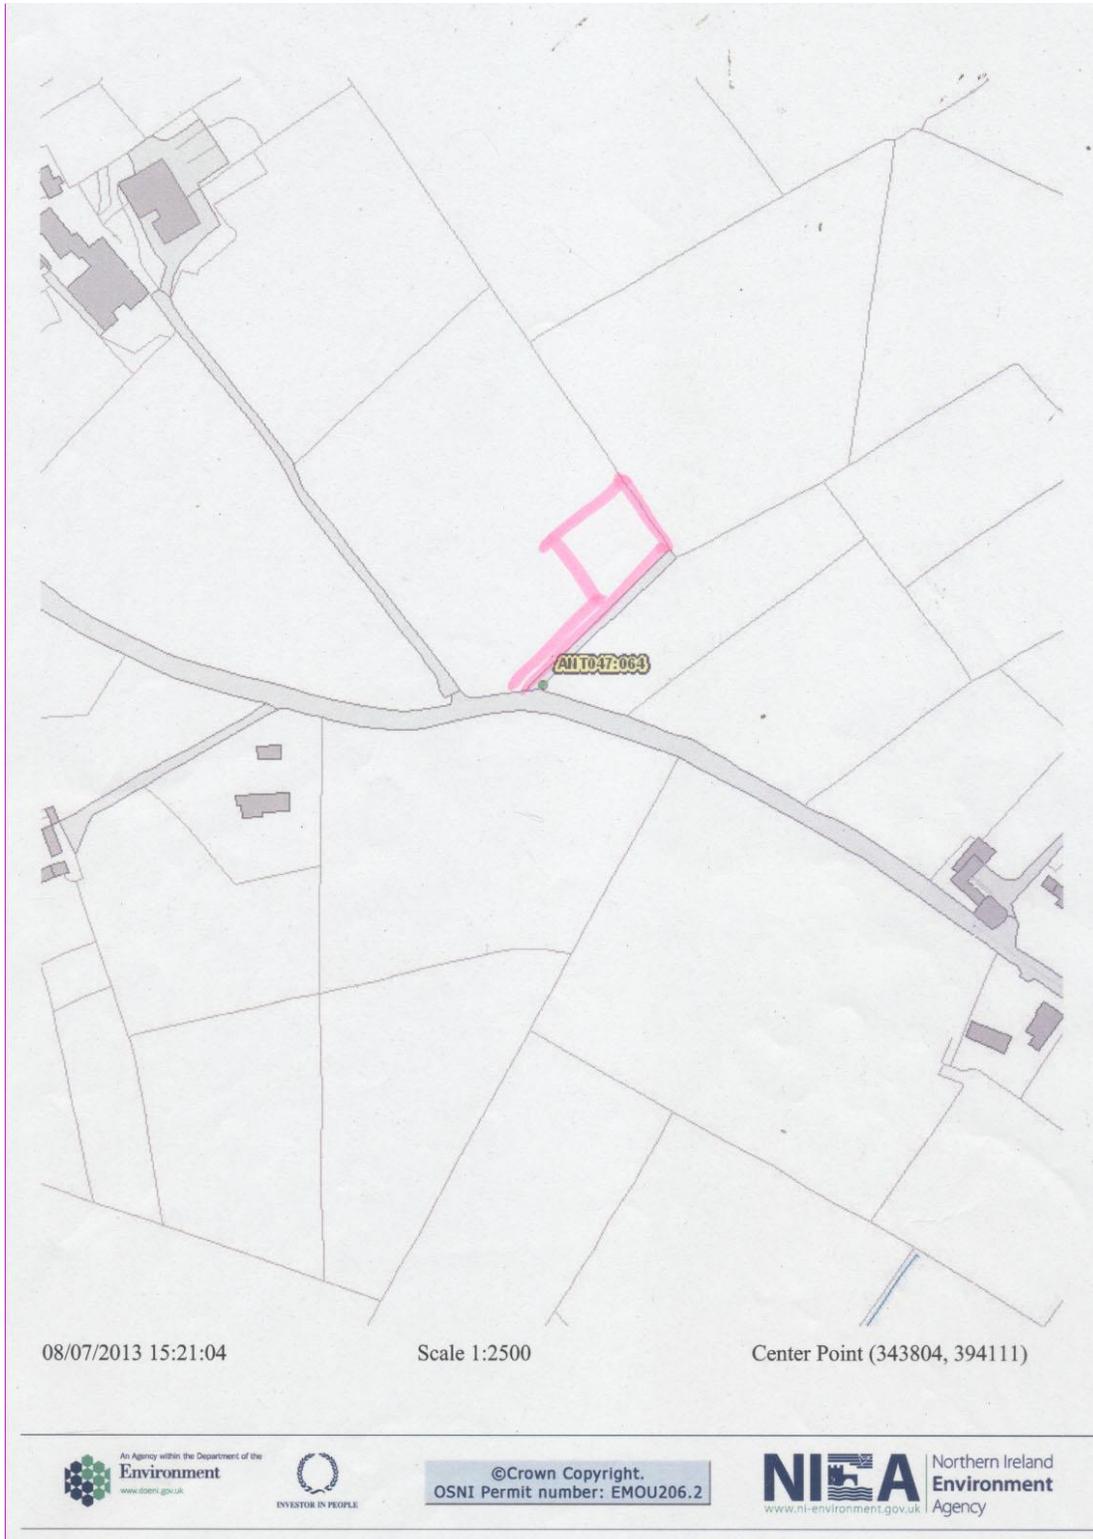
**Figure 3: Proposed development site (F/2010/0402/O) in relation to the location of a supposed burial ground (ANT 047:064).**

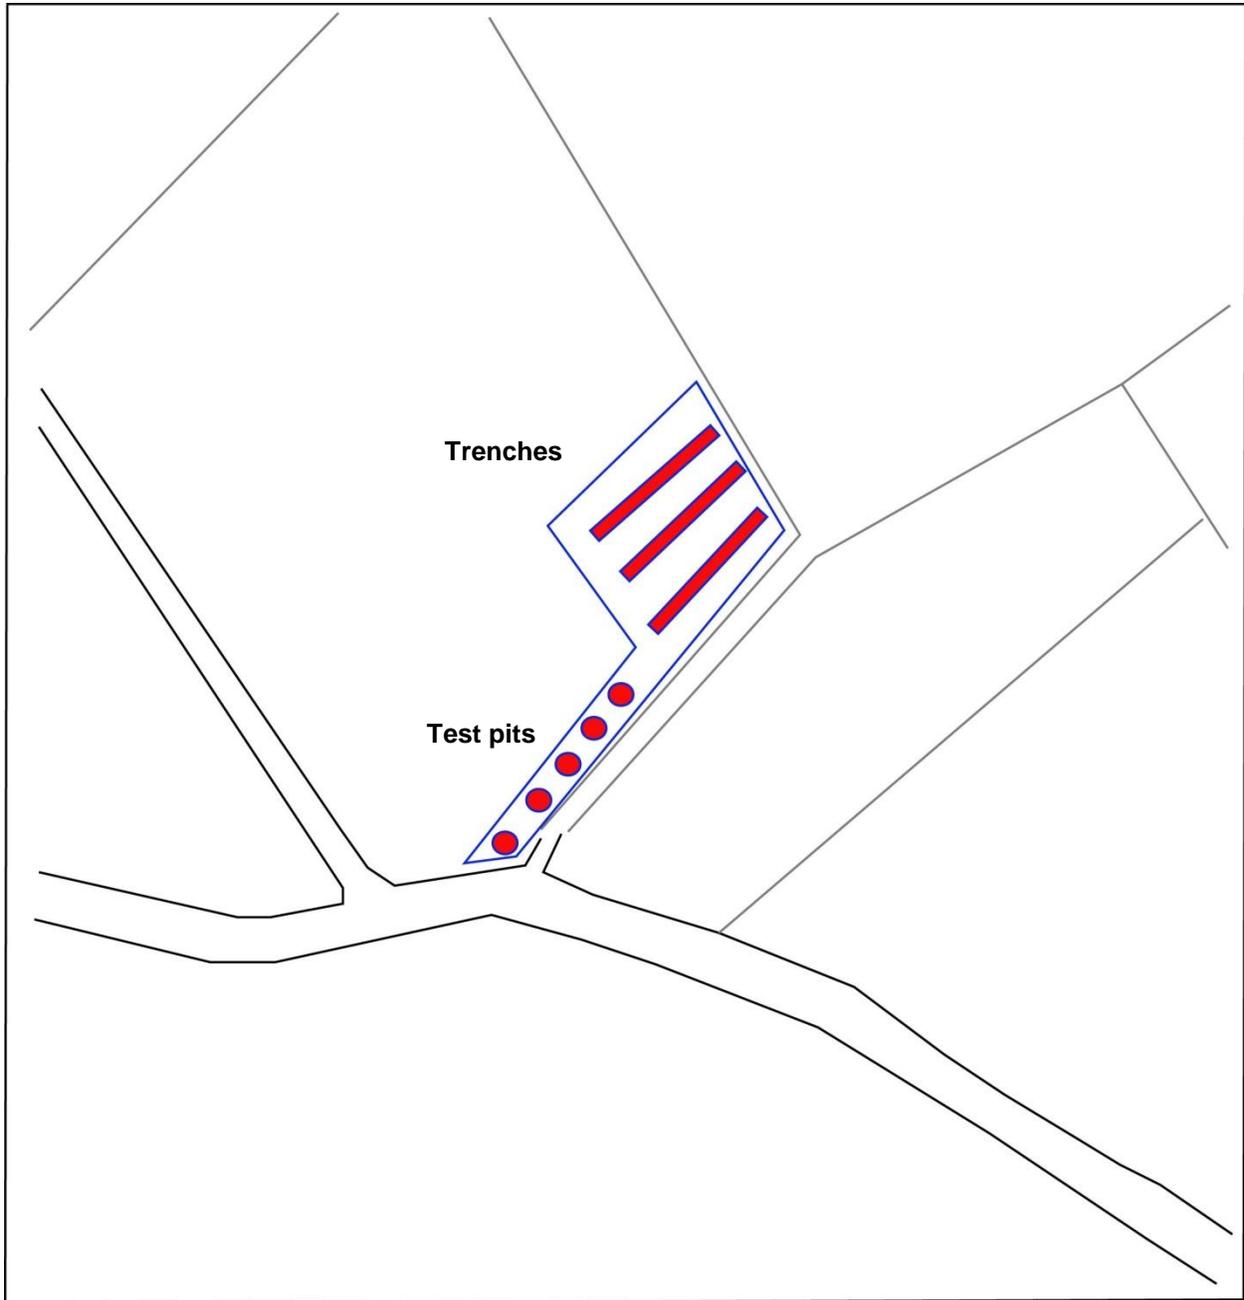
**Figure 4: Schematic plan of the development site (blue outline) showing the approximate location of the manual test pits (red circles) and mechanical test trenches (red rectangles).**

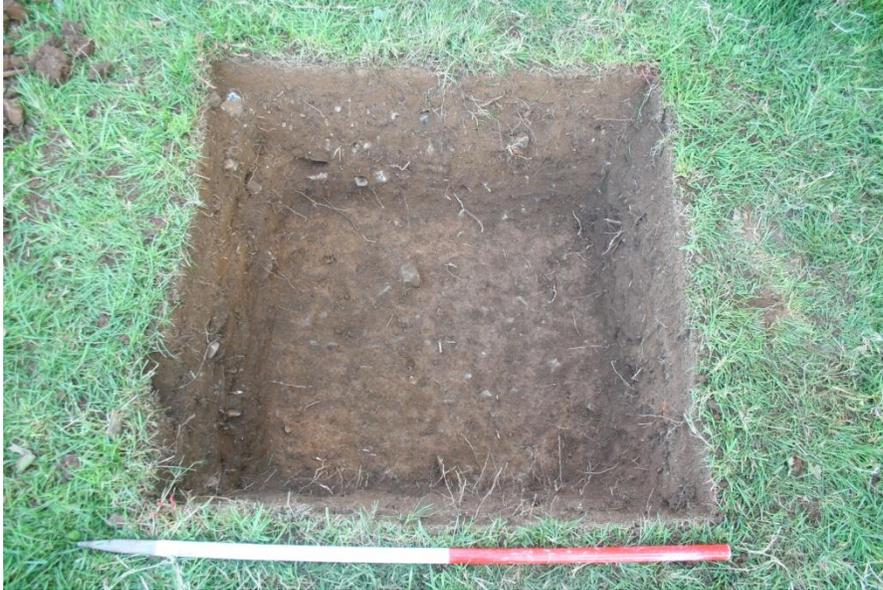
**Plate 1: Post-excavation view of Test Pit 1 looking west.**

A series of test pits were manually excavated along the line of the proposed access lane to the new development as it was deemed that this location would be the most archaeologically sensitive (on account the proximity of this area to the supposed site of the burial ground). A simple stratigraphic sequence was encountered in all the test pits with the sod directly overlying topsoil which in turn overlay the natural subsoil. A mixed assemblage of finds was recovered from the topsoil deposits in all the test pits with flint fragments and modern ceramics accounting for the majority of the artefacts. Nothing of archaeological significance was encountered during the excavation apart from a single possible posthole encountered in Test Pit 4 (Plates 4 & 5). This feature (Context No. 404) measured 0.3m north/south by 0.2m east/west and had a maximum depth of 0.18m. It was filled by a sterile silty loam with occasional small angular stones throughout (Context No. 405). Further investigation by the mechanical excavator (during the excavation of Trench 6) showed this feature to be isolated and with the lack of artefactual evidence from the fill (Context N. 405) a date or function of the feature is difficult to ascertain.

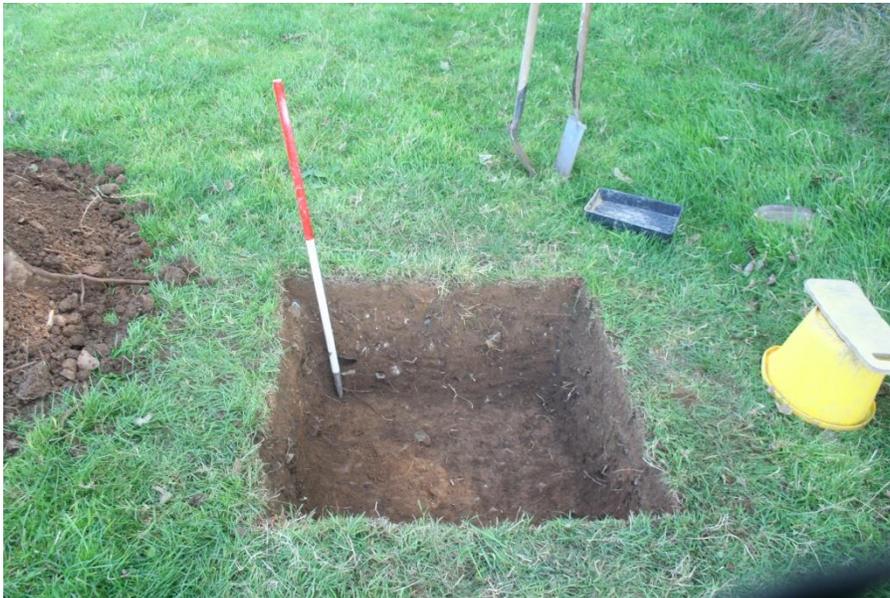
**Plate 2: Post-excavation view of Test Pit 2, looking north.**

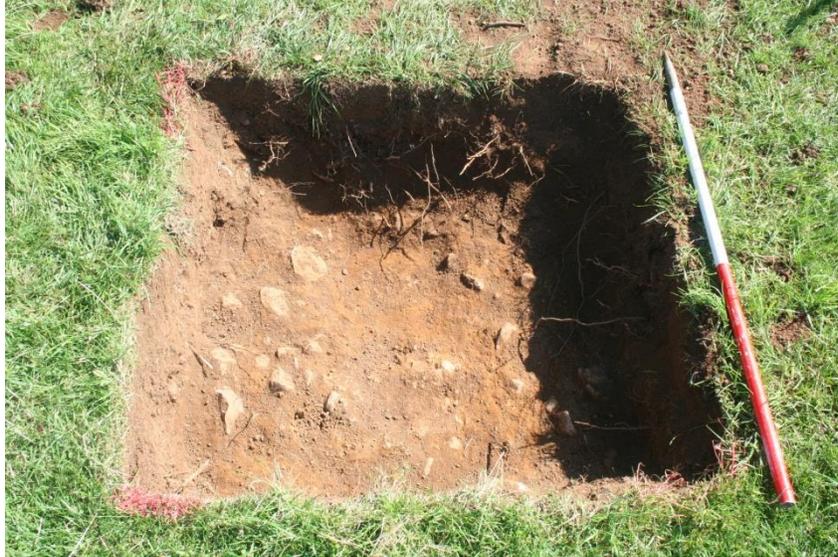
**Plate 3: Post-excavation view of Test Pit 3, looking south.**

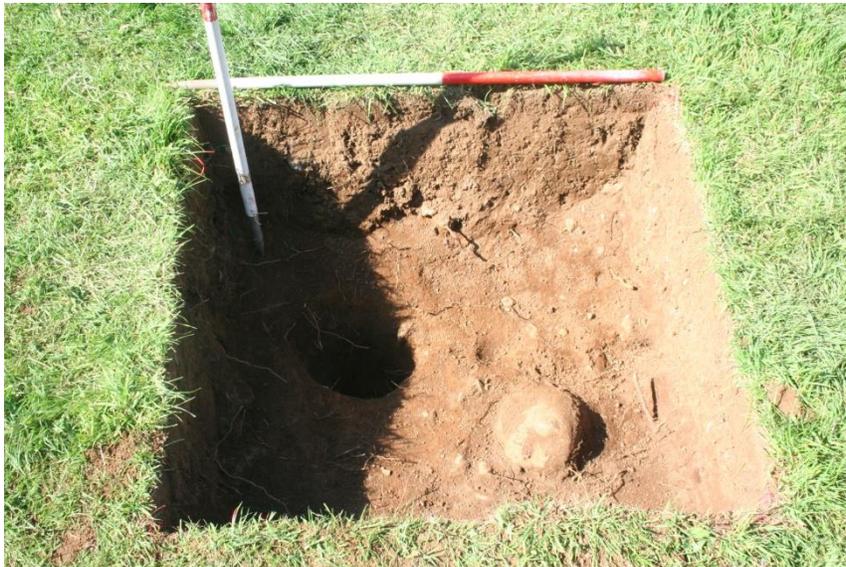
**Plate 4: Post-excavation view of Test Pit 4, looking east.**

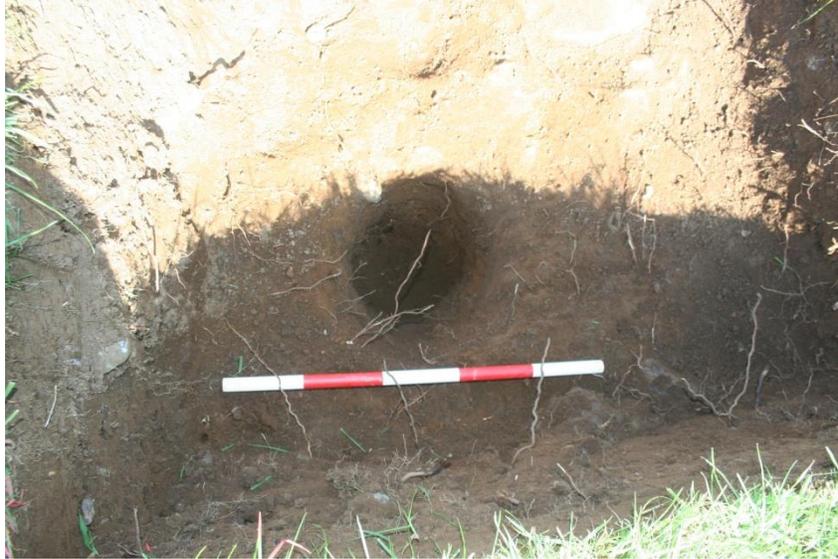
**Plate 5: Post excavation view of the possible posthole (Cxt No. 404) encountered in Test Pit 4.**

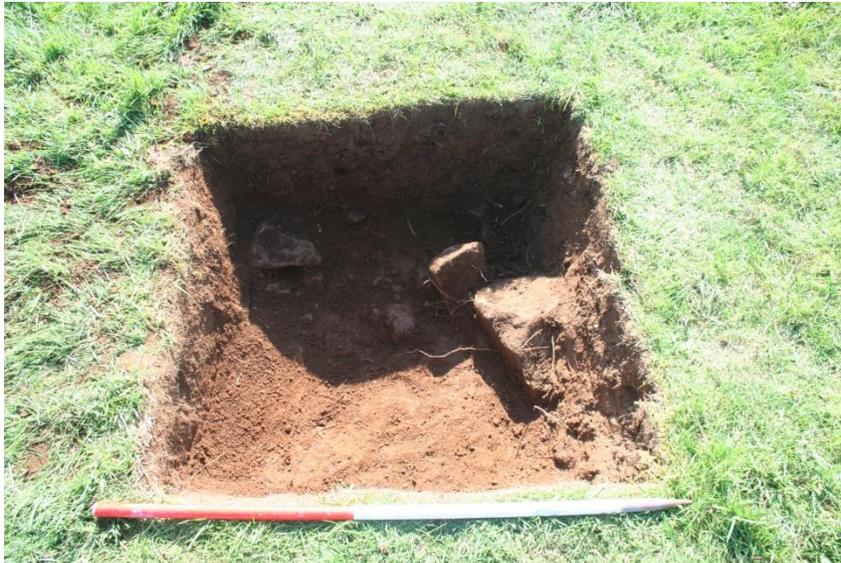
**Plate 6: Post-excavation view of Test Pit 5, looking north.**

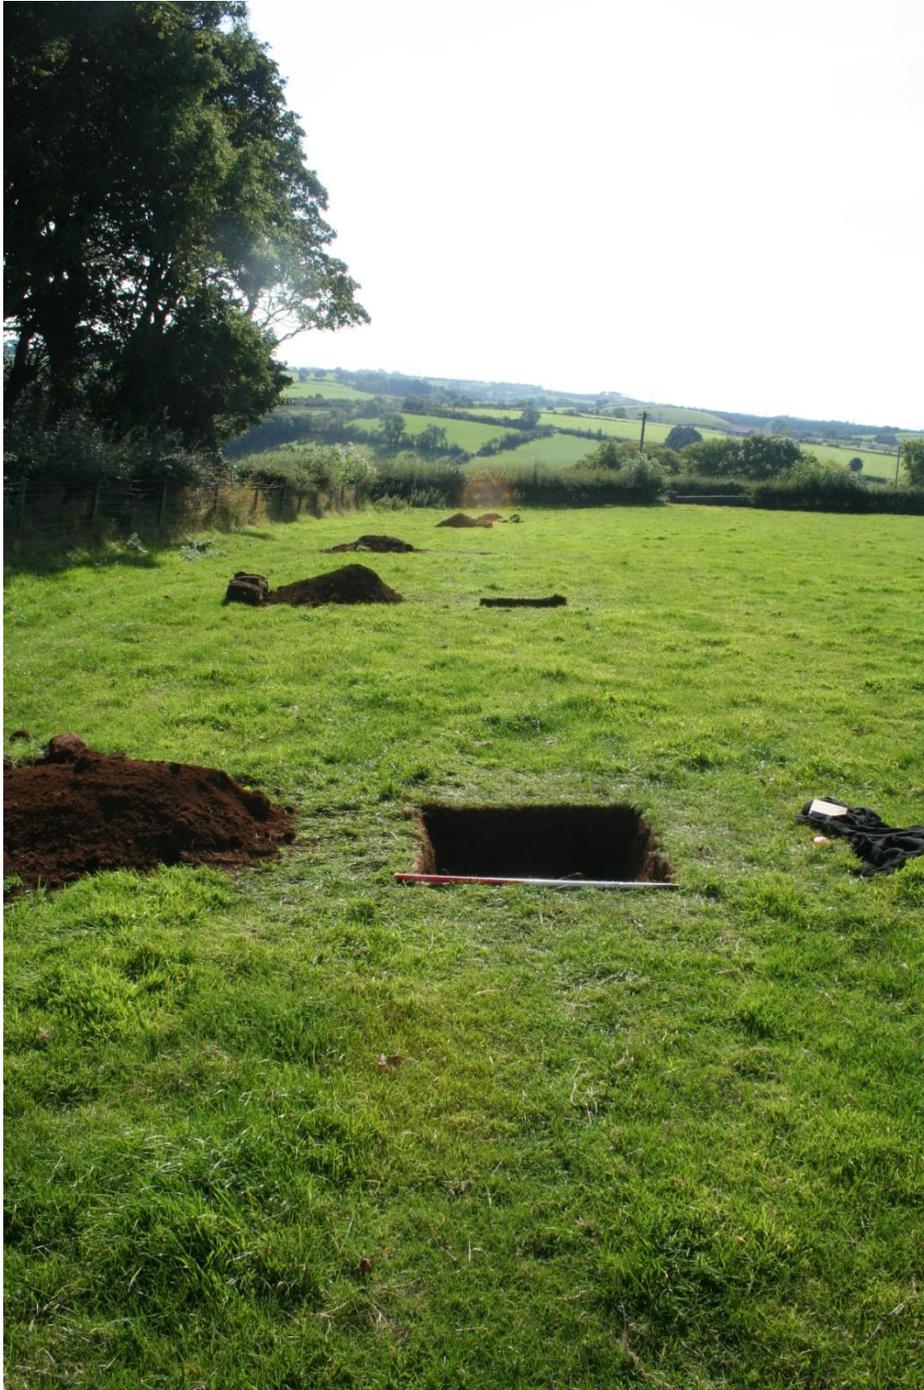
**Plate 7: Overview of the manually excavated test pits, looking south-west.**

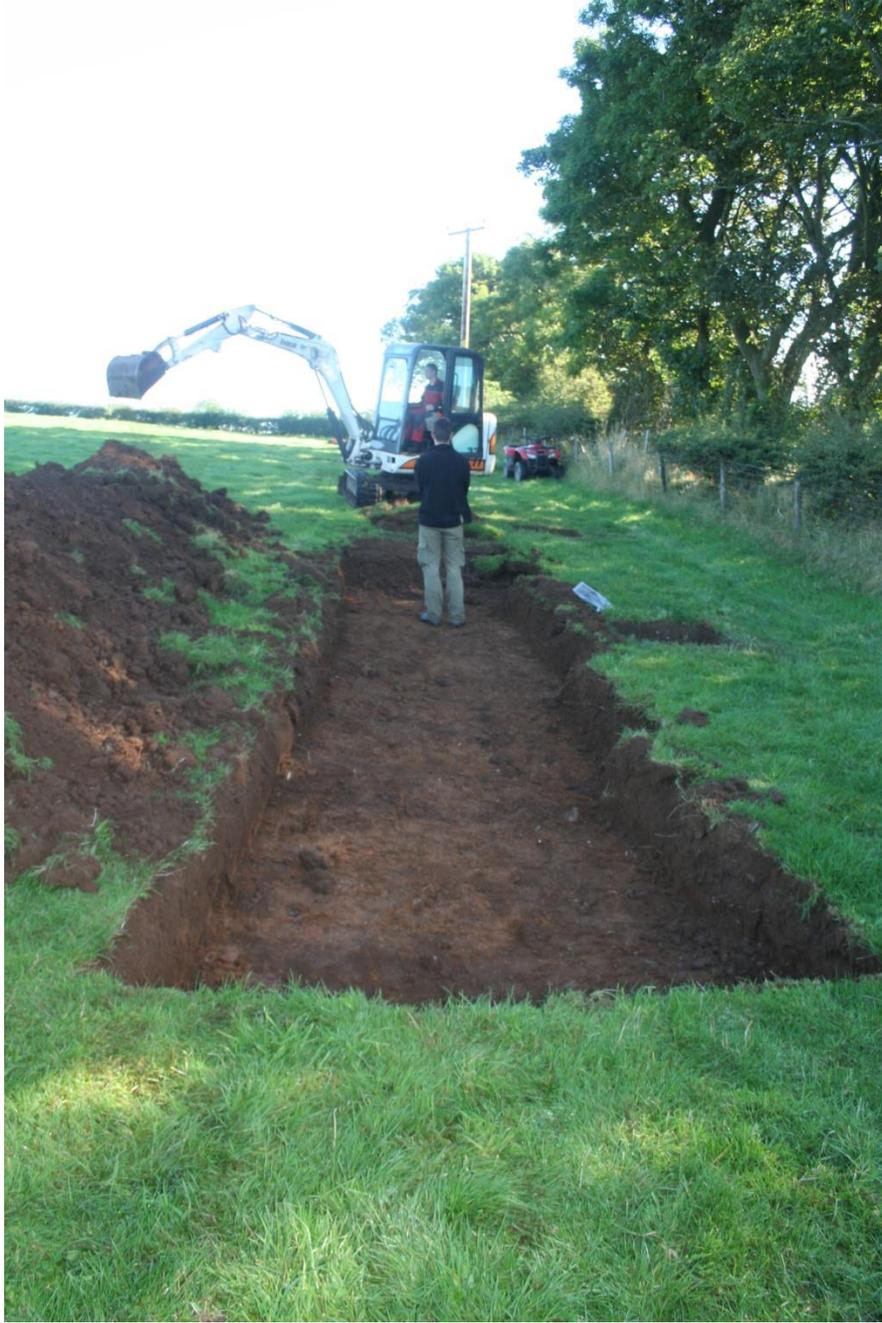
Trench 6 was aligned south-west/north-east and measured 47m in length by 2m in width. The trench was located along the proposed access lane to the development and incorporated test pits 1-5. The trench was excavated to the surface of the natural subsoil (Context No. 603) which was encountered at an average depth of 0.3m and consisted of a reddish orange clay with the occasional protrusion of the bedrock visible. A simple stratigraphic sequence of topsoil (Context No. 602) directly overlying the natural subsoil (Context No. 603), with nothing of archaeological significance was encountered during the excavation of this trench.

**Plate 8: Trench 6 mid excavation, looking north-east. Test Pit 1 is visible in the middle of the picture.**

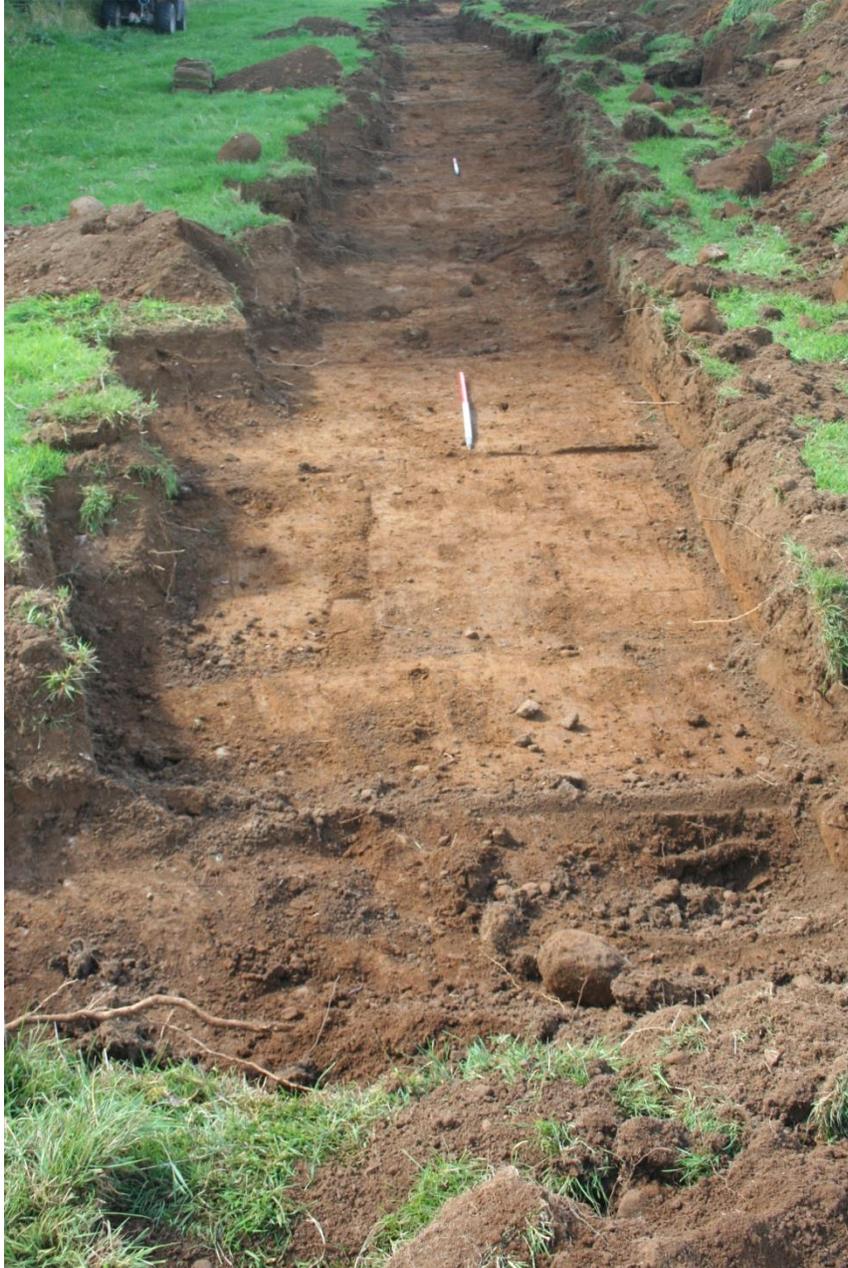
**Plate 9: Trench 6 following mechanical excavation to the surface of the natural subsoil (Cxt. 603), looking north-east.**

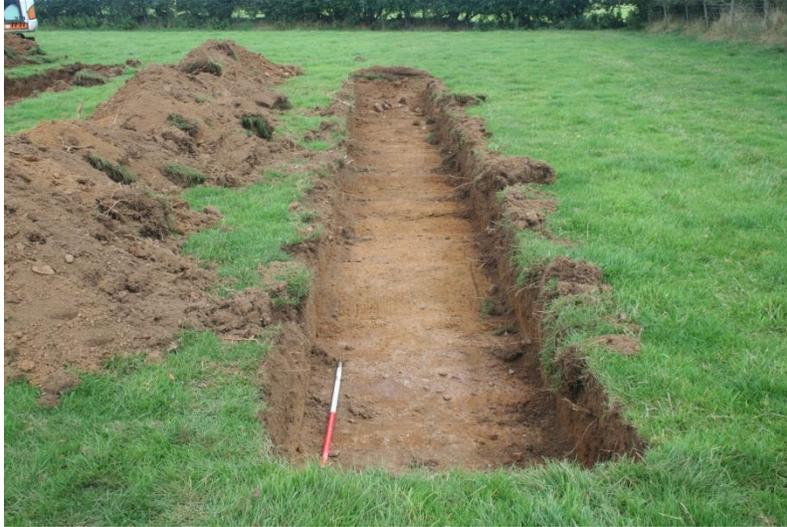
Trench 7 was positioned approximately 6m to the north-east of Trench 6 and measured 19m in length by 2m in width. The trench was aligned south-west/north-east and was excavated to the surface of the natural subsoil (a reddish orange clay - Context No. 703), which was encountered at an average depth of 0.35m. Again a simple stratigraphic sequence of topsoil (Context No. 702) directly overlying natural subsoil (Context No. 703) was encountered. Nothing of archaeological significance was encountered in this trench.

**Plate 10: Trench 7 following excavation to the surface of the natural subsoil (Context No. 703), looking north-east.**

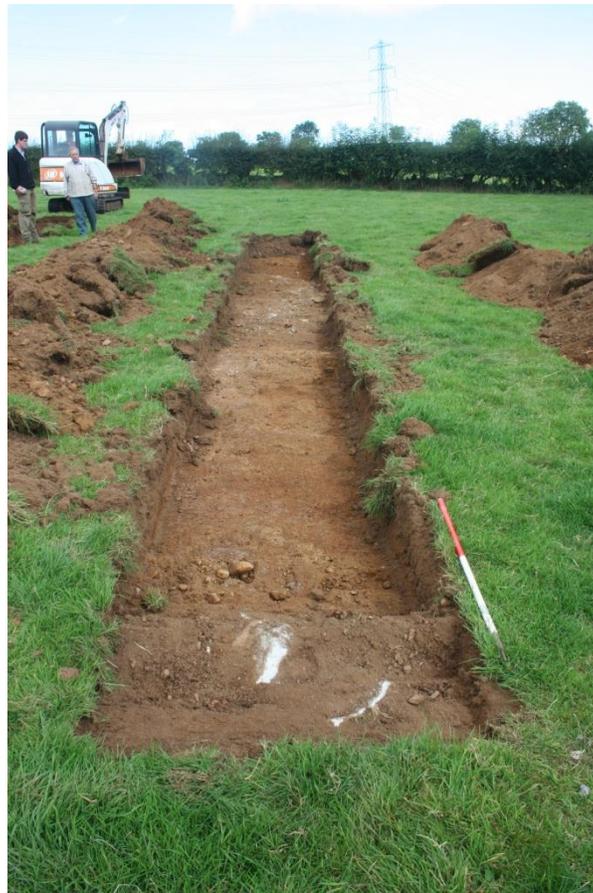
Trench 8 was positioned approximately 4m to the north-west of, and parallel to Trench 7. The trench measured roughly 21m in length by 2m in width and was excavated to the surface of the natural subsoil (a reddish orange clay – Context No. 803) which was encountered at an average depth of 0.25m. A simple stratigraphic sequence of topsoil (Context No. 802) directly overlying the natural subsoil (Context No. 803) was encountered. Nothing of archaeological significance was encountered during the excavation of this trench.

**Plate 11: Trench 8 following excavation to the surface of the natural subsoil (Context No. 803), looking north-east.**

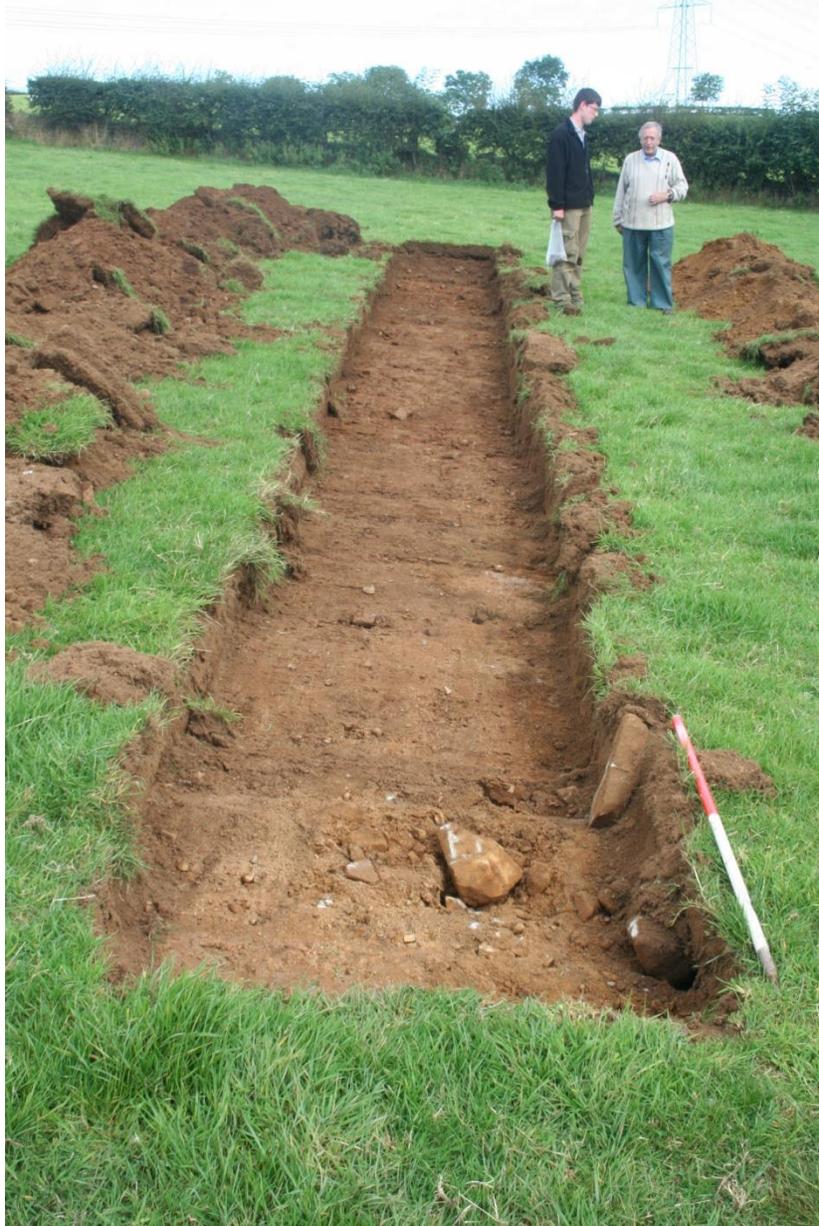
Trench 9 was positioned approximately 3.5m to the north-west of, and parallel to Trench 8. The trench measured roughly 20m in length by 2m in width and was excavated to the surface of the natural subsoil (a reddish orange clay – Context No. 903) which was encountered at an average depth of 0.2m. A simple stratigraphic sequence of topsoil (Context No. 902) directly overlying the natural subsoil (Context No. 903) was encountered. Occasional protrusions of the bedrock were noted in this trench. Nothing of archaeological significance was encountered during the excavation of this trench.

**Plate 12: Trench 9 following excavation to the surface of the natural subsoil (Cxt. 903), looking north-east.**

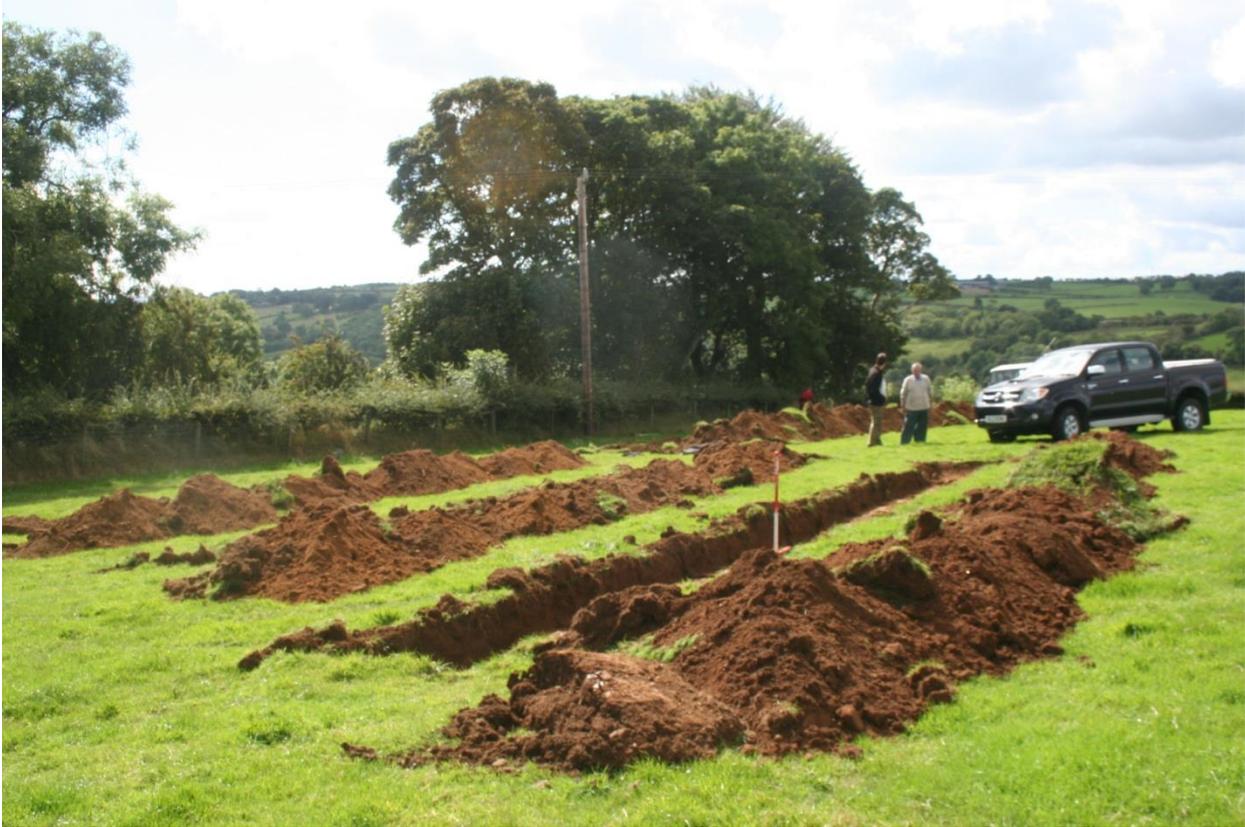
**Plate 13: Overview of the proposed development site (F/2010/0402/O) following the evaluation, looking south.**

The manual test pits as well as the four evaluative test trenches excavated in the application area contained nothing of archaeological significance. It is not thought that the development of the dwelling will impact upon previously unrecognised and unrecorded archaeological remains. It is therefore recommended that
