Data Structure Report No.: 098

Excavations at Clonallon Church of Ireland, Clonallon Glebe, Warrenpoint, County
Down

Grace McAlister

Licence No: AE/12/103

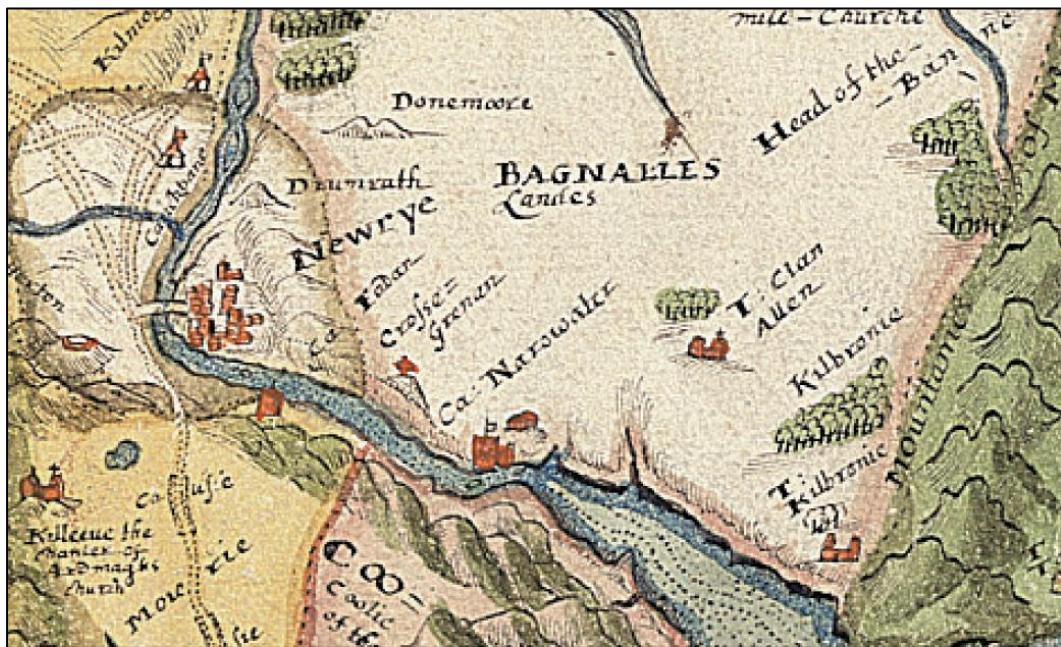
Figure 2: Depiction of Clonallan (T:Clan Allen) in the South-east Ulster 1602-3 'The campaign map'

- 2.6.1 The late medieval church is depicted on the 'Cotton' map of southeast Ulster dated to AD 1600 (British Library Ref. Cotton MS Aug. I, ii, 37; reproduced in Andrews 2008, pl.1) where 'T. Clan = Allen' is depicted as an apparently intact structure consisting of a tower, nave and chancel (or possibly apse) and in the AD 1601 map of Southeast Ulster (Trinity College Dublin Ref. TCD MS 2379; reproduced in Andrews 2008, pl.4), where 'Tempall Clonallen' is depicted as a gabled ruin. The church is also represented on one of Bartlett's regional maps of AD 1602-3 - the 'campaign map' of southeast Ulster (Figure 2; National Archives, London (formerly the Public Record Office) Ref. MPF 1/36; reproduced in Andrews 2008, pl.18) where 'T. Clon Allen' is also represented as a gabled ruin, but it is not featured on the other Bartlett's regional map of 1602-3 the later 'generalle description of Ulster' (National Archives, London Ref. MPF 1/35) (reproduced in Andrews 2008, pl.19).

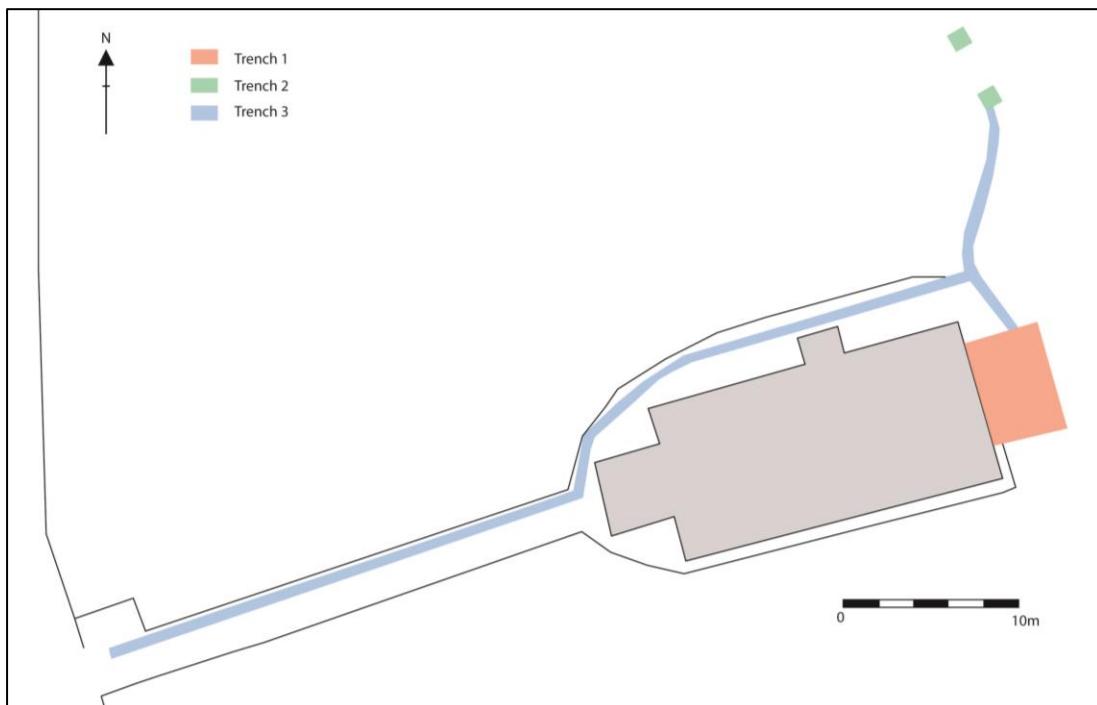
Figure 5: Plan of church showing the location of the excavation trenches

- 3.1.1 The excavation area consisted of 3 trenches located over the development area of the site (Figure 5). Trench 1 was rectangular in plan measuring 6.24m (north/south) and 4.4m (east/west). It was positioned at the rear of the church against the east gable. Archaeological surveillance was carried out by archaeologists from the Northern Ireland Environment Agency, which revealed articulated human remains. After initial mechanical excavation, the area was hand excavated when the presence of articulated skeletal remains began apparent. Prior to archaeological surveillance, no burials were known to be within the excavation area, but graves were present close to the southern and eastern limits of the excavation. To the north-east of the main excavation area 2 1m² pits (Trenches 2A and 2B) were dug over the location of the septic tank, this was then mechanically excavated to a depth of 1.8m. Trench 3 was approximately 55m in length and 0.4m in width and was mechanically excavated. It extended from the septic tank to the main excavation area and along the northern side of the church to connect with the water supply at the Clonallan Road.

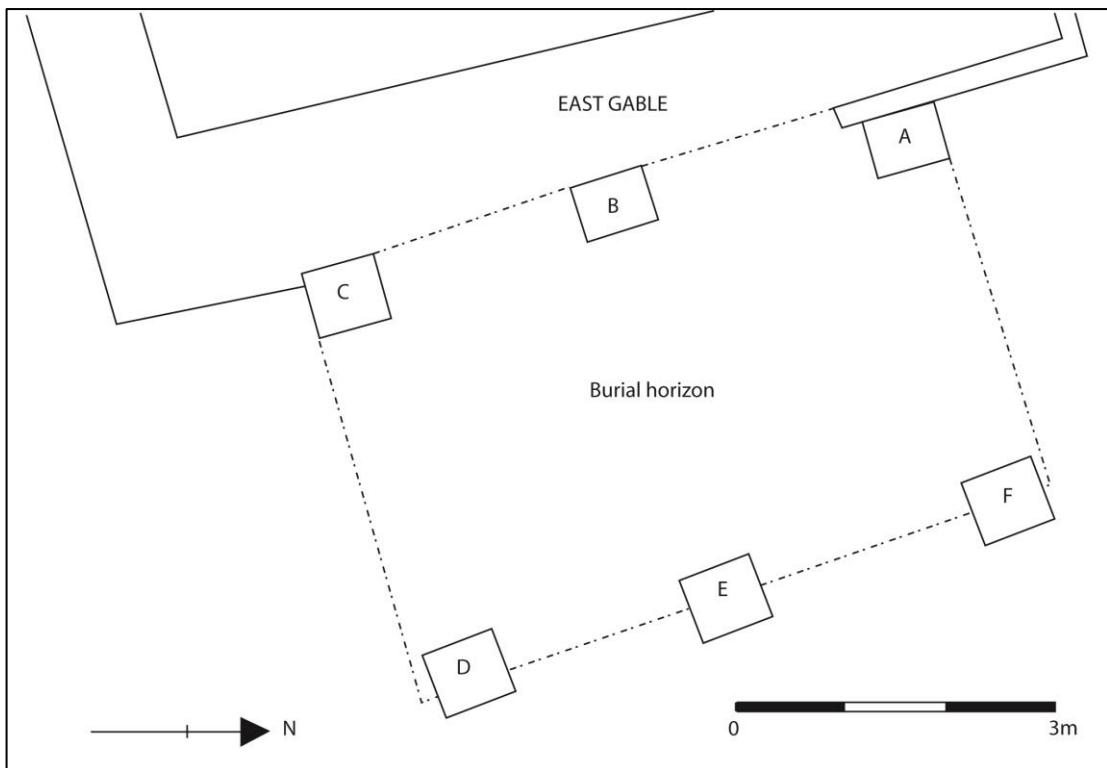
Figure 6: Location of Pads A-F within Trench 1

- 3.2.5 The burials detailed above were recorded, photographed and planned (Figure 7) and it was at this point the excavation methodology changed and the 6 pads were excavated. Due to the small size of these pads, only parts of the burials were within the excavation area and therefore the burials were only partially excavated.

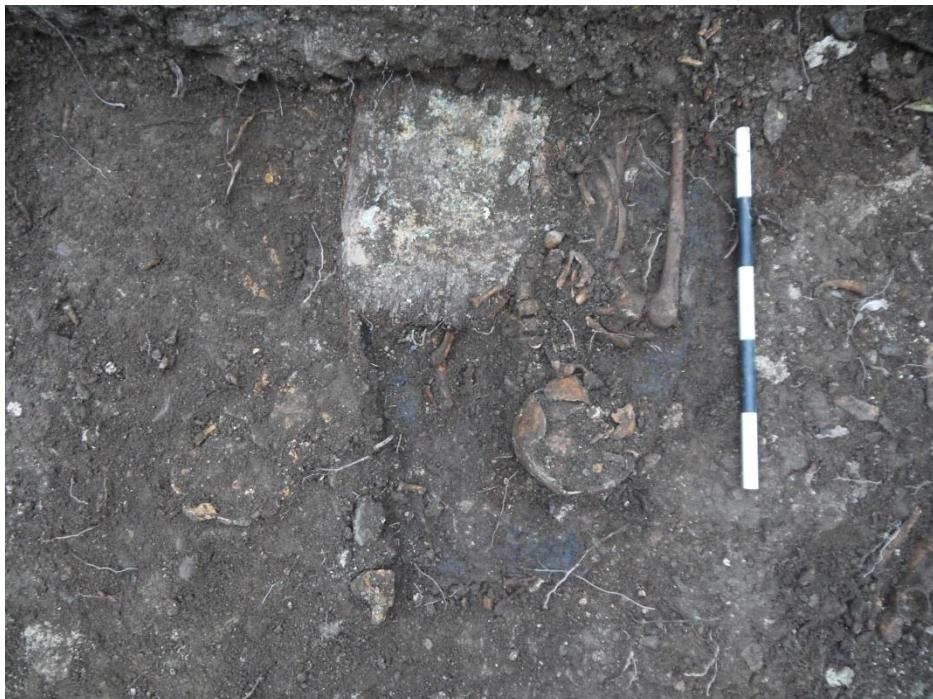
Plate 1: SK122 and coffin 123

- 3.2.4 5 Burials were cut in the 137. To the south of SK119, was another burial (SK122). Only the upper torso lay with the area of excavation and the remains that were visible were very

fragmentary. Associated with the cranium of this skull was the upper denture plate made out of vulcanised rubber, indicating that this burial probably dates to the twentieth century. The remains were still within a partially intact coffin (123) of which the base, sides and lid were present but in a fragmentary condition. A flaky, metal material was present on the lid (Plate 1). To the west, SK122 truncates SK130. This skeleton was in a poor state of preservation with only the cranium and rib fragments surviving. The burial of a female young adult (SK126) was disturbed during the mechanical excavation, the skull was missing and the lower legs were truncated by the fragment of another coffin (127) and a disarticulated skull (SK132).

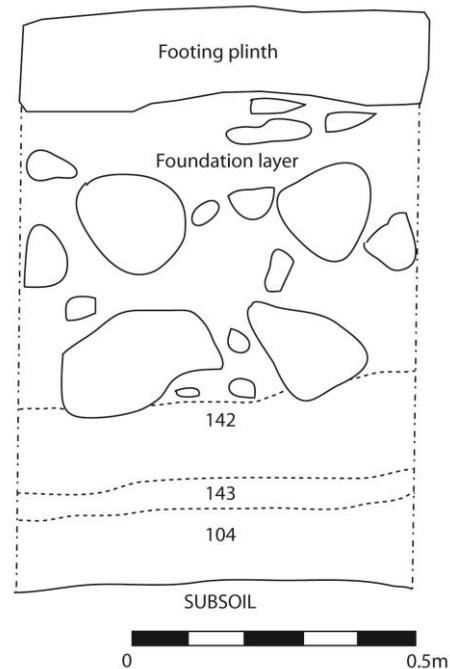
Figure 8: East facing section of Pad A

3.2.6 Pad A (Figure 8) was located in the north-west corner of the trench, against the east gable of the church. The uppermost layer within the pad was 112 which was excavated and revealed another burial (SK141). Only the skull of this burial was within the excavation area of the pad and so it was removed, the rest of the burial extends beyond the eastern limit of excavation. This burial seems to be within grave cut 111, the same grave cut as for SK110. The removal of SK141 revealed a soft, reddish-grey, loam with mortar inclusions (142), 0.25m deep. This was overlying a thin gravelly/stoney layer (143), 0.08m deep. Both these layers extended under the footing stones of the church and are most likely providing a bedding layer for the foundations of the church in this area. Subsoil was encountered at a depth of 1.1m below the top of the footing plinth.

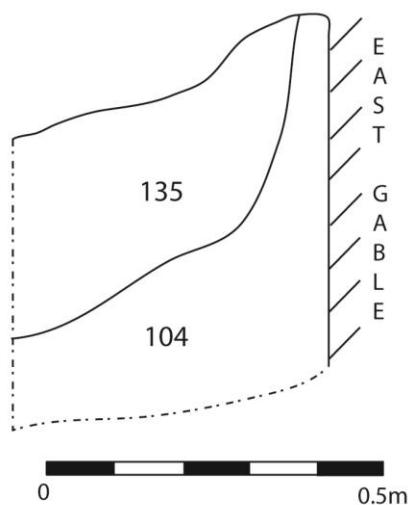
Figure 9: North facing section of Pad B

3.2.7 Pad B (Figure 9) was positioned against the east gable of the church, and centrally along the western excavation limit of the trench. 135 was removed and was within a larger cut (140) which was steep sided and 0.28m in depth. Disarticulated bone was present in 135 and articulated remains were observed in the north facing section (SK168). 140 was cut into 104 and the subsoil was encountered at a depth of 0.48m

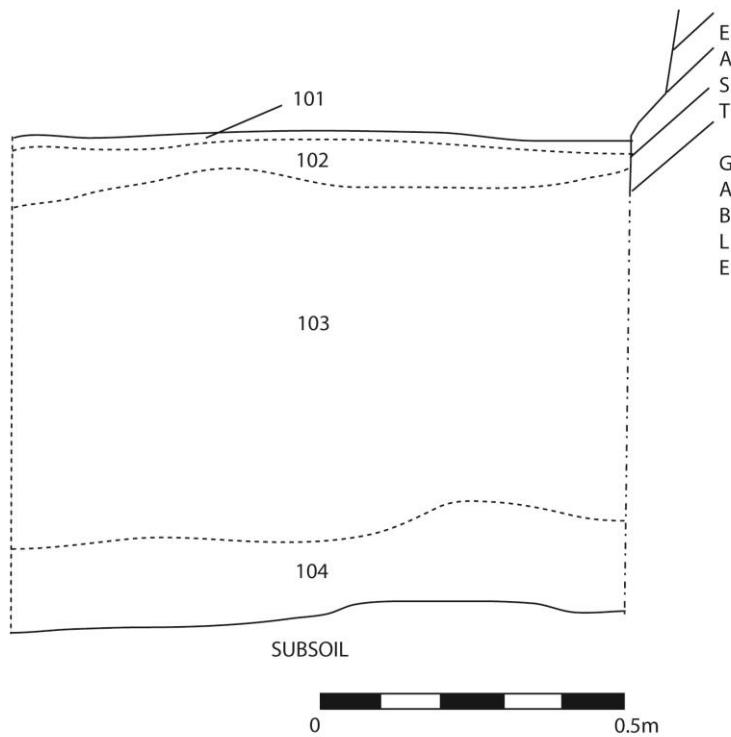
Figure 10: North facing section of Pad C

3.2.8 Pad C (Figure 10) was located in the area of the mechanically excavated test-pit, in the south west corner of the trench. The mechanical excavation had reduced the level to 0.8m so the remaining 104 was excavated to the level of the subsoil, a depth of 0.8m below the present ground surface

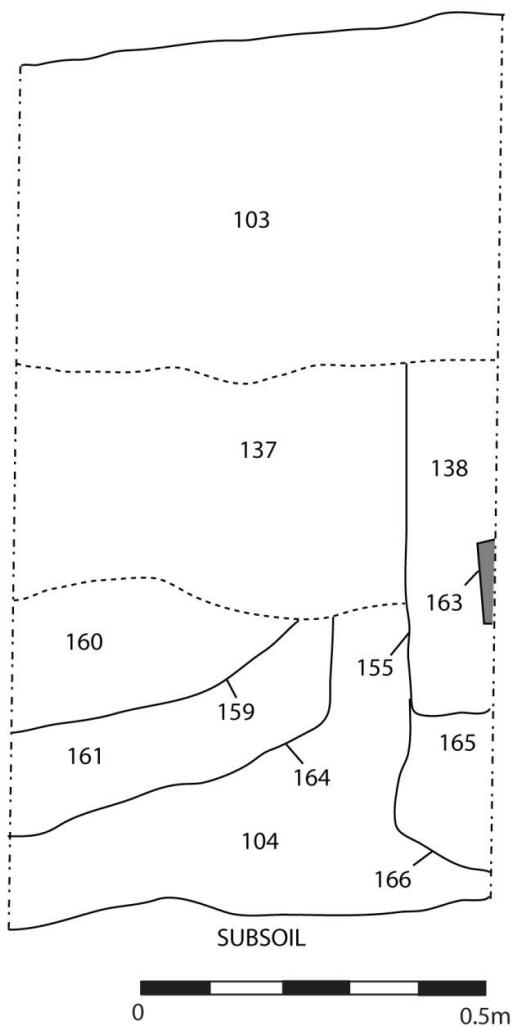
Figure 11: West facing section of Pad D

3.2.9 Pad D (Figure 11) was located in the south-east corner of the trench against the eastern limit of excavation. The excavation of Pad D revealed another 4 burials within the 137 which was approximately 0.35m deep in this area. The uppermost of these burials was the truncated remains of an infant skeleton (SK147), only the vertebrae pelvis and arms were excavated as the rest extended beyond the limit of excavation. This was overlying an adult skeleton (SK148), of which the arms and ribs were within the excavation area. Underneath this burial were the pelvis and arms of another adult burial (SK154). Below were the vertebrae and ribs of a third burial (SK156), again the rest of the skeleton extended beyond the limit of excavation. Underlying SK156 there was a grave cut (159) which contained a burial (SK158) surrounded by a dark greyish brown spongy loamy grave fill (160), 0.19m in depth. Only the right side of the burial was within the excavation area, so the vertebrae, pelvis and right arm and hand were excavated. A steep sided grave cut (164), 0.17m in depth was underneath and contained the partial remains of another burial (SK162), surrounded by a friable, loamy clay grave-fill (161). The right side of the torso and the skull were excavated, the rest remained preserved beyond the excavation area. This grave was cut into the reddish gravelly clay encountered in the mechanically excavated test-pit (104). Also cut through 104 were two other grave cuts (155 and 166). 155 is stratigraphically earlier than the other burials in this pad as it is cut through 137 as well as 104. This grave cut was steep sided, with a depth of 0.66m and was at the very limit of excavation with only the northern side showing, therefore no skeletal remains could be discerned. Within the cut, the left side of a coffin (163) was apparent in the north facing section and was covered in a white plastic covering with a chrome plated coffin handles. There was also a synthetic material protruding from the coffin and within 138. This artefactual evidence indicates that this burial is relatively modern, perhaps dating to the second half of the twentieth century. Directly beneath this burial was grave-cut 166, this was filled by a mid-brown, stony, loamy clay (165) 0.22m thick. No skeletal remains were found associated with this cut and fill but they may be preserved beyond the limit of excavation. The subsoil was encountered under the 104 at a depth 1.2m beneath the current ground surface.

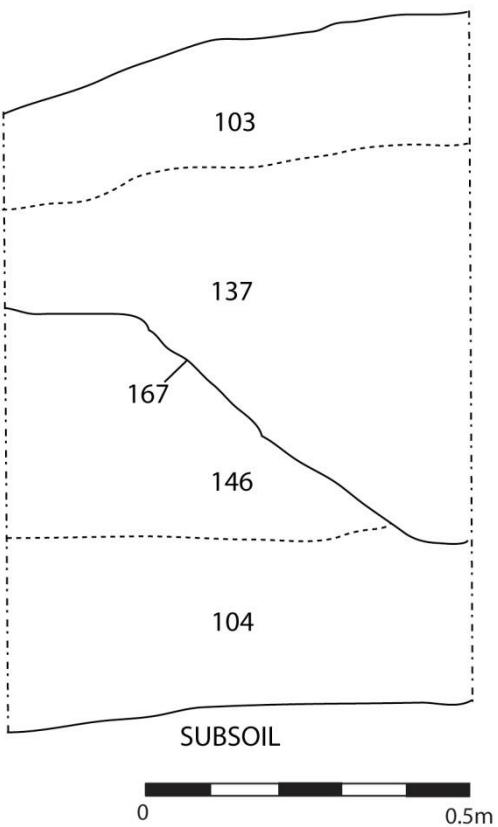
Figure 12: west facing section of Pad E

3.2.10 Pad E (Figure 12) was located half way along the eastern limit of excavation. Within 137 was another possible grave-cut (167), this had a depth of 0.6m. No skeletal remains were discerned in this small area of excavation. 167 was cut into a 0.34m thick deposit of clayey silt was uncovered (146) this contained disarticulated bone but again no articulated skeletal remains, it overlay 104 which was over the subsoil, encountered at a depth of 0.95m below the present ground surface

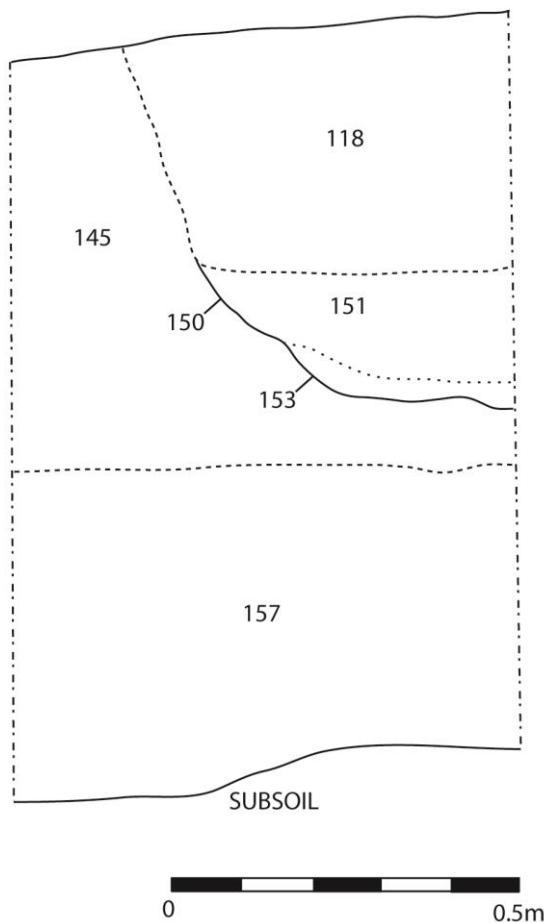
Figure 13: West facing section of Pad F

3.2.11 Pad F (Figure 13) was located in the north-east corner of Trench 1. 136 was removed and a light grey brown silt (151; 0.17m in depth) was uncovered, the fill of a grave cut (150) and surrounding a burial (SK149). Only the lower legs and feet were within the limit of excavation, with feet were in a crossed position. Judging by the associated coffin nails, this was probably a coffin burial. A piece of post-medieval pottery was found underneath the skeleton. 150 truncated another grave cut (153) which contained a fragmentary burial (SK152). Only the left side of the body lay within the excavation area, and the lower left arm, ribs and left femur were excavated. Although a separate grave cut was apparent, a separate grave fill was not and so cut 153 was also filled with 151. These burials were cut into loose clayey silt with mortar and slate inclusions (145; 0.08 - 0.52m in depth), this was overlying a dark brown compact layer with some larger stones (157). The consistency of this deposit suggests that it may be a buried soil horizon and an arbitrary level indicates that this deposit is at the same level as the present ground level at the adjacent field boundary. A fragment of a humerus was found in this layer which may provide good dating evidence. This deposit was up to 0.5m in depth and was overlying the subsoil that was encountered at a depth of 1.04m.

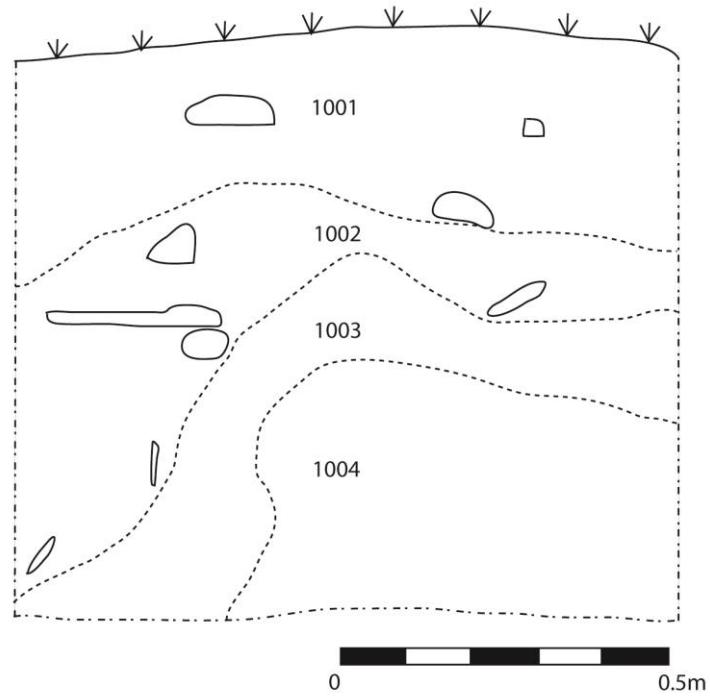
Figure 14: South facing section of 2A

3.3.1 Trenches 2A and 2B were both 1m² test-pits, positioned approximately 2m apart, in a lower lying, wetter area to the north-east corner of the graveyard. In 2A (Figure 14), the topsoil (1001), 0.32m in depth was removed and revealed multiple layers of modern dumped material, included a shaly clay (1002), ranging in depth from 0.10-0.45m. This was overlying a clayey loam (1003), 0.20-0.36m in depth, which in turn was over a loose gravel (1004), 0.38m in depth. 1004 was removed to revealed the stony fill (1005) of a drain (1006) running east/west through the trench. In 2B (Figure 15), a 0.14m thick layer of topsoil (2001) was removed to reveal a substantial deposit of silty loam (2002), 0.7m in depth, within this deposit there was a gravel lens (2003). Finds from 2002 included a glass milk bottle and plastic. The drain uncovered in 2A did not continue into 2B. The deposits in these trenches are explained by the insertion of a drainage system and the attempts to raise the ground level through modern dumping and consolidation works. The trench was excavated to a depth of approximately 0.8m and then was mechanically excavated and archaeological monitored to a depth of 1.8m.

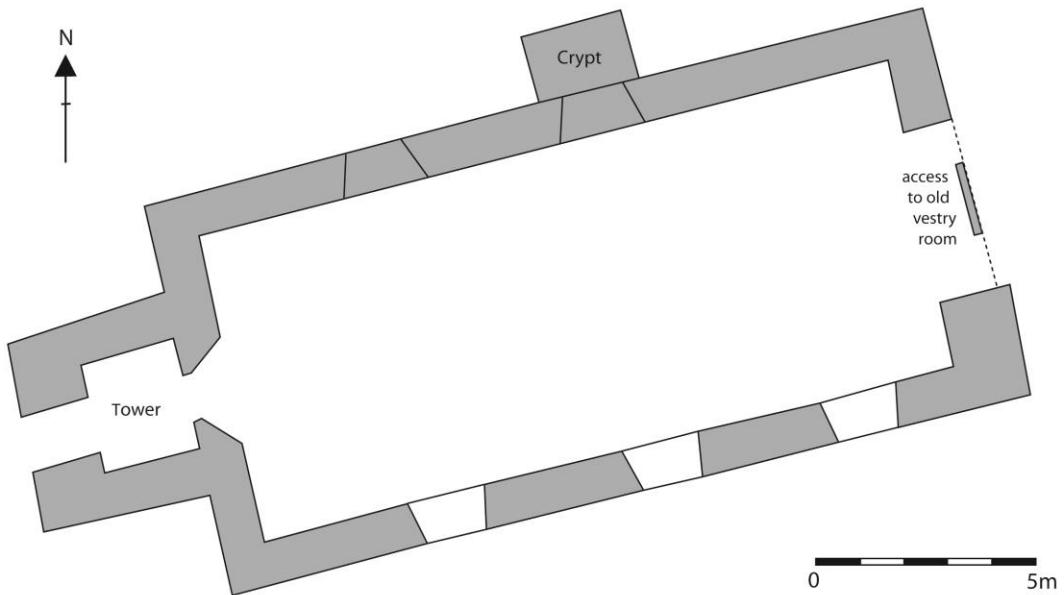
Figure 16: Floor plan of church, after demolition of previous vestry room

- 4.1.1 The ground plan of the church and graveyard was EDM surveyed (Figure 16). Any individual architectural features within the church fabric were measured and drawn by sketch plan and individually photographed. Scale drawings were then reproduced by combining the EDM survey data, the sketch plans and photographs back in the office. The results of the building survey and interpretation of the architectural features are detailed below.

- 4.1.2 The church is barn shaped with a tower to the western gable, a porch on the northern side. Prior to the survey the church walls were wet cement dashed with a smooth rendered base course. The church was constructed of local rounded granite undressed stone, squarer quoin stones are at the corners. Smaller dressed stones and red brick are used around windows and doorways. Prior to excavation a vestry room was attached to the eastern gable of the church (Plate 2), this was a one-storey flat roofed extension which was demolished prior to survey being carried out.

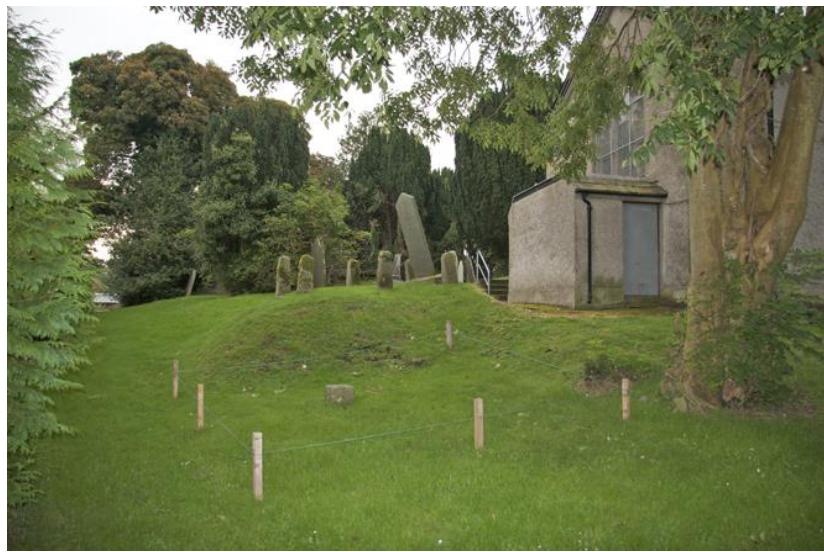
Plate 2: Previous vestry room looking south-west

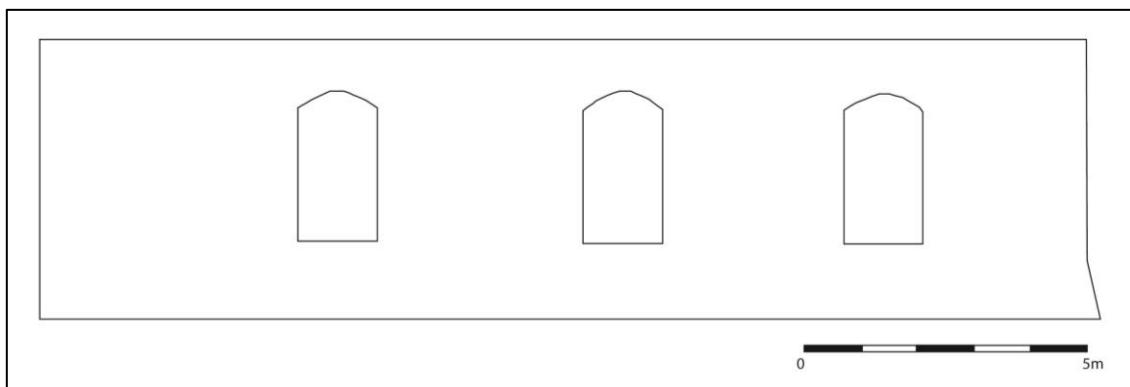
Figure 17: Elevation of southern wall

- 4.2.1 The south side of the church measures 18.8m in length (Figure 17). Little changes appear to have been made to this side of the church, there are three round headed windows, measuring 1.4m in width and 2.6m in height. The western most window is 4.6m from the south western corner of the church, with the eastern most window 3m from the east gable. The spacing between the windows is between 3.25 and 3.64m. The batter of the east gable extends around the south-east corner to the south side of the church, the batter is not as obvious on this side but the ground level is higher here which may be masking the continuation of the base batter (Plate 3)

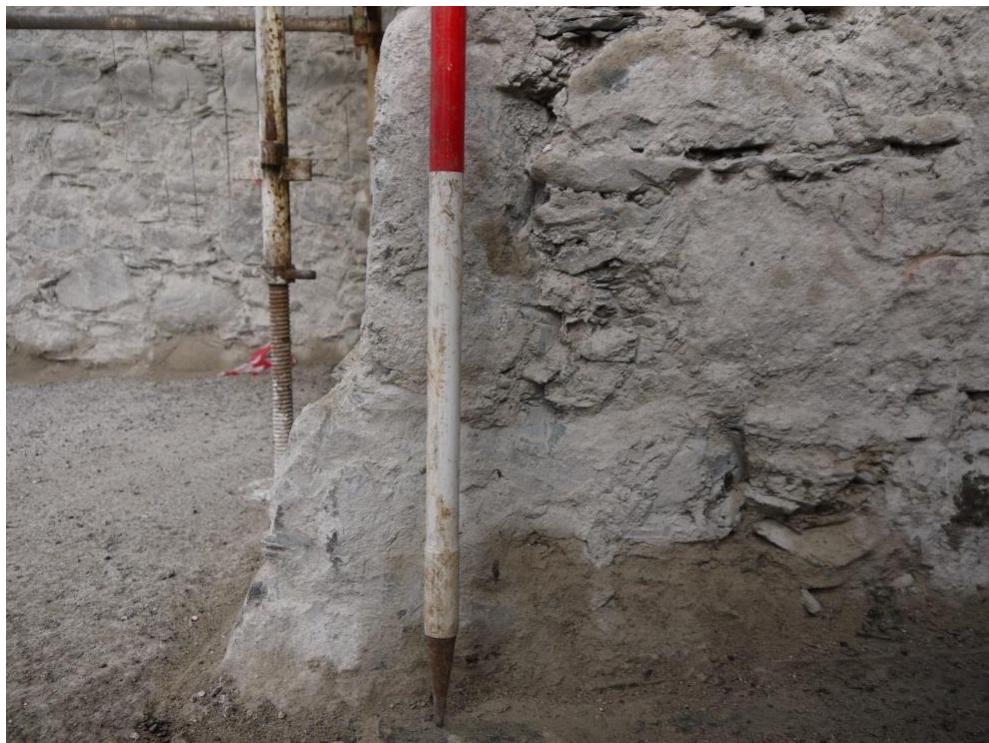
Plate 3: Slight base batter at south-west corner of church

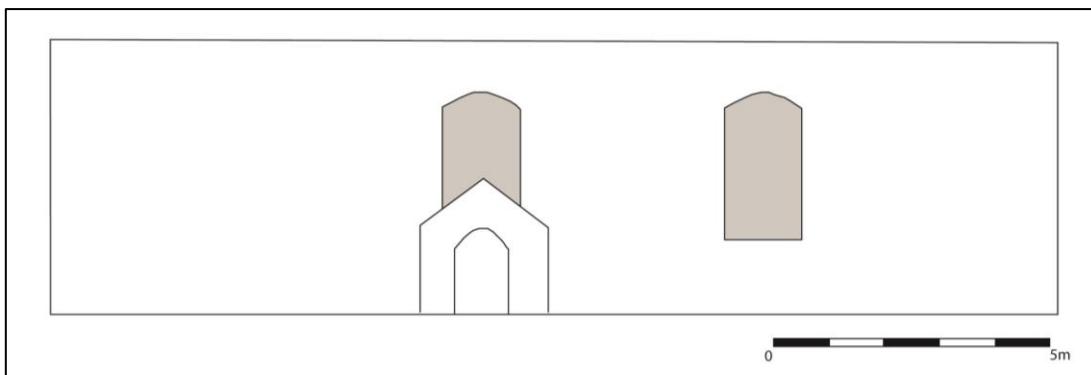
Figure 18: Elevation of northern wall

- 4.2.2 On the north side the building is constructed on a plinth footing, and measures 18.12m in length and 4.9 metres in height (Figure 18). On first view it was thought there were no windows on this side of the church, but the removal of the render revealed two blocked up windows. These windows are round headed and measuring 1.4m in width and 2.6m in height, with an architrave is approximately 0.24m deep. The western most window is 4.6m from the west gable, with the second window 7.1m from the eastern gable. The windows are 3.64m apart. These windows correspond with the 2 western most windows on the southern wall. A small porch is abutted to the northern wall 6.72m from the east gable, it measures 2.36m east-west and 1.6m north-south. It has a pitched roof and a maximum height of 2.4m. A round-headed doorway on its northern face, this was blocked up recently due to vandalism but is approximately 1m in width and 1.5m in height. This porch provides an entrance to steps which lead to a family crypt below the main body of the church. The crypt is positioned over one of the blocked up windows meaning that its addition post-dates or is contemporary with the blocking up of the windows.

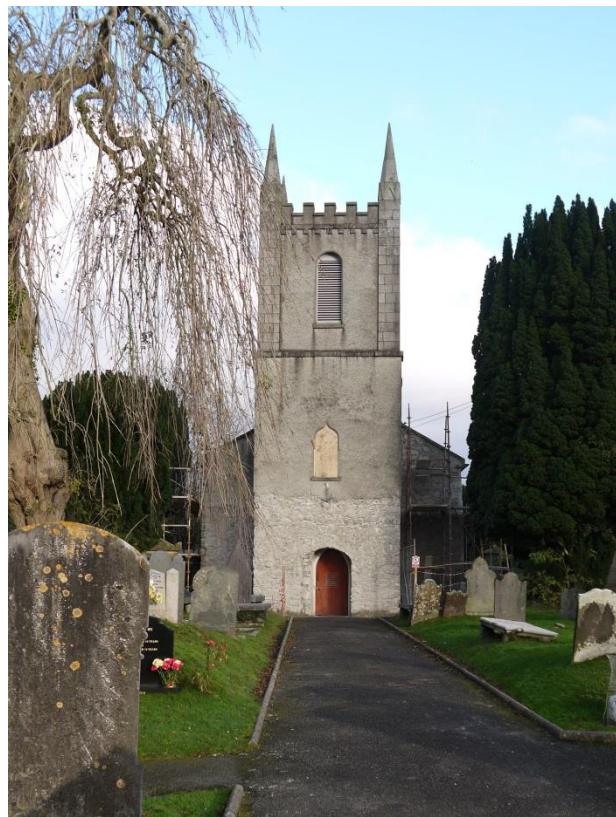
4.2.3 The west gable is dominated by the roughly square, 2 storey tower (Plate 4). The tower is not perfectly centered along the west gable but is 2.6m from the south-west corner and 2.1m from the north-west gable. Along its western face the tower measures 4.44m, the northern face measures 3.2m with the southern face slightly longer at 3.88m. The walls are approximately 1m thick but the western (front) wall is more substantial. The tower has an internal diameter of 2.2m east-west by 2.6m north-south. There is a wooden staircase leading to the first storey against the northern wall. A footing plinth is visible on the internal side of the southern tower wall. The entrance is at the front (western side) of the tower. It is in a perpendicular gothic style and chamfered with an exterior width of 1.22m and an interior splay of 1.45m. It has a slightly skewed appearance and is not perfectly centered within the western face of the tower, evidence in the stonework shows that the entrance has been narrowed to the northern side, most likely to insert a new doorway (Plate 5). The first storey of the tower extends to the apex of the nave roof; there is one ogee headed window. The second storey has a semi-circular-headed louvered opening on all four faces; these and the window of the first floor all have dark red brick surrounds. There are no other features on the western gable of the church itself.

Plate 4: Tower looking east

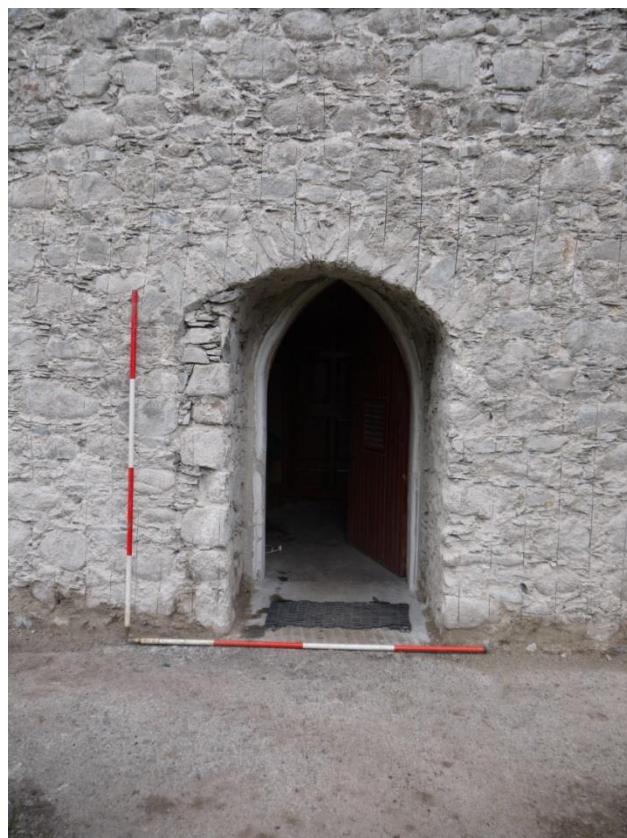
Plate 5: Entrance showing alterations made to the left hand side

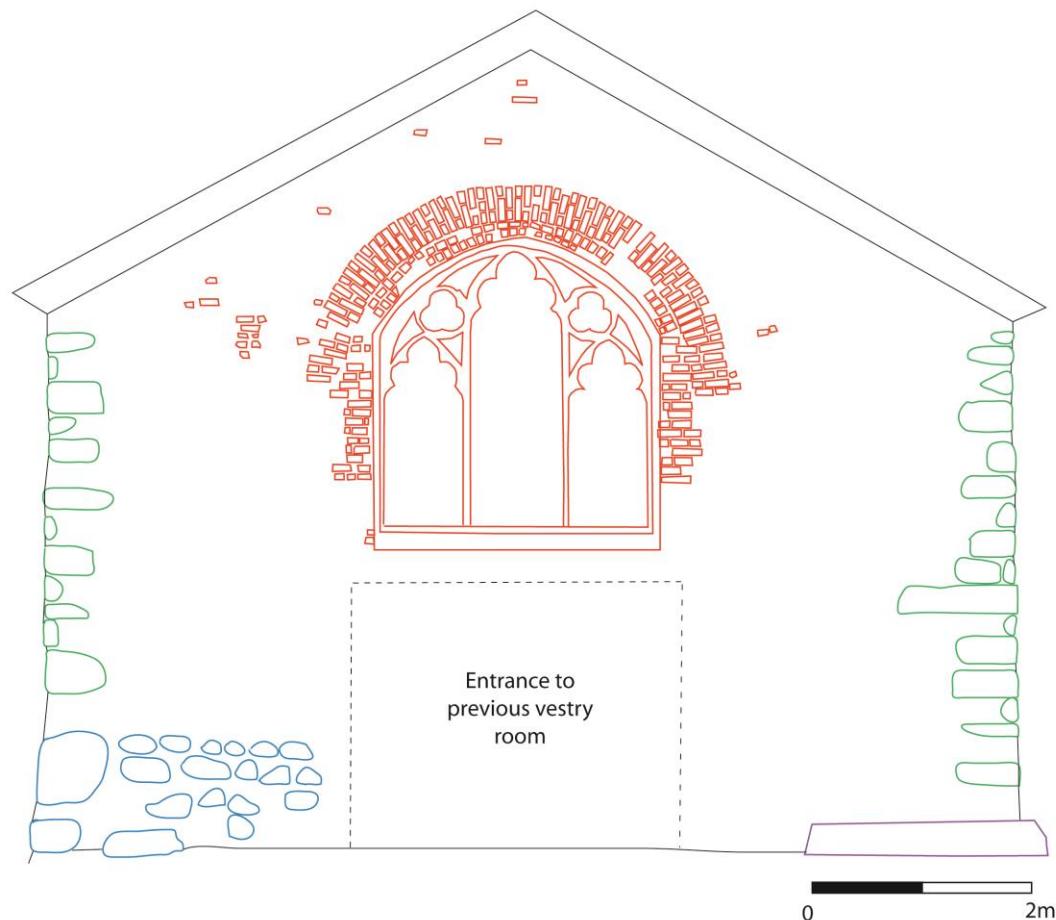
Figure 19: Elevation of eastern gable showing phasing

4.2.4 The eastern gable (Figure 19) has had the most redevelopment due to the addition of the flat roofed extension. It measures 9.2m in length, and approximately 7.7m in height at the apex of the roof. There is a squat window measuring 2.44m in width and 3.04m in height (highlighted in red). The window itself has a slight pointed arch but the setting itself is round-headed, constructed using two different types of red brick. The removal of the mortar from the church and the demolition of the extension revealed an interesting feature in terms of the construction of the building. At the base of the wall towards the south-east corner there is an obvious batter (highlighted in blue), which extends a maximum of 0.6m from the line of the building. This differs to the section of wall towards the north-east corner where the wall is built directly on to a footing plinth (highlighted in purple). Where the division between these two construction types occurs is difficult to locate as the works to construct the extension have masked this. There is also evidence of insertions and additions in the main body of the church. This includes two areas of red brick with a thin flat stone underneath (highlighted in). There may represent the location of the original wooden roof beams. Towards the base at the centre of the gable, there was an opening under the floor level of the interior of the church; this is probably a vent feeding the interior heating system (Plate 6).

indicating a post 17th century date for the construction of this feature. We know for certain that there is an extension to the eastern gable by 1838 when the 1st edition ordnance survey map was published, and so the squat window in the eastern gable probably dates to this time. An apse is also depicted 'Cotton' map of southeast Ulster dated to AD 1600. However Andrews has observed that the Cotton map was produced at a time when Bartlett's cartographic style was still developing and his representations of 'settlement-symbolism' is 'fussier' than it would become by the following year (Andrews 2008, 22). In order for structure 109 to be built, the footprint would have most likely been reduced to provide a level surface, this would account for the relatively shallow depth of the burials in Trench 1, and their poor preservation in places.

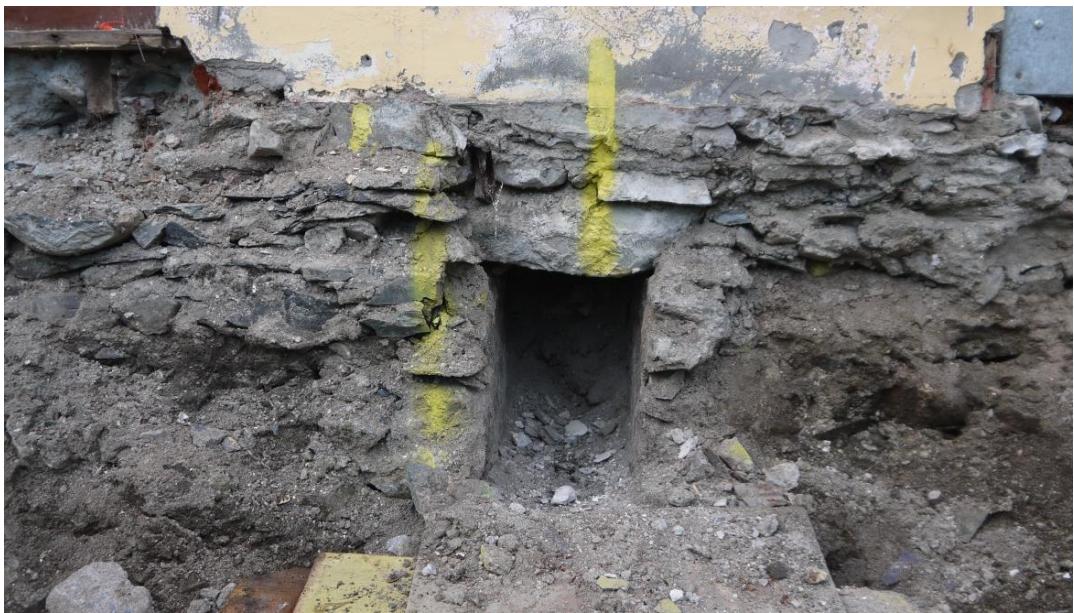
Plate 6: Air vent below the floor level in the eastern gable

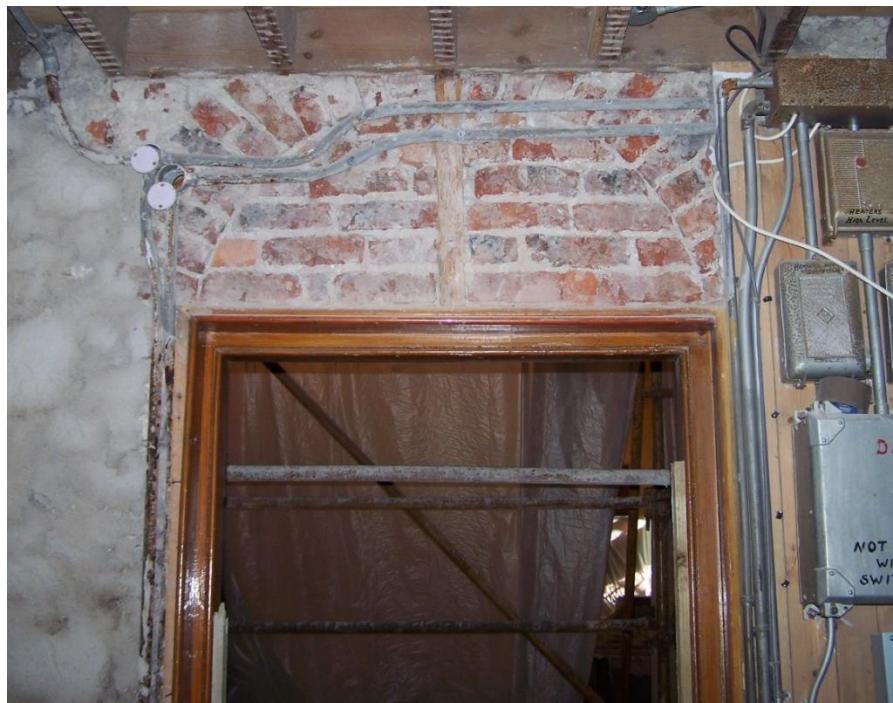
4.2.5 The interior of the church measures 16.24m east-west by 7.2m north-south. The entrance from the tower to the main church building is through square door, which appears to have originally been round headed with red brick architrave, the arch head was then brick up with red brick (Plate 7). It has a width of 1.15m and an internal splay of 1.54m. There is a flagged stone floor, the paving stones do not appear to form a consistent pattern and are irregularly sized. In the ceiling is a circular opening which has been sealed, this was most likely the chimney, from when the church was heated by a central stove, a feature which relates to the vent in the east gable. The Victorian box pews survive with the Hall Family seat positioned on the left side of the church, directly over the family crypt. There is no evidence for burial within the church.

Plate 7: Bricked up archway above interior entrance from tower to doorway

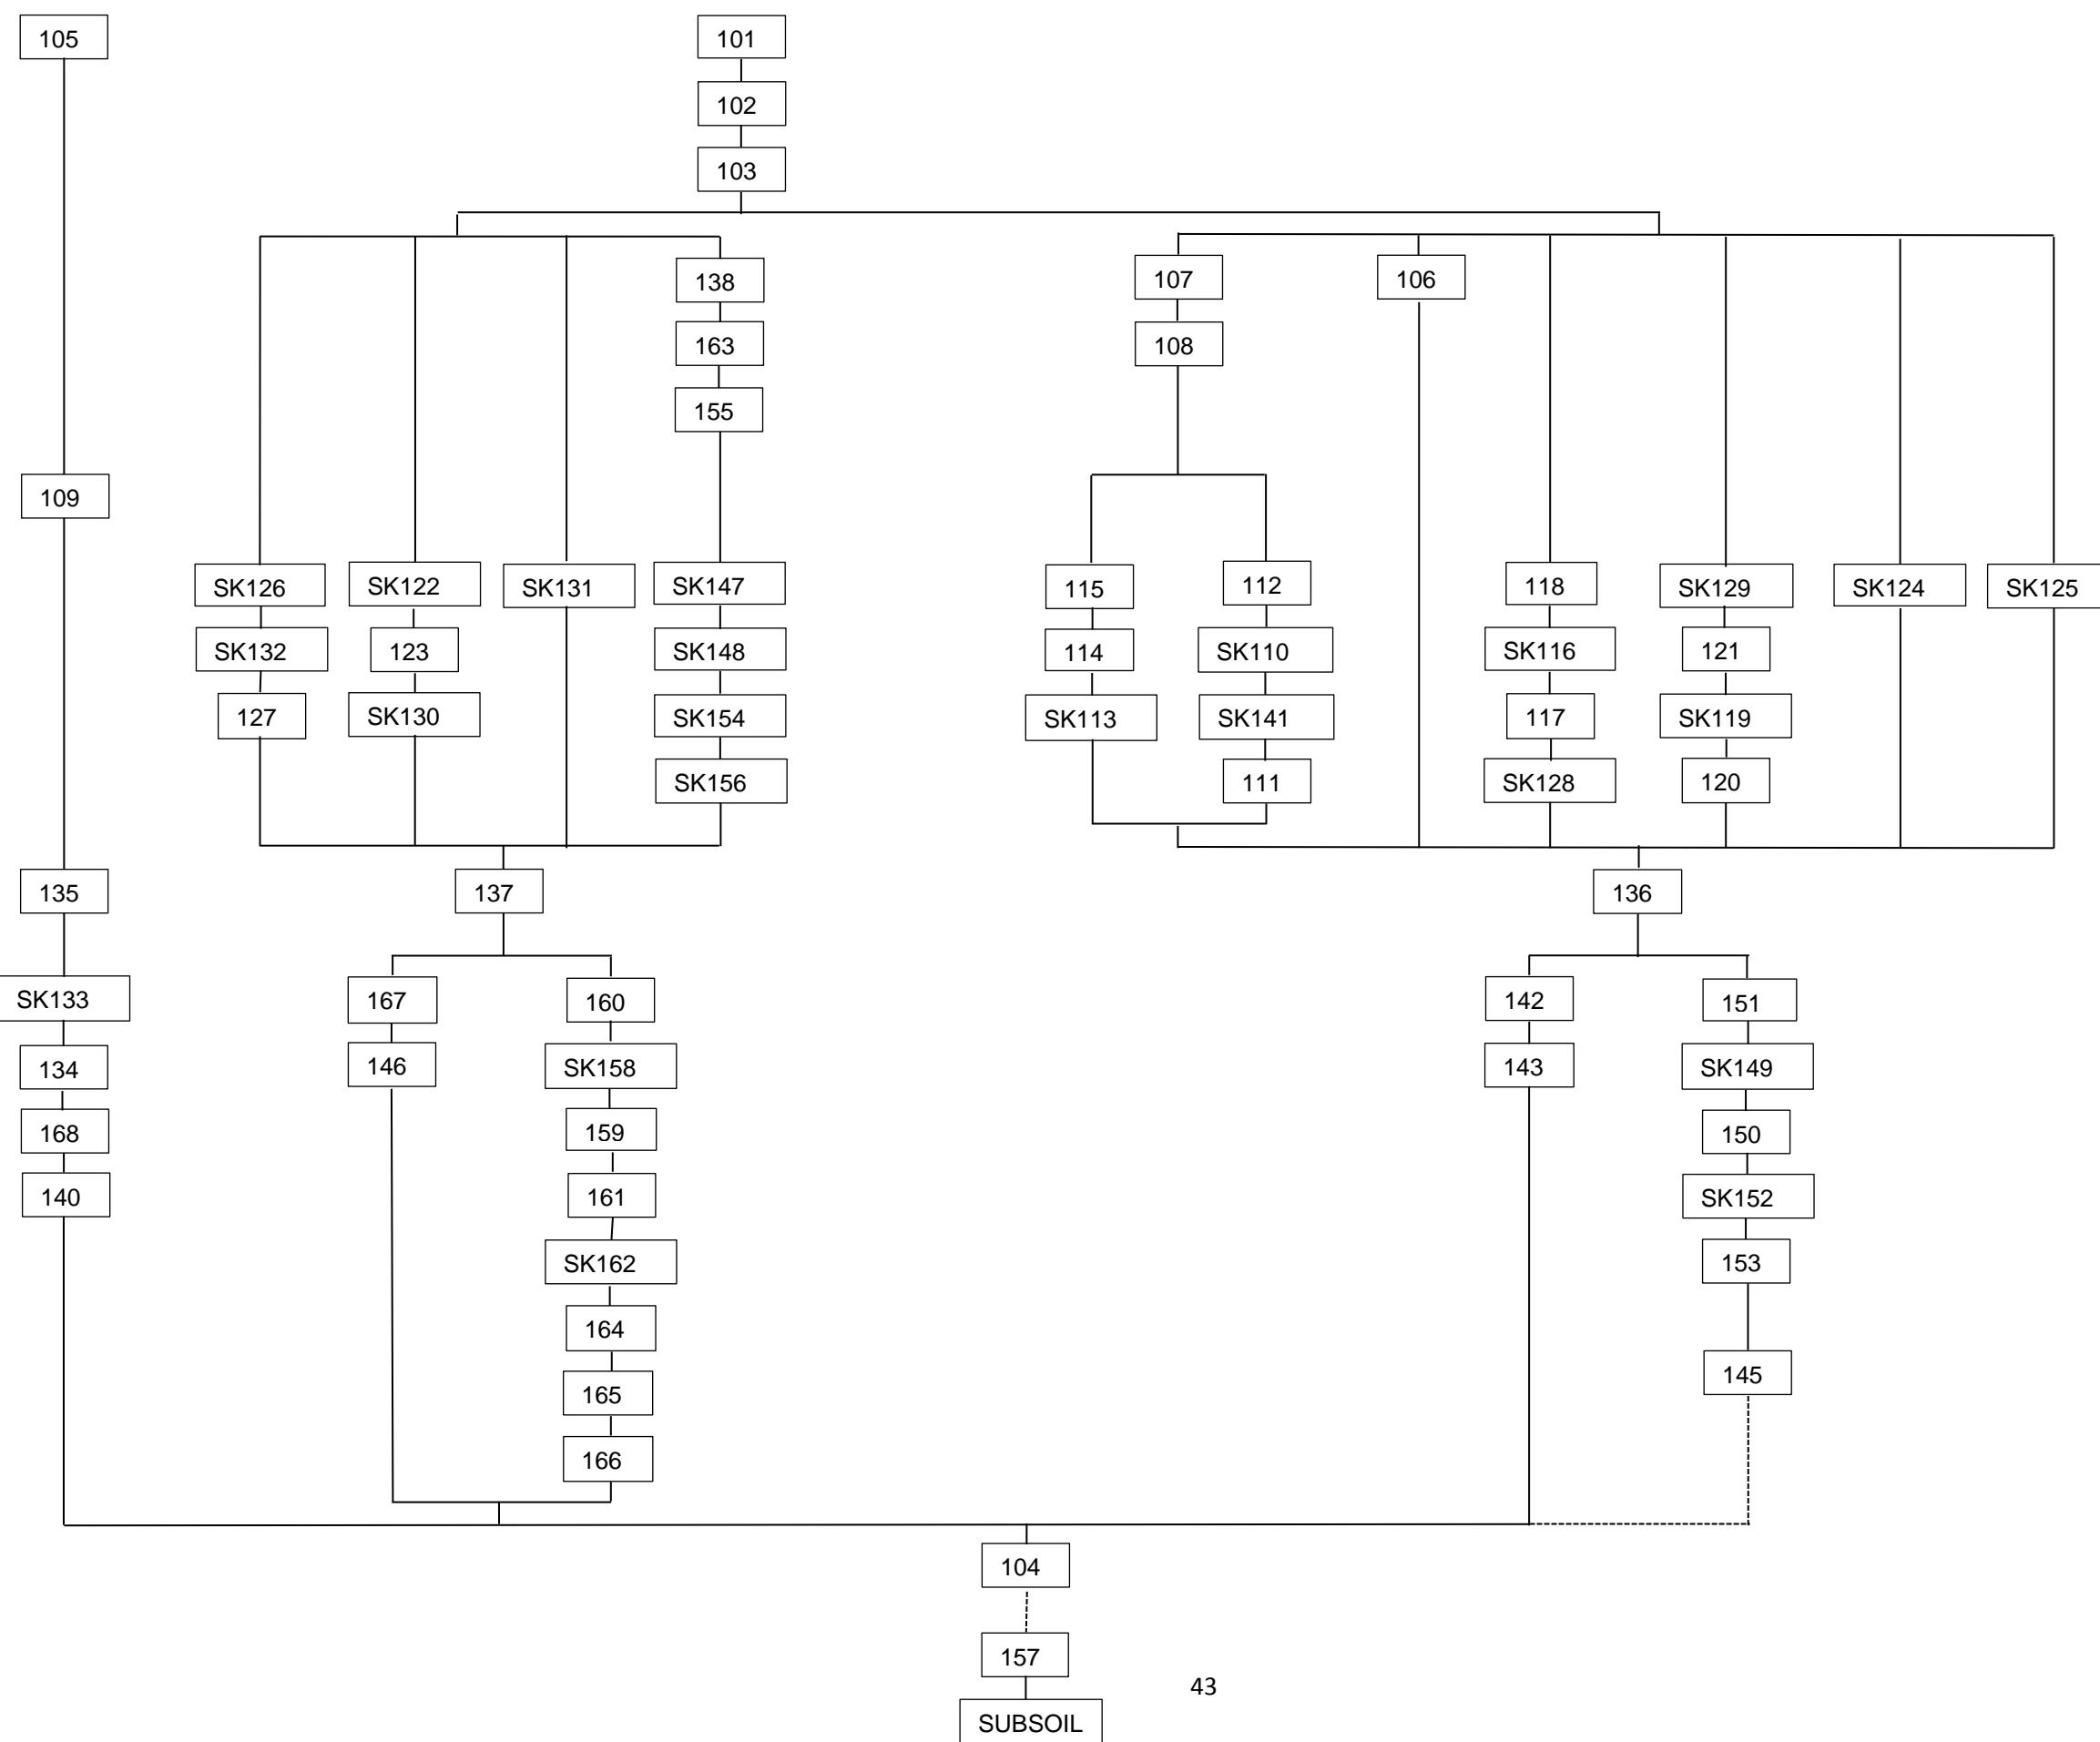
APPENDIX 2: Trench 1 Harris Matrix

3.5.1 The stratigraphically earliest deposits are 157 and 104. The relationship between these two deposits is unknown but it could tentatively be said that 104 is stratigraphically later than 157. 157 is a potential buried soil horizons, and levels taken on site attest the level of the surface of this deposit is similar to the present ground surface at the eastern field boundary (where the ground drops away sharply). 104 was similar to the subsoil but was loose with occasional fragments of bone, this deposit is a re-deposited subsoil, possibly brought on to site to provide more room of burial. The burials uncovered during the excavation post-date this deposit.
