Site Specific Information

Site Name: 79 Vianstown Road, Downpatrick.

Excavation Licence No.: AE/14/181.

Brief Summary: Archaeological excavation of the footprint of a single residential development undertaken in order to fulfill a condition of planning permission. No deposits, features or artefacts of archaeological significance were observed during the course of the excavation.

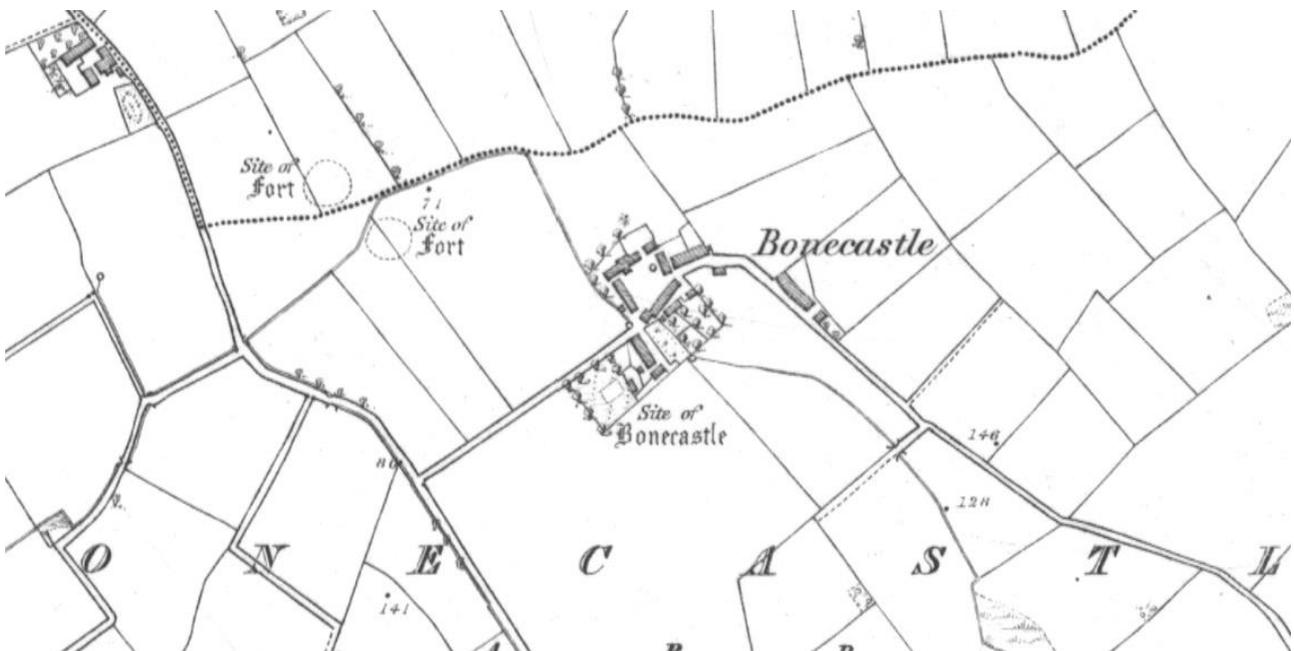
Figure One: Detail of the revised 1859 Ordnance Survey 6” map (Sheet

The excavation site to the rear of 79 Vianstown Road is located approximately 175 metres to the eastnortheast of the ‘Site of Bonycastle’ on the revised 6” Ordnance Survey map of 1859 (Sites and Monuments Record No. DOW 037:041; Irish Grid Reference J46324139). The site is shown on the 1859 map as a ruin on the southeastern edge of a complex of farm buildings also called Bonycastle (Figure One). The *Archaeological Survey of County Down* records that built traces of stone and mortar masonry could be traced beneath the turf during the middle of the twentieth century and that the structure occupied a rock outcrop whose quarrying had furthered the destruction of the building (Anon. 1966, 228, no.846). The castle site is currently occupied by a large silage shed. The Sites and Monuments Record notes that during the construction of this shed in the early 1980s, ‘large flat slabs together with lime mortar’ were found.¹ These slabs and mortar were presumably elements of the lower courses of the apparent castle building. The compilers of the *Archaeological Survey of County Down* plausibly identified the site with the historically attested *Buncastellis* - first recorded in the *Rental of the Ninth Earl of Kildare* (begun in 1518 and now preserved among the Harleian Collection of manuscripts in the British Library) as being in the ‘countie of Lecale’ and consisting of two carucates (Quinn 1933-34, 61). A report on royal possessions prepared by a special commission in 1540 confirms that the ‘two towns of Buncastells’ formed part of the manor of ‘Strongforde in Co.Leacayll’ and consisted of a nominal figure of 240 acres (Quinn 1933-34, 77). The age of the possible castle and the associated holding of two carucates is uncertain. The description of the footings of a mortared masonry structure noted above suggest the building was a towerhouse of later medieval date, however, if speculation that the name Bonycastle is an Anglicisation of

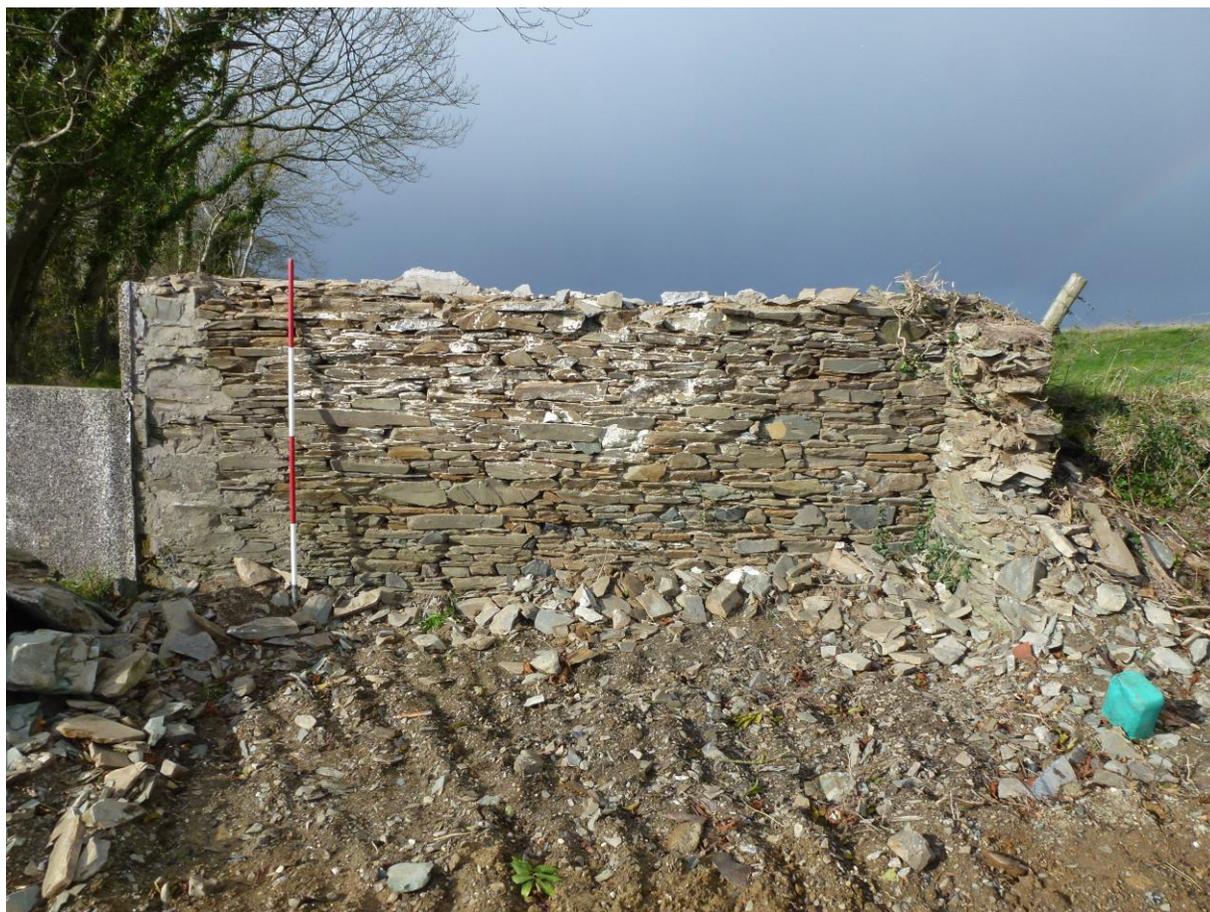
Figure Two: The reduced, northwestern gable of the former property at No.79 Vianstown Road, looking northwest. Scale 2.0 metres.

Notes the clay-mortared masonry and small patches of whitewash and secondary concrete pointing.

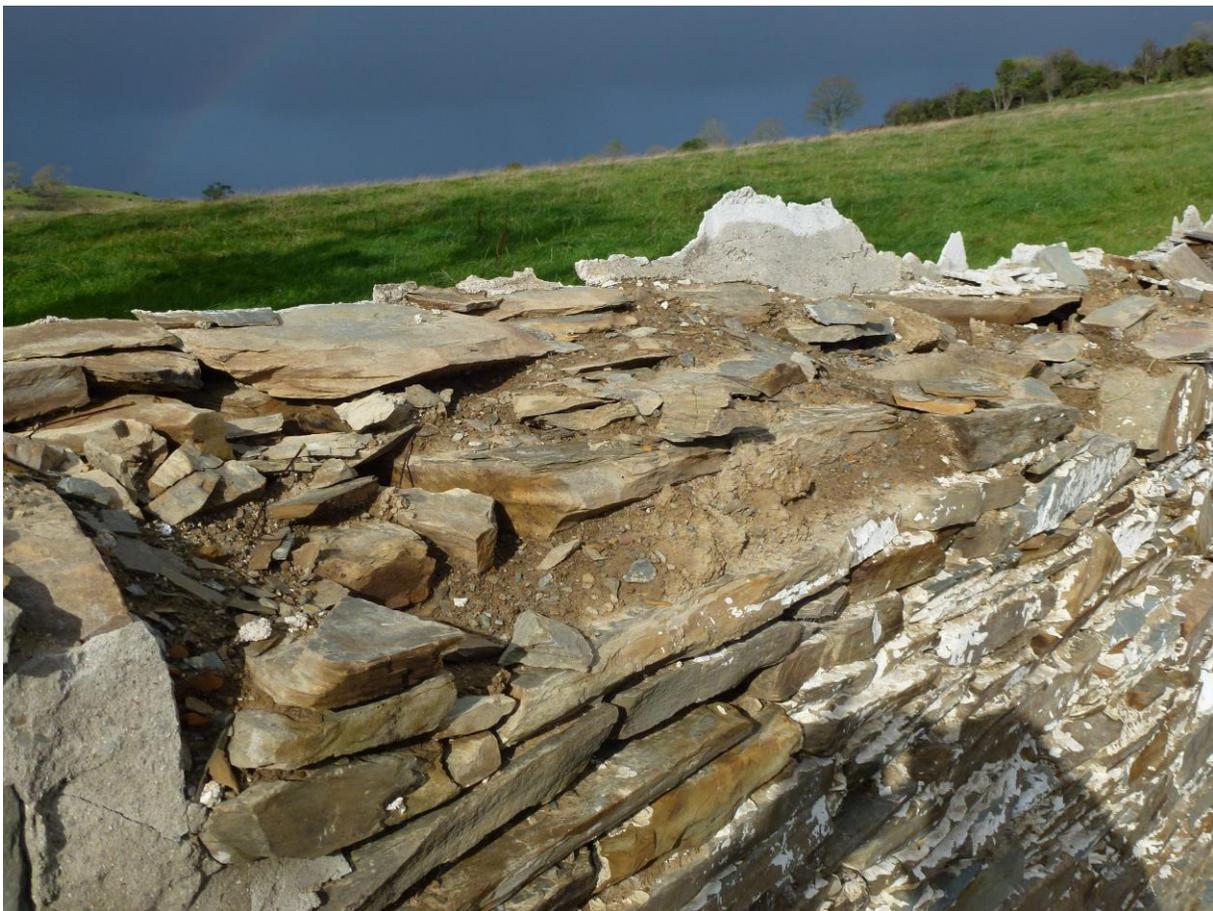
Figure Three: Part of the clay-bonded northwestern gable of the former property at No.79 Vianstown Road, looking north.

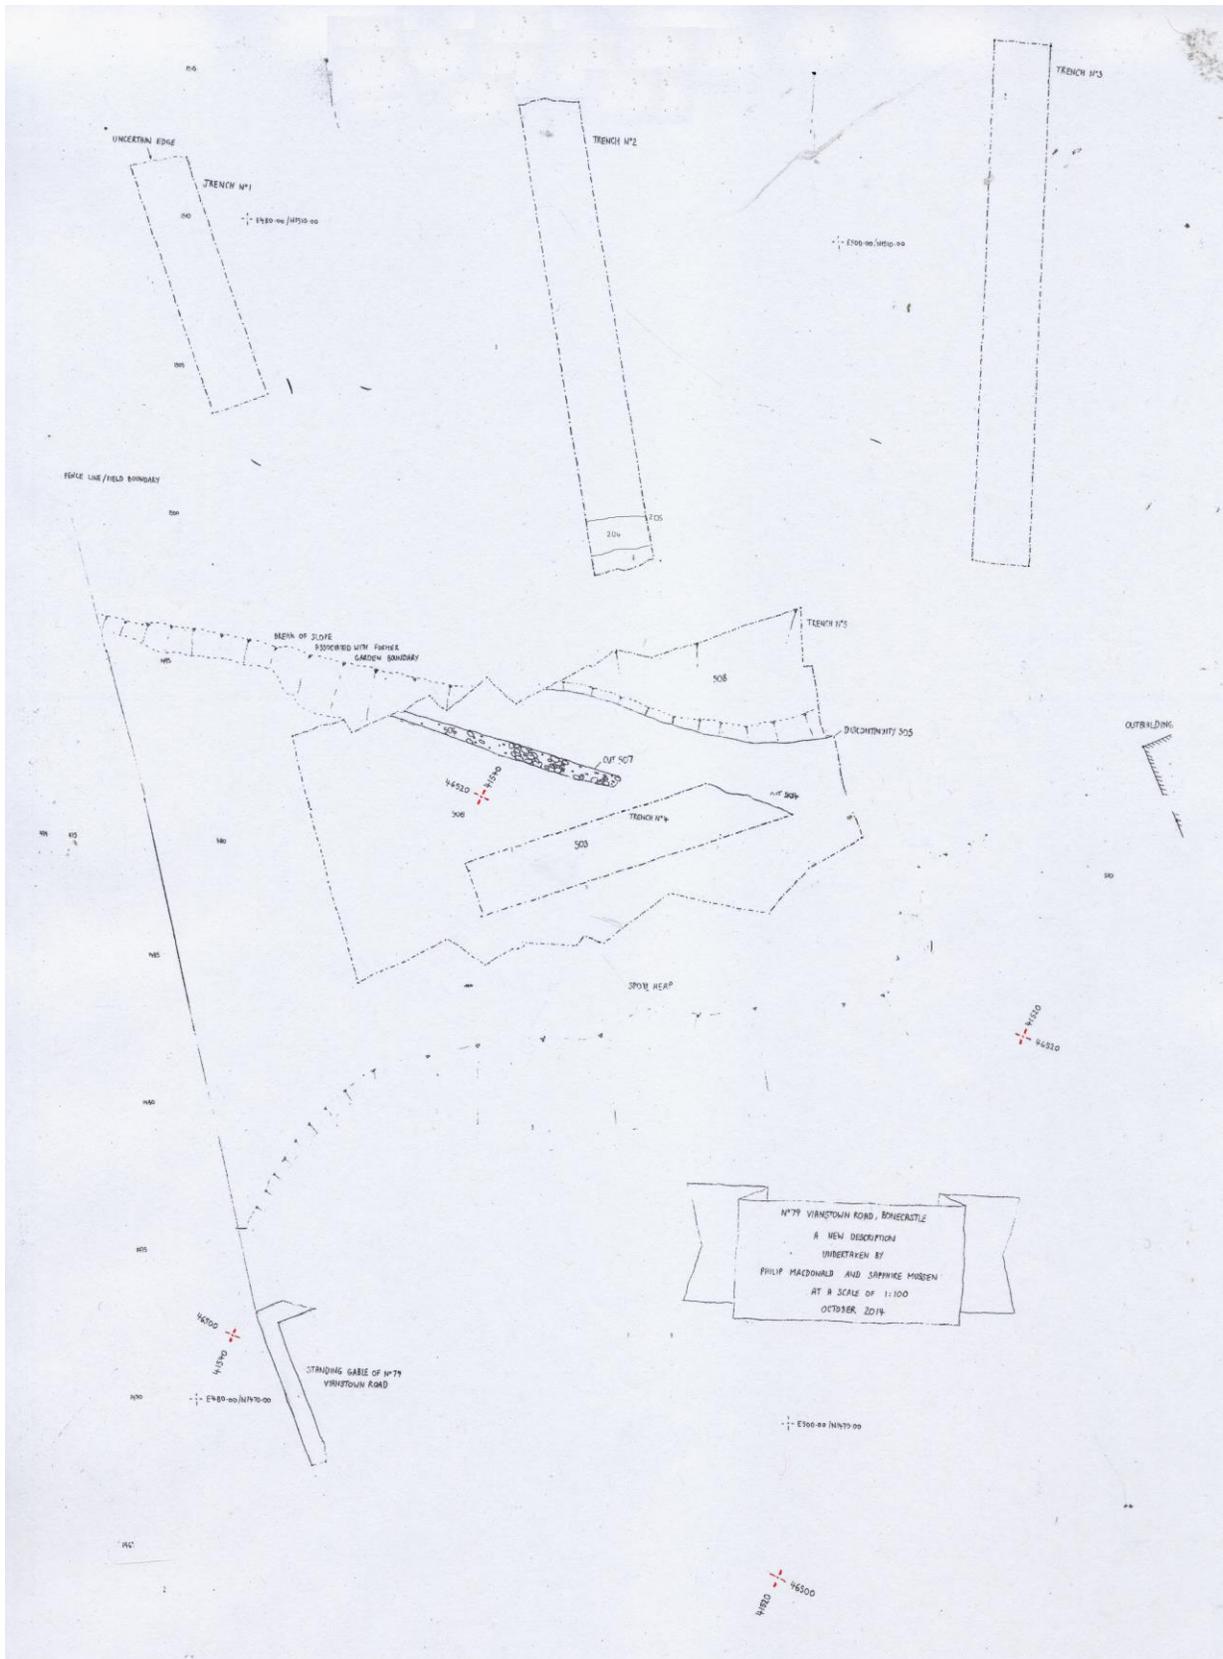
Figure Four: Field survey of site at 79 Vianstown Road showing position of the 2012 and 2014 excavation trenches. Ordnance Survey grid points are marked in red, site grid points are marked in black.

Plans / Drawings: A single site plan (Scale 1:100) showing location of 2012 evaluation trenches and 2014 excavation trench (reproduced here as Figure Four), temporarily held by the Centre for Archaeological Fieldwork, Queen's University Belfast.

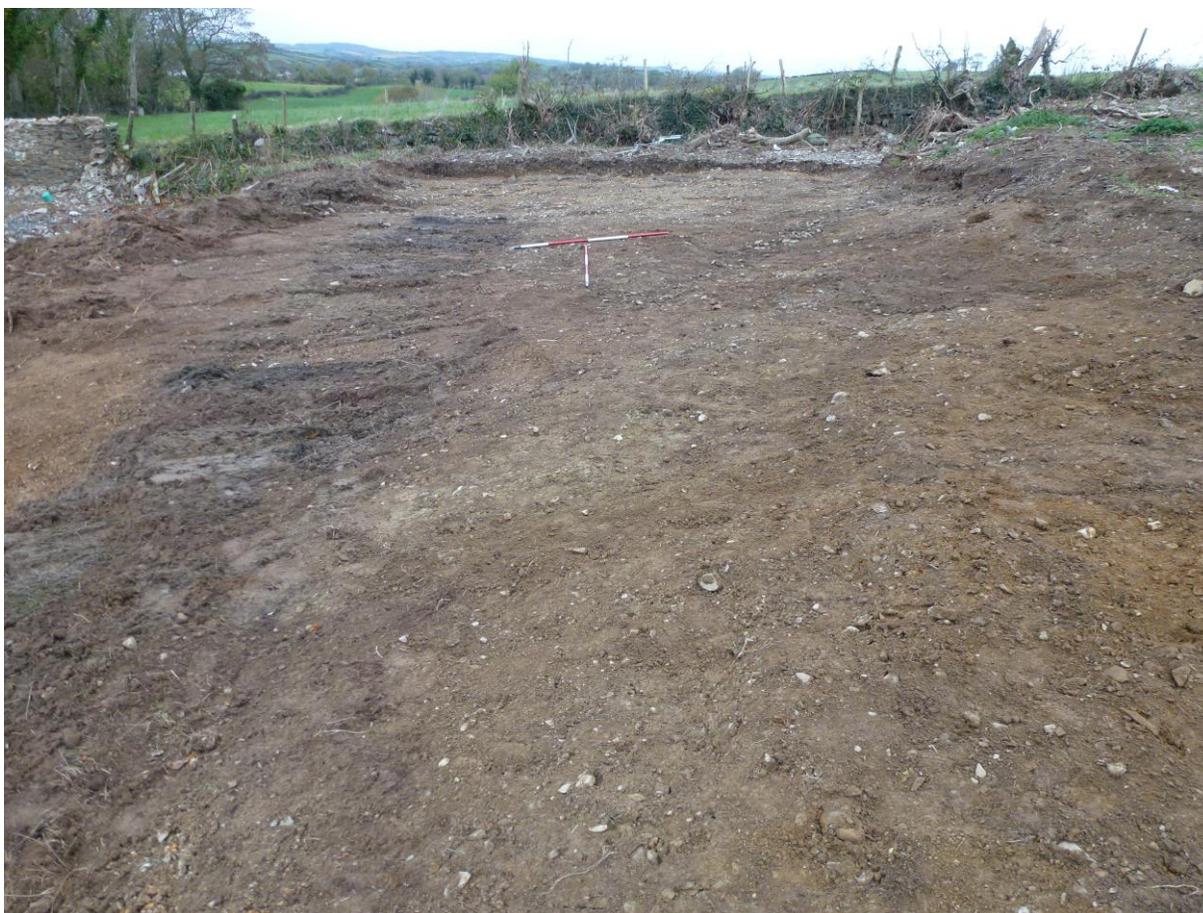
Figure Five: Trench 5 following mechanical excavation of topsoil and cultivation soil (502), looking northwest. To the left of the ranging rods the truncated base of Trench 4 (504) is clearly discernable, to the right of the ranging rods the field drain (507) is also visible. Scales 2.0 metres.

Removal of the disturbed topsoil and cultivation soil (502) revealed the surface of the natural, glacial till subsoil (508), which in the area of the former garden had been truncated by a near horizontal discontinuity (505) that had evidently been dug into the hillside in

order to create a comparatively level area (Figure Five). Within this garden area survived the bases of two truncated features: a field drain (507) and one of the trenches that had been excavated in 2012 (i.e. Trench 4 - which was awarded the context number 504). No features were present in the surface of the subsoil in the exposed area of the field above the line of the hedge. The line of the former field boundary was visible as a comparatively steep break in slope upon the surface of the natural subsoil. The character of the natural, glacial till subsoil varied markedly across the site. Over a short distance it changed from a relatively stone-free, light grey, very sticky and plastic clay to a stone-rich, orangey brown, sandy clay.³

A large section of one of the 2012 evaluation trenches (Trench 4 / 504) extended across much of the southwestern part of Trench 5. This cutting was 1.80 metres wide, aligned approximately northwest-southeast and survived for a maximum length of 10.95 metres. The width of the trench is consistent with the standard size of bucket used during archaeological evaluations undertaken with mechanical excavators. The feature's location and alignment is consistent with that recorded in 2012 (Mussen 2012, 7, fig.3). Consequently, its identification with the previously excavated Trench 4 is certain. Excavation in 2014 demonstrated that Trench 4 had been backfilled with a mixed, waterlogged deposit of old turves and cinder-rich clay soils (503). The southeastern end of the feature was not identified, presumably because this end of Trench 4 had not been overcut into the natural subsoil during the 2012 evaluation.

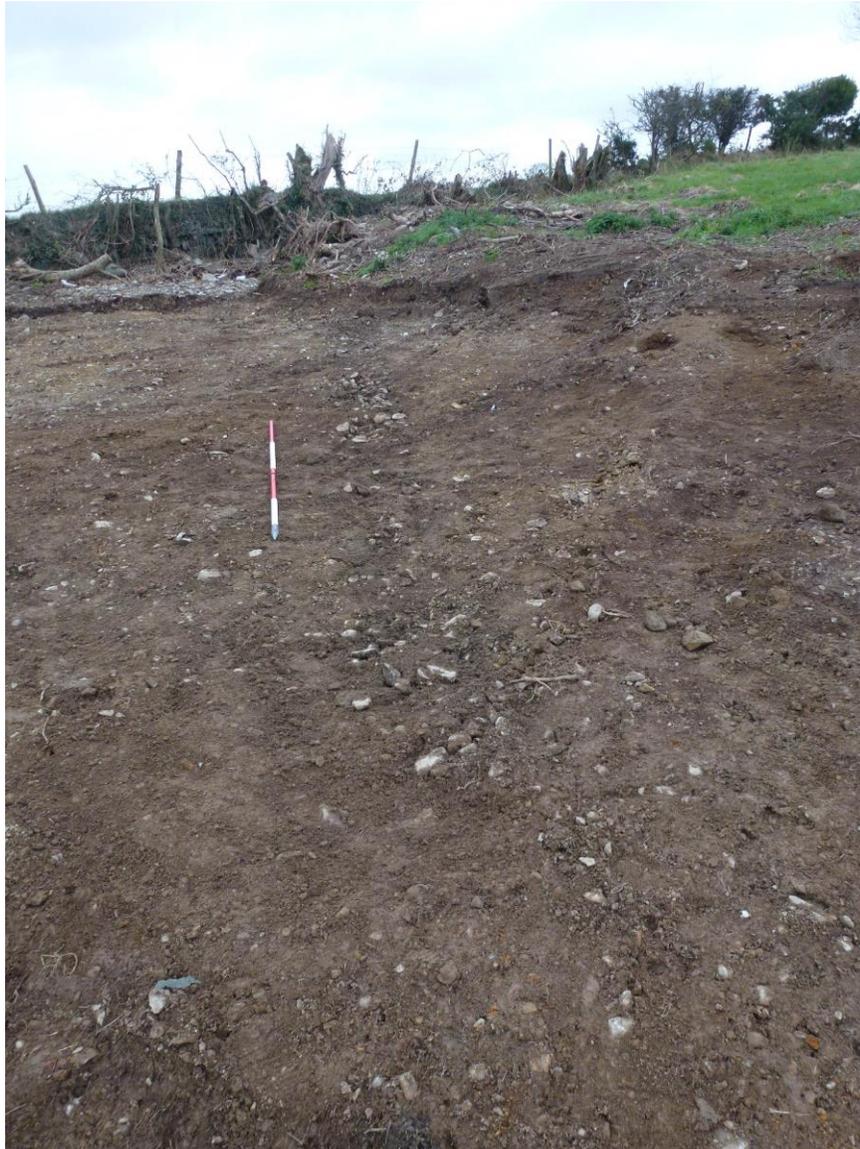
Figure Six: the truncated field drain (507) following mechanical excavation of the topsoil and cultivation soil (502), looking north.
Scale 2.0 metres.

The field drain (507) was aligned north-south and slowly diverged away from the line of the adjacent field boundary as it ran southwards (Figure Six). The drain had a width of 0.35 to 0.45 metres and extended towards the centre of Trench 5 for an exposed distance of 7.9 metres where it terminated. It was filled with medium-sized (maximum dimension 0.15 metres), sub-rounded to sub-angular stones the air gaps between which had largely become choked with a greyish-brown, silty clay loam soil matrix (506). In character, the field drain was identical to that uncovered during the 2012 evaluation within Trench 3 cf. Mussen 2012, 4, pls.9-10. Although the field drain was not excavated, careful examination indicated that the northern end of the drain which lay closest to the field boundary was more heavily truncated. This suggests that the field drain (507) was truncated by the near horizontal discontinuity (505) cut during the terracing of the hillside to create the garden to the rear of the former property at 79 Vianstown Road. Given that the earliest representation of the garden is that contained on the first edition 6" Ordnance Survey map, this indicates that the field drain predates 1834. Furthermore, the presence of the field drain strongly suggests that the excavation site was an unoccupied green field prior to the construction of the former property at 79 Vianstown Road. By extension, it also suggests that although the property was located on the periphery of the farm complex arguably associated with the late medieval 'Bonecastle' estate, it was not built on the site of an earlier medieval dwelling. It is unlikely that the field drain predates the beginning of organised agricultural improvement in the north of Ireland during the eighteenth century.
