EVALUATION REPORT No. 300

Southwest of 2A Cloughey Road,
Portaferry,
Co. Down

Licence No.: AE/135/85E

Report Date: 14th May 2015

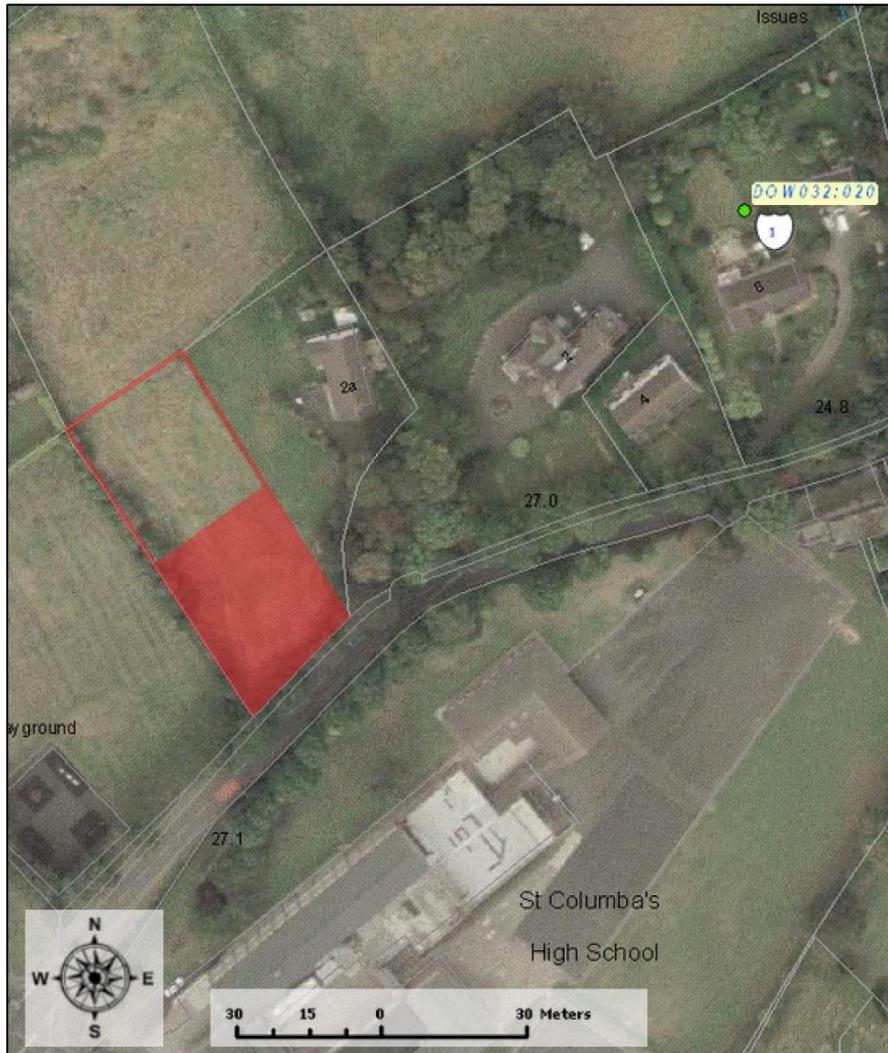
Figure 2: Development site, outlined in red: Area for development in block red, the remainder is to remain undeveloped. Proximity to site of medieval church and graveyard (DOW 032:020) also shown.

Three trenches measuring approximately 2m x 20m were mechanically excavated using a 1m straight-edged sheugh bucket under archaeological supervision, on 11th May 2015. These trenches ran northeast to southwest across the site, parallel to the Cloughey road (figure 2).

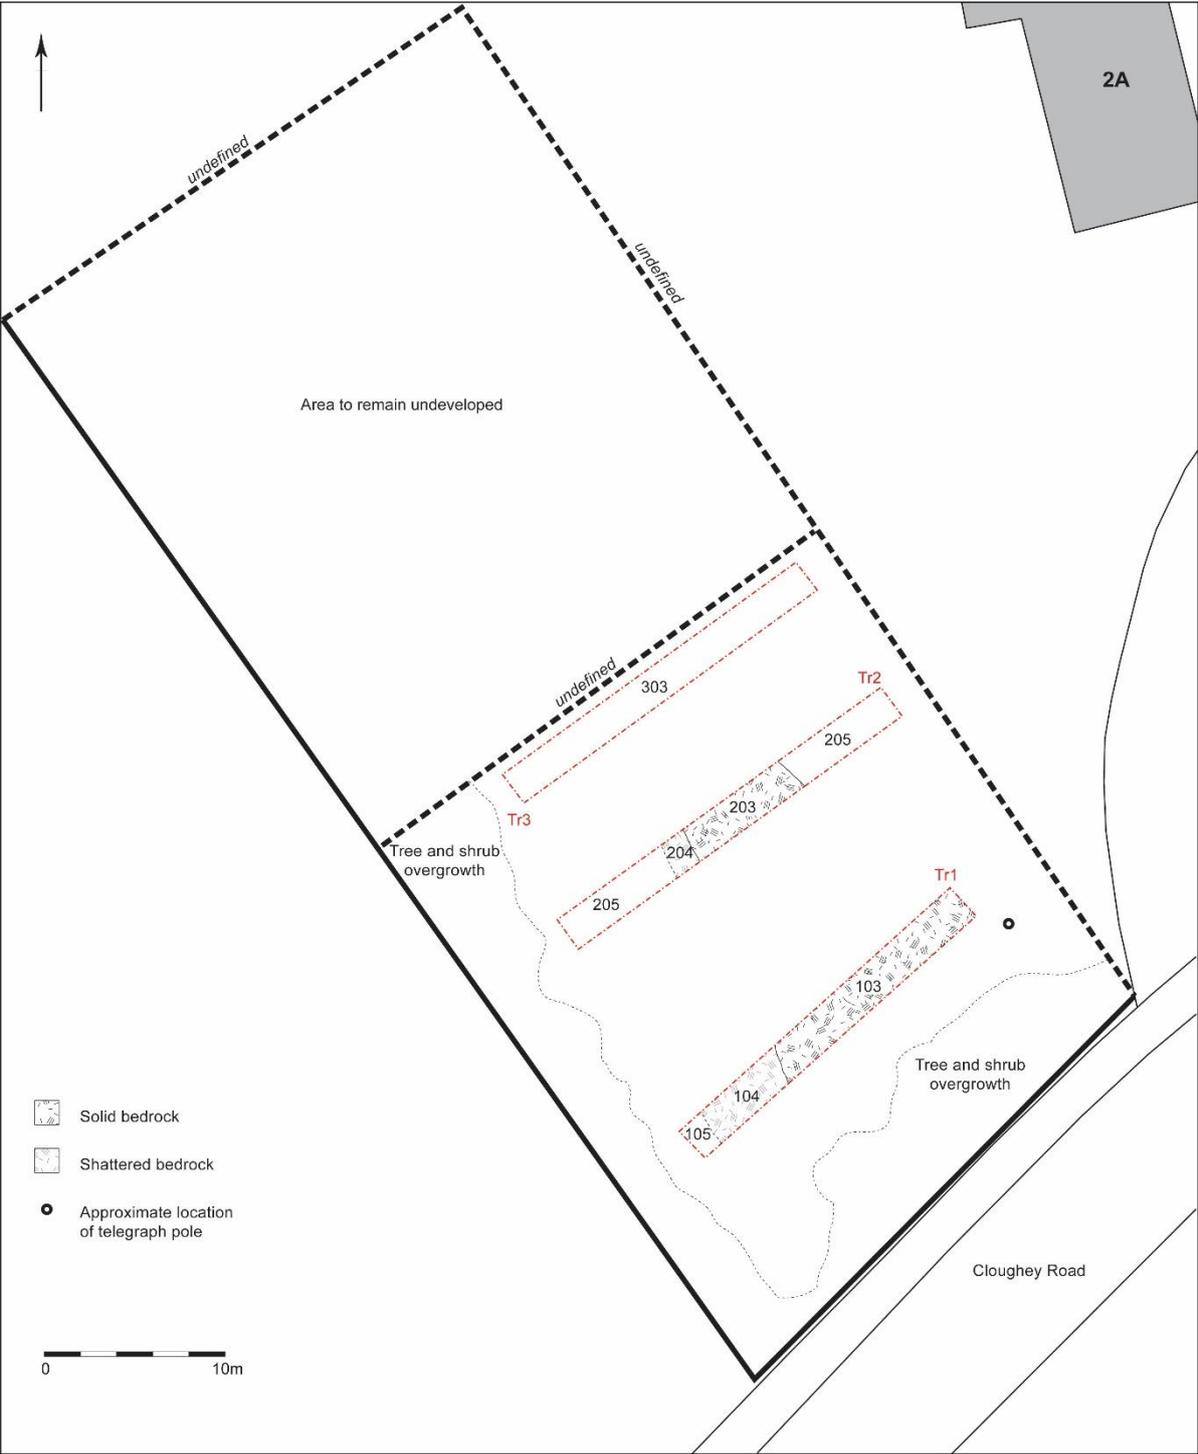
Figure 3: Trench location map showing scaled and planned findings of evaluation.

Excavation of the three trenches revealed nothing more than the natural underlying geology of the site. The bedrock lies immediately below the ground surface in the centre of the development area and is surrounded by fairly level, sterile, orange natural clay subsoil (figures 3 & 20). No finds or features indicative of archaeological remains were uncovered. As such it is not foreseeable that further surveillance or mitigation work will be necessary and the development will not impact on any previously unidentified archaeological remains. A short summary of this report will be submitted for inclusion in the Excavations Bulletin-no further publication is merited.

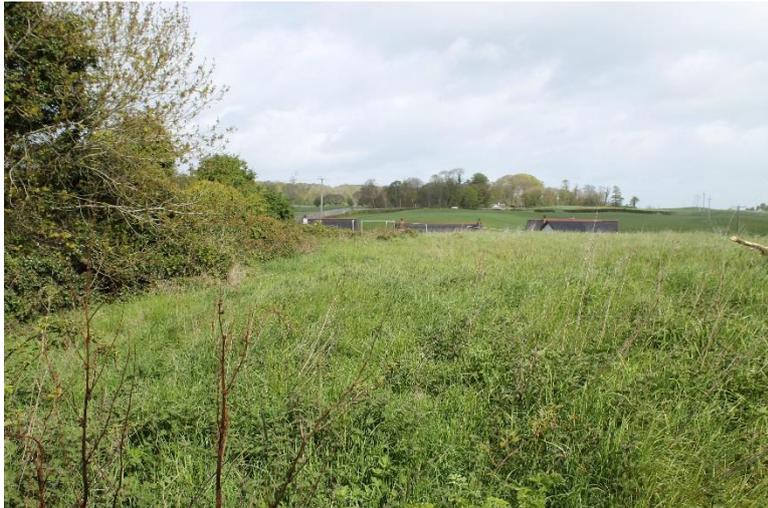
Figure 4:
Pre-excitation view of development area looking northwest along southwest boundary (hedge-line can be seen encroaching onto site).

which bounds the site along the southwest and southeast has encroached into the development area. The ground slopes approximately 35° from the east to the south and west, and more gently towards the northwest (figures 4-6). Beyond the north-western edge of the site, the ground drops sharply away to a depth of approximately 6m due to the cutting of earth and rock from the natural hillside for previous developments in this area and bedrock and clay can clearly be seen in an exposed section (figure 19). The site measures approximately 30m northeast to southwest and 70m northwest to southeast and has been roughly divided in two along its northeast-southwest axis. The development area lies to the south of this line, closest to the Cloughey road and the area to the north of this line is to remain undeveloped so as not to obstruct neighbouring views (figure 2). Archaeological evaluation of the area was warranted as it lies approximately 150m to the southwest of the site of a medieval church and graveyard (NISMR DOW 032:020) (figure 2). Three parallel linear trenches running northeast to southwest and measuring approximately 2m x 20m were excavated within the footprint of the development site (figure 3). As set out in the research design, trenches were originally intended to be 30m length. However, due to the overgrown nature of the site and its indefinable boundaries, alterations to the methodology were necessitated. All archaeological artefact material was retrieved from the topsoil and comprised of 20th-century debris. No finds or features of archaeological interest were uncovered, each trench concluded on encountering bedrock or sterile subsoil.

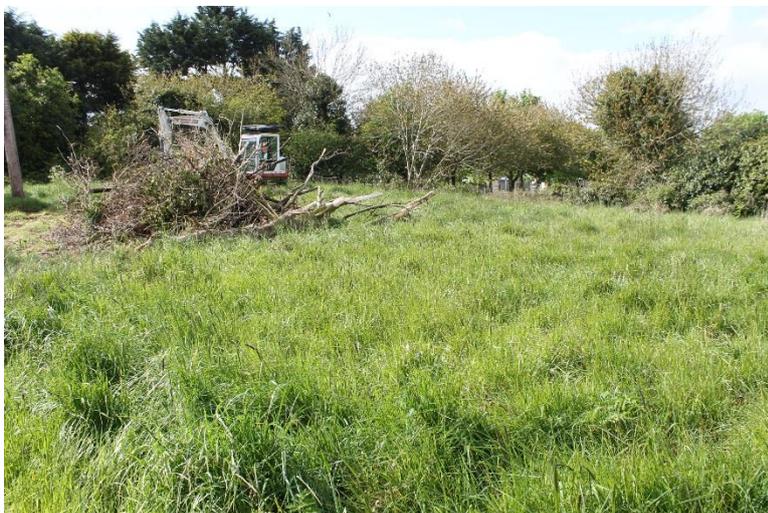
Figure 5:
Pre-excitation view of development area looking south towards Cloughey road (mature trees and hedges spreading inwards from edges of site).

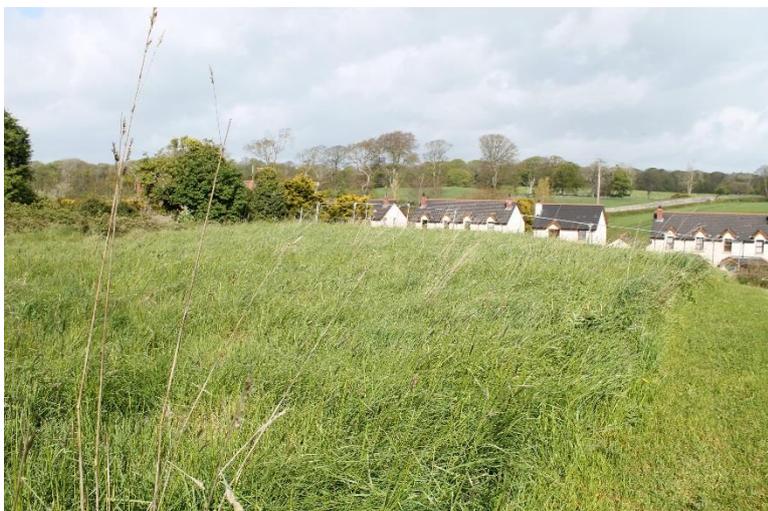
Figure 6:
View looking west-northwest across the northern half of the site-to remain undeveloped.

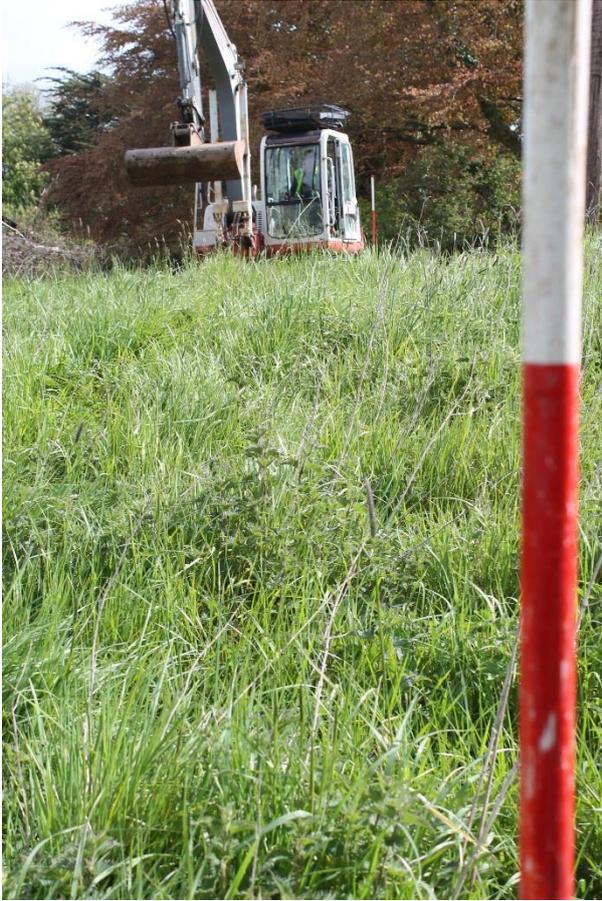
Figure 7:
Line of trench 1, pre-excitation.

Trench 1 measured 2m x 20.5m and was located as close to the Cloughey road as the current tree and shrub growth would allow. The presence of a telegraph pole within the development area also influenced the placement of trench 1 (figures 1, 7 & 18). After removal of the sod layer C101 (figure 8), the loamy brown topsoil C102 was excavated which revealed bedrock C103, shattered bedrock C104, and orange clay subsoil, C105, directly beneath. Solid bedrock ran from the centre of the trench and beyond its eastern end (figures 9-12). A 5m wide band of shattered bedrock ran along the western edge of the solid rock mass, at a depth of 0.60m and beyond this, at the westernmost end of the trench, sterile, orange clay subsoil with bedrock was encountered (figures 11-12). Scattered fragments of 20th-century brick, ceramics, coal, and confectionery wrappers were uncovered from the topsoil of trench 1. Solid bedrock was encountered at a depth of 0.10 - 0.15m and subsoil at 0.60m. No archaeological finds or features were noted.

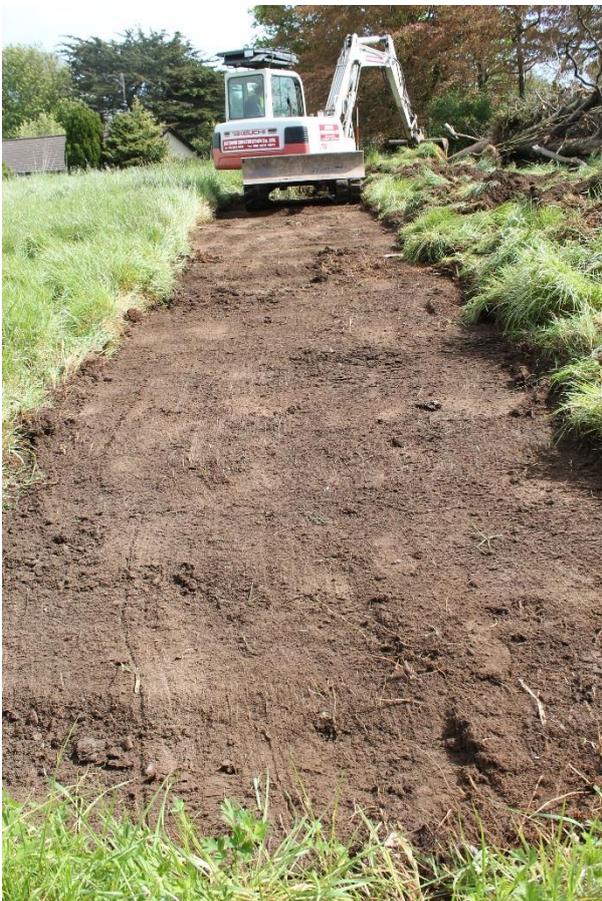
Figure 8:
Trench 1, post-removal of sod layer C101,
showing topsoil layer C102.

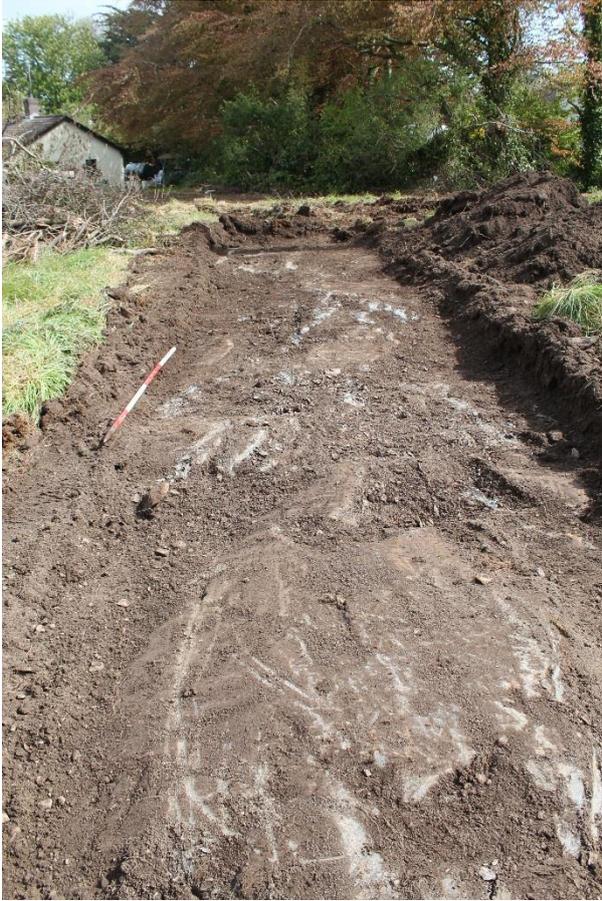
Figure 9:

Post-excavation view of solid bedrock C103 in trench 1, looking northeast from centre of trench.

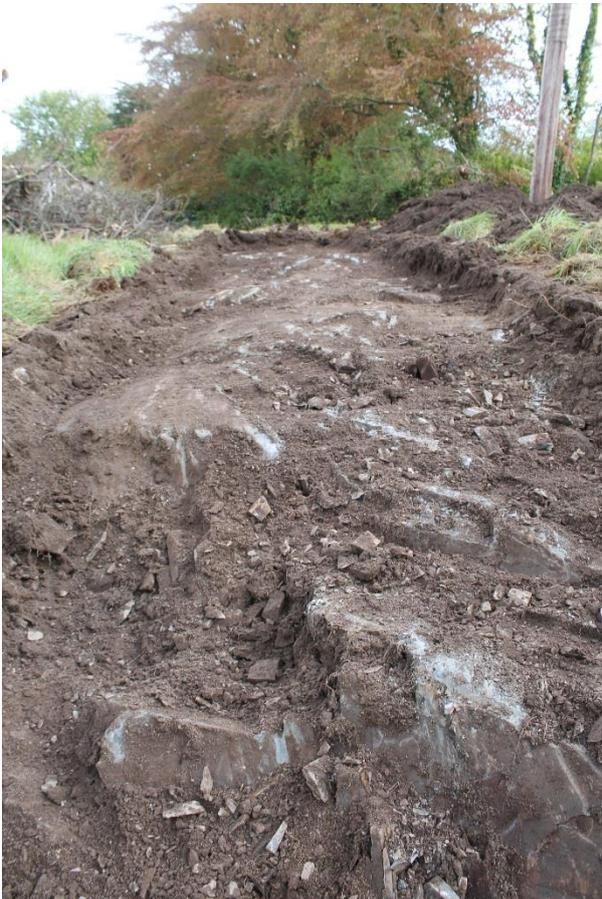
Figure 10:

Post-excavation view of trench 1, looking northeast, showing western edge of solid bedrock C103 in foreground.

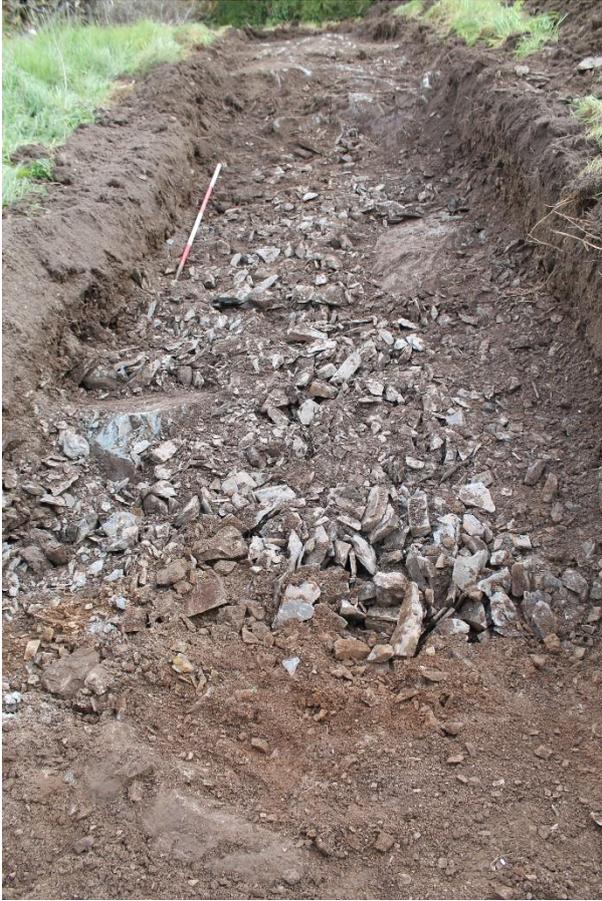
Figure 11:

Post-excitation view of trench 1 looking northeast, following removal of topsoil C102. Solid bedrock C103 in background, shattered bedrock C104 in centre and natural clay subsoil C105 in foreground.

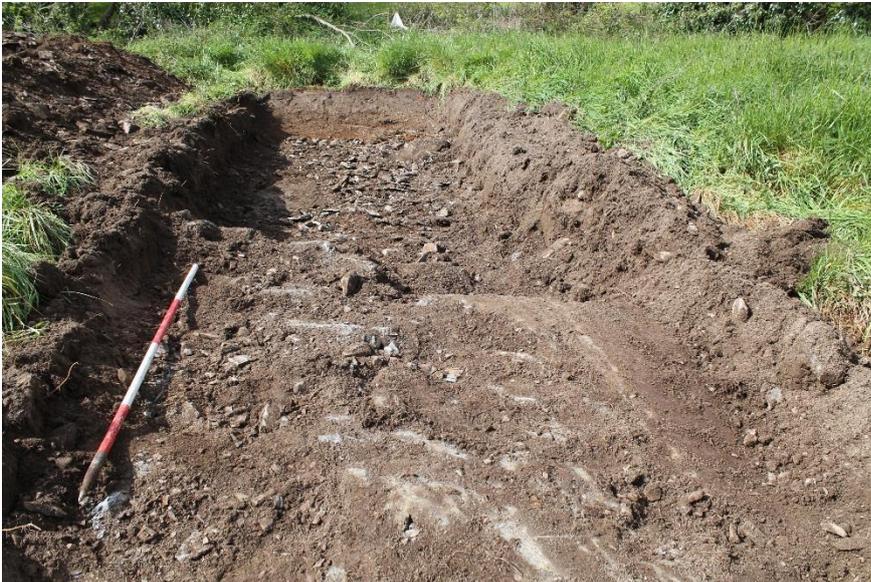
Figure 12:

Post-excitation view of trench 1 looking southwest, following removal of topsoil C102. Showing edge of solid bedrock C103, with shattered bedrock C104 beyond and orange clay natural C105 at the end of the trench.

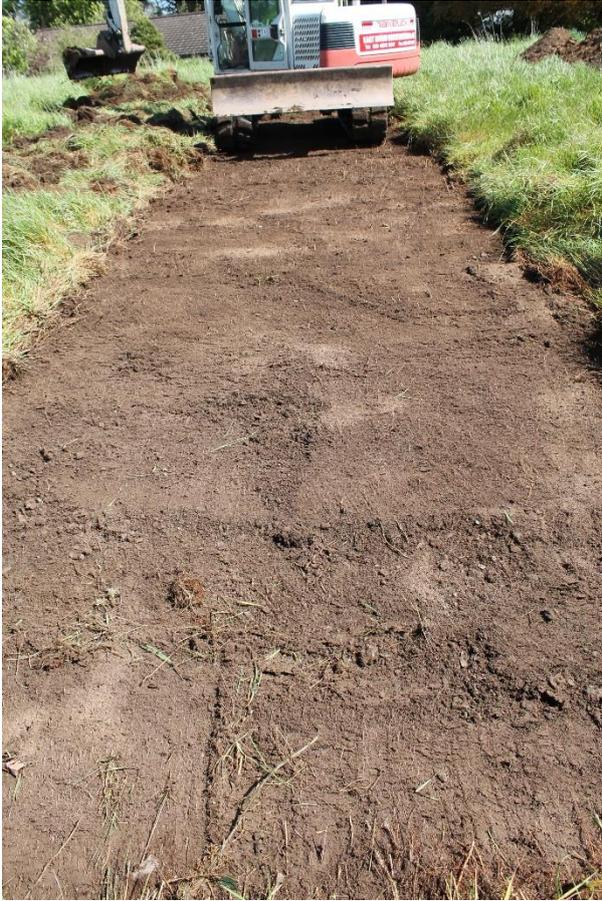
Figure 13:

Trench 2 post removal of sod layer C201,
looking northeast across topsoil layer C202.

Trench 2 measured 2m x 22m and was located north of trench 1. Due to the presence of obstructing shrubs and felled trees, the trench could not run directly through the centre of the development area but was placed as close to this as possible. Removal of the sod layer C201, revealed loamy brown topsoil C202 (figure 13), and directly below that lay solid bedrock C203, located centrally within the trench at a depth of 0.15m (figure 14). A 2m wide band of shattered bedrock, C204, ran along the western edge of this solid mass and beyond this, at either end of the trench, lay sterile orange clay subsoil C205, at a depth of 0.30 – 0.50m (figure 14). Scattered fragments of 20th-century brick and coal were uncovered from the topsoil of trench 2. No archaeological finds or features were noted.

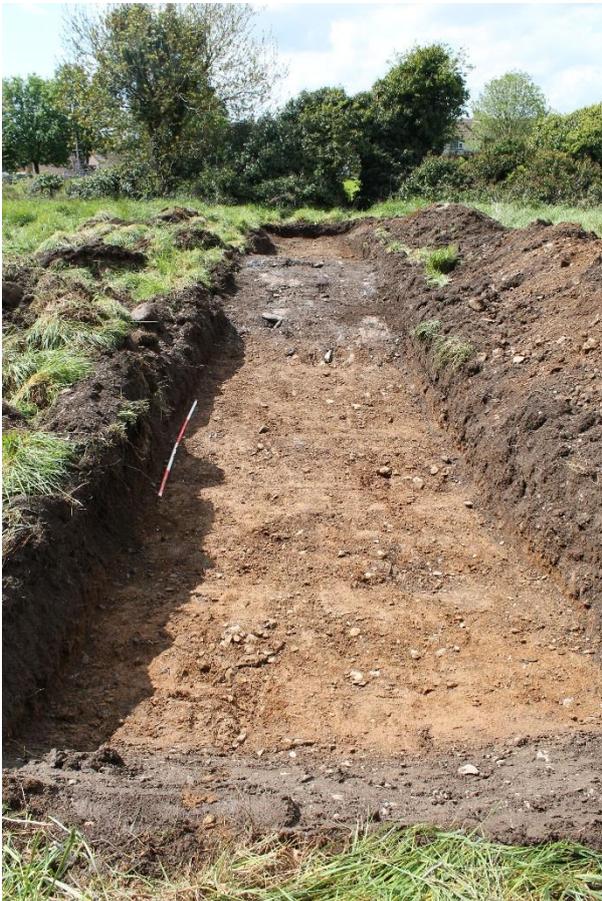
Figure 14:

Trench 2 looking southwest, post removal of
topsoil layer C202. Solid bedrock runs through
the centre of the trench (C203) and is bounded
on either side by sterile natural clay C205 which
runs beyond either end of the trench.

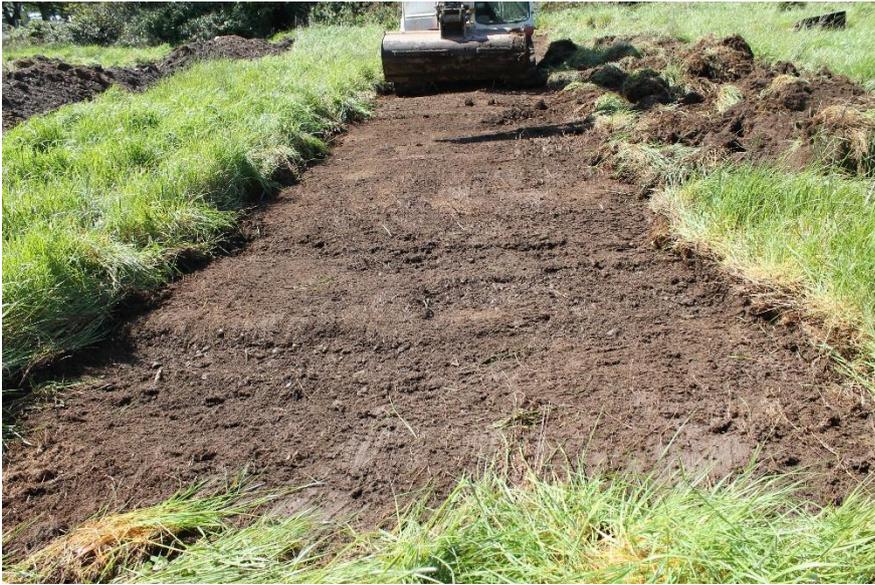
Figure 15:
Trench 3 following
removal of sod layer
C301, looking southwest
across topsoil layer
C302.

Trench 3 measured 2m x 20m and was located north of trench 2, along the north-eastern edge of the development area. The sod C301 was removed to reveal the same loamy brown topsoil (C302) as found in trenches 1 and 2 (figure 15). This removed directly onto sterile orange clay subsoil which ran the entire length of the trench (figure 16). No artefact material or archaeological features were noted.

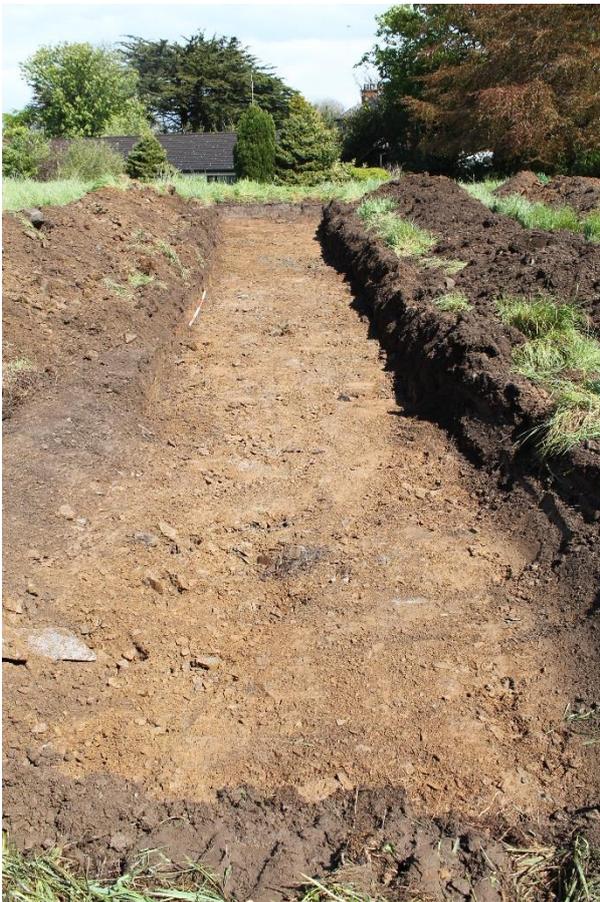
Figure 16:
Trench 3 following removal of topsoil layer C302,
looking northeast. Showing sterile natural clay
subsoil C303 extending throughout trench. Any
observed discoloration of the clay is due to
shattered bedrock lying just below the surface in
several locations.

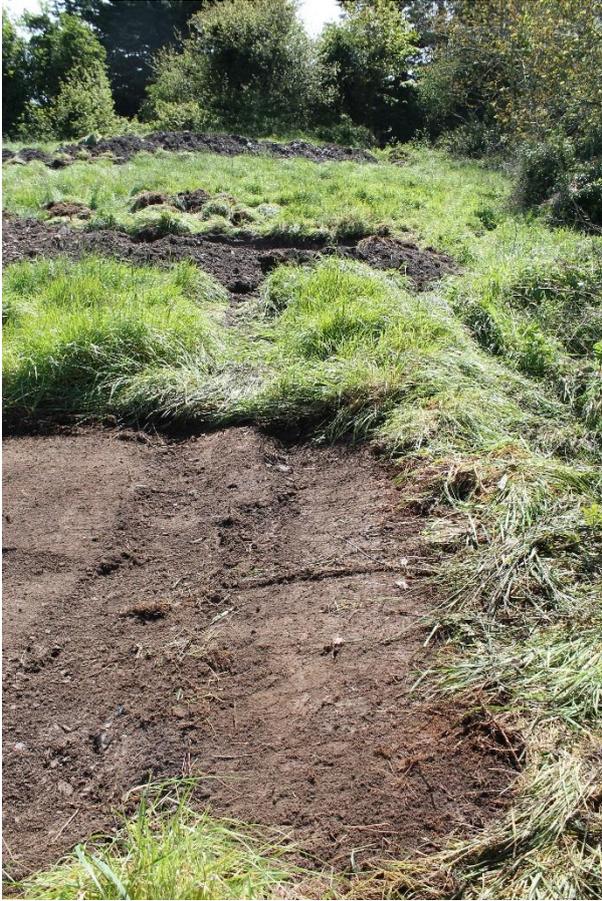
Figure 17:

General mid-excavation view of site looking southeast towards the Cloughey road and along the south-western boundary of the site. Trench 3 visible in foreground, trench 2 in centre and trench 1 in background.

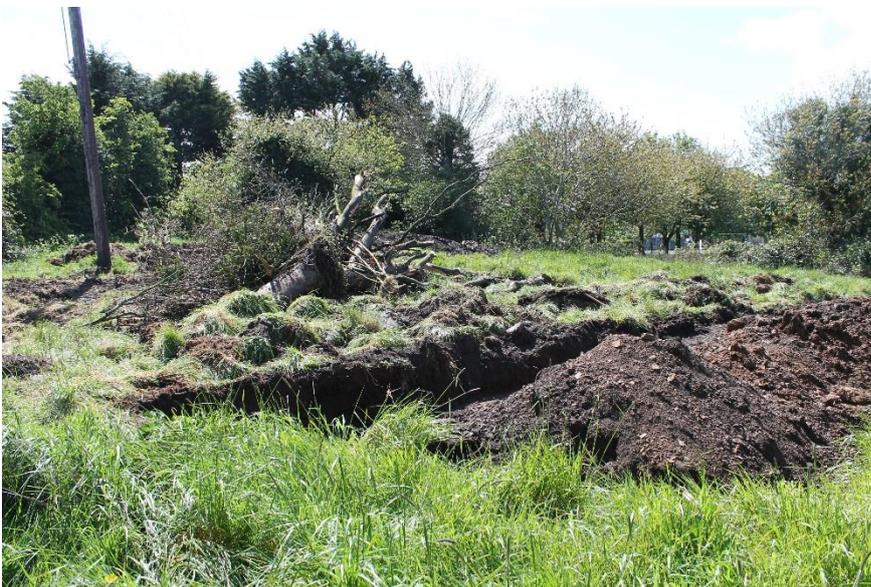
Figure 18:

General mid-excavation view of site looking south towards Cloughey road. Showing telegraph pole, trees, shrubs and other obstructions, and northern end of trench 2 in foreground.

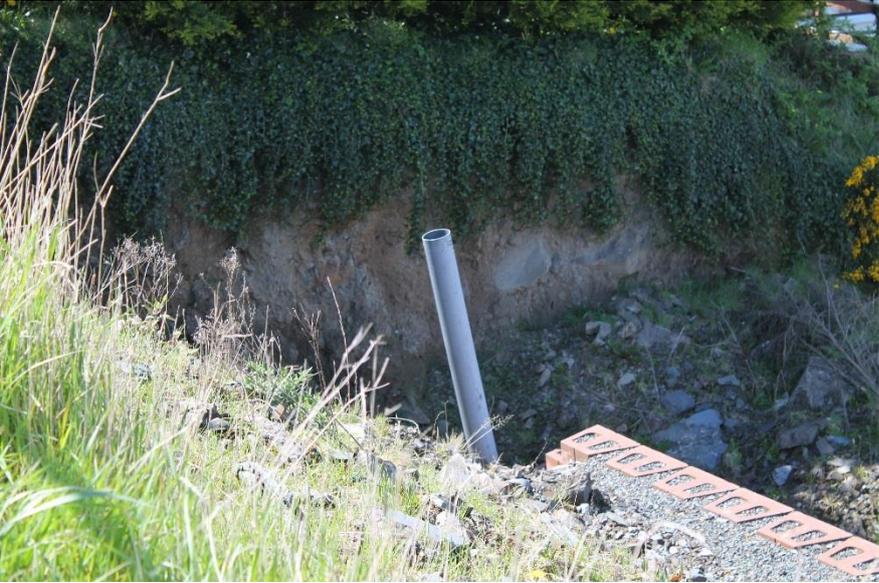
Figure 19: View from northern end of site (to remain undeveloped). Looking west towards cut-away, developed ground beyond the development area. Sterile clay and bedrock is visible throughout the exposed section. Difference in ground levels is approximately 6m.

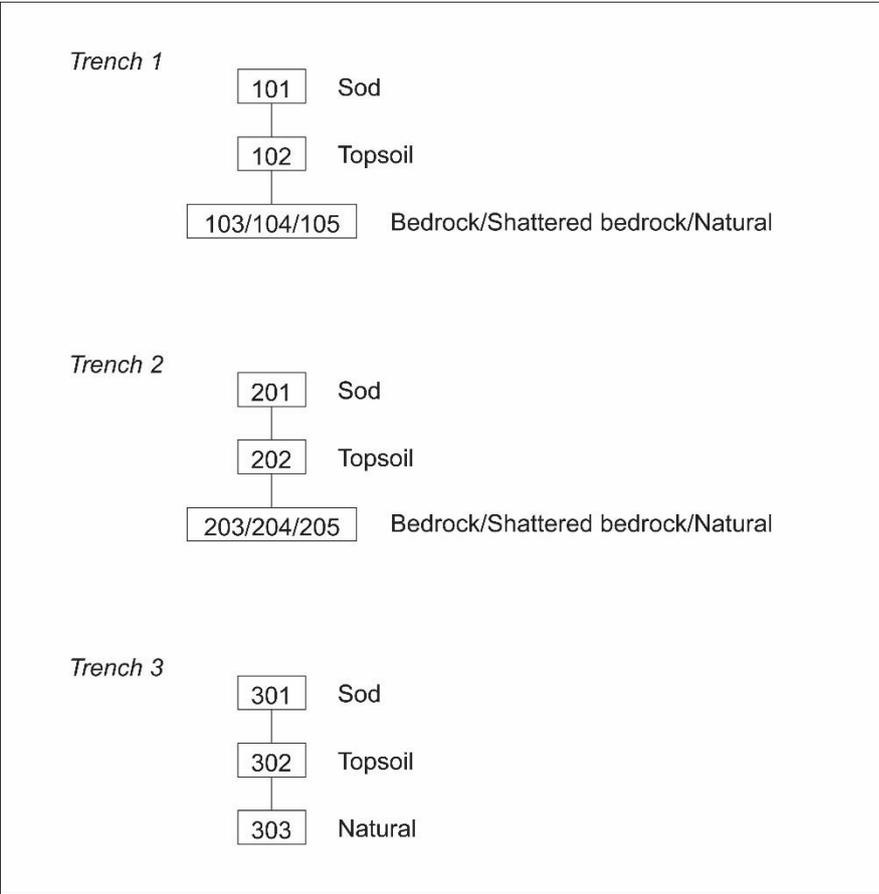
Figure 20: Harris matrices for trenches 1-3
