CAF Data Structure Report No. 113

AE/14/200

**Excavations at Carrickfergus Castle, Co. Antrim, carried
out in November 2014**

Excavations carried out on behalf of
The Northern Ireland Environment Agency: Built Heritage

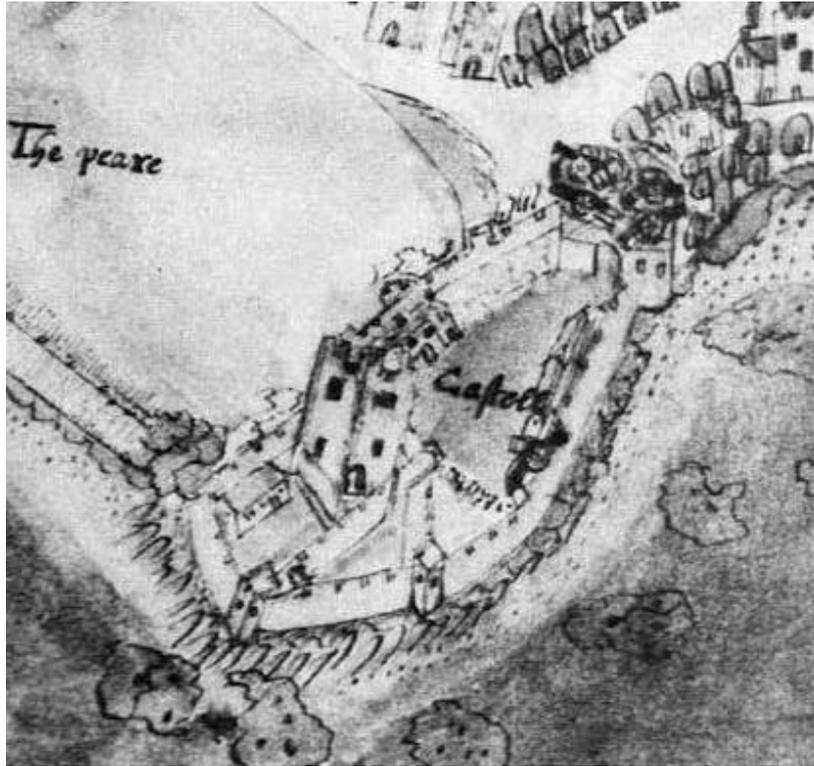
Plate 2. Detail of Carrickfergus Castle from the 1567 Robert Lythe map of Carrickfergus (Trinity College, Dublin, MS 1209 (26)).

Robert Lythe's map of Carrickfergus from a decade later (1567; Plate 2) shows a building in the south-western corner of the Inner Ward and a building along the western wall of the Outer Ward, again close to where Trenches 5-8 were located.

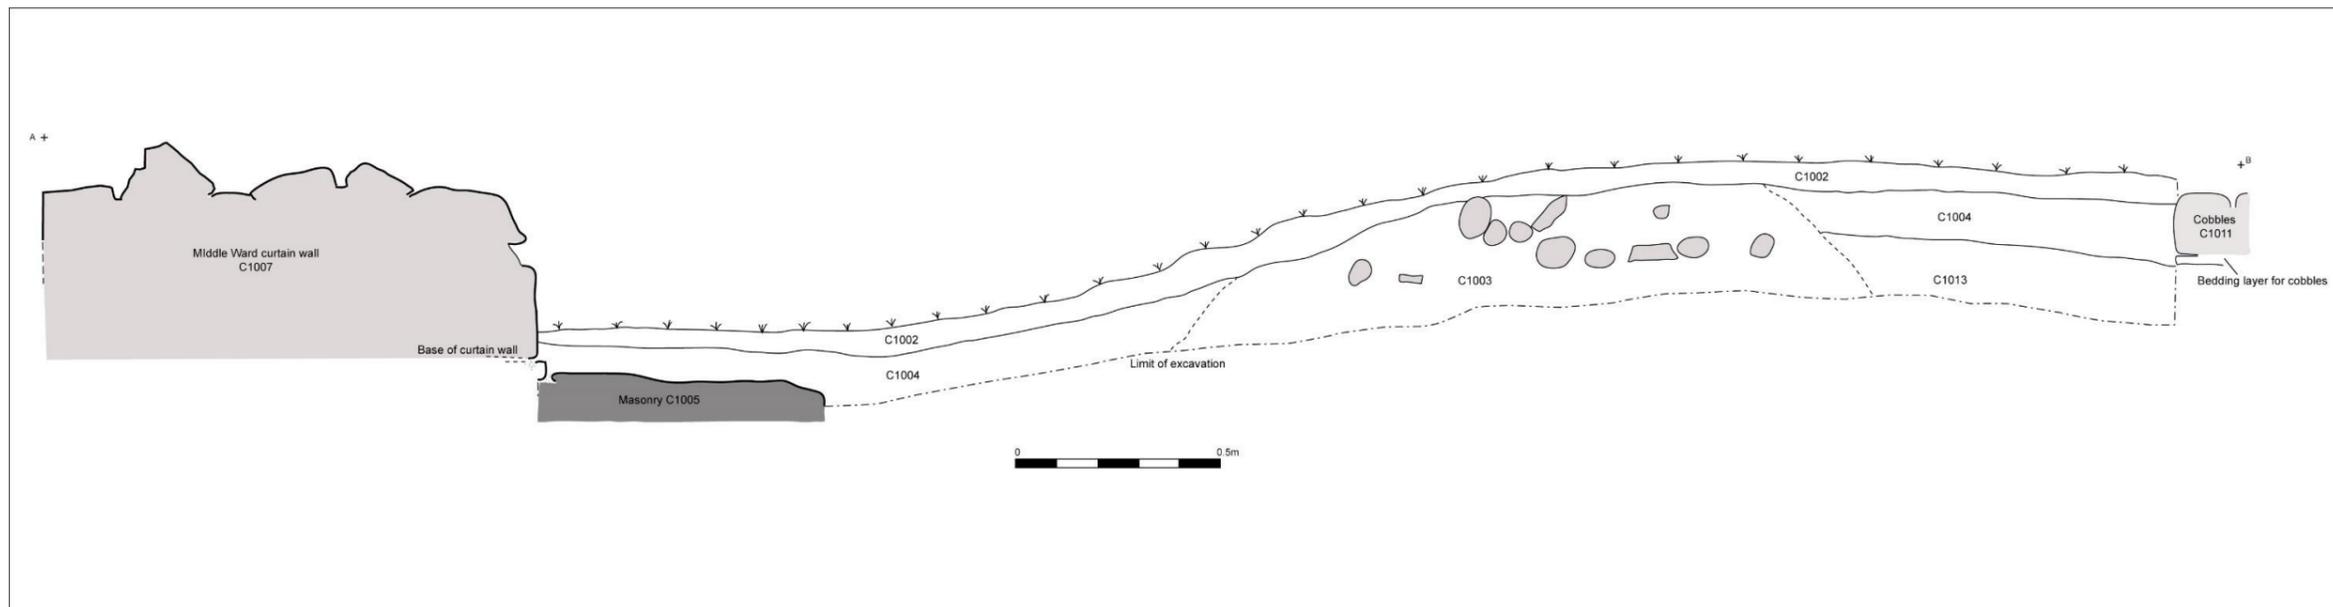
Fig 5. Trench 10. East-facing section of trench before the south-west corner of the trench was extended.

Trench 10 was the most easterly of the three excavated trenches and was located close to the junction of the Middle Tower and Middle Ward curtain wall. The trench was 4.10m long, north-south by 0.50m wide, east-west. Close to the external face of the curtain wall the trench was later extended to a 1m in width, to more fully investigate aspects of the masonry there. A maximum of 0.36m depth of stratigraphy was investigated within the trench before excavation here ceased. Most of the stratigraphy in the middle and north of the trench appears to represent dumped deposits, some of which possibly represent the backfilling of some of the 1955 excavation trenches and subsequent landscaping.

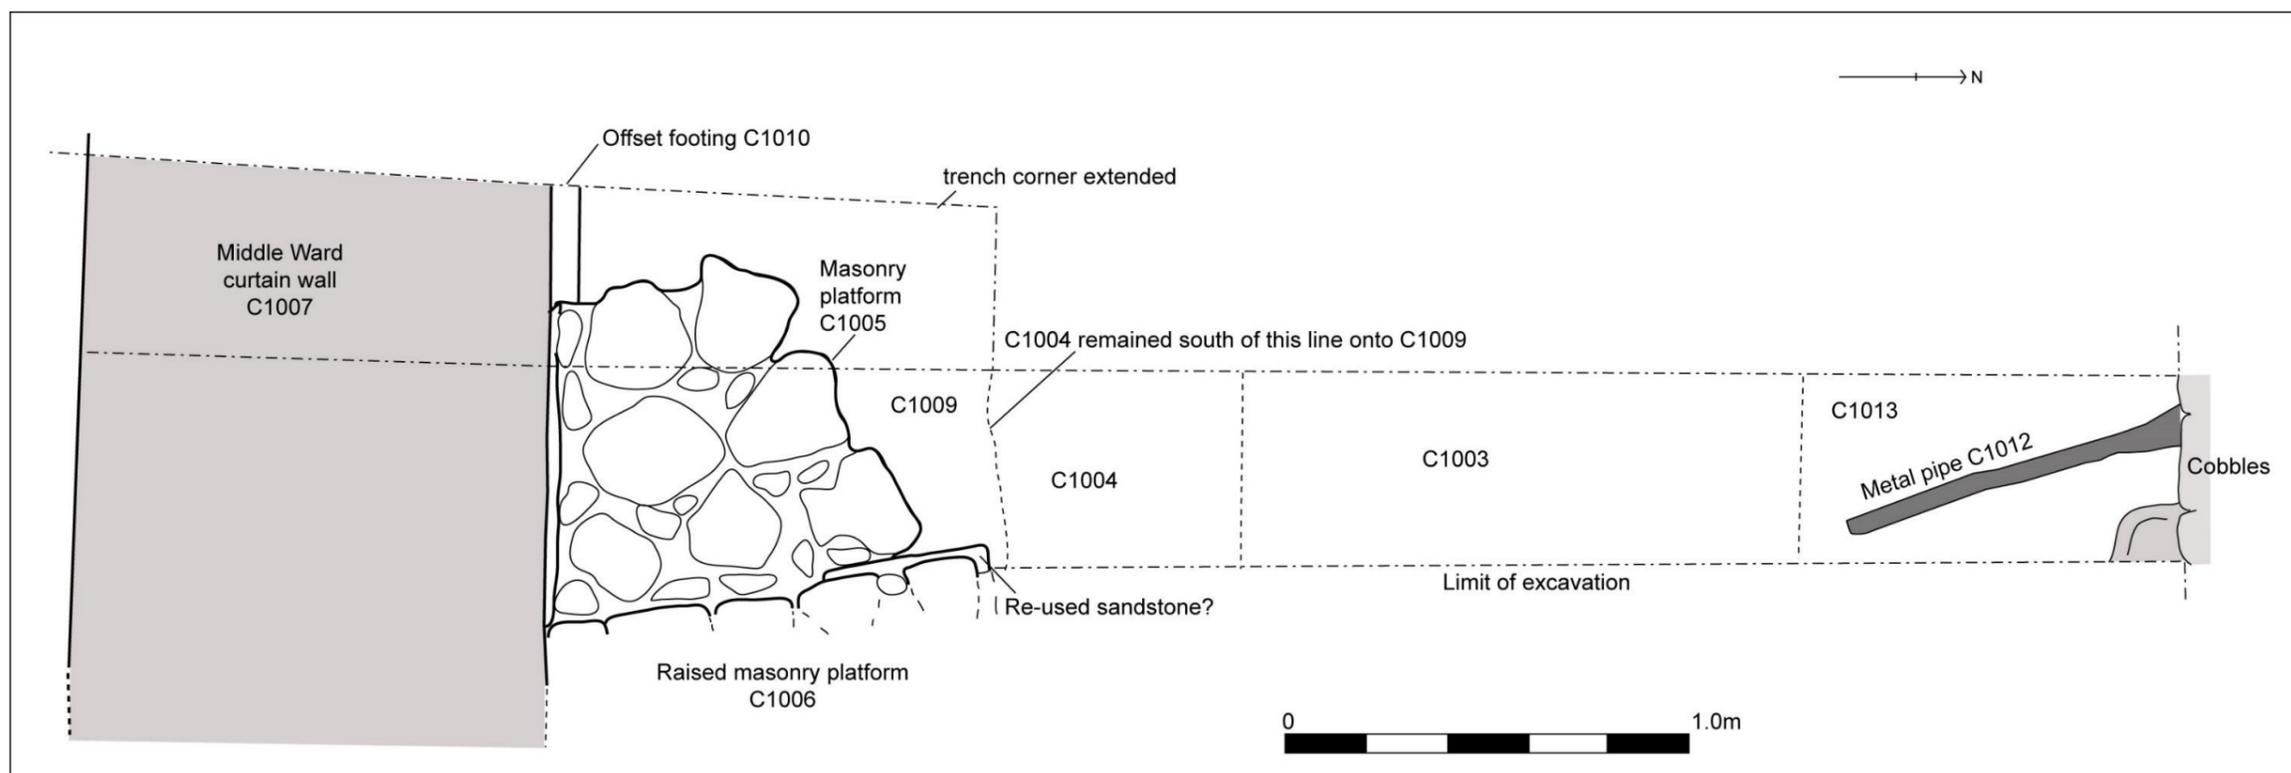
Fig 6. Trench 10. Plan showing all the principal features uncovered during the excavation.

The earliest feature in the Trench 10 was the remains of the Middle Ward curtain wall (C. 1007), built in the first quarter of the 13th century. By the 18th century some of the Middle Ward curtain wall appears to have either collapsed or had been at some point partially removed, presumably to facilitate easier movement around the castle. The wall is thus illustrated on the 1760 map of Carrickfergus (*British Magazine*, May 1760) and is shown completely missing from the 1811 plan of the castle (PRO WO 78/1158). So the structure was completely gone above ground, apart from a stump north-west of the castle, by the second half of the 18th century, perhaps in the years immediately after 1793 when keep/ Great Tower was converted into a barracks and other works were carried out within the castle (Mc Neill 1981, 49). The full line of the curtain wall was 're-found' during the archaeological excavations of 1955 and 1962. The probable reason that the ground level in the Outer Ward now slopes down steeply close to the outside face of the Middle Ward curtain wall is that this landscaping took place after the 1955 and 1962 excavations to display the newly-exposed foundations of the wall. A certain amount of restoration/ conservation of the wall has been carried out in the decades since then and without deeper excavation it is uncertain how much of the visible wall is original 13th century masonry or 20th century rebuild.

Within Trench 10 the earliest deposit found was a mound of rubble and soil (C. 1003) which was located roughly in the middle of the trench. The deposit consisted of a mixture of red brick, slate, small and medium-sized stones, fragments of cement and mortar, light brown clay, lumps of pinky salmon clay, and a number of small and medium sized cobbles. The base of the deposit was not uncovered and it also extended both east and west beyond the limits of excavation. Within the Trench 10 the deposit was a maximum of 1.75m long, north-south, and 0.28m deep and had the appearance of possible building demolition rubble.

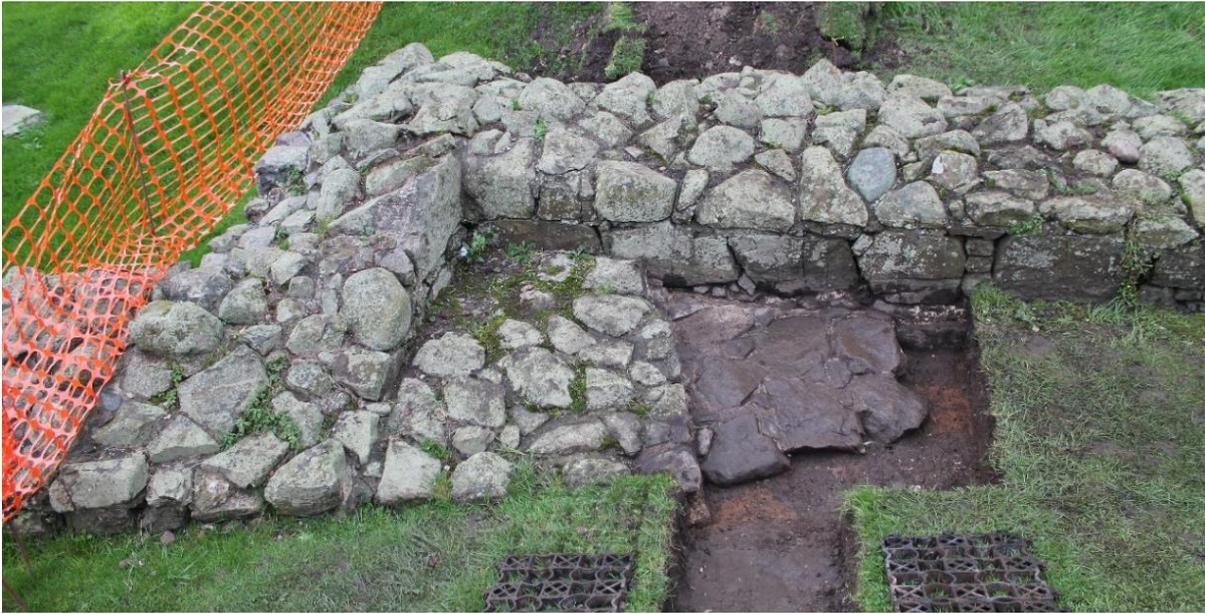
Plate 11. Trench 10. Shot of the southern end of the trench showing the newly exposed masonry surface (C. 1005), the section previously exposed (C. 1006) and the junction of the Middle Tower and the Middle Ward curtain wall (C. 1007) that sits on an off-set plinth (C. 1010). Looking south.

second course but seem to have been added post 1955/62 so that visitors to the castle will not hurt themselves if they stand on them. The curtain wall sits on a slightly offset plinth (C. 1010). Only a very small section of one course of this plinth, to a depth of 0.12m, was uncovered during the 2014 excavation before digging ceased. The plinth only extends out a few centimetres from the face of outer face of the curtain wall. Again, without deeper excavation, it is uncertain whether or not the offset plinth is a 20th century construct. However, most of the section drawings reproduced in McNeill (1981) of trenches excavated across or against the Middle Ward curtain wall in 1955 and 1962 show at least one, sometimes more, offset footings below the wall proper.

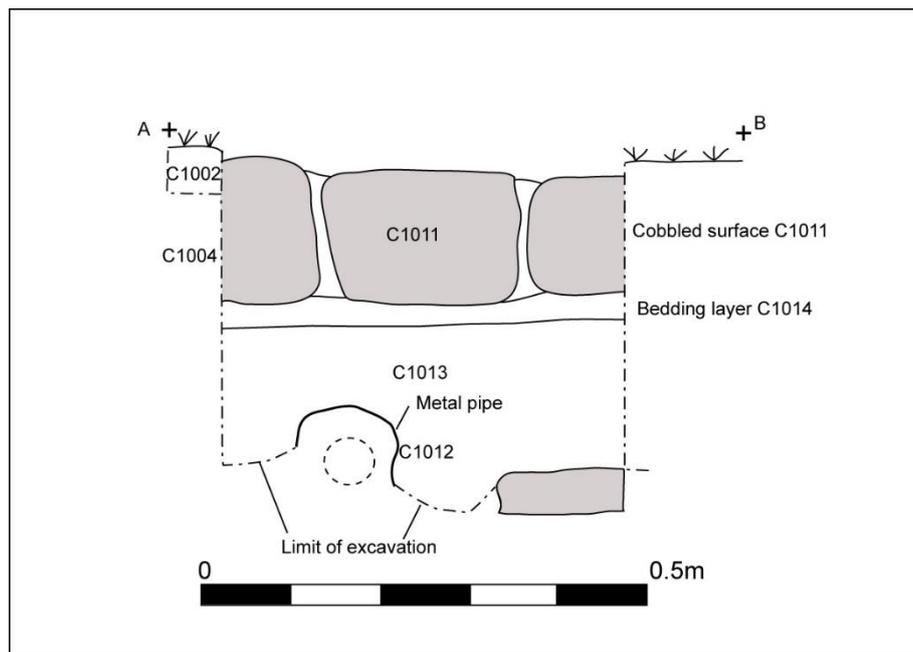
Fig 7. Trench 10. South-facing section of trench showing 20th century cobbles C. 1011 (= C. 113 in Trench 11).

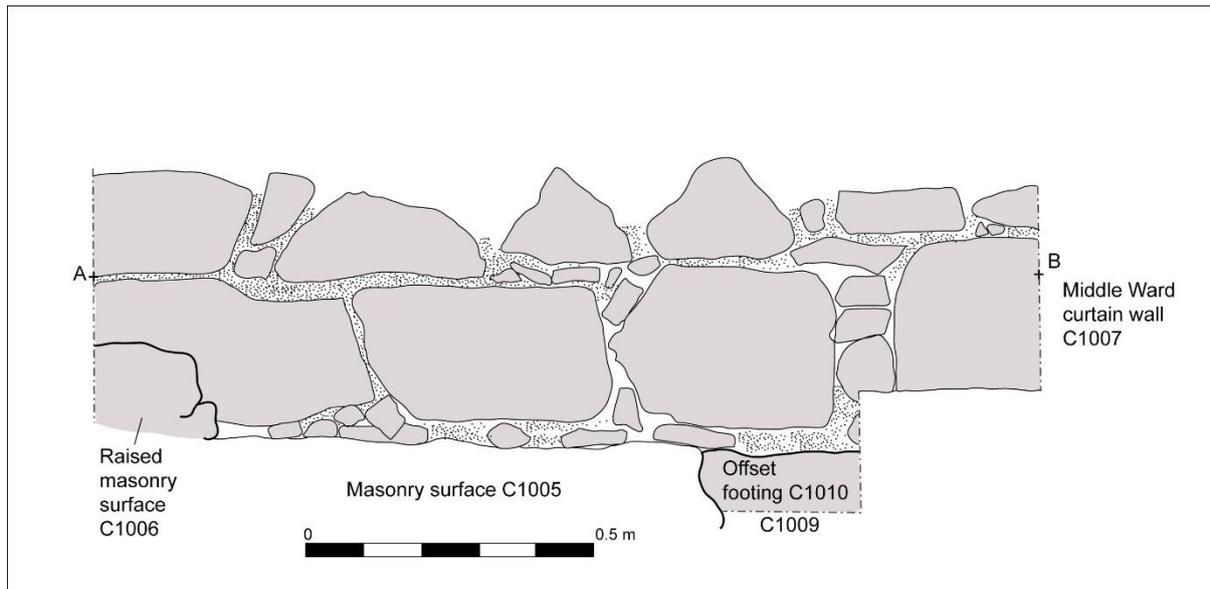
Fig 8. Trench 10. North-facing elevation showing the various masonry surfaces (C.1005 and C. 1006), the offset plinth (C. 1010) and the above ground section of the Middle Ward curtain wall (C. 1007). How much of this masonry dates to before the second half of the 20th century is open to question.

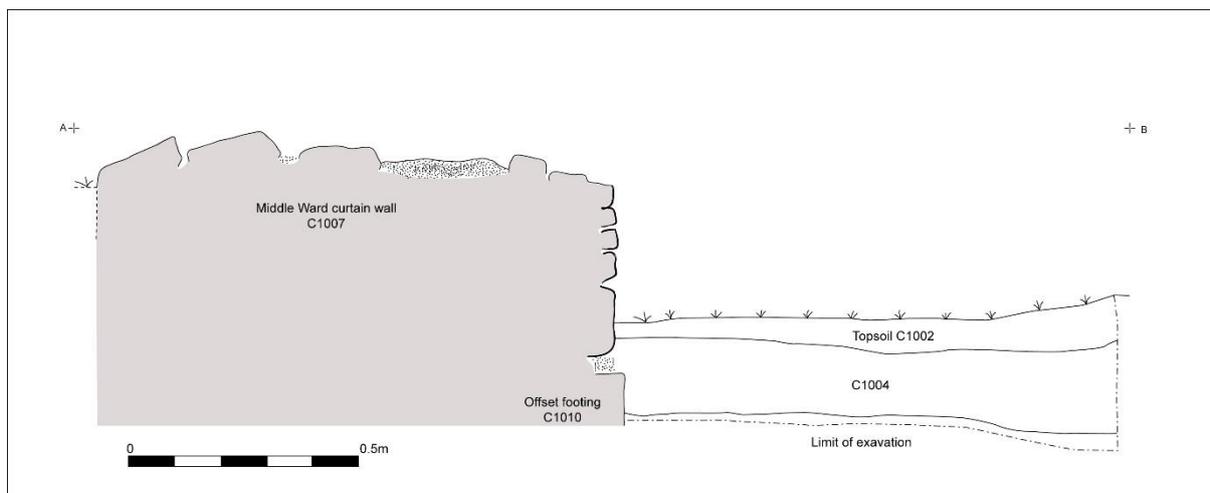
Fig 9. Trench 10. East-facing section of the western extension to the trench.

Butting against the northern edge of dump C.1003 and filling the northern end of the trench was a deposit of brown soil (C.1013) that contained small to medium-sized stones and fragments of red brick. The deposit was a maximum recorded length of 0.85m and depth of 0.15m. It ran below a large cobbled surface (C. 1011,) and its bedding layer (C.1014), which constitute the northern limit of the trench and the southern limit of modern cobbled surface which covers much of the Outer Ward. It also covered an iron pipe (C. 1012) and other metalwork which may be evidence of Victorian services in the Outer Ward. The deposit (C. 1013), like all of the horizons uncovered within Trench 10, appears to be a dumped layer used to level up this part of the Outer Ward.

Layer C. 1004 appears to represent a dumped layer used to level the ground surface in this part of the Outer Ward, probably after the excavations of 1955 were backfilled. Versions if the layer were found in all of the three trenches excavated in November 2014.

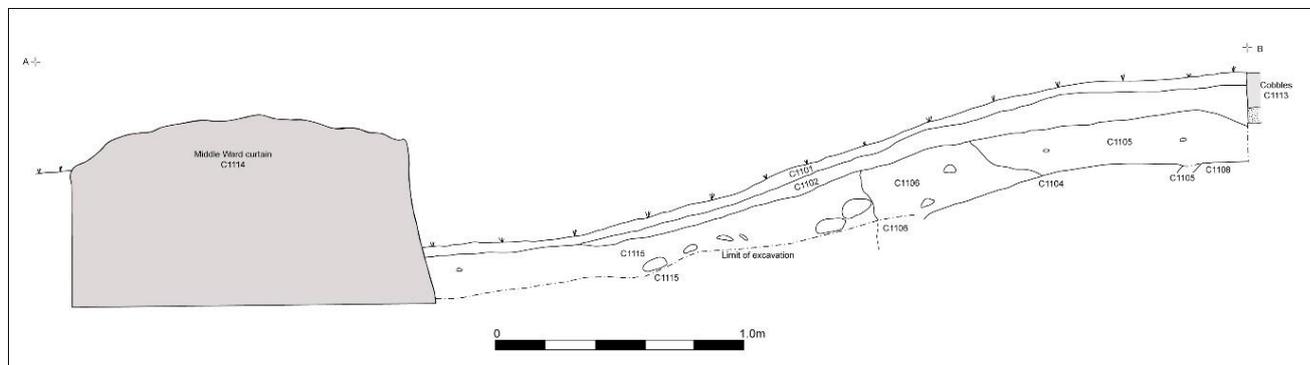
Fig 10. Trench 11. South facing section of trench.

Trench 11 was the middle of the three trenches excavated in November 2014. The trench was 3.50m long, north-south, and 0.50m wide, east-west. It was excavated to a maximum depth of 0.38m deep before investigations were halted under instruction from NIEA. As in Trench 10, the southern limit of Trench 11 was the outside face of the Middle Ward curtain wall (C. 1114 = C. 1007 in Trench 10) and

the northern limit was the edge of large cobbles that framed the cobbled surface in the Outer Ward (C. 1113 = C. 1011 in Trench 10).

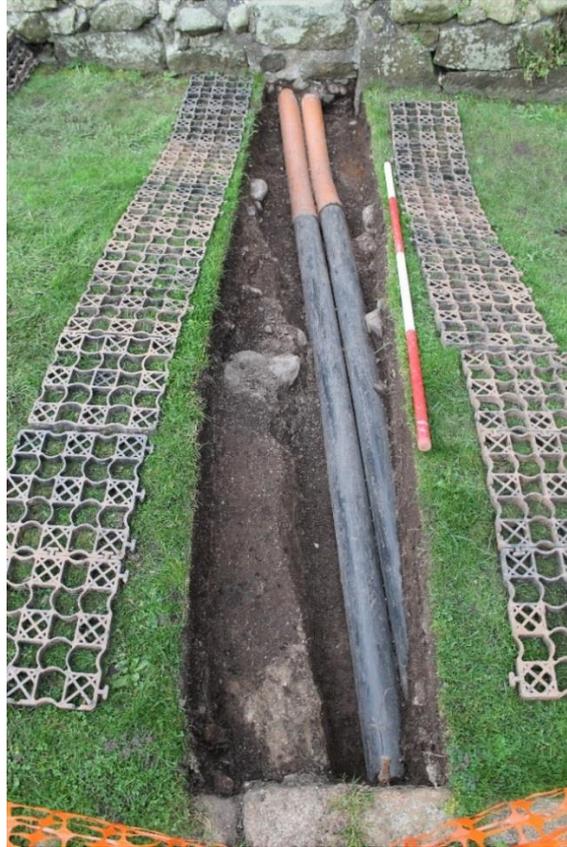
Plate 12. Trench 11. Shot of southern end of the trench showing the modern plastic pipes (C1103/ C. 1108 and C. 1104/ C. 1007) within their foundation trench (C. 1109) running through the Middle Ward curtain wall (C. 1114). Looking south.

All of the above-mentioned features were cut by the main features uncovered in Trench 11 which was two modern plastic service trenches, sited directly beside one another, and both in two sections. The most westerly pipe (C. 1104/ C. 1107) ran into the western section face 0.40m from the northern limit of the trench. The eastern plastic service pipe (C. 1103/ C. 1108) ran the full length of the trench and beyond below the cobbles of the Outer Ward. It had *Marley. 100mm. Sewer. BS 4660E* stamped on it. Beyond the trench to the north the pipes lined up with the visible marking of a linear service trench in the cobbles of the Outer Ward and ultimately to a manhole located close to the south-east corner of the castle Visitor Centre. At the southern end of the trench the pipes ran through and under the courses of the Middle Ward curtain wall. This draws into question the antiquity of the masonry that currently constitutes the most visible, upper courses, of the Middle Ward curtain wall. It is uncertain how much mid-20th century rebuilding took place over the line of the wall once the Medieval masonry was exposed during the 1955 excavation. This is a question for further research. The service pipes in Trench 11 may be related to the insertion of the toilet block in the Inner Ward in recent decades.

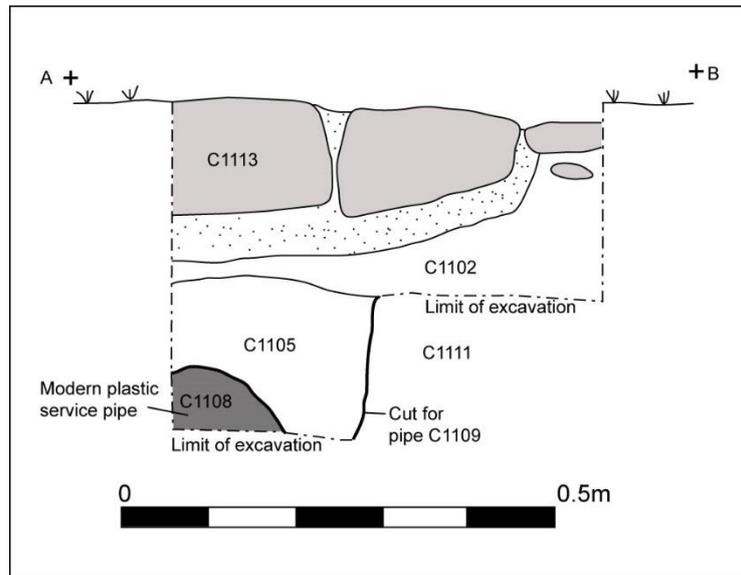
Fig 11. Trench 11. South-facing section of the trench showing the 1980s plastic service pipes below the cobbled surface of the Outer Ward, C. 1113.

The earliest layer encountered within Trench 11 was a dark brown silty loam containing small-medium sized stones (C. 1111/ C. 1112) and appeared to have originally covered the whole trench and may represent the ground surface in this area of the Outer Ward at the time of the 1955 excavation. The layer was given two different numbers as it was cut by an east-west linear cut (C. 1110). This cut was aligned roughly east- west and was excavated to a maximum depth of 0.25m before investigations were curtailed. The cut was filled with a grey brown silty loam containing stones, fragments of brick and lens of orange keuper marl clay (C. 1106). The cut feature may be the relict remains of Trench A excavated in 1955 and illustrated in McNeill (1981, 62, Fig 19) and the fill certainly had the appearance of backfilled material.

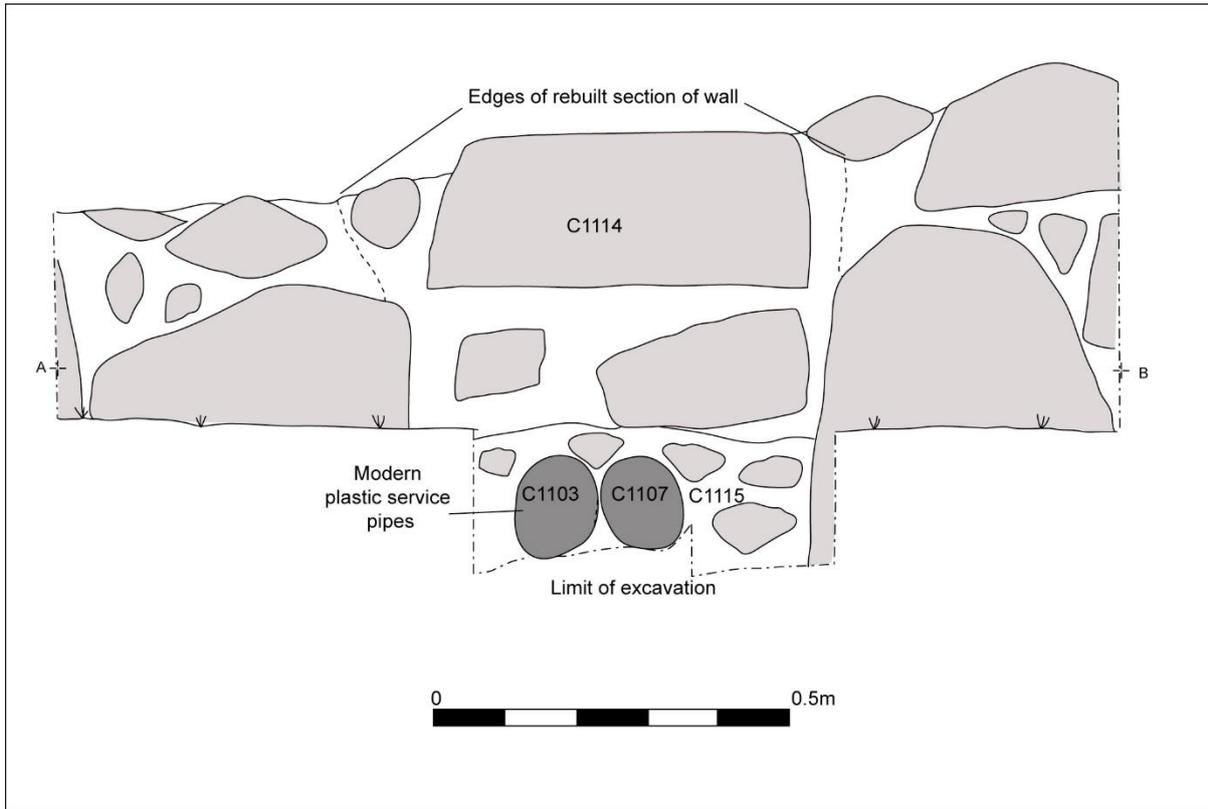
Fig 12. Trench 11. North-facing elevation across the end of the trench showing a rebuilt section of the Middle Ward curtain wall and the 1980s plastic service pipes cut through the curtain wall.

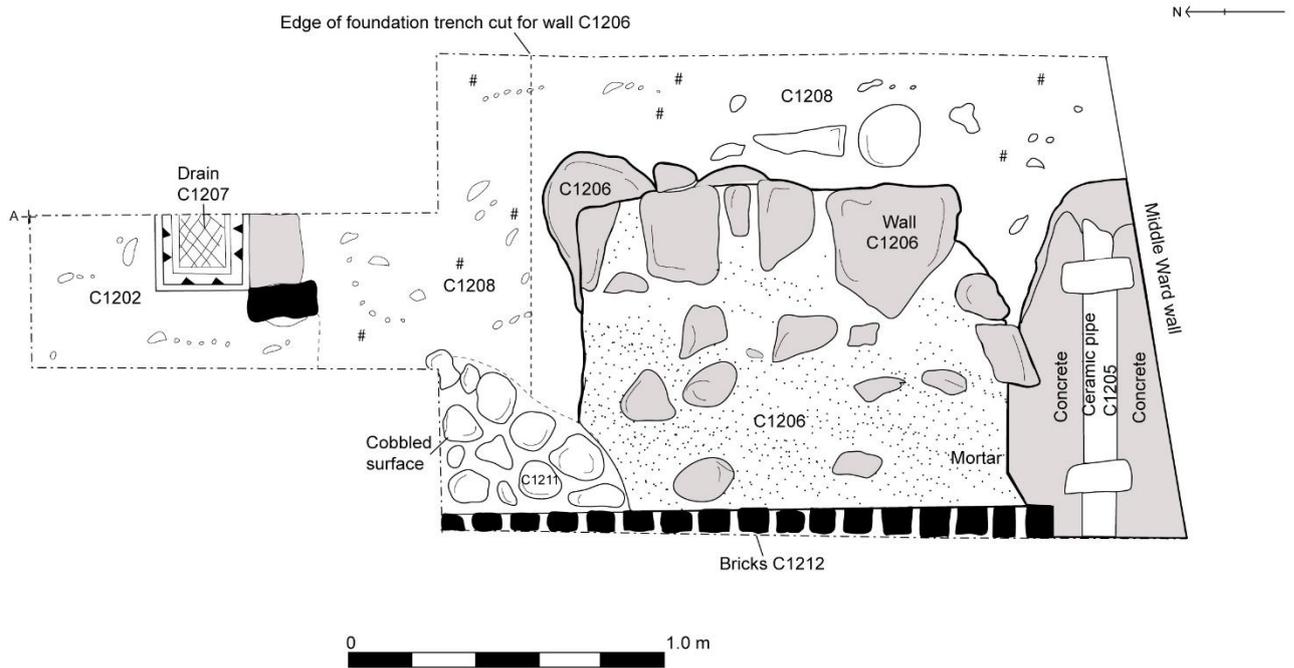
Fig 13. Plan of Trench 12 showing all the principle features uncovered during the excavation.

Trench 12 was the most westerly positioned of the three trenches investigated in November 2014. It was located west of the kink in the line of the Middle Ward curtain wall and was the trench in which the most significant archaeological features were uncovered during the 2014 excavation. The trench was initially 3.60m long, north-south, by 0.50 wide east west. However, the northern two-thirds of the trench was later extended another 0.50m to both east and west, so that this excavated section was 1.50m wide.

The earliest strata encountered within the trench was a grey clay loam containing small stones and charcoal flecks (C. 1208). This surface was cut by a steep-sided foundation trench (C. 1209) within which a portion of masonry (C. 1206) sat. The foundation trench was a maximum recorded width of 0.50m east-west, depth of 0.47m and length of 0.13m, north-south, within Trench 12. Due to later disturbance only the northern edge of the foundation cut was uncovered during the excavation.

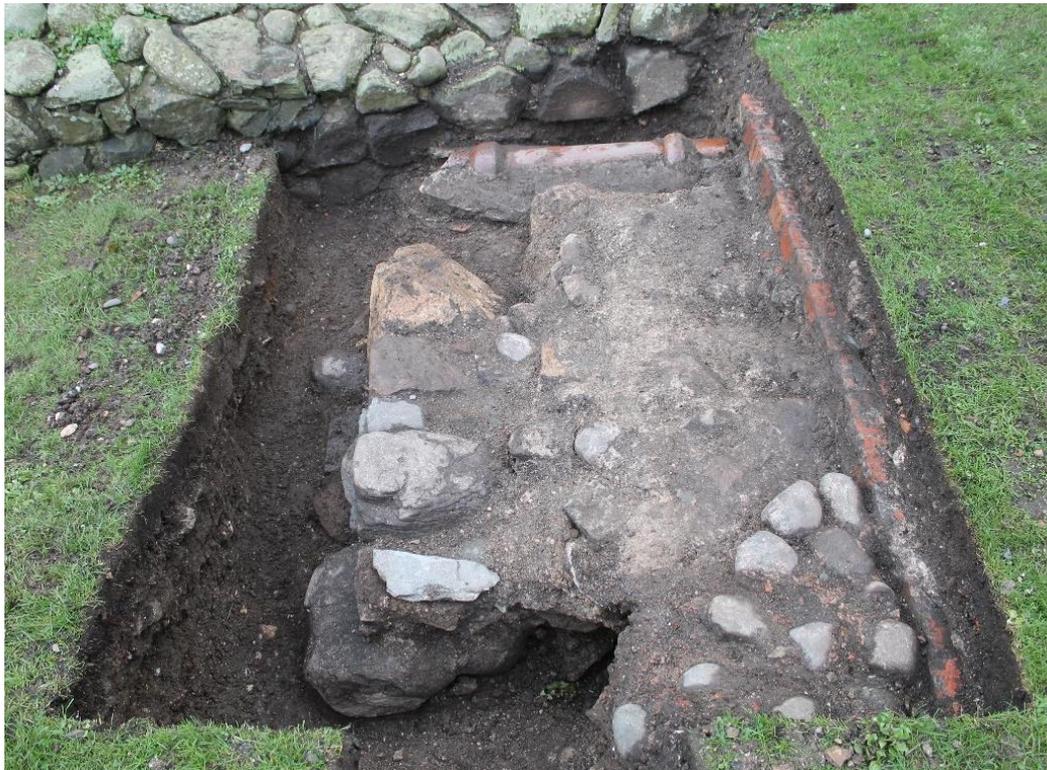
Plate 13. Trench 12. Shot of the southern end of the trench showing the Middle Ward curtain wall (C. 1213), the newly exposed masonry with stone facing (C. 1206), the later red brick surface (C. 1212), cobbled surface (C. 1211) and ceramic service pipe (C. 1205). Looking south.

Within the foundation trench was the base of a heavily damaged section of masonry that was located 0.25m below modern ground level and 0.40m north of the outer face of the Middle Ward curtain wall.

The structure was a maximum recorded length of 1.5m long, north-south, by 1.10m wide, east-west. The wall survived to a height of 0.51m on its northern side and 0.42m along the eastern side. The masonry was made up of large basalt stones heavily mortared together. The eastern end was faced with large stones, one of which appeared to be (?re-used) Cultra sandstone. Closer to the western limits of the trench the stones were smaller and the mortar content was higher suggesting that the wall was constructed with a rubble core.

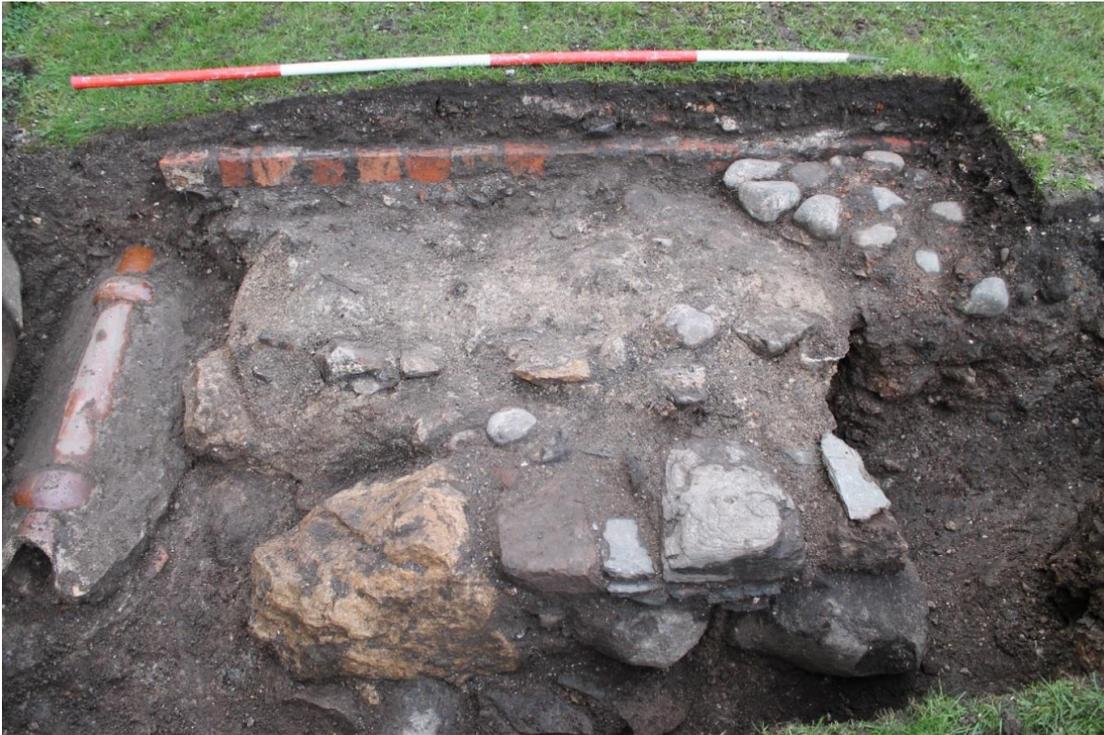
Plate 14. Trench 12. Shot of the stone facing of the early masonry (C. 1206), the later red brick surface (C. 1212), cobbled surface (C. 1211) and ceramic service pipe (C. 1205). Looking west.

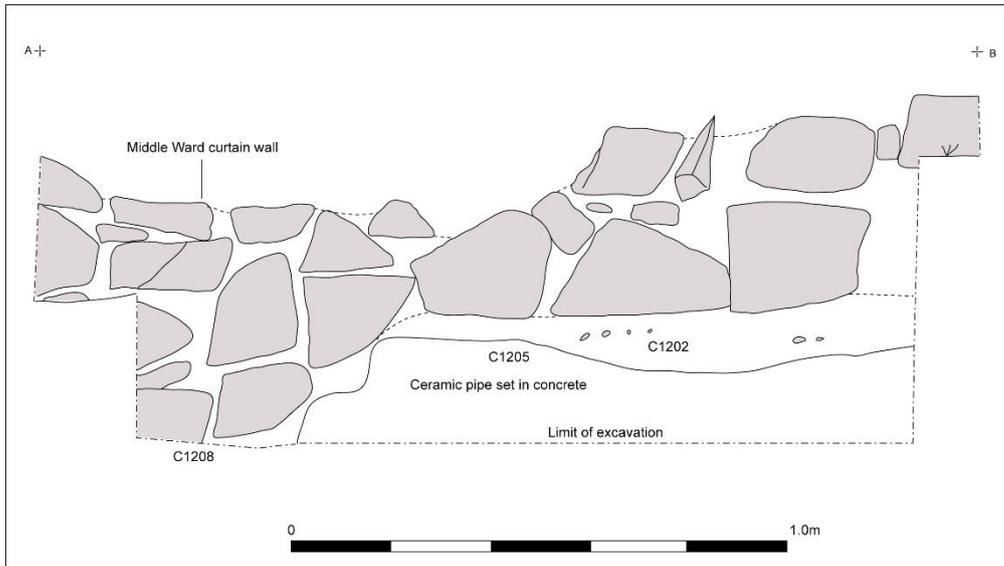
Fig 14. North-facing elevation across the southern end of Trench 12 showing external face of the Middle Ward curtain wall and 19th century ceramic service pipe C. 1205.

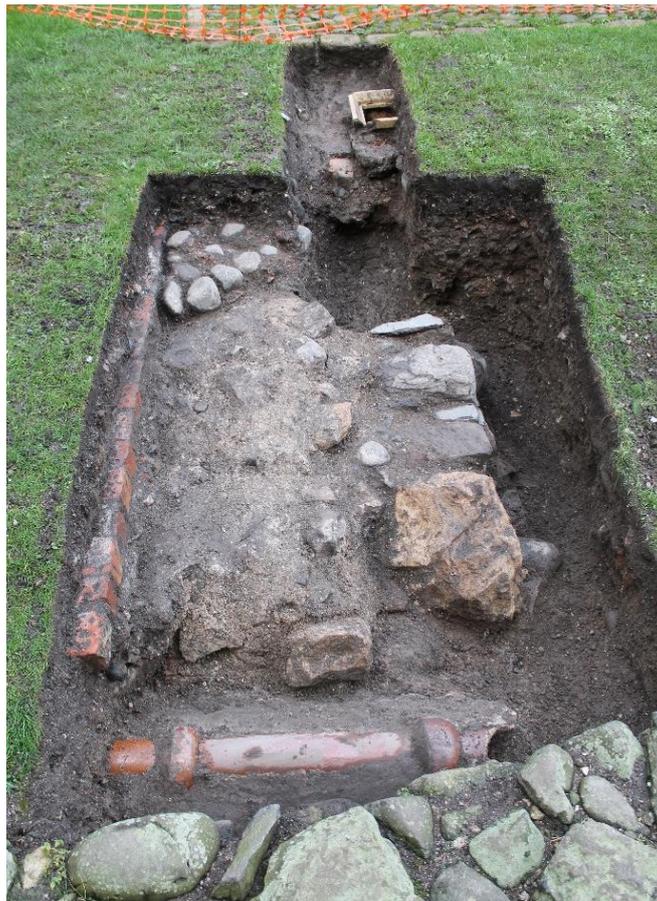
Plate 15. Trench 12. Shot showing the exposed masonry with stone facing (C. 1206), the later red brick surface (C. 1212), cobbled surface (C. 1211) and ceramic service pipe (C. 1205) and drain (C. 1203/ C. 1207). Looking north.

Directly above the section of damaged masonry was a red brick surface (C. 1212), one course of brick thick and located at the western extremity of the trench. Possibly contemporary was the patchy remains of a cobbled surface (C. 1211) in the north and west of the Trench. Both these surfaces may relate to the construction of the barracks buildings in the Outer Ward in the late 18th and early 19th centuries, sections of which were investigated in the spring 2014 excavation very close by to Trench 12.
