## Data Structure Report No. 119

### Excavations at Retreat, Cushendall, Co. Antrim

EXCAVATIONS AT RETREAT  
CUSHENDALL  
CO. ANTRIM

*Brian Sloan, Colm Donnelly,  
William Roulston, and  
Siobhan McDermott*

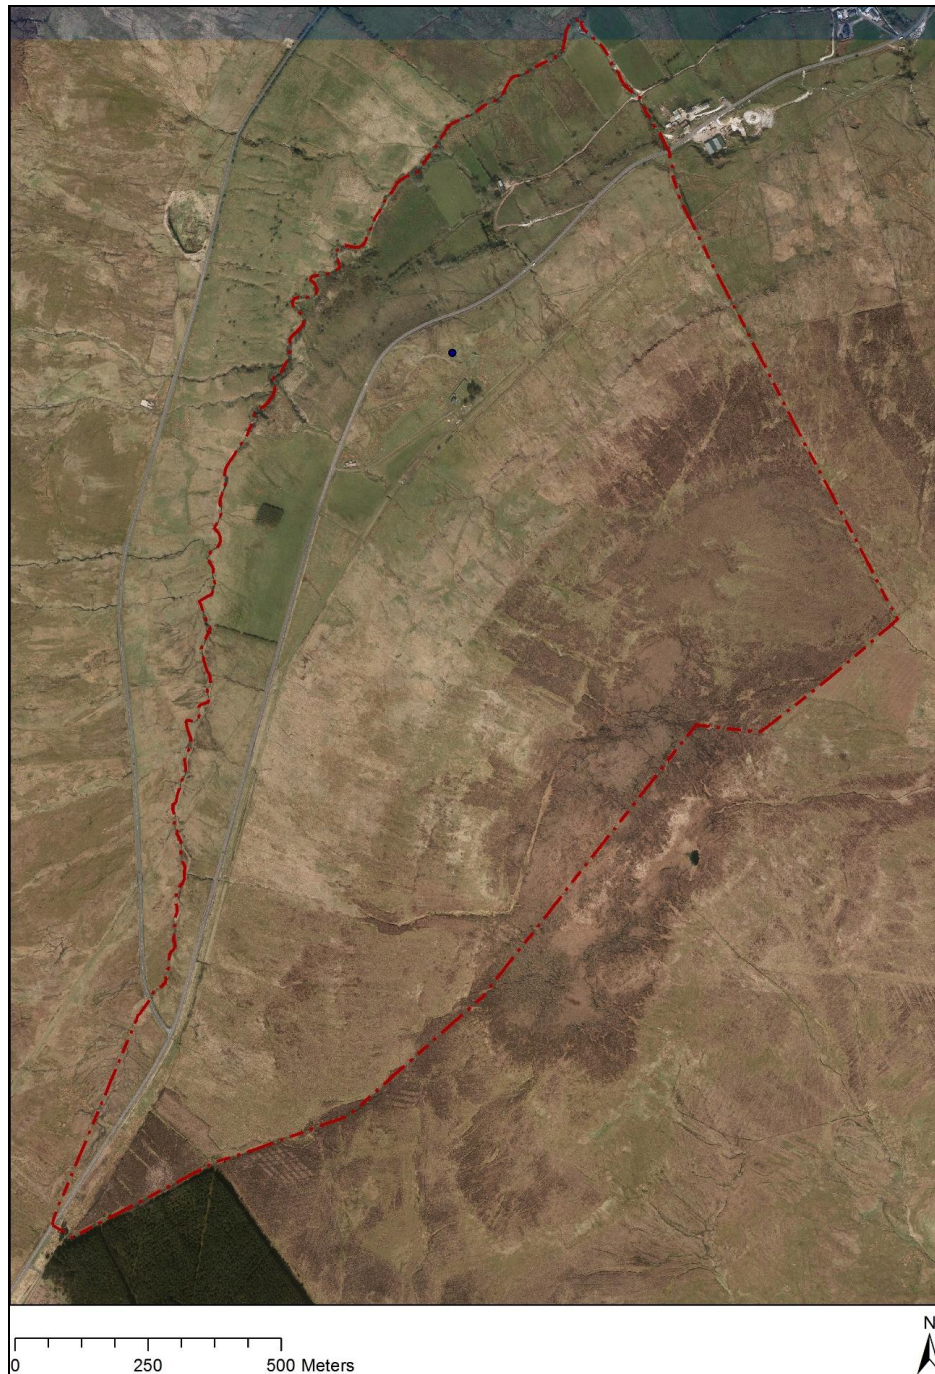
*Figure 2: The townland of Retreat or Cloghglass. The location of complex is denoted by the blue dot, while the townland boundary is highlighted in red.*

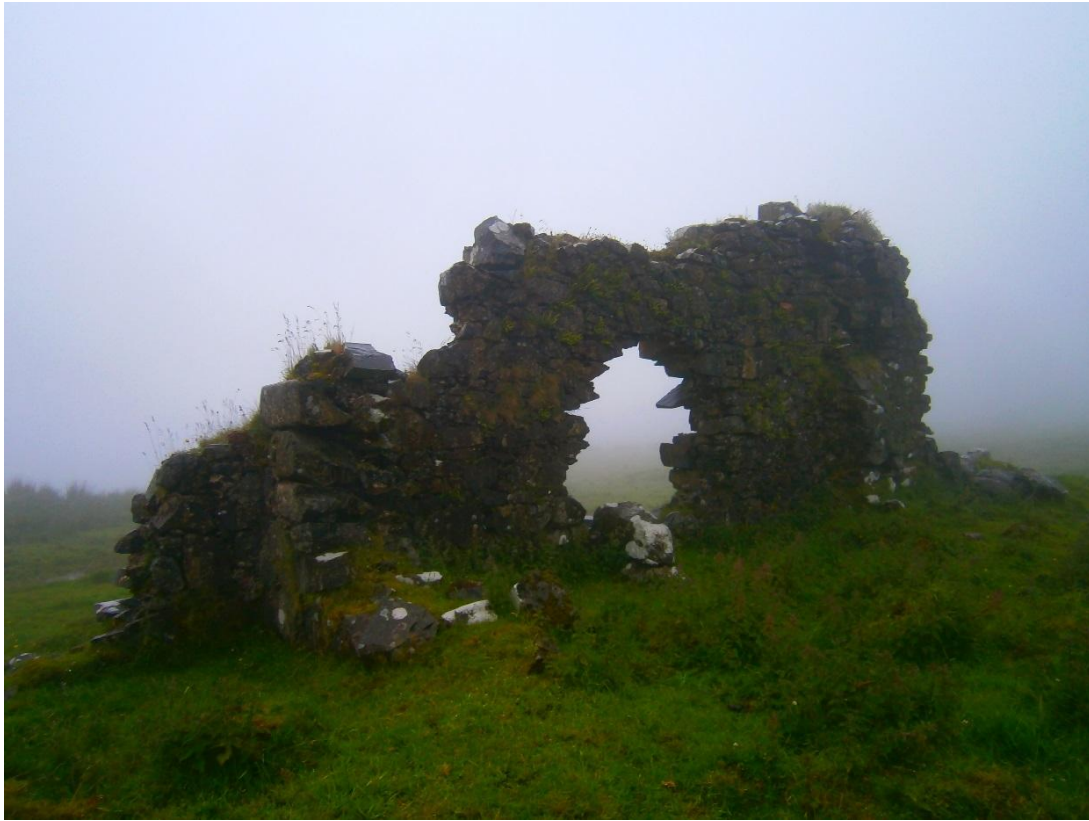
*Figure 4: The northern gable of the dwelling house, 4<sup>th</sup> July 2016*

the last standing fragments of walls currently at the site (Figures 4 and 5) would make it somewhat more challenging to reach such a conclusion some 40 years later!

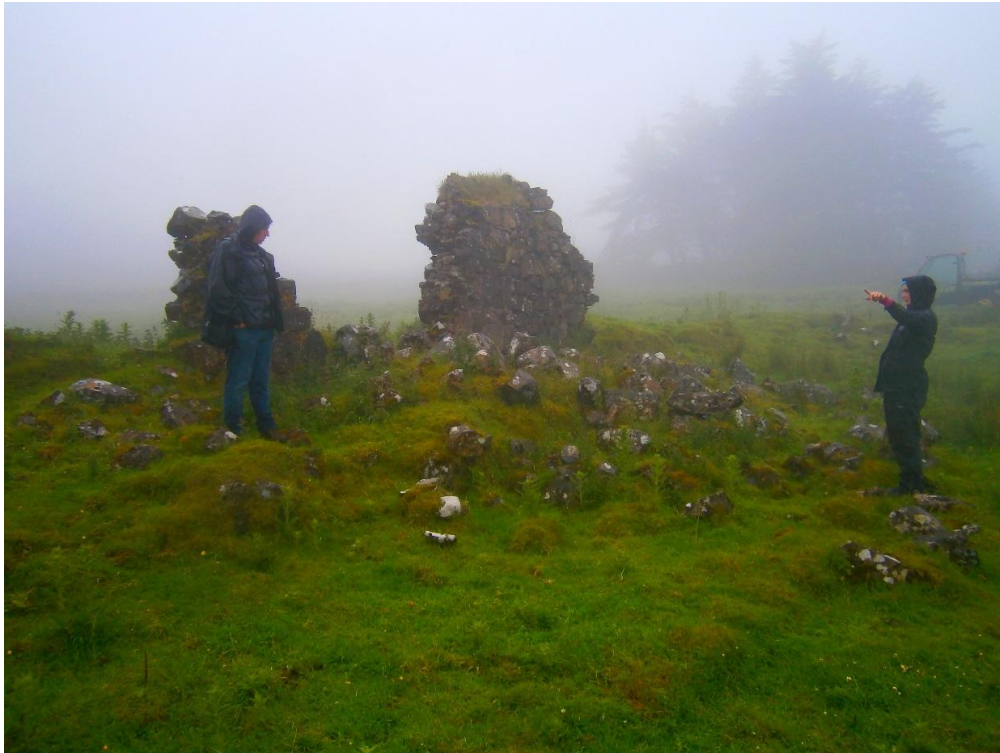
*Figure 5: The remaining sections of upstanding masonry within the interior of the dwelling house, 4<sup>th</sup> July 2016.*

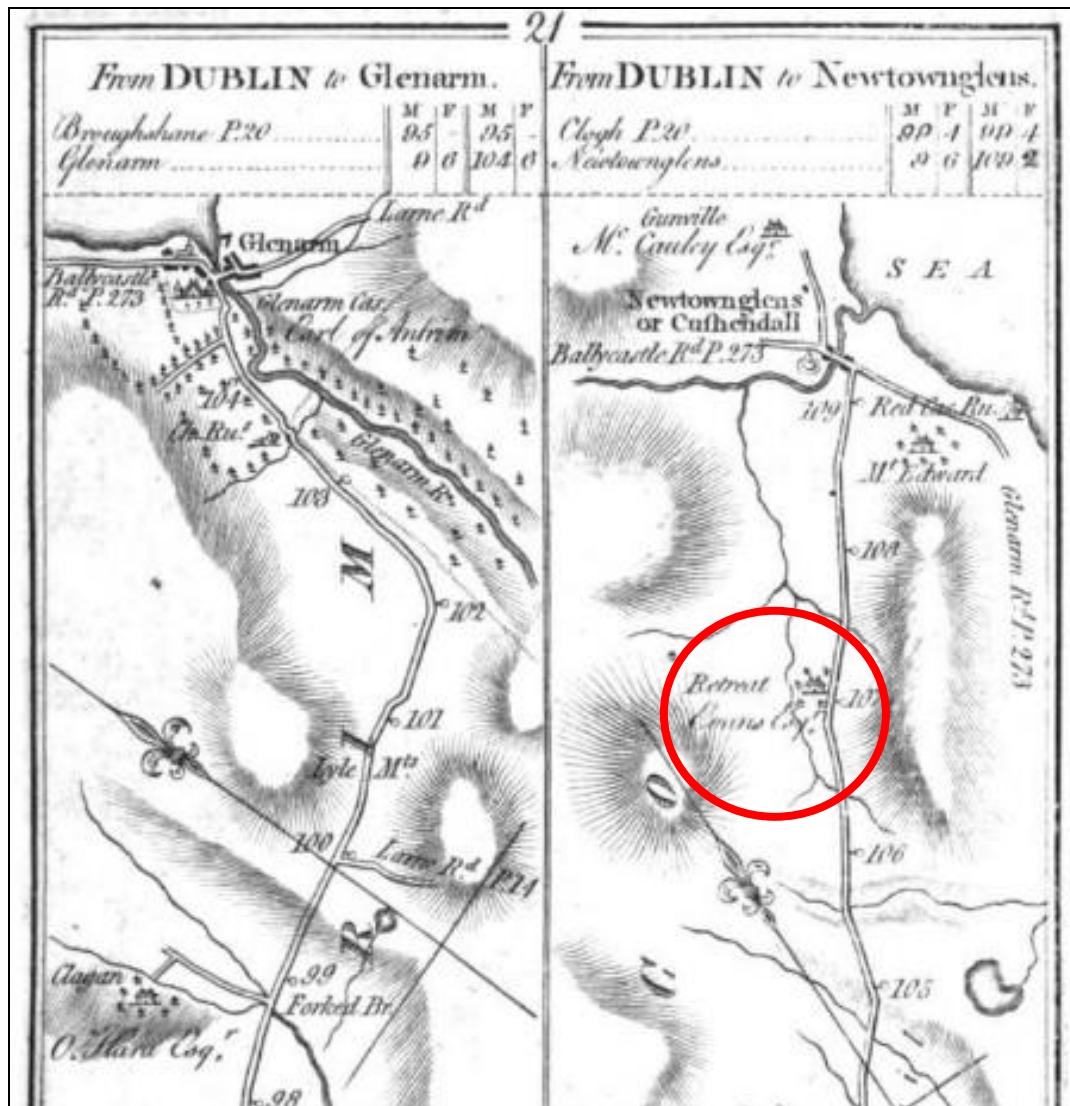
Figure 6: Retreat Castle, as marked on Taylor and Skinner’s 1778 road-map outside the village of “Newtownglen or Cushendall”.

Brett had been able to deduce the occupant of the property as Mr Evans in 1778 by the fact that its location had been marked on the Taylor and Skinner road-map published in that year, where it was denoted as "Retreat, Evans Esquire" (see Figure 6), but evidently sufficient fabric survived in the 1970s for him to be able to establish that this was a two-storey building;

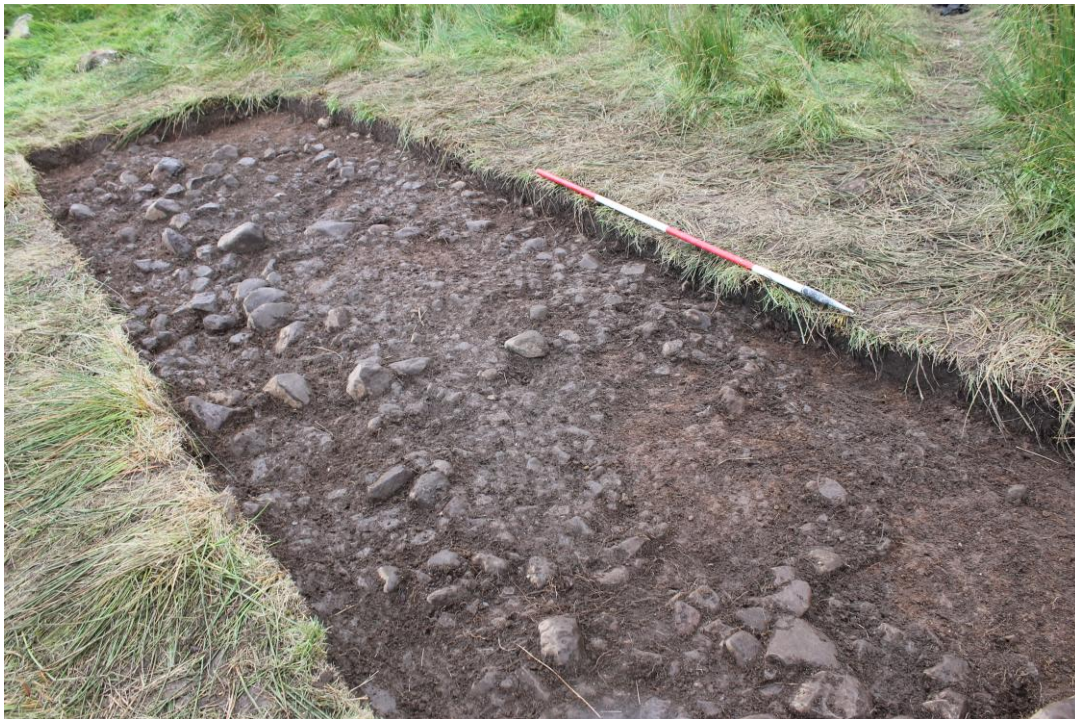
*Figure 22: The rough metallated surface (Context No. 103) revealed in Trench One, looking north. The deposit shows that the stones incorporated into this surface were not sorted but would have provided a firm working surface rather something that was aesthetically pleasing (as in Trench Two). Also visible are patches of the subsoil where the stone metallating is at its thinnest.*

Excavation ceased at the metallated surface, although the opportunity was taken to explore the relationship of the surface and the underlying subsoil. Removal of some of Context No. 103 revealed that it was sitting directly on the surface of the subsoil (Context No. 104) which consisted of a gravel rich reddish brown clay. No features were observed cutting the subsoil (Context No. 104) where it was exposed and the trench was backfilled following recording.

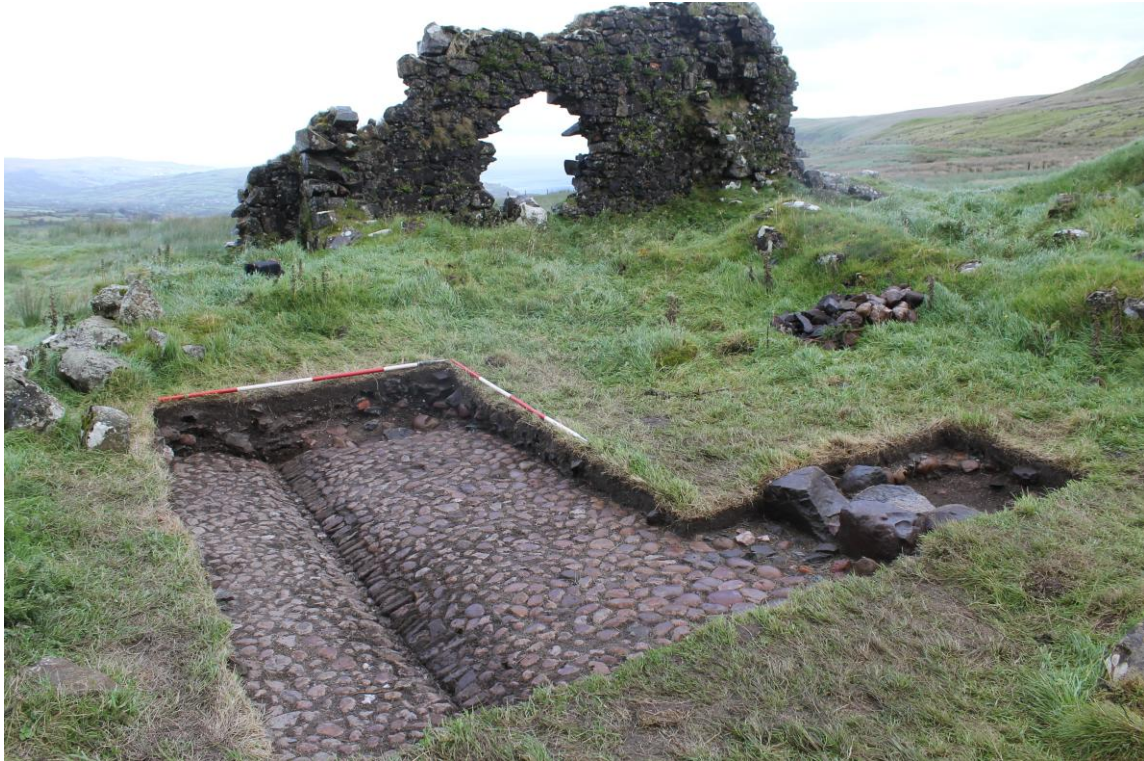
*Figure 23: Trench Two looking east. The foreground of the picture shows the finely constructed cobbled surface (Context No. 202) as well as the foundations of an internal wall within the house (Context No. 205) The gentle slope to the surface of the cobbles which directed water into the drain (Context No. 204) which runs roughly north-east/south-west across the cobbles (Context No. 202).*

within an enclosed yard, evidenced by the foundations of walls to the immediate east and west. It became obvious, however, that this was not the case, and the trench was found to be located within the interior of the building. A simple stratigraphic sequence was encountered during the excavation of this trench which consisted of sod (Context No. 201), directly overlying a deposit of rubble (Context No. 203) which in turn lay over a finely laid cobbled surface (Context No. 202). A drain (Context No. 204) running roughly north-east/south-west was encountered along the western side of the cobbled surface (Context No. 202) and the foundations of a wall (Context No. 205) bounded the cobbled surface at the eastern end; this wall lines up directly with a stump of wall that protrudes from the upstanding gable of the house. The remains of a disturbed cobbled surface (Context No. 206) was encountered to the east of this wall, similar in appearance to the main cobbled surface (Context No. 202). An exploratory investigation of the cobbles showed them to be pressed directly onto surface of the underlying subsoil (Context No. 207).

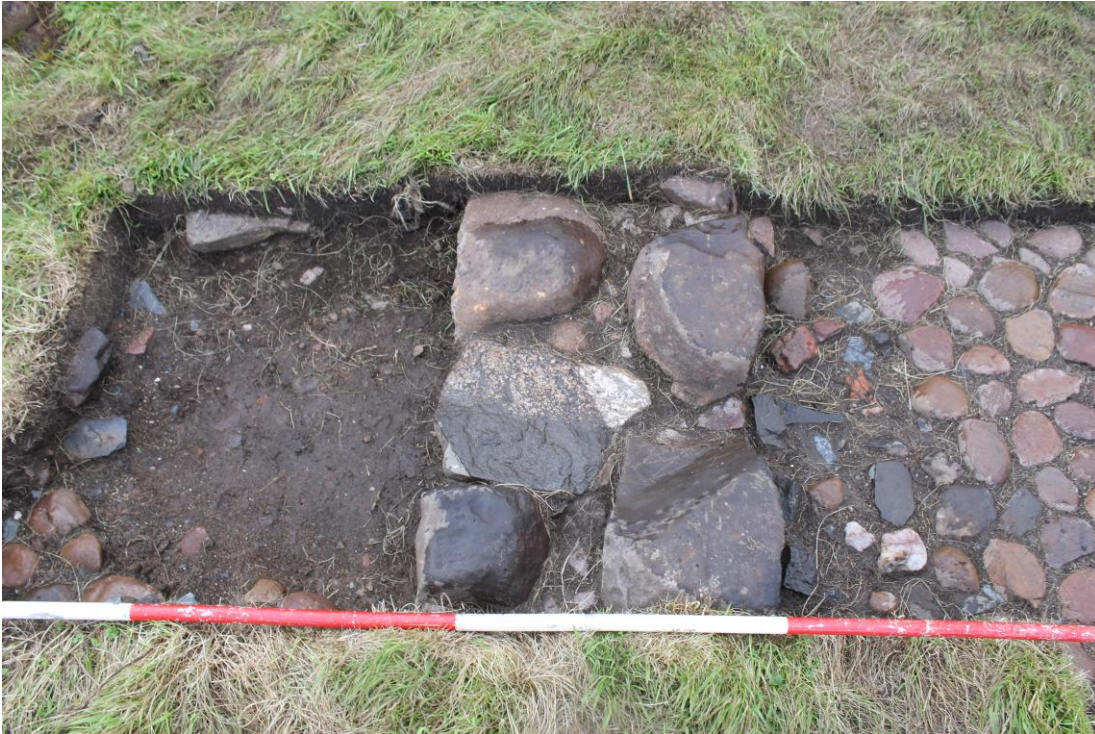
*Figure 24: The 2m x 1m extension to Trench Two showing (left to right); the disturbed cobbled surface (Context No. 206) with underlying geological subsoil (Context No. 207); wall foundations (Context No. 205); and cobbled surface (Context No. 202) looking south-east.*

Following the removal of the sod (Context No. 201) and the identification of the cobbled surface (Context No. 202), the trench was extended to the south-east. This extension measured 2m x 1m and was intended to investigate the relationship between the cobbled surface (Context No. 202) and the visible foundations of the wall within the house (Context No. 205). Removal of the sod in this extension revealed the extent of the wall (Context No. 205) and a disturbed cobbled surface (Context No. 206). The foundation of the wall (Context No. 205) was comprised of two rows of angular rocks (averaging 0.35m in length) set directly on the surface of the subsoil (Context No. 207). The wall ran roughly north-east/south-west and averaged 0.6m thick. Minimal mortar was observed as having survived, with the gaps in the rocks being infilled with small angular stones. To the immediate east of this wall (Context No. 205), a layer of disturbed cobbling (Context No. 206) was encountered which sat directly on the subsoil (Context No. 207). These cobbles (Context No. 206) survived in the northern corner of the trench extension, although it was evident that further cobbled associated with this surface had been removed (Figure 26). The cobbles averaged 0.1m in length and consisted of rounded quartzite beach pebbles. The portion of this surface (Context No. 206) is similar in appearance to the main cobbled surface (Context No. 202)

and it is evident that the surface has been laid directly on the subsoil (Context No. 207) and not bedded in mortar.

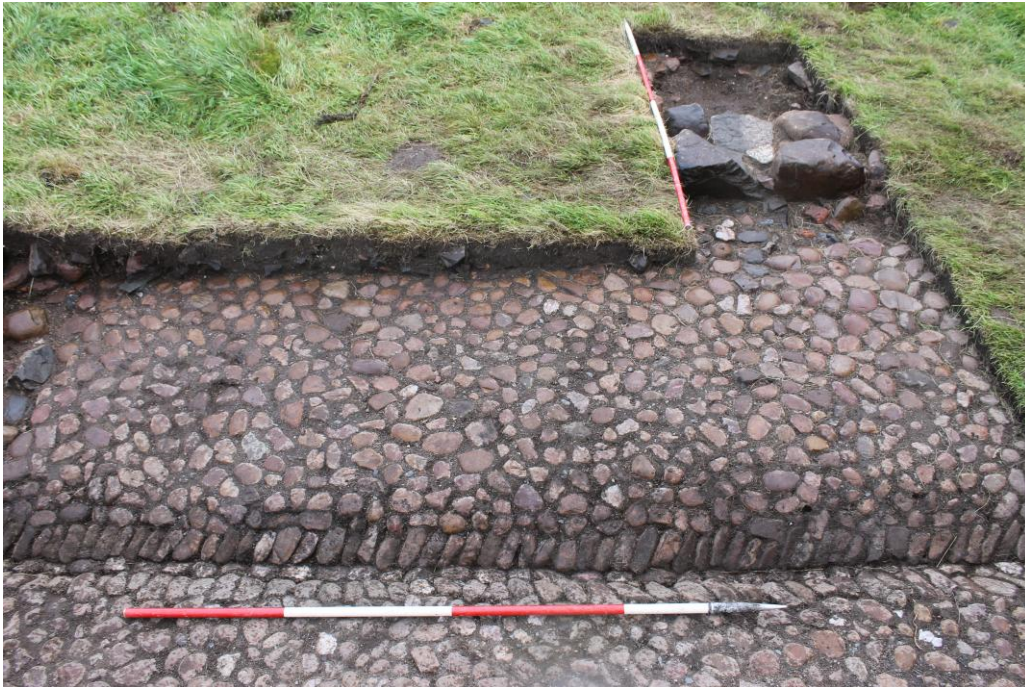
*Figure 26: Post-excitation view of Trench Two showing detail of the cobble surface (Context No. 202) and drain (Context No. 204), looking south-east.*

The cobbled surface (Context No. 202) exhibits well sorted rounded stones, which range in size from 0.05m to 0.12m in length. The cobble stones appear to be derived from water rolled beach pebbles, with rounded quartzite stones being the most prevalent type. Exploration of the cobbles found them to be set directly onto the natural subsoil with no bedding layer evident. A well-constructed drain (Context No. 204) ran the length of this cobbled surface and its construction adds an aesthetically pleasing effect to the cobbled surface (Context No. 202). The drain was 0.28m at the top and gently slopes to a width of 0.06m at its base. The base of the drain is lined with white quartzite pebbles with the sides consisting of rounded beach pebbles set in a herringbone pattern.

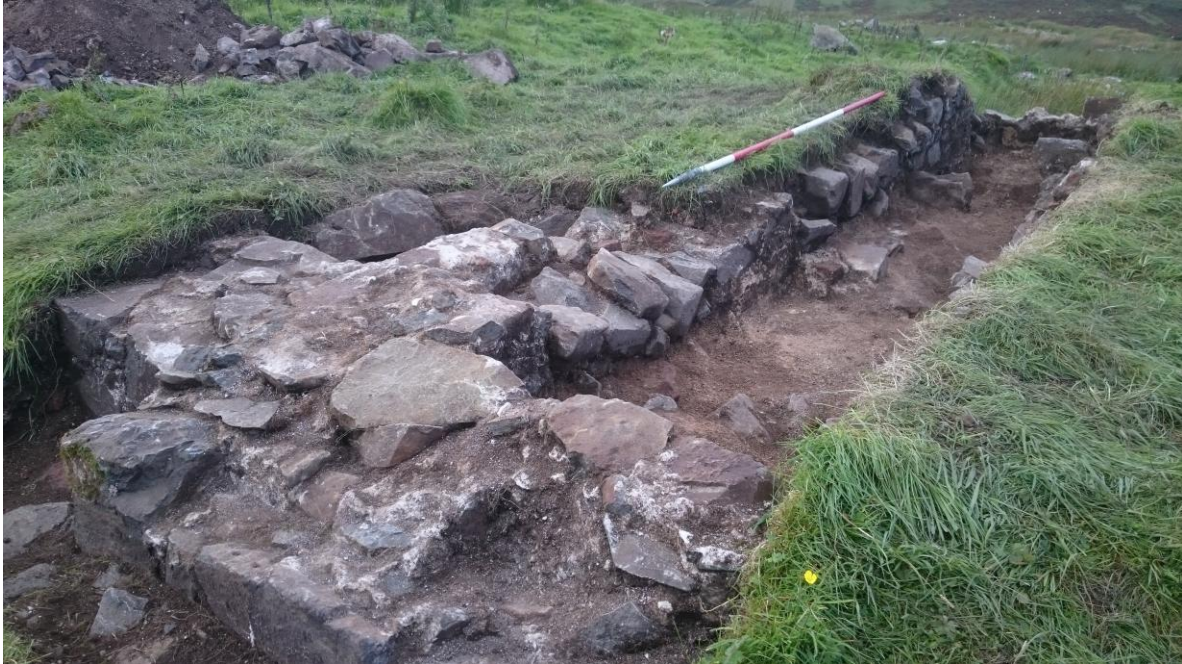
*Figure 27: View of Trench Three during its excavation, showing the thick deposit of mortar (Context No. 303), looking west.*

Stratigraphically beneath the episodes of blocking was a relatively thick layer of a mortar rich deposit (Context No. 303). This deposit (Context No. 303) was a light yellowish white in colour and compact in nature. The thickness of this layer varied with the maximum being 0.24m. Frequent inclusions of brick fragments, slate and large chunks of render were noted throughout this deposit, which was confined to the interior of the room investigated (6.2m north-west/south-east x 1.15m south-west/north-east). Removal of the mortar deposit (Context No. 303) revealed aspects of the structure of the houses including walls (Context Nos. 305, 306, 307 and 314), as well as a fireplace and hearth (Context Nos. 304 and 309 respectively) and a floor surface (Context No. 308).

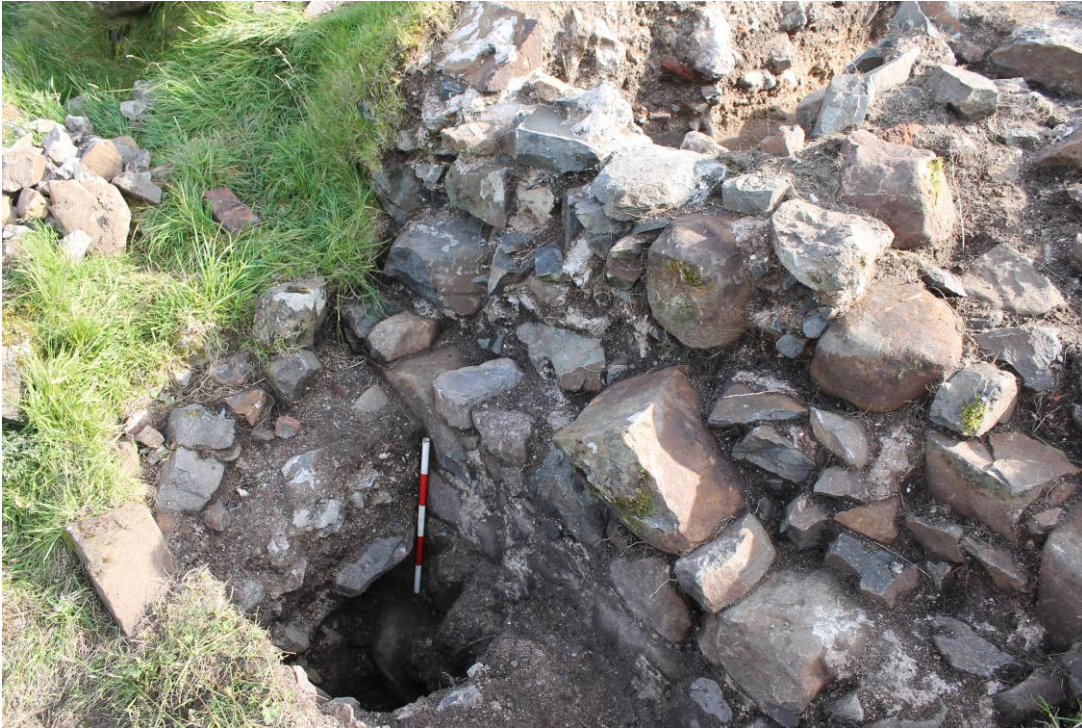
*Figure 28: Exploratory sondage into topsoil (Context No. 310) that has banked against the external face of wall (Context No. 307), looking east. NB: Scale = 0.5m.*

The topsoil in the north-western end (Context No. 310) consisted of a mid-brown grey clay silt and was investigated by a narrow sondage against the outer face of the wall (Context No. 307). This deposit was excavated to a depth of 0.72m when the foundation course of the wall (Context No. 307) was encountered. The topsoil (Context No. 310) was of a gravelly consistence and contained occasional medium sized angular stones, brick and charcoal fragments. Frequent mortar flecking was noted through this deposit which was relatively uniform throughout, and yielded fragments of a glass bottle as well as the occasional struck flint. No floor surface was

encountered during the excavation of this sondage, although it is conceivable that this has been robbed out and re-used, as was encountered during the excavation of Trench Two.

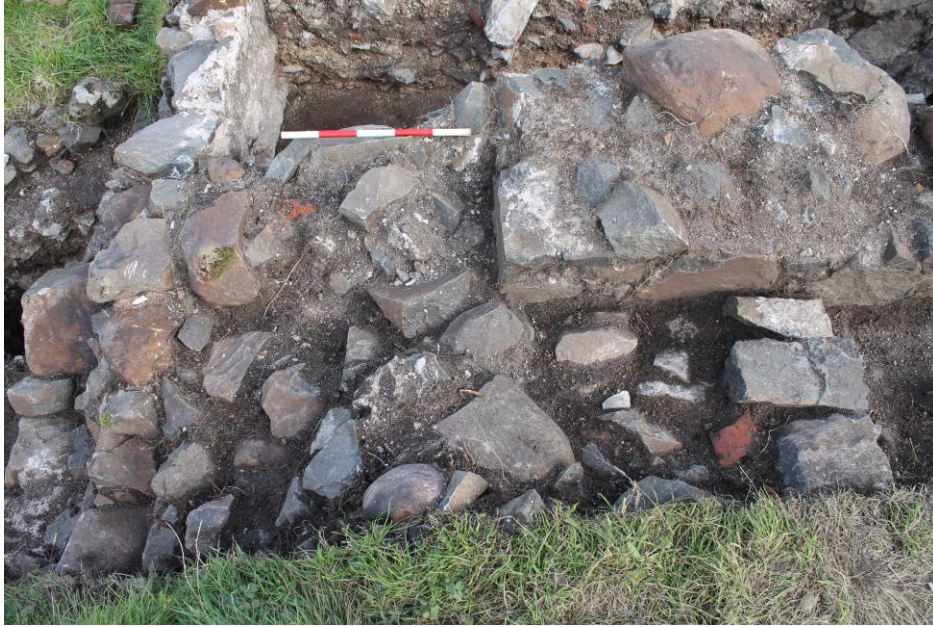
*Figure 29: Rubble fill deposit (Context No. 312) that blocked access to the south-western most wing of the structure, looking north-east. NB: scale = 0.5m.*

Removal of the demolition deposit revealed an episode of re-use within the structure. This took the form of rubble blocking up an alcove (Context No. 311) made in the internal division wall of the room (Context No. 305) and a blockage of a doorway leading into the south-western wing of the house (Context No. 312). In both cases these deposits (Context Nos. 311 and 312) consisted of large angular blocks of basalt that averaged 0.3m in length.

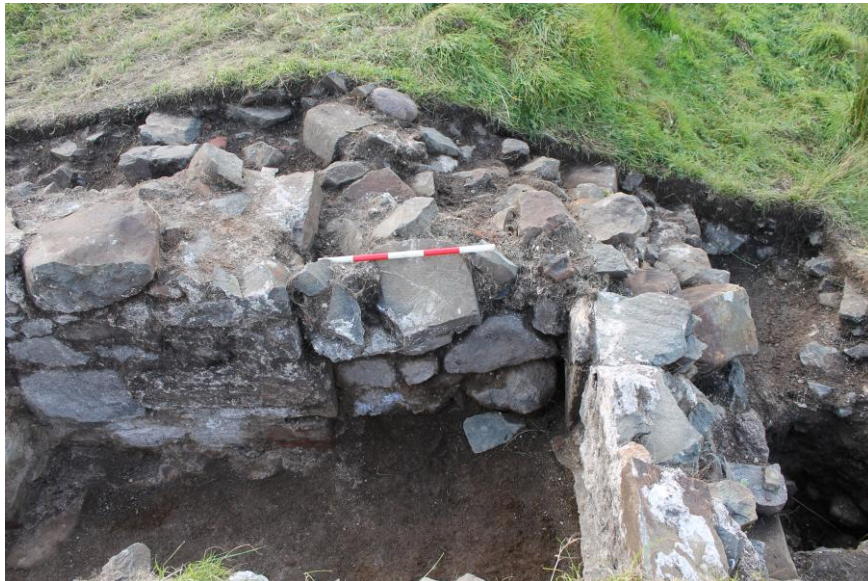
*Figure 30: View of rubble fill deposit (Context No. 312) blocking the doorway, looking south-west. Also visible is the floor surface (Context No. 308) with the ephemeral impression of floor boards. NB: Scale = 0.5m.*

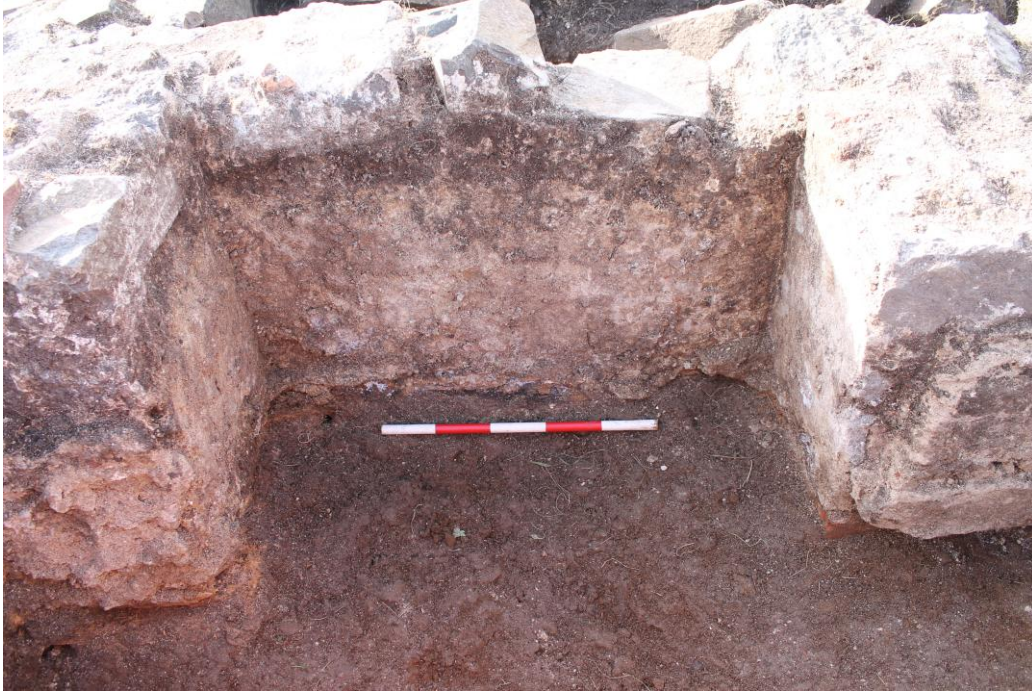
*Figure 32: Alcove in wall (Context No. 305) following removal of blockage (Context No.311), looking south-west. NB: Scale = 0.5m*

The north-west/south-east aligned internal division wall (Context No. 305) revealed interesting aspects on the layout of this room of the house. The wall was 5.4m long and averaged 0.63m thick. It survives to a maximum height of 0.9m from the floor surface (Context No. 308) and is comprised of roughly dressed basalt blocks. The wall appears to have been constructed on a foundation of brick, as these were visible along the basal course at floor level. An alcove (Plate 9) had been constructed into this wall (and later blocked by Context No. 311) which measures 1.1m in width by 0.5m in depth. It is unclear what this alcove might have accommodated although it is possible that a desk or bookcase would have been positioned here when the house was in use. Roughly halfway along this wall (Context No. 305) at a distance of approximately 2m from the front (Context No. 306) and rear (Context No. 307) walls of the room was an intact fireplace and hearth (Context No. 304 and 309 respectively) (Plate 10).

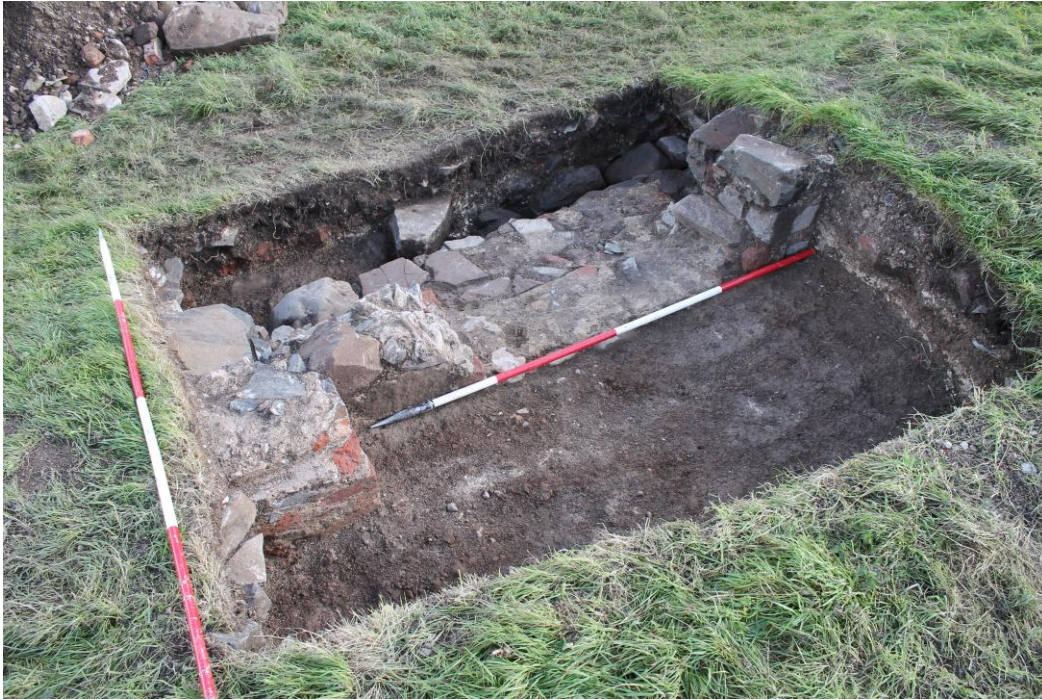
*Figure 34: Post-excavation view of Trench Four looking south-east. This shot shows the doorway and threshold, as well as the remnants of the wooden floor (a similar deposit to that encountered in Trench Three – Context No. 308).*

The two stretches of wall physically overlay the threshold (Context No. 406) into the structure. This feature consisted of a collection of brick, rounded and angular stone and broken sand stone slabs, firmly mortared together to create a relatively flat surface. It is likely that a sandstone slab would have sat directly upon this surface and that this has been removed and re-used elsewhere (a shattered length of sandstone slab was visible mortared into the base of Context No. 404). The threshold (Context No. 406) had a maximum length of 1.5m (north-east/south-west) and width of 0.96m (north-west/south-east).

The floor surface encountered in the north-western portion of the trench (Context No. 407) consisted of a mid-reddish brown gravelly clay (similar to the floor deposit encountered in Trench Three – Context No. 308). As with Trench Three, discreet south-west/north-east depressions were noted indicating the presence of floor boards.

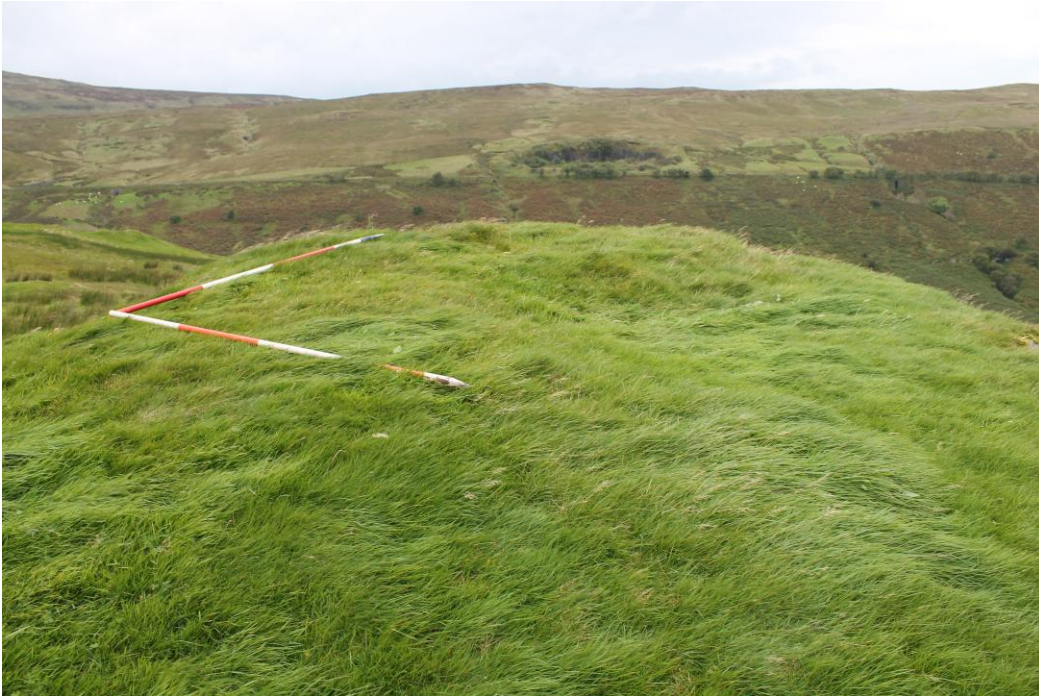
*Figure 36: The hollow at the summit of the conical mound looking north-west.*

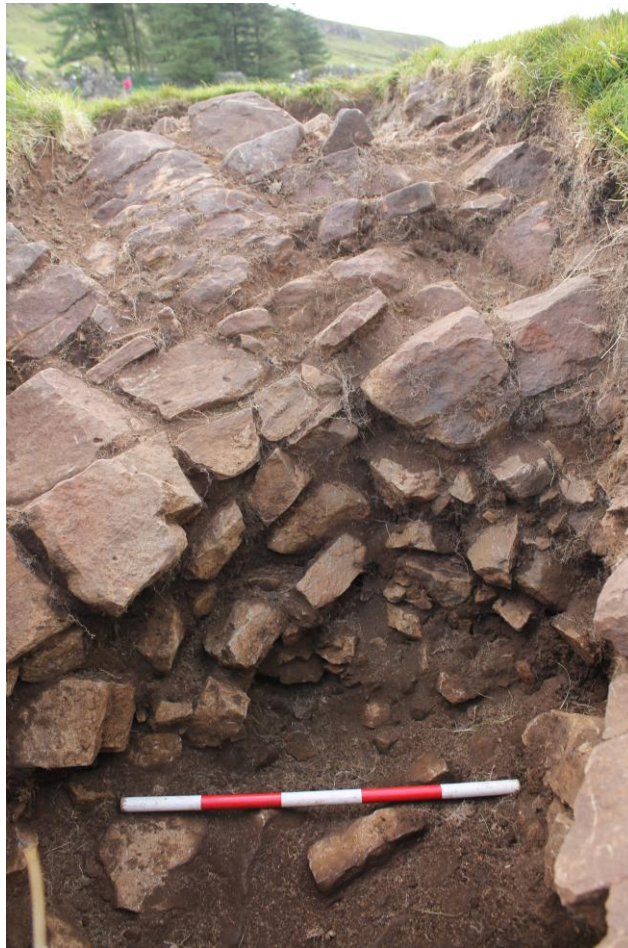
*Figure 39: Detail of the structure of the kiln (Context No. 505), looking south-west (scale = 0.5m).*

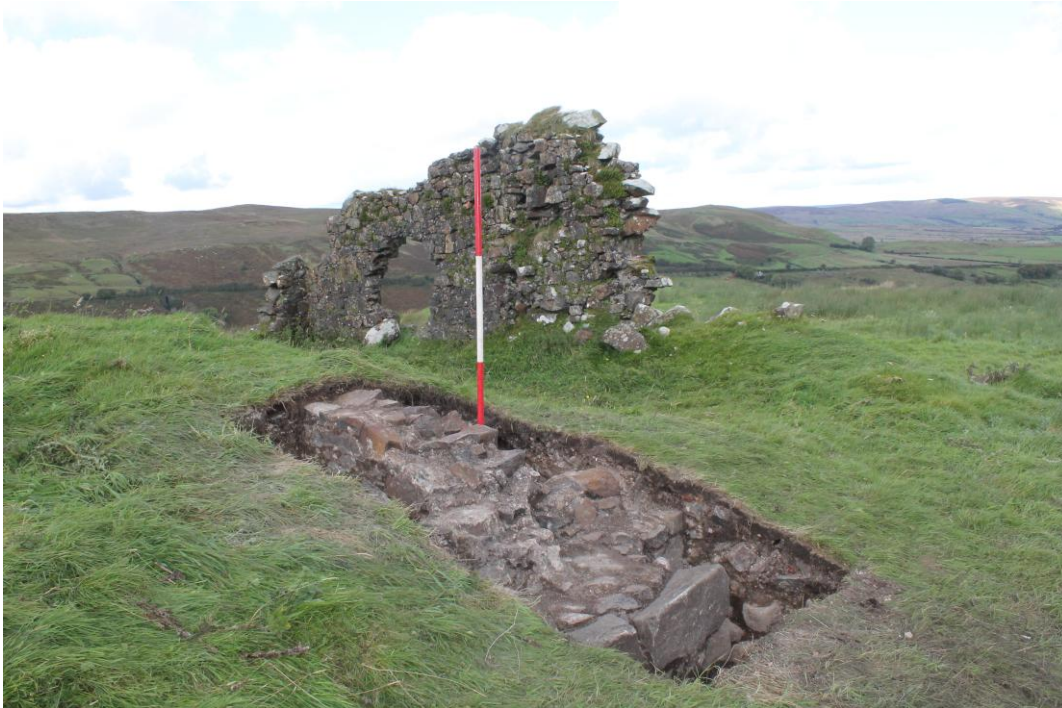
*Figure 40: Post-excavation view of Trench Six looking north. This picture illustrates the proximity of Trench Six to the upstanding north gable wall of the dwelling house.*

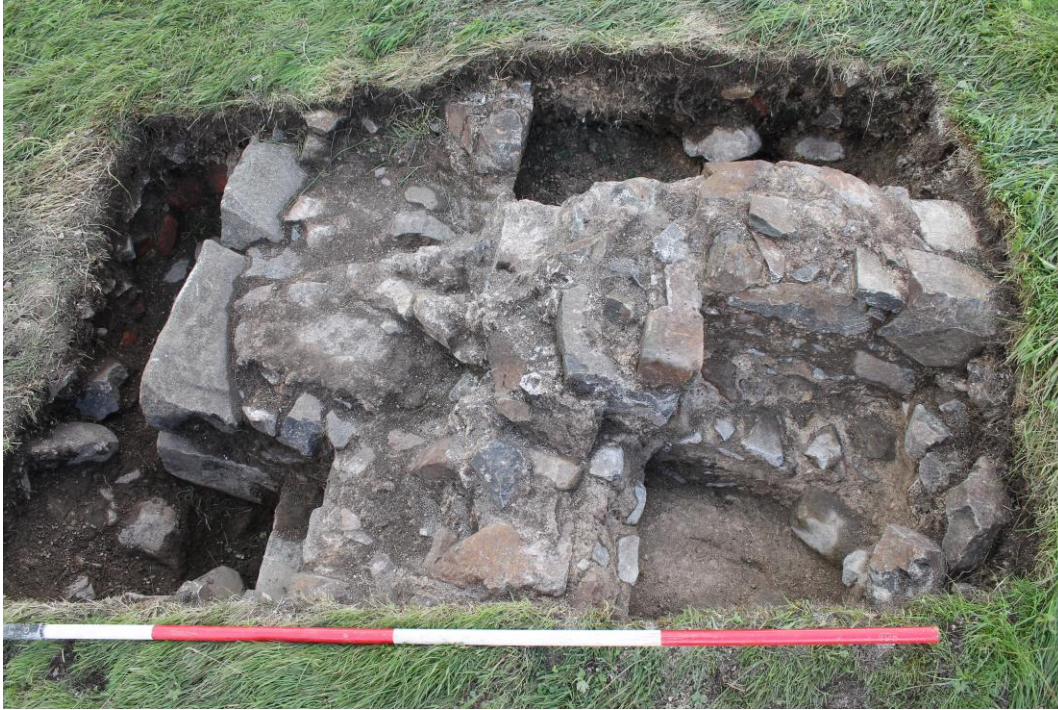
*Figure 41: Post-excavation view of Trench Six, looking south-west. This picture shows the lower courses of the front wall of the house (Context Nos. 604/605) as well as an internal dividing wall (Context No. 606).*

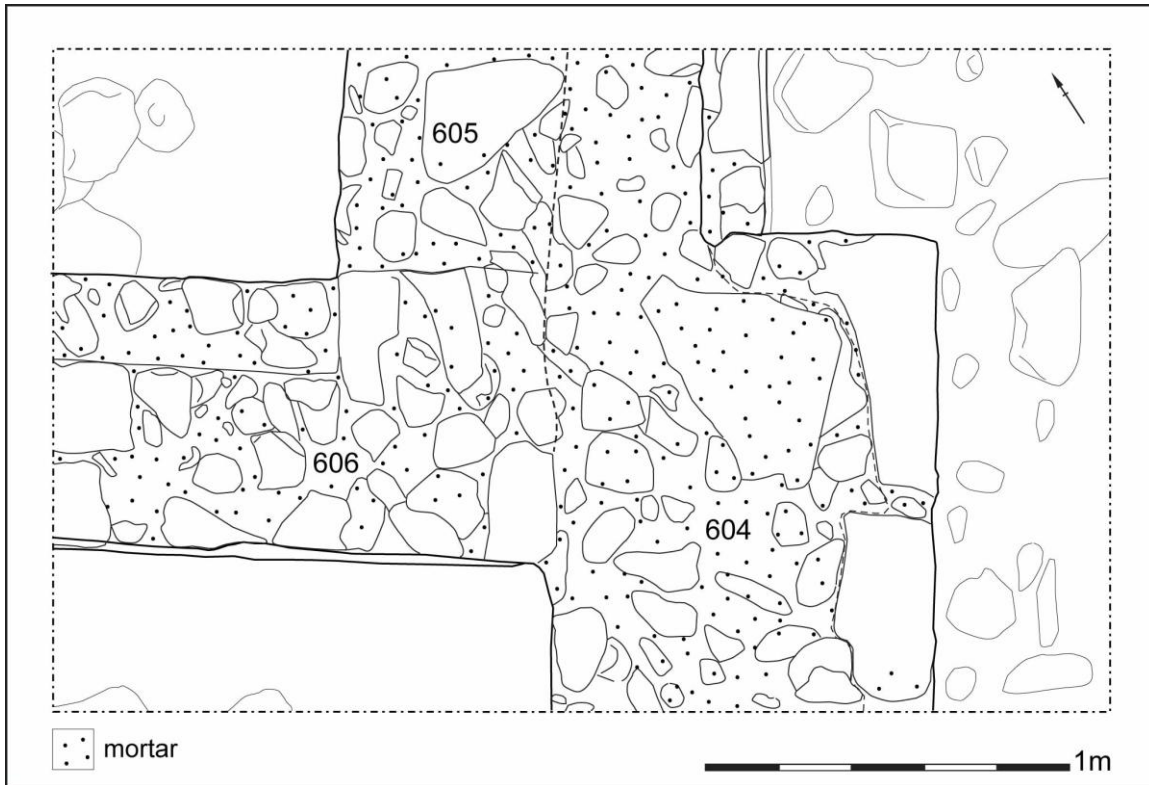
*Figure 42: Post-excavation plan of Trench Six.*

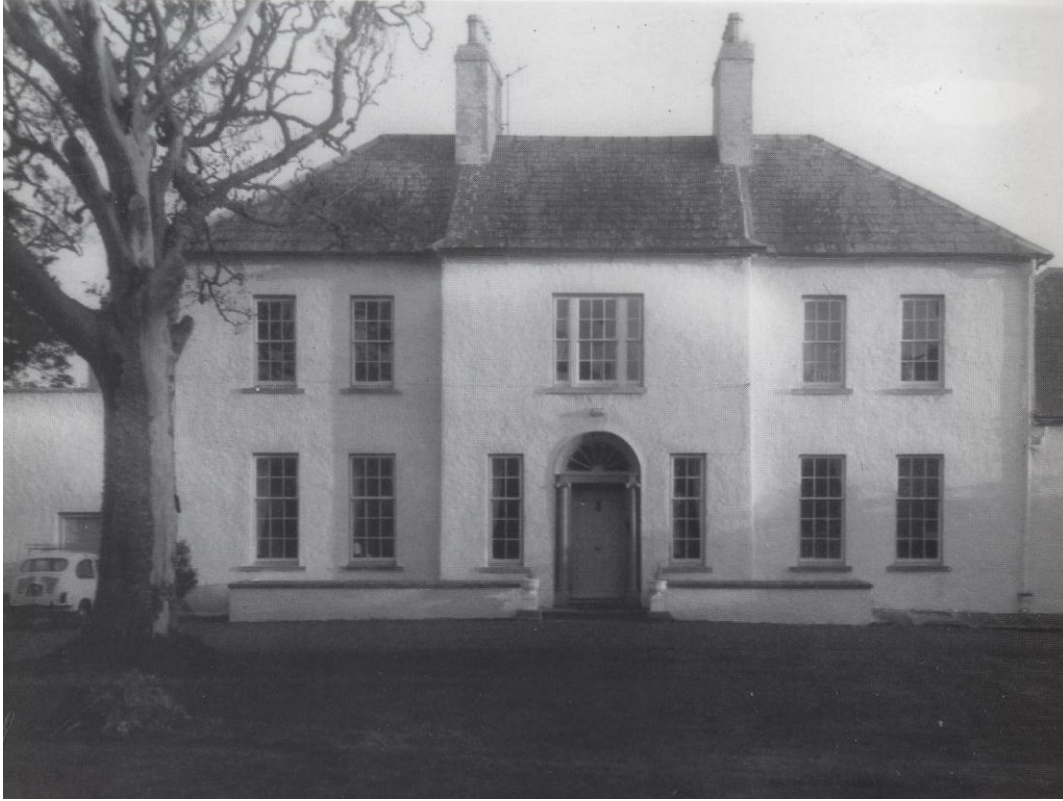
*Figure 43: Church Hill (or Churchill) House near Fenit in County Kerry. A mid-18<sup>th</sup> century building, the front façade is similar to how the house at Retreat would have appeared, with a central unit containing the doorway projecting forward from the main facade.*

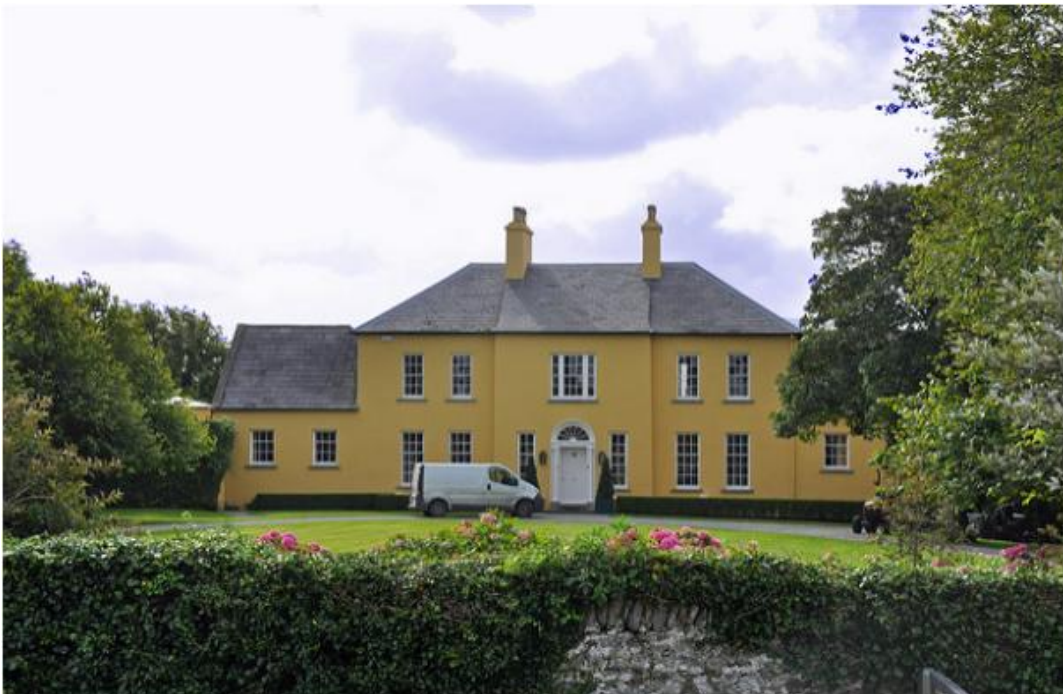
*Figure 44: Church Hill (or Churchill) House near Fenit, County Kerry*

The fireplace encountered in Trench Three would indicate that the dwelling house at Retreat had internal chimneys and there is no evidence for fireplaces having been located in the northern (certainly) or southern (probably) gables of the building. Consequently, we can hypothesise that – like Church Hill – it would have been under a hipped roof with the chimney stacks centrally positioned. This trench also revealed decorative detail as the internal walls revealed still had the remnants of plaster and/or render adhered to its surface. Preserved wood was encountered along the base of the internal wall surfaces and this could represent a skirting board. The recovery of several square-sectioned nails from the basal stony clay deposit (Context No. 308) indicates that the room had a wooden floor laid directly on this surface. Indeed, discreet lines noted in this surface when encountered in both Trench Three (Context No. 308) and Trench Four (Context No. 404) could represent where the floorboards had become pressed into this surface. A number of roofing slates (both complete and fragmentary) were recovered during the excavation. These have undergone a visual examination by geologist Dr. Ian Meighan (formerly of QUB). The absence of mica crystals within the slates preclude them from having originated in Scotland, while the light to mid grey colouring suggests that they did not originate in Wales either. As such, and without XRF analysis (see Section 5), the probable source for the roofing slates was in County Down. The presence of thumb-impressed brown glazed ridge tiles is interesting and provides a picture of how the apex of the roof of the house might have looked.

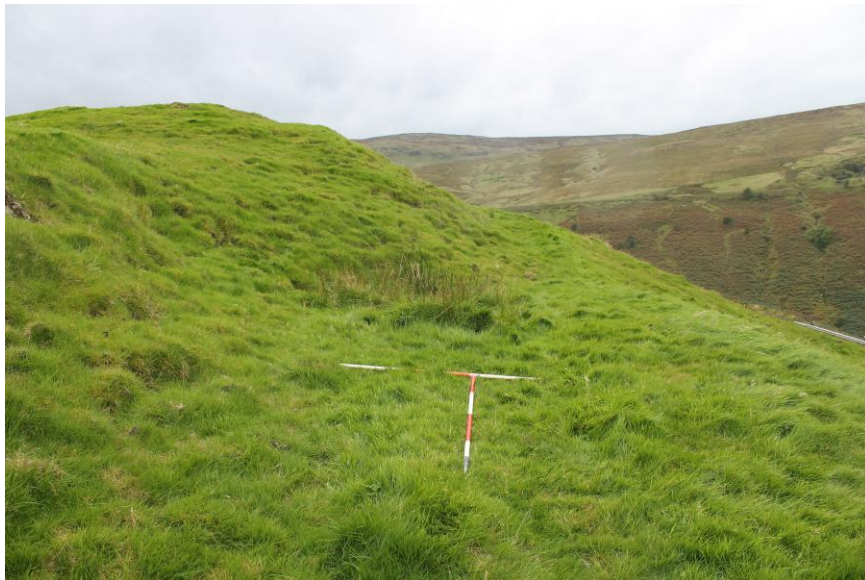
*Figure 47: The wide berm along the base of the conical mound that leads to the centre of the farm complex. At this point the berm is in excess of 5m wide but thins to approximately 1.5m closer to the base of the mound.*

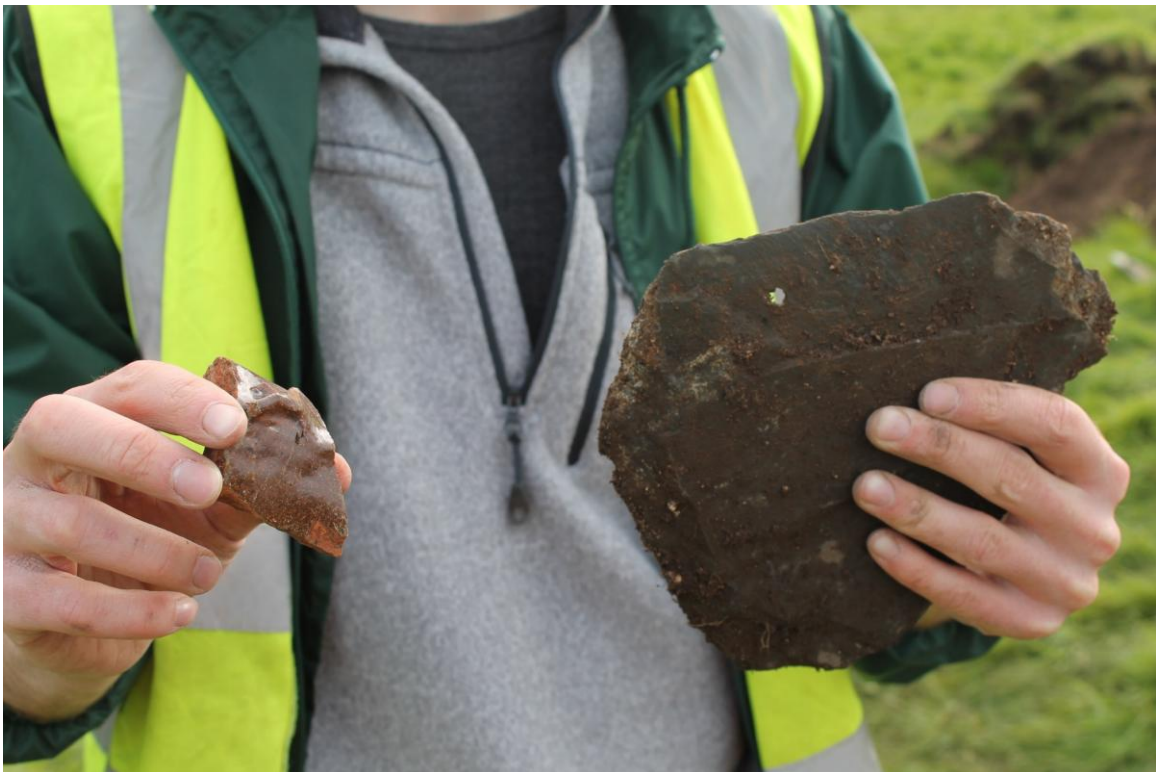
*Figure 48: Grazed ridge-tile and perforated roofing slate retrieved during the excavation from Trench 3*
