**Archaeological Evaluative Trenching at Ardboe Point,
Co. Tyrone, carried out on 5th December 2017**

AE/17/186

CAF Monitoring Report No. 302

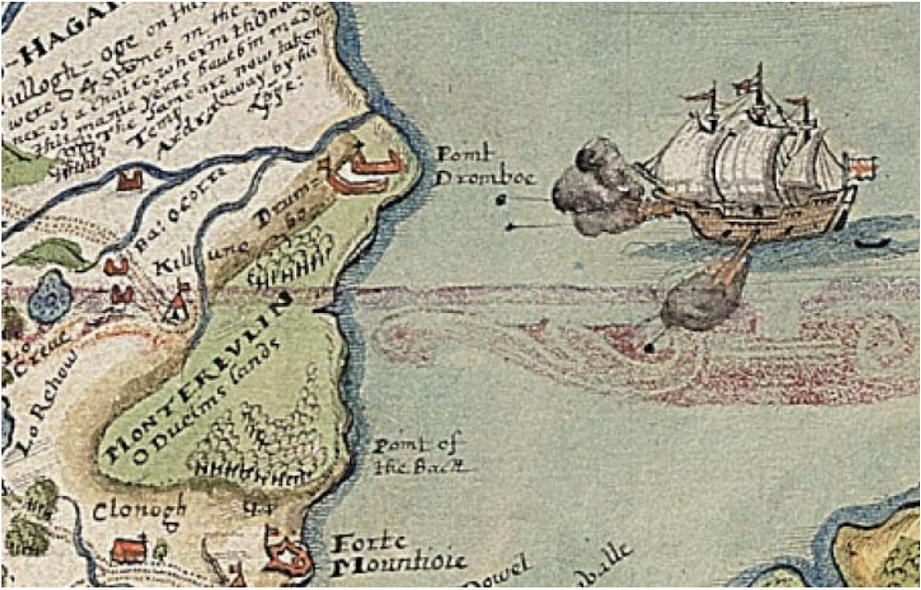
Figure 3 Extract from the Bartlett map of South Ulster (National Archives; Kew MPF 1/36)

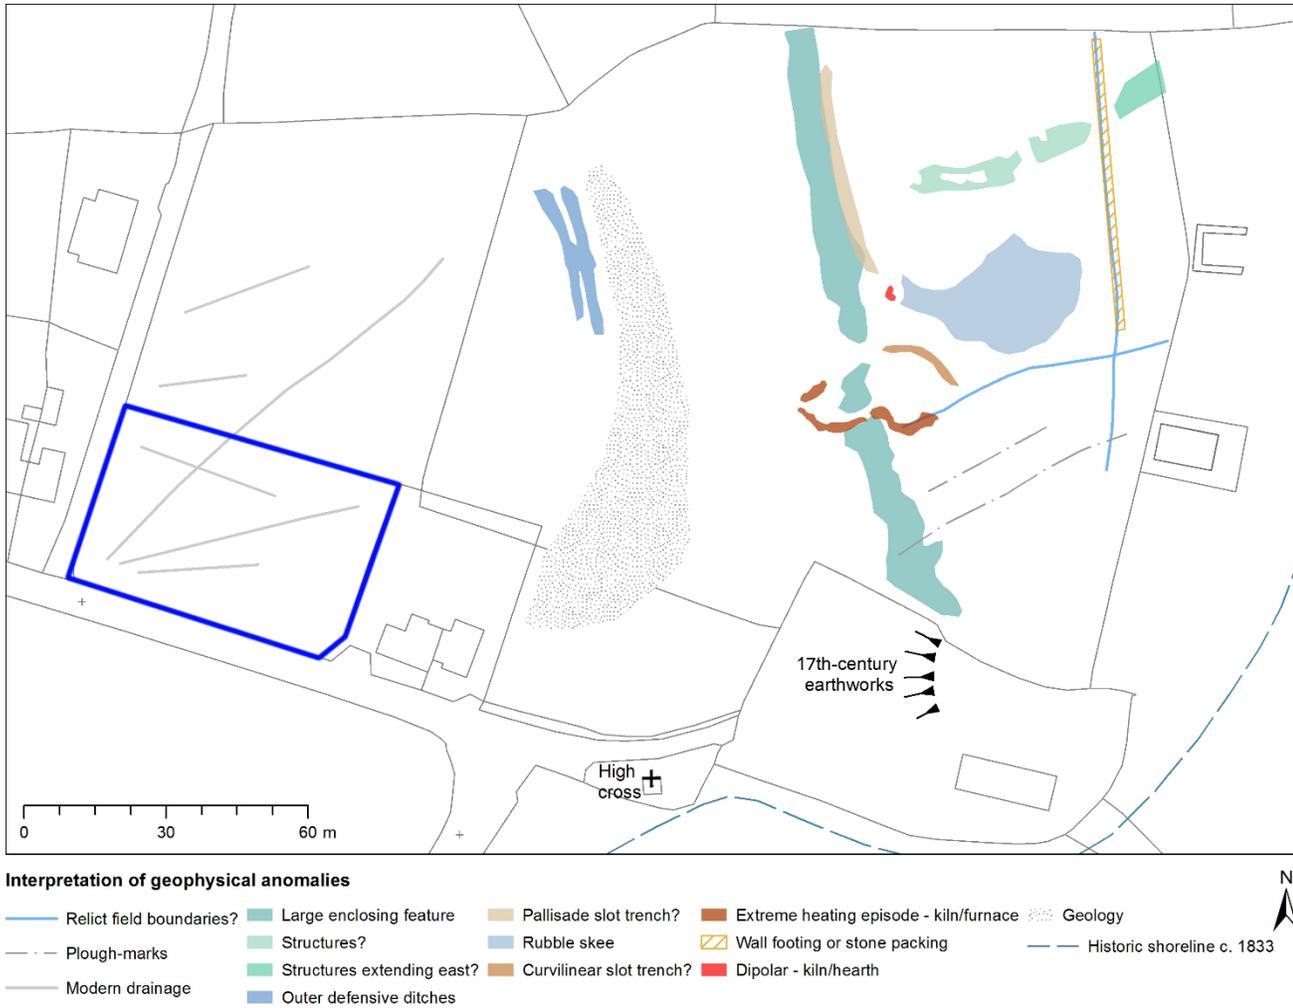
Figure 5 Interpretative plot of geophysical anomalies in the areas around Ardboe ecclesiastical complex, as recorded in the CAF geophysical surveys carried out in March and April 2017. The faint anomalies within the proposed development area (outlined in blue) were all interpreted as field drains.

The proposed development land is at the extreme southwest of the scheduled area, approximately 200m away from the standing ecclesiastical remains. A few faint features, recorded as geophysical anomalies, were picked up during a geophysical survey of the field carried out by the CAF in March and April 2017¹ (Figures 2, 4 and 5). These were

interpreted as probably indicating drainage channels. It was thought unlikely that the proposed development area had any archaeological features within it prior to the archaeological evaluative trenching taking place on 5th December 2017.

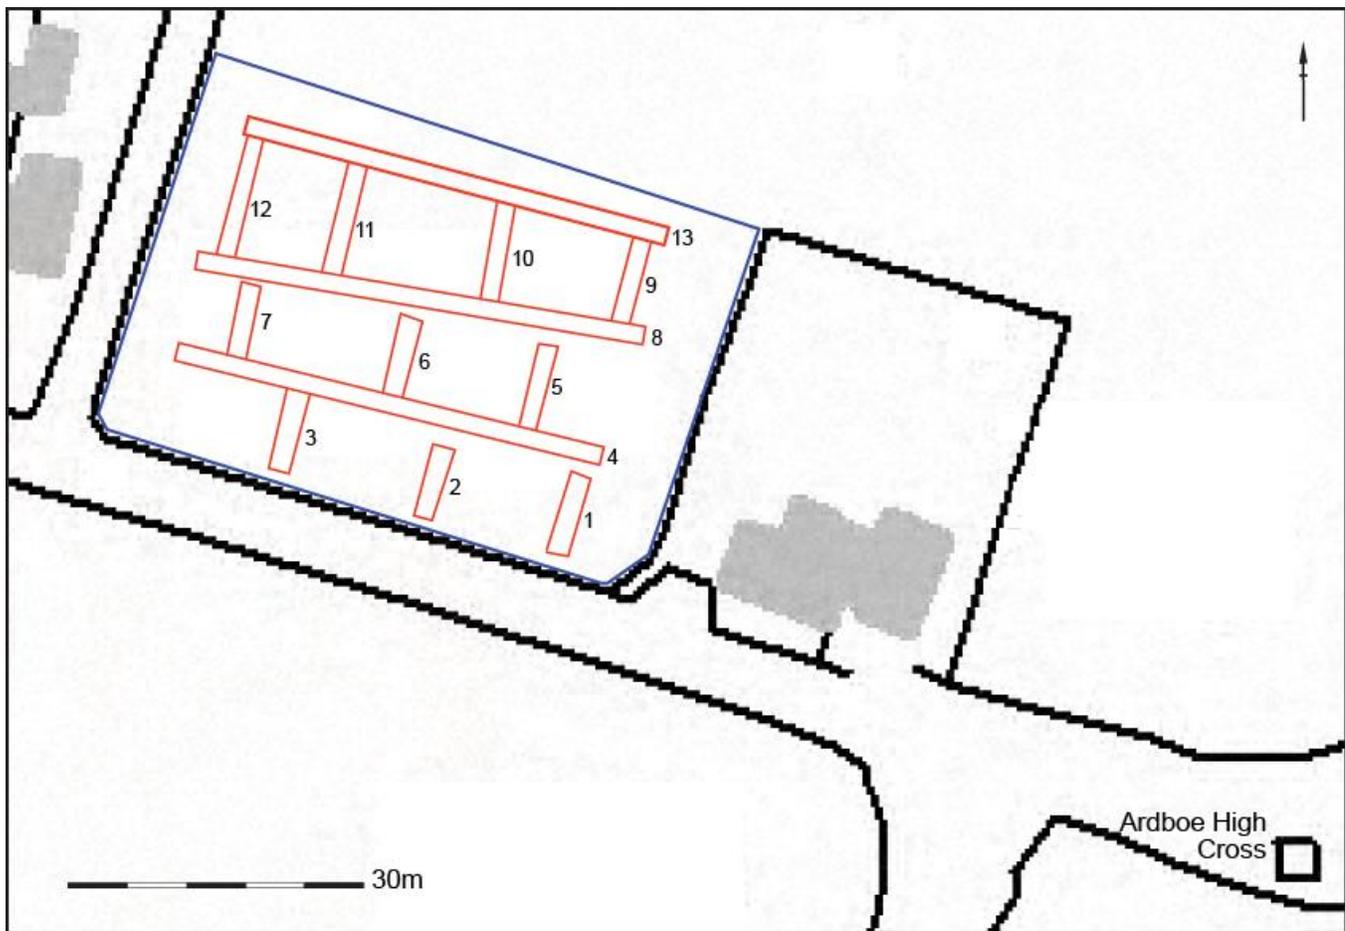
Figure 6 Location of the archaeological evaluative trenches within the area of the proposed development.

The archaeological evaluative trenching, under the direction of Ruairí Ó Baoill and Brian Sloan, CAF QUB, was carried out on 5th December 2017 and took the form of 13 mechanically excavated trenches across the proposed development area. These consisted of three long trenches, ranging 45-47m long, and running roughly east-west, and ten shorter trenches, ranging from 7.5-12.5m, running roughly north-south, at right angles to the longer trenches (Figure 6). All the trenches were 2m wide.

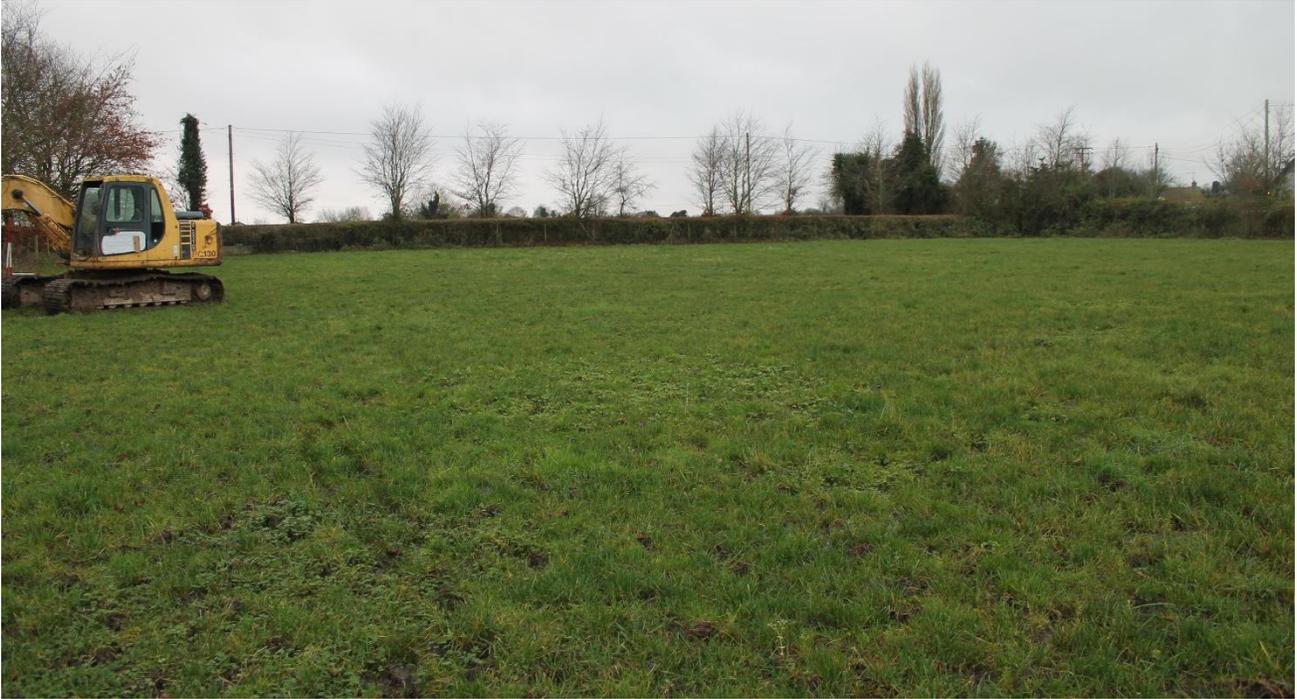
Plate 1. Ardboe, Co. Tyrone. General shot of the area to be archaeologically test-trenched on 5th December 2017, prior to work commencing. From the north-east.

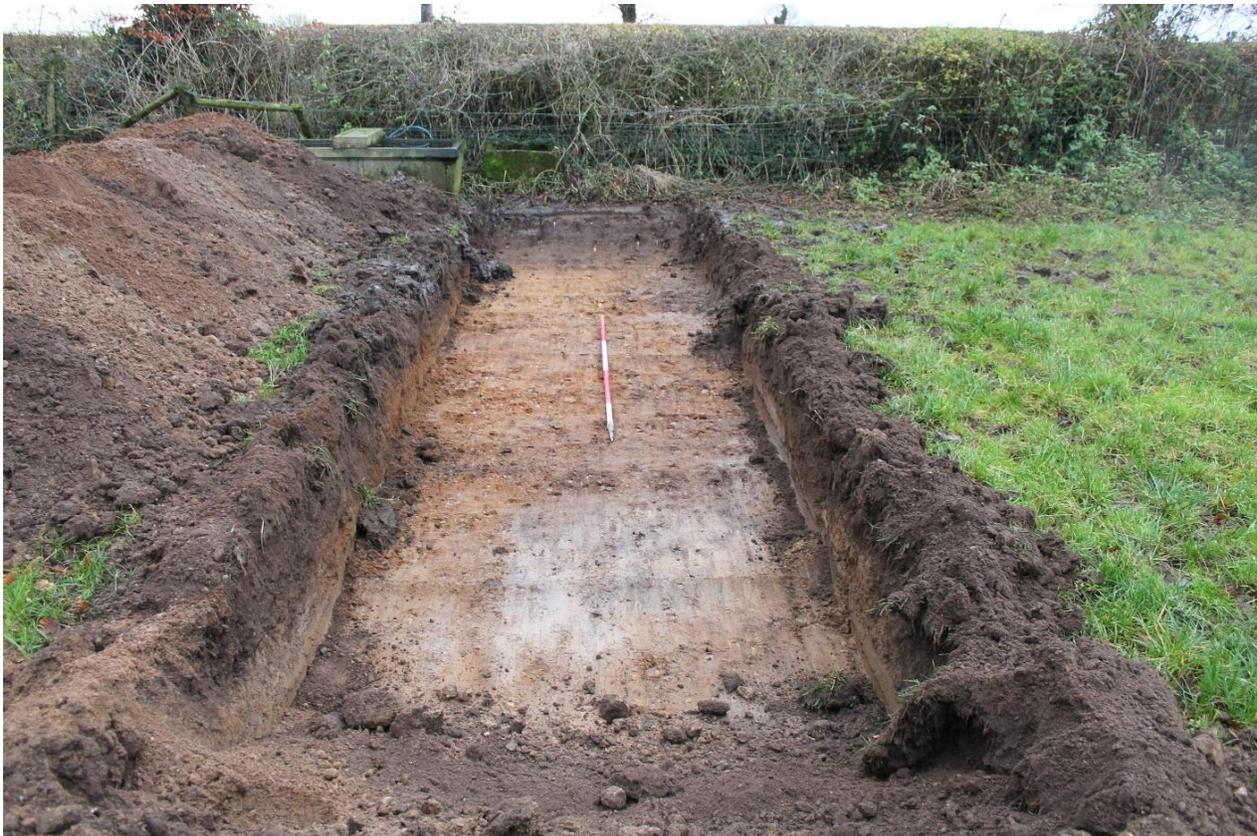
Plate 2. Ardboe, Co. Tyrone. Subsoil in Trench 1. From the north.

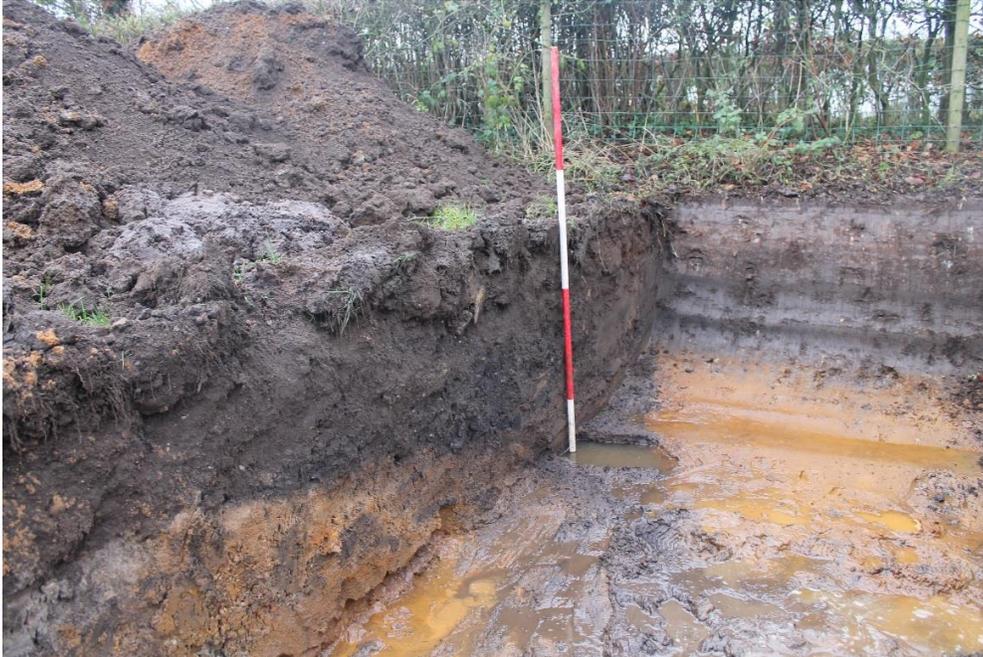
Plate 3. Ardboe, Co. Tyrone. Trench 2. Modern linear cut to subsoil level, possibly to dump rubbish from the adjacent farm and whose fill yielded 19th century pottery. From the north-west.

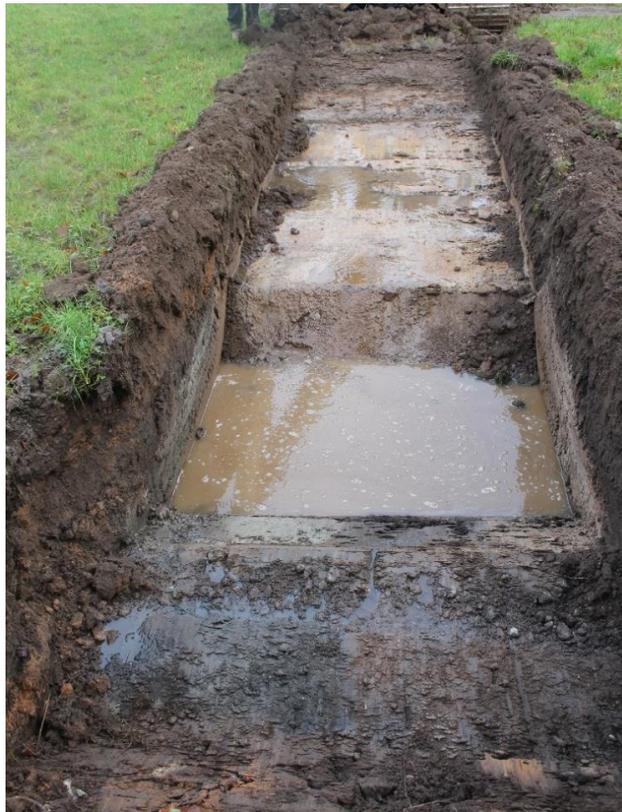
Plate 4. Ardboe, Co. Tyrone. Trench 3. Trench at subsoil level. Field drain running across the southern limit of the trench and flooding of trench. From the south.

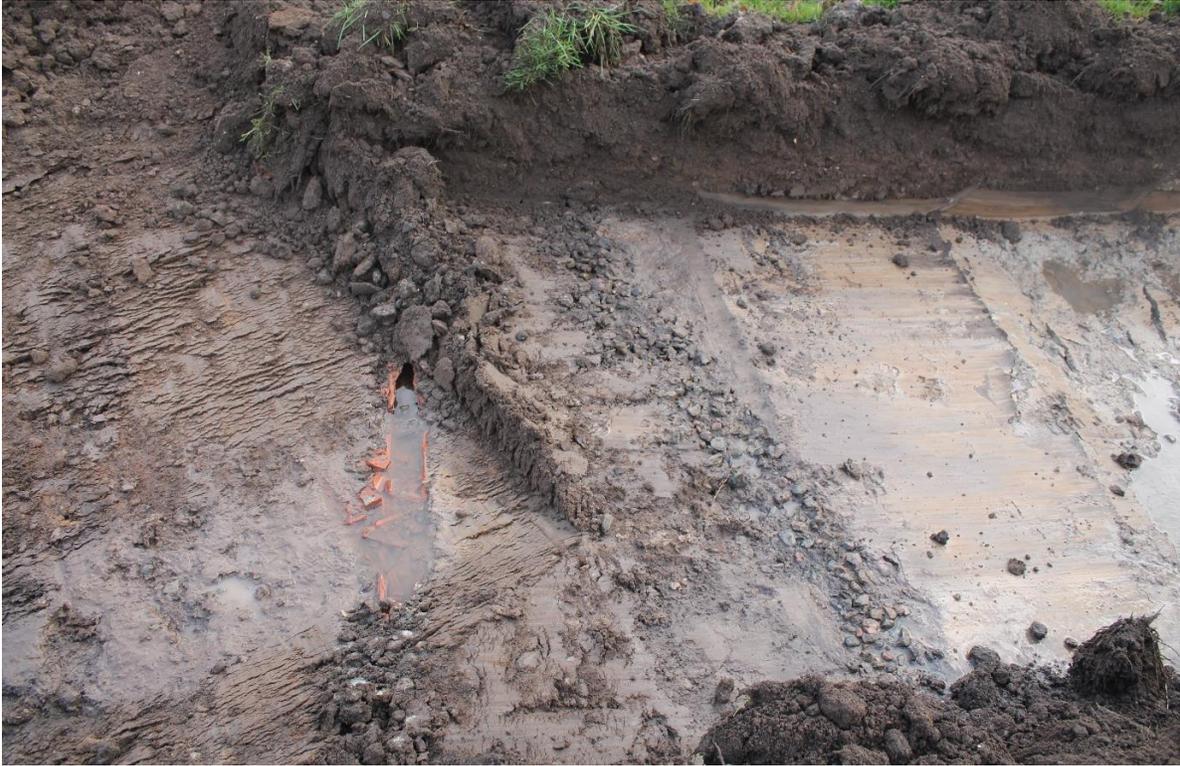
Plate 5. Ardboe, Co. Tyrone. Trench 3. Trench at subsoil level. Two fields drain running across the northern limit of the trench. From the north-west.

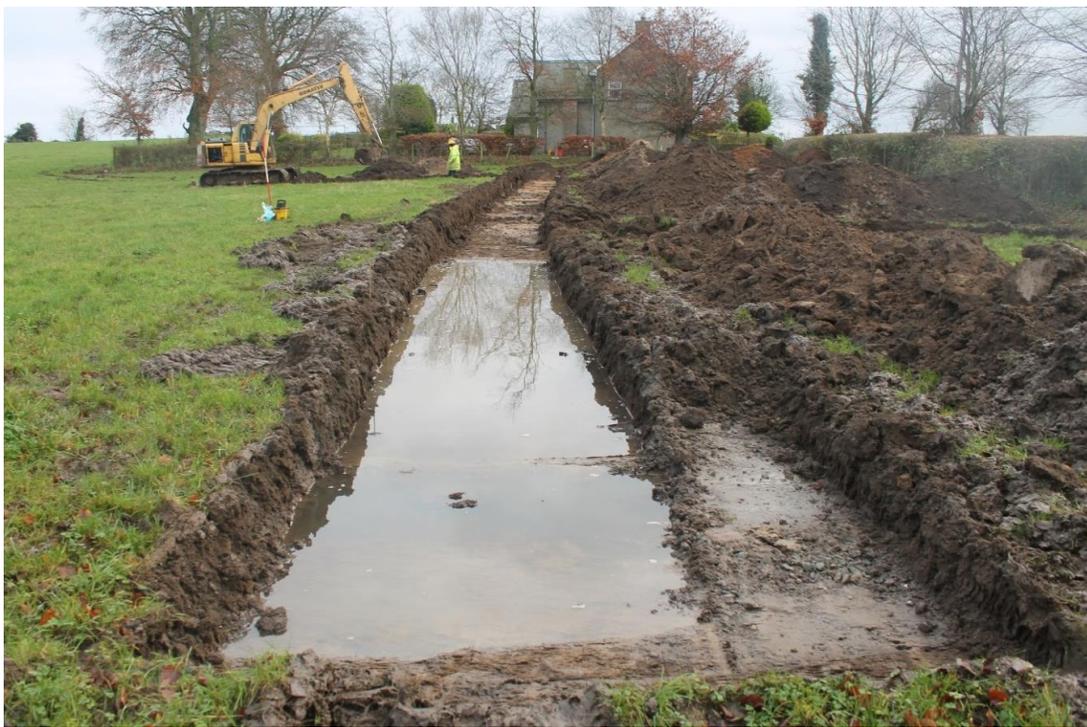
Plate 6. Ardboe, Co. Tyrone. Long Trench 4 at subsoil level. Flooding at the western end of trench, covering a field drain. From the west.

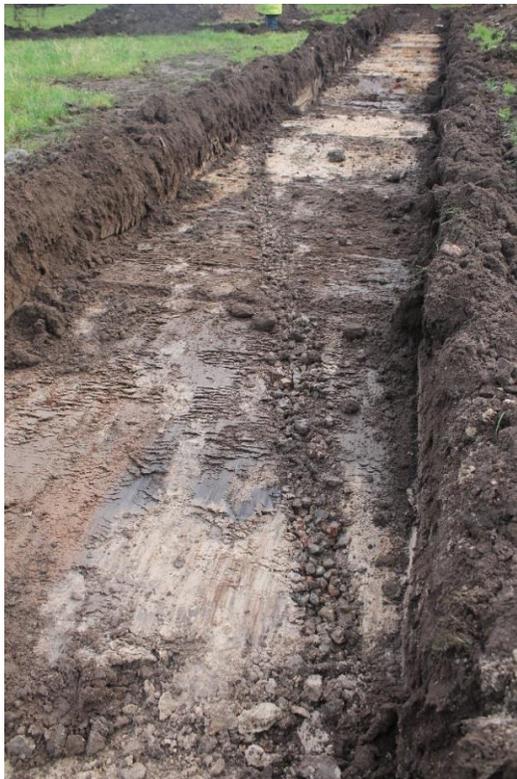
Plate 7. Ardboe, Co. Tyrone. Long Trench 4 at subsoil level. Field drain, containing fragments of red brick, running diagonally across the middle of the trench. From the west.

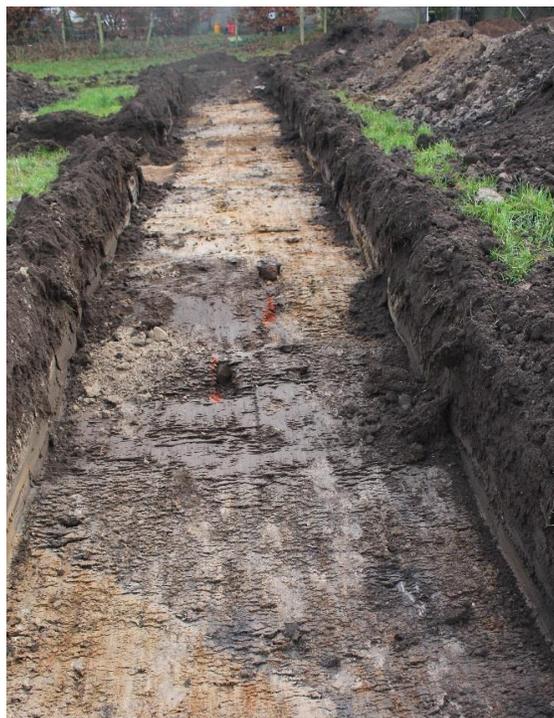
Plate 8. Ardboe, Co. Tyrone. Long Trench 4 at subsoil level. Modern rubbish pit, containing fragments of red brick, at eastern end of trench. From the west.

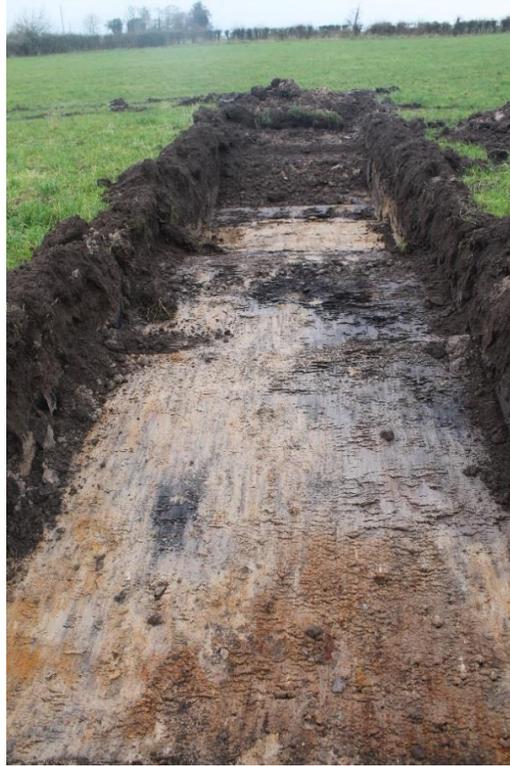
Plate 9. Ardboe, Co. Tyrone. Subsoil in Trench 5. From the south.

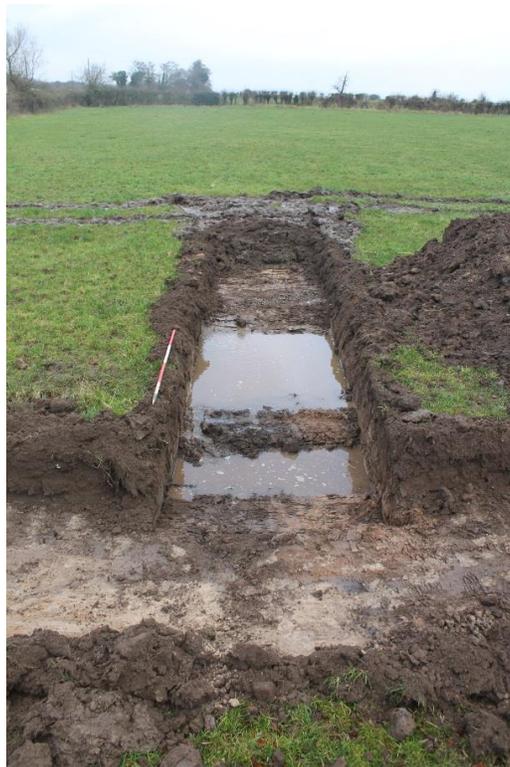
Plate 10. Ardboe, Co. Tyrone. Subsoil in Trench 6. Flooding covering a field drain running across the trench. Long Trench 4 in foreground. From the south.

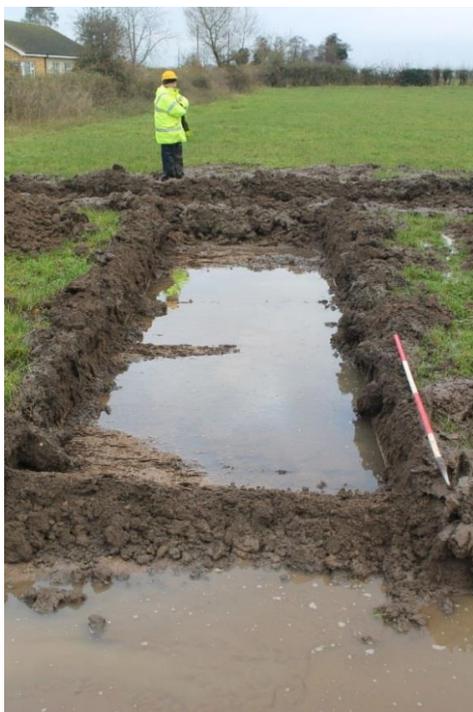
Plate 11. Ardboe, Co. Tyrone. Subsoil in Trench 7 immediately flooded after the soil cover was removed. From the south.

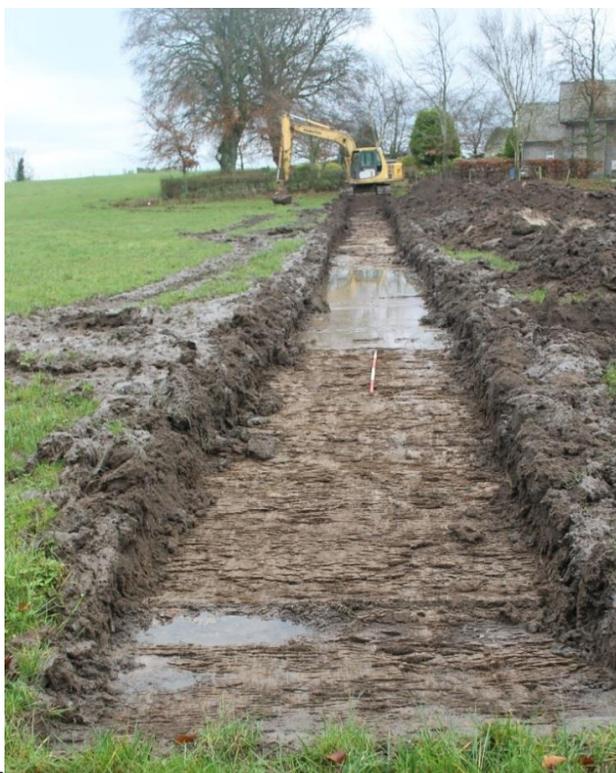
Plate 12. Ardboe, Co. Tyrone. Subsoil in Long Trench 8. Western end. Field drain running across the trench in foreground. Flooded area in the middle of the trench also covering a field drain. From the west.

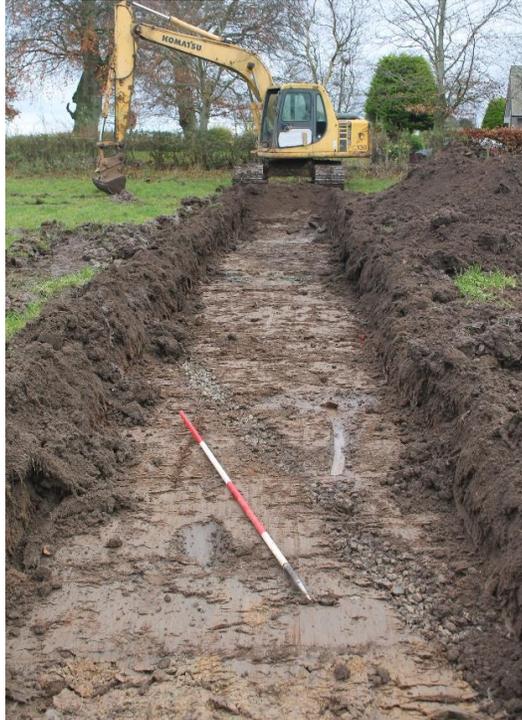
Plate 13. Ardboe, Co. Tyrone. Long Trench 8. Field drain running diagonally across the trench and cut into the subsoil. Looking towards the eastern end of trench. From the west.

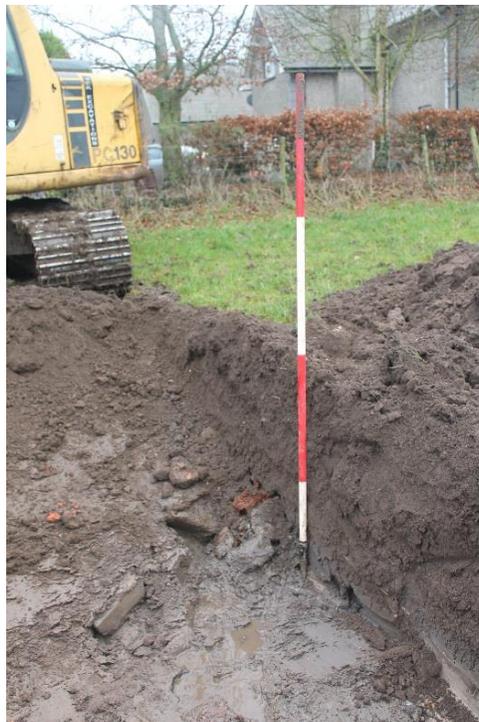
Plate 14. Ardboe, Co. Tyrone. Long Trench 8. Stone drain with red brick cut into the subsoil at the eastern end of trench. From the north-west.

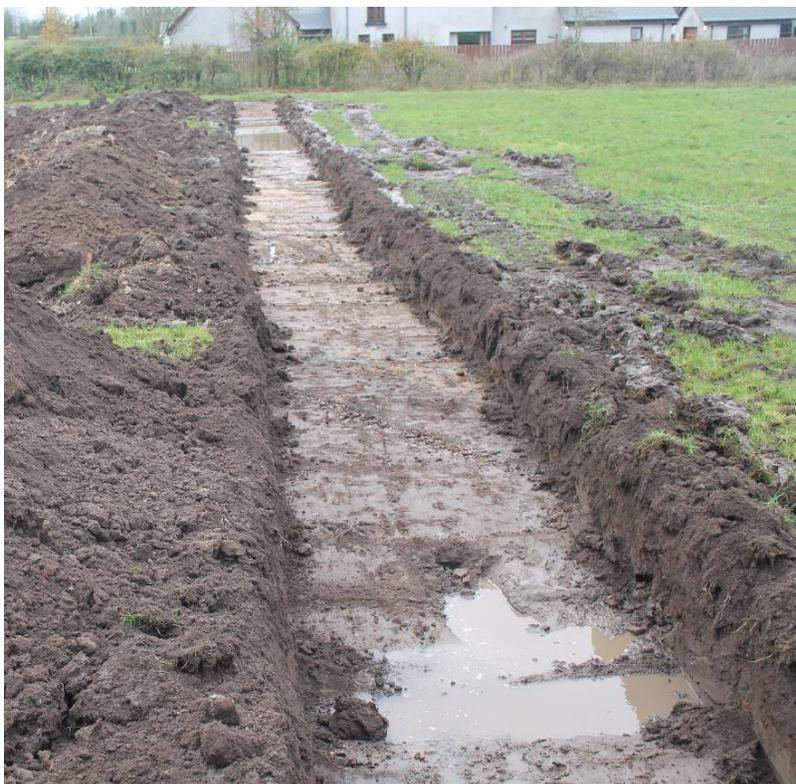
Plate 15. Ardboe, Co. Tyrone. Looking back along Long Trench 8. Stone drain with red brick cut into subsoil in foreground, two field drains running diagonally across the trench in the middle of the shot and water covering a field drain at the eastern end of the trench in the background. From the east.

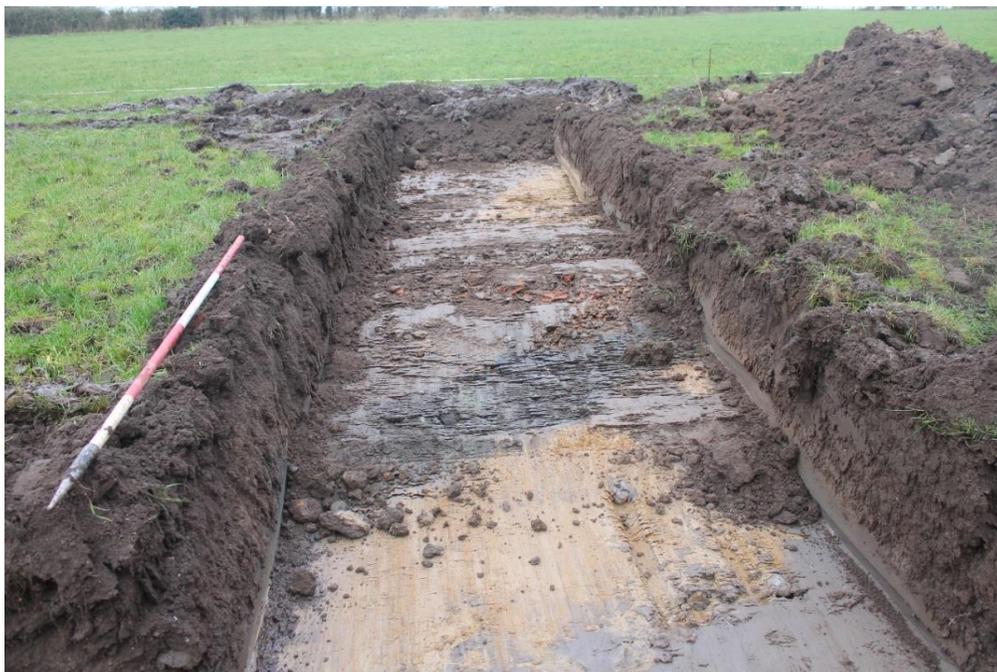
Plate 16. Ardboe, Co. Tyrone. Trench 9. Several field drains, including one incorporating ceramic tiles, cut into subsoil at the northern end of the trench. From the south.

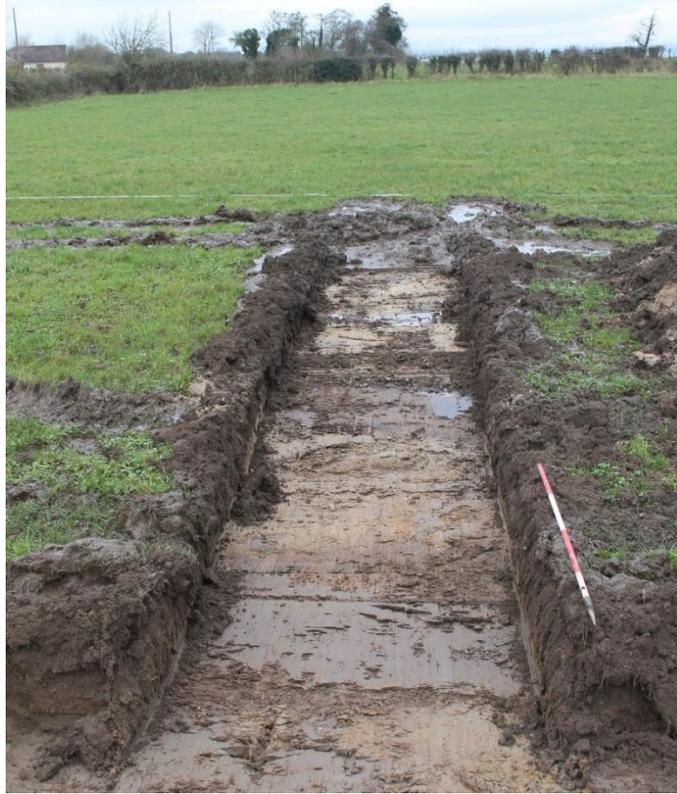
Plate 17. Ardboe, Co. Tyrone. Trench 10. Field drain running across the middle of the trench. From the south.

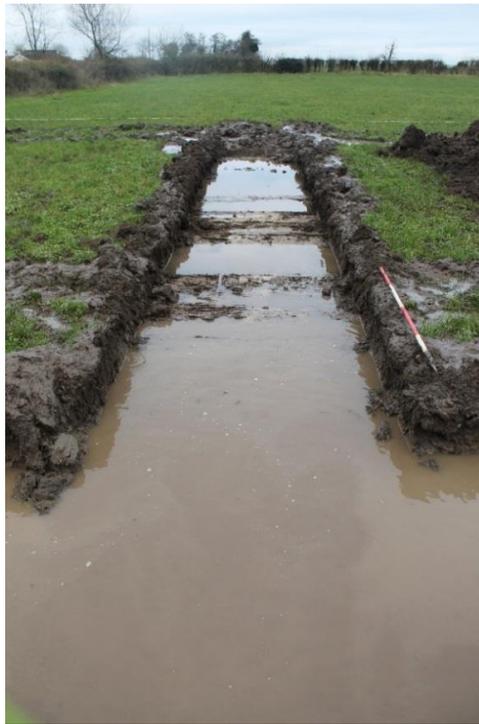
Plate 18. Ardboe, Co. Tyrone. Subsoil in Trench 11 with two field drains running across the trench, immediately flooded after soil cover removed. From the south.

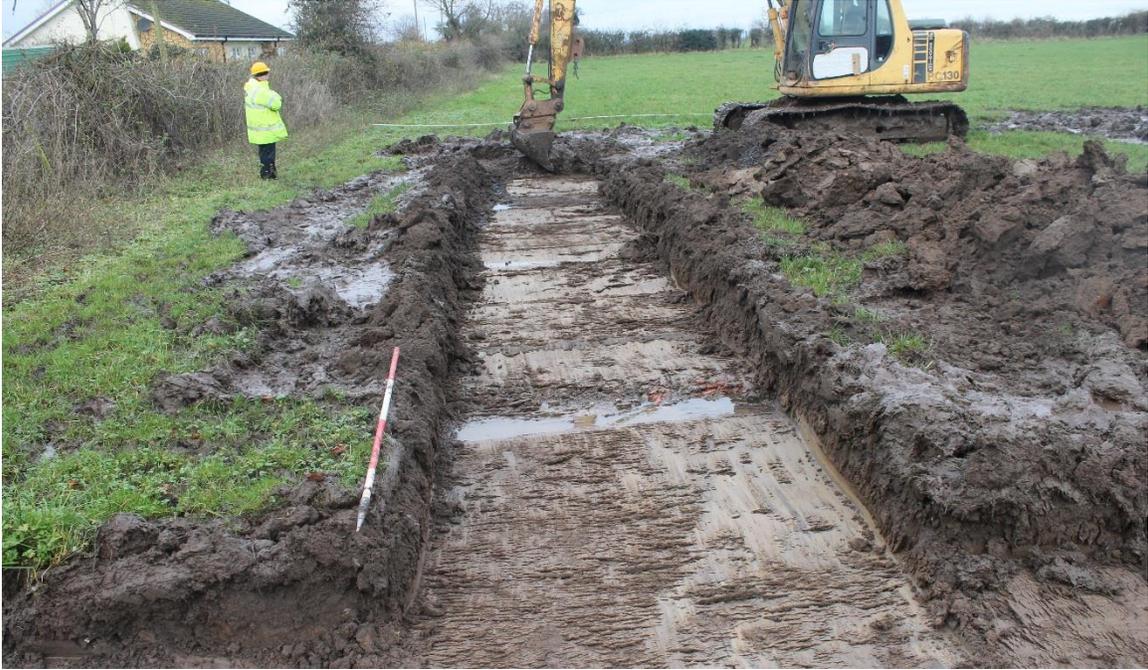
Plate 18. Ardboe, Co. Tyrone. Subsoil in Trench 12 with two field drains running across either end of the trench. From the south.

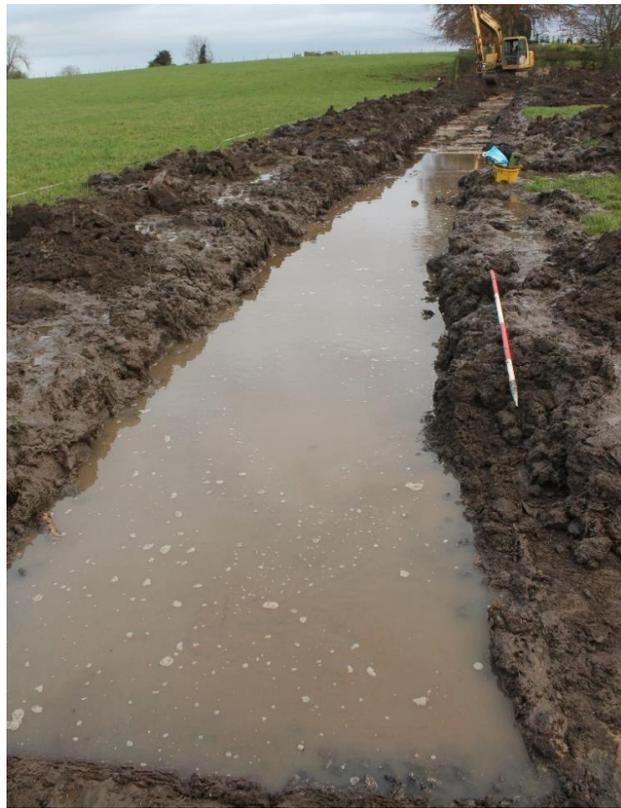
Plate 19. Ardboe, Co. Tyrone. Long Trench 13 at subsoil level. Flooding at western end of the trench, covering a field drain in foreground. Field drain running along the middle of the trench at the eastern end. From the west.

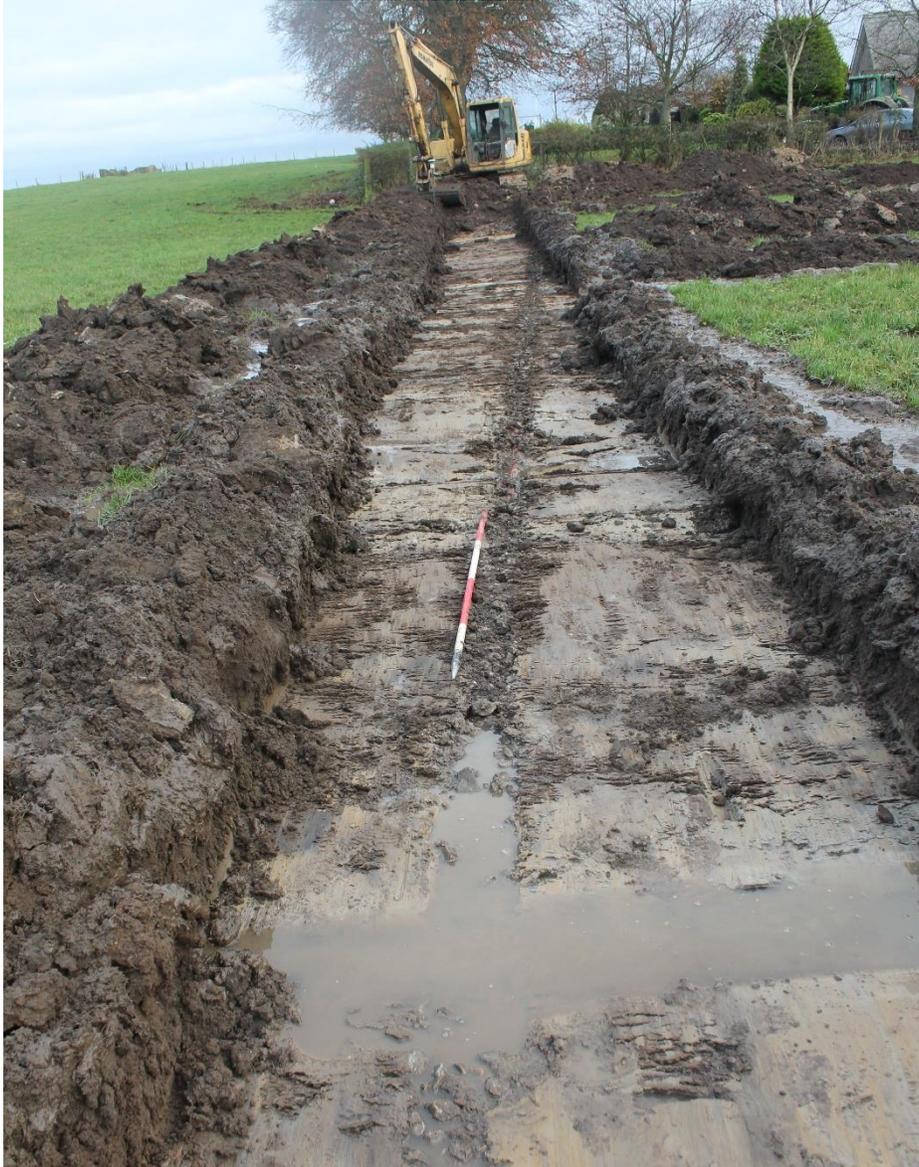
Plate 19. Ardboe, Co. Tyrone. Long Trench 13 at subsoil level. Eastern half of the trench with field drain running across the trench in foreground and another running along the middle of the trench in the background. From the west.
